# Langley Hall

Langley Park, Derwentside, County Durham

TOPOGRAPHIC SURVEY

Summer 2011

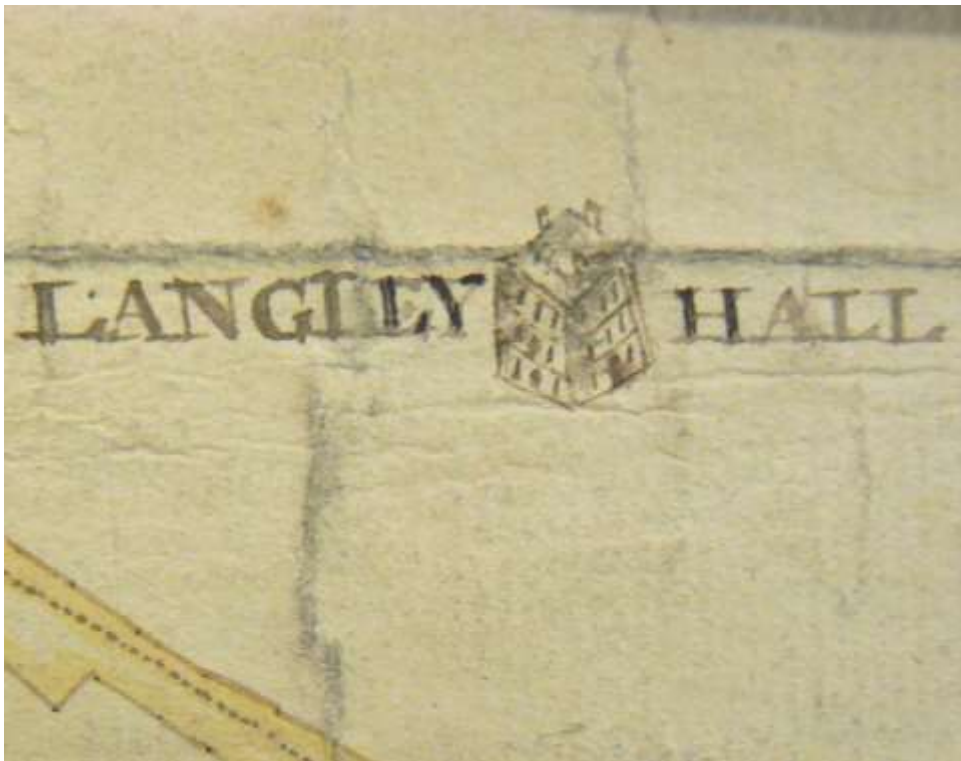
**Figure 1:** A representation of Langley Hall on a Church Commissioners plan of the Manor of Langley made prior to 1736 (Durham University Library Archives and Special Collections CCB/MP/51)

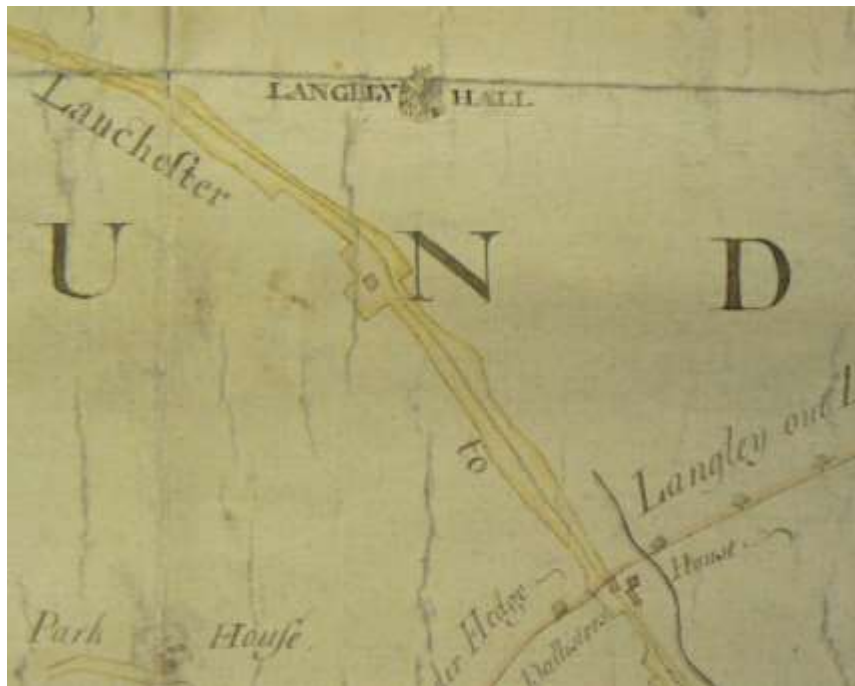
*Figure 7: Langley Hall shown on a Church Commissioners Plan dating to before 1736 (see figure 1 for enlargement and reference)*

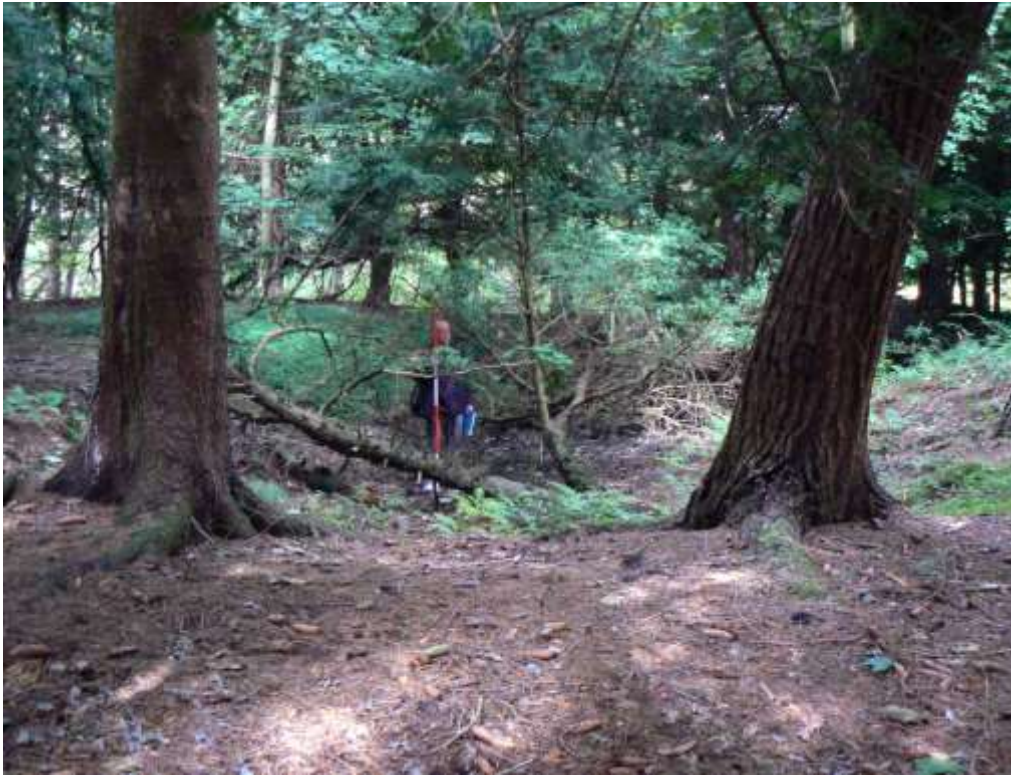
*Plate 1: The southern terminal of the moat ditch, looking north-west*

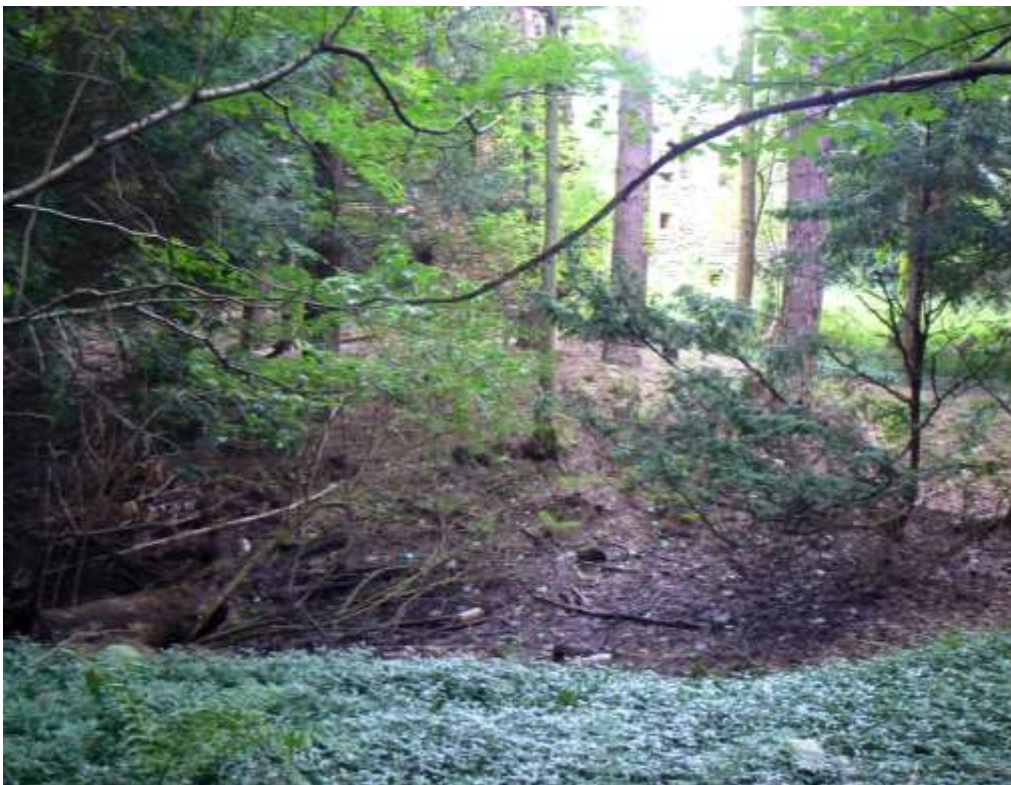
*Plate 2: Looking east across the south end of the moat ditch*

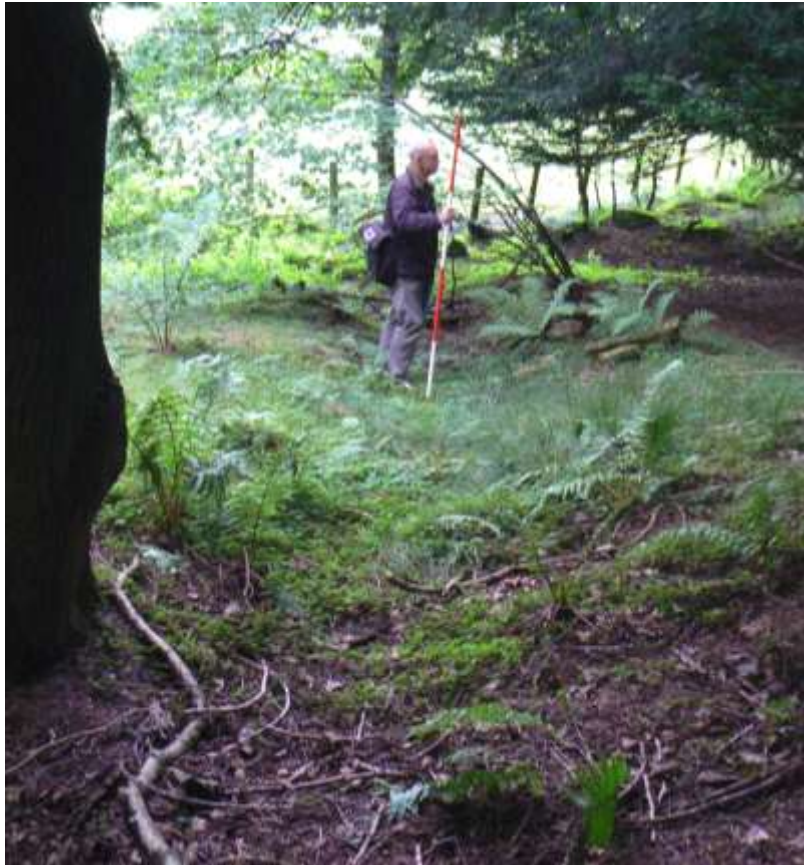
A broad, shallow ditch 0.5m deep and 3m wide, falling to the north towards a stone culvert. The ditch is shown on the first edition Ordnance Survey marking the eastern edge of Old Hall Wood.

***Plate 3: Looking north along the line of ditch [3]***

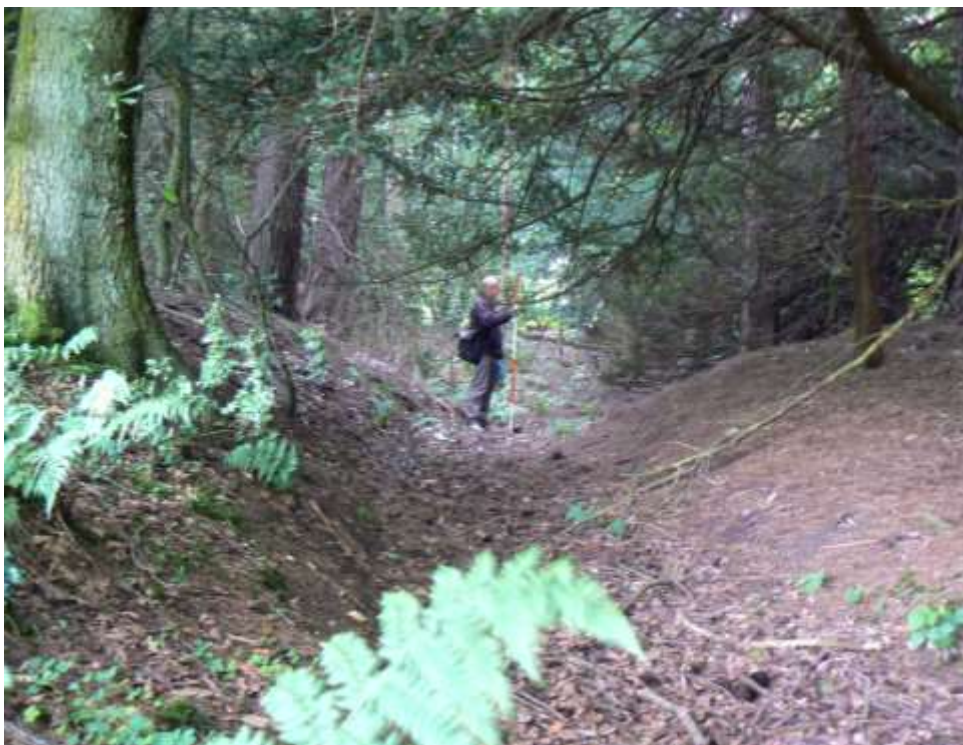
A ditch running at right angles from the western lip of the moat ditch. Narrowing from 6m at the edge of the moat to 4m, and 1.2m -1.3m deep. Falls slightly to west. On the first edition Ordnance Survey it is shown forming or accessing a tributary to the Old Hall Burn, acting as a leat or overflow from the moat.

***Plate 4: Looking south-east along ditch [4]***

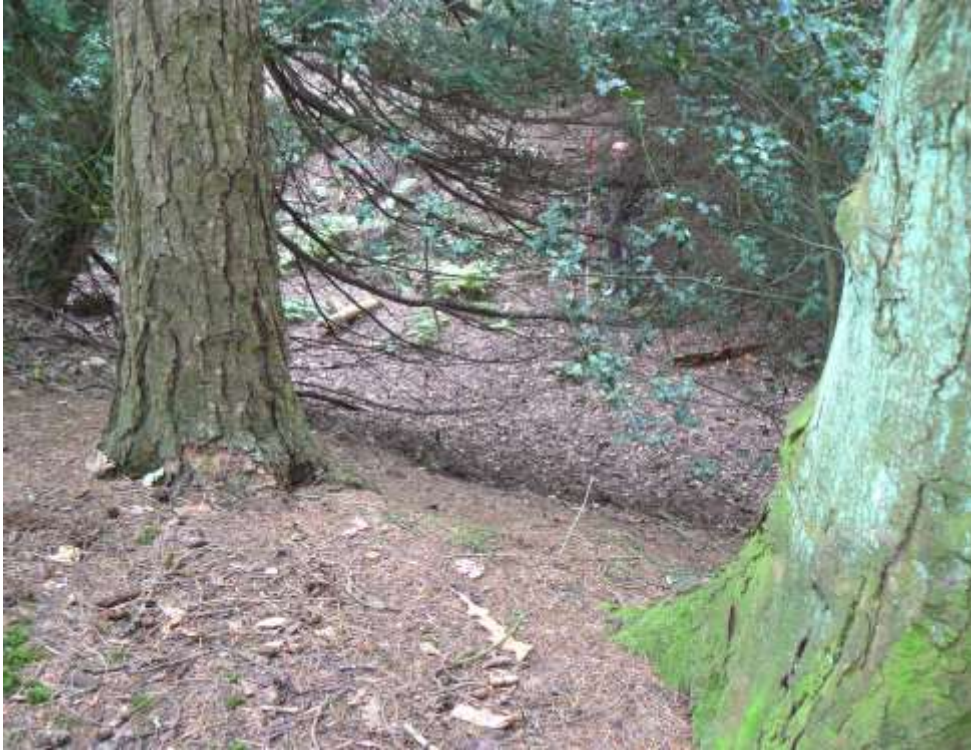
*Plate 5: Looking down the east edge of the moat ditch*

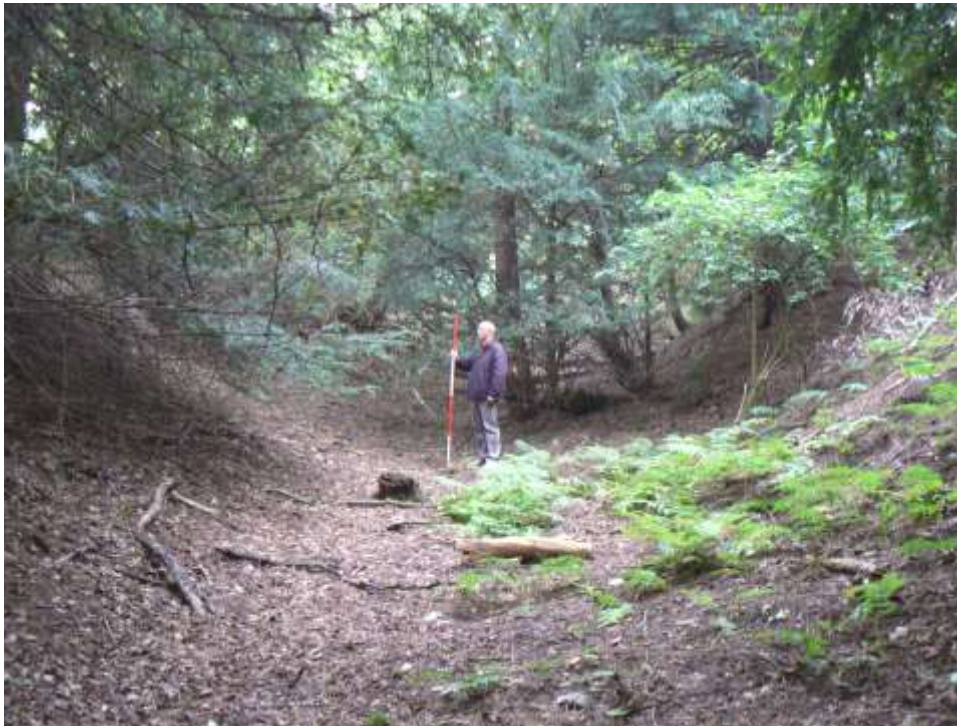
*Plate 6: Looking north-east along the west arm of the moat ditch*

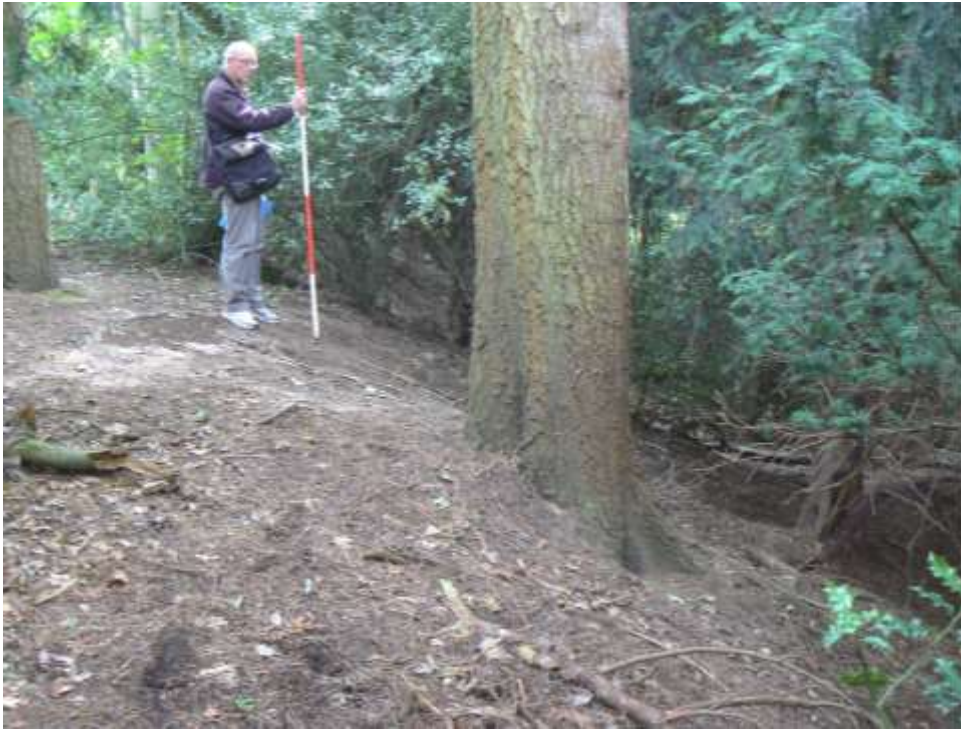
*Plate 7: Looking south east along the northern arm of the moat ditch*

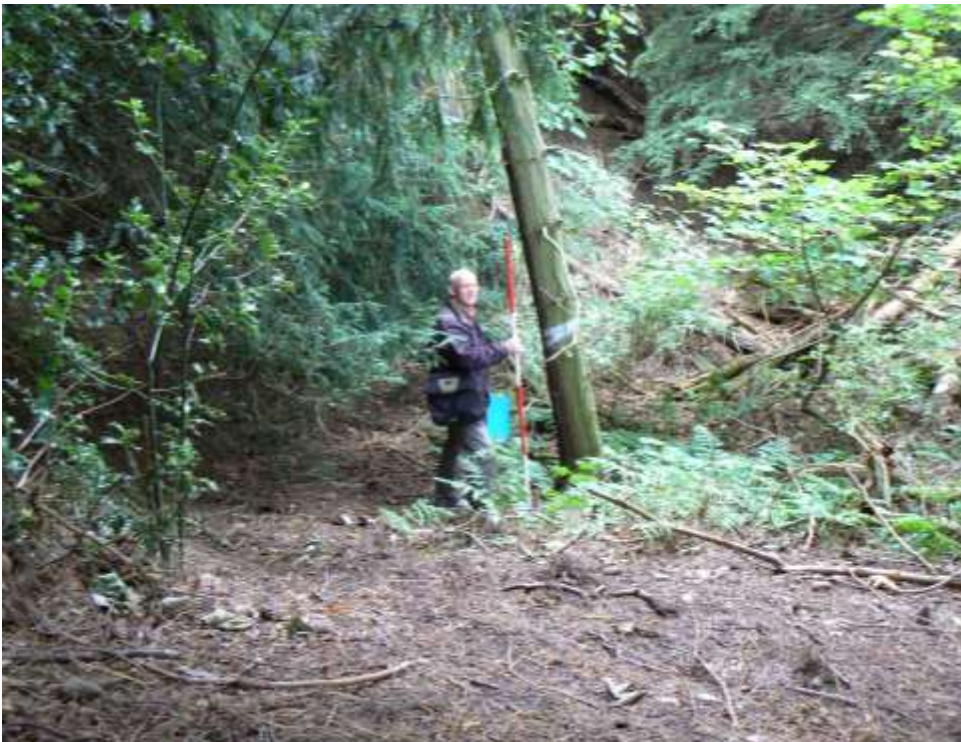
*Plate 8: View into the base of the north arm of the moat ditch, looking south*

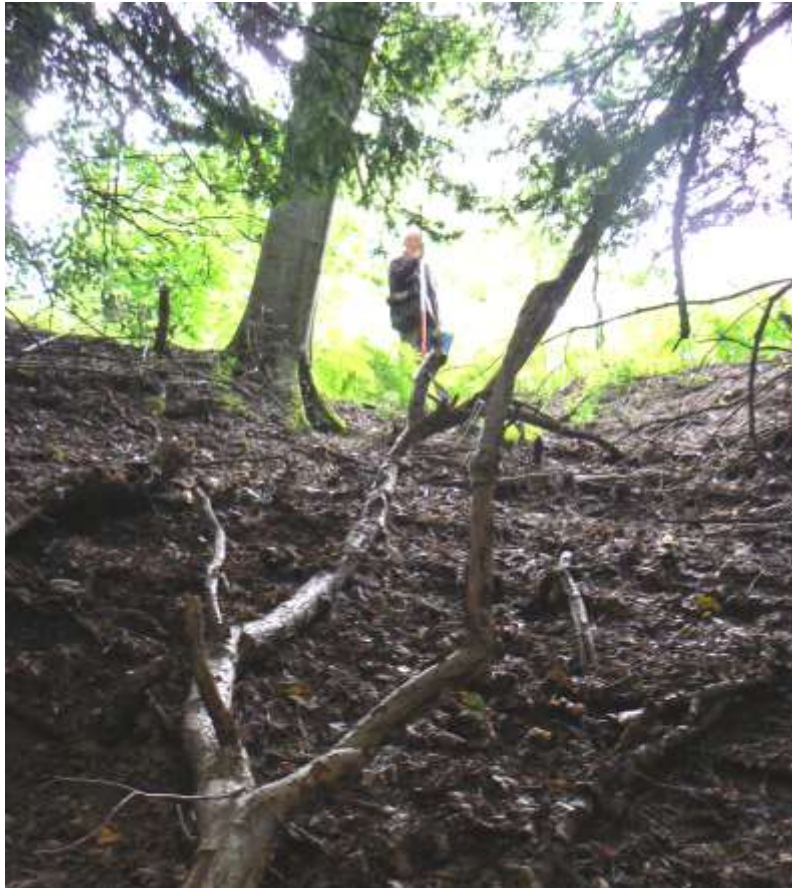
A channel running into the north-eastern arm of the moat ditch at its broadest and deepest point. Possibly associated with a narrow water course shown on the first edition Ordnance Survey running from Old Hall Well upslope to the north of the moat

**Plate 9:** Looking up the channel [5] on the north side of the moat ditch

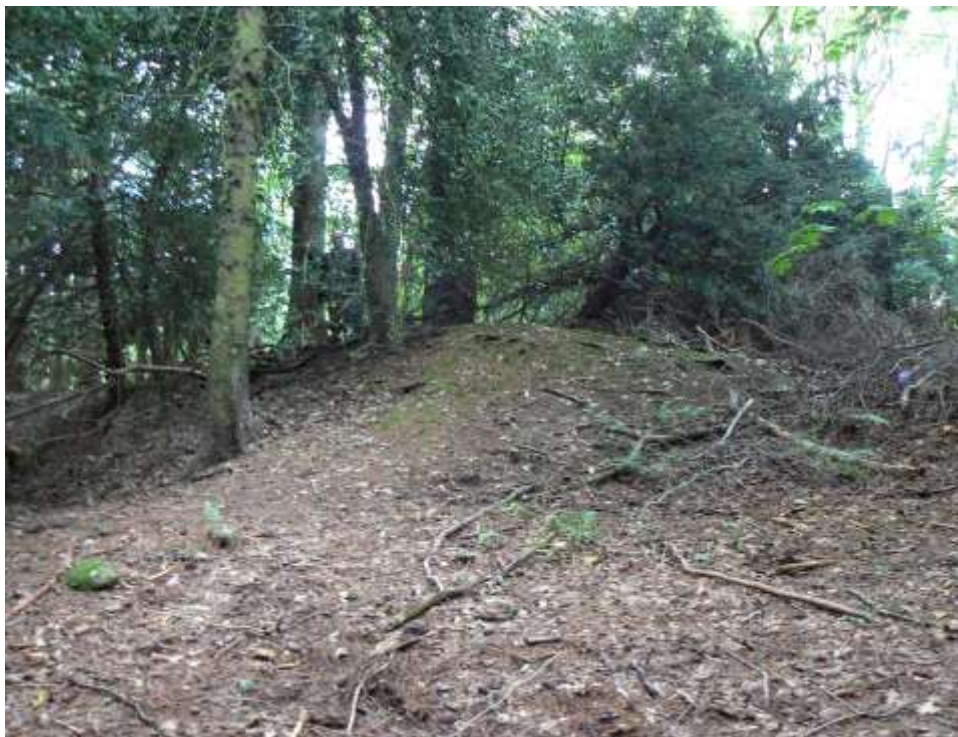
A bank, 35m long, between 10m and 12m wide and up to 2m high along the inner lip of the north-eastern arm of the moat ditch and separated from it by a narrow berm or path. The north face is regular, the south irregular and cusped with a narrow spur running back from the eastern edge, this possibly formerly associated with an extension of the moat to the south as suggested on figure 9 which is now lost. The bank is shown on the first Ordnance Survey as a simple, regular feature with no sign of the irregularity to the south as apparent

today. There is no evidence on the ground that it was formerly more extensive. What purpose it served is unknown.

**Plate 10:** Looking north along the eastern spur of the bank [6]

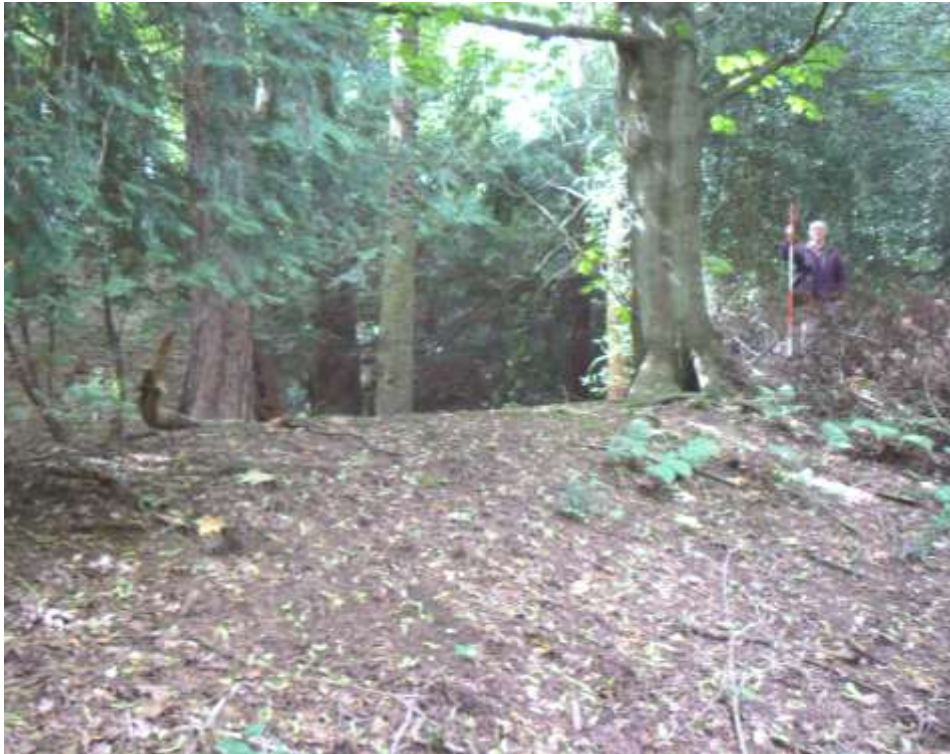
**Plate 11:** *Looking west across the top of the bank [6]*

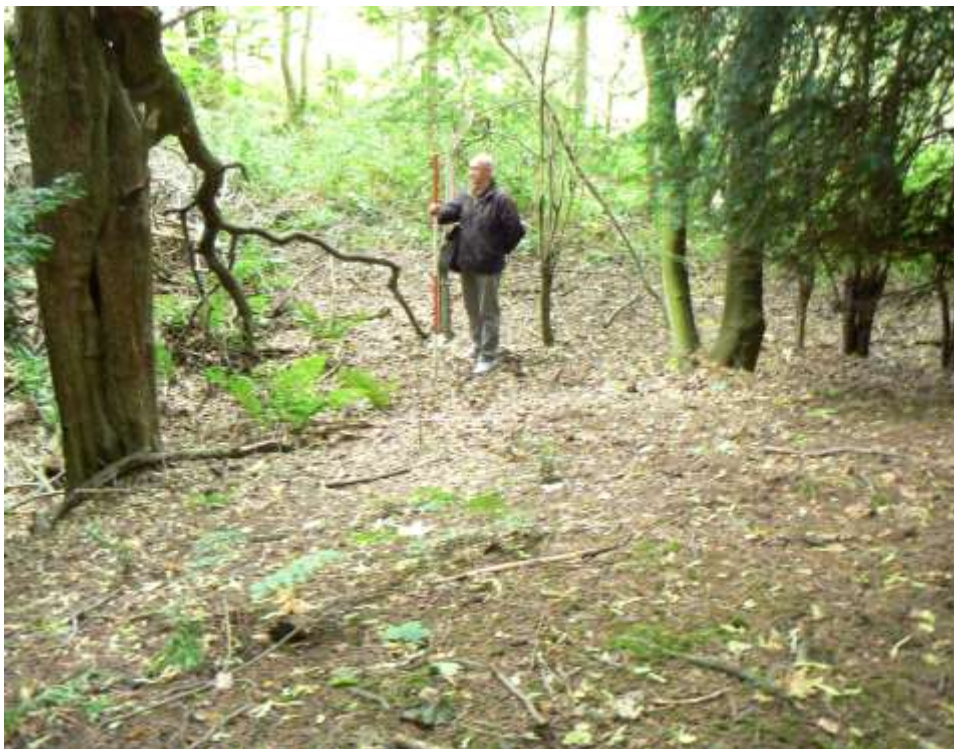
An intermittent hawthorn hedge and redundant track formerly running north to Langley Hall Farm (this now removed by opencasting) and beyond. The hedge and track are of some age, shown on the first edition Ordnance Survey, but postdate the levelling of the eastern arm of the moat ditch. The track has now been superseded adjacent to the moat ditch by a curving detour to the east.

**Plate 12:** *Hedgeline [14] Looking east*

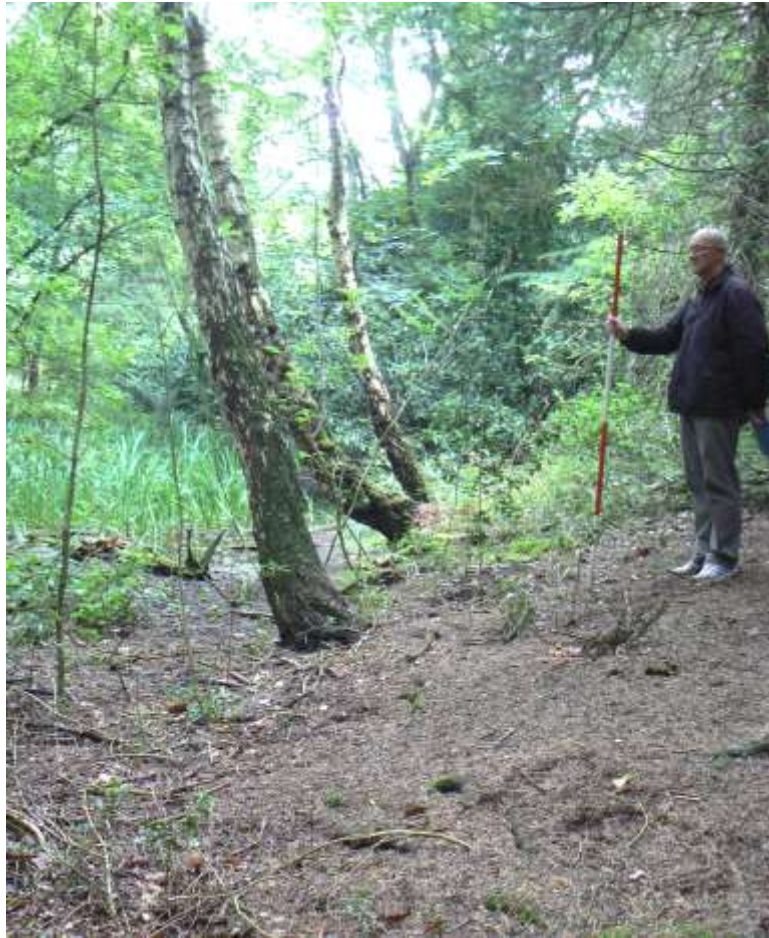
A shallow channel, slightly constricted at its mid point and running downslope from (9). It is between 2m and 4m wide and a maximum of c0.5m deep. Presumably served as a leet for overflow from (9).

**Plate 13:** Looking north-east along channel [10] running into the pond [9]

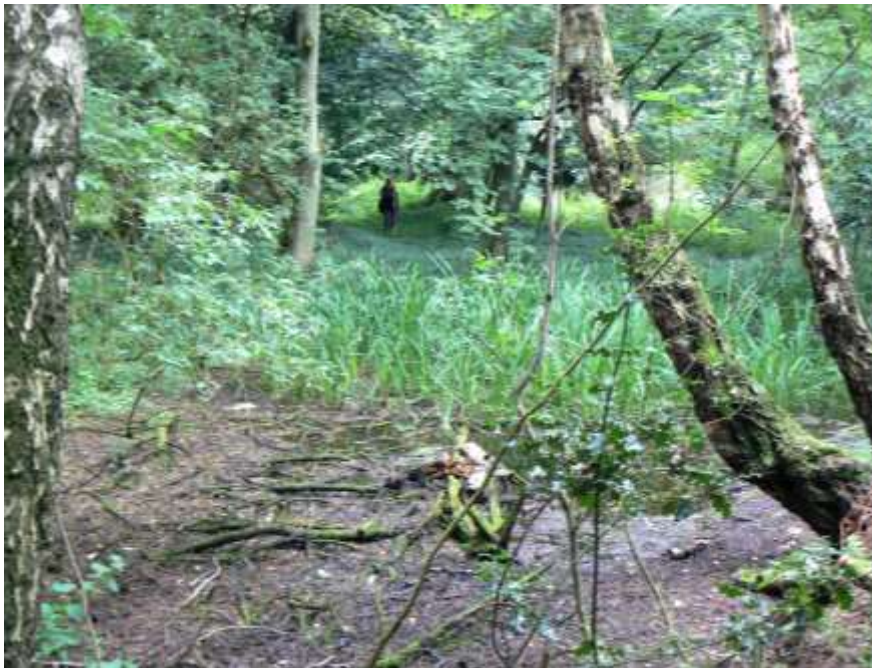
A shallow, sub-rectangular and overgrown pond, 20m long by 10m wide in a broader depression beyond the south range and on the edge of the terraced platform of the hall. A channel (10) runs from it to the south-west and a linear hollow (11) runs in from the east. The first edition Ordnance Survey (figure 8) shows the pond as having formed the south-east corner of the moat ditch with an arm extending to the existing ditch to the north-west and an extension to the north-east running along much of length of the indicated outer face of the south-east range.

**Plate 14:** Looking north-east across the pond [9]
