# **CONVERSION OF AGRICULTURAL RANGE**

Wallhouses South Farm  
Matfen, Northumberland

## **ARCHAEOLOGICAL WATCHING BRIEF**

September 2011

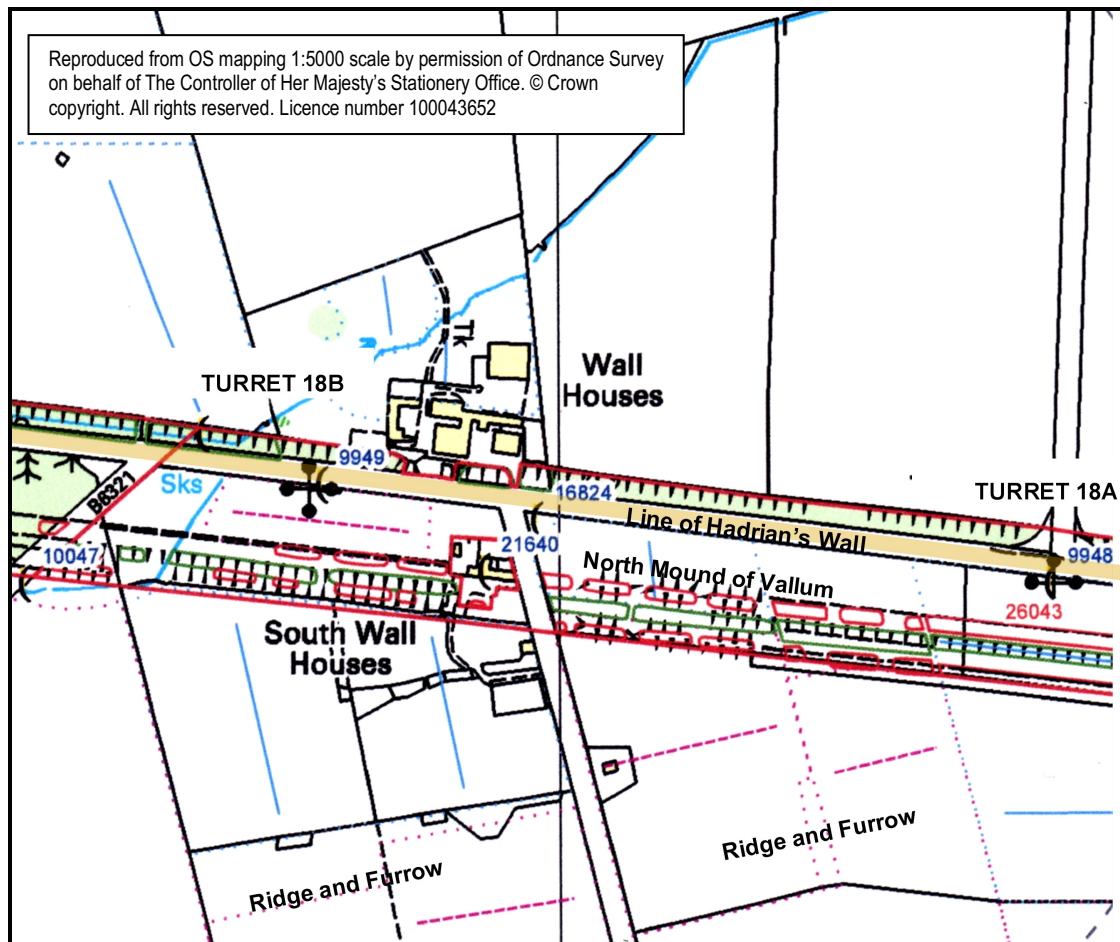
**Figure 2:** Wallhouses South Farm showing adjacent archaeological features. North to top of page

South Farm itself is of 18<sup>th</sup> century date and is listed grade II (HER 21640). It consists of a stone-built farmhouse attached to what were formerly stables, a byre and a workshop, this latter including a blacksmiths window in its south face (figs 4 and 5). The eastern portion of the ranges is the subject of the proposed development (fig 3). The roof structure of this block is modern and of simple truss construction with upright members. It is surfaced with red pantiles. The floor of the building is intermittently hard standing and dark ashy earth, this latter possibly a reflection of the former use of a portion of the building as a workshop.

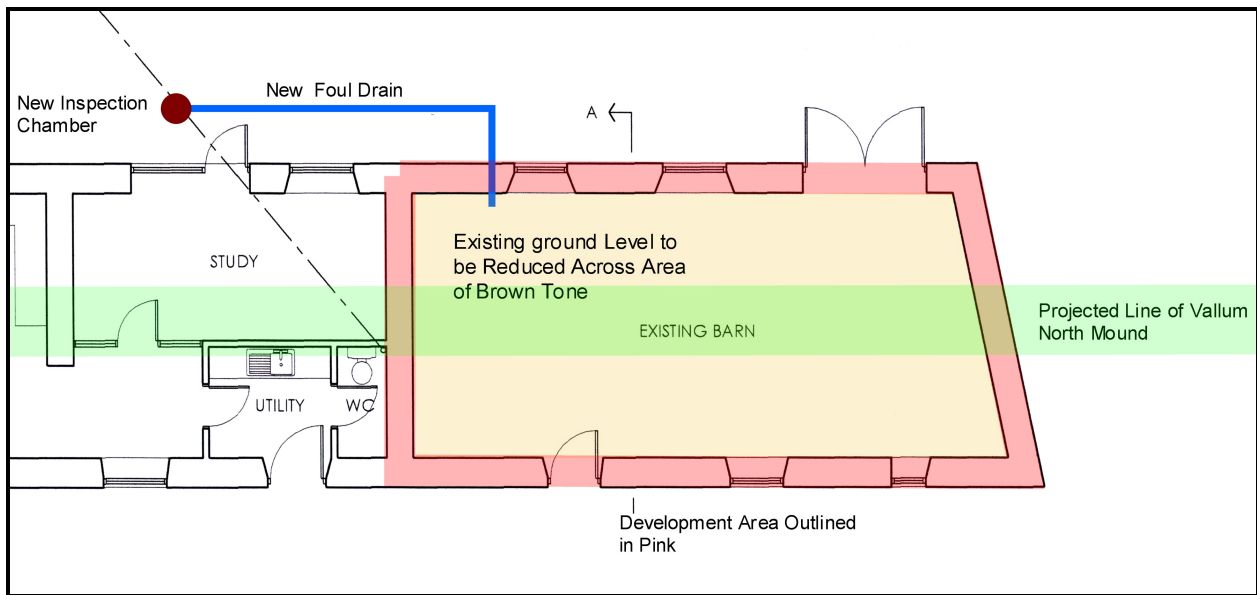
**Figure 3:** The attached former agricultural range to be converted at South Farm  
North to top of page

The developments at South Farm involve the conversion of the eastern range to residential occupation. The building will remain as standing with no extensions. A new door will be knocked through the west internal wall to access the existing domestic range and a window on the south face of the range will be increased in size to match the adjacent opening. A first floor will be added but the current roof structure retained.

**Drainage Works** A new 100mm diameter foul drain will run for 7m from a WC through the north wall of the building and to the existing foul water drain. At the junction of these runs a new inspection manhole will be inserted (see fig 3). Excavation for the drains and manhole will be a max. of c750mm deep.

The drainage trench was cut on 6<sup>th</sup> September 2011. It is located as per the line shown on figure 3 within a yard area to the north of the range. The trench was cut by a mini-excavator with narrow bucket to a depth of 700mm and a width of 300mm. The gravel surface directly overlay the clay subsoil. No intervening layers over the subsoil nor discrete features cut into the subsoil were seen during the excavation.

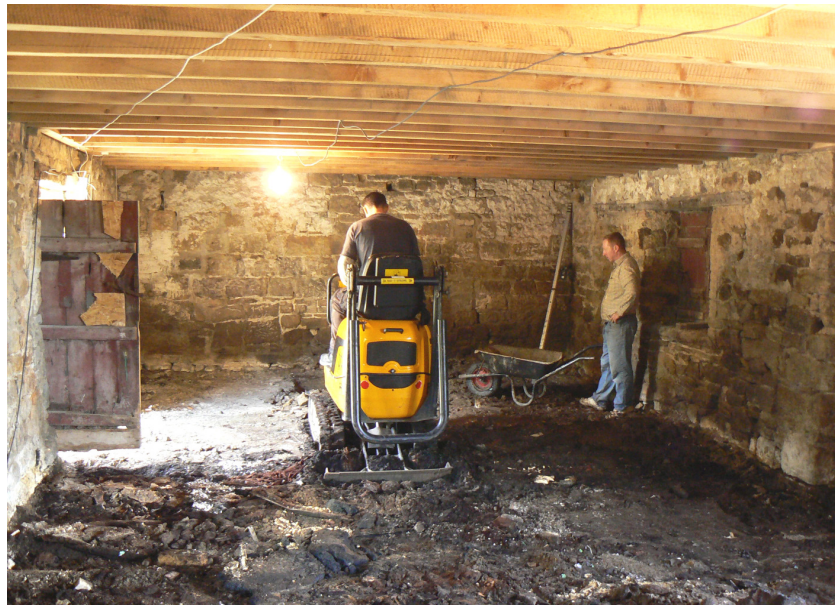
**Plate 1:** *Beginning the excavation of the floor of the range*

Lowering of floor level in the range was carried out on 5<sup>th</sup> and 6<sup>th</sup> September 2011, the existing surface within the range was lowered by 400mm to accommodate the new floor construction. This was carried out using a mini excavator with a 600mm wide ditching blade. The existing floor, fairly consistently throughout the range 200mm deep, consisted of a dark, ashy, friable soil with numbers of substantial wooden sleepers within the matrix. It also contained some sherds of 19<sup>th</sup> century pottery including fragments of jars, plates and bowls. The floor directly overlay sticky grey-brown boulder clay which included numerous stone fragments. This was also removed by mini excavator.

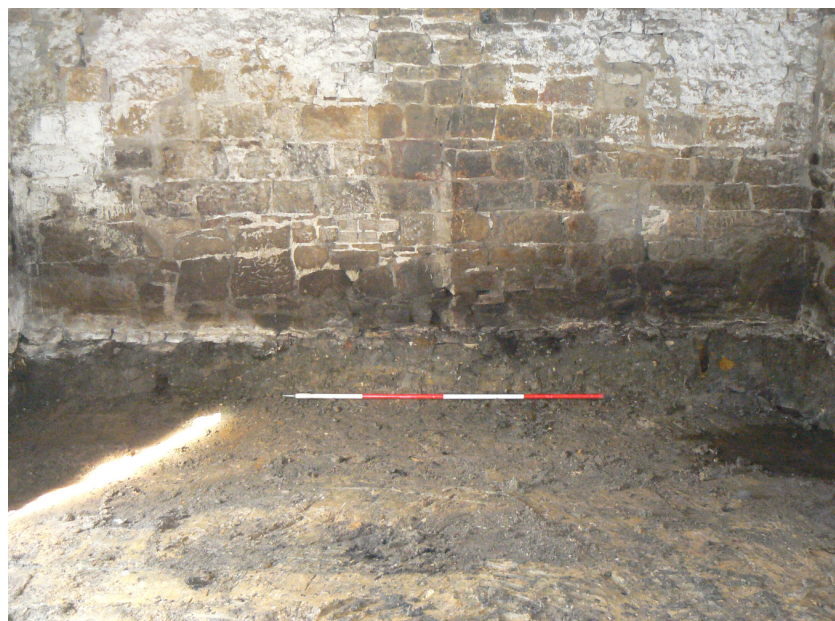
**Plate 2:** *The west wall of the range sits directly on subsoil  
Post-excavation photograph. The scale is 2m long*

At no point within the range did any deposit intervene between the relatively modern floor and the underlying boulder clay. It is likely that any build-up over the natural clay subsoil was stripped away when the range was constructed. Nor was there any evidence for features cut into the surface of the exposed boulder-clay such as cord-rigg.

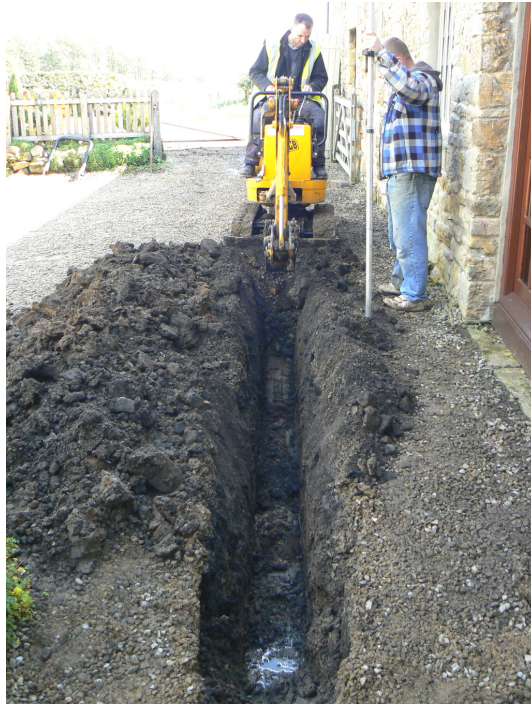
**Plate 3:** *Excavating the foul-water trench*

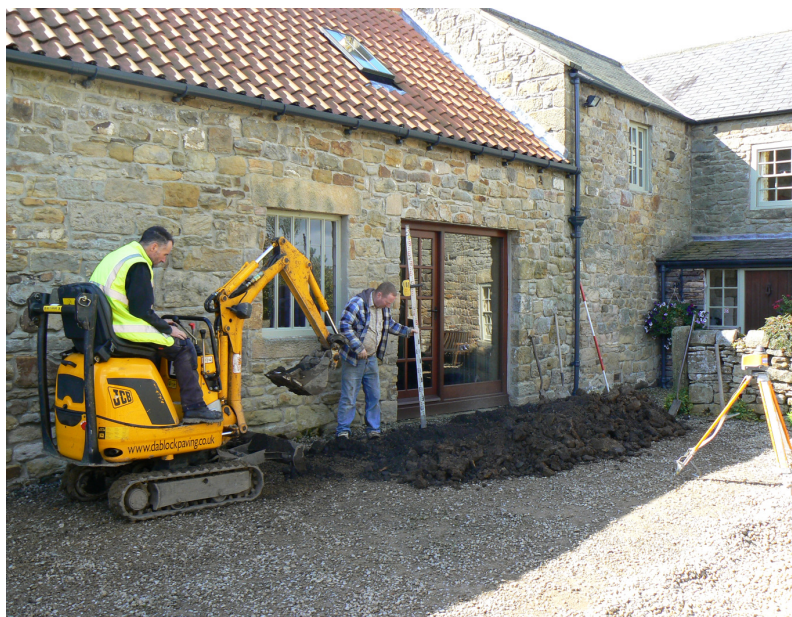
**Plate 4:** *Location of the trench alongside the range*

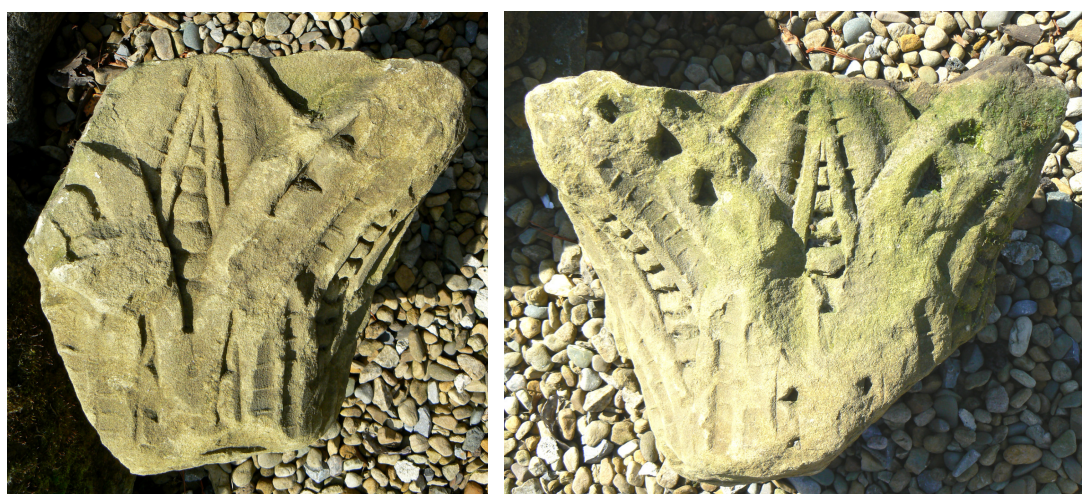
About three-quarters of the original capital survives. It is 26cms high and 34cms wide. The top is squared in plan although with a portion broken away. The base of the piece is worked to a near-circular form. The three unattached faces are decorated in a foliate pattern, possibly acanthus leaves. The form does not conform to any specific classical order or model. The fourth, attached face is fractured and broken away. Neither top nor bottom edges of the capital have horizontal mouldings interrupting the foliate decoration. The piece of shaft is 35cms long with a diameter of 21cms. It is of good cylindrical form apart from the attachment on the rear. It has one original flat end and is broken away at the other. It appears proportionate in size to the capital.

*The capital: Side (left) and front views*

Both pieces are of the same fine, buff-yellow sandstone. Both are worn but neither shows any certain evidence for plough strikes. Despite the damage it is still clear that the workmanship was competent.

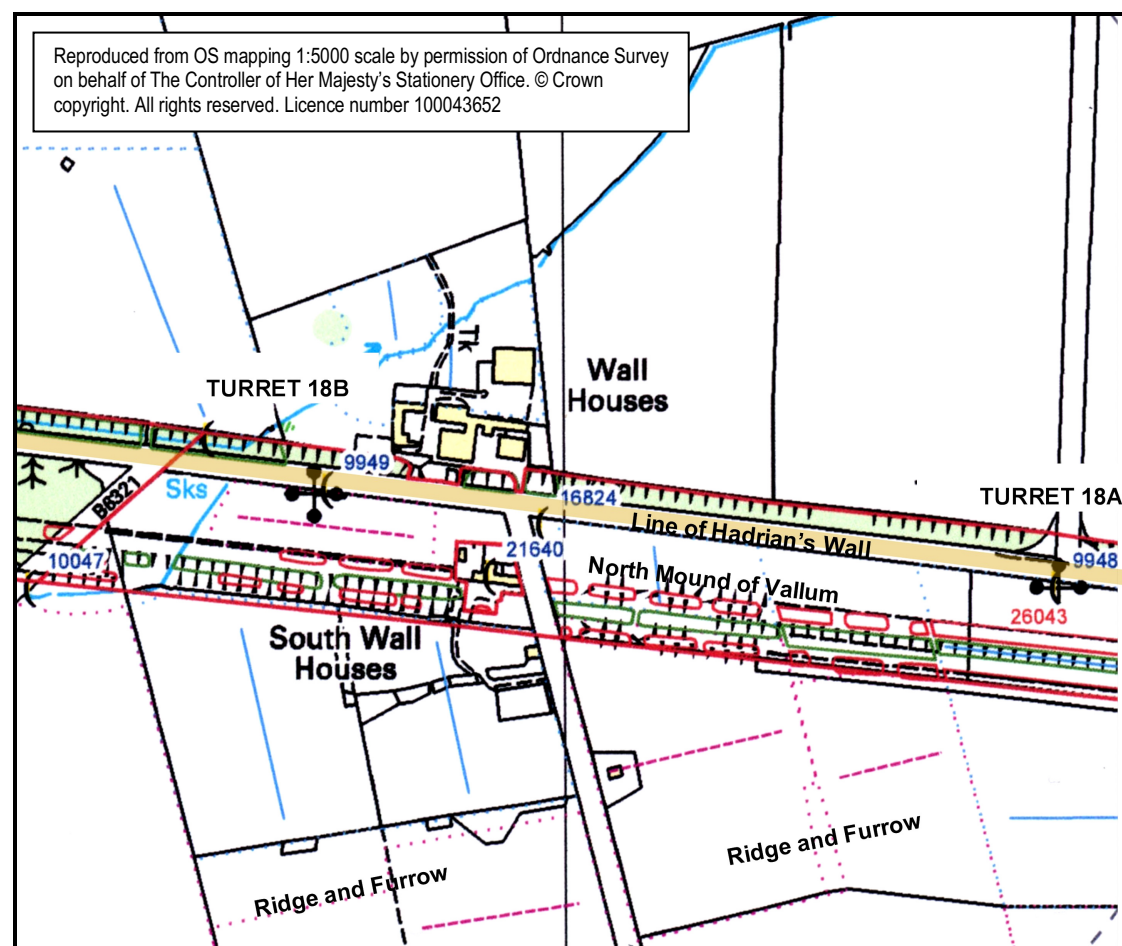
**Figure 2:** Wallhouses South Farm showing adjacent archaeological features. North to top of page

South Farm itself is of 18<sup>th</sup> century date and is listed grade II (HER 21640). It consists of a stone-built farmhouse attached to what were formerly stables, a byre and a workshop, this latter including a blacksmiths window in its south face (figs 4 and 5). The eastern portion of the ranges is the subject of the proposed development (fig 3). The roof structure of this block is modern and of simple trusse construction with upright members. It is surfaced with red pantiles. The floor of the building is intermittently hard standing and dark ashy earth, this latter possibly a reflection of the former use of a portion of the building as a workshop.

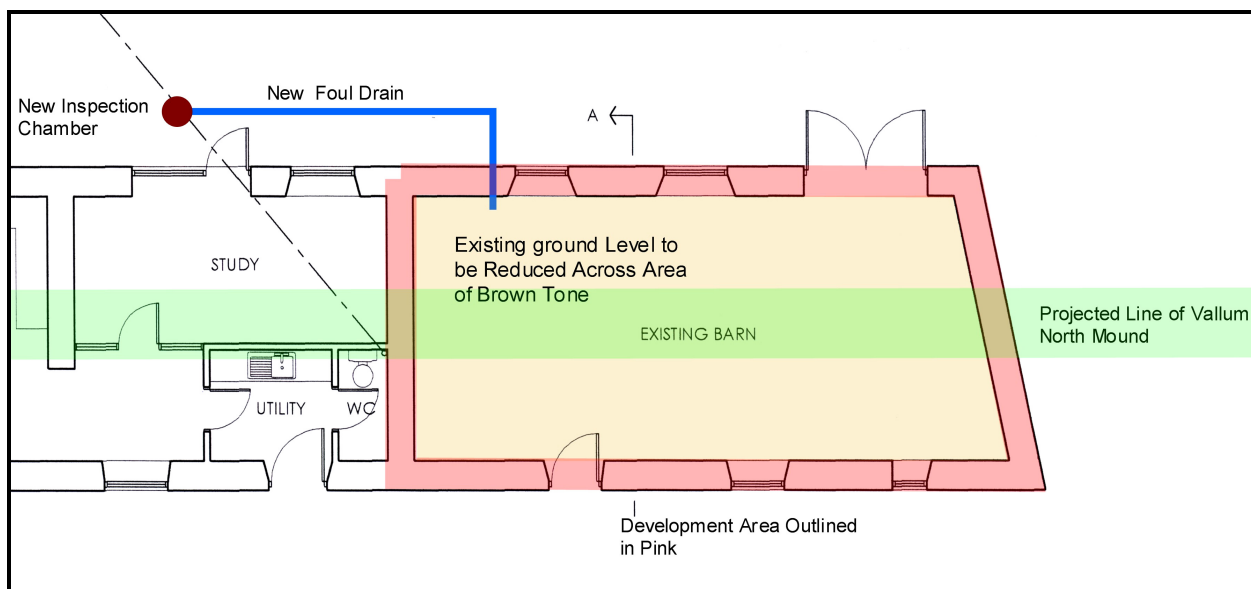
**Figure 3:** The attached former agricultural range to be converted at South Farm  
North to top of page

The proposed development at South Farm involves the conversion of the eastern former range to residential occupation. The building will remain as standing with no extensions. A new door will be knocked through the west internal wall to access the existing domestic range and a window on the south face of the range will be increased in size to match the adjacent opening. A first floor will be added but the current roof structure retained.

**Drainage Works** A new 100mm diameter foul drain will run for 7m from a WC through the north wall of the building and to the existing foul water drain. At the junction of these runs a new inspection manhole will be inserted (see fig 00). Excavation for the drains and manhole will be a max. of c750mm deep.

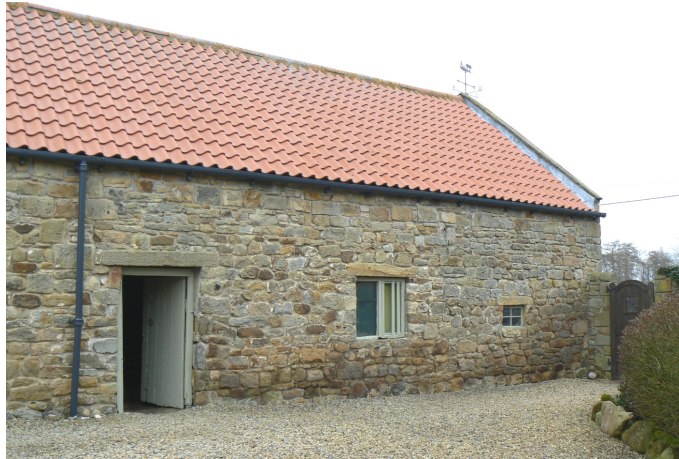
**Figure 4:** The south face of the attached agricultural building The farmhouse lies to the left

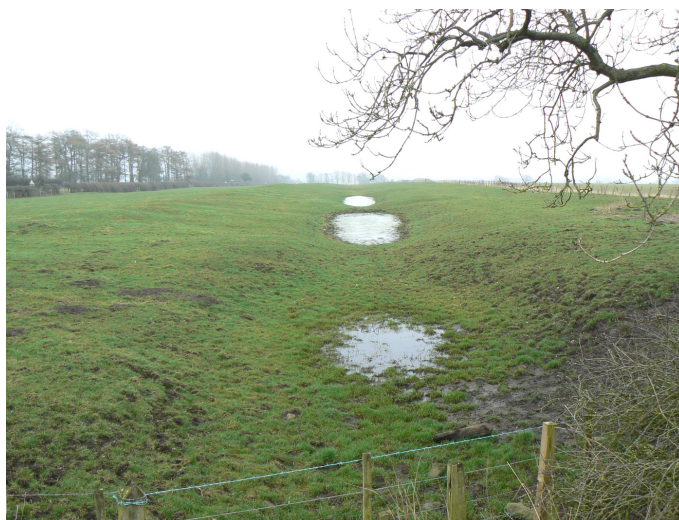
**Figure 6:** The Vallum running east from South Farm. The line of the north Vallum mound, interrupted by crossings, can be seen to the left of the ditch
