Overgrass Tower

Felton, Northumberland

HISTORICAL ANALYSIS

Proposed Development: Repair and Consolidation Works to Overgrass Tower through English Heritage Grant Funding

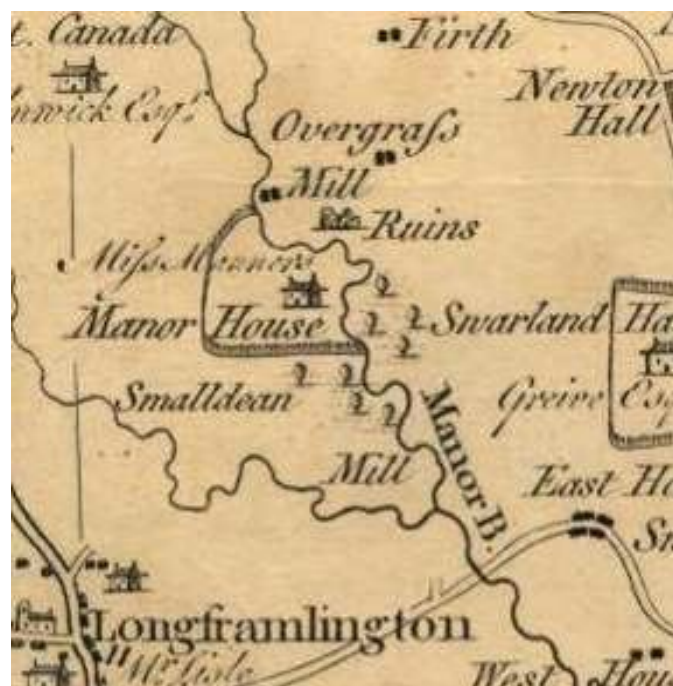
Figure 15: Armstrong's Map of Northumberland 1769

No enclosure or Tithe map has been found which covers the area of Overgrass. The earliest map located showing the settlement is Armstrong's map of the County of Northumberland of 1769 (figure 15). The post-medieval settlements of Overgrass and the Firth are shown to the east of the Manor (later Swarland) Burn. Armstrong also shows 'Ruins' in the area, but whether these refer to Overgrass Tower (which was certainly functional and certainly incorporated into a small-holding at a later date) is uncertain. The position would also seem rather misplaced for the tower.

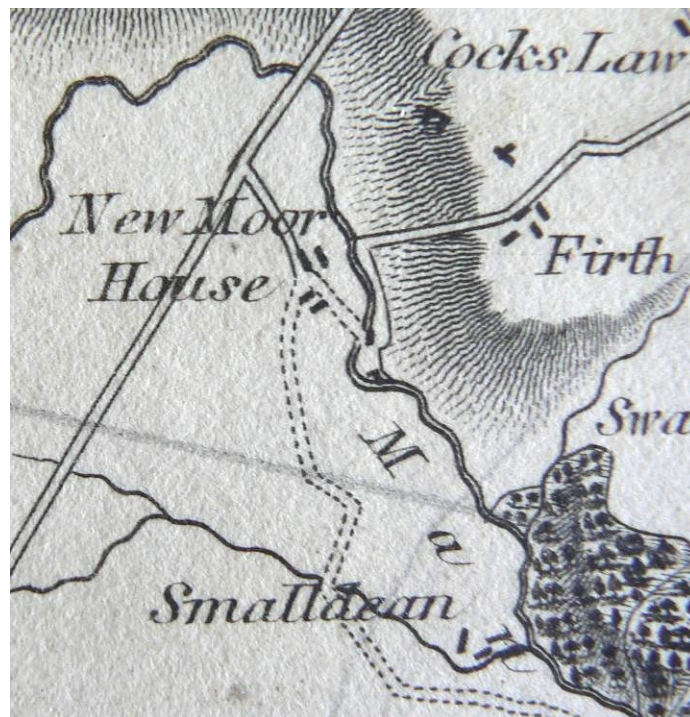
Figure 16: Fryer's Map of Northumberland, 1820

The county maps of Fryer and Greenwood (1820 and 1828, respectively) show the area in some detail and include local routes. Fryer (figure 16) shows two coalescing at Newmoor House to the west of the Manor (Swarland) Burn. They ford the burn at Overgrass Tower. This route runs to the mill to the south as well as north up the east side of the burn to the settlements of Firth and Overgrass and beyond.

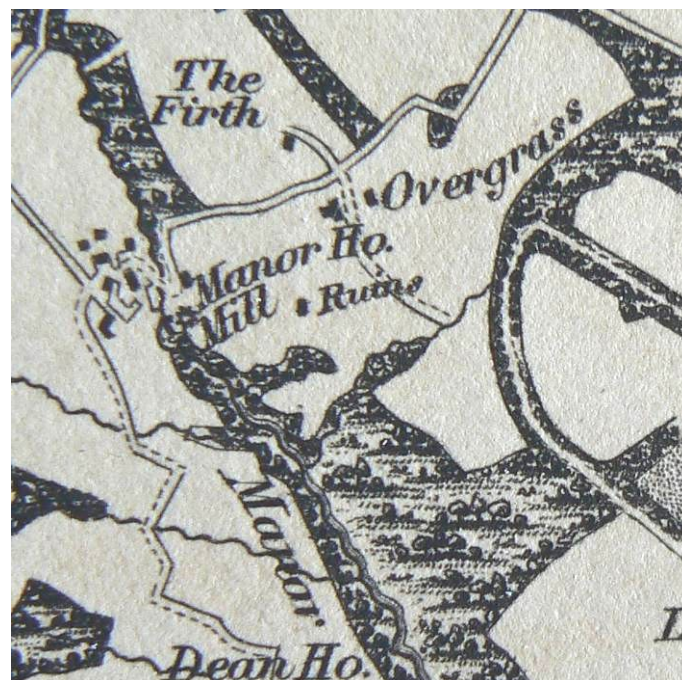
Figure 17: Greenwood's Map of Northumberland 1828

Greenwood (figure 17) shows the same pattern of routes with the Manor Burn negotiated by the ford at Overgrass Tower. The mill to the south of the tower is named Manor Mill. Interestingly, Greenwood shows 'Ruins' to the east of the mill (cf. Armstrong), certainly not the tower.

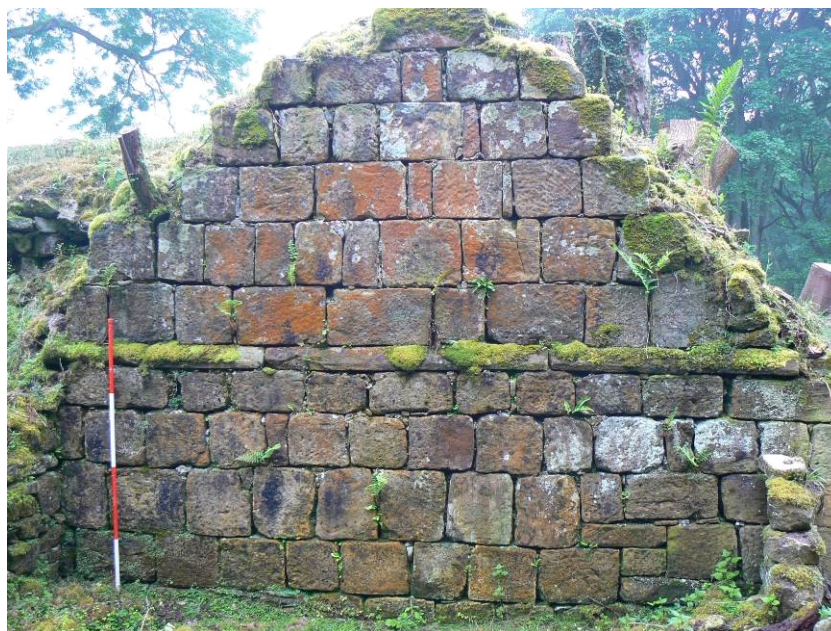
Plate 3: *The western part of the north face of Overgrass Tower. To the east of this all facing stones have been robbed away. Red colouration on the stones is lichen. Scale used throughout is 2m long.*

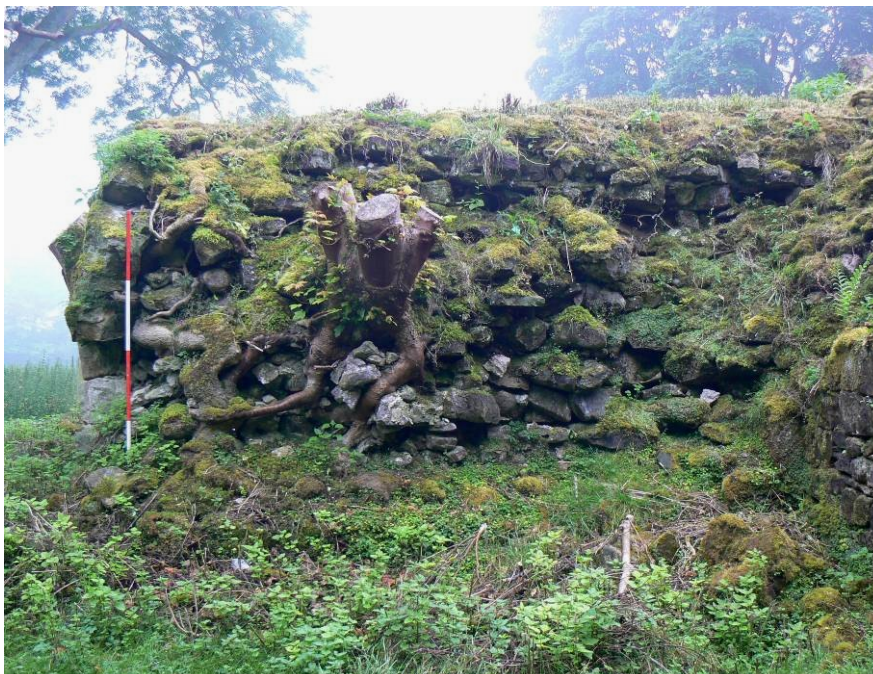
Plate 4: *The eastern part of the north wall of Overgrass Tower reduced entirely to corework*

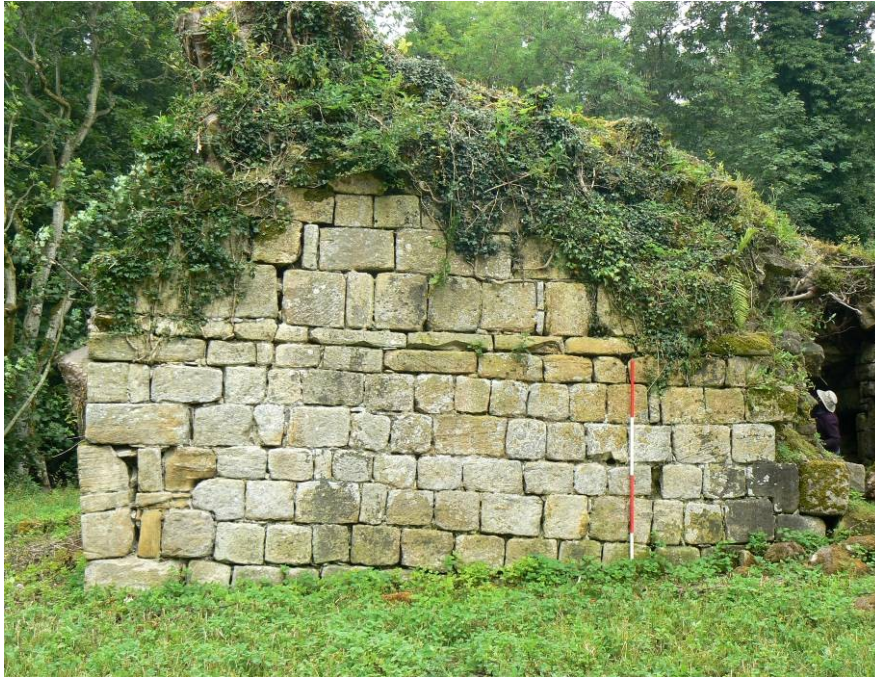
Plate 5: *The western part of the south face of Overgrass Tower. To the east, the area of the entrance, the wall has gone*

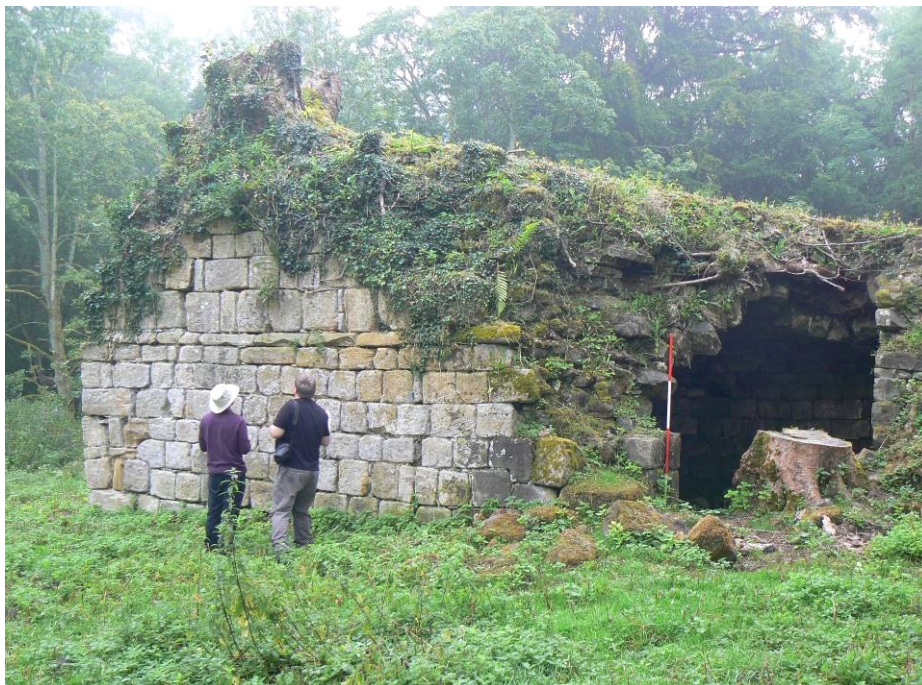
Plate 6: *The tumbled south-east angle of Overgrass Tower. The scale stands against the surviving west jamb of the entrance lobby with the tumbled vault to the right*

Prior to repair works commencing, and to guide and inform these works, a range of archaeological investigations should be carried out to establish the survival and nature of currently obscured features. This would include: Excavation of a test pit (or pits) on the first floor level to establish the presence of floor surfaces, walls and other discrete features beneath the current build up of soil and tree/shrub roots; Excavation of a test pit or pits within the basement to establish original floor level; Excavation of an area around the entrance complex and newel stair to establish the survival of these features prior to the removal of the large tree stump within the lobby area.

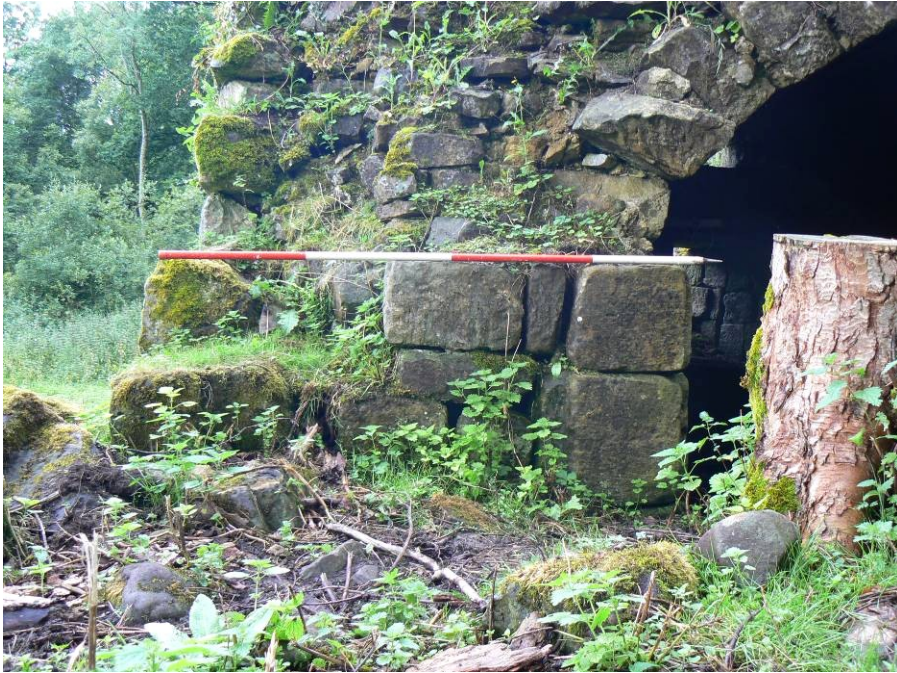
Plate 7: The west jamb of the entrance lobby

1.2 Western jambs of inner and outer doors and intervening lobby wall in south wall of tower. This can be seen on figure 12 and in elevation and plan on figure 14 as it was around the turn of the 19th/20th century. At that time one half of the arched head of the inner door remained in situ. This has now fallen but survives in a pile of rubble just outside the entrance. Soil deposits have accreted in front of the face and the current position is shown on figure 7.

5.6 There is little visible evidence for the entrance complex at the south-east angle of the tower other than the west jamb of the entrance lobby. Although likely to be severely impacted by tree growth, it is possible that elements of the newel stair and east jamb of the outer doors may survive. One of the arch stones for the inner door survives within a pile of tumble at the south-east angle of the tower. It is possible that the other half survives inside the tower as shown on figure 13. Clearance and display of this area would be a valuable addition in understanding and appreciating the nature of the tower and its function.

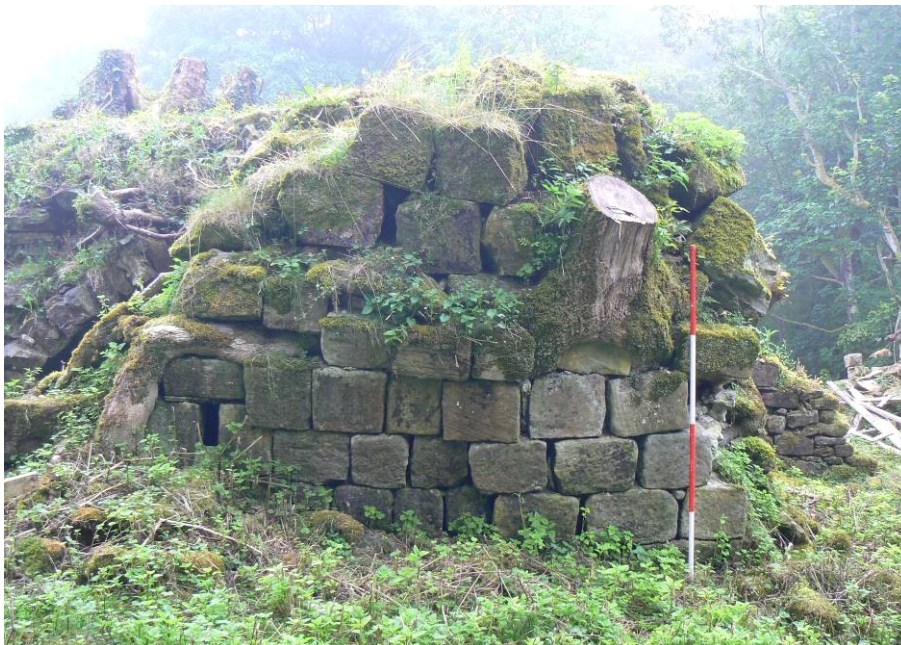
Plate 8: The surviving east face of Overgrass Tower, fallen away to both north and south. The face is leaning precariously and distorted by tree growth. The eastern loop [1.5] can be seen below the elbow in the tree root

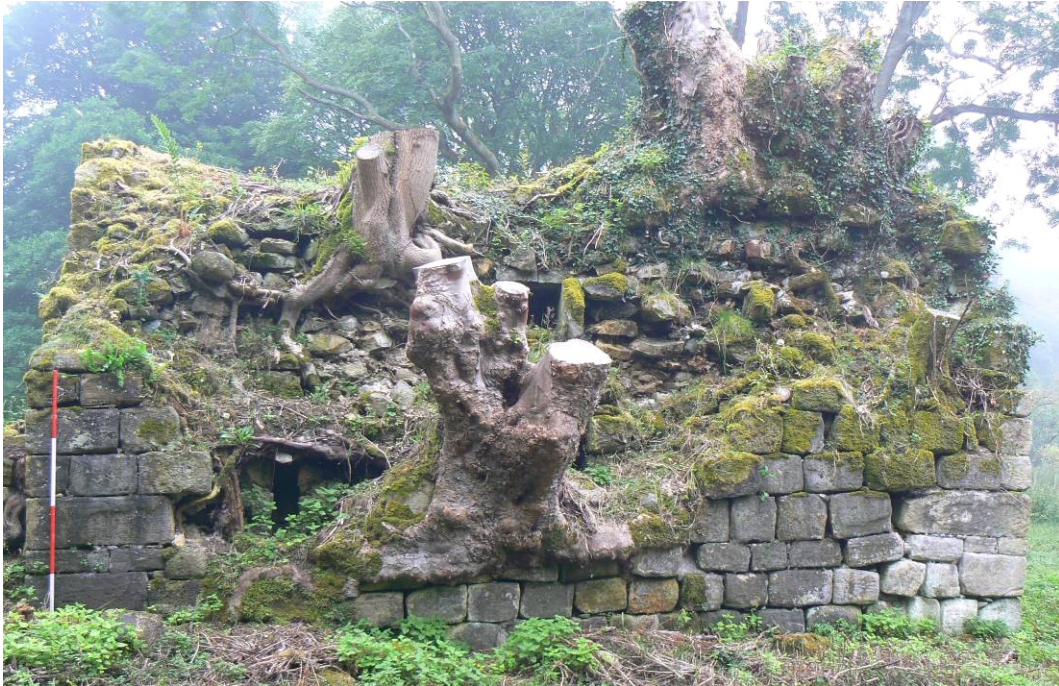
Plate 9: *The west face of Overgrass Tower. A large scooped area has gone from the centre exposing the core. The garderobe chute [1.7] can be seen low down, towards the northern block of facing stones and light [1.6] immediately to the right of the central stump.*

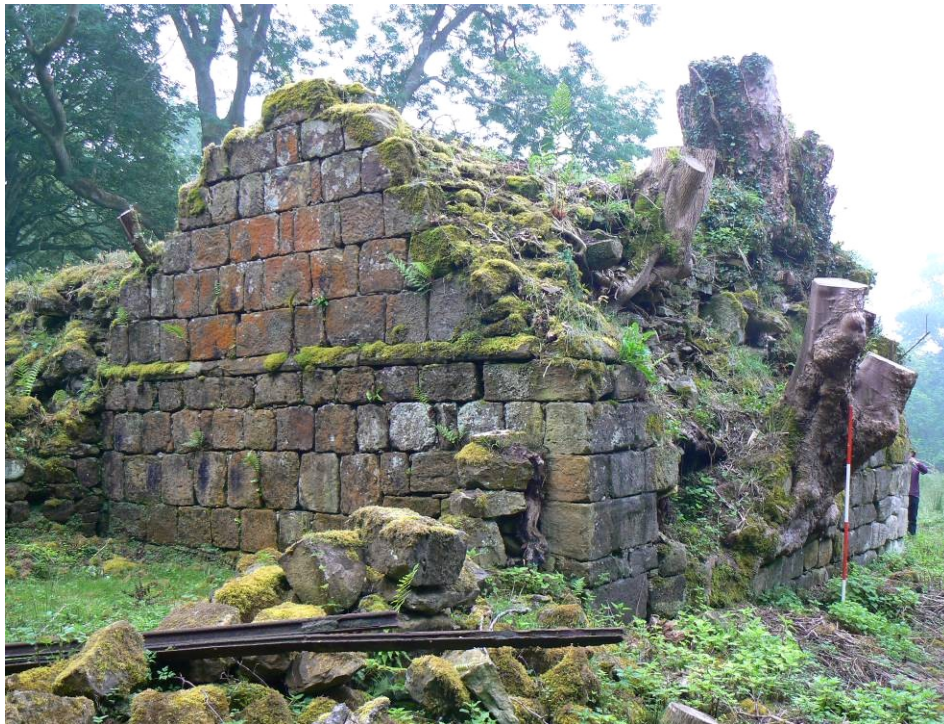
4.1.6 West Face (figure 11, plates 9 and 10) This has been heavily impacted by a number of large trees which have grown within the core and between facing stones. The central area of the wall has been reduced to three courses. To north and south, the face of the wall survives to the eighth (chamfered) course. Two superimposed lights lie centrally ([1.4] and [1.6]). A garderobe chute [1.7], set within the core of the west wall, but now exposed because of the loss of facing stones, lies to the north of the lights. A garderobe chute [1.7], set within the core of the west wall, but now exposed because of the loss of facing stones, lies to the north of the lights.

Plate 10: *The north-west angle of Overgrass Tower. The remnants of the west wall of building 2 in the foreground.*

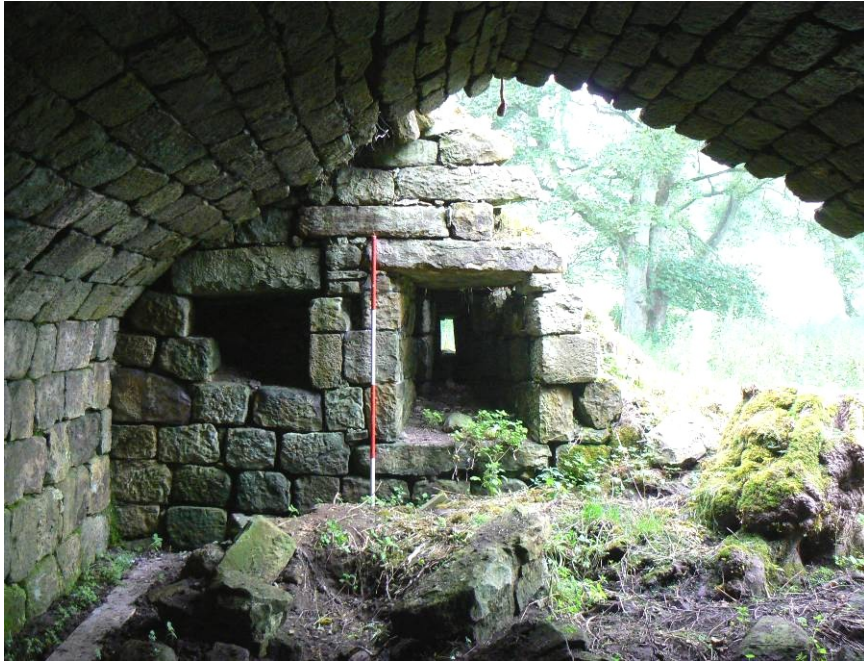
Plate 11: *The basement of Overgrass Tower. Looking at the partially tumbled east wall with splayed loop [1.5] and cupboard [1.8]*

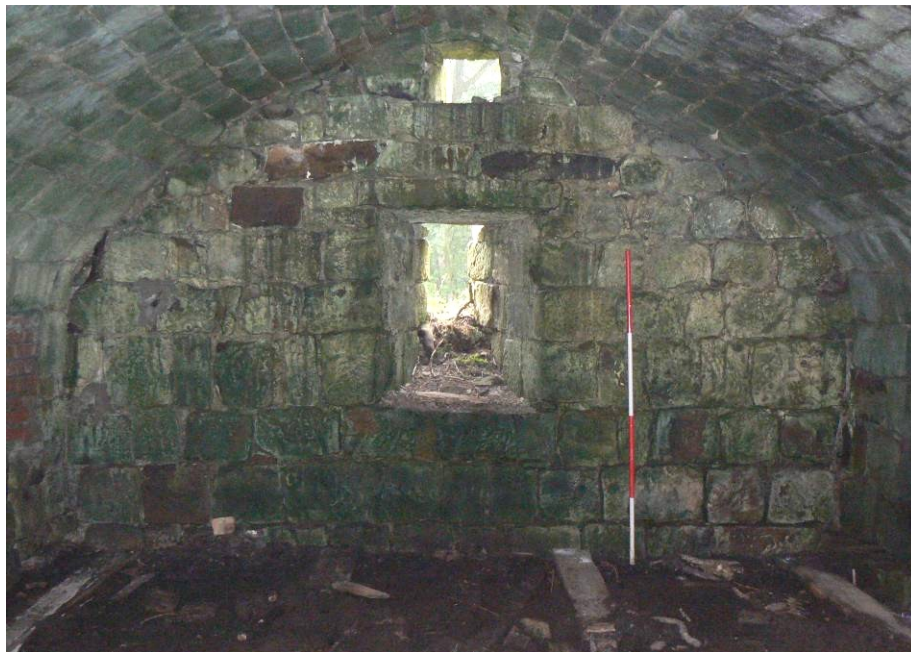
Plate12: *The basement of Overgrass Tower. Looking at the west wall with splayed loop [1.4] and light [1.6] above*

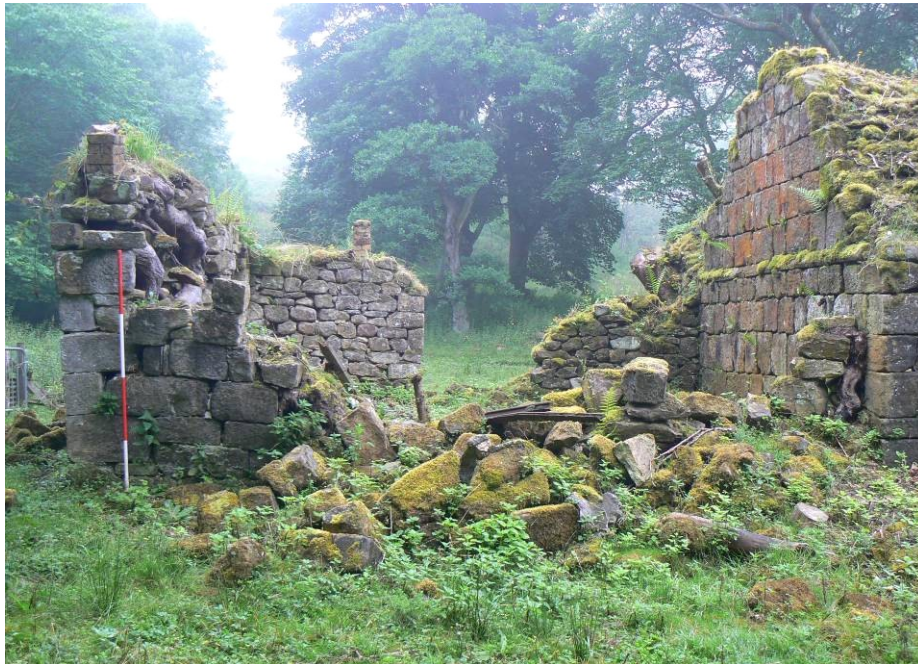
Plate 15: Looking east at the tumbled west wall of Building 2

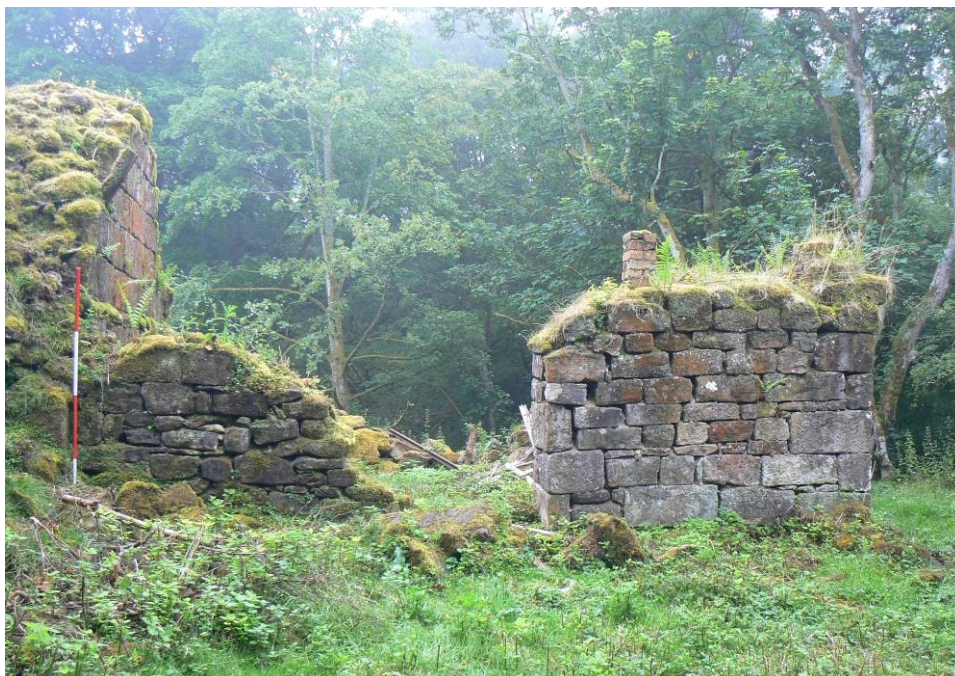
Plate 16: looking west at the east wall of Building 2 and the surviving north jamb of the door [2.1]

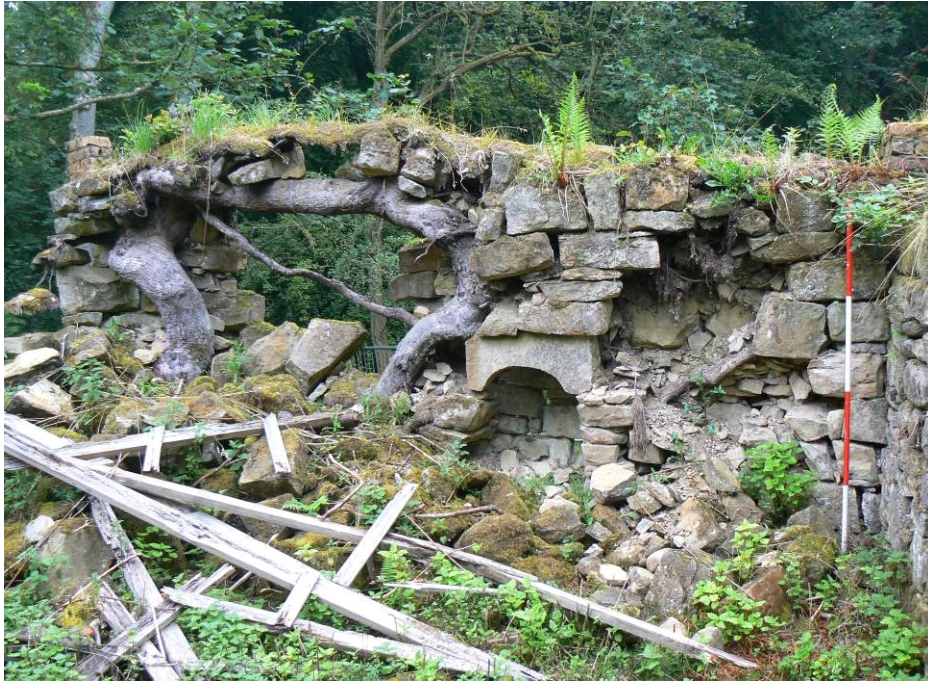
Plate 17: The extensively tumbled (and holed) inner face of the north wall of Building 2 with arched niche [2.2] surviving

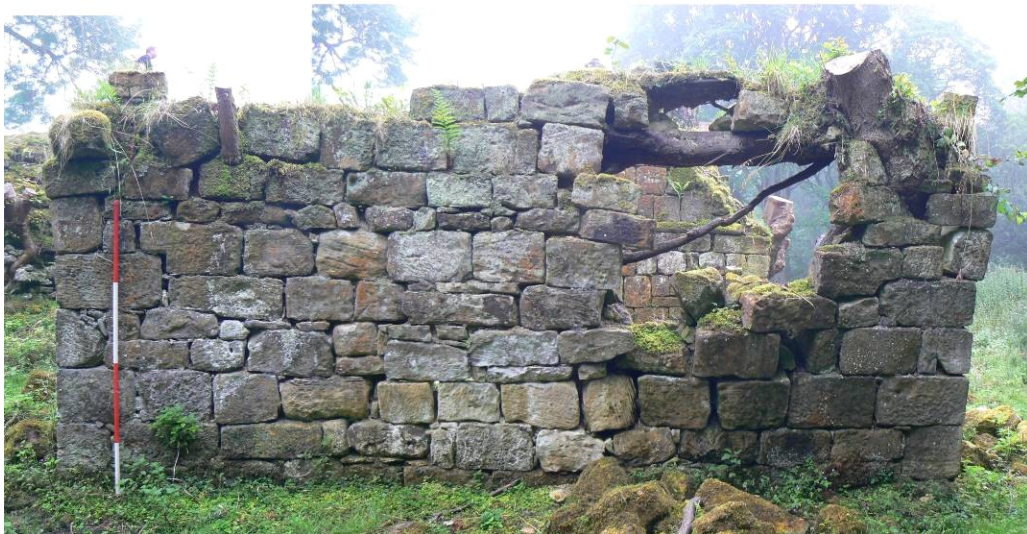
Plate 18: North face of the north wall of Building 2. The facing stones are mostly re-used from the tower

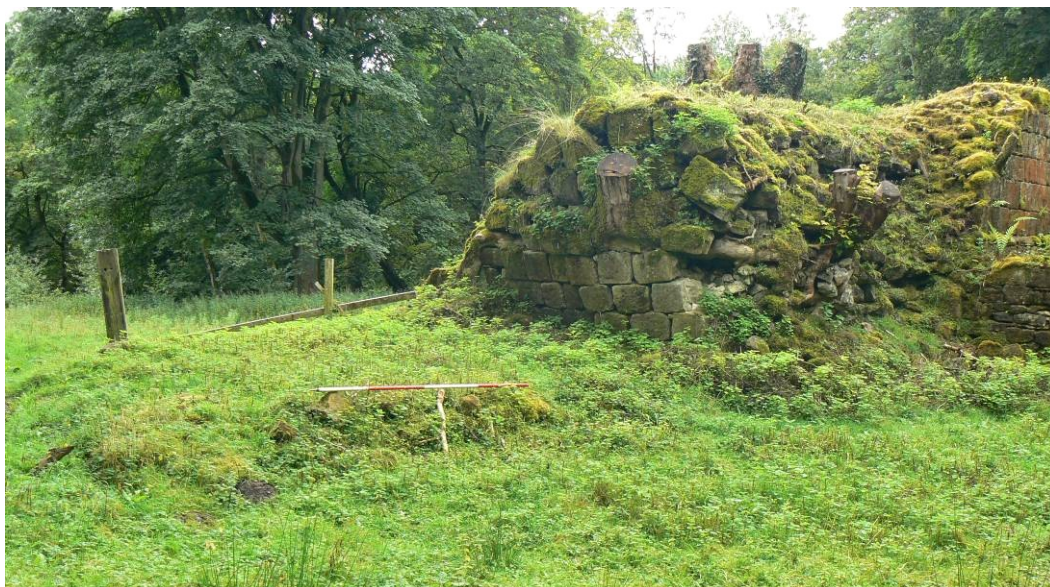
Plate 19: *Looking south-west across the north-east angle of Overgrass Tower
A low platform, the location of Building 3, can be seen to the east (left) of the
tower. The scale lies along the north wall of this building*
