# MOTE HILL, WARK-ON-TYNE PROPOSED RESIDENTIAL DEVELOPMENT

# **Archaeological Evaluation**

**July 2013**

Proposed Development: Construction of Two Residential Dwellings

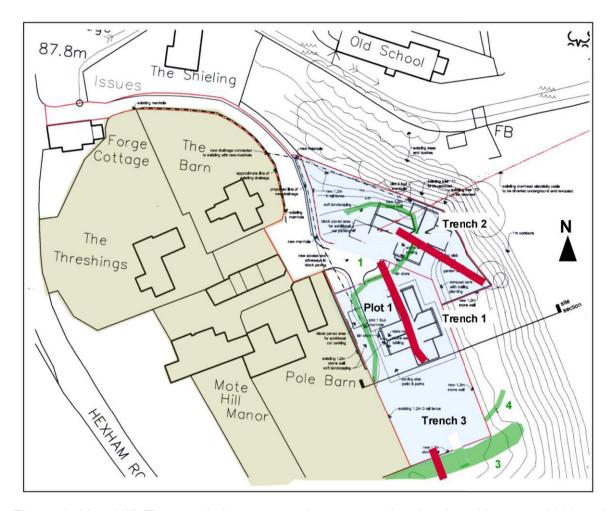
Figure 2: Mote Hill. The area in brown tone shows properties developed between 2003 and 2005; the area in pale blue covers the current proposed developments (plots 1 and 2) including the outlines of the new-build structures. Earthworks are shown and numbered in green. Evaluation trench locations are in red.

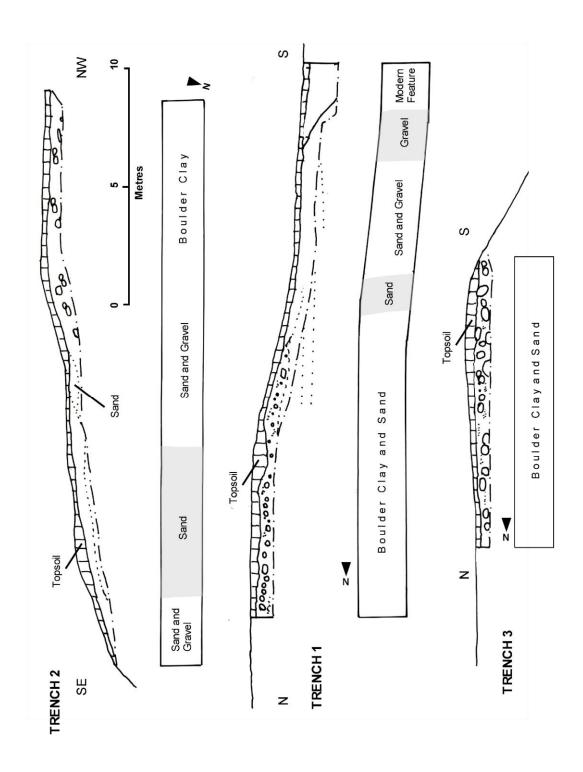
**Figure 3:** Sections and plans of Trenches 1, 2 and 3. In all cases, stratigraphy consisted of topsoil directly overlying varied drift-geology.

This was cut on a north-south orientation across the footprint of property 1 from the top of the plateau across the flat gently sloping ground to the south. Grey-brown mineralic topsoil, between 0.2m and 0.30m deep overlay a drift geology formed of bands of boulder clay and sand and sand and gravel. No archaeological features were seen within the trench other than an area of modern disturbance at its southern end, presumably a substantial pit, containing corrugated iron sheeting, timbers and other modern waste materials. The only other finds material from the trench was a few sherds of C18-C19 pottery and clay pipe stems from topsoil. No medieval pottery was recovered.

This was cut on a north-west - south-east orientation across the footprint of property 2, from the top of the plateau downslope to a sharp break of slope at its eastern edge. A medium grey-brown friable mineralic topsoil, c. 0.2m deep, overlay superimposed layers of (from the

top of the plateau down to the south-east) boulder clay and sand; fine gravel; sand and gravel. No archaeological features or structural remains were identified to interrupt the sequence between topsoil and drift geology. Artefactual material recovered consisted of a

This was cut on a north-south orientation through the broad ridge or bank at the south edge of the plateau. Grey-brown topsoil, c0.2m deep overlay boulder clay incorporating patches of compacted orange sand. This was consistent throughout the trench. No finds were recovered during the excavation. The boulder clay seen in the trench was similar in nature to deposits seen in trenches 1 and 2. Presumably, the area to the north has been reduced in fairly modern times leaving a lip or ridge along the edge of the plateau in this area. There was no indication that any of the boulder clay and sand had been re-worked or dumped.

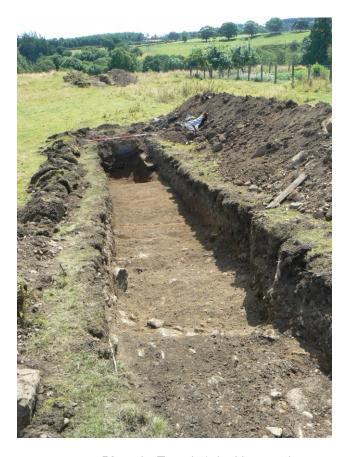
Plate 1: Trench 1, looking south

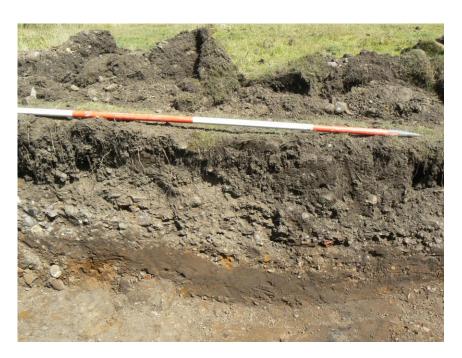
Plate 2: Gravels and sand below topsoil exposed in the central part of the west-facing section of Trench 1

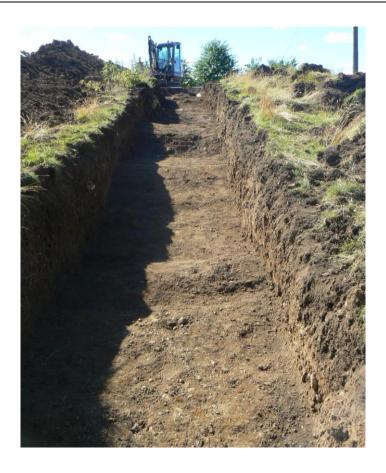
**Plate 3:** Trench 2, looking north-west. Gravels and sands exposed in the base

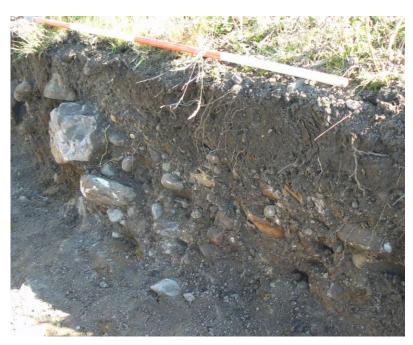
**Plate 4:** Boulder clay, sand and gravel below topsoil in the northern section of Trench 2

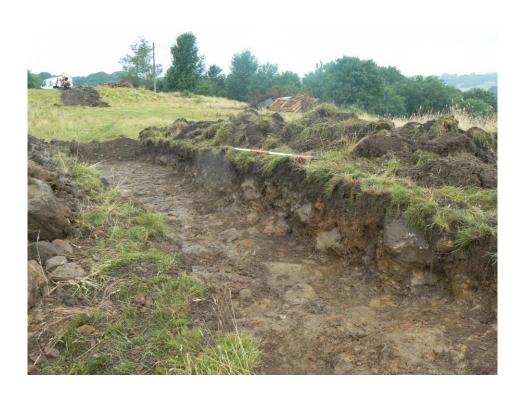
Plate 5: The west facing section of trench 3: Boulder clay below a thin topsoil.

Boulder clay is also exposed in the base of the trench

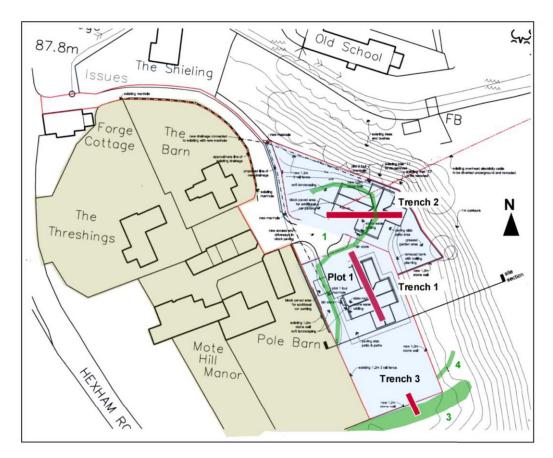
Figure 2: Developments at Mote Hill. The area in brown tone shows properties developed between 2003 and 2005; the area in pale blue covers the current proposed developments (plots 1 and 2) including the outlines of the new-build structures. Earthworks are shown and numbered in green (see section 4.1 and figure 3). Suggested evaluation trench locations are in red.

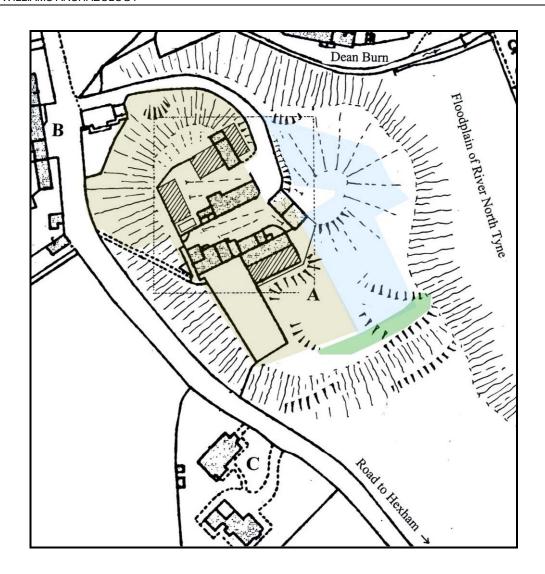
Figure 3: Peter Ryder's 2003 earthwork sketch of Mote Hill. It is annotated with the extent of the hill developed between 2003 and 2005 in brown and proposed development area in pale blue. The green area marks the approximate location of bank 3 along the southern edge of the plateau.

No ground investigations have been carried out in the area of the proposed residential development to determine its archaeological potential although Ryder prepared a sketch plan of Mote Hill in 2003 showing topographic features and earthworks then visible (figure 3). Ryder's plan differs with regard to the aspect of the current development area in that:

- 1. The garden area of the re-developed Pole Barn property extends to the south edge of the plateau. This has been levelled and is flanked along much of its eastern boundary with a low terraced bank ([4] on figure 2)
- **2.** A prominent bank lies along the south edge of the plateau ([3] on figure 2). Presumably, this is a modern feature.
