WEST FENWICK FARM

Fenwick, Northumberland

ARCHAEOLOGICAL WATCHING BRIEF DURING SERVICE TRENCHING

January 2015

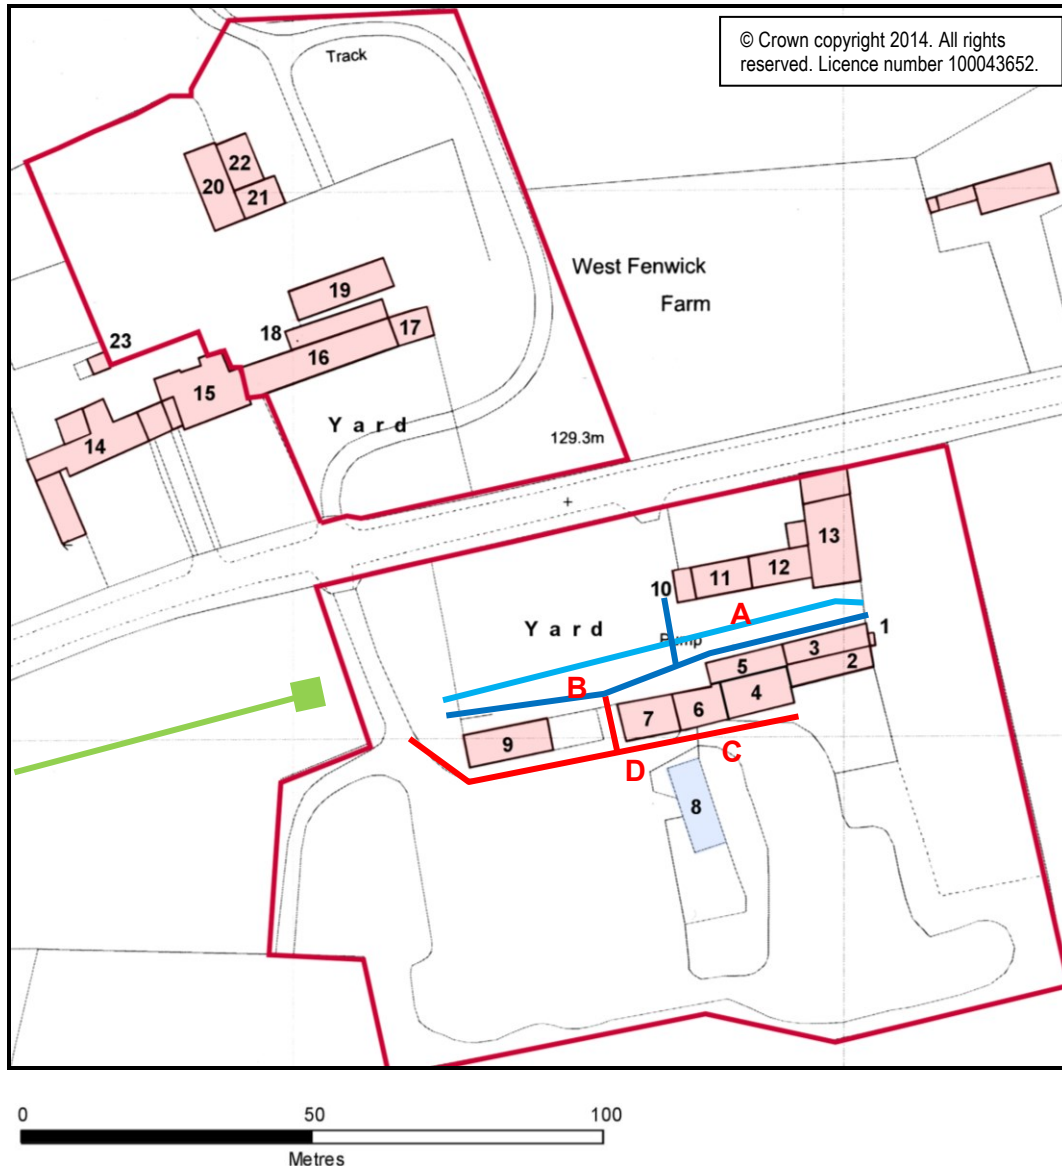
Figure 2: The building ranges of West Fenwick Farm. Building 8, in blue, has been partially demolished. North is to top of page. Excavations monitored (in green, red and blue) are described in section 6. Red letters (A, B, C and D) indicate location of illustrated sections.

The watching brief was carried out intermittently and over a period of 12 months as the installation of services was carried out across the site. This input can be broken down into three blocks of work shown on figure 2:

- Installation of sewage treatment plant and overflow trench to the west of the farm ranges in June 2013 (green line);
- Installation of drainage runs and power cables between the ranges in August 2013 and September 2014 (blue lines);
- Installation of drainage runs to south of ranges and linking with previous runs in September 2014 (red line).

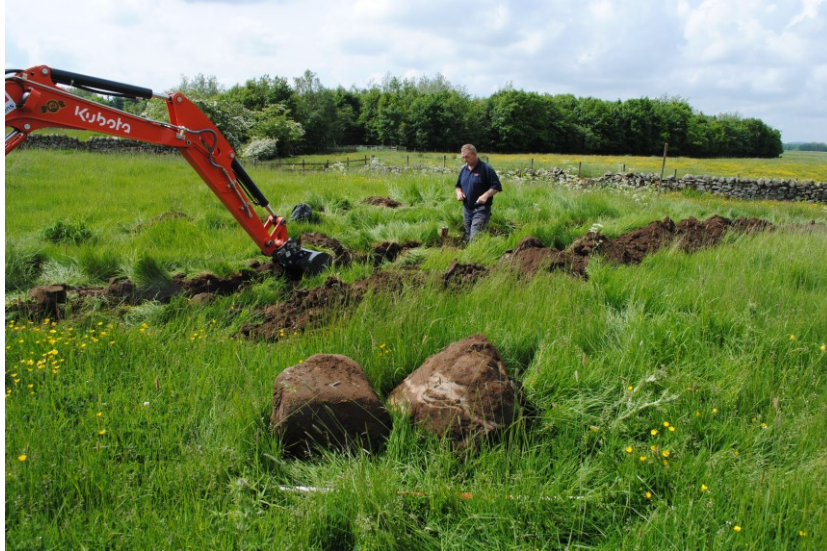
Plate 1: Excavation of the outfall drain trench for the sewage treatment plant beyond the western end of the farm ranges. Looking south-west. The boulders on the grass were removed from the trench.

This work involved the excavation of a trench to the burn flowing to the west of the site taking clean water from a sewage treatment plant to the east and the excavations for this sewage treatment plant in June 2013. Excavation of the trench was carried out by a mini excavator with ditching blade and using a toothed bucket where necessary. Deposits consisted of a very silty and friable medium grey-brown topsoil overlying mixed sandy clay and gravels which incorporated many large boulders. There was no indication that these were anything other than geological, deposited in the area at the end of the last glaciation. All of the boulders sat directly over/within the subsoil.

No archaeological features or evidence of structural remains was noted along the trench, but a number of pieces of 18th or 19th century white and blue glazed table wares were recovered from topsoil as well as one piece of medieval pottery. This was a fragment of the base of a 13th-14th century sandy-ware pot with one splash of green splatter-glaze on the base. The form of the pot could not be established from the small piece recovered.

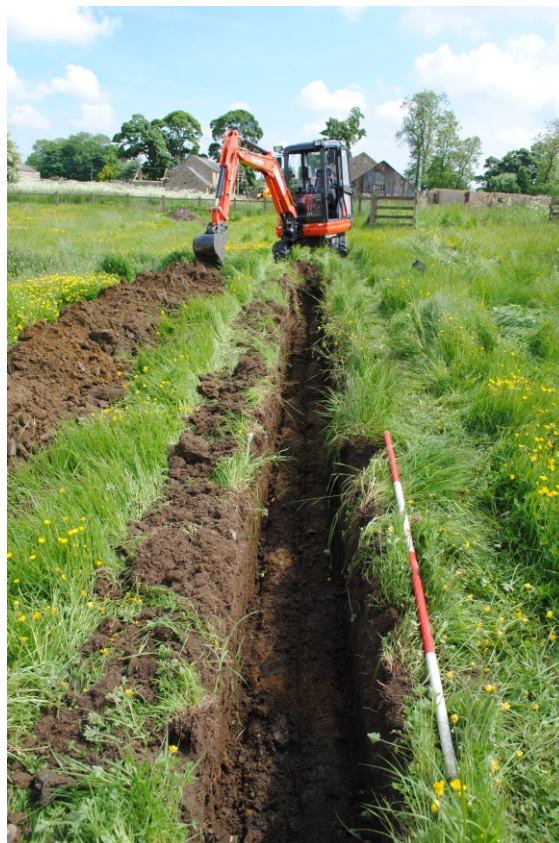
Plate 2: Excavating the outfall drain trench for the sewage treatment plant. Looking east.

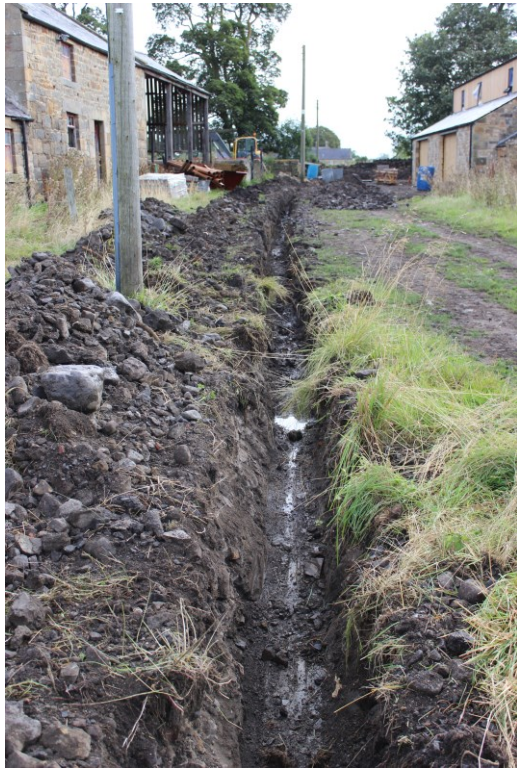
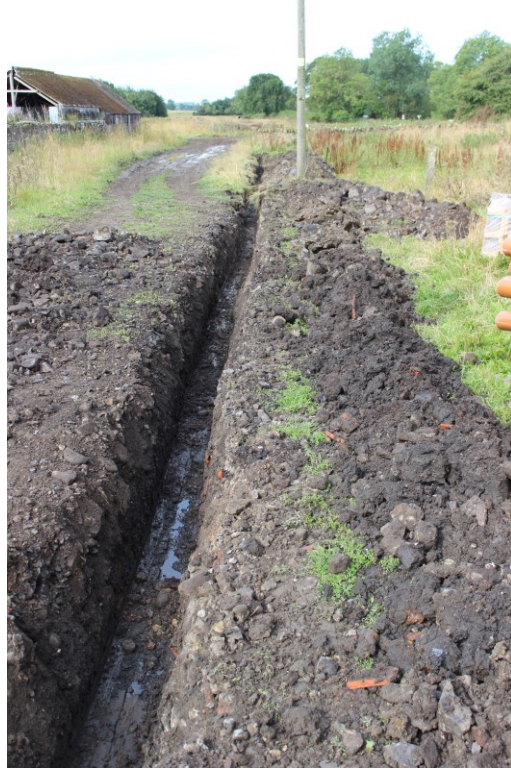
Plates 3 and 4: Looking east (left) and west along the cable trench between the farm ranges.

These trenches were excavated in the summer of 2013 (drains) and the autumn of 2014 (electricity cables) between the farm ranges to the south of the road. The general character of the areas exposed on both occasions was very similar: A substantial hard standing of cobbles and water-worn river boulders **[1]** forming the farm yard – with occasional deeper areas of stone presumably inserted in wet areas and where there were pre-existing irregularities - overlay intermittent remnants of a buried topsoil and underlying deposits of fire ash **[2]**. This in turn overlay a glacial Boulder clay subsoil including much gravel and sand, sometimes banded. No discrete archaeological features or deposits were seen.

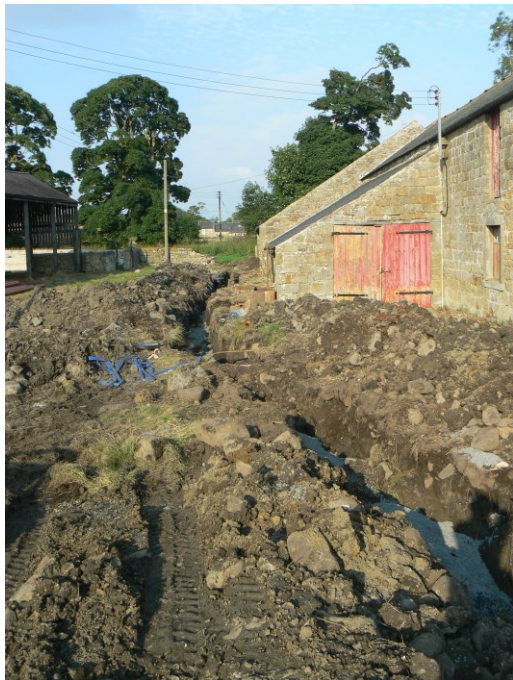
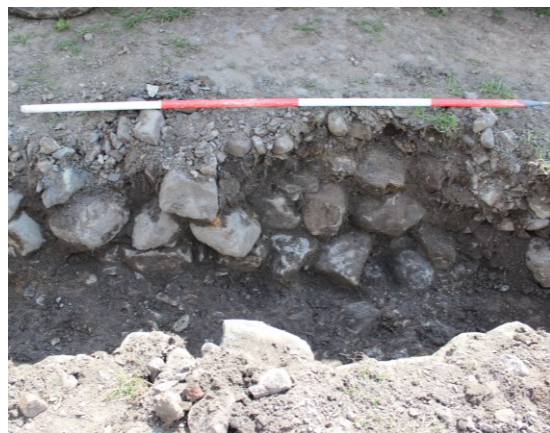
Plates 5 and 6: The plate to left shows the drainage run looking east. The plate to right shows a deep area of the farmyard cobbles.

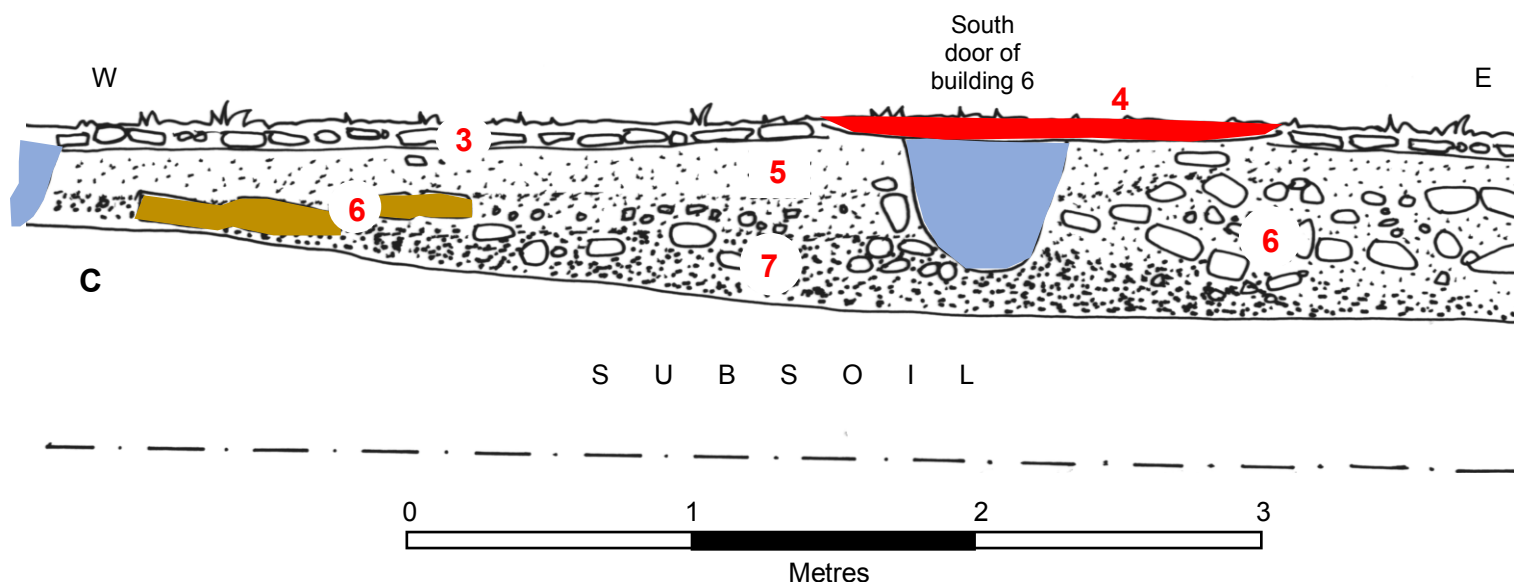
Figure 4: Trench section (C on figure 2) to the south of building 6. For description of the context numbers (in red) see text. Base of trench marked with broken line. Old service trenches shown in blue tone.

This drainage trench was excavated in autumn 2014 along the south side of the south ranges: the bastle-like building 4 and later domestic building 6. Section C shows the most complex area of stratigraphy along this trench seen in front of building 6. A very fragmented and largely turf-covered concrete yard extended across this area. This was seen in the trench as a fragmented crust [3] below a thin turf layer. A discrete concrete path [4] was also seen in section (in pink on figure 4), running south from the south door of building 6. Deposits of ash [5], especially in front of buildings 4 and 6 sat below yard surface [3]. Running below this upper ash deposit in the area of the same buildings were the remnants of a cobble/boulder surfaced yard [6]. A part of this, towards the western end of building 6, was fairly well preserved (shown in buff tone on figure 4); further to the east, and across building 4, the stones became very badly jumbled together with ash deposits. A layer of dark ash and loamy soil [7] lay below surface [6] where this was preserved to the west.

No artefactual material was recovered from ash layers or yard surface [6] to provide a date for their formation. It is feasible that yard surface [6] was of a similar date to the yard seen to the north but overlaid during fairly recent updating of buildings on the south of the ranges. Subsoil lay between 0.5m to 0.6m at most points along the trench.

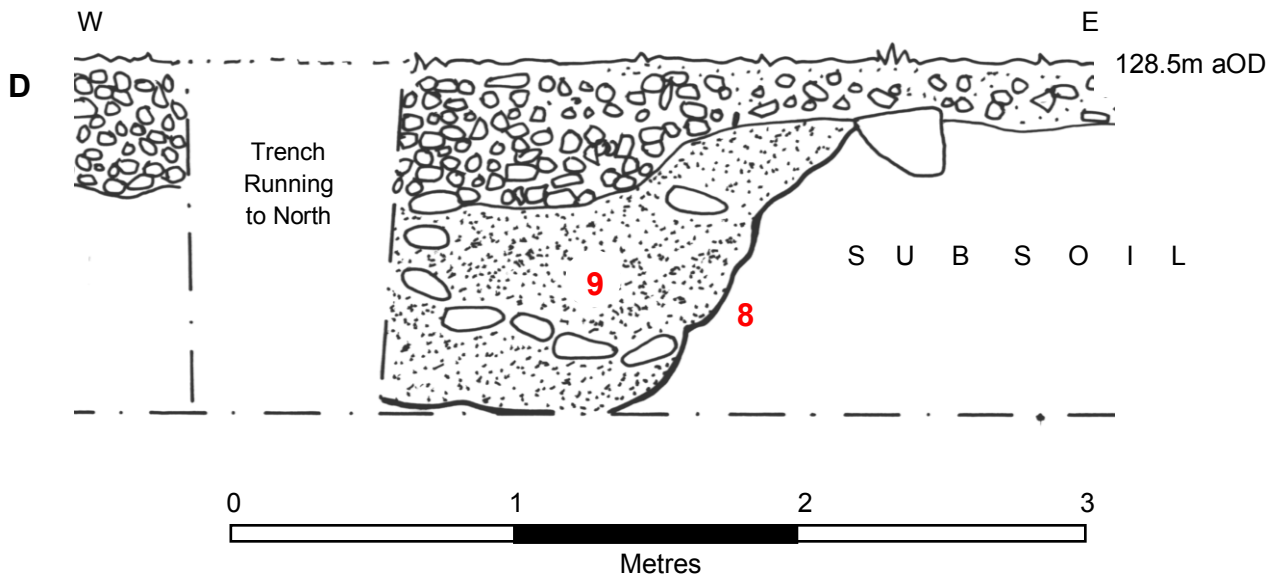
Figure 5: Trench section (D on figure 2) to the west of building 7 showing feature [8].

To the west of the building ranges was a substantial cut feature [8] (see figure 5). This had been truncated on its western edge by a connecting pipe run extending to

the north. It was 1.2m deep and at least 1.5m wide east-west with a steep and irregular east edge and filled with a medium grey-brown sandy loam with some large stones [9]. No clear edge was seen in the face of the trench cut to the north. No artefactual material was recovered from within [8] to suggest a date. It may have been a relatively modern feature, perhaps the product of the removal of agricultural fixtures in this area.

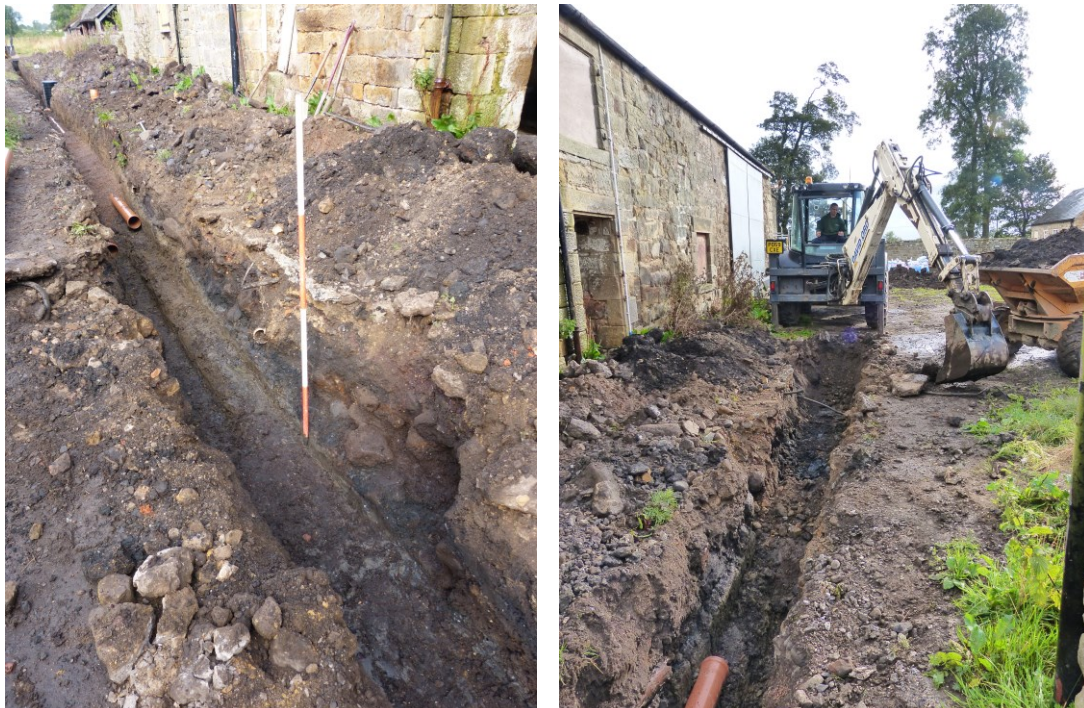
Plates 7 and 8: Plate to left shows the trench alongside building 6, looking west. Plate to right shows the same location, looking east.

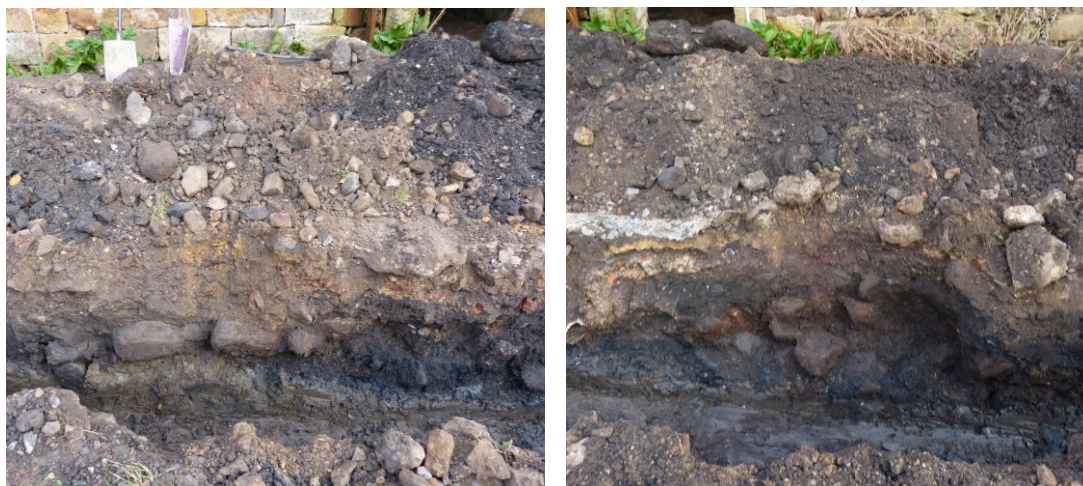
Plates 9 and 10: Trench to south of ranges. Plate to left shows the western part of yard surface [6] which was well-preserved in the section. Plate to right shows the eastern part of [6] in which stones were jumbled together with ash deposits.

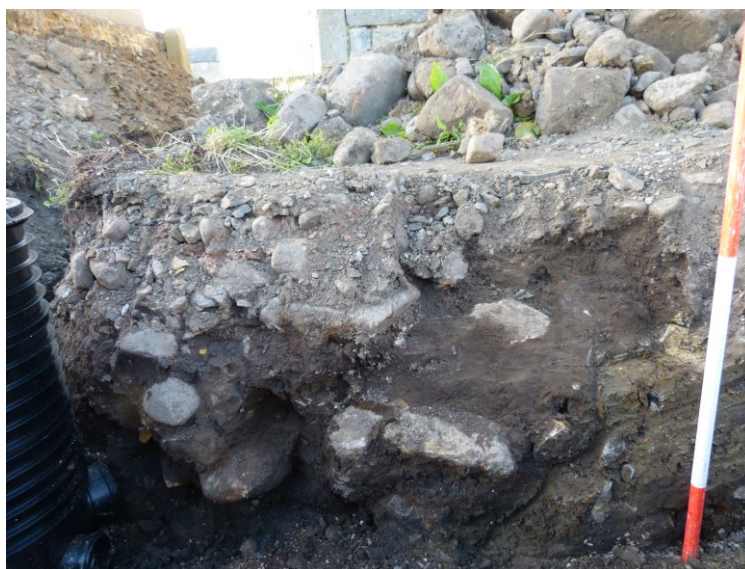
Plate 11: Cut feature [8] in the north face of the trench to the south of the farm ranges to the west of building 7.

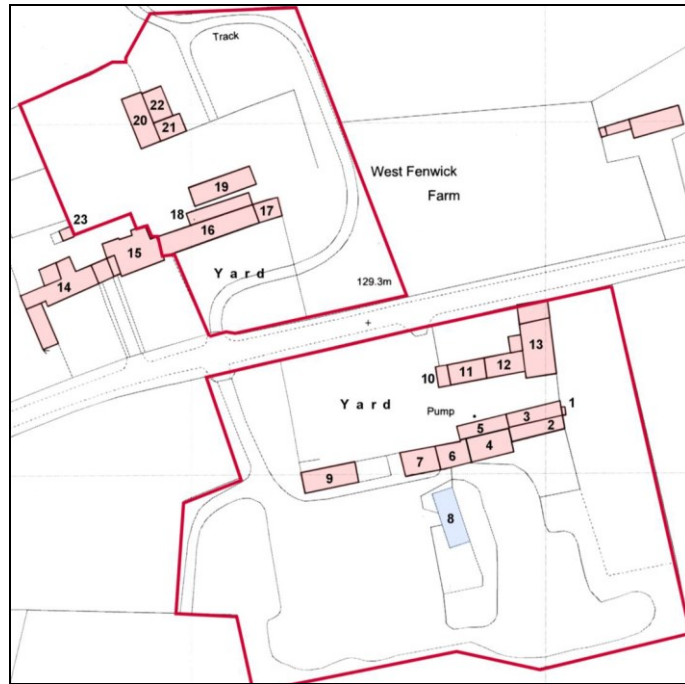
Figure 2: The building ranges of West Fenwick Farm. Building 8, in blue, has been partially demolished. North is to top of page.

South of the road, farm buildings border the southern and eastern edges of a now-grassed and waterlogged farm yard. The long south row, all sandstone buildings, include a netty (1); cart shed/shelter shed with stone piers and first floor granary (2); an equipment store and shelter-shed with cast-iron columns (3); the shell of a heavily-converted bastle-house (4); a domestic lean-to extension on the north side of the bastle (5); a domestic block to the west of the bastle (6) and a cattle byre beyond (7); a now roofless barn with evidence of raised cruck roofing timbers (8); and a brick structure to the west beyond an entrance into the yard (9). The shorter northern row to the east of the yard includes a loose box (10); a stable for five horses with one stall intact (11); a timber barn (12); and a modern roofed animal-pen built around a walled yard and a demolished stone structure (13).

Farm buildings to the north of the road consist of a long row of buildings running east-west including listed agricultural ranges (14) and North Fenwick Farmhouse (15) both beyond the current application area; a long range of stone buildings (16) with a former house attached to the east end (17); a shelter shed and Dutch barn to the north (18) and (19); with a discrete block of structures beyond including a stone barn (20) and adjoining block (21) with a timber, open-fronted lean-to in the angle between (22) and a stone netty block (23) to the north-west of North Fenwick Farmhouse.

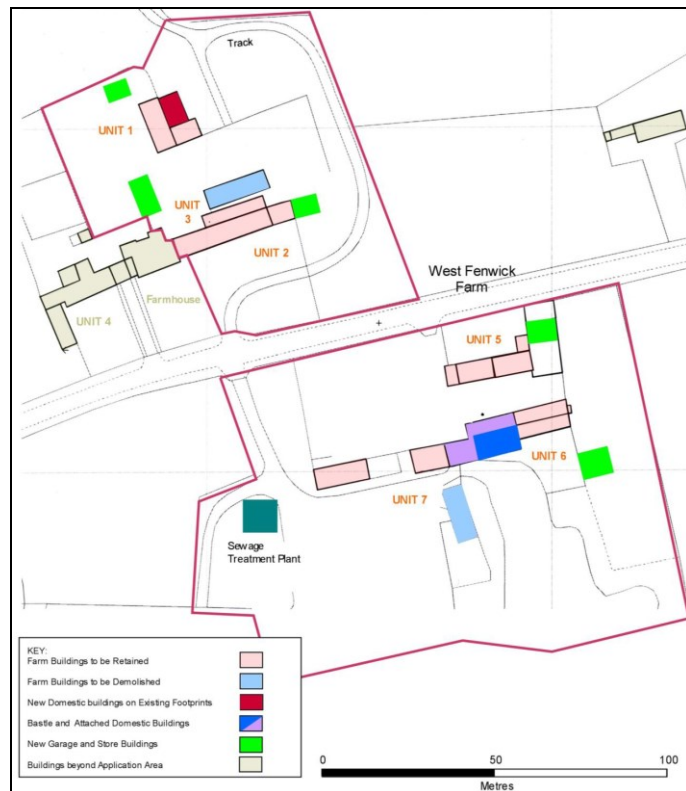
Figure 3: Developments at West Fenwick Farm. North to top of page.

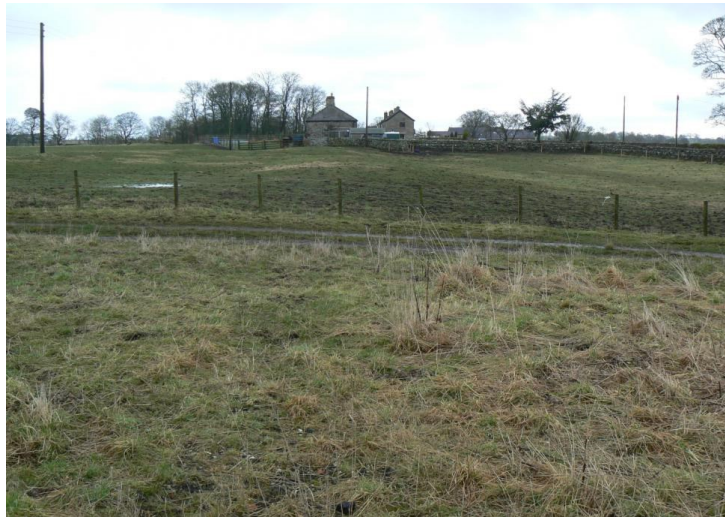
Plate 1: An earthwork running from The Forge (centre of frame) towards the buildings of North Fenwick Farm. As noted above, it probably marks the line of medieval tenements
