# BRADLEY HALL

Wolsingham, County Durham

## ARCHAEOLOGICAL WATCHING BRIEF DURING EXCAVATION OF TRENCH FOR HEATING MAIN

September 2014

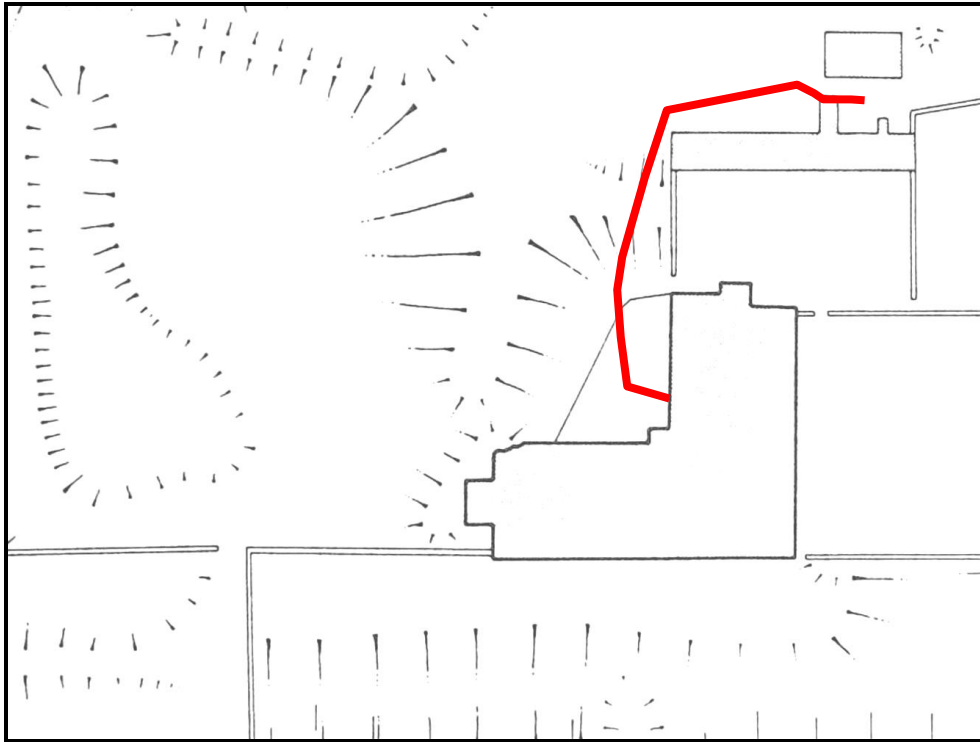
**Figure 4:** Part of the earthwork survey (see figure 17 for whole extent) of the moated site carried out in 1992 at Bradley Hall (Annis and Ryder 1992). Line of trench is annotated in red.

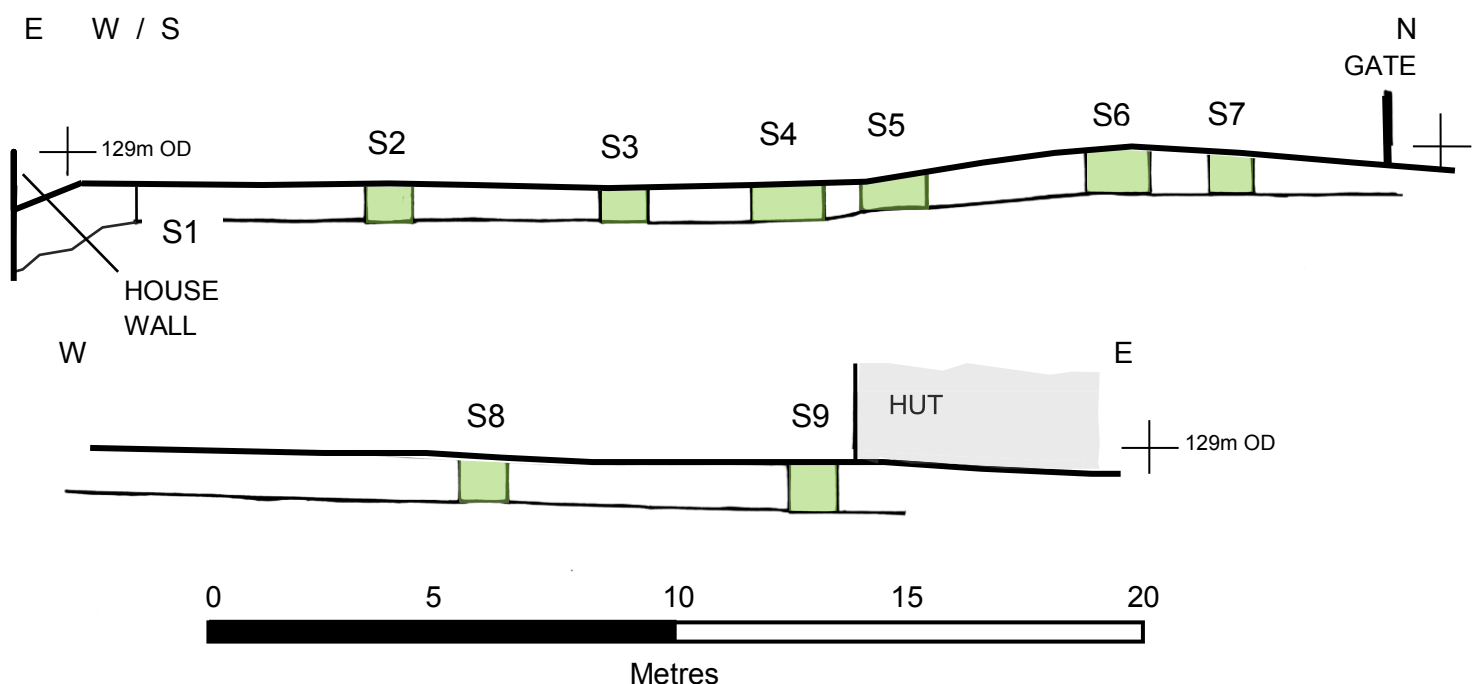
**Figure 6:** Profile of Pipe trench with location of section drawings 1 to 9 (green tone).  
S1 is a transverse section. Level aOD of trench run shown above.

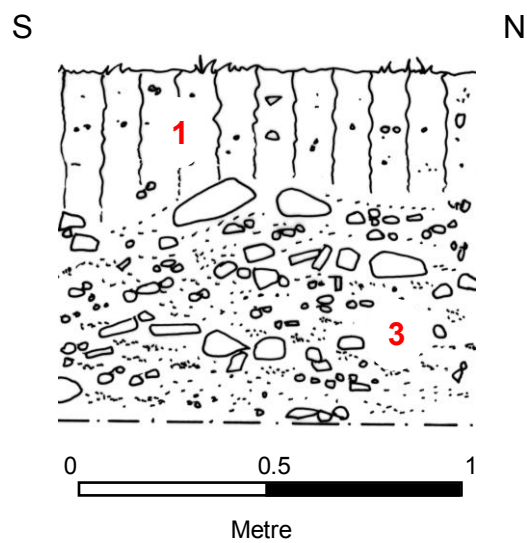
**Figure 8:** Section 2 (see figure 6) along the western side of the pipe trench (1:20).

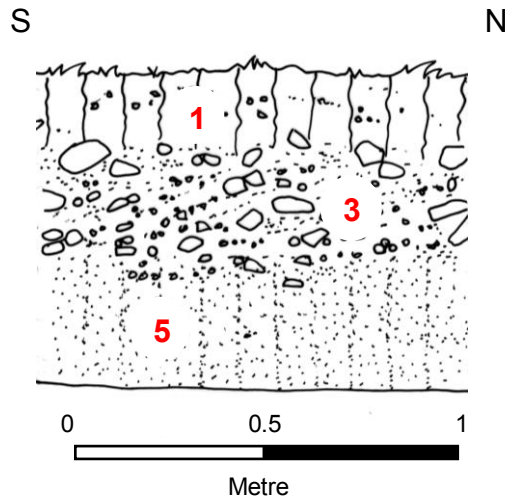
**Figure 9:** Section 3 (see figure 6) along the western side of the pipe trench (1:20).

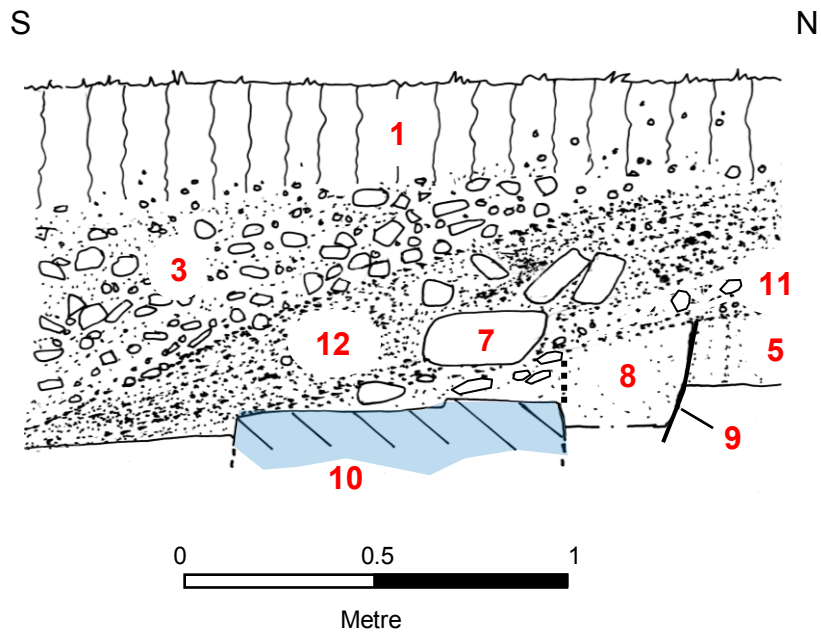
**Figure 10:** Section 4 (see figure 6) along the western side of the pipe trench (1:20) showing the remains of wall [10] and cut [9] to its north (1:20).

Khaki-brown topsoil [5] developed over clay subsoil across the area. This was cut away towards the middle of the north-south run of the trench by a foundation cut [9] for an east-west running sandstone wall [10]. This was c.0.85m wide and had been truncated to the level of subsoil. To the north, the foundation trench was 0.4m wider than the wall and was filled with a pale grey-brown sandy loam [8] with some small stones. The east-west extent of the wall is not known.

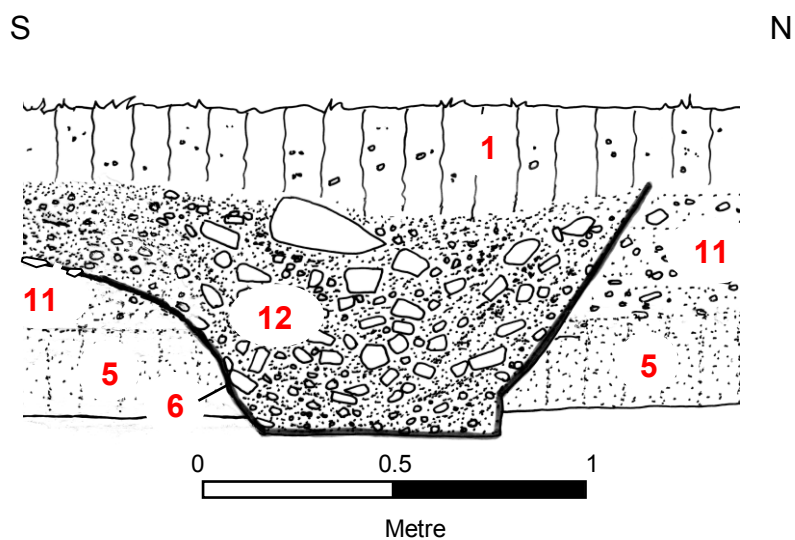
**Figure 11:** Section 5 (see figure 6) along the western side of the pipe trench (1:20) showing cut [6] (1:20).

Cut into [11] was a broad east-west running trench with sloping sides and a flat base. This probably marks the robbing of a pre-existing feature, possibly a wall, from which all fabric had been removed. The trench was filled with a very dark grey gritty loam with many small fragments of stone [12]. This deposit extended to the south of the trench, spilling over the exposed robbed out remains of wall [10]. Overlying deposit [12], and extending from the south end of the trench, was a very substantial rubble and mortar spread [3], presumably the residue of a demolished structure.

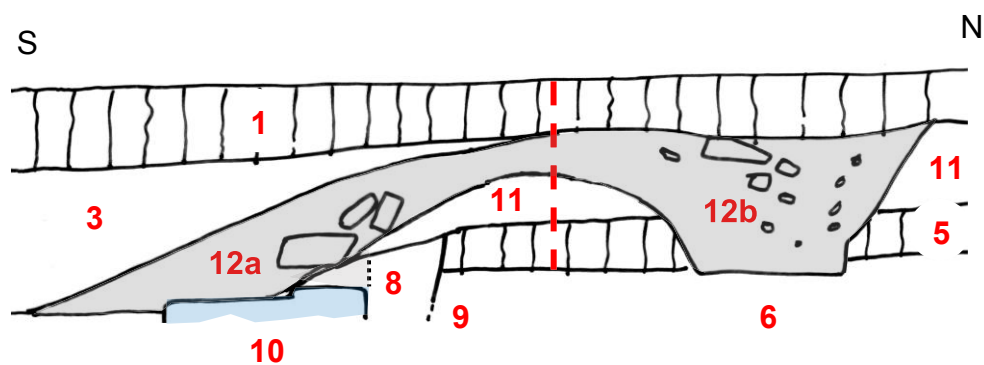
**Figure 12:** Amalgamation of sections 4 and 5 (junction on red dashed line) showing stratigraphic association (not to scale).

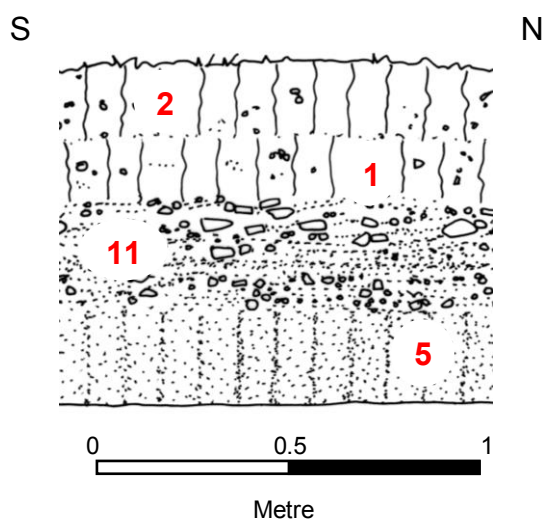
**Figure 13:** Section 6 (see figure 6) along the western side of the pipe trench (1:20).

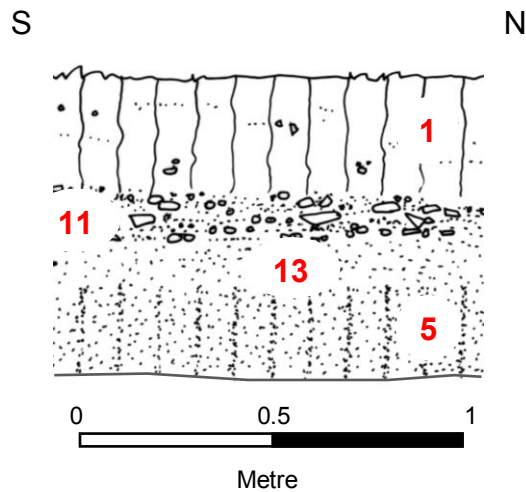
**Figure 14:** Section 7 (see figure 6) along the western side of the pipe trench (1:20).

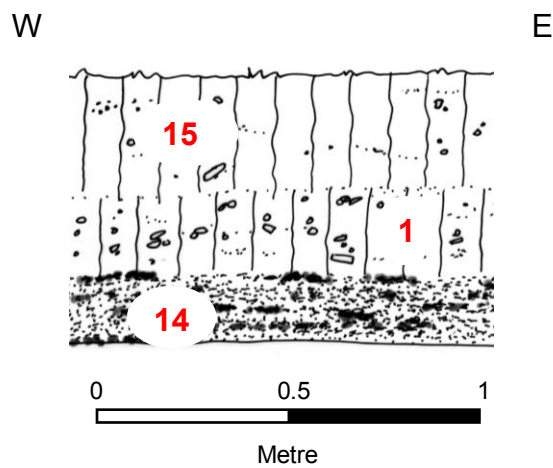
**Figure 15:** Section 8 (see figure 6) along the northern side of the pipe trench (1:20).

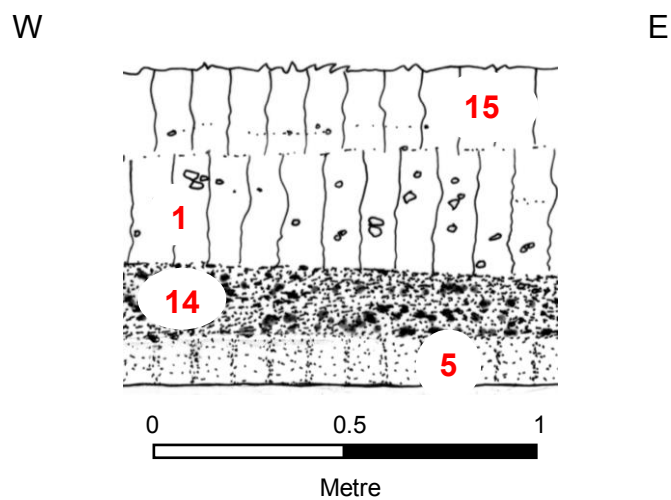
**Figure 16:** Section 9 (see figure 6) along the northern side of the pipe trench (1:20).

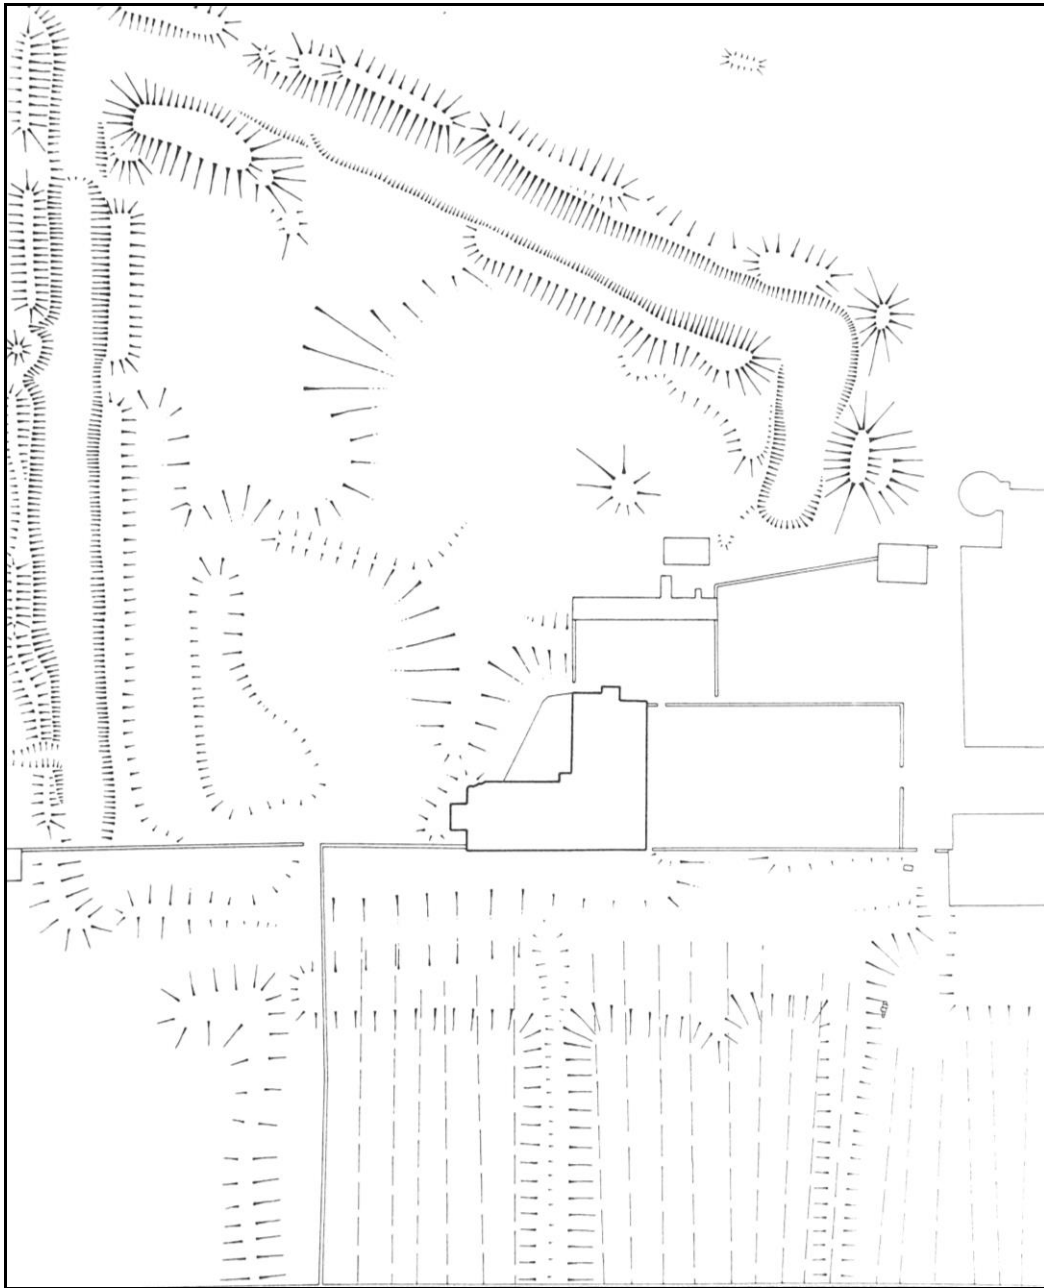
**Figure 17:** *Earthwork survey of Bradley Hall and earthworks prepared during a survey of the complex (Annis and Ryder 1992).*

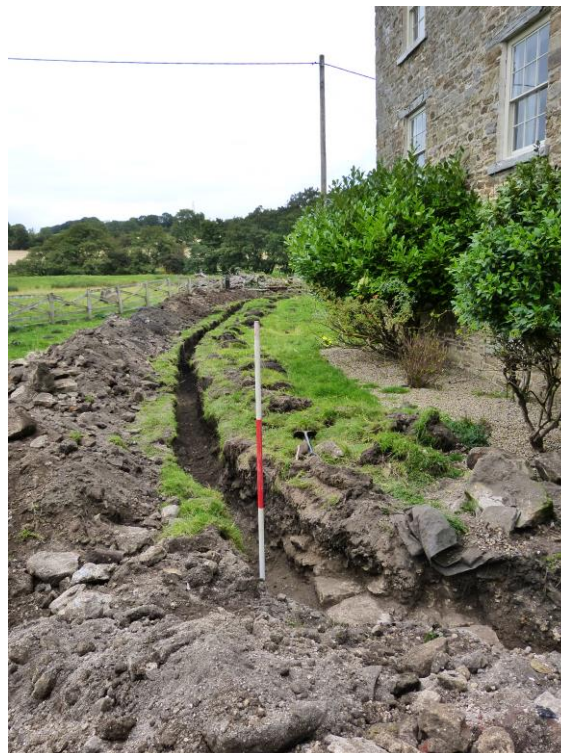
**Plate 4:** *Looking north. Trench excavated to west of farmhouse. Wall [4] can be seen to right of 2m ranging rod.*

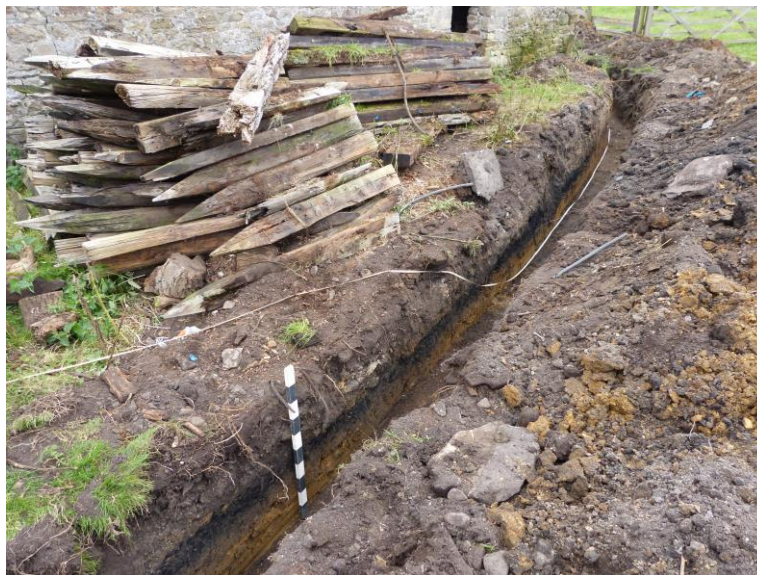
**Plate 6:** *Looking west along the northern run of the trench. Layer [14] can be seen as a dark band running along the trench. 1m scale.*

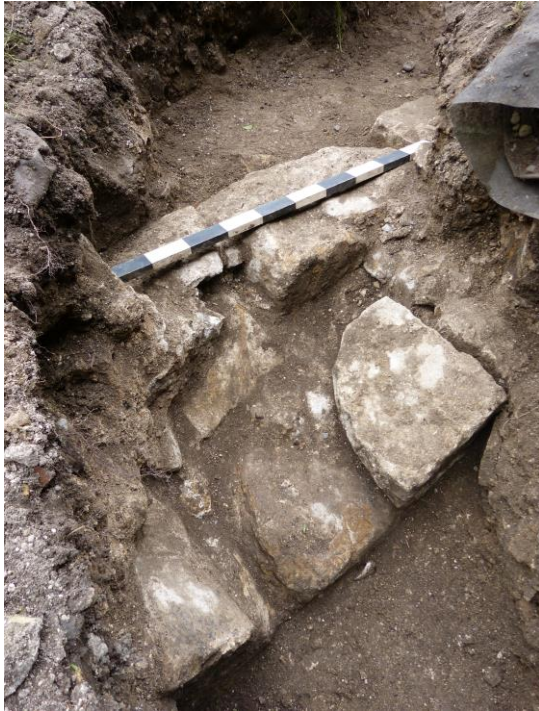
**Plate 7:** Wall [4] looking north-west. 1m scale.

The trench exposed the truncated remains of at least two walls. North-south running wall [4] was seen at the south end of the trench. It was of large sandstone blocks

bonded with mortar and 1m wide. Its length was untested. It may have joined to the north with another truncated wall [10] seen within the trench or terminated before it reached that wall. Wall [10] ran east-west 3.4m to the north of the northern corner of the farmhouse. It was narrower than [4] at 0.8m wide but was also mortared. The robbed-out remains of a possible third wall may have been marked by trench [6] which ran parallel with and just over 1m to the north of [10].

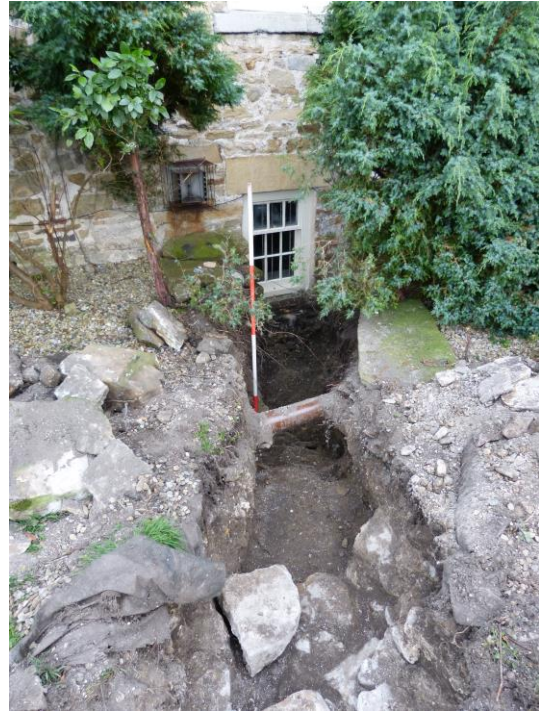
**Plate 8:** Looking south-west along trench to farmhouse wall. Wall [4] at bottom.

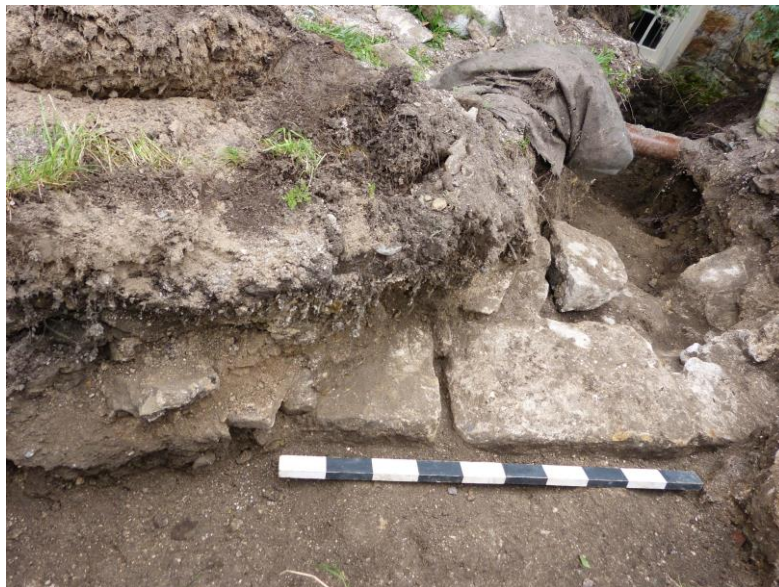
**Plate 9:** Wall [4] looking south-east. 1m scale.

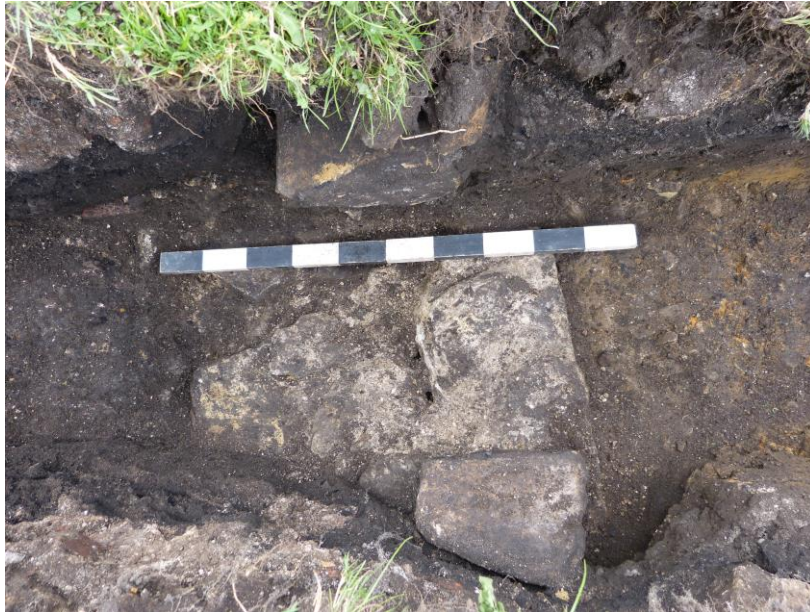
***Plate 10: Wall [10] looking west. 1m scale.***

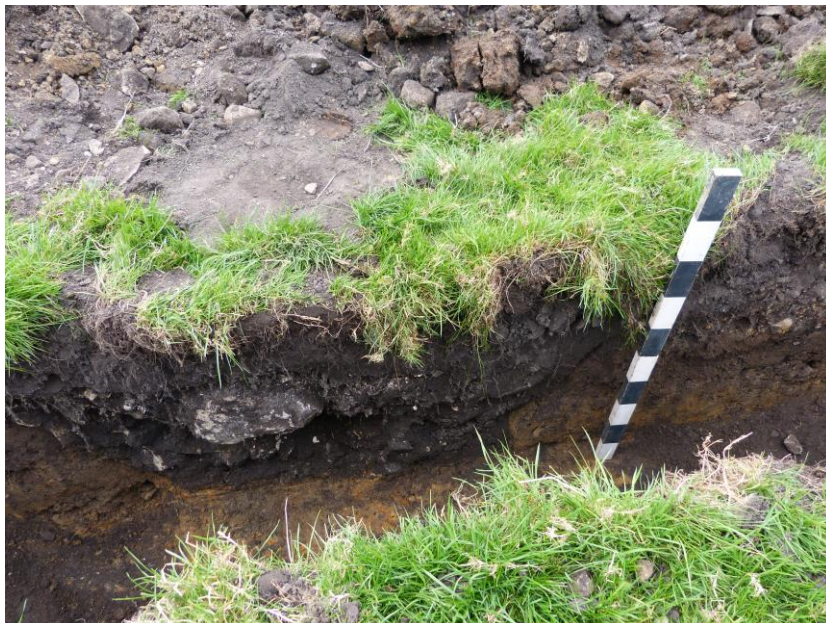
***Plate 11: Feature [6] in section. Looking west. 1m scale.***

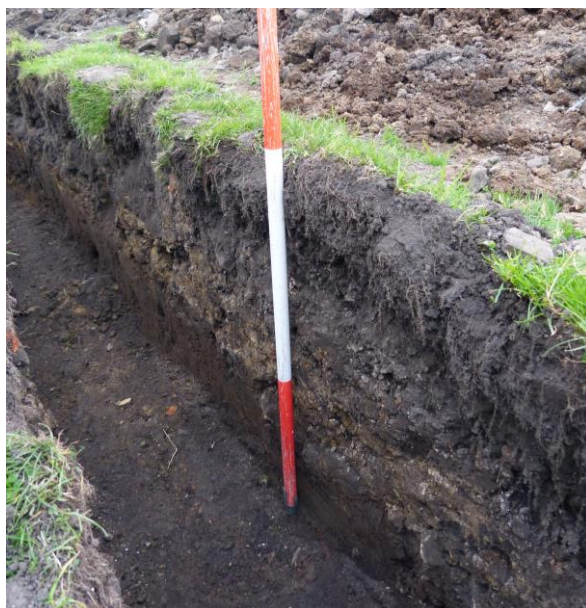
**Plate 12:** Section through east-west running bank looking south-west. Ranging rod with 0.5m divisions.

No evidence was found to suggest that the east-west bank to the north of the farmhouse had formed over the demolished remains of a north range of the medieval house.

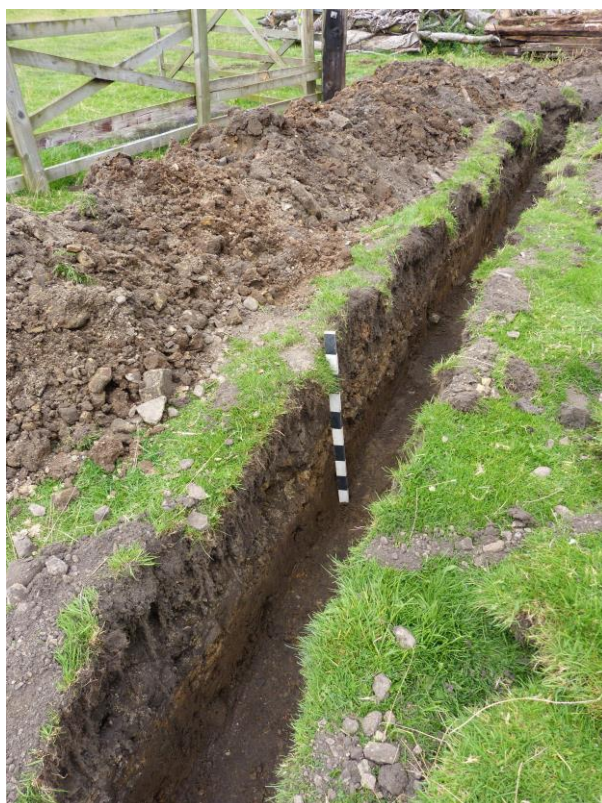
**Plate 13:** Section through east-west running bank looking north. 1m scale.
