Corbridge Old Pottery

Corbridge, Northumberland

Post-Conservation Photographic Review

March 2016

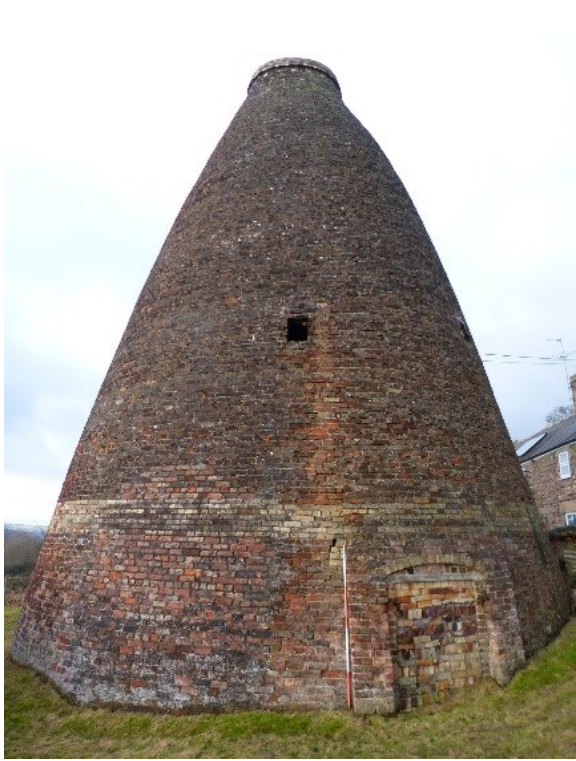
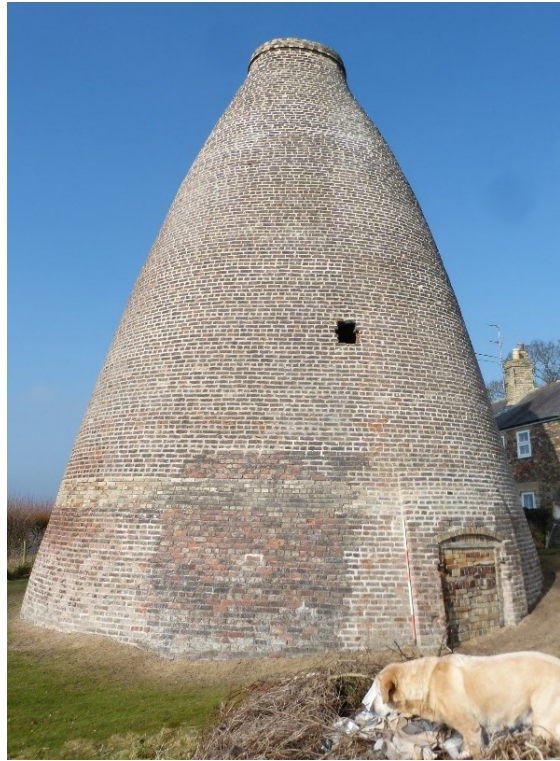
Plates 1 and 2: Western bottle kiln from the east. Pre (left) and post conservation. 2m scale.

The larger of the two bottle kilns at the pottery and of rather more conical form than the eastern kiln. It is c.10.5m diameter at the base and just over 14m high with an opening at the top of around 2m across. In red brick English garden-wall bond with a yellow brick band of seven courses running around the kiln above the lintels of the original entrances and with a mixed yellow and red brick collar. The kiln wall is one and a half bricks thick (0.38m) up to c.3m from ground level and then one brick thick (0.25m). Internally, the walls are corbelled, externally they are smooth. The kiln has a number of large yellow bricks set in the wall face internally, their function is not certain. The two original opposing entrances to south-west and north-east have vertical brick jambs, framed with projecting piers to either side. Both entrances are 1.2m wide and have flat timber lintels topped with a row of bricks set below a yellow-brick segmental arch. The north-east door has been blocked with yellow and glazed bricks. A later opening in the south-east face of the kiln has been blocked and can be seen as a rough, round-headed scar. Three small rectangular openings have been made through the brick shell of the kiln at around mid-height and on the east and north-east faces. One of the openings has a lintel set above it. Internally, a pottery workshop was constructed within the kiln in the late 1970s. This is a free-standing structure which still survives and does not physically impact on the kiln.

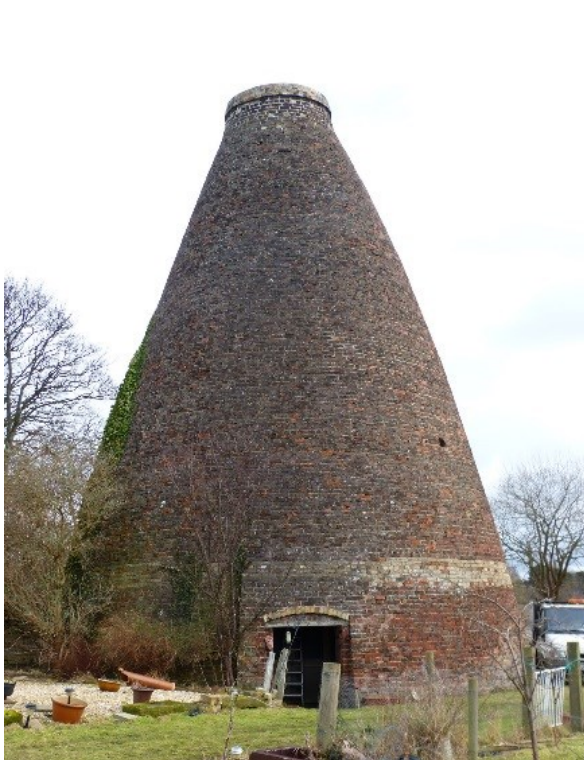
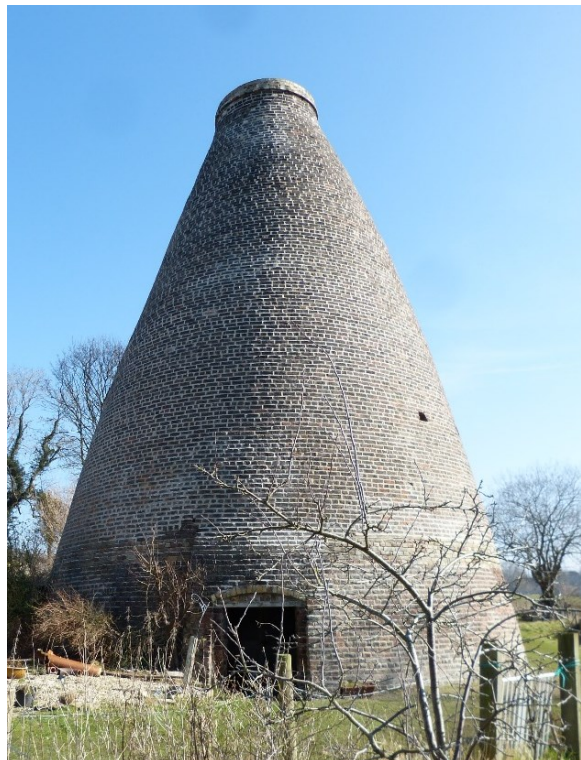
Plates 3 and 4: Western bottle kiln from the south-west. Pre (left) and post conservation.

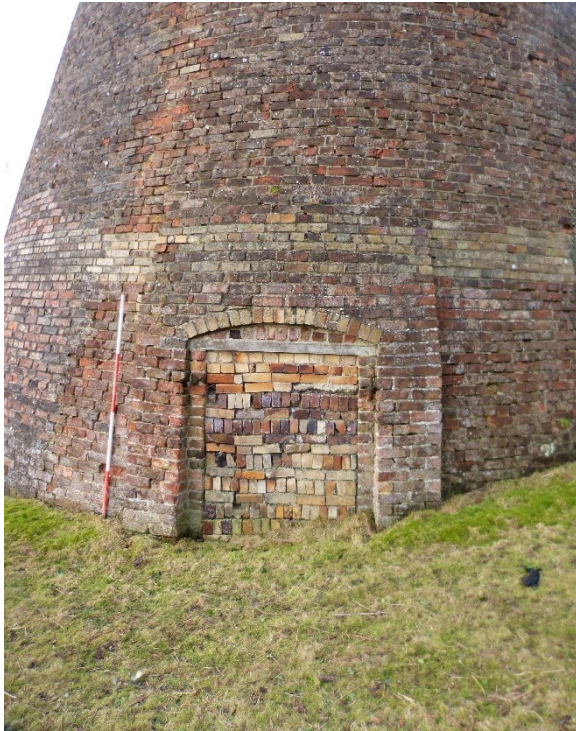
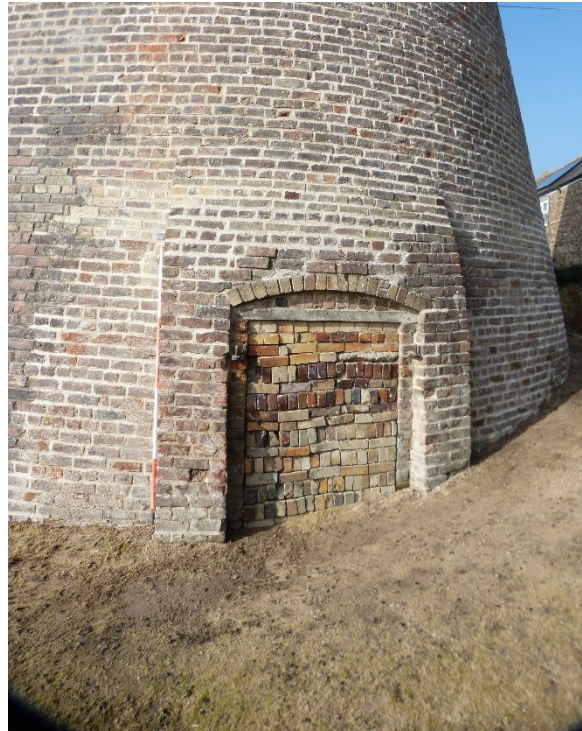
Plates 5 and 6: Western bottle kiln. The eastern entrance. Pre (left) and post conservation. 2m scale.

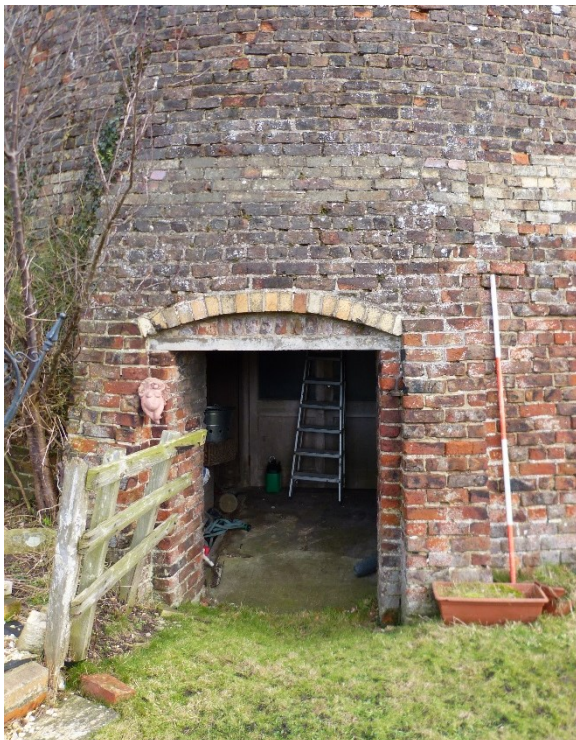
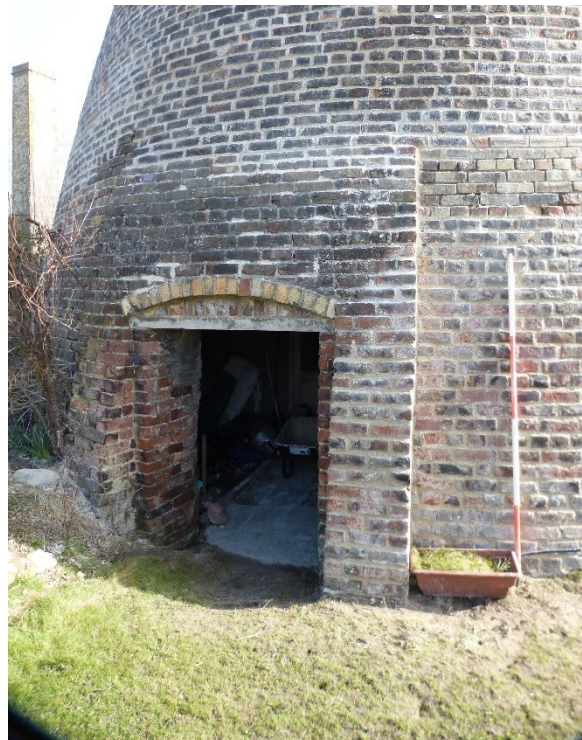
Plates 7 and 8: Western bottle kiln. The western entrance pre (left) and post conservation. 2m scale.

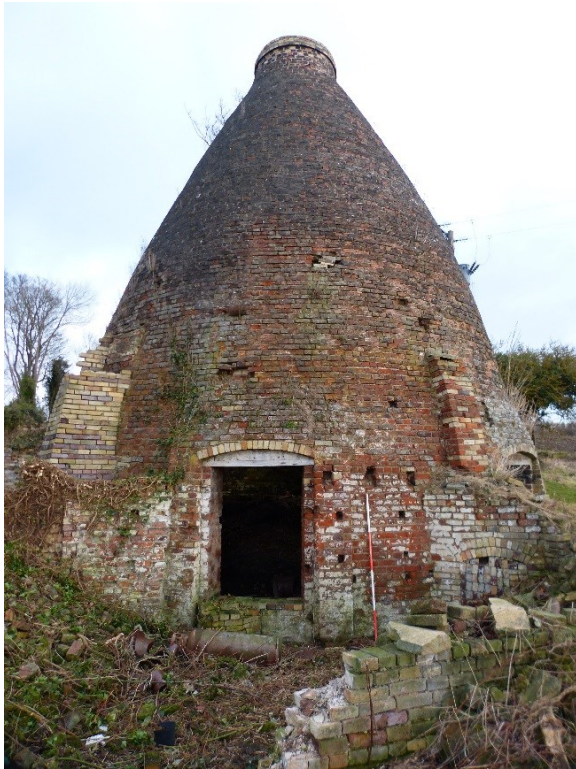
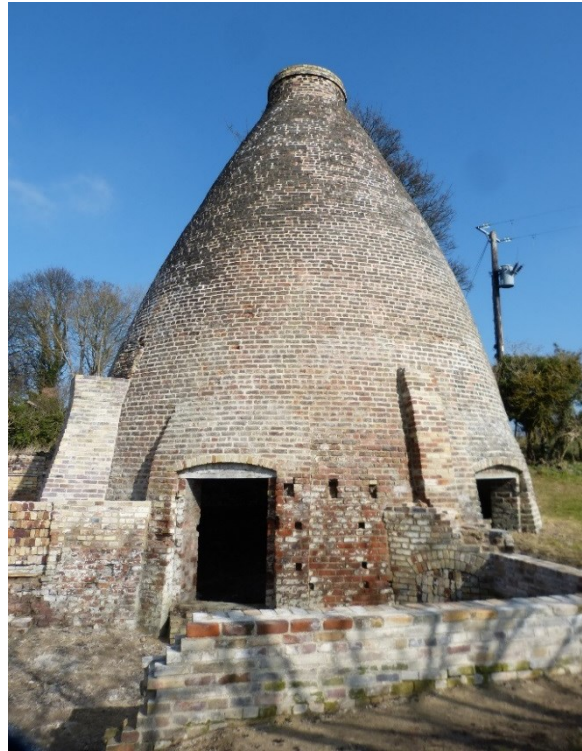
Plates 9 and 10: Eastern bottle kiln from the south. Remains of building (8) in front. Pre (left) and post conservation. 2m scale.

The smaller of the two bottle kilns at the pottery and of a more bulbous form than the west kiln. Red brick with infrequent yellow brick in English garden-wall bond with a number of patches and areas of repointing. The collar at the top is in yellow brick headers. The shell of the kiln is one and a half bricks thick (0.38m) up to c.3m from ground level and then one brick thick (0.25m). Base diameter is c.10m, height just under 13m. Opening at top is c.2m diameter. Brickwork is corbelled internally but smooth externally. Internally, there is a number of large yellow bricks set horizontally, their function not certain.

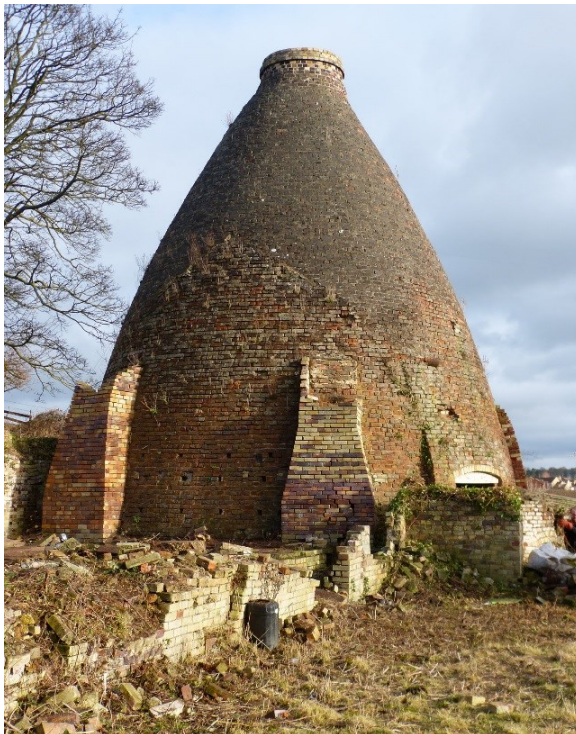
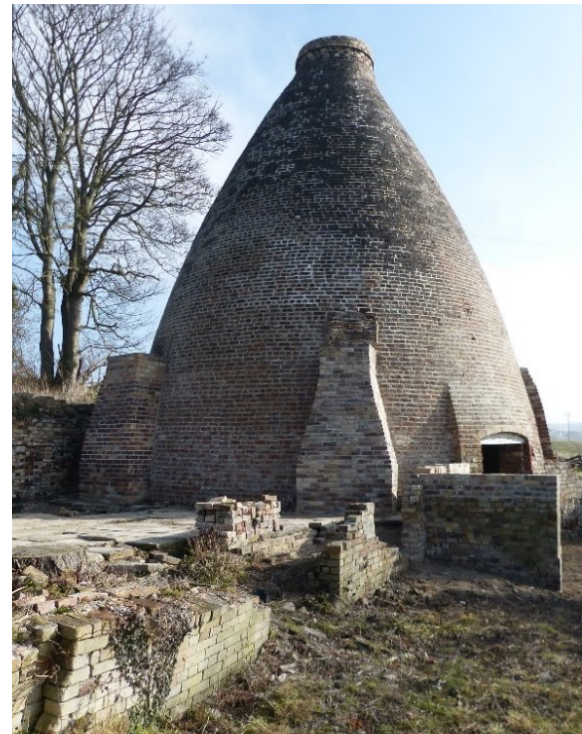
Plates 11 and 12: Eastern bottle kiln from the west. Remains of drying floor (7) and building (8) in front. Pre (left) and post conservation. 2m scale.

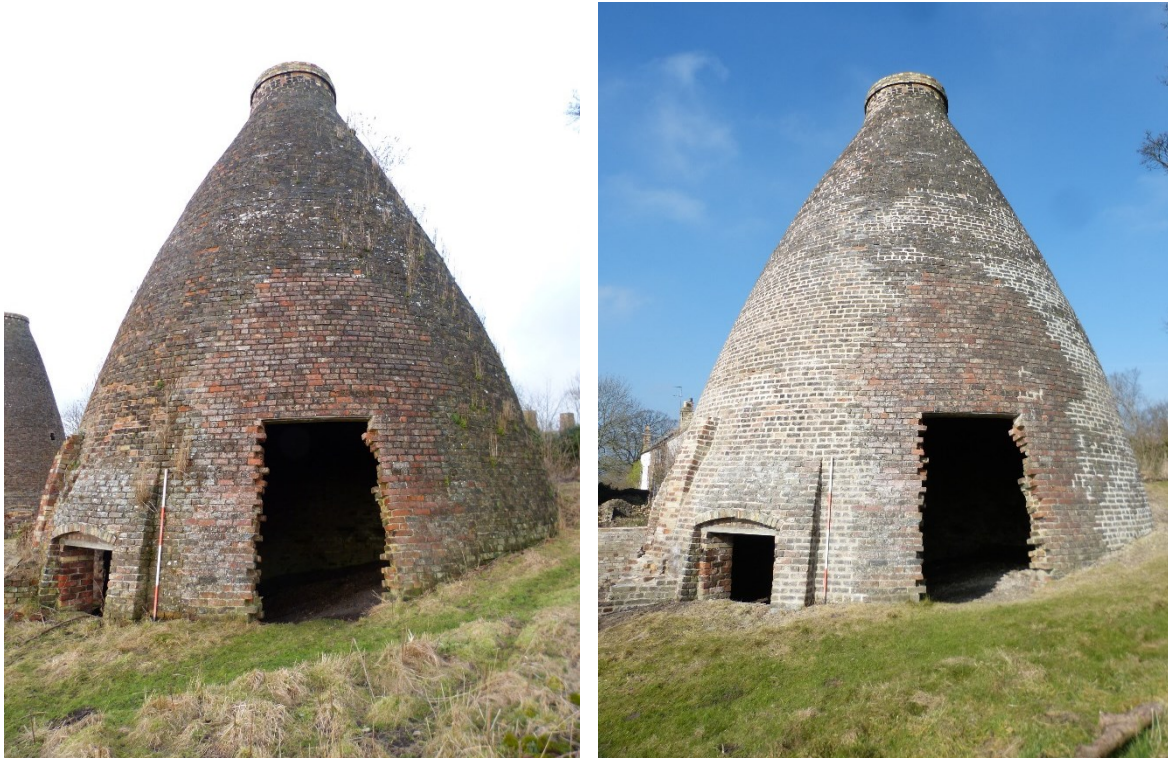
Plates 13 and 14: Eastern bottle kiln from the east. Original south-east entrance at left and late entrance at centre. Pre (left) and post conservation. 2m scale.

There are original entrances in the south-east and south-west faces of the kiln with vertical jambs set between projecting brick piers internally and externally. Both entrances have flat timber lintels topped with a row of bricks set below a yellow-brick segmental arch. There is a large, later opening in the east wall which has now been partially infilled. Ground level within the kiln slopes markedly from north to south. There are no internal features. Externally, there are two rectangular and tapering flues attached to the west face of the kiln in yellow and glazed brick. The flues served the now demolished drying-shed (7) which extended from and abutted the western face of the kiln which bears the marks of the roof of this structure. Between the flues is a rectangular pattern of holes in the brickwork, possibly for holding racking for the drying products within. A further range (8), running along the south face of the drying shed, abutted the kiln on its south face. Within the area of this building there is an oblique fireplace with shallow flue above which runs up the south face of the kiln adjacent to its south-east entrance; this is of red and yellow brick. The rectangular pattern of holes seen in the west face of the kiln also appears within the footprint of this building.

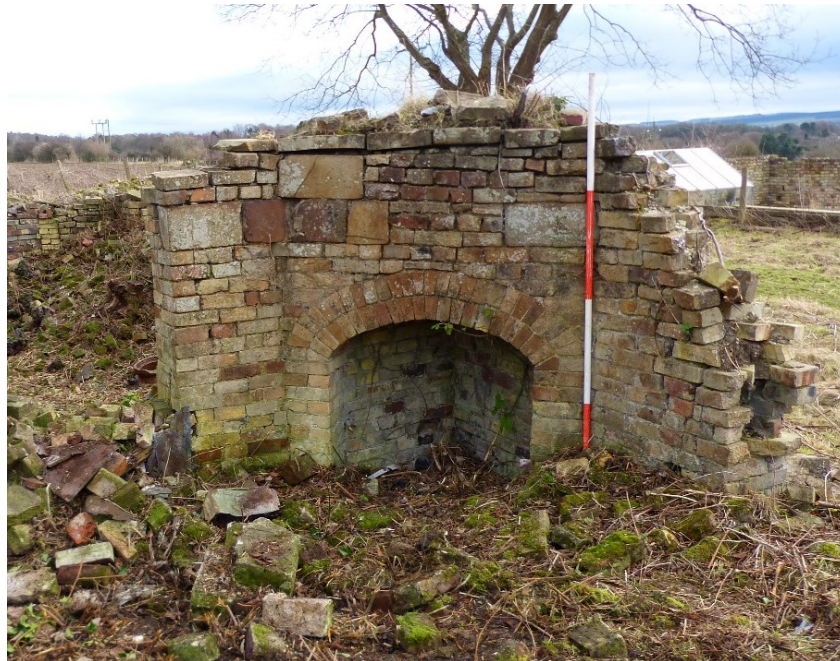
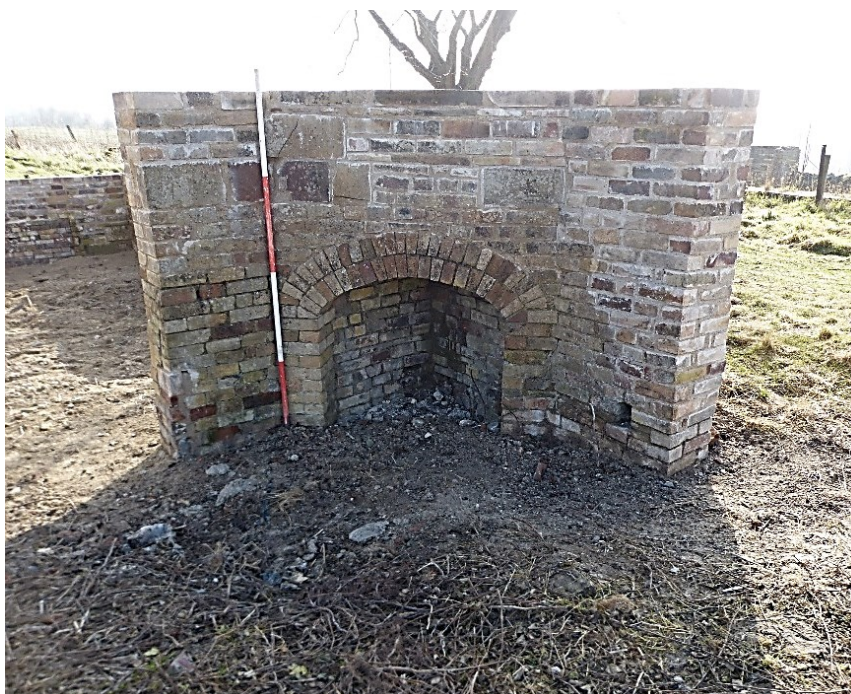
Plates 15 and 16: Fireplace in the south-east corner of the middle room of building 8 to the south of the eastern bottle kiln. Pre (top) and post conservation. 2m scale.

3.3 The remains of building (8) were cleared of vegetation and surviving stub walls (including two fireplaces) capped and edged with new brickwork.

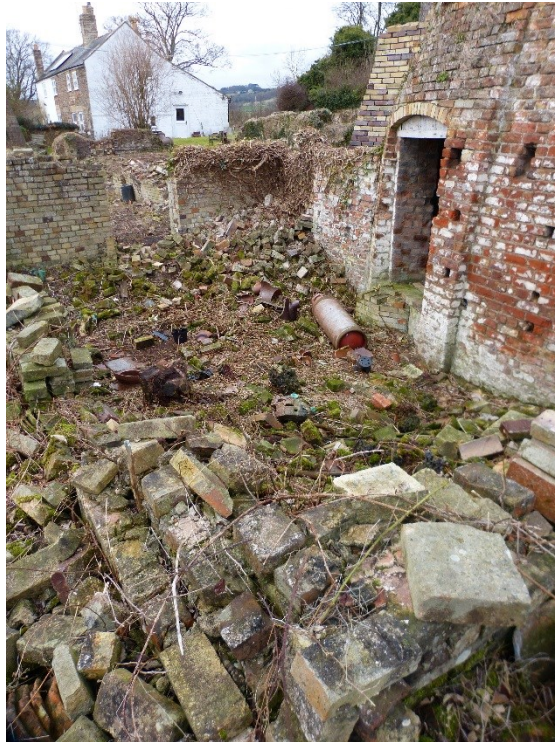
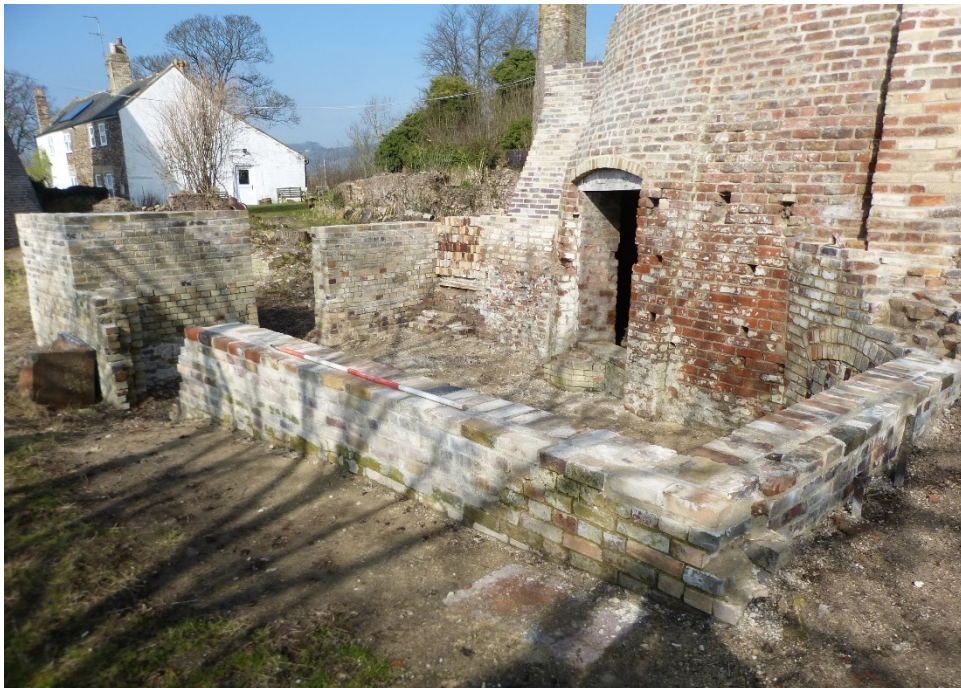
Plates 17 and 18: Looking north-west across remains of building 8 to the south of the eastern bottle kiln. Pre (top) and post conservation. 2m scale.

The central block of the range is the earliest part of this east-west row and was free-standing. Drawings and photographs from the 1970s show that it was of yellow brick and of two storeys with loft space above. Coped gables sat to north and south with a short ridgeline between. It was then abutted by a building to the east which was also attached to the bottle kiln. This too had gables to north and south, that to the north partial and attached to the kiln wall. It was of mixed red and yellow brick construction with a pantile roof. There were two southern entrances into the building. These were superimposed, the upper doorway accessed via a flight of steps.

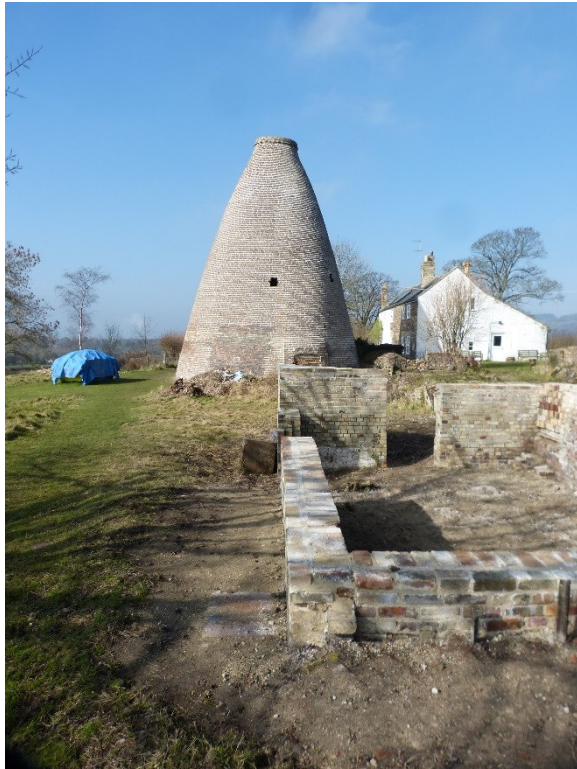
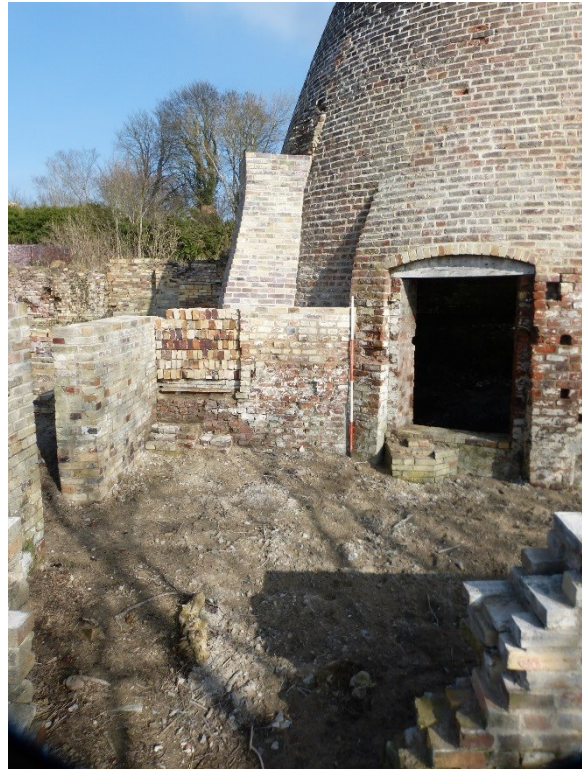
Plates 19 and 20: Looking west (left) and north across the conserved remains of building 8 south of the eastern bottle kiln. 2m scale.

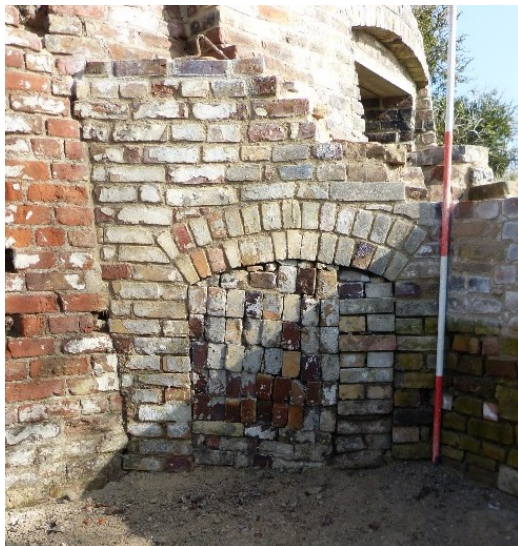
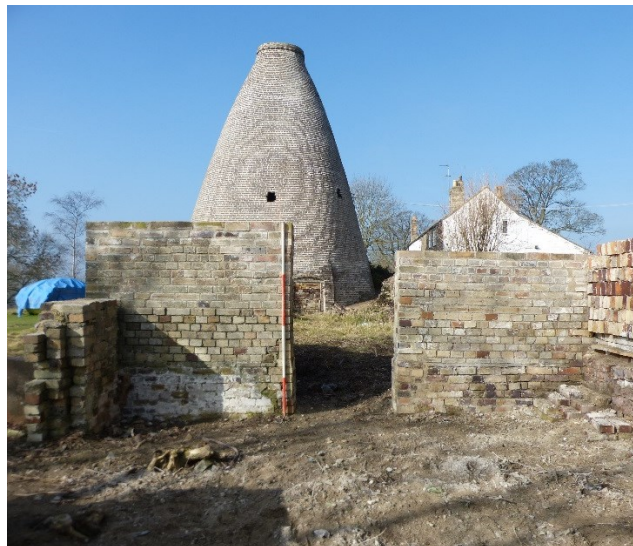
Plates 21 and 22: Post-conservation views of fireplace in north-east angle of building 8 against eastern bottle kiln (left) and from same point west across building 8. 2m scale.

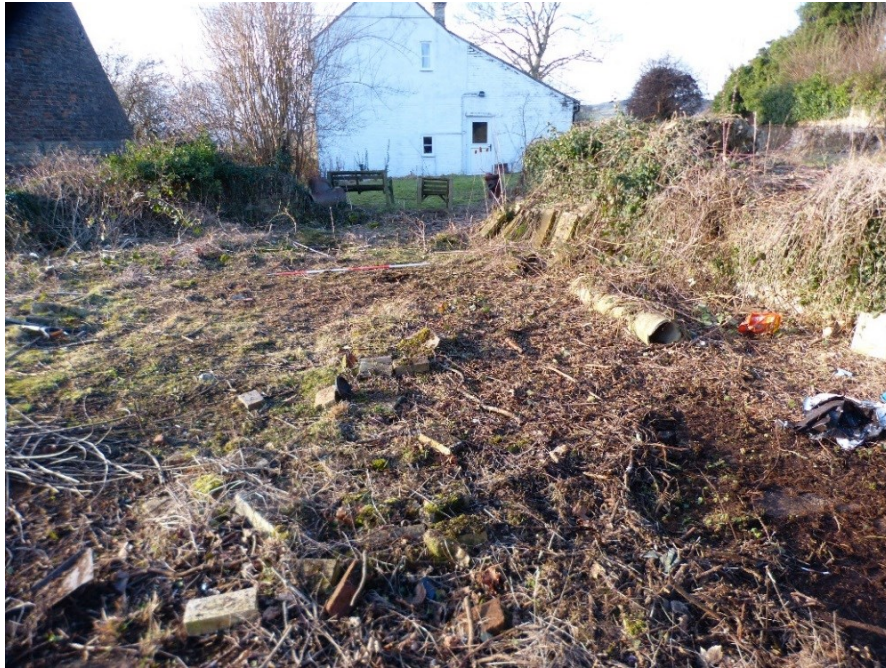
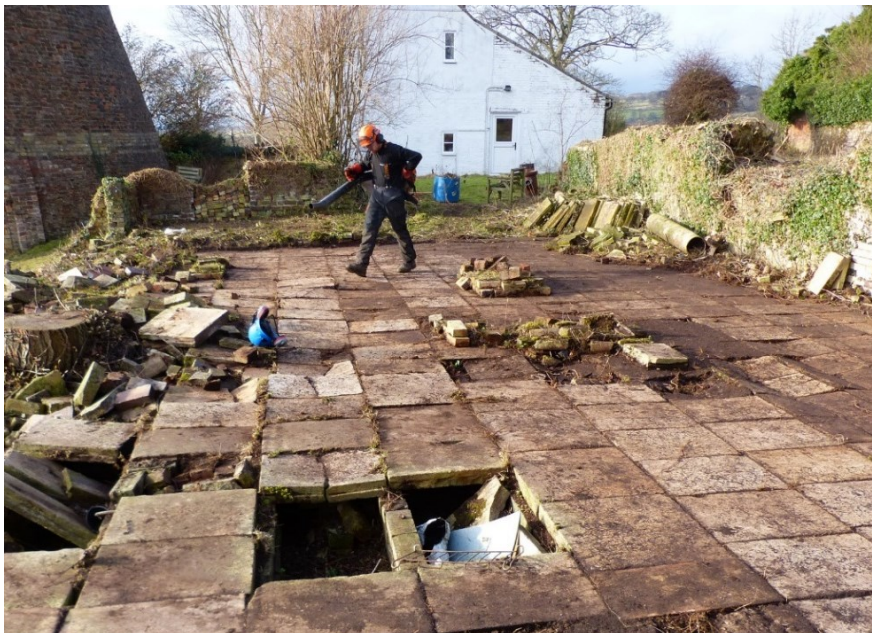
Plates 23 and 24: Pre (top) and post-clearance views of the drying floor (building 7) between the bottle kilns. Looking west.

The building served as a drying shed for wares prior to firing and presumably recovered waste heat from the eastern kiln via its underfloor 'hypocaust' arrangement. This was formed of longitudinal brick walls c.0.5m high supporting 10 rows of substantial clay slabs or quarls. Two flues attached to the west face of the east bottle kiln would have helped to draw warm air through the floor. This underfloor arrangement did not continue into the western lean-to block which may have been the location of a separate heating source for the shed.

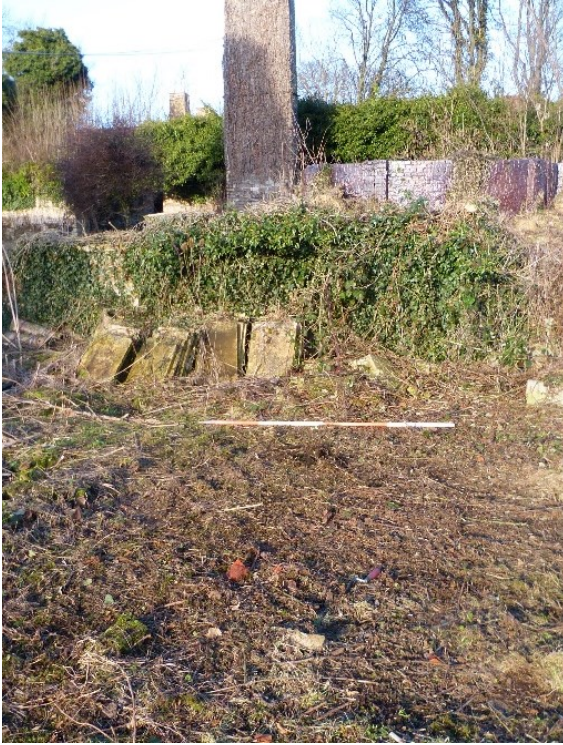
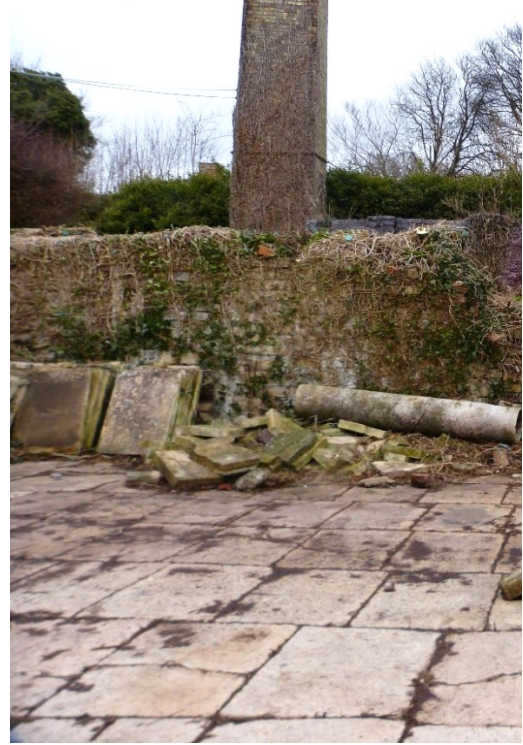
Plates 25 and 26: Pre (left) and post-clearance views of the drying floor (building 7) between the bottle kilns. Looking north. 2m scale.

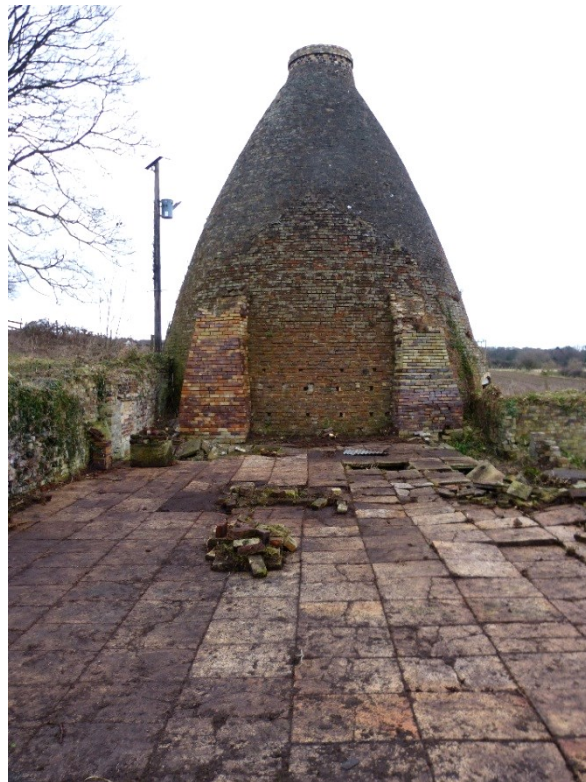
Plate 27: Drying floor (building 7) post clearance. Looking east towards the east bottle kiln.

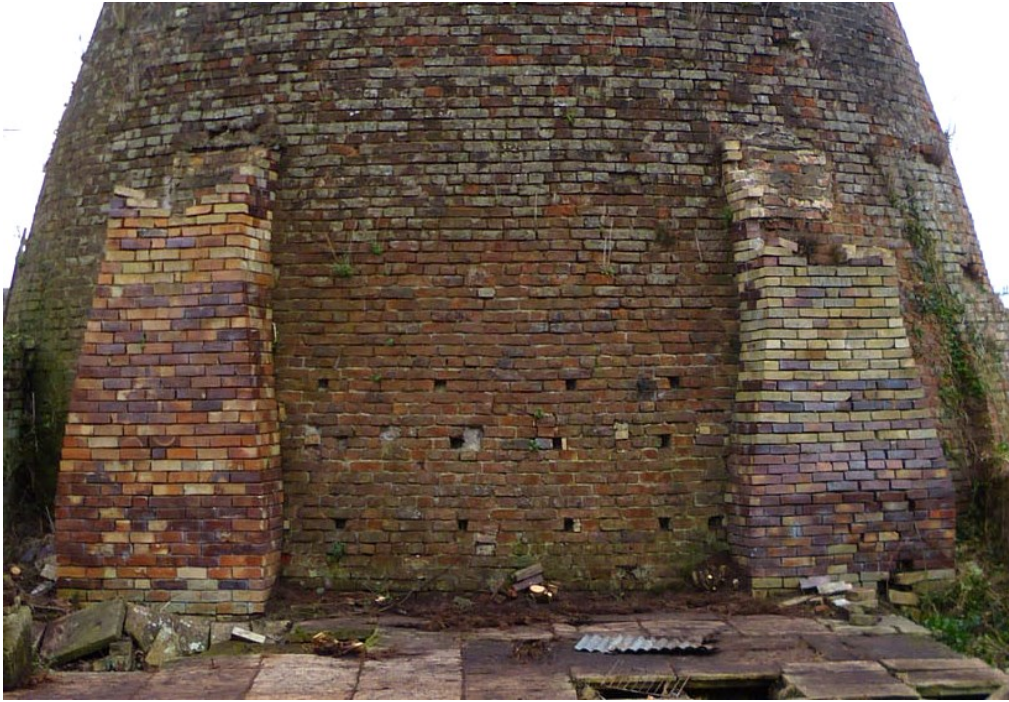
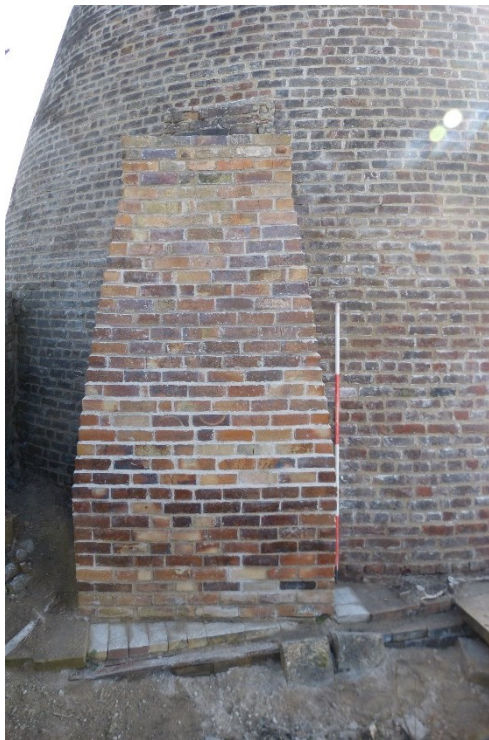
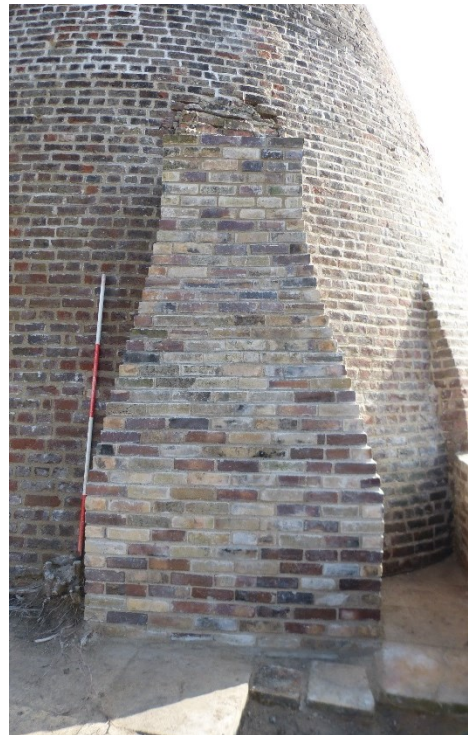
Plates 28, 29 and 30: Vents on the west face of the eastern bottle kiln. Views pre (top) and post-consolidation and rebuilding. 2m scale.

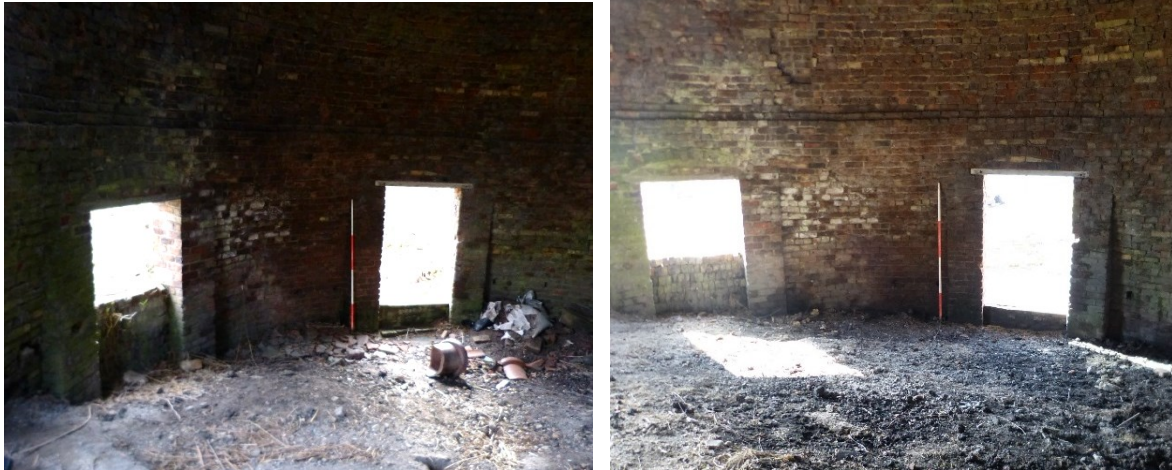
Plates 31 and 32: Pre (left) and post-clearance views of the interior of the eastern bottle kiln. Looking south. 2m scale.

3.2 Work on the bottle kilns was largely superficial, involving clearance of vegetation from the outer faces, removal and repointing of areas of impoverished mortar and consolidation and replacement of defective brickwork where necessary. The earth-floor in the eastern bottle kiln was cleared and animal burrows filled and levelled to provide a sloping but regular surface. No work was carried out within the western kiln which is in use as a studio and storage space by the owner.

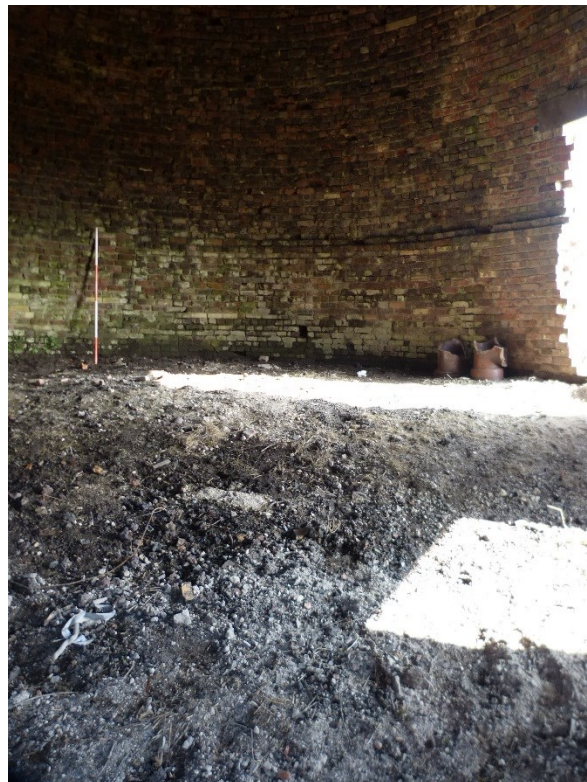
Plate 33: Post clearance view of the eastern bottle kiln. Looking north. 2m scale.

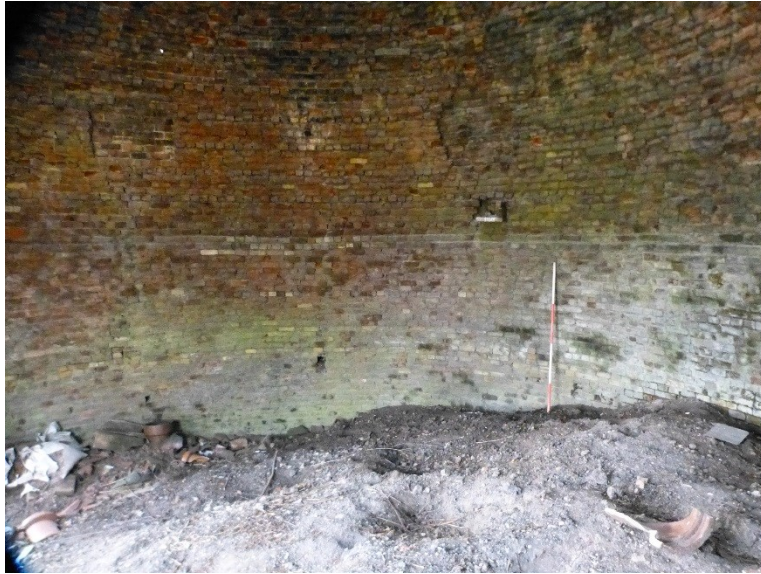
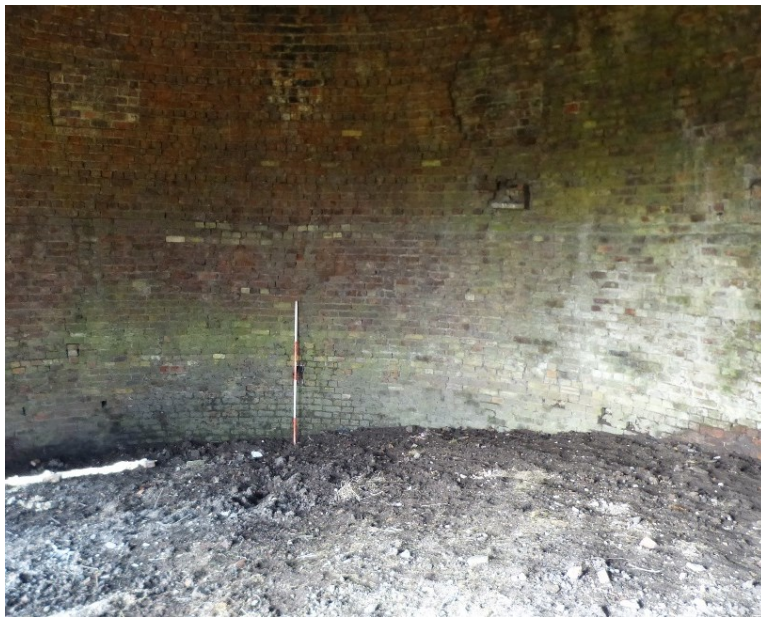
Plates 34 and 35: Pre (top) and post-clearance views of the Interior of the eastern bottle kiln. Looking west. 2m scale.
