CLOSE HOUSE

HEDDON-ON-THE-WALL, NORTHUMBERLAND

ARCHAEOLOGICAL WATCHING BRIEF DURING DEVELOPMENTS 2014-2015

April 2016

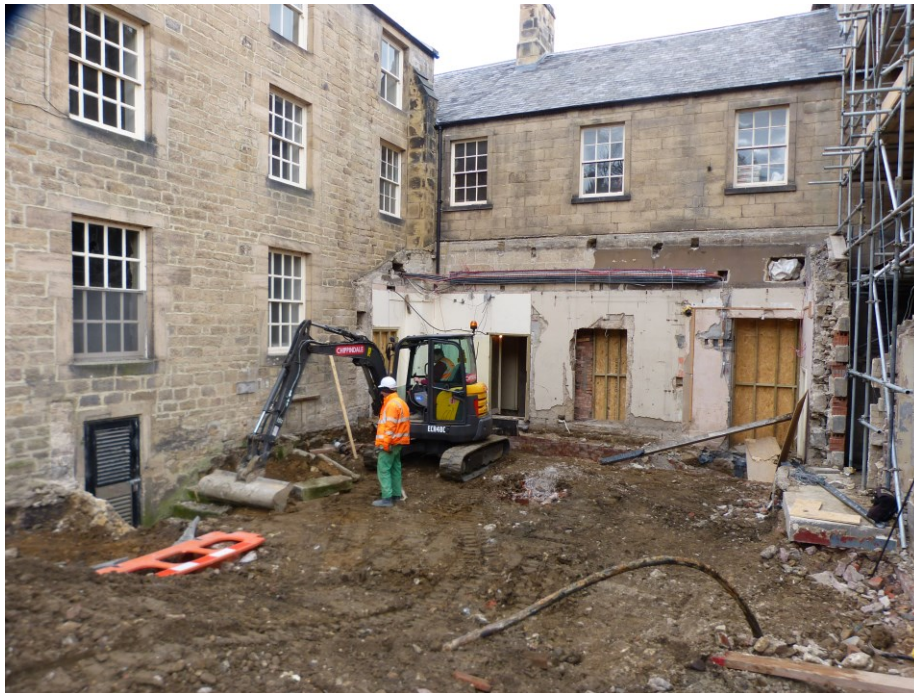
Groundworks were carried out on this area over March and April 2015 (see figure 3). Lowering of ground level was intended to be limited to a shallow strip to remove sub base of existing stone slab surfacing of the courtyard, followed by discrete excavations for shallow (0.3m deep) foundation pads for columns to hold the new library structure. However, deposits in the courtyard below the existing surface were poorly compacted clay, soil and rubble; fill and dump deposits, presumably introduced to the area when cellars to both east and west were cut.

Plate 1: Courtyard post removal of floor slabs and during reduction Of ground level. Looking north-east.

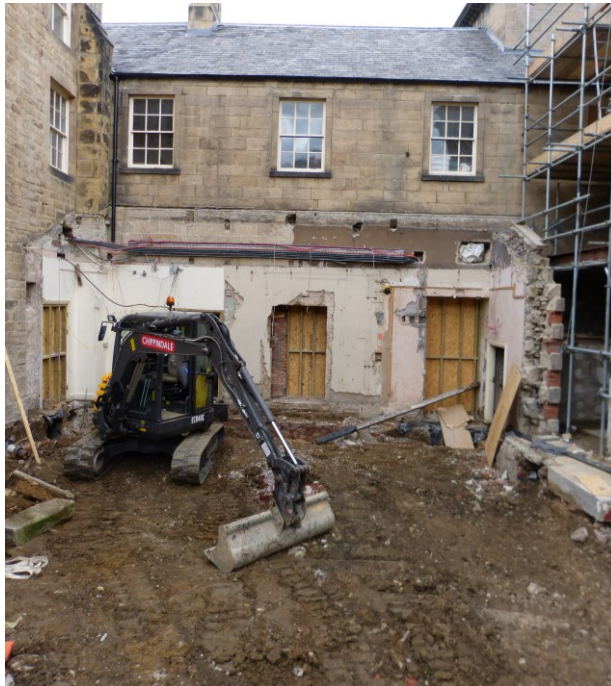
Plate 2: Courtyard post removal of floor slabs and during reduction of ground level. Looking east.

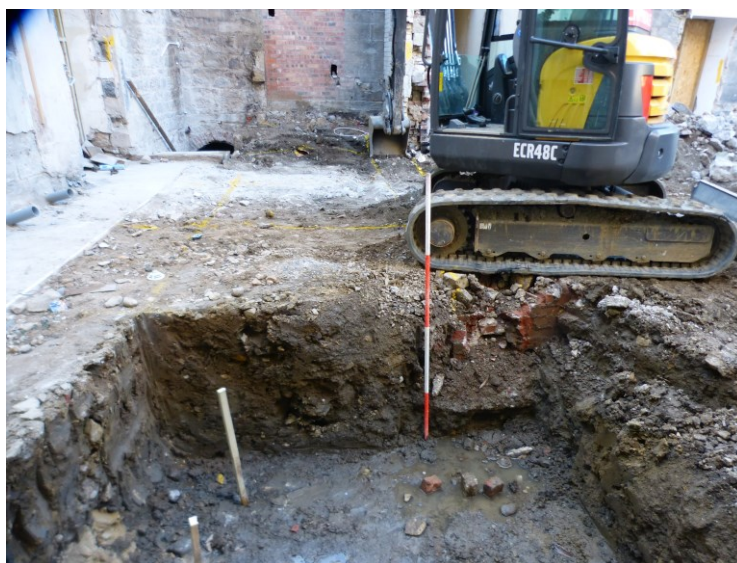
Deeper foundations were required to a depth of 1.2m from the stripped courtyard surface. The courtyard surface was stripped to c.29.5m aOD and foundations pits cut to a depth of c.28.5m aOD. All stages of excavation were monitored. No structural remains or deposits were seen during the monitoring or any significant artefactual material recovered.

Plate 3: Foundation pit for the library room within the courtyard. Looking south.

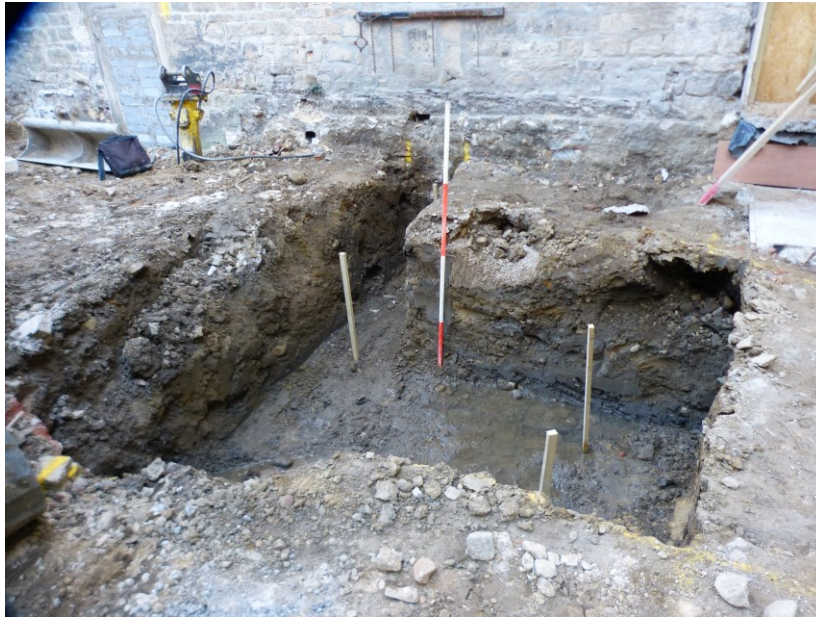
Plate 4: Foundation pit for the library room structure within the courtyard. Looking north.

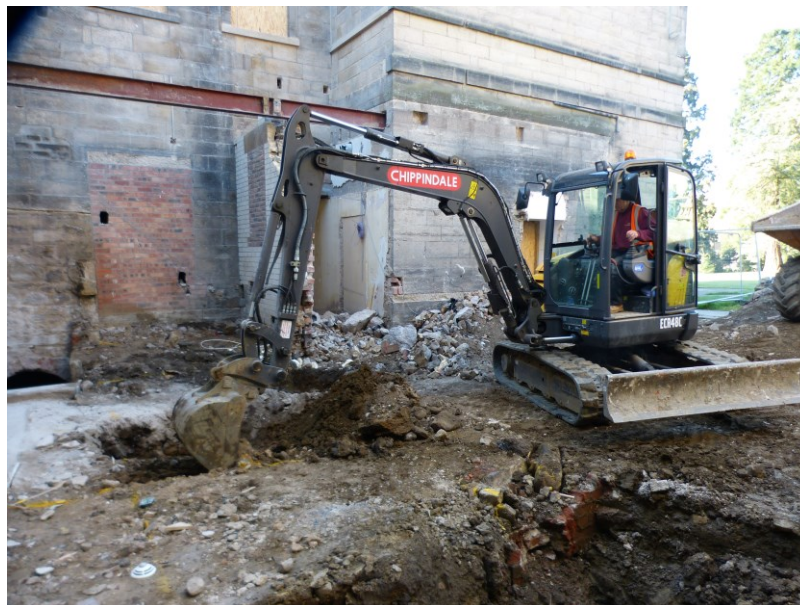
Plate 5: Cutting foundations for the library room structure. Looking south-west across the courtyard.

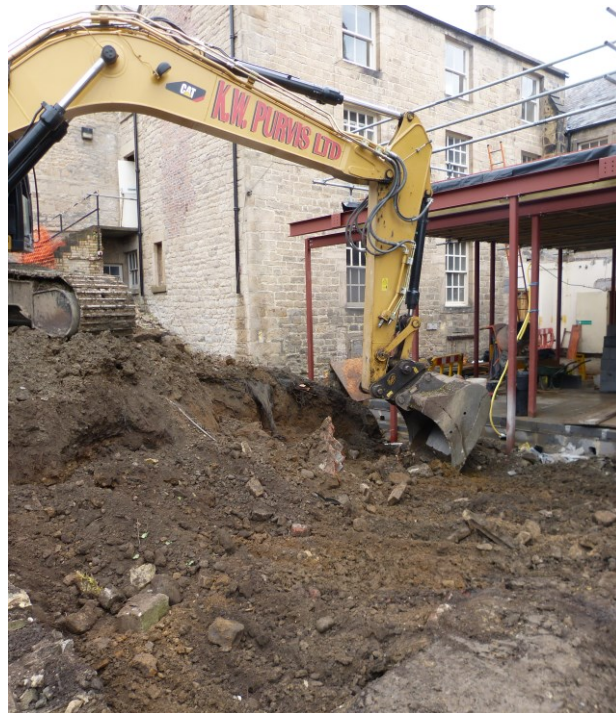
Prior to development, the area to the west of Close House was a gently sloping part of the garden flanked to the north by a steep bank inset with a flight of stone garden-steps oblique to the house. The southern area was levelled for construction of the Garden Room (see figure 3). This was carried out in late June 2015 using a 360 degree excavator. Subsoil, sandy boulder-clay, was uncovered c0.3m below original

ground level on the south edge of the area (at around 29.7m aOD), and progressively deeper as ground level rose to the north. Subsequent cutting of foundation pads for the garden room was not monitored as subsoil had already been exposed throughout the area of the extension during this initial strip. Overall surface strip was to a little over c. 29m aOD. No structural remains or deposits were seen during the monitoring or any significant artefactual material recovered.

Plate 6: Reducing ground level west of Close House for the garden room. Looking north-east.

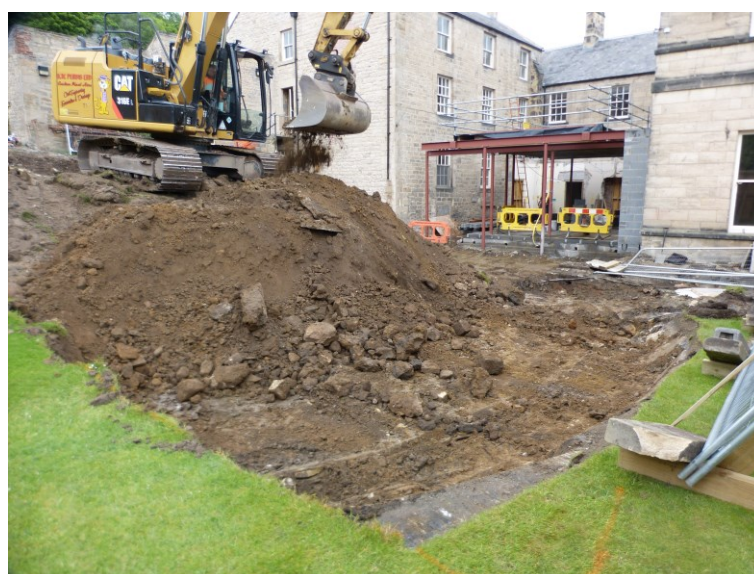
Plate 7: Reducing ground level west of Close House for the garden room. Looking north-east.

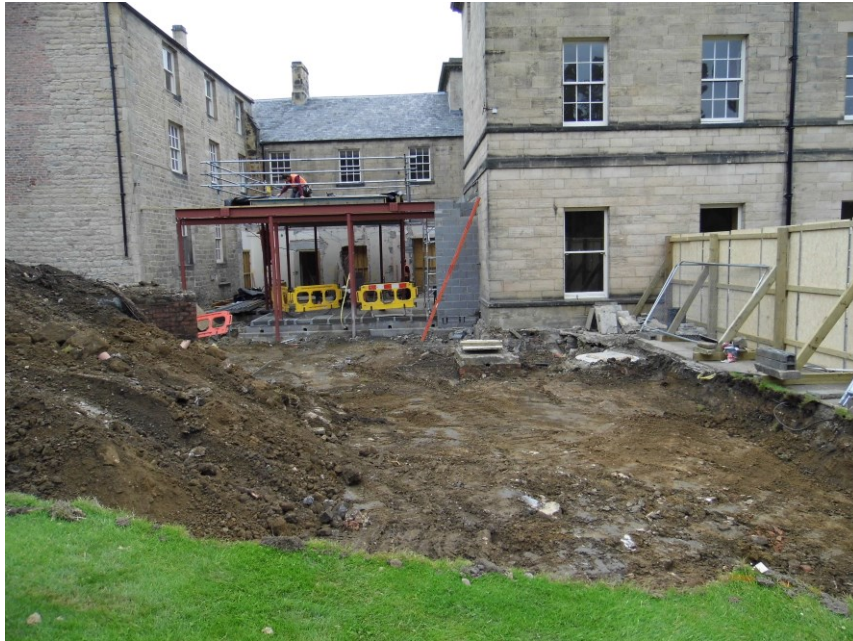
*Plate 8: Reduced ground level west of Close House.
Looking east.*

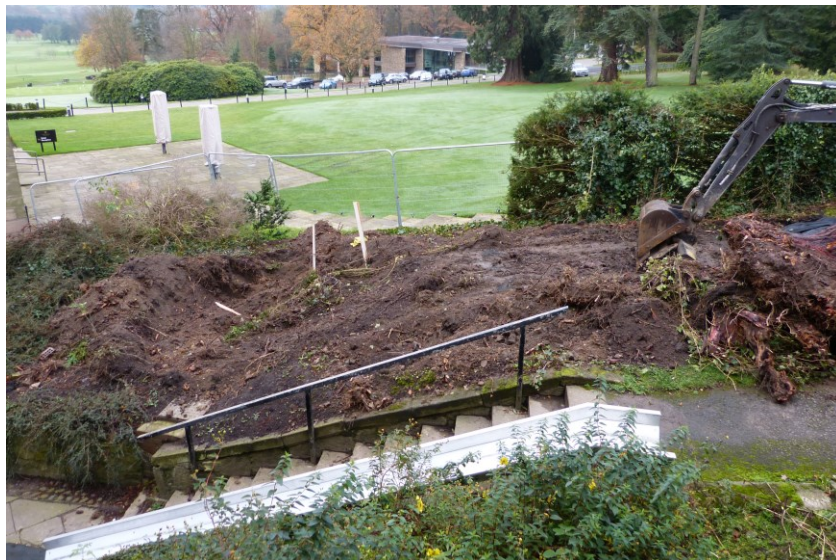
*Plate 9: Removing topsoil from the slope next to the Garden Room.
Looking south-west.*

The area was cleared of topsoil in November 2014 and a shallow access-ramp cut down the slope. No archaeological features or deposits were exposed during this phase of monitoring. Subsequently, deep excavation for the steps was carried out in

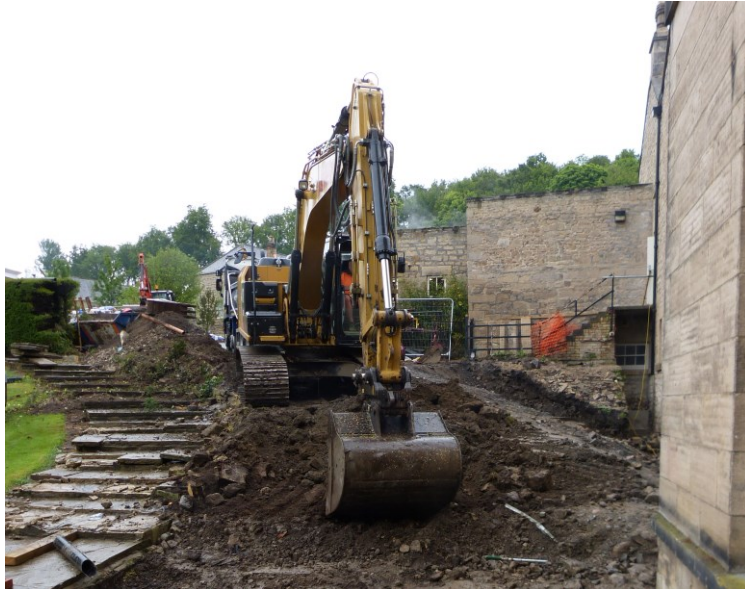
Plate 10: Beginning to cut back the slope north of the Garden Room for the retaining wall. Looking north.

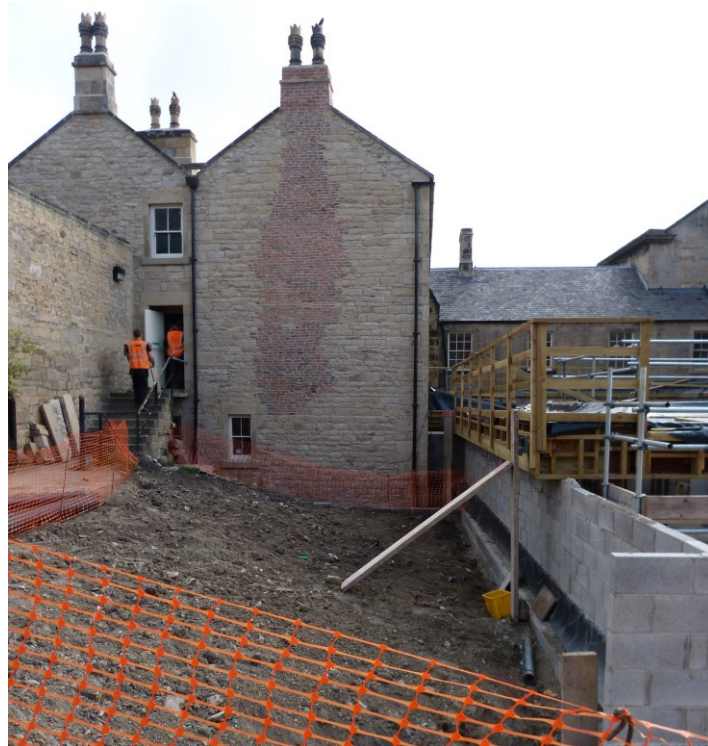
Plate 11: Retaining wall constructed. Looking east.

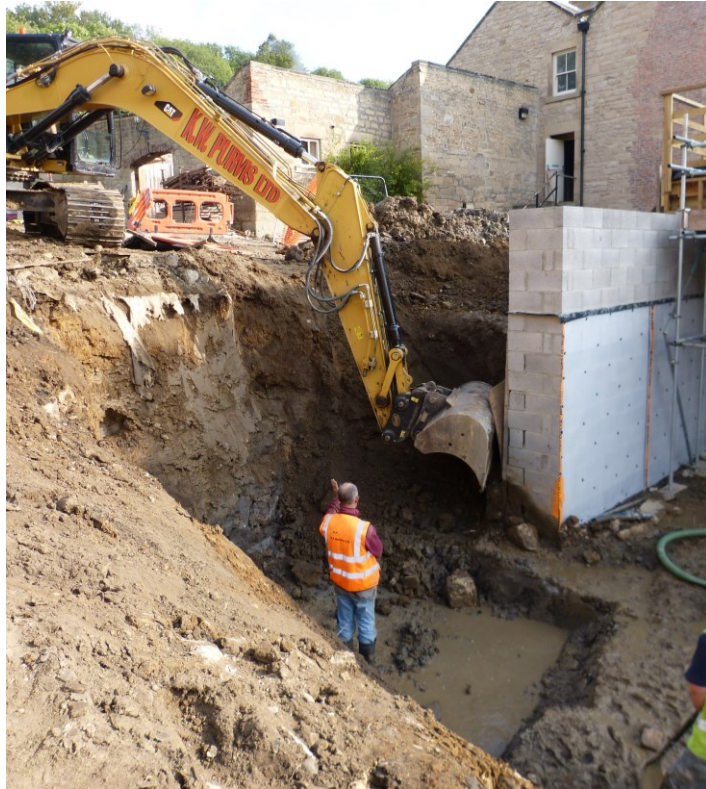
June 2015. In-situ boulder clay was exposed across the area, overlaid with dumped clay and soil. The area had been heavily disturbed during terracing and re-contouring in relatively recent times as well as by the insertion of services, this last shown by the presence of a mains water pipe at c. 3m deep exposed in the face of the slope (plates 12 and 13).

Plate 12: Deep excavation at the north end of the Garden Room with retaining wall to right. Services and other intrusions had previously cut deeply into the area. Looking east.

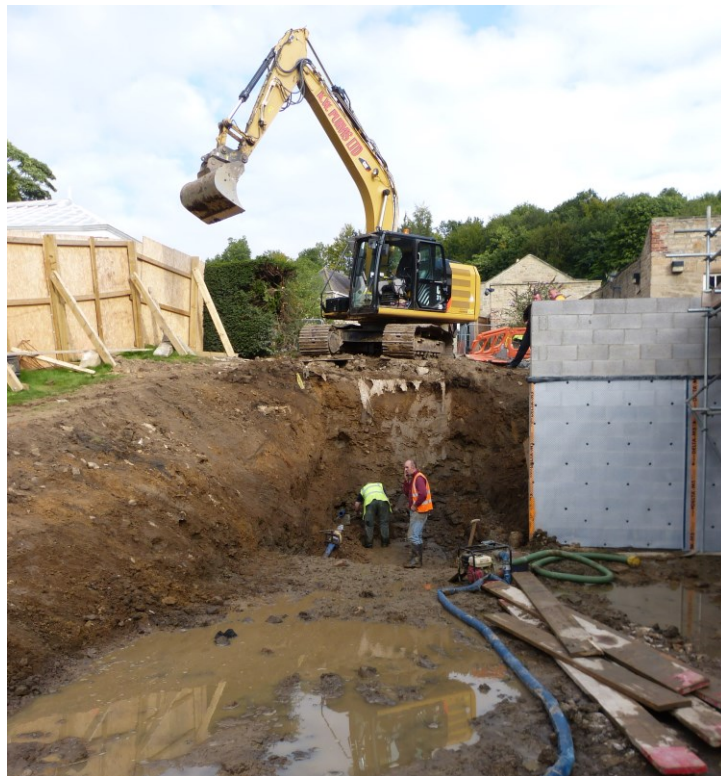
Plate 13: Deep excavation at the north end of the Garden Room with retaining wall to right.

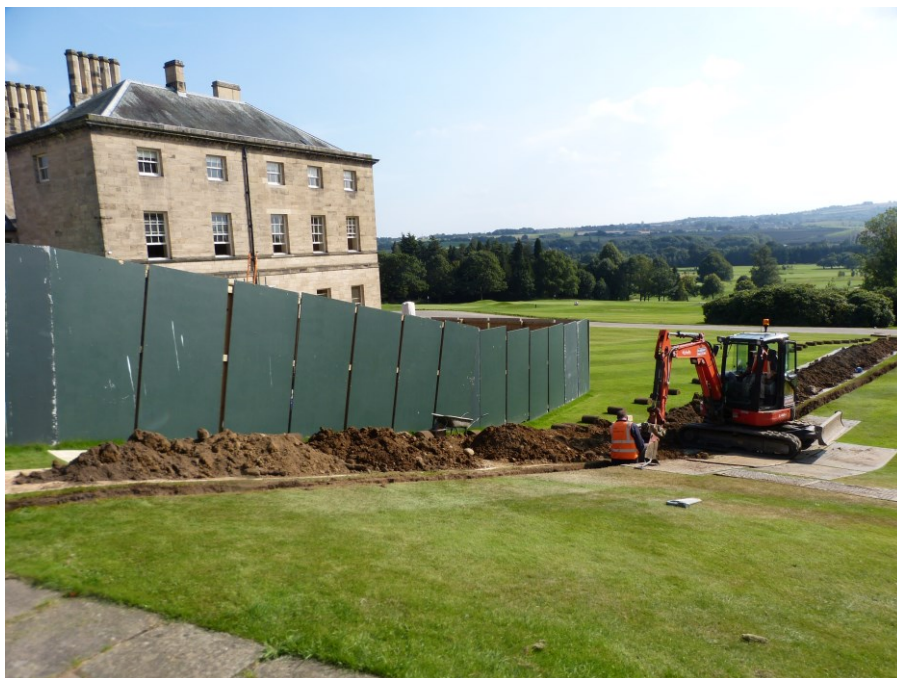
A service trench was cut north-south across the lawn to the west of Close House (see figures 2 and 3) in September 2015 to a maximum depth of 0.8m and between 26.6m aOD (south) and 31.2m aOD (north). Clay subsoil was exposed at the base of the trench at a number of points. General stratigraphy was thin topsoil over amorphous dumped clay and sandy loam. There was a concentration of sandstone rubble towards the middle of the trench. None of the rubble was mortared or in any context, lying within the matrix of loose loam and clay. It was certainly dumped rather than the remains of a structure.

Plate 14: Excavation of service trench (5). Looking south-east across Close House

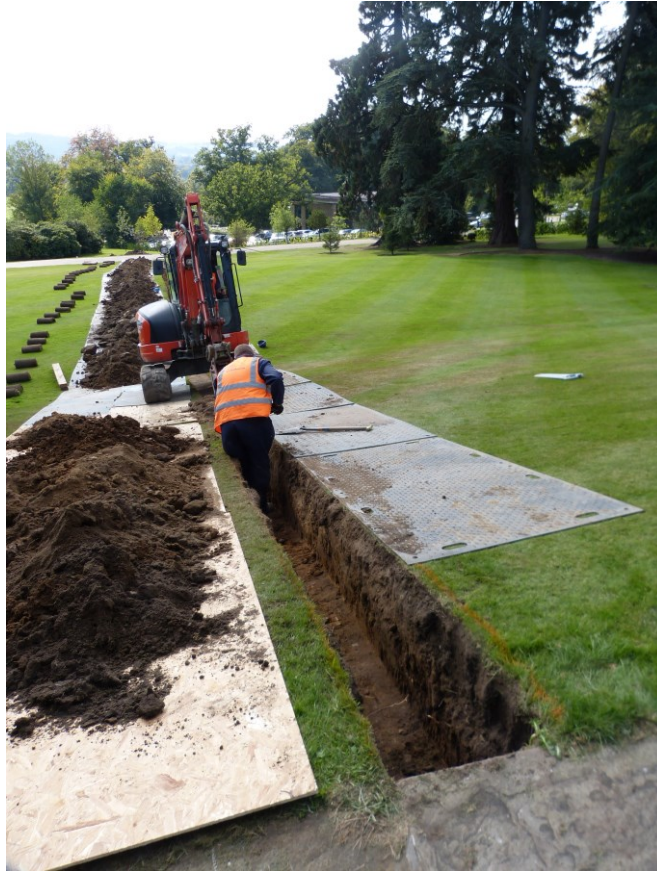
Plate 15: *Excavation of the north end of service trench (5) next to the Orangery. Looking south.*

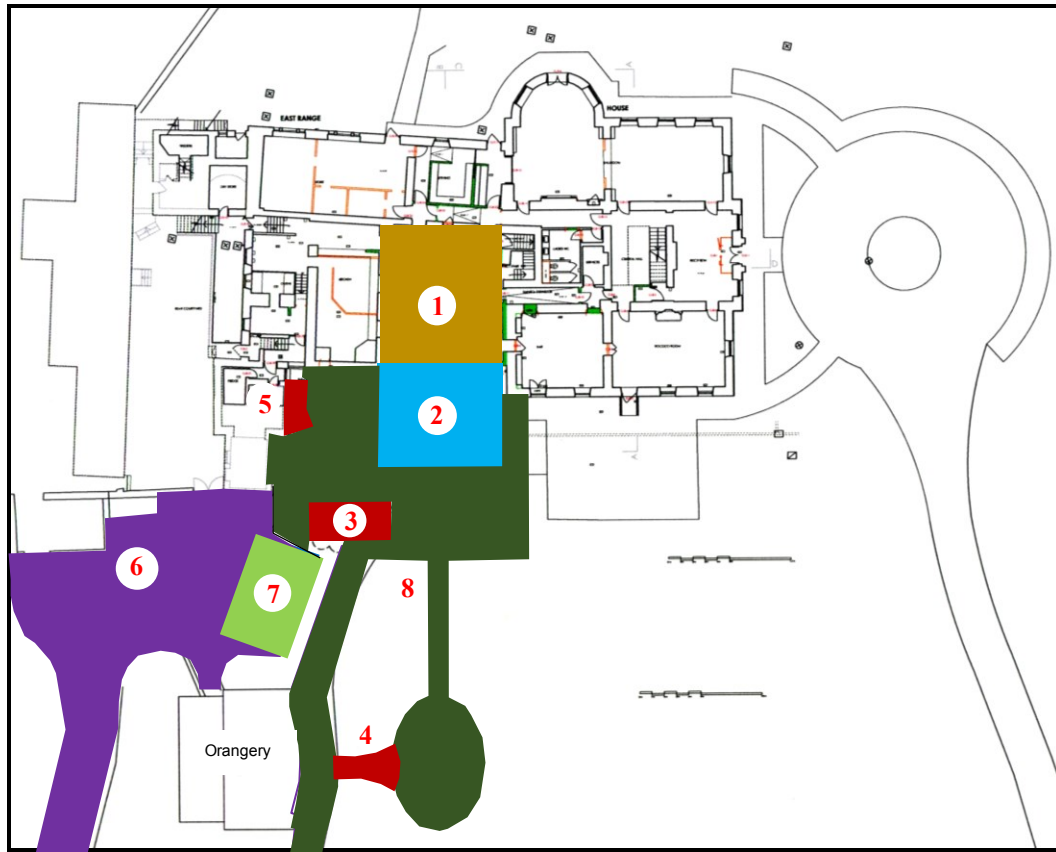
An as-existing plan of the house is shown as figure 2, with developments which require a watching brief during groundworks highlighted and numbered. These include:

Figure 2: An as-existing plan of Close House and environs with areas of development requiring an archaeological watching brief during associated groundworks highlighted: 1. Library; 2. Garden room; 3. Garden steps; 4. Garden steps; 5. External steps; 6. Driveway and vehicle access areas; 7. Parking bays; 8. Garden paths and seating areas. Not to scale. North to left (Kevin Doonan Architect Drawing No: 1000TE01).
