PROPOSED RESIDENTIAL DEVELOPMENT SHEPHERD'S HOUSE

Halton, Northumberland

ARCHAEOLOGICAL EVALUATION

July 2016

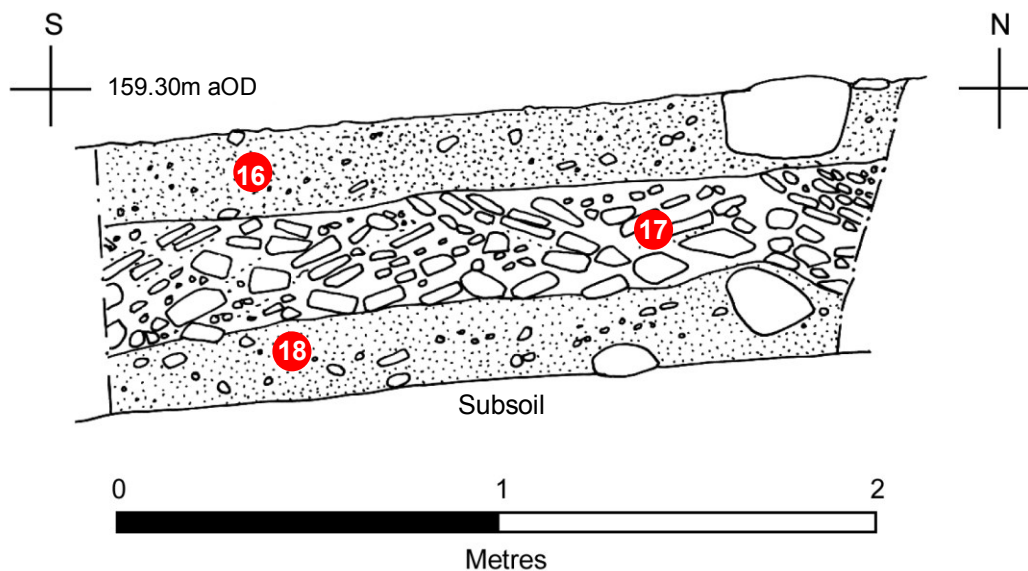
Figure 8: Test Pit 4. East-facing section. 1:20 scale.

The surface of the western part of the yard, as seen in test pit 4, was formed of a layer of fairly loose dark grey-brown gritty and ashy loam with infrequent cobbles [16]. This sat over a substantial dump of sandstone fragments [17] in which there were very clear tip lines. Beneath this layer, and overlying mottled yellow and grey clay subsoil, was a medium to dark brown clay loam with a few regular and rounded sandstones [18]. This contained a number of sherds of C19 glazed whitewares. There was no gradation of layer [15] over subsoil which would appear to have been truncated prior to its formation. The surface of subsoil at the northern end of the test pit was 158.60m aOD.

Stratigraphy in test pit 4 was of relatively recent formation: [18] sat over truncated subsoil and contained pottery of 19th century date. It is likely that this evident cutting back of deposits is related to the construction of the Shepherd's House, or more probably of the northern extension of the house.

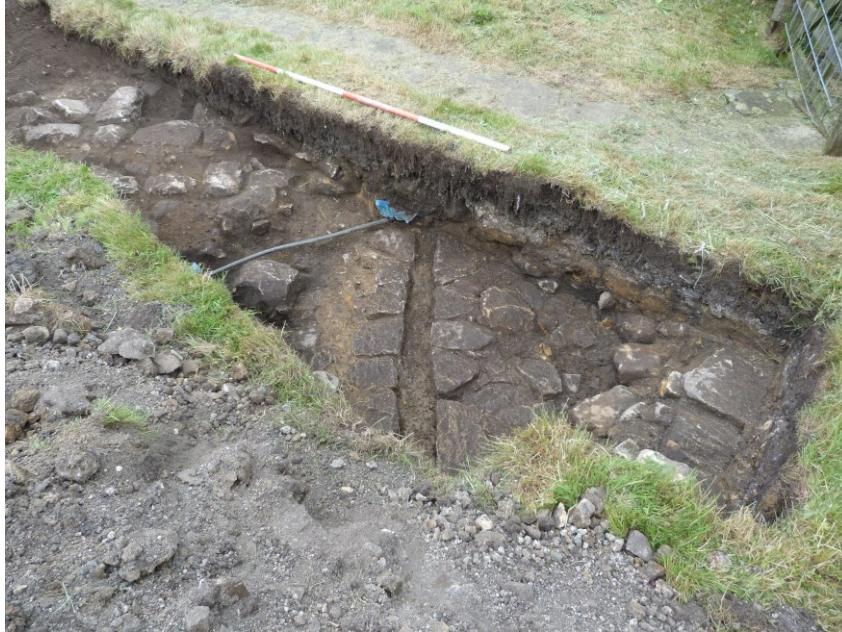
Plate 1: Trench 1 looking south along the line of conduit [5]. 2m scale.

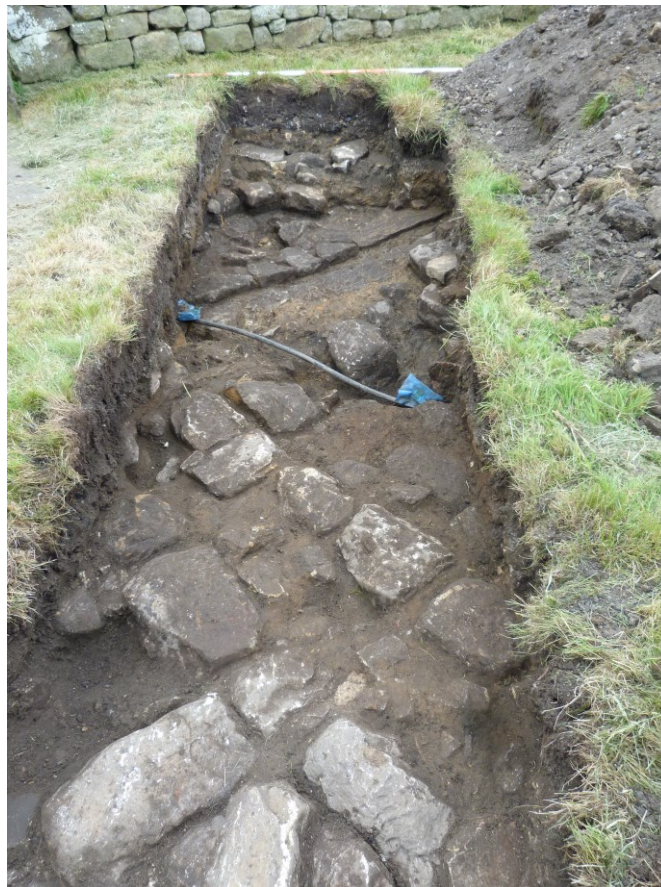
Plate 2: Trench 1 looking north-west along the trench wall [7] in the foreground. 2m scale.

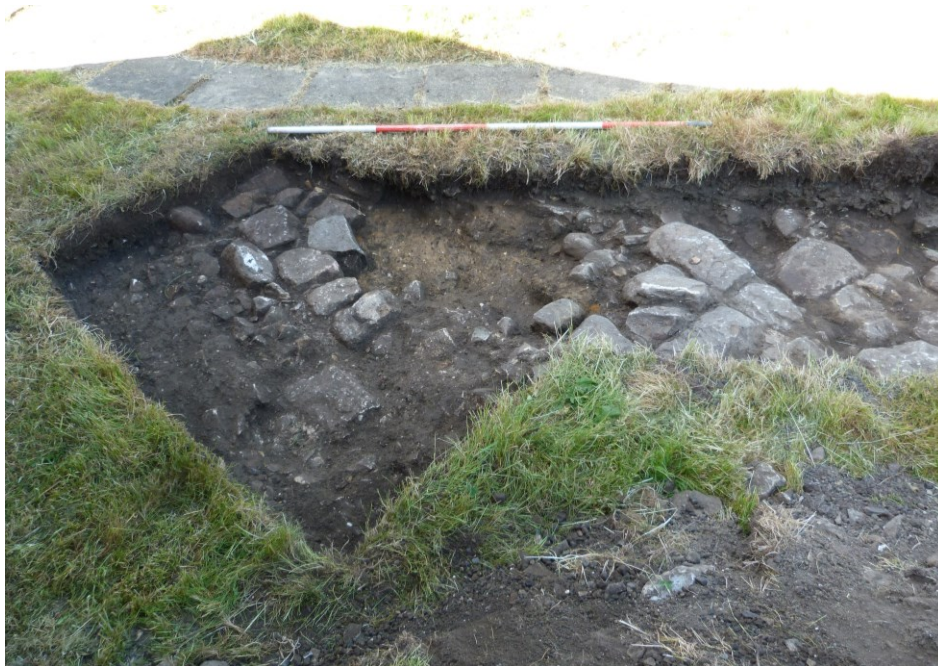
Plate 3: Trench 1 looking south across the eastern end of the trench. 2m scale.

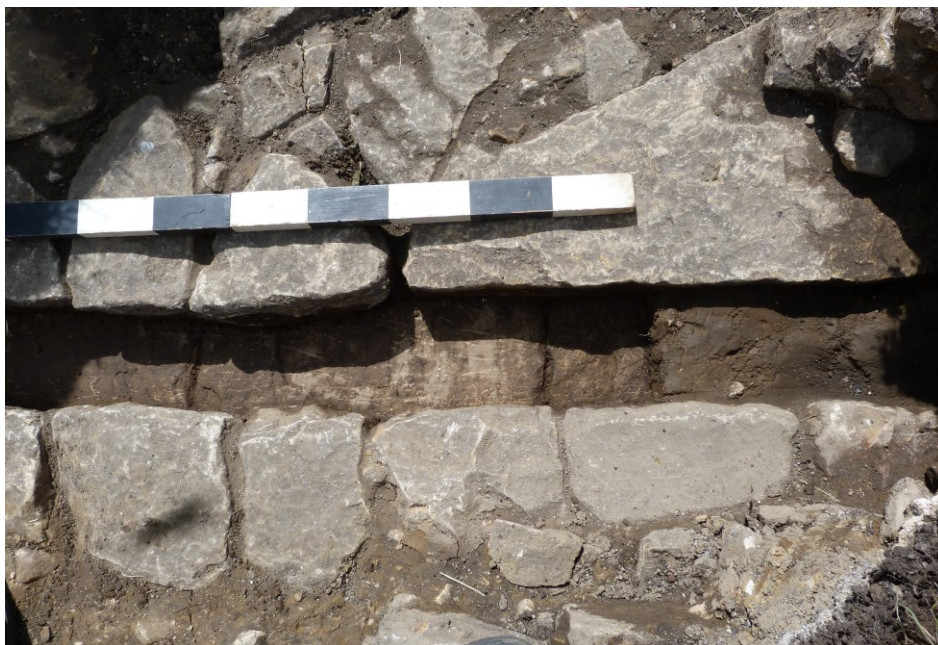
Plate 4: Trench 1. Stone-lined conduit [5] running obliquely across the trench. 1m scale.

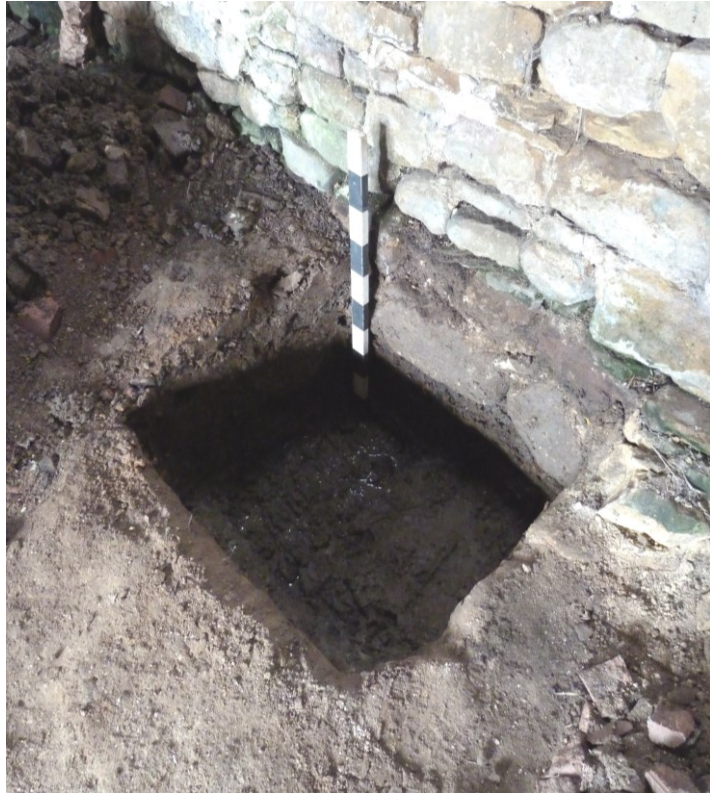
Plate 5: Test Pit 2, against the inner face of the north wall of building C. Looking north-west. 1m scale

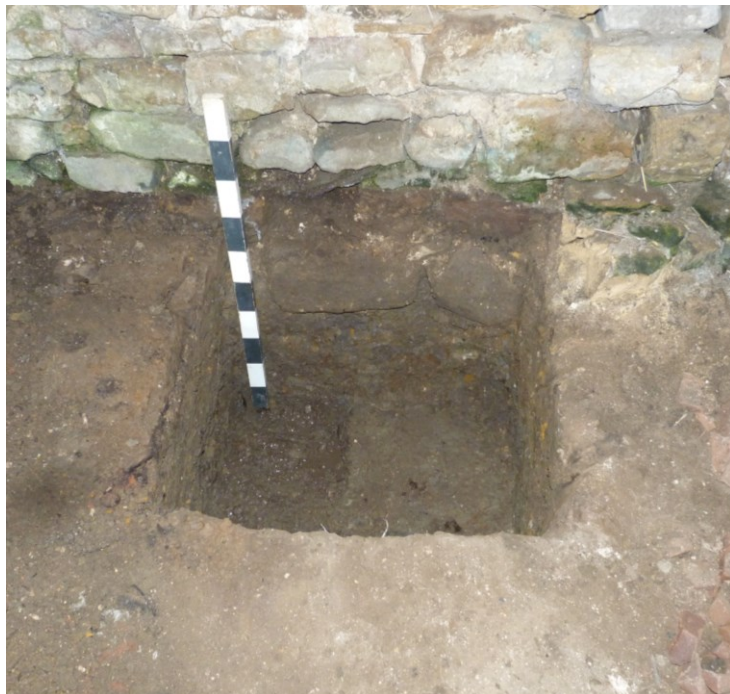
Plate 6: Test Pit 2. Looking north, showing depth of wall foundation and fill of pit [12]. 1m scale.

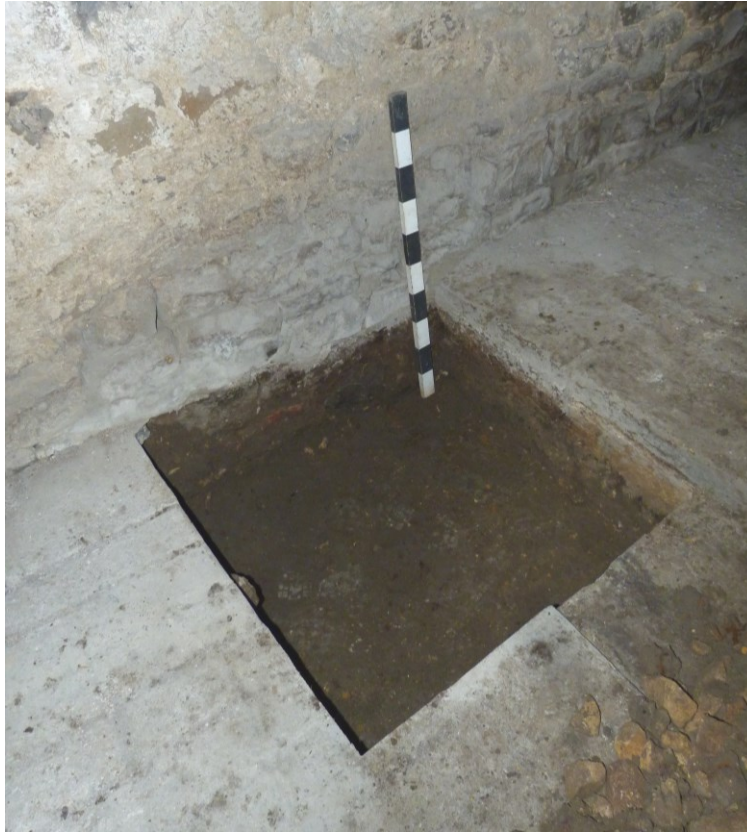
Plate 7: Test Pit 3, against the inner face of the north wall of building C in the eastern stable block. The 1m scale is standing on clay subsoil.

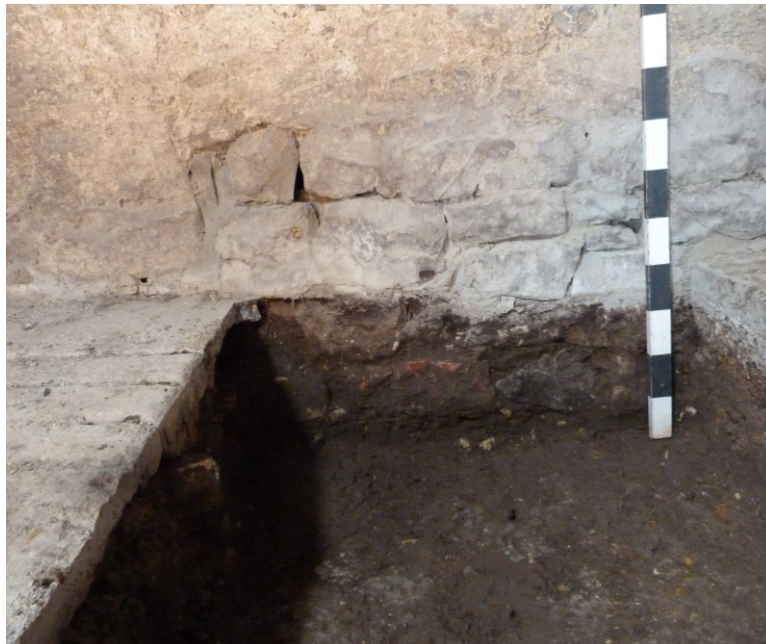
Plate 8: Test Pit 3, against the inner face of the north wall of building C, showing the depth of foundations of the wall and clay subsoil within the pit. 1m scale.

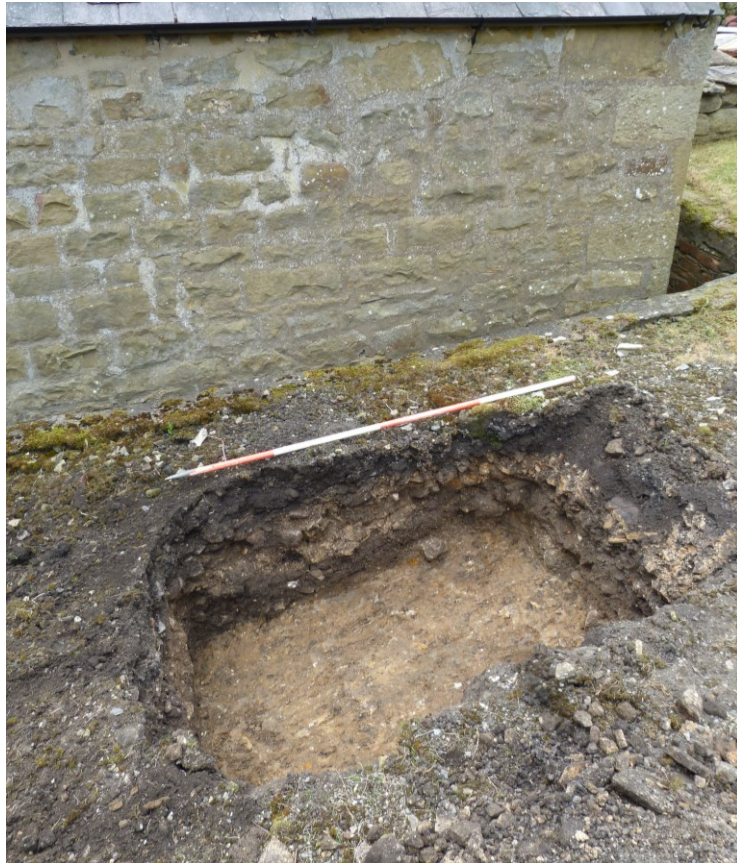
Plate 9: Test Pit 4 towards the western edge of the yard and building B. The banded stratigraphy is all fairly modern lying over truncated subsoil C. 2m scale

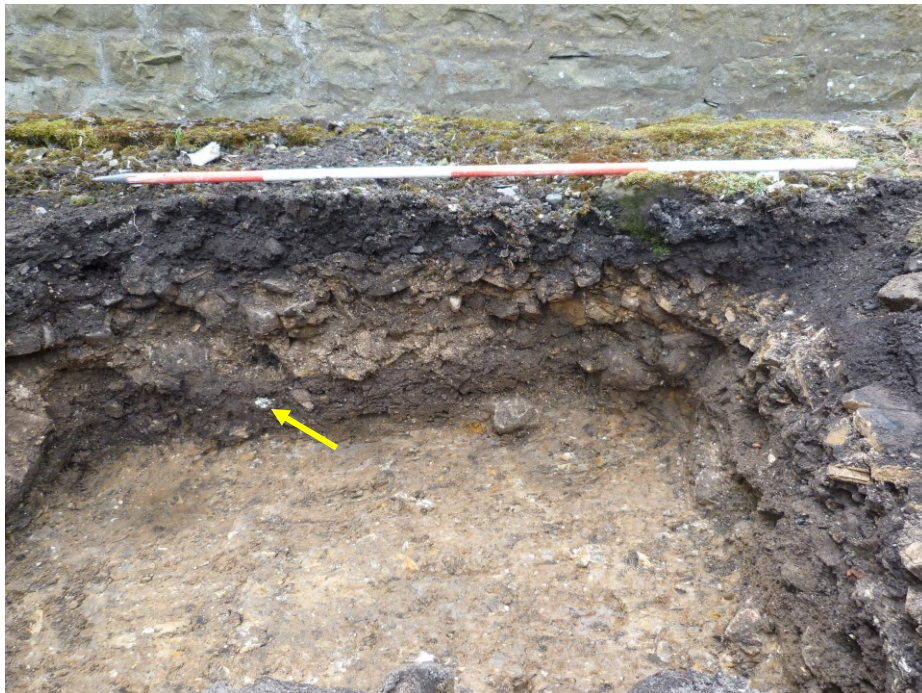
Plate 10: The east-facing section of Test Pit 4. The arrow locates a large sherd of glazed-whiteware pottery. 2m scale.

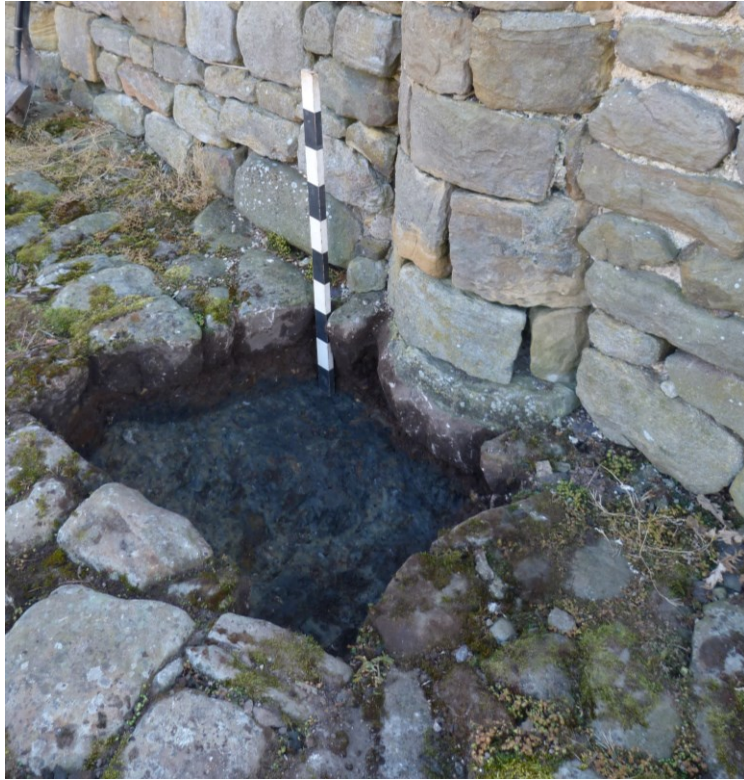
Plate 11: Test Pit 5, against the outer face of the wall of building C fronting the east side of the yard. The cobble surface and pillar base sit directly over grey clay subsoil 1m scale.

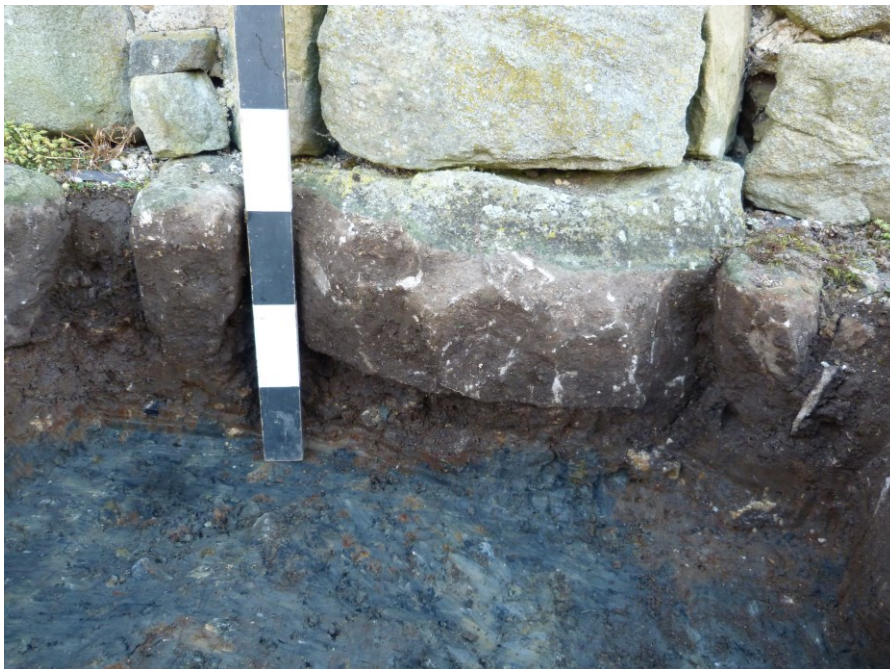
Plate 12: Test Pit 5. Pillar base and cobbles set in shallow make-up layer above grey clay subsoil.. 10cm divisions on scale.

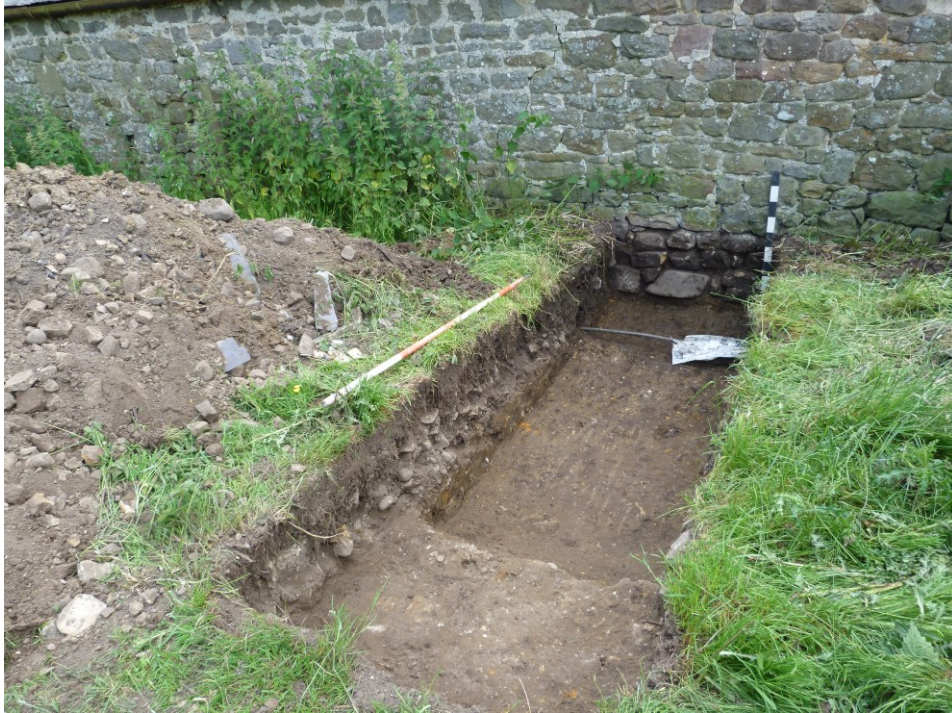
Plate 13: Trench 6, running at right-angles from the north wall of building C
2m and 1m scale.

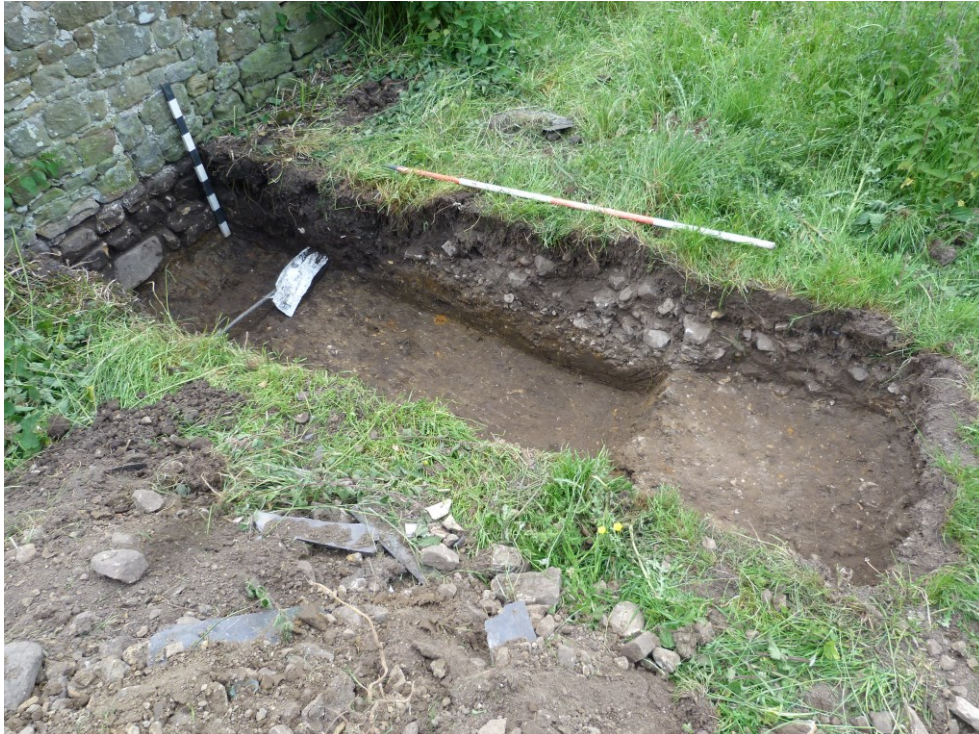
Plate 14: Trench 6, looking at east-facing section. Stone dump layer [23]
Is prominent. 2m and 1m scale.

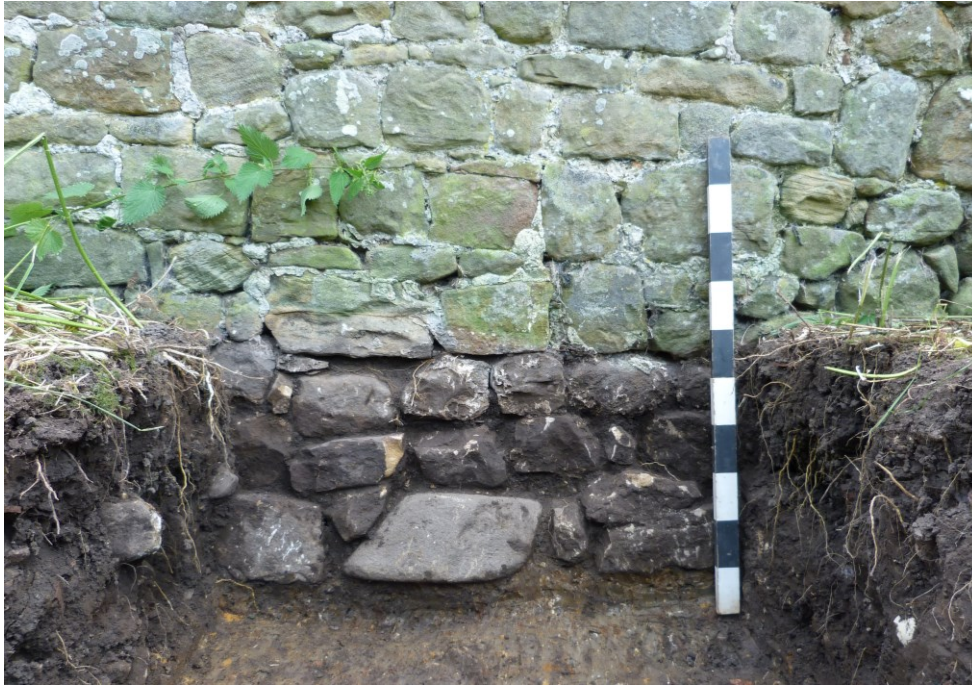
Plate 15: Trench 6. Foundations of the north wall of building C. 1m scale.

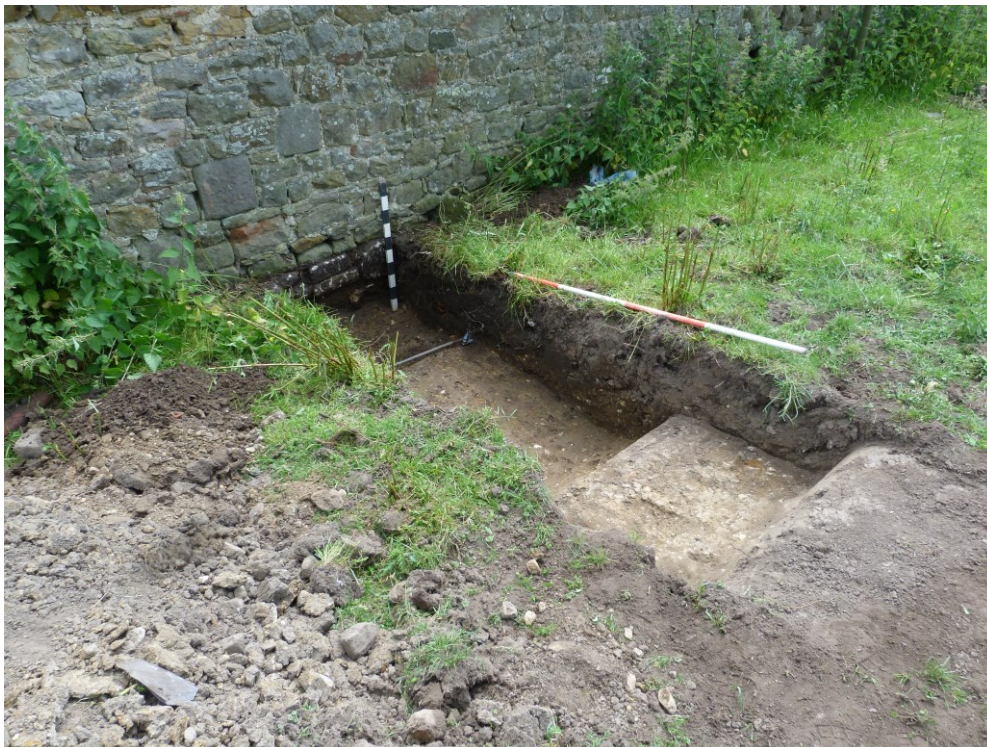
Plate 16: Trench 7, running at right-angles from the north wall of building C showing the east-facing section. 2m and 1m scales.

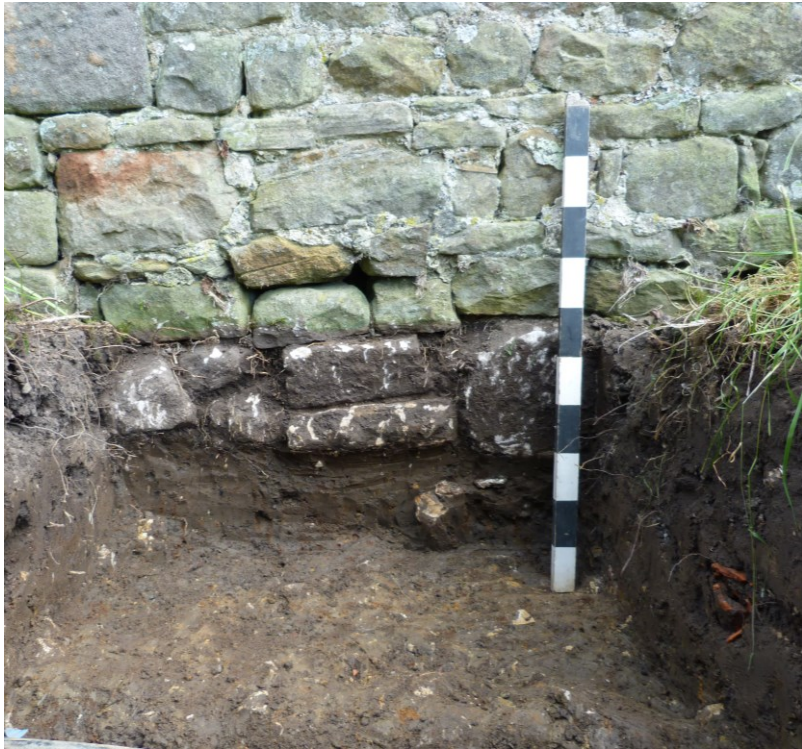
Plate 17: Trench 7. Foundations of the north wall of building C.
1m scale.

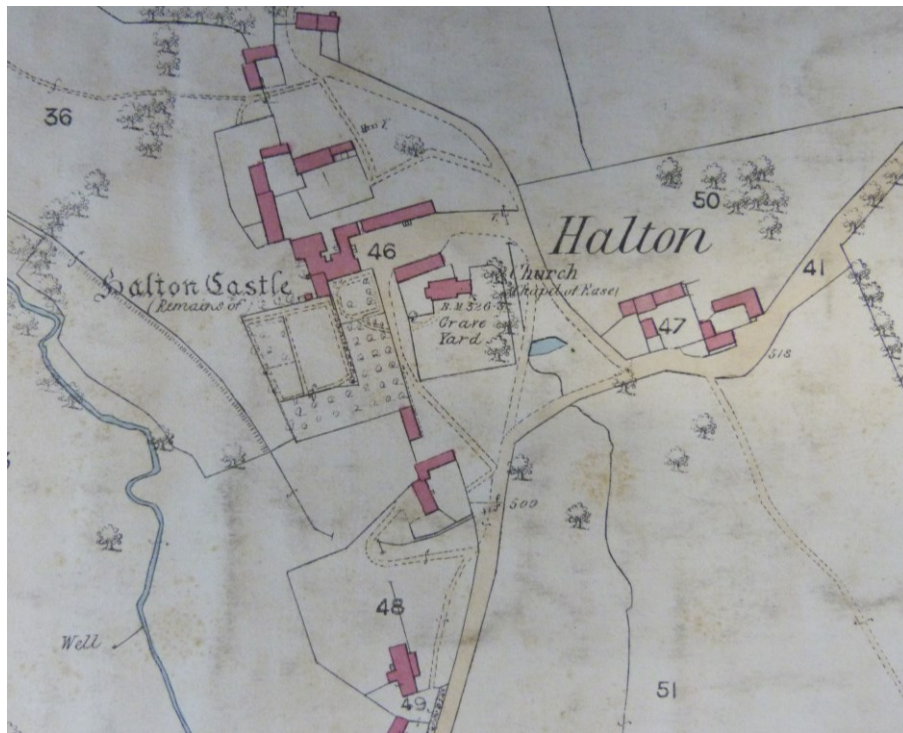
Figure 8: First edition Twenty Five Miles to One Inch Ordnance Survey (1860) showing the settlement at Halton. Shepherd's House and adjacent stone-built ranges are all present.

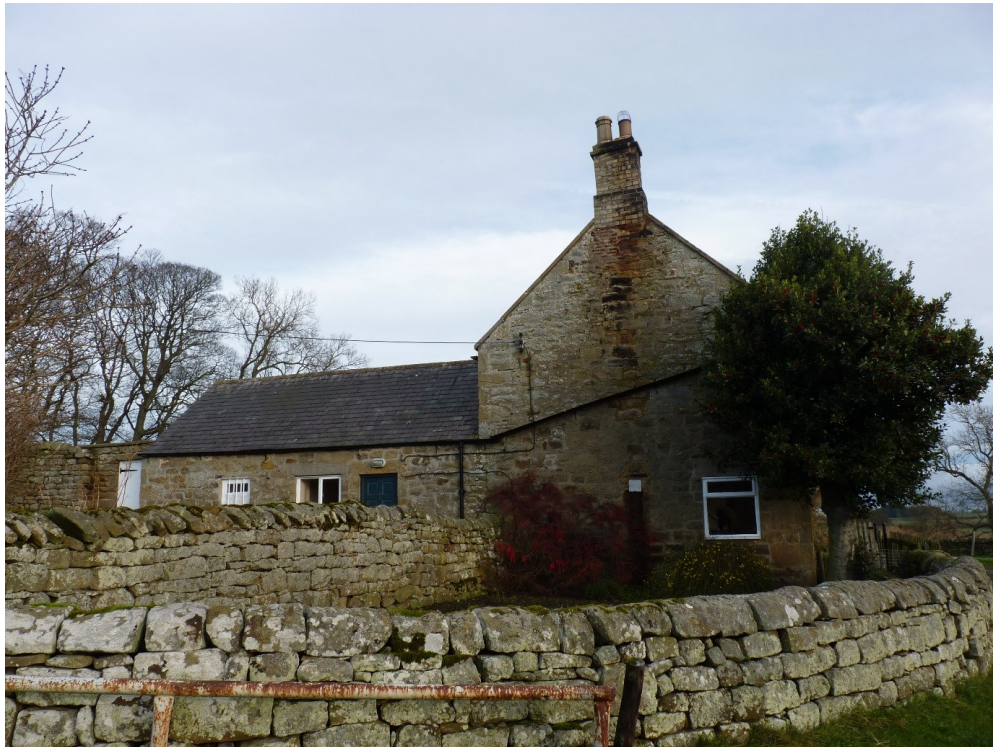
Plate 1: Shepherd's House (A) and northern offshot (B) from the south-west.

2 and plate 1 and see Appendix 2 for development proposals), the demolition of the rear offshot block **B** (plates 1 and 3) and its rebuilding on a slightly expanded footprint and linking with building **C** to the north; conversion of the stone agricultural range to the north (**C**) to domestic use (plates 4 and 5); and for the demolition of the modern agricultural shed (**D**) at the eastern end of the property and removal of its underlying concrete base. Limited re-arrangement of access arrangements would also be required. Requirements for service arrangements have not as yet been finalised.

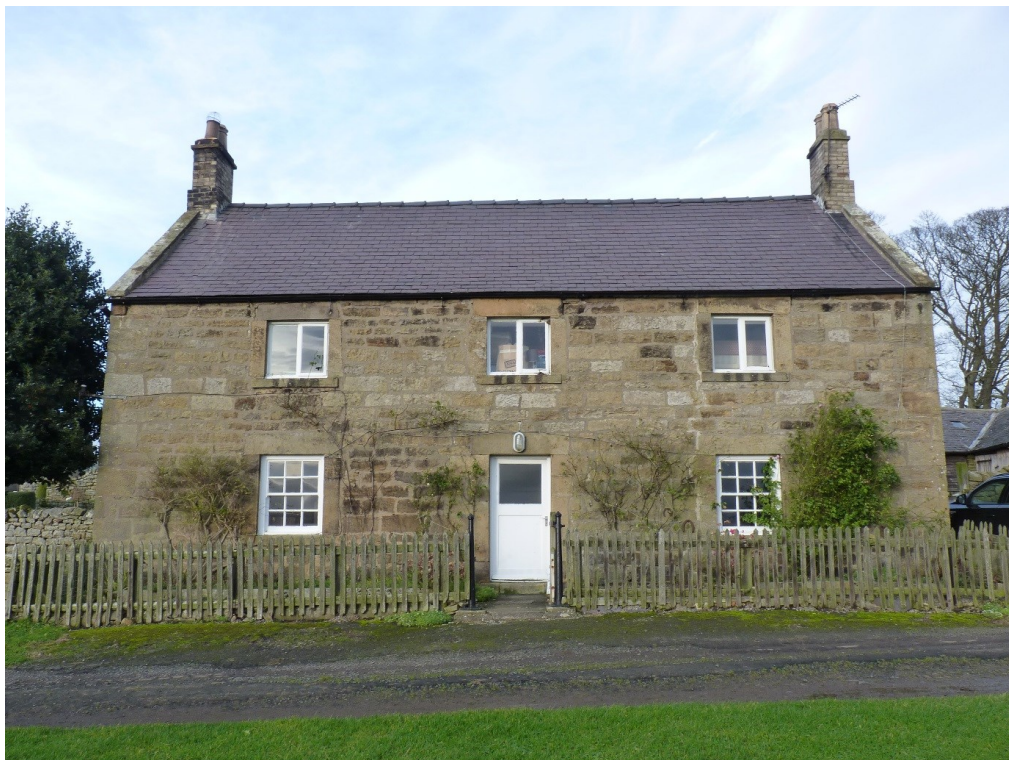
Plate 2: Shepherd's House (A) from the south.

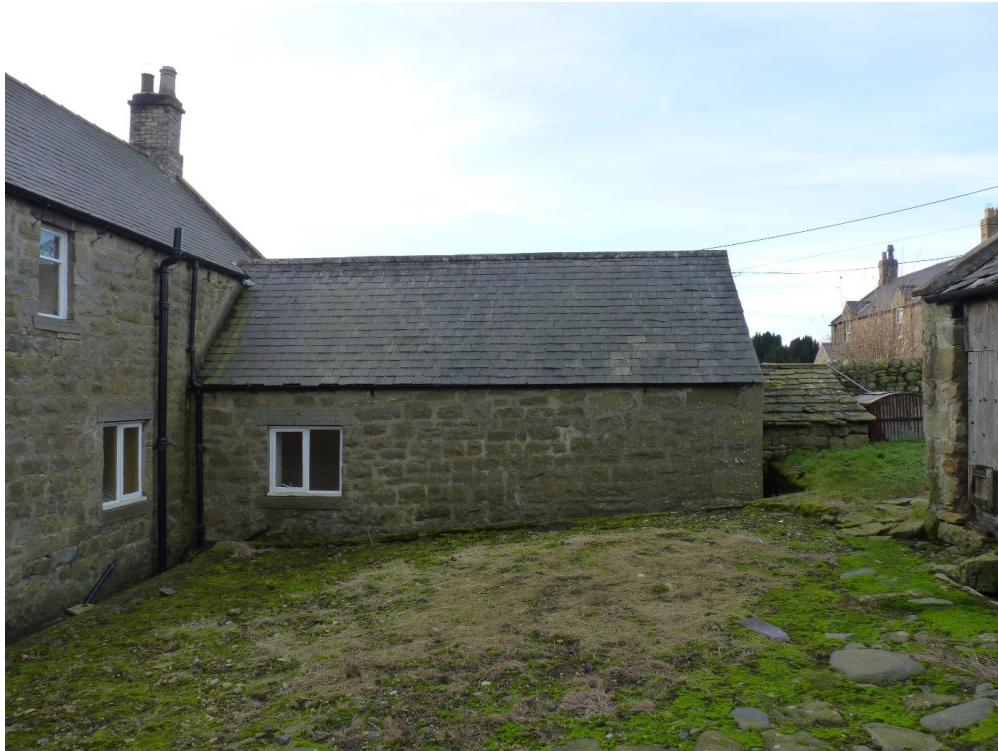
Plate 3: Shepherd's House to the left (A) and the east face of the northern offshot (B). Looking west across the yard.

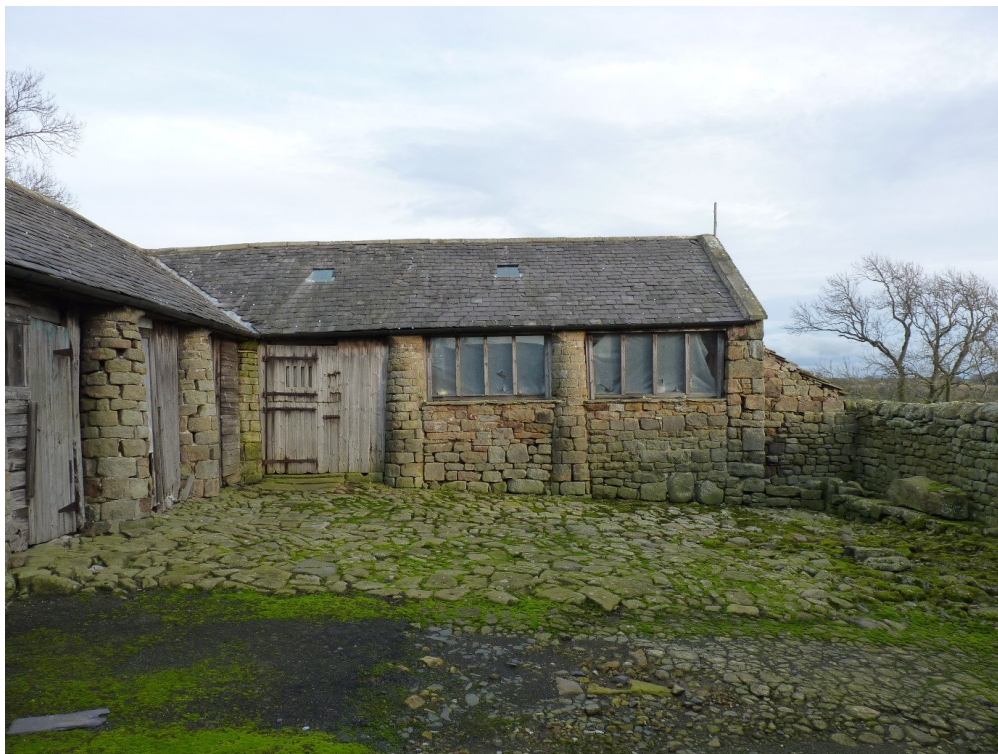
Plate 4: The west face of stone-built agricultural range (C). Looking east across the yard. Originally open between the columns, the bays were at some point infilled with stone.

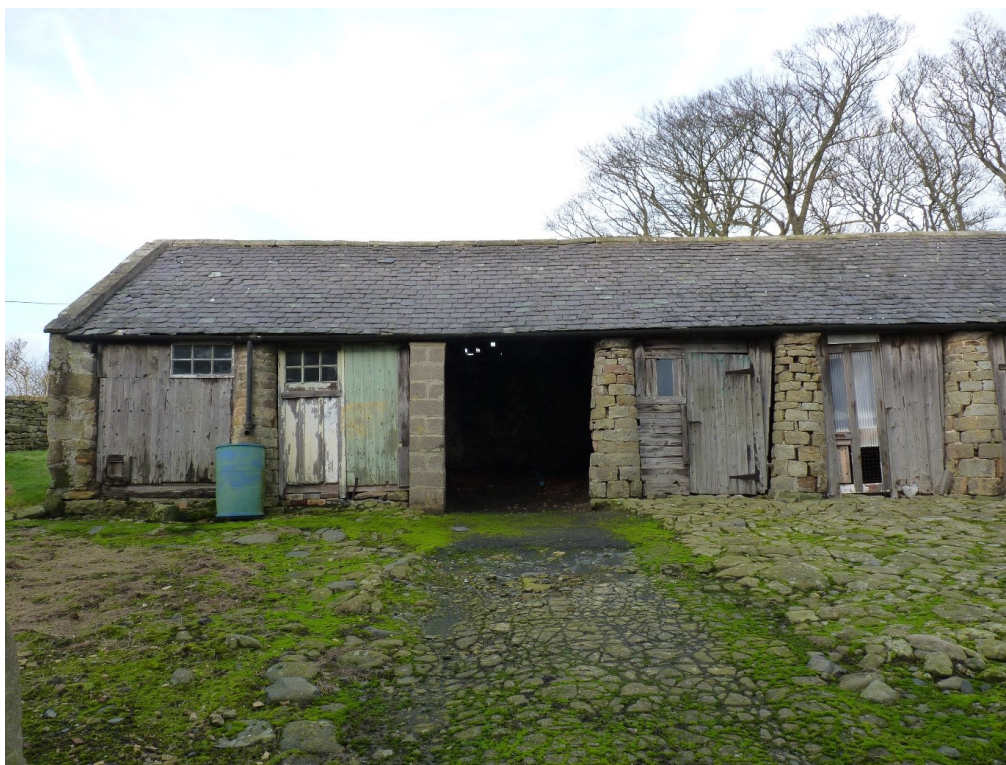
Plate 5: The south face of building (C). Looking north. Bays between columns have been infilled with timber.

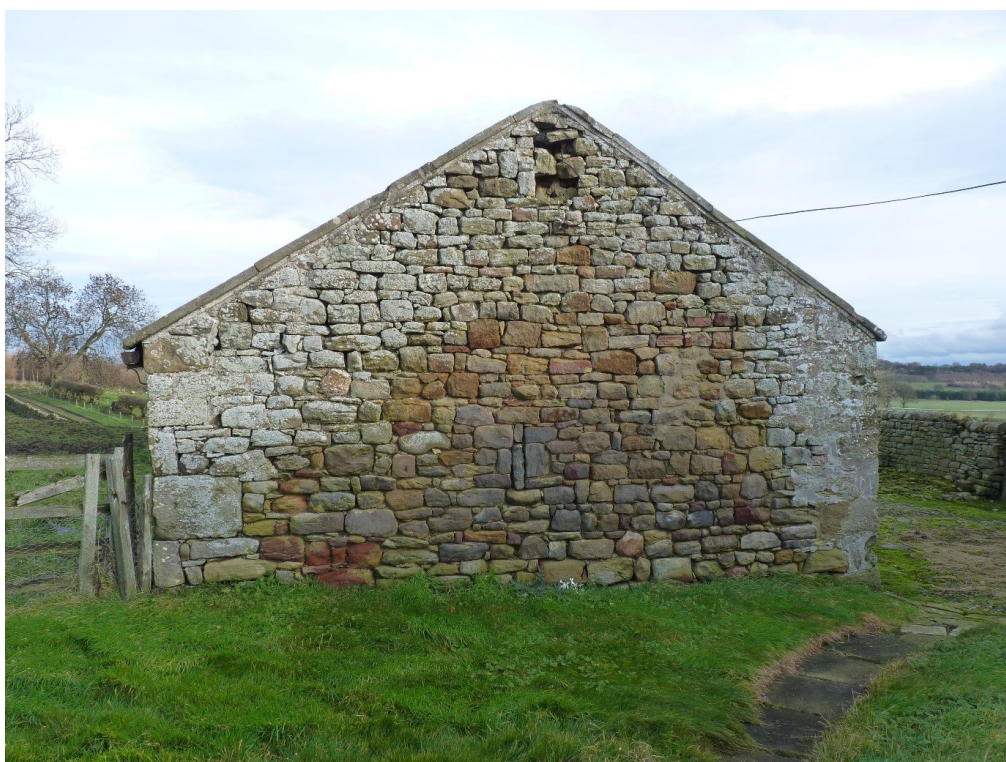
Plate 6: The west gable wall of building (C). Looking east. This would be the location of Trench 1.

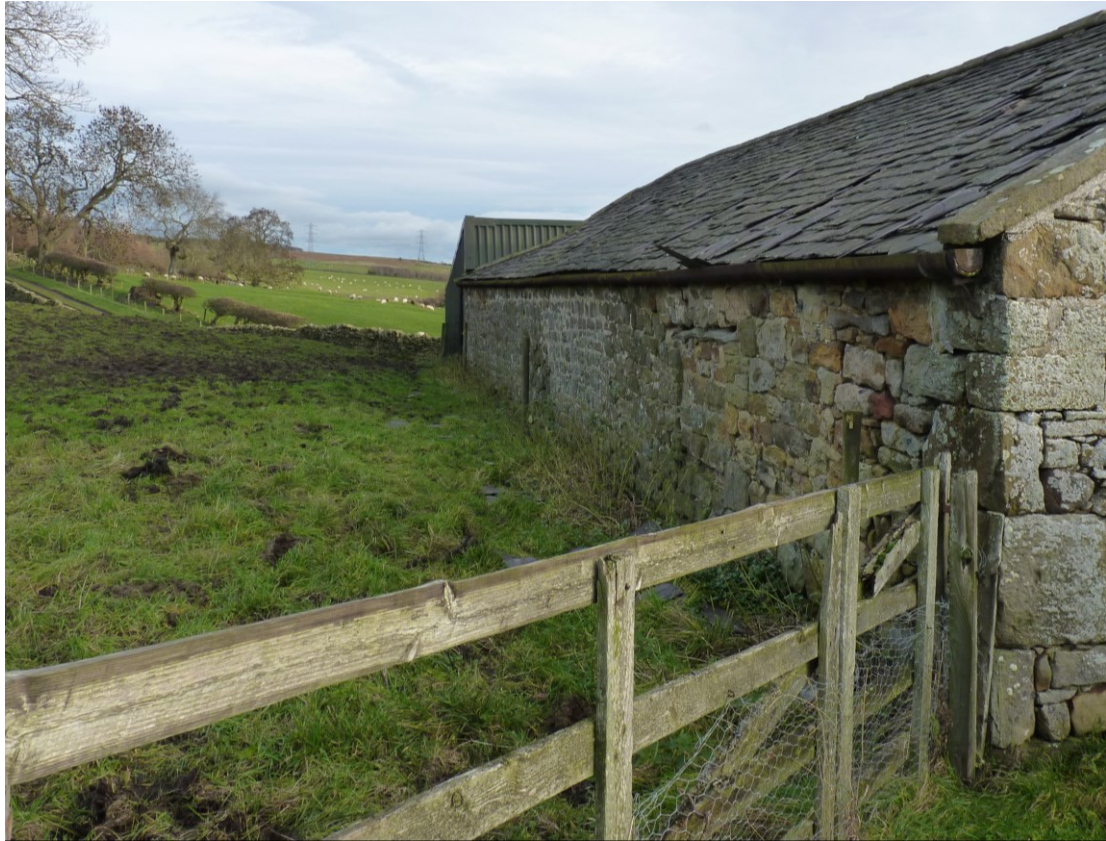
Plate 7: *The west gable wall of building (C) at the right. Looking east along the north face of the building, the location of trenches 6 and 7.*

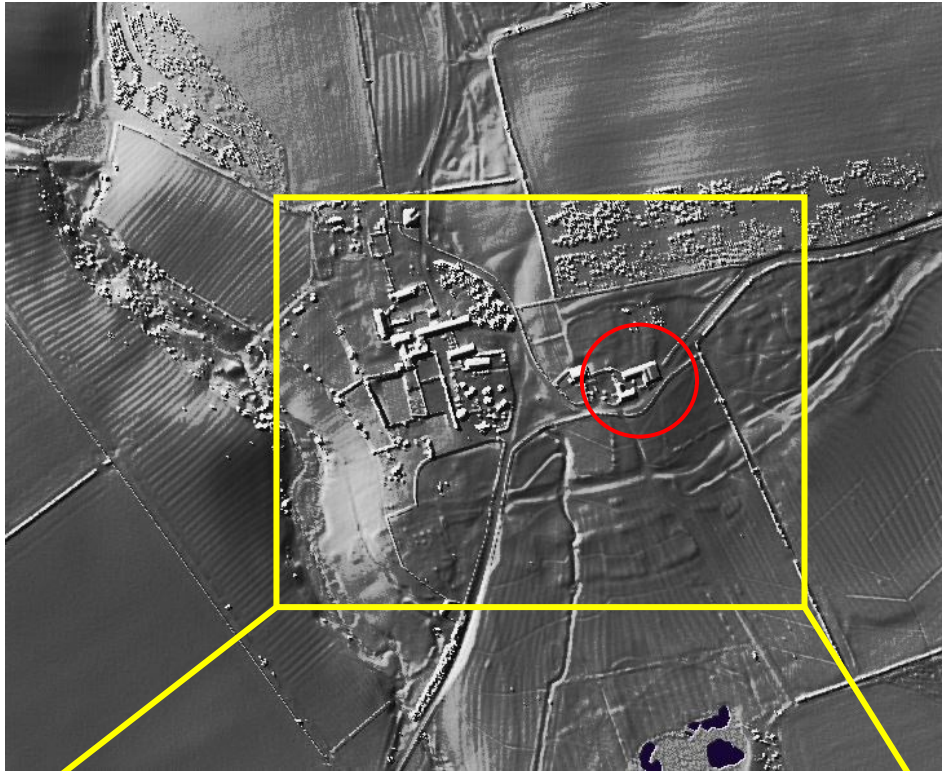
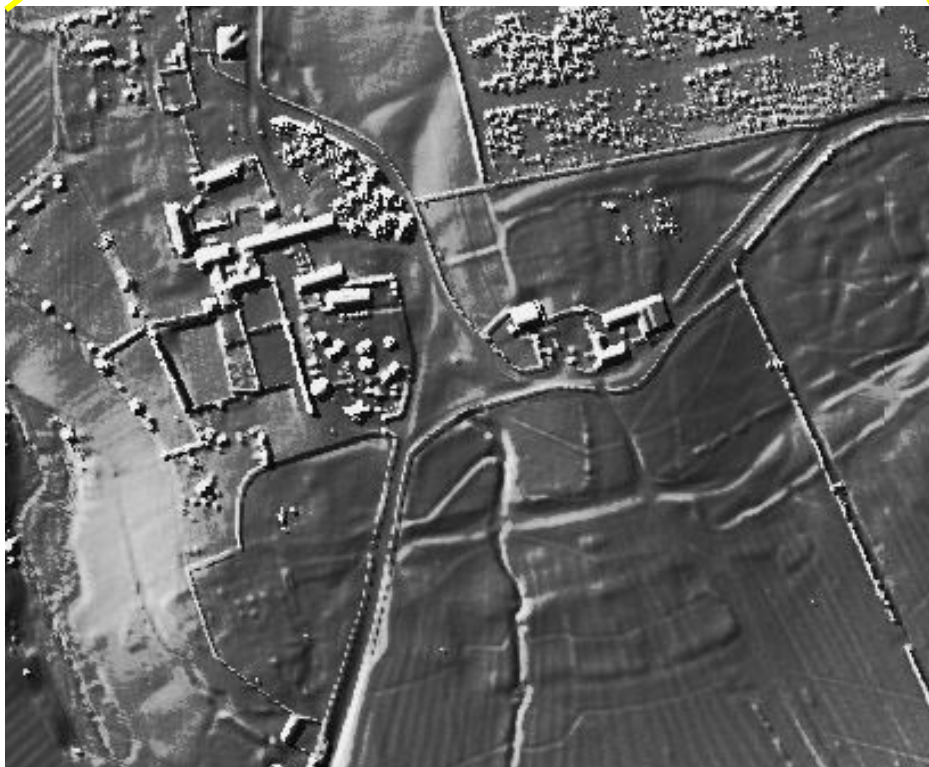
Figures B and C: LIDAR survey of Halton, showing a clear picture of the encompassing medieval earthworks. Site circled in red on B.

Figure A: Hadrian's Wall National Mapping Project for Halton showing earthworks, mostly relating to the medieval settlement, in red and blue line. Compare with figures B and C. HER entries are in bold. The PDA is arrowed.
