HADRIAN'S WALL PATH AT BOGLE HOLE

MELKRIDGE, NORTHUMBERLAND

ARCHAEOLOGICAL MONITORING DURING
FORMATION OF PITCHED STONE SURFACES

March 2018

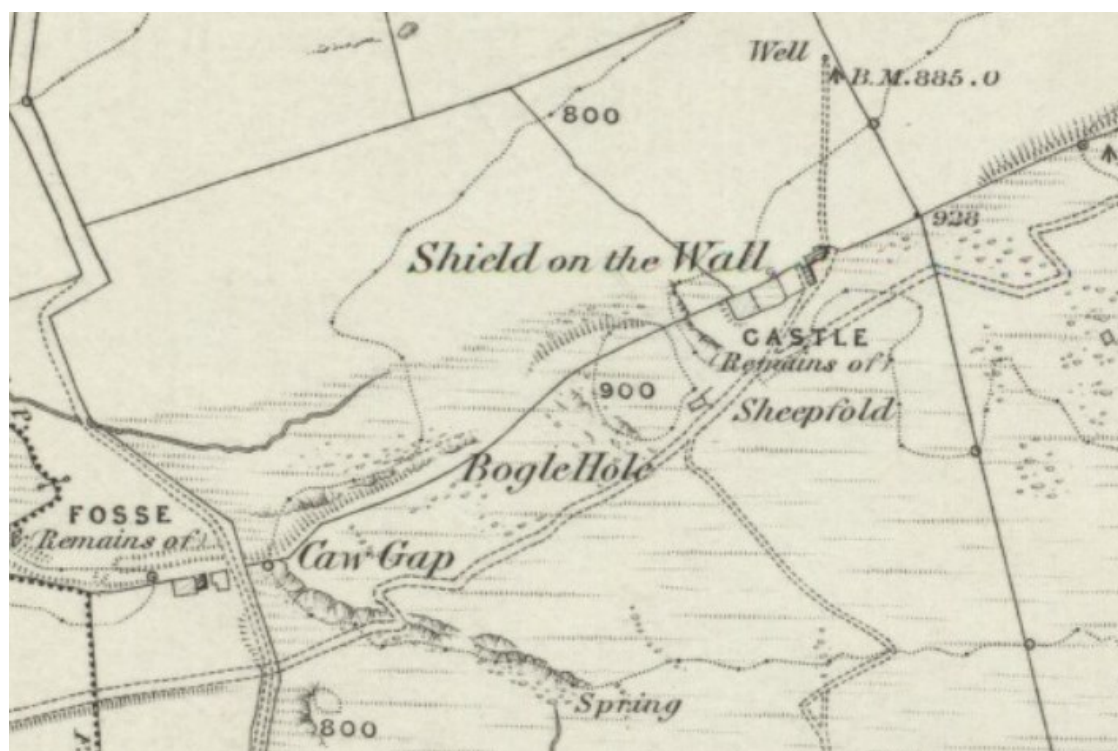
Figure 2: First Edition Ordnance Survey (1858) showing Caw Gap, the Bogle Hole and the early site of Shield on the Wall Farm, immediately to the east of Milecastle 41.

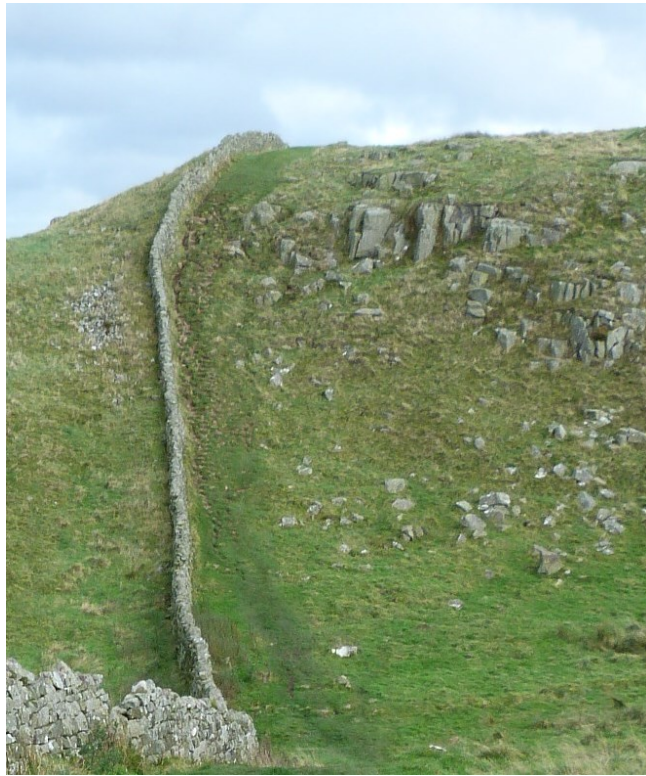
Plate 1: Looking east at Area A (the slope climbing eastwards from Bogle Hole) prior to pitching works.

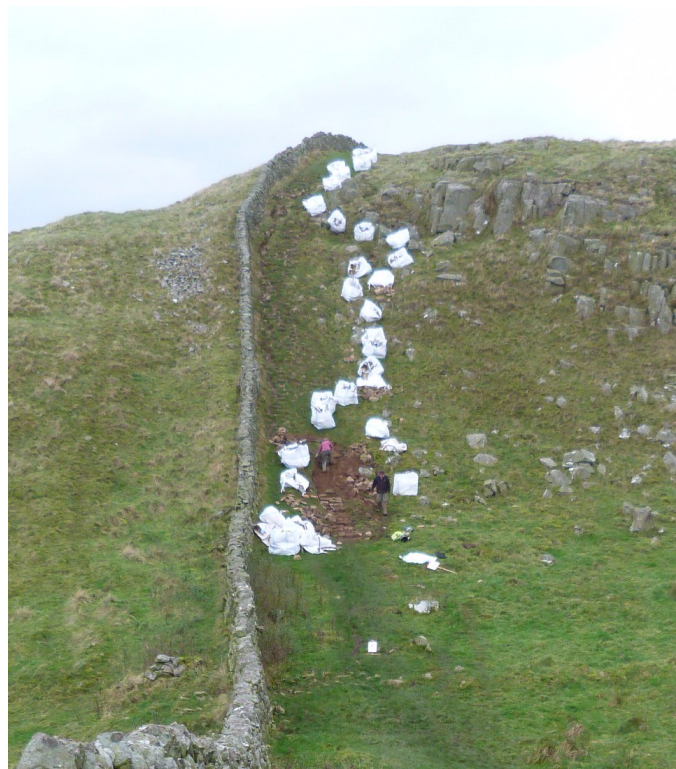
Plate 2: The same area as works commenced. The white sacks hold the air-lifted pitching stone.

Given the difficult topography, pitching stones (plough-derived whin, sourced from field clearance on Chesters Estate) were air-lifted by helicopter to site in bags each weighing around 900kg and set in place for use up both slopes (front cover). Work was continued from the foot of the Bogle Hole slope eastwards. A tray or slot was manually cut along the favoured route to take the pitched stones, laid to create a comfortable walking surface and set to be in character with exposed Whinstone geology. The slot rarely exceeded 0.3m in depth (only where a substantial stone was removed or a large pitching stone required secure bedding) and never over 1m in width.

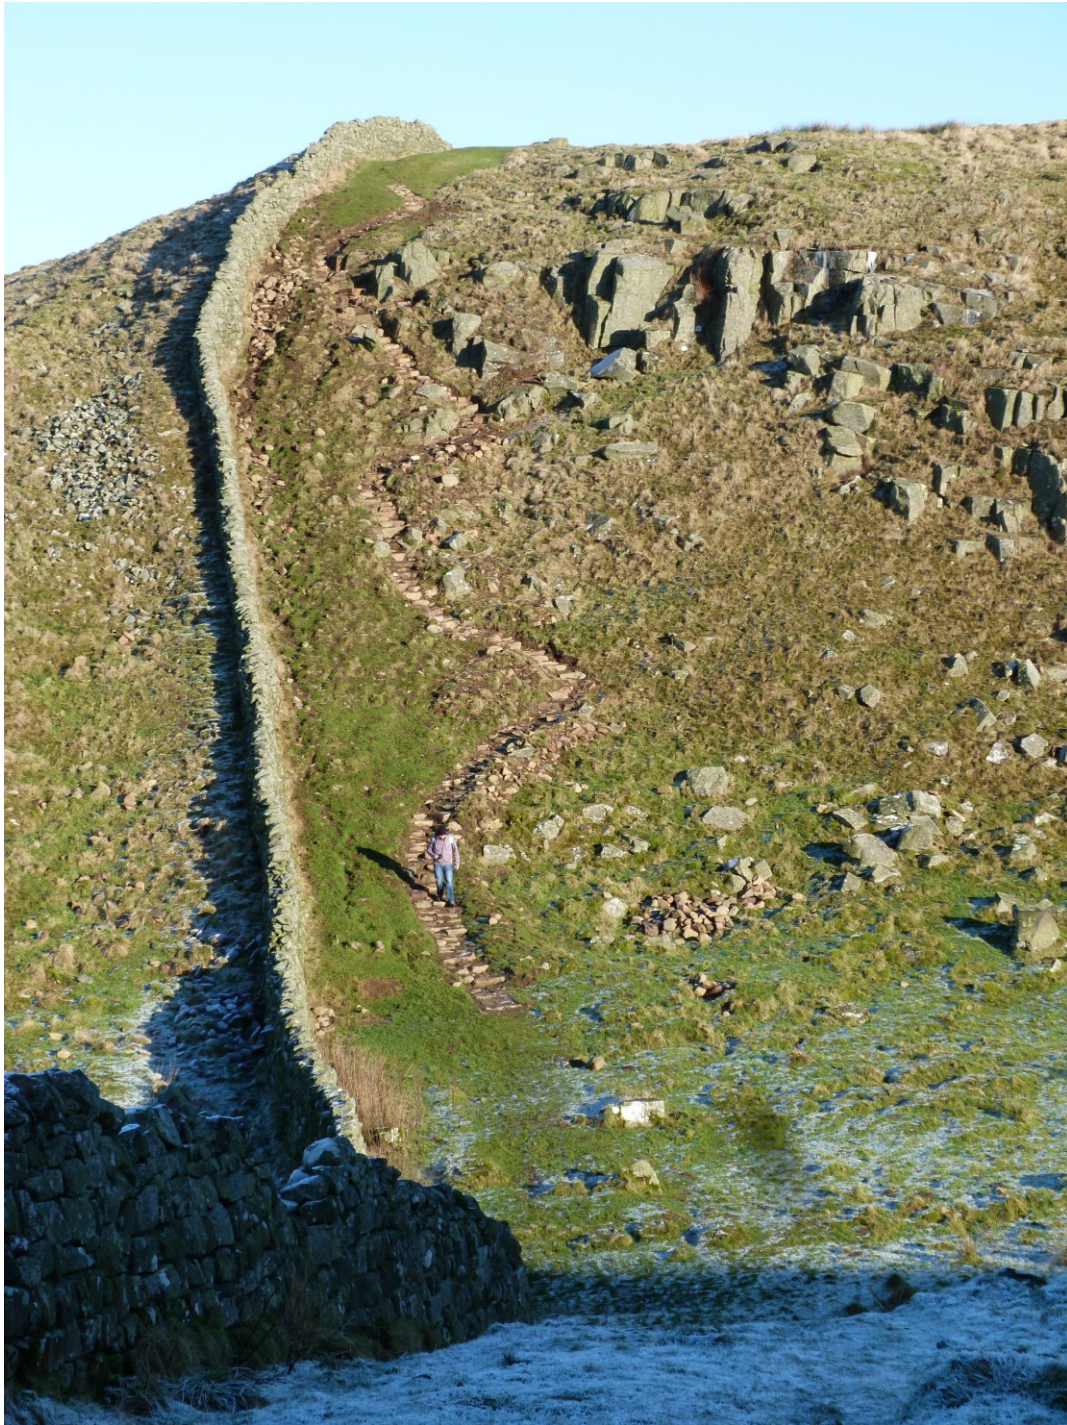
Plate 3: Area A. Looking east, following completion of the pitching. The developed path utilised natural contour to create an easier route.

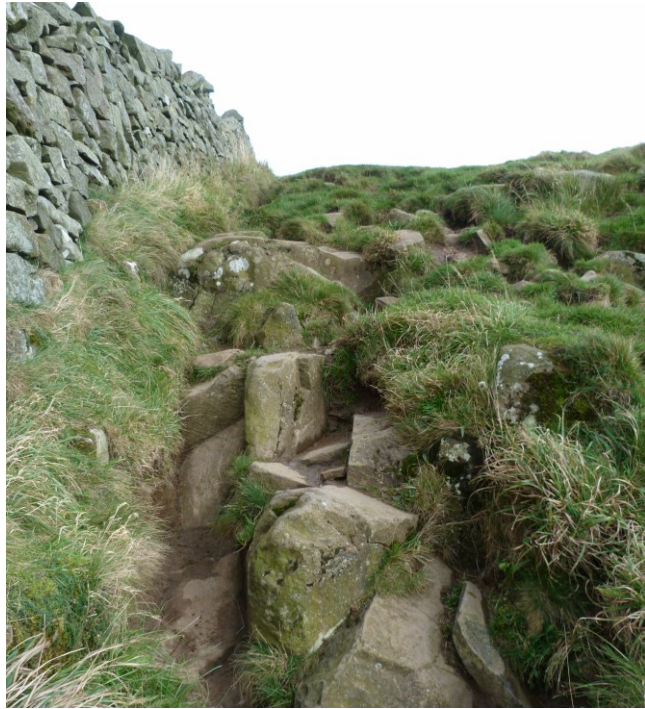
Plate 4: Area of deep erosion with exposed bedrock Area A, towards the top of the path, looking east.

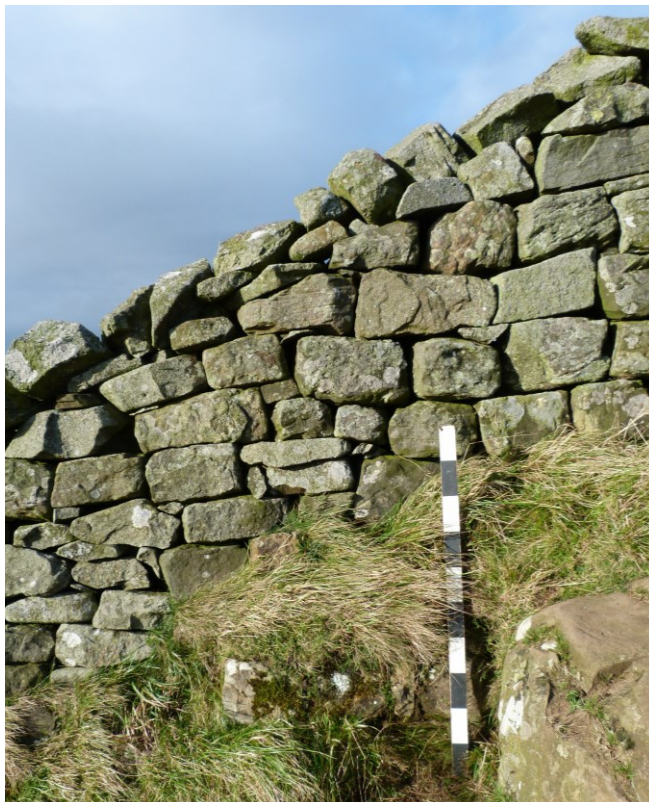
At one point on the upper area of the slope adjacent to Bogle Hole, a number of possibly *in situ* Wall facing stones had been partially exposed by the erosion gully. They were photographed as a record prior to filling of the gully.

Plate 5: Area of deep erosion with exposed bedrock. Area A looking north. Dry stone wall overlies the Roman Wall. Possibly insitu facing stones exposed at base of 1m scale.

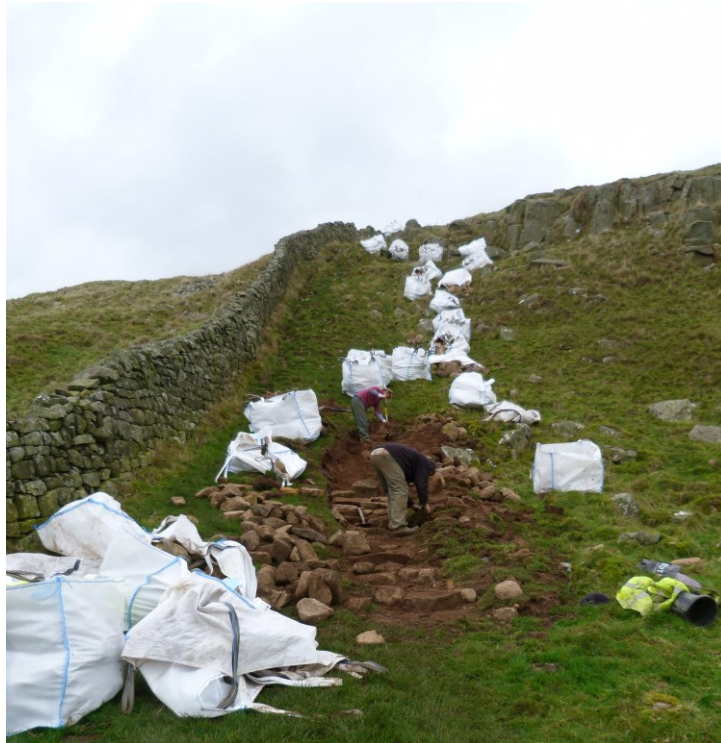
Plate 6: Looking east. Constructing steps at the western end of Area A.

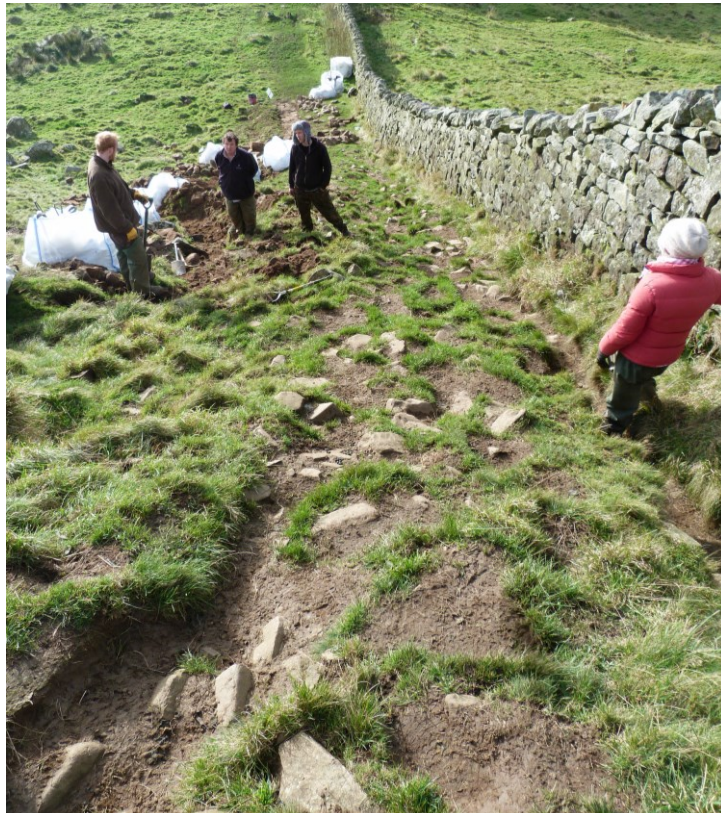
Plate 7: Looking west. Area A. Manual excavation for the 'tray' or slot. Working upslope.

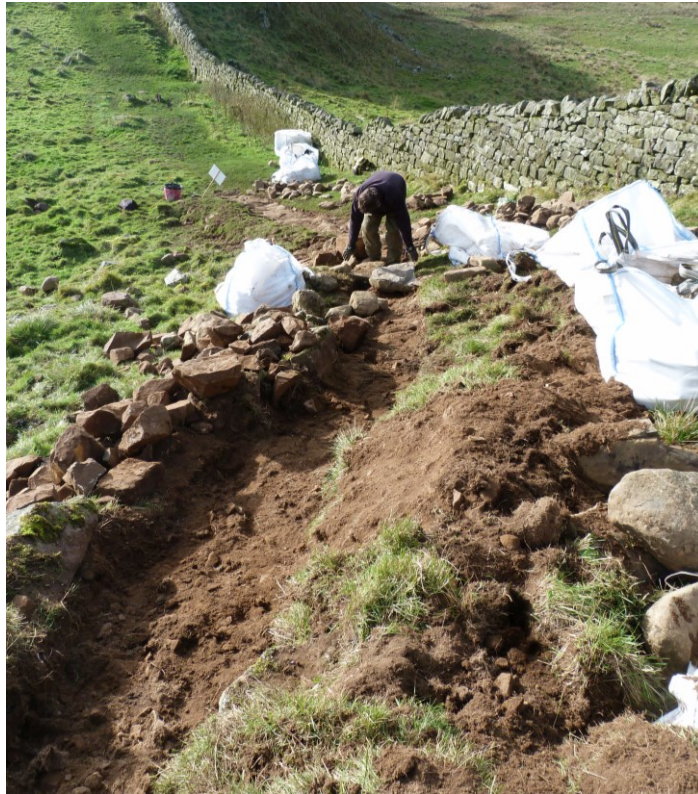
Plate 8: *The slot excavated. Same area as shown in plate 7.*

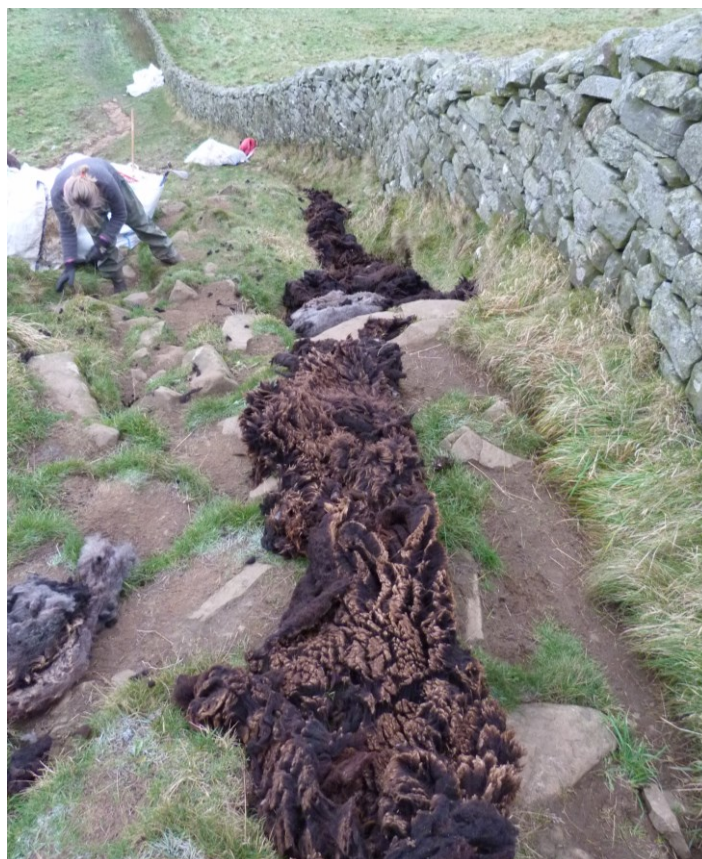
Plate 9: *Sheep fleece set at the base of the erosion gully in Area A as a marker. Looking west.*

In addition to the pitching work, an erosion gully running alongside the south face of the drystone field wall was filled with stone spoil from the groundworks and topped with turf which had also been removed during groundworks. The depth of the scour was marked with sheep fleece.

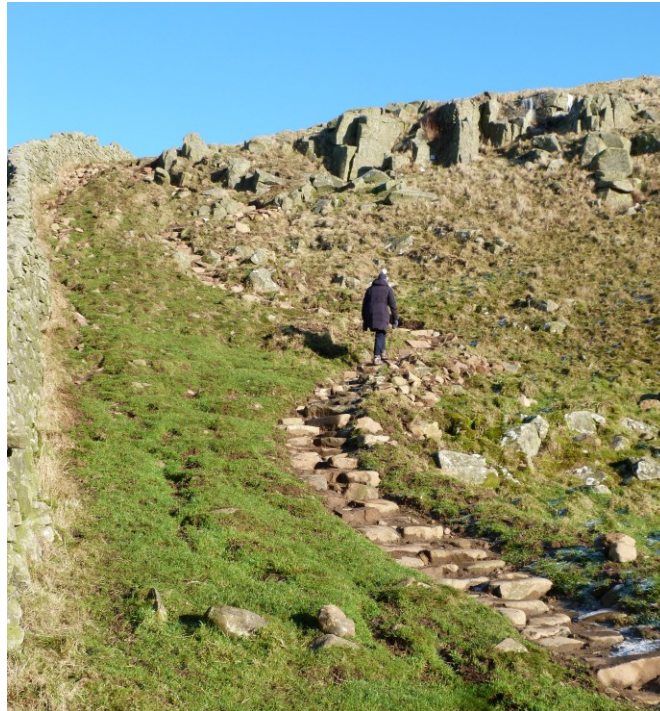
Plate 10: Looking east. Area A in use as part of the Hadrian's Wall Path.

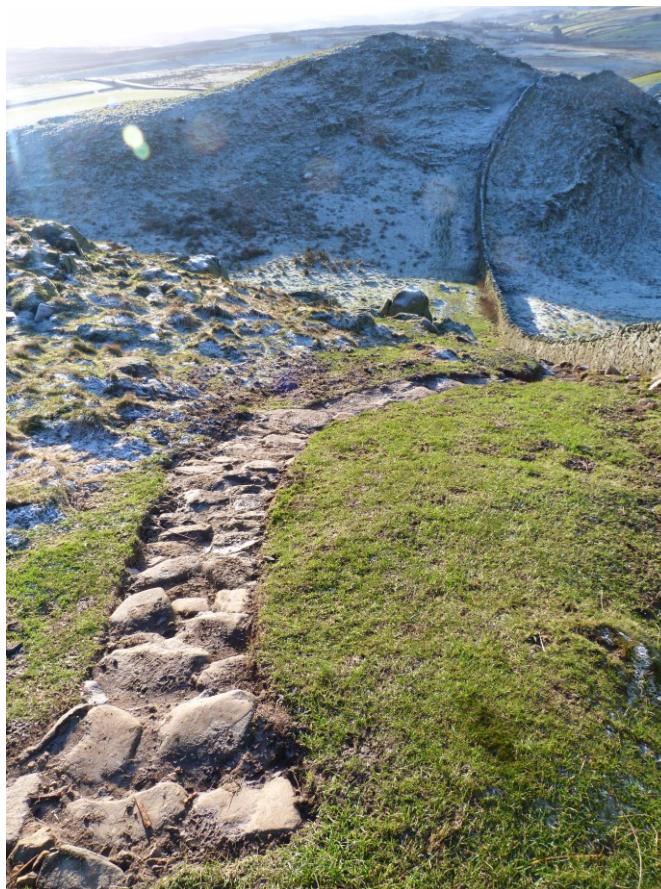
Plate 11: The east end of pitched stone in Area A set into the bank flanking the Wall line. Looking west over Bogle Hole.

The only discrete feature impacted was the 'robbing' bank alongside the south flank of the Wall line. This occurred at the top of the slope climbing east from Bogle Hole and confirmed the nature of the bank as a loose pile of stones and earth, presumably a product of the wholesale scouring and relocation of an existing mound

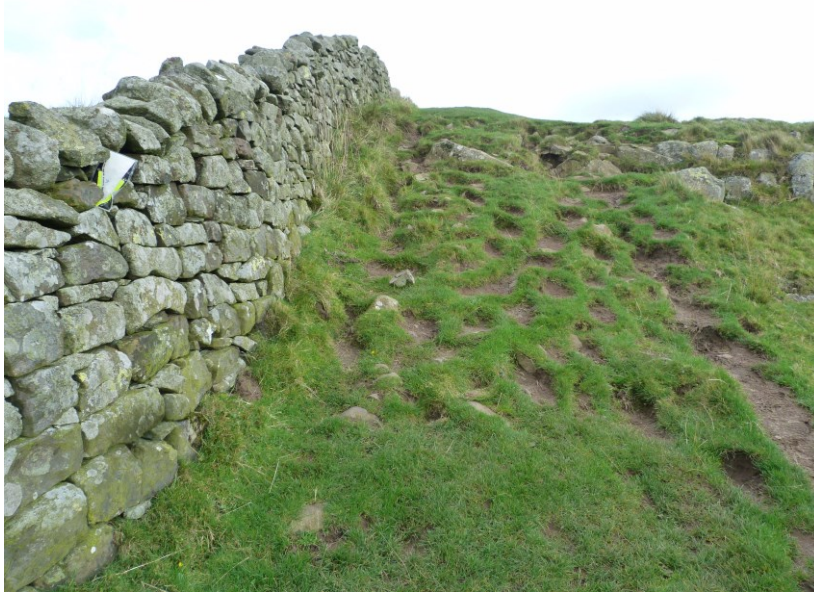
Plate 12: Area B, looking east. Prior to remedial works.

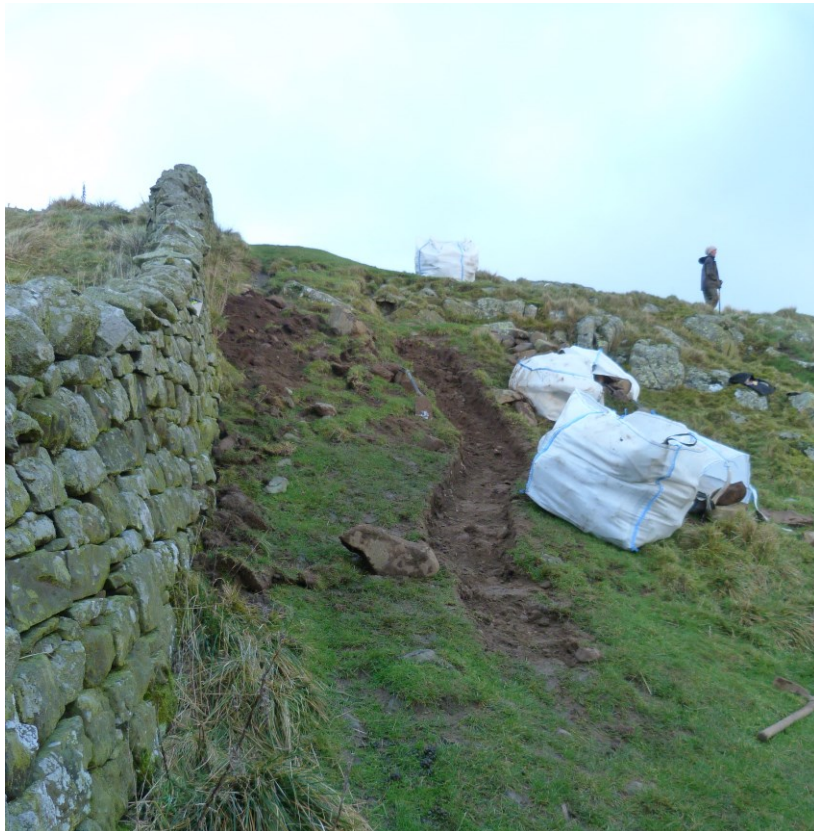
Plate 13: The same area as shown on plate 12, during excavation of the foundation slot or 'tray' for the pitched stone steps. Looking east.

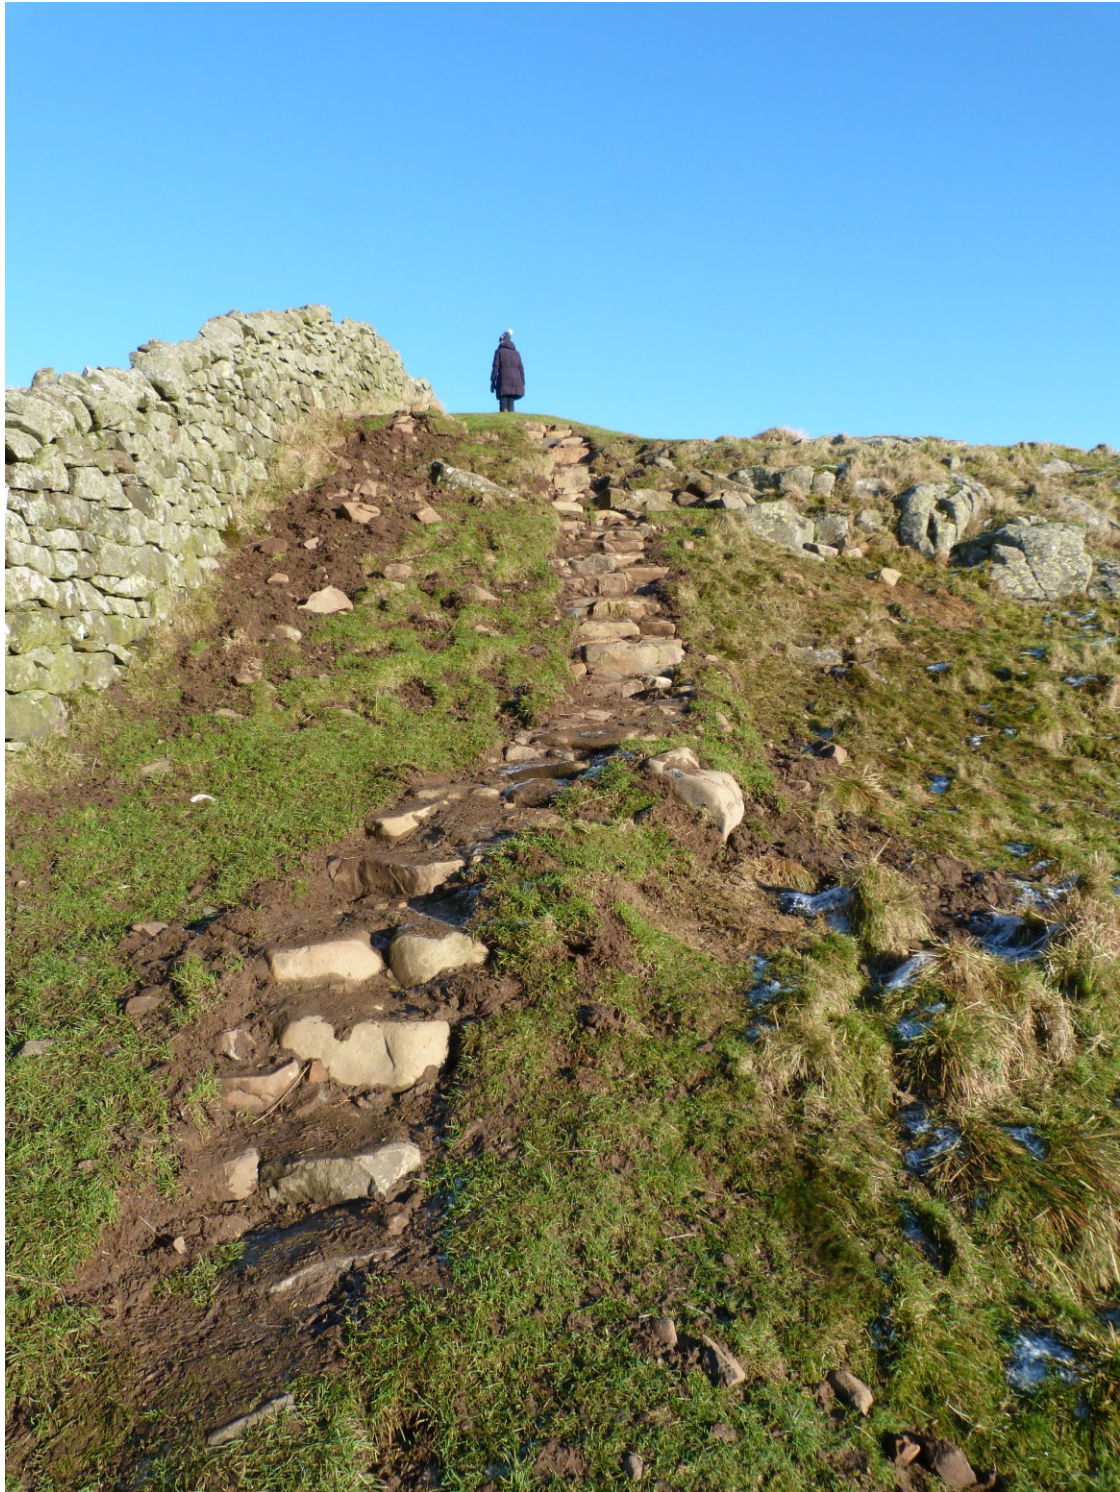
Plate 14: *The same area as shown on plate 12 following completion of the pitching works. Looking east.*

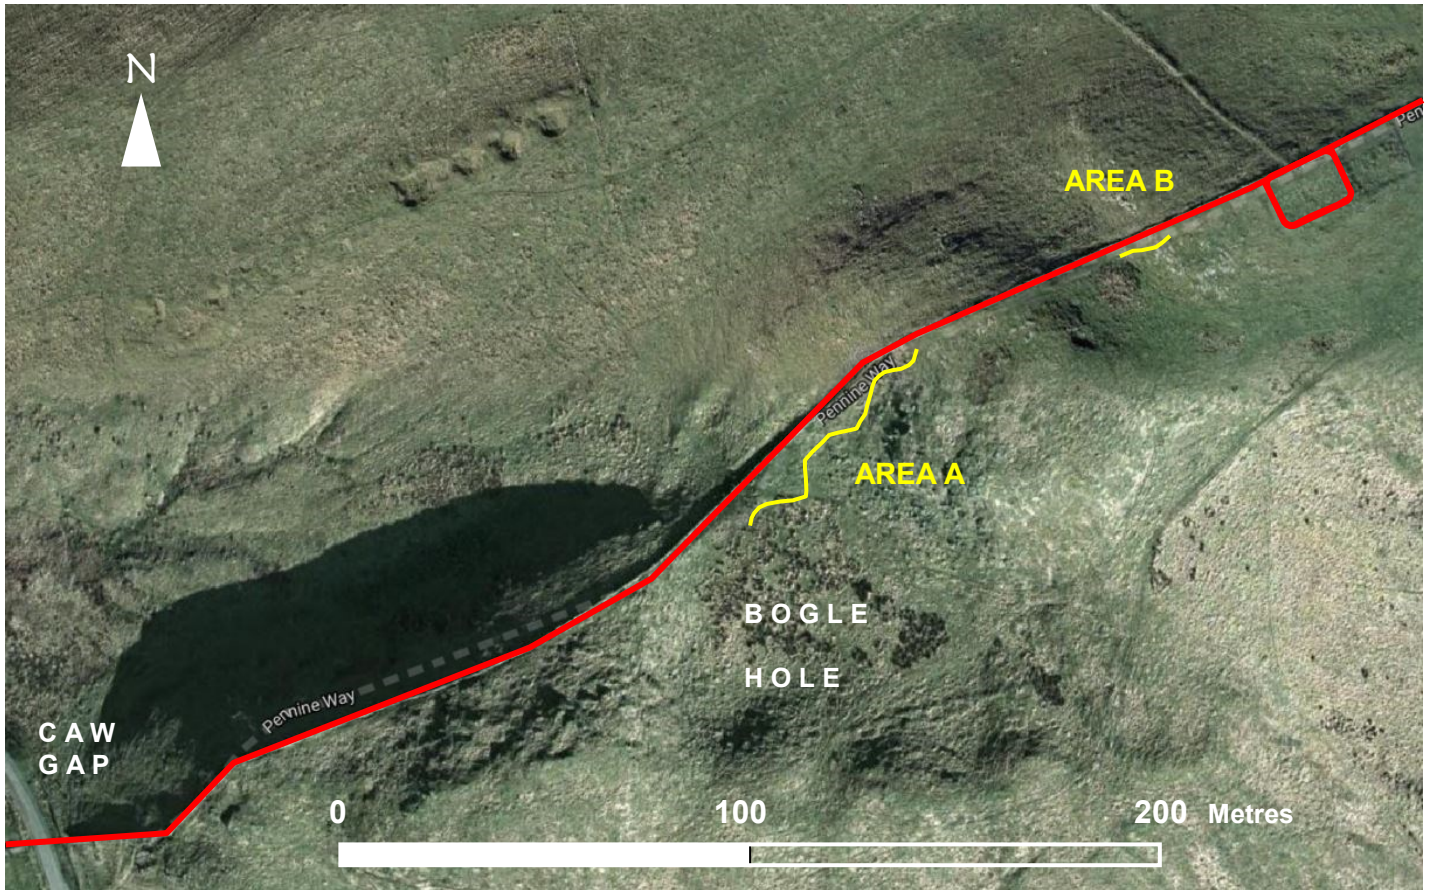
Figure 4: Areas of remedial work A and B shown on a Google Earth background. The approximate extents are shown in yellow line. The course of Hadrian's Wall, now overlaid by a modern drystone field wall, is shown in red as is the location of Milecastle 41, now marked only by earthworks. The Caw Gap road is at the lower left of the frame.

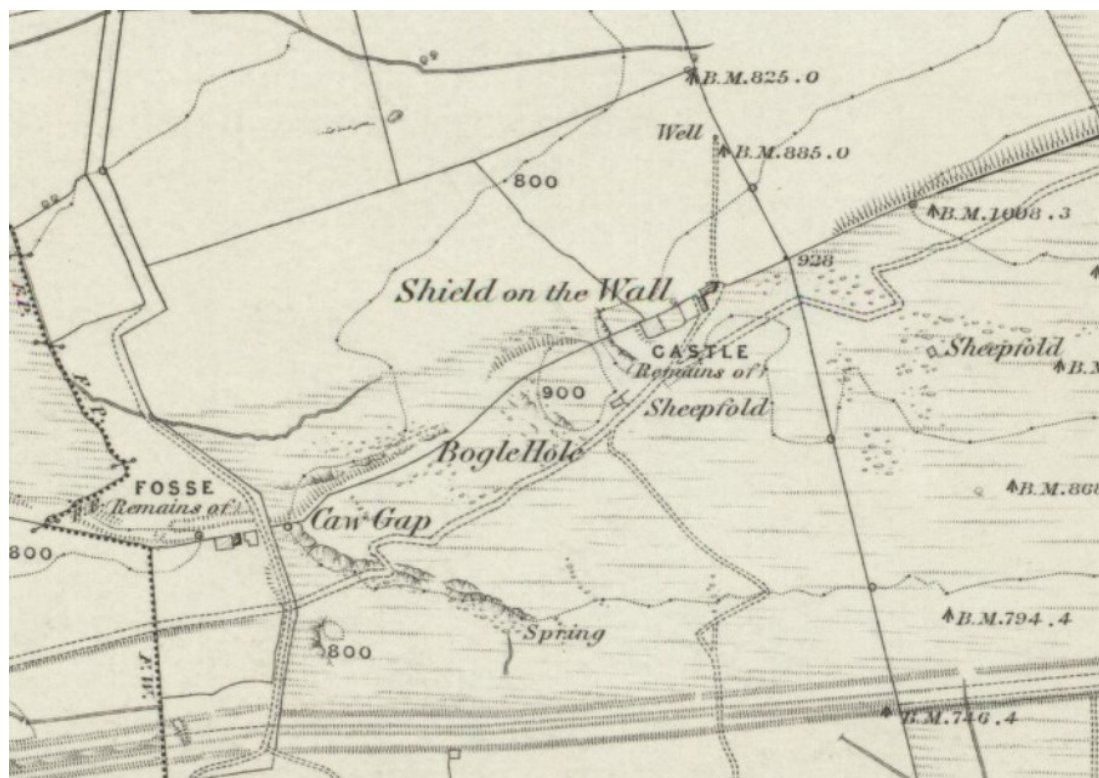
Figure 2: First Edition Ordnance Survey (1858) showing Caw Gap, the Bogle Hole and the early site of Shield on the Wall Farm, immediately to the east of Milecastle 41.

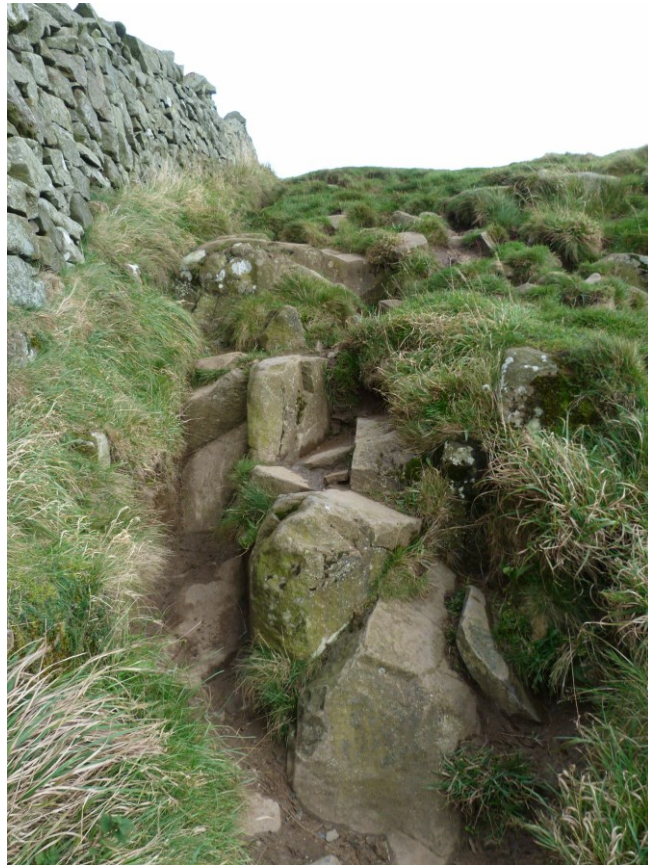
Plate 1: Area of deep erosion with exposed bedrock. East slope of Bogle Hole looking east. Dry stone wall overlies Roman Wall.

- c) The erosion gully will be lined with fleece (marking the limit of current intervention) before primarily filling it with the same sort of stone that is to be employed in the pitching works. There may also be some consolidation with a small quantity of smaller whinstone chippings. The infill will then be topped off with soil and turf findings from the tray excavation for (a). If necessary, the site will also be seeded which may necessitate some light, superficial, scarification.

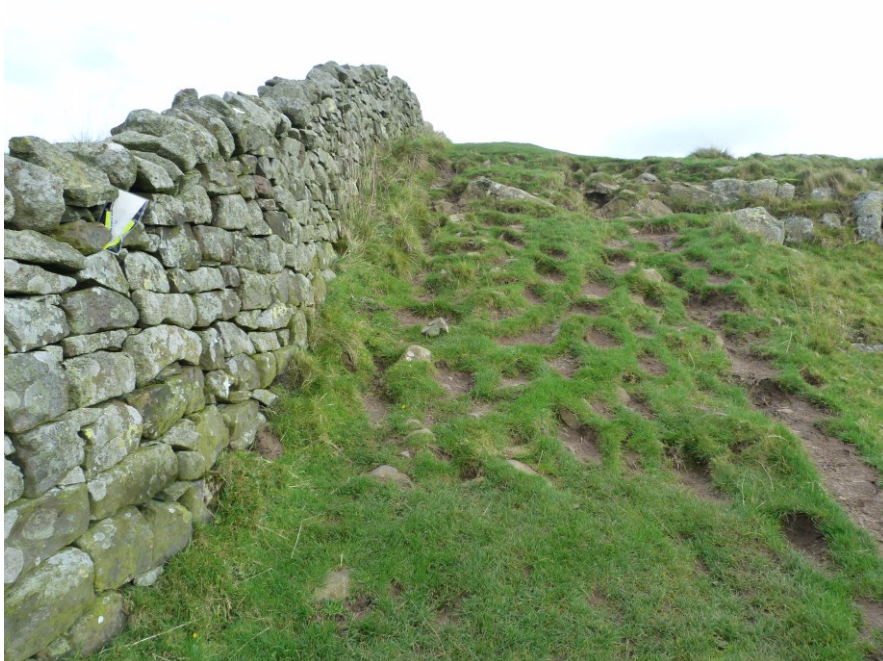
Plate 2: The eastern area of erosion, east of Bogle Hole. Dry stone wall overlies Roman Wall.

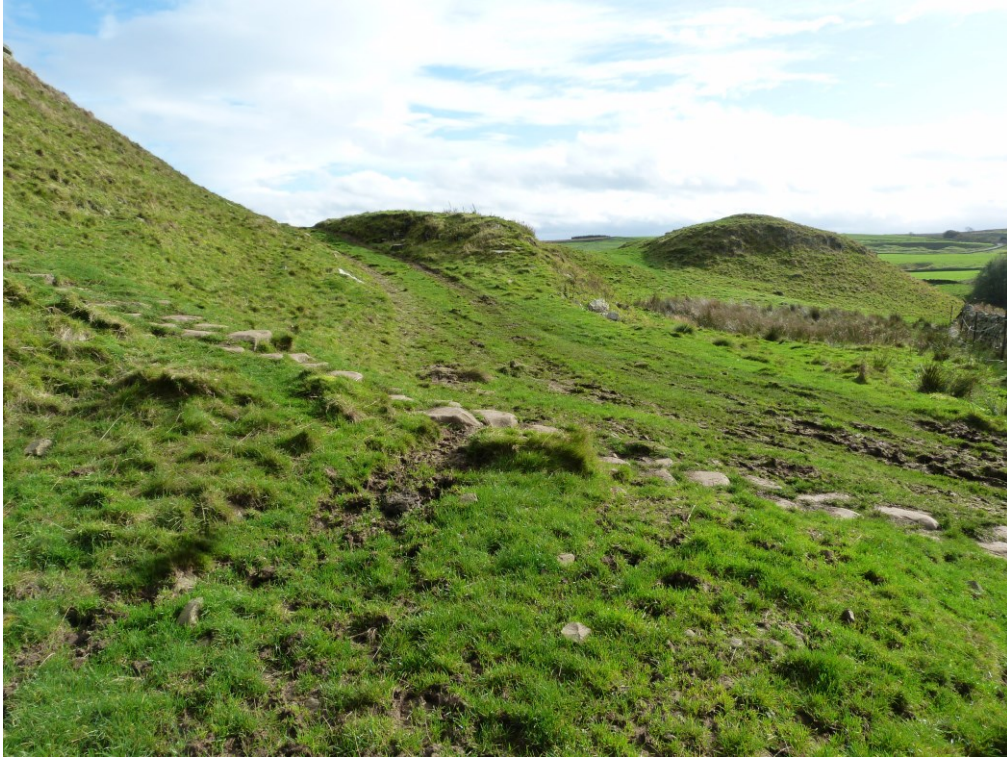
Plate 3: *The area immediately east of Caw Gap, looking south-east. The boulder will be placed along the desire line running across the middle of the frame. Pitched stone path running up to Wall line in foreground.*

- d) A single boulder will be airlifted to site and put in place amid existing exposed rock-bed. The block will mainly be held in place by its own bulk, but some tightening-in may be necessary. If so, any soil will be obtained from findings as above, and any geological material from that imported for (c).
