BERWICK-UPON-TWEED

ARCHAEOLOGICAL WATCHING BRIEF DURING
IMPROVEMENTS TO A FOOTPATH ON THE
NORTH-EASTERN EDGE OF THE
SCHEDULED FORTIFICATIONS

August 2017

Grid Reference: From NT 9989 5361 to NU 0014 5330
Scheduled Monument No: SM 28599 (HA 1019821)
SM Consent No: S00135005
Fieldwork Dates: February to August 2017
Oasis Reference: alanwill1-312458

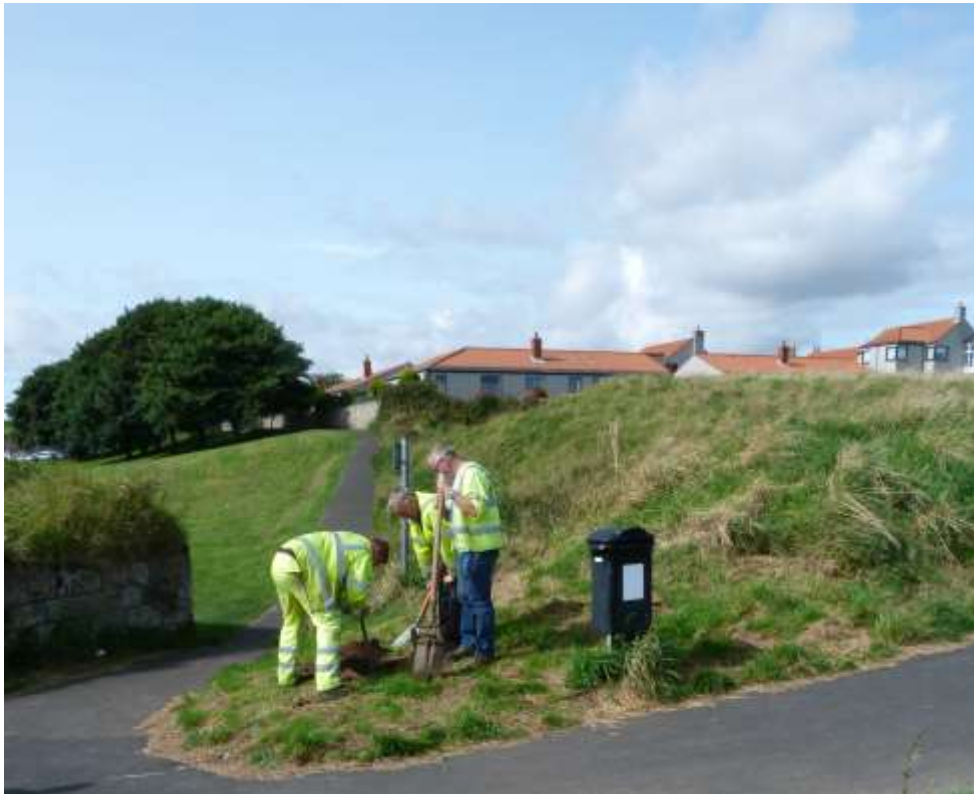
Frontispiece: Excavating a post hole for the new way-markers north of the Batardeau.

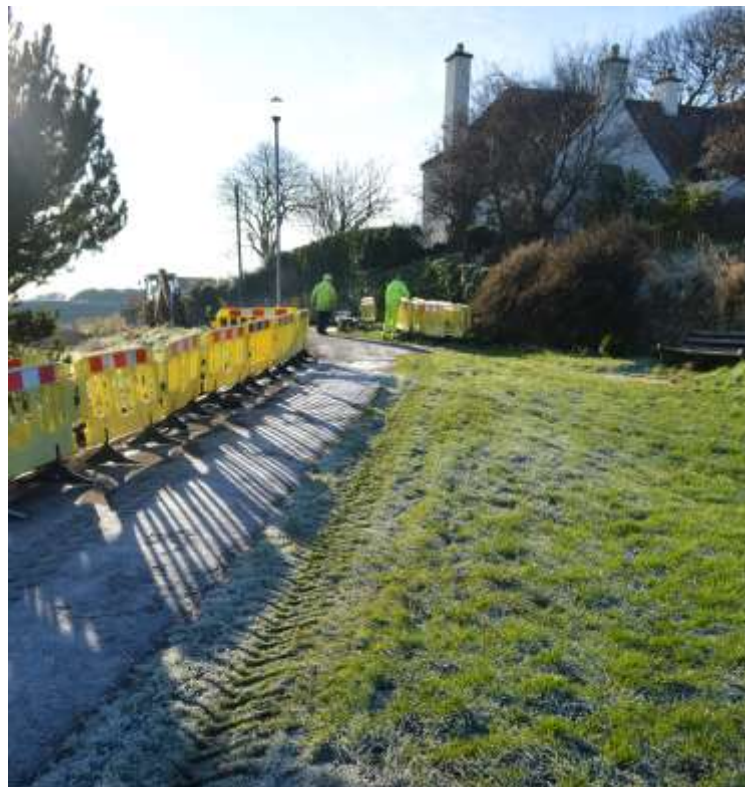
***Plate 1:** Working south towards Fields House at the north end of the footpath.*

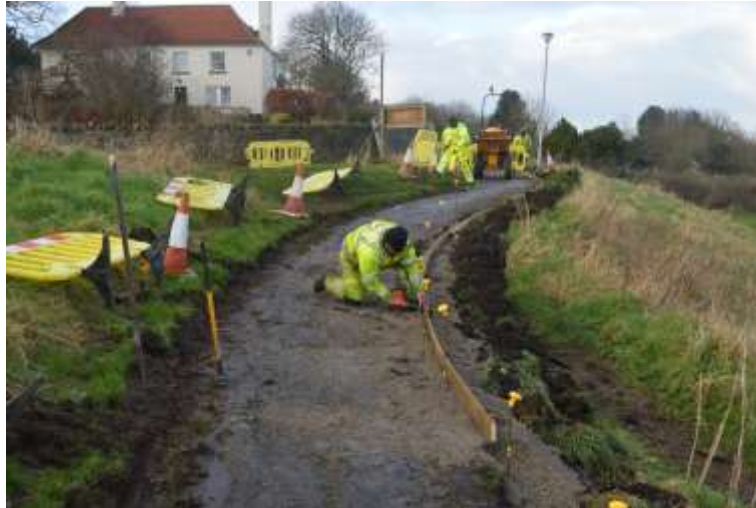
Plate 2: *Fixing the wooden kerbing. Looking north towards Fields House.*

Installation of edging timbers, defining the new width, preceded stripping of the surface and involved the excavation of a narrow slot into which the edging timber was set in a concrete footing. Removal of existing surfacing was carried out by machine excavator and generally only to a depth of 0.25m. Over the great extent of the works, no archaeological impact was observed, the excavations consistently cutting into a friable medium to dark brown loam. Other than a few sherds of modern pottery, no artefactual material was recovered.

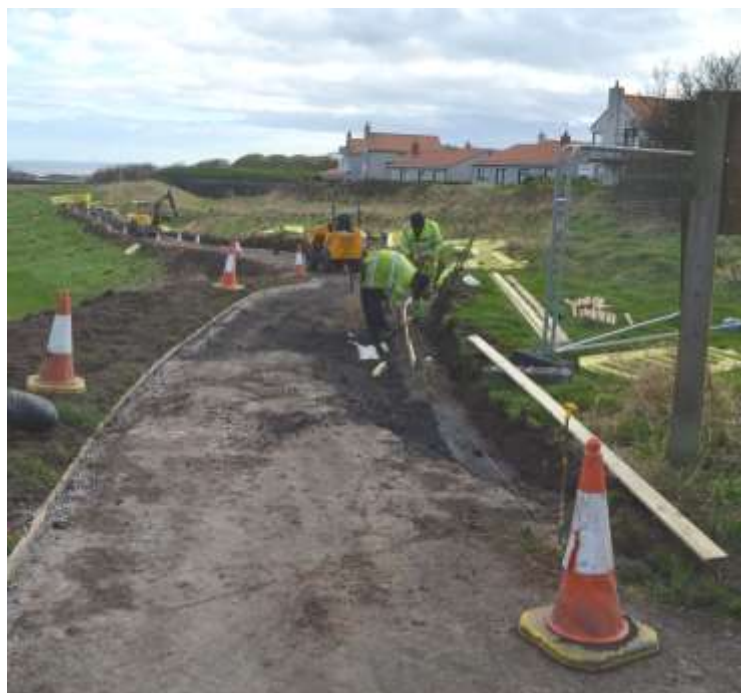
Plate 3: *The new line defined with kerbing on both edges. Looking south just past Fields House, the Edwardian defences to the right*

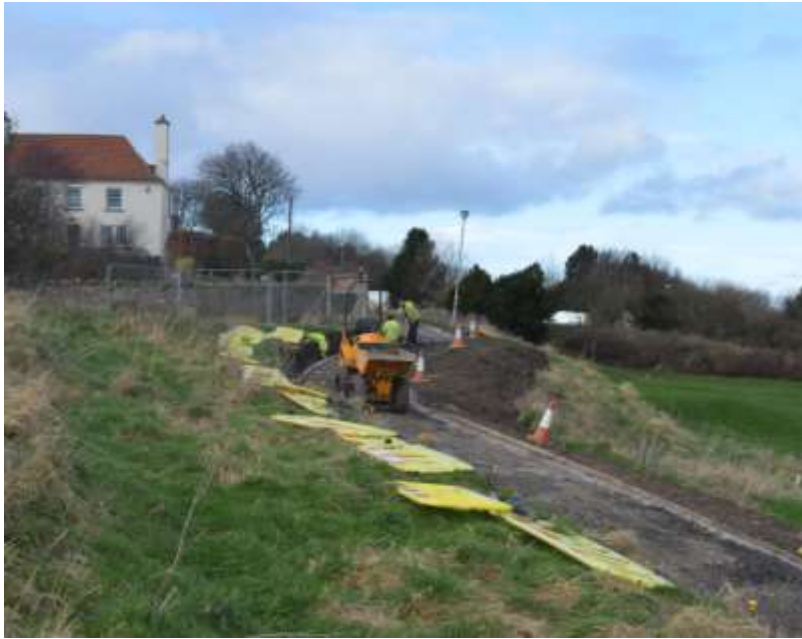
Plate 4: *The surface of the old path stripped away and soil from trimming back the west flank of the path spread on the eastern slope.*

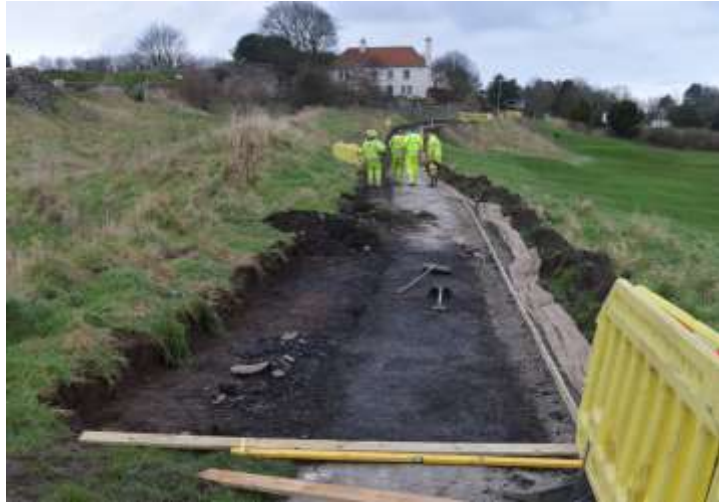
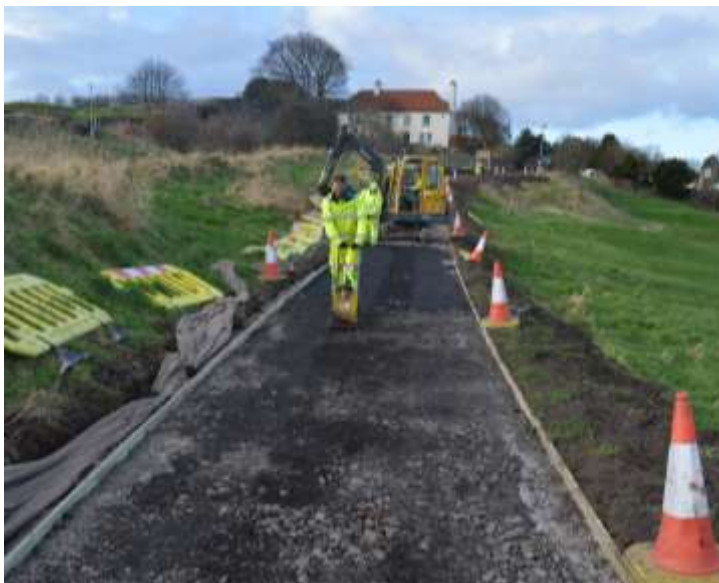
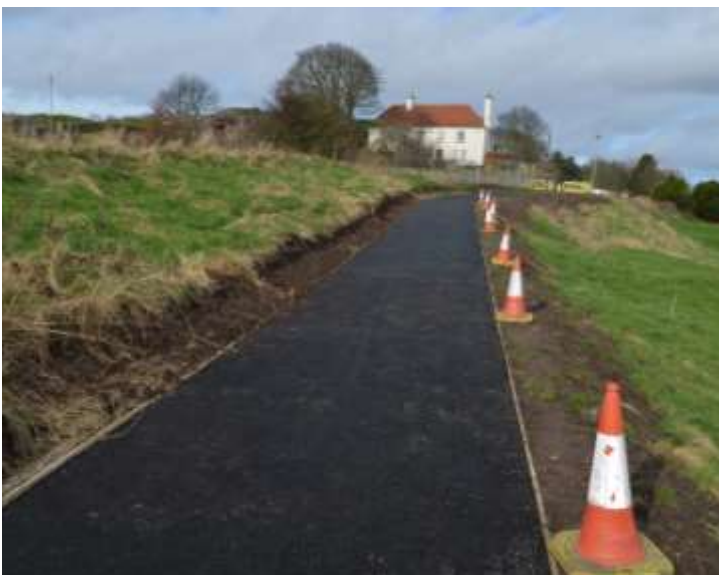
Plates 5, 6 and 7: Looking north at work progressing to the south of Fields House. Upper: East kerb fixed with groundworks progressing on the west flank; Middle: Compacting sub-base; Lower: The new path completed. Soil removed from the west flank was spread to the east.

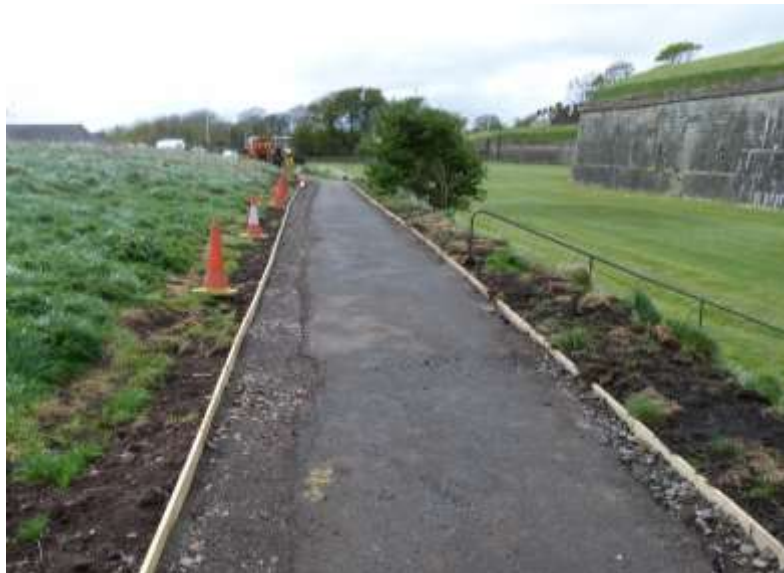
Plate 8: *Wooden kerbing set out on the path alongside Brass Bastion. Looking south. In this area the path has been widened to the east.*

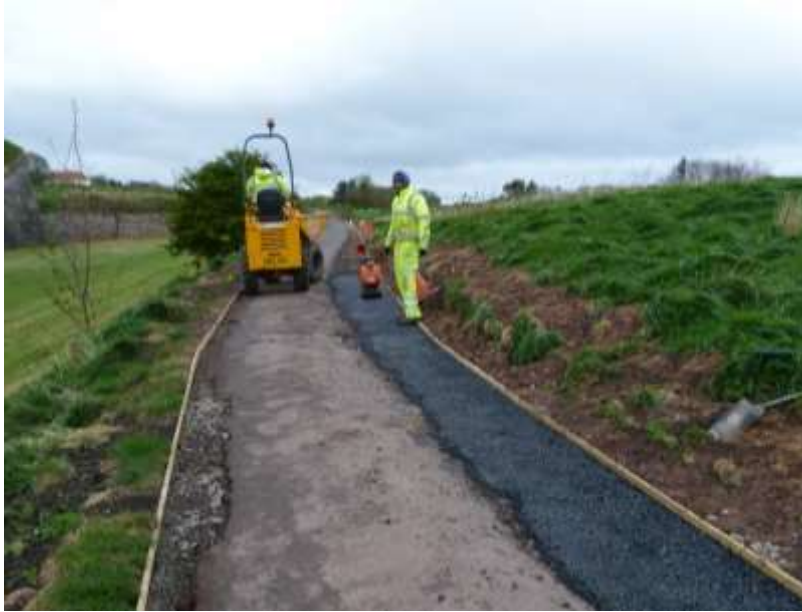
Plate 9: The same stretch of path as seen on plate 8 but looking north. Laying the first strip of tarmac.

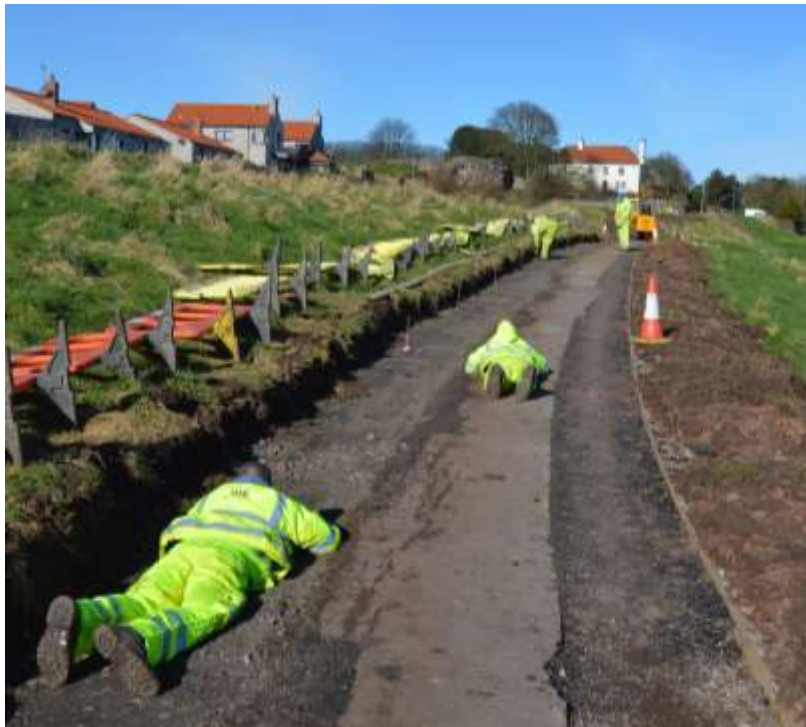
Plate 10: Checking the slope profile of the new path following completion of ground works.

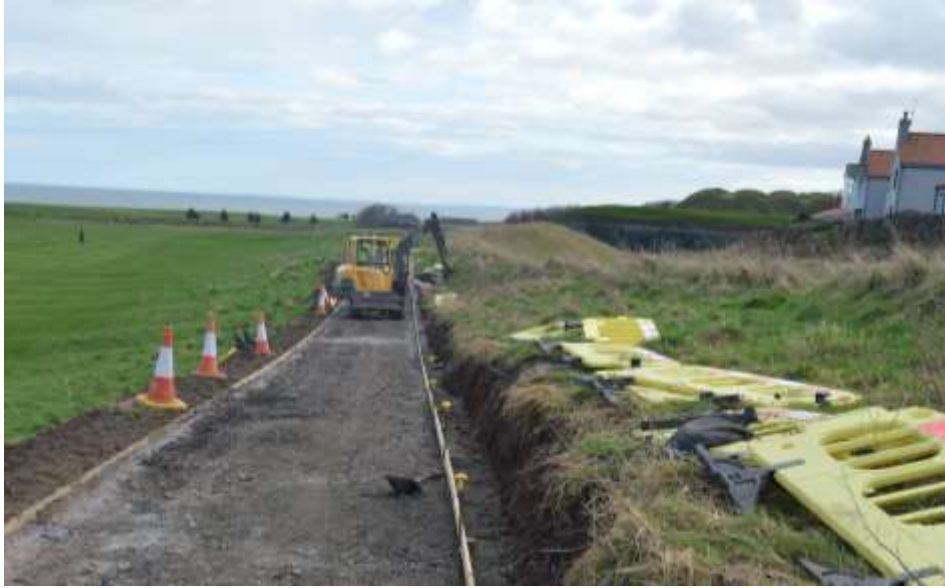
Plate 11: *The maximum encroachment into deposits west of the path. Looking south c.120m from Fields House.*

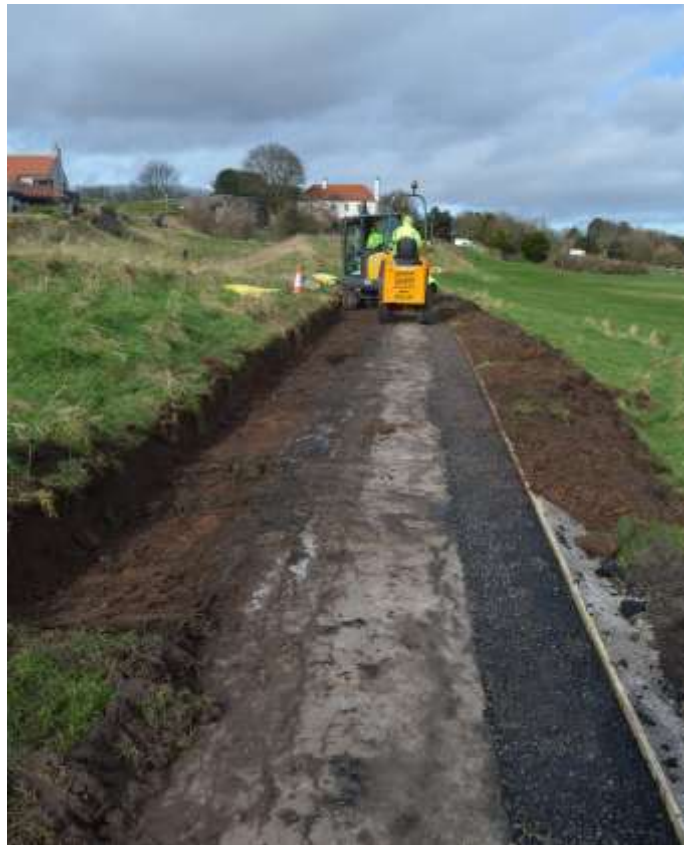
Plate 12: *Similar location as plate 11 but looking north showing maximum encroachment into deposits to the west of the path marginally into the medieval counterscarp.*

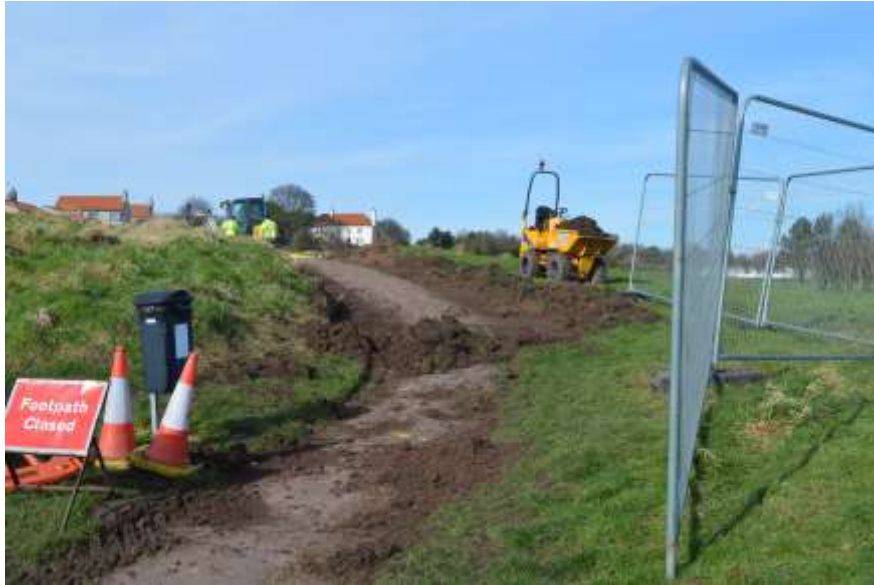
Plate 13: Just north of the batardeau, showing excavation along the east side of the path, avoiding the medieval earthwork to the west.

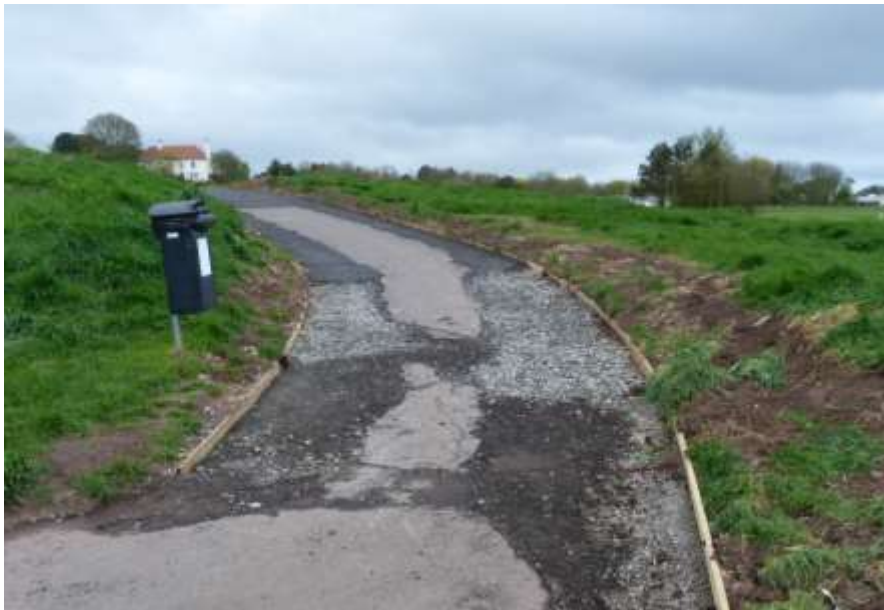
Plate 14: Same view as plate 13 with earthworks completed and kerbing laid for the wider path.

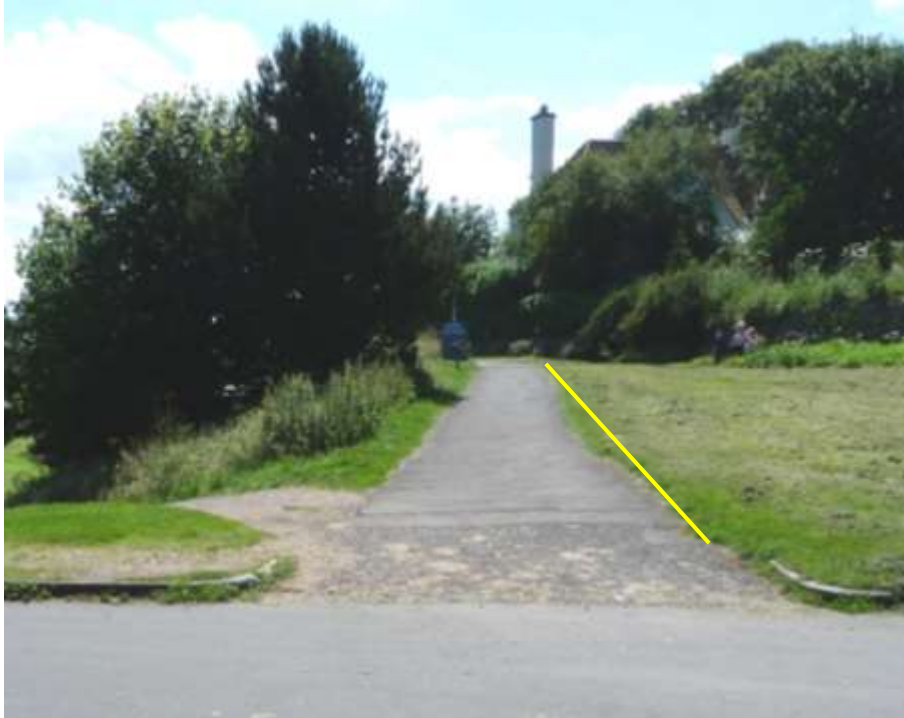
Plate 15: Before works. Looking south across the eastward extension of Northumberland Avenue. Fields House behind trees. Yellow line shows intended widening.

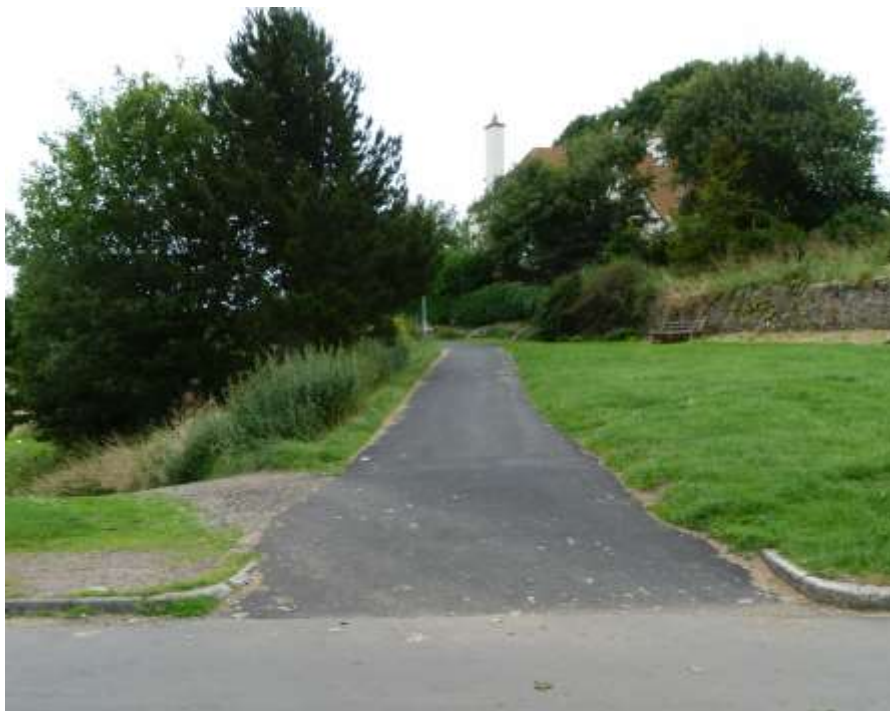
Plate 16. After works. Same view as Plate 15.

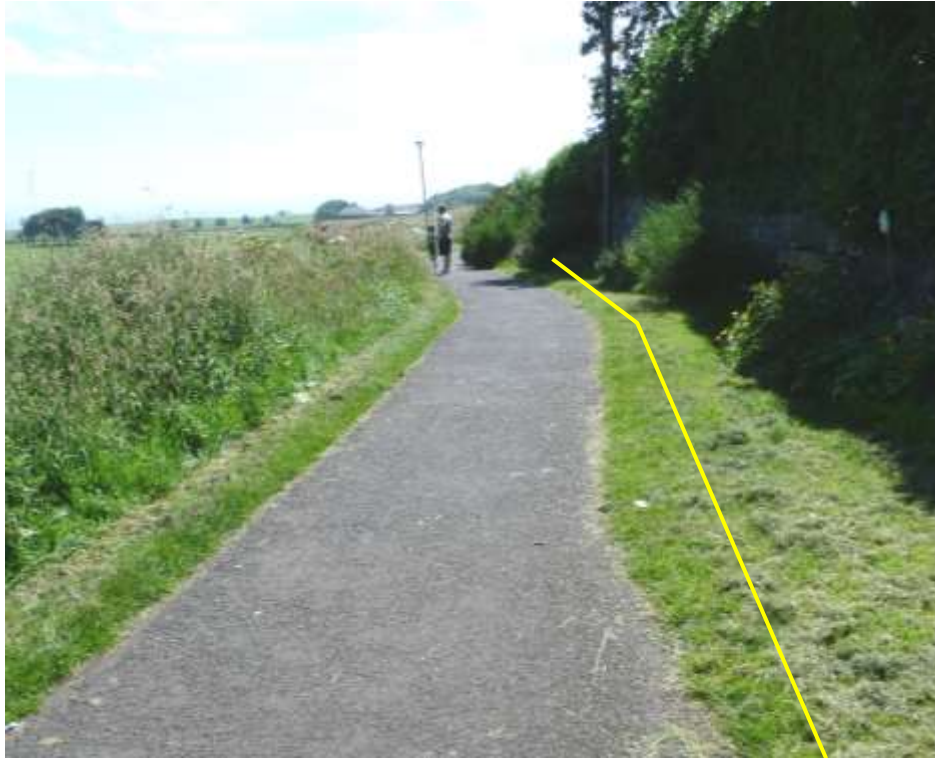
Plate 17: Before works. Looking south alongside Fields House. Yellow line shows intended widening.

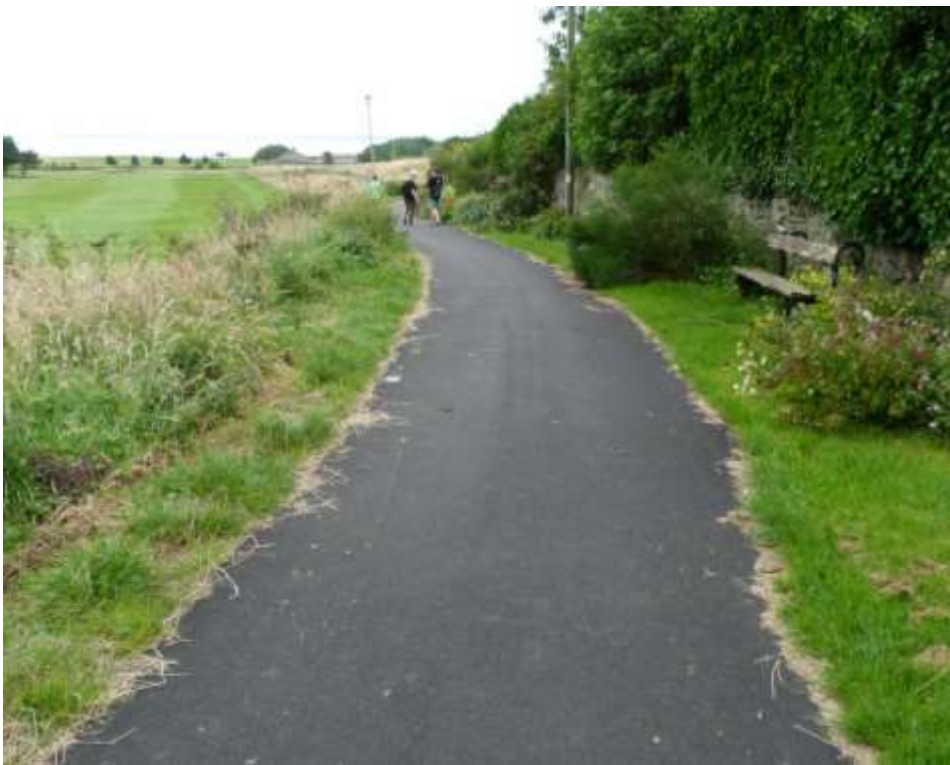
Plate 18: After works. Same view as plate 17.

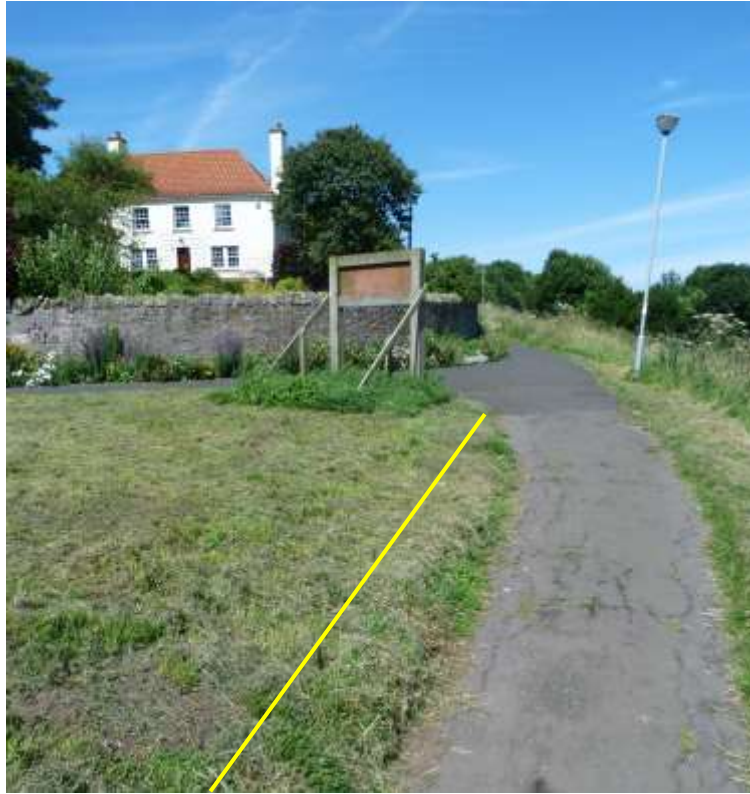
Plate 19: Before works. Looking north towards Front House.
Yellow line shows intended widening.

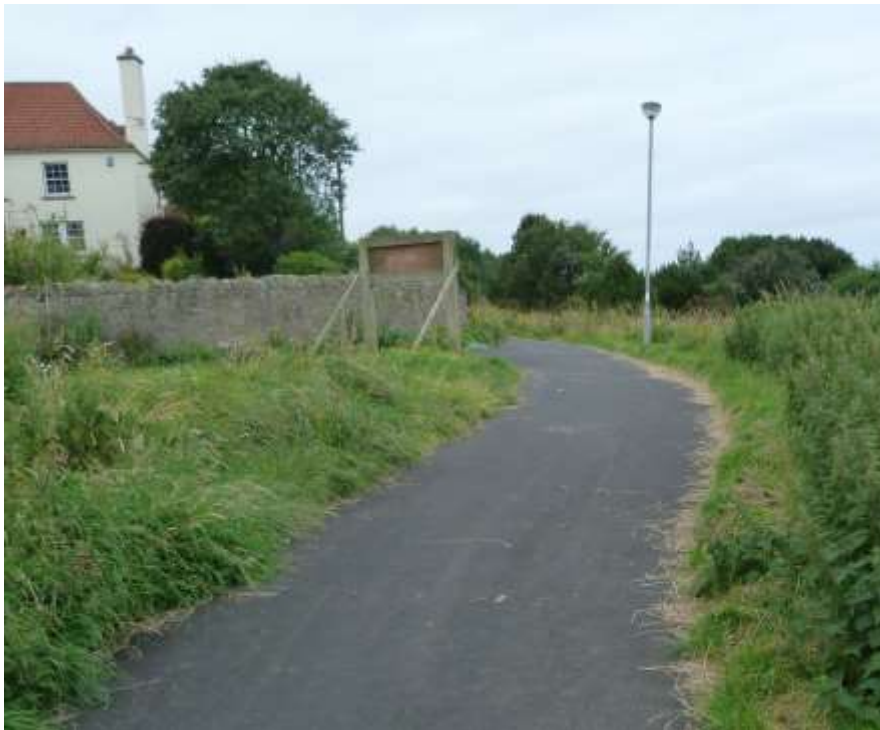
Plate 20: After works. Same view as plate 19.

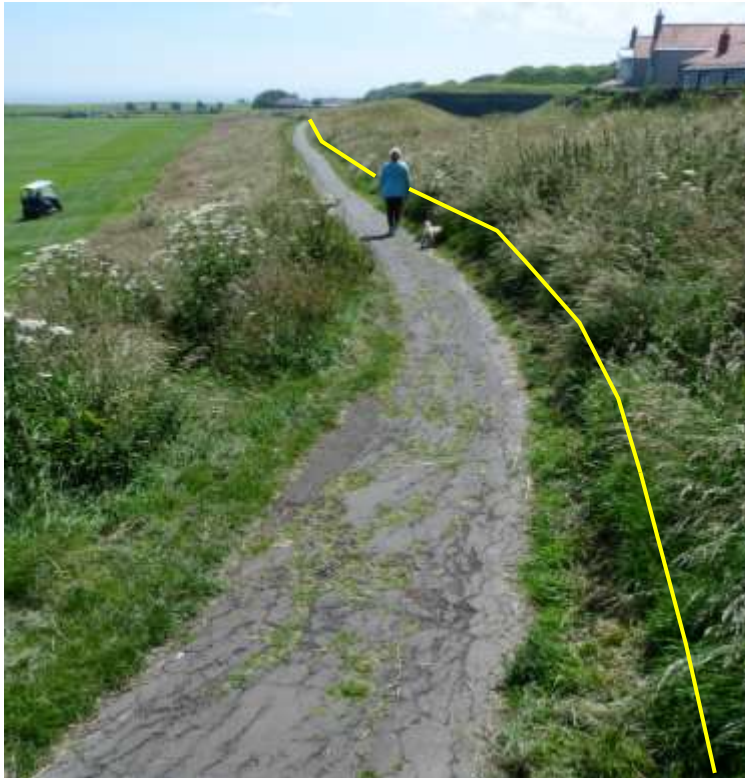
Plate 21: Before works. Looking south alongside Edwardian ditch (to right). Extent of counterscarp can be seen in distance. Yellow line shows intended widening.

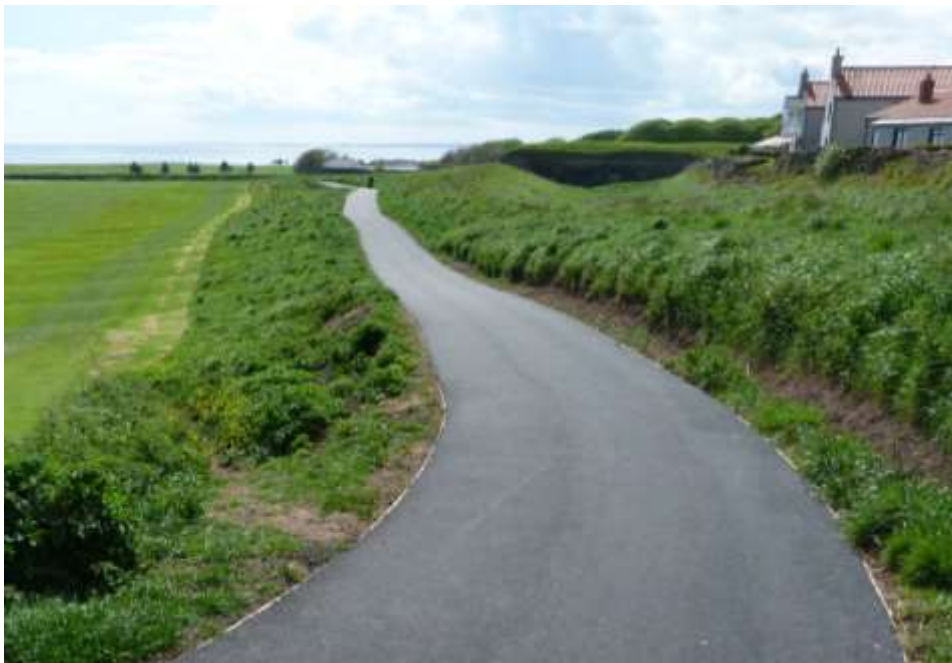
Plate 22: After works. Same view as plate 21. Limited impact to area flanking the footpath is clear.

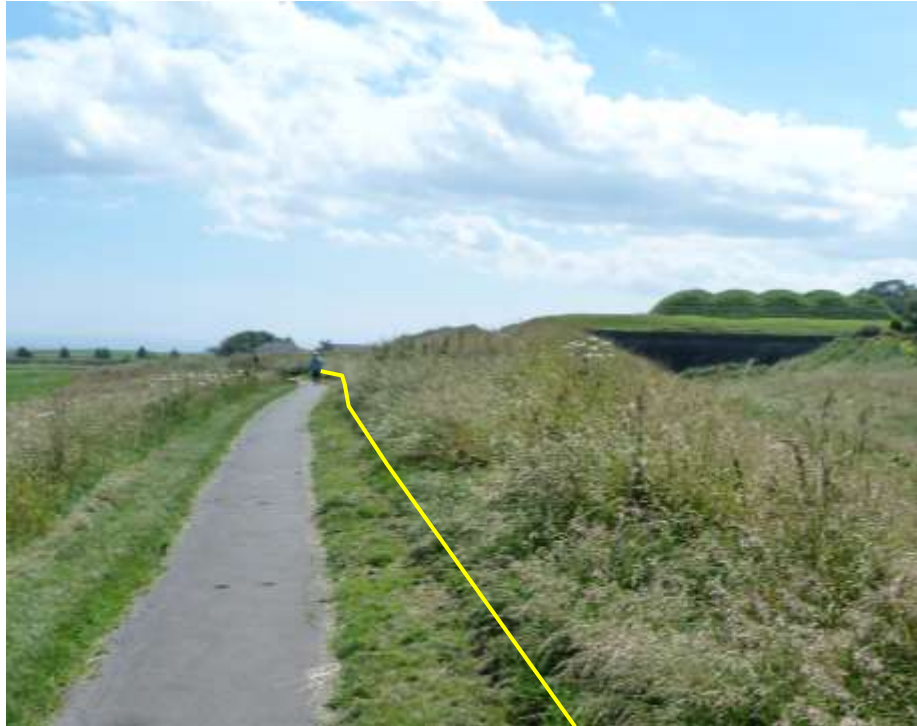
Plate 23: Before works. Looking south alongside Edwardian ditch (to right) Brass Bastion beyond. Yellow line shows intended widening.

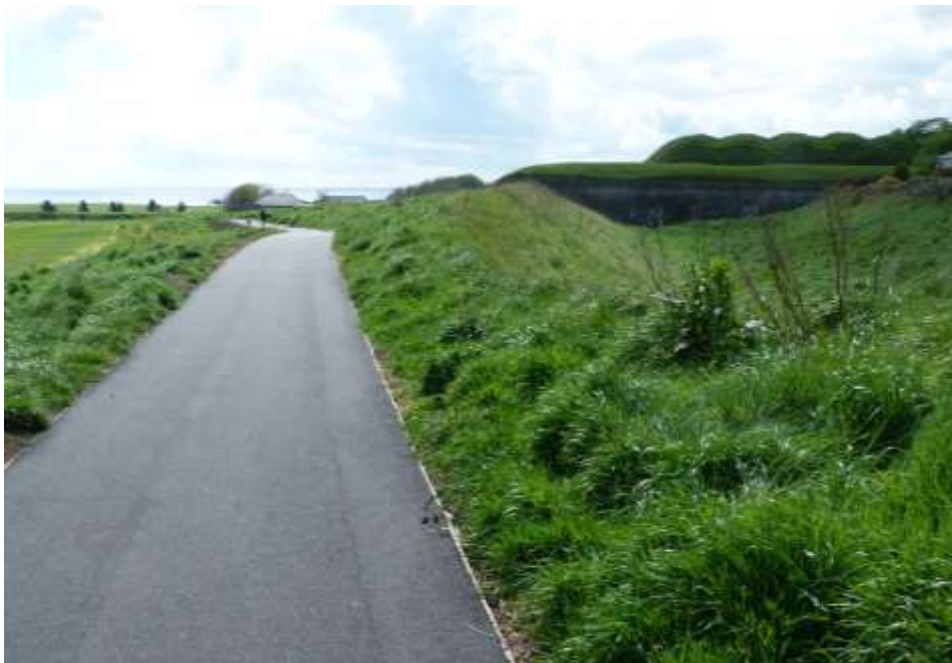
Plate 24: After works. Same view as plate 23.

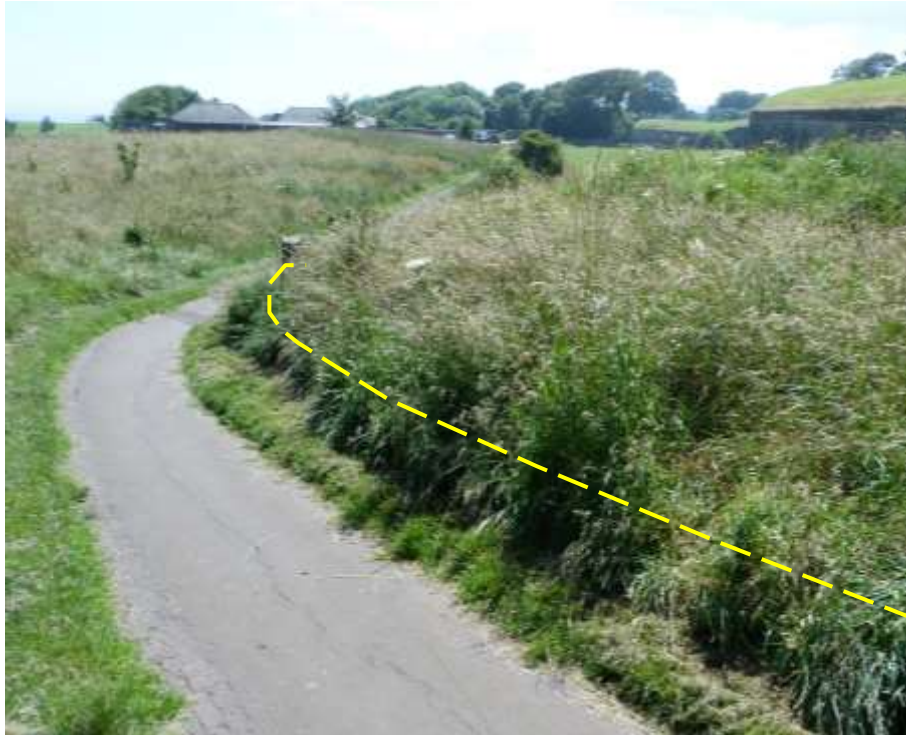
Plate 25: Before works. Located on figure 6. Looking south. Earthworks of north-east angle of Brass Bastion Counterscarp to right. Hatched yellow line shows intended widening.

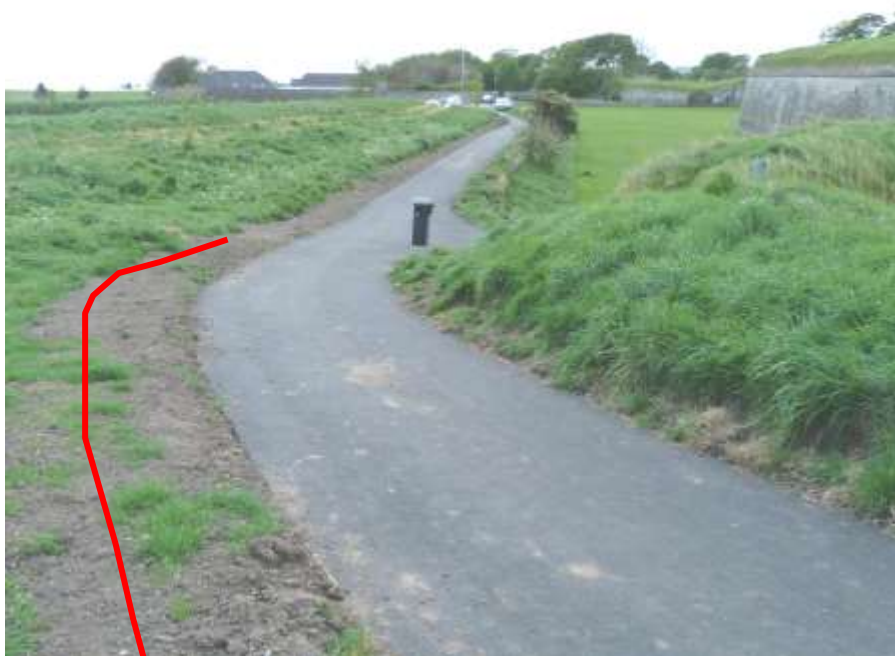
Plate 26: After works. Same as figure 25. Red line shows actual widening of footpath to avoid impact on counterscarp bank of Brass Bastion to right.

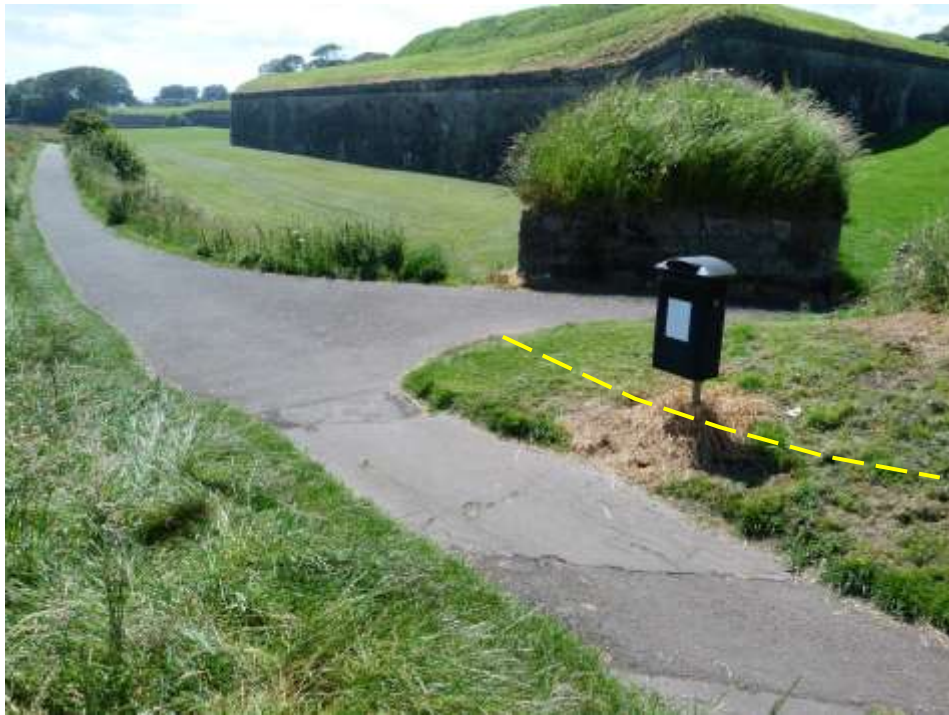
Plate 27: Before works. Looking south-west towards Batardeau and Brass Bastion beyond. Hatched yellow line shows intended widening.

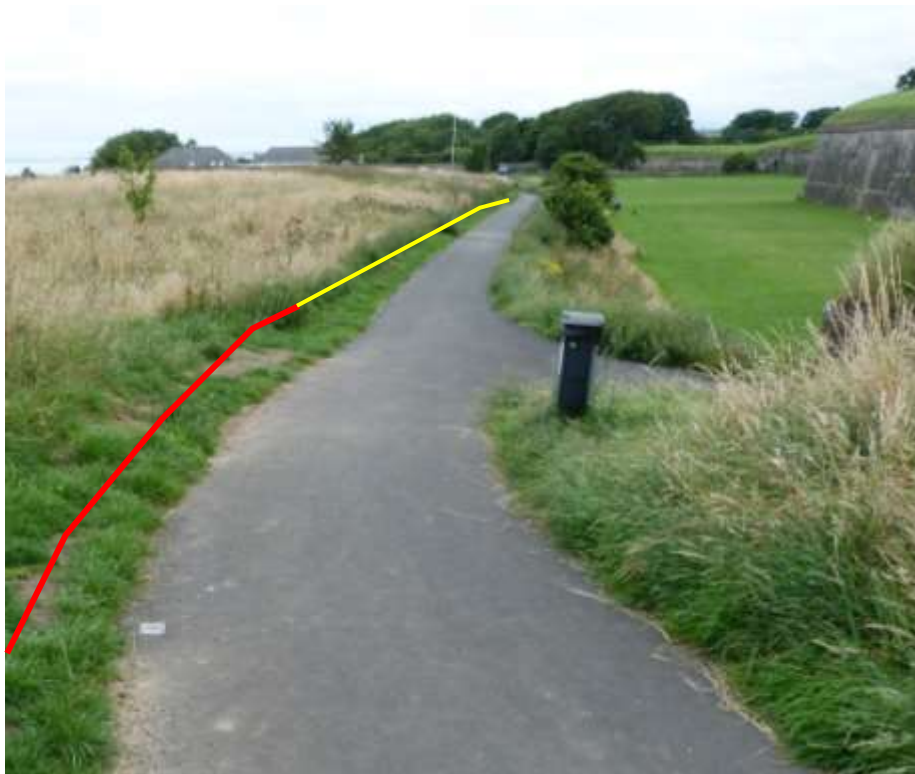
Plate 28: After works. Same as plate 27. Red line shows widening as carried out and continuation in yellow.

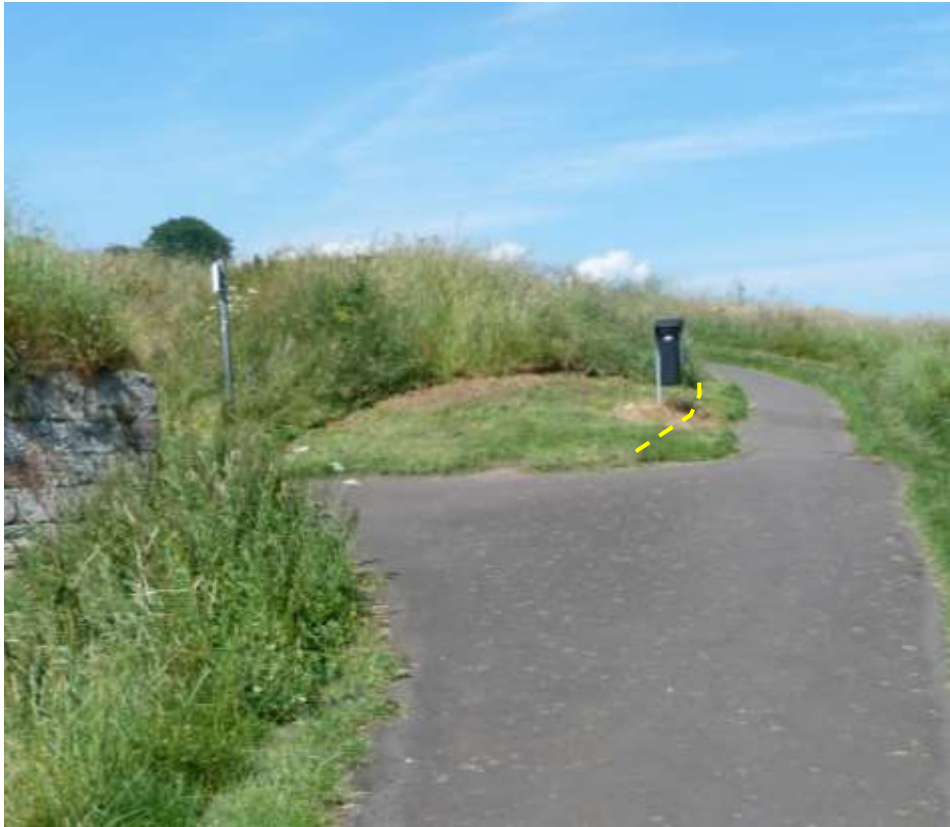
Plate 29: Before works. Located on figure 6. Looking north, Batardeau to left. Hatched yellow line shows intended widening.

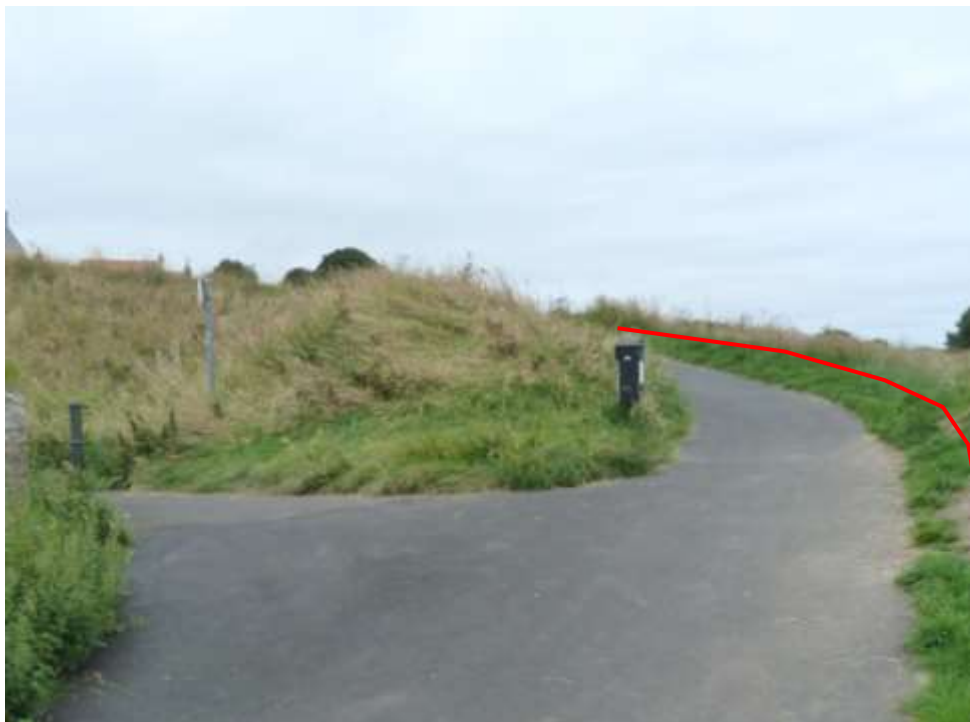
Plate 30: After works. Same as plate 29. Red line shows actual line of widening to avoid counterscarp bank of Brass Bastion.

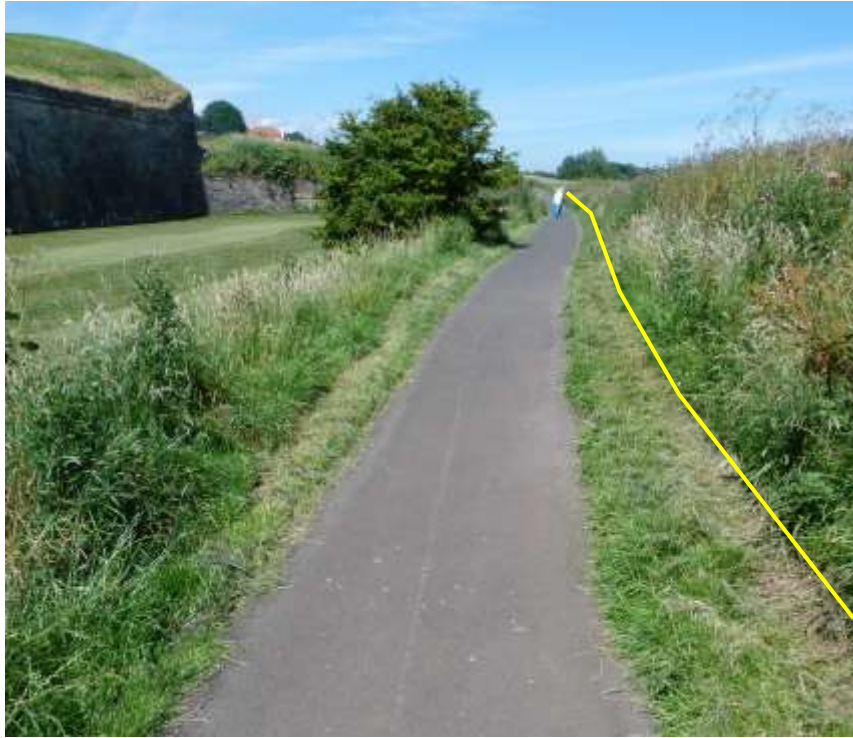
Plate 31: Before works. Looking north. Brass Bastion to left. Yellow line shows intended widening.

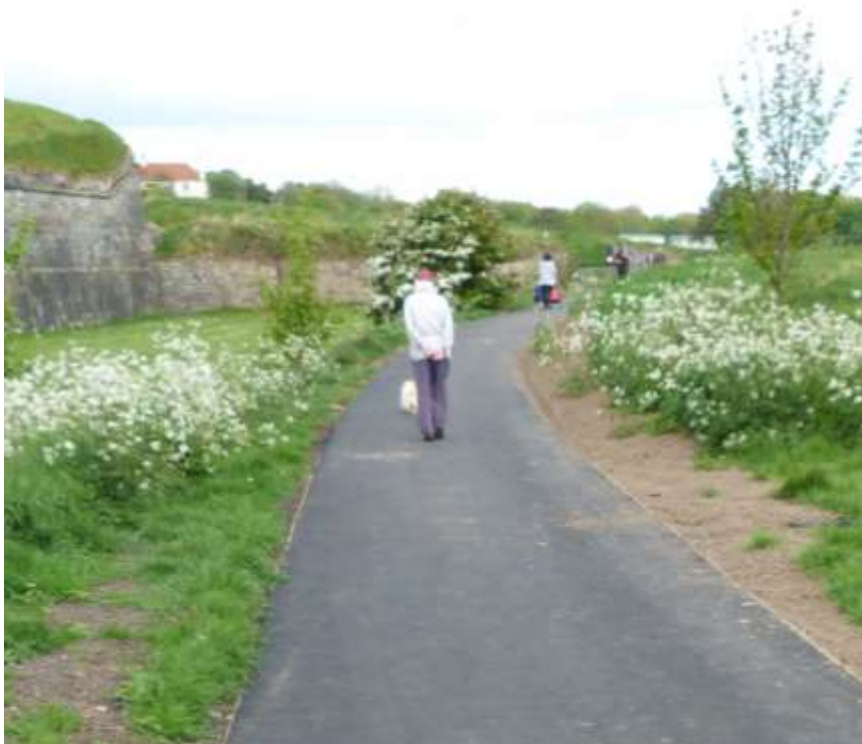
Plate 32: After works. Same as figure 31.

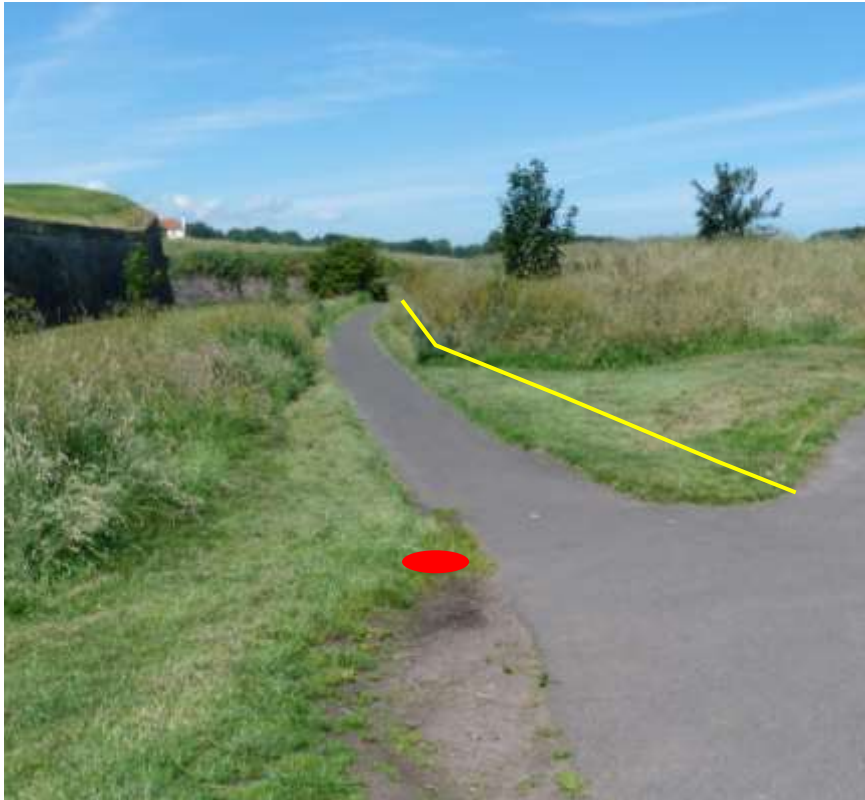
Plate 33: Existing footpath. Looking north. Brass Bastion and Batardeau to left. Yellow line shows intended widening. Red disk location of way marker.

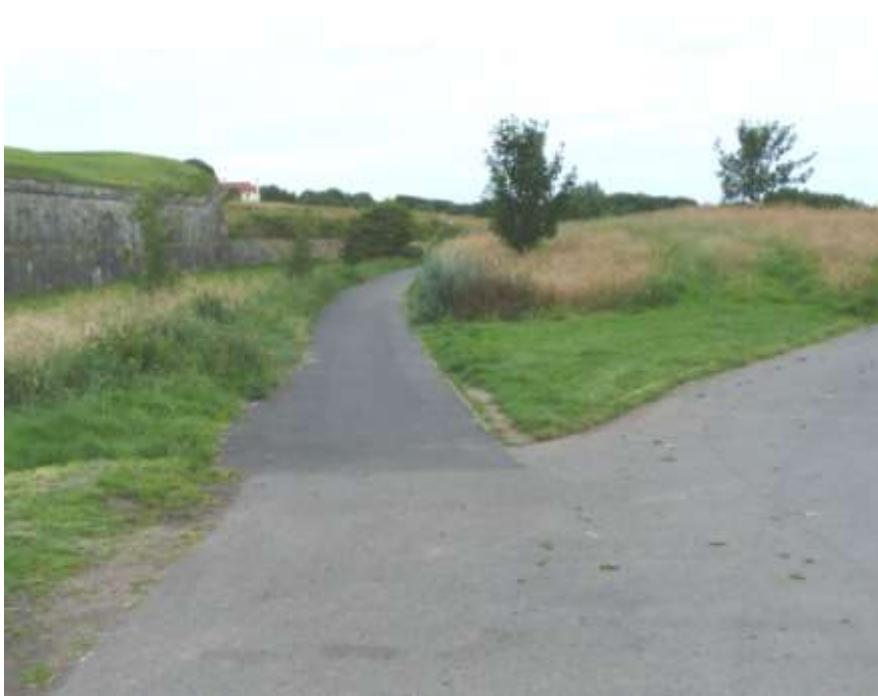
Plate 34: After works. Same as plate 33.
