BERWICK-UPON-TWEED

ARCHAEOLOGICAL WATCHING BRIEF DURING
IMPROVEMENTS TO A FOOTPATH ON THE
NORTH-EASTERN EDGE OF THE
SCHEDULED FORTIFICATIONS

August 2017

Grid Reference: From NT 9989 5361 to NU 0014 5330
Scheduled Monument No: SM 28599 (HA 1019821)
SM Consent No: S00135005
Fieldwork Dates: February to August 2017
Oasis Reference: alanwill1-312458

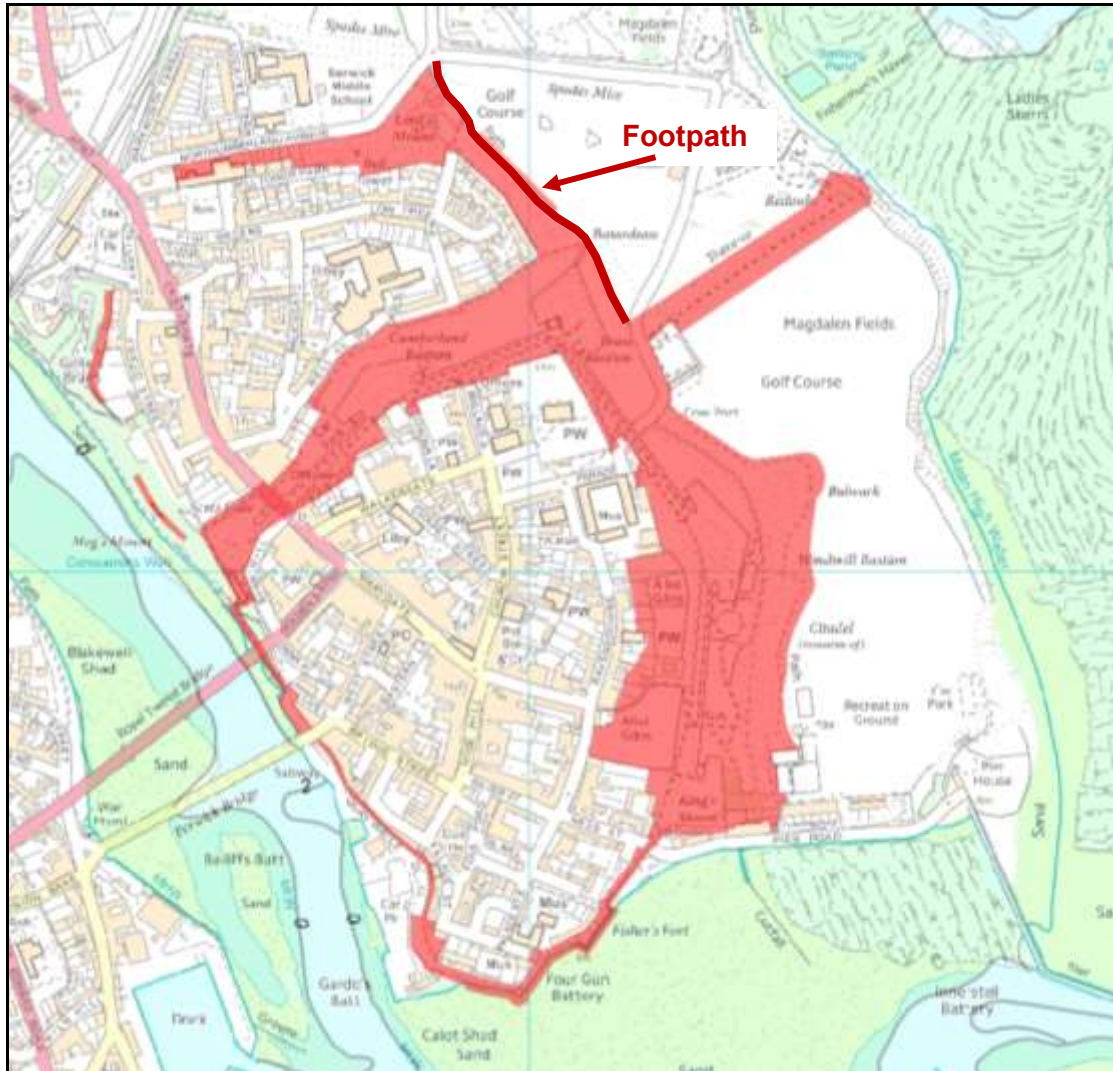
Figure 3: Berwick-upon-Tweed, showing the extent of the scheduled Medieval and Post-Medieval Fortifications (List Entry 1015968). The footpath is highlighted in brown. Map courtesy of Historic England and Ordnance Survey.

Northumberland County Council Highways and Neighbourhood Services intend to repair, enhance and widen footpath No. 237/054 running alongside and within the north-eastern flank of the scheduled monument encompassing the medieval and post-medieval fortifications at Berwick-upon-Tweed, Northumberland (SM No. 28532; List entry 1015968). The area of works to the footpath, running for c. 430m, is between an eastern extension from Northumberland Avenue along the line of Spades Mire and south as far as the south end of Brass Bastion (figure 2) where it joins with footpath 236/056. The extent of the scheduled area is shown on figure 3.

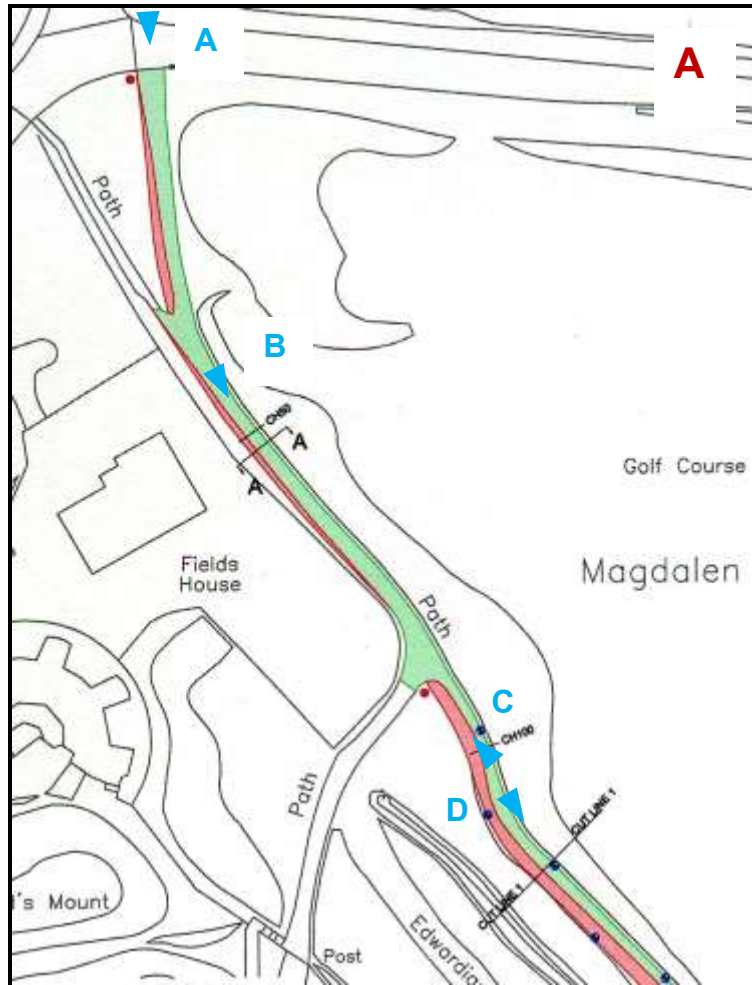
Figure 5: Northern area of footpath works (see figure 4).
 Green tone: existing path; Pink tone: path to be widened;
 red dot: finger post; blue dots: LED demarcation lights.
 Blue arrows locate plates A to D.
 From NCC drawing HE141308- 16/00U107/01/01.

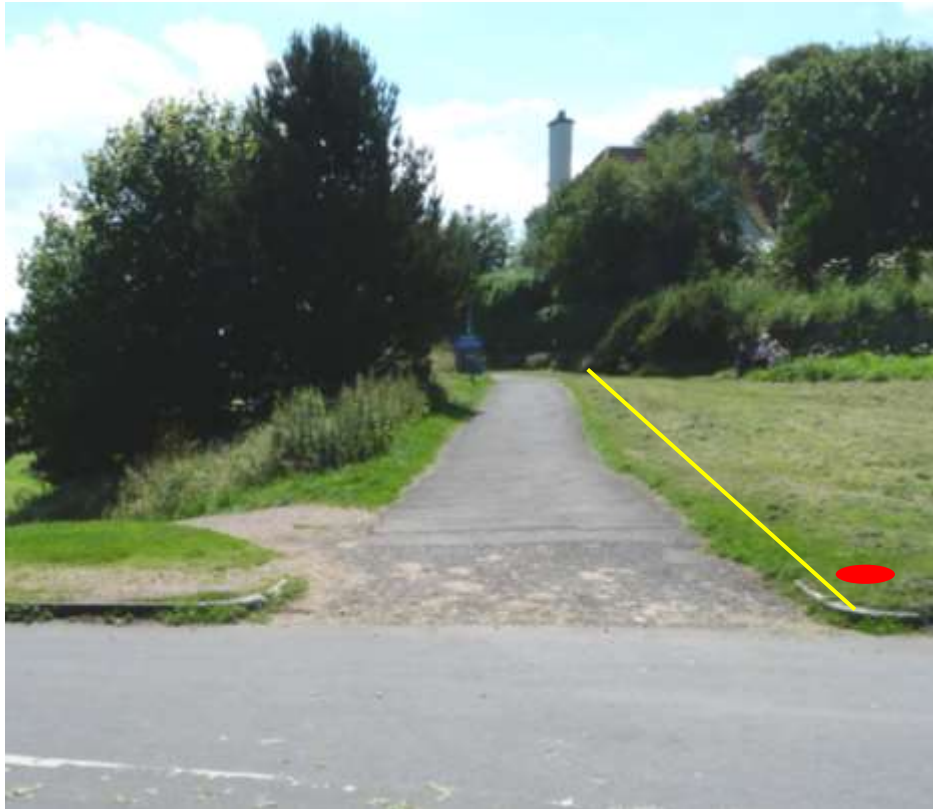
Plate A: Existing footpath. Located on figure 5. Looking south across road to coast. Fields House behind trees. Yellow line shows intended widening
Red disc location of finger post and pole.

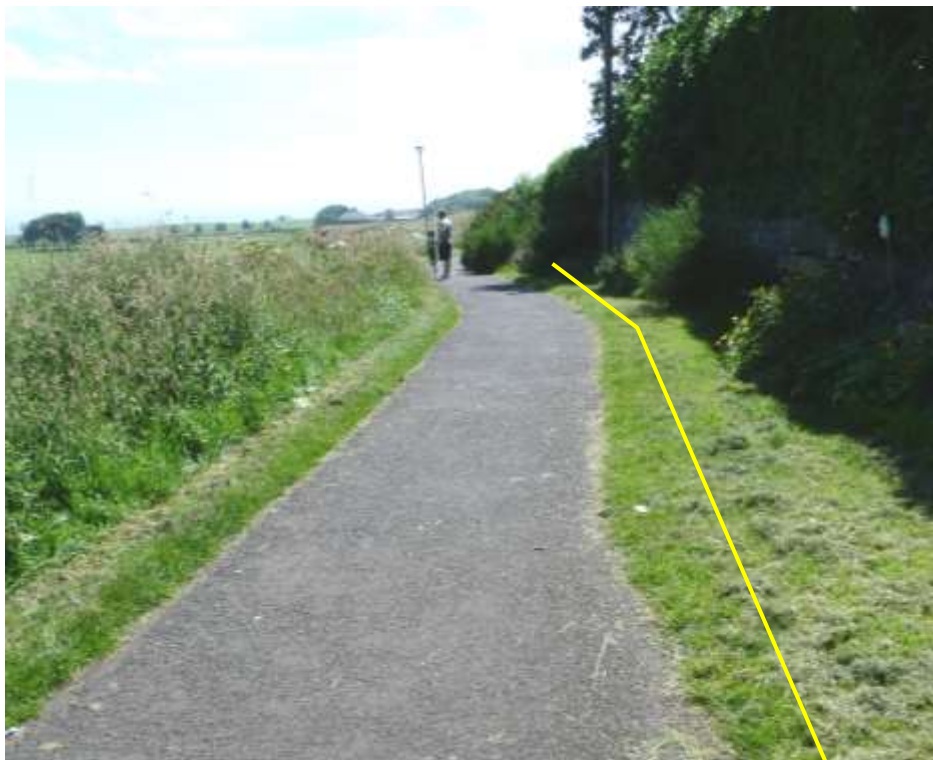
Plate B: Existing footpath. Located on figure 5. Looking south alongside Fields House. Yellow line shows intended widening.

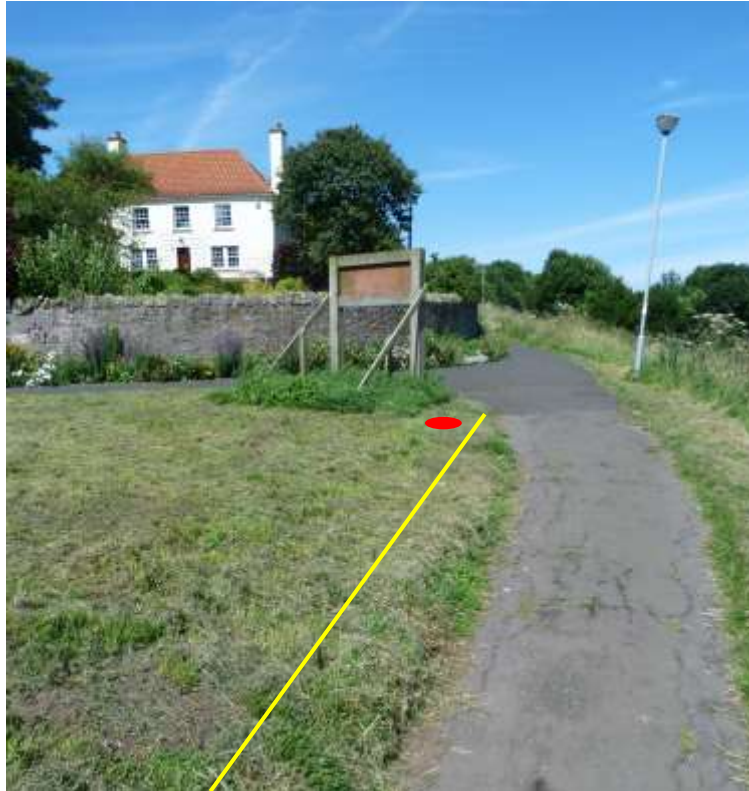
Plate C: Existing footpath. Located on figure 5. Looking north towards Front House. Yellow line shows intended widening. Red disk, location of finger post and pole.

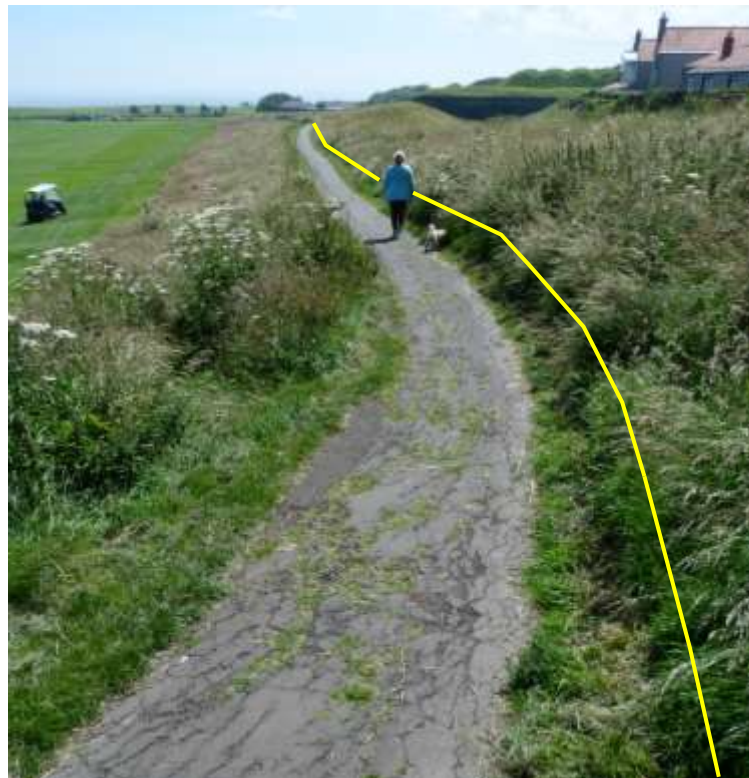
Plate D: Existing footpath. Located on figure 5. Looking south alongside Edwardian ditch (to right). Extent of counterscarp can be seen in distance. Yellow line shows intended widening.

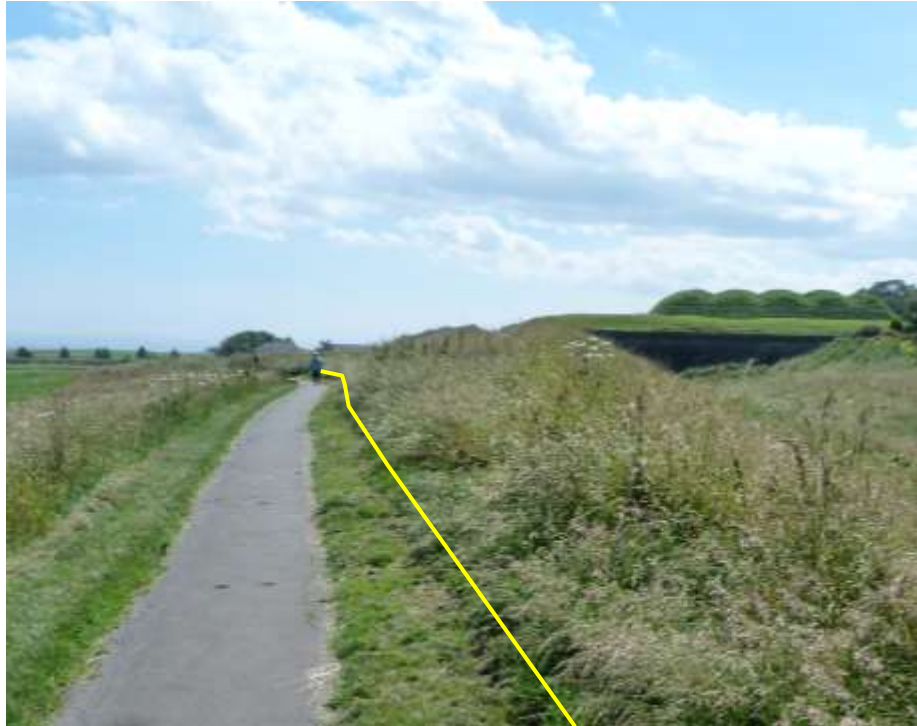
Plate E: Existing footpath. Located on figure 6. Looking south alongside Edwardian ditch (to right). Brass Bastion beyond. Yellow line shows intended widening.

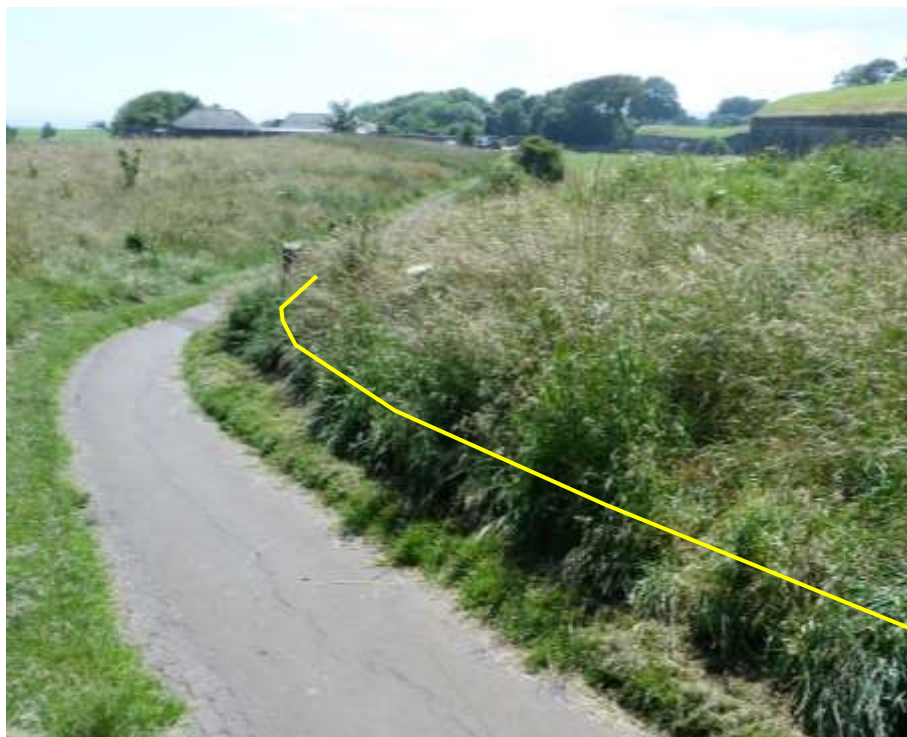
Plate F: Existing footpath. Located on figure 6. Looking south. Earthworks of north-east angle of Brass Bastion Counterscarp to right. Yellow line shows intended widening.

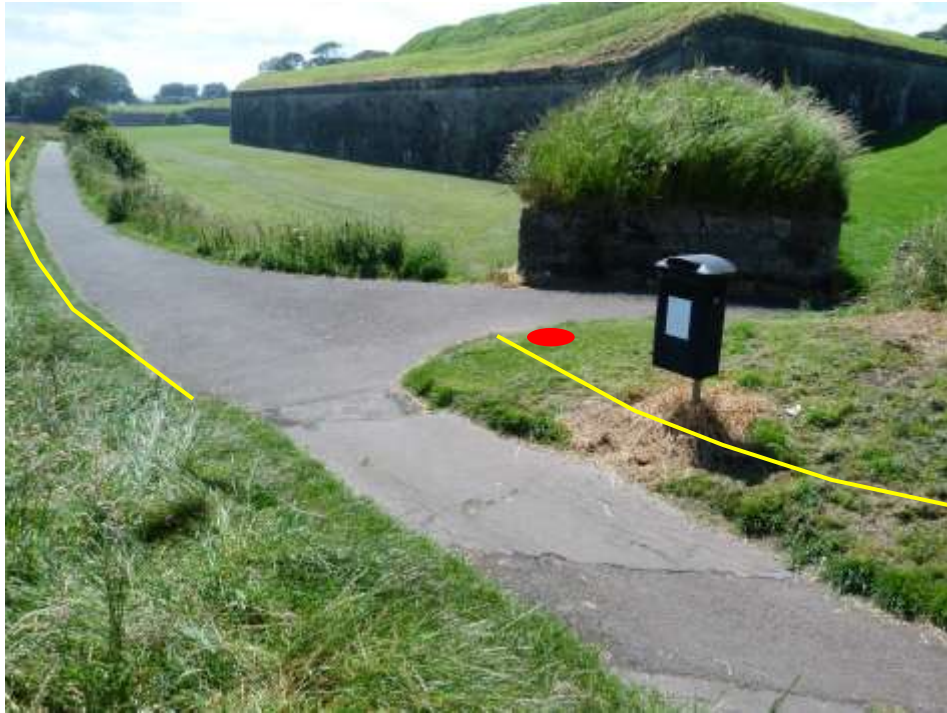
Plate G: Existing footpath. Located on figure 6. Looking south-west towards Batardeau and Brass Bastion beyond. Yellow lines show intended widening. Red disk location of finger post and pole.

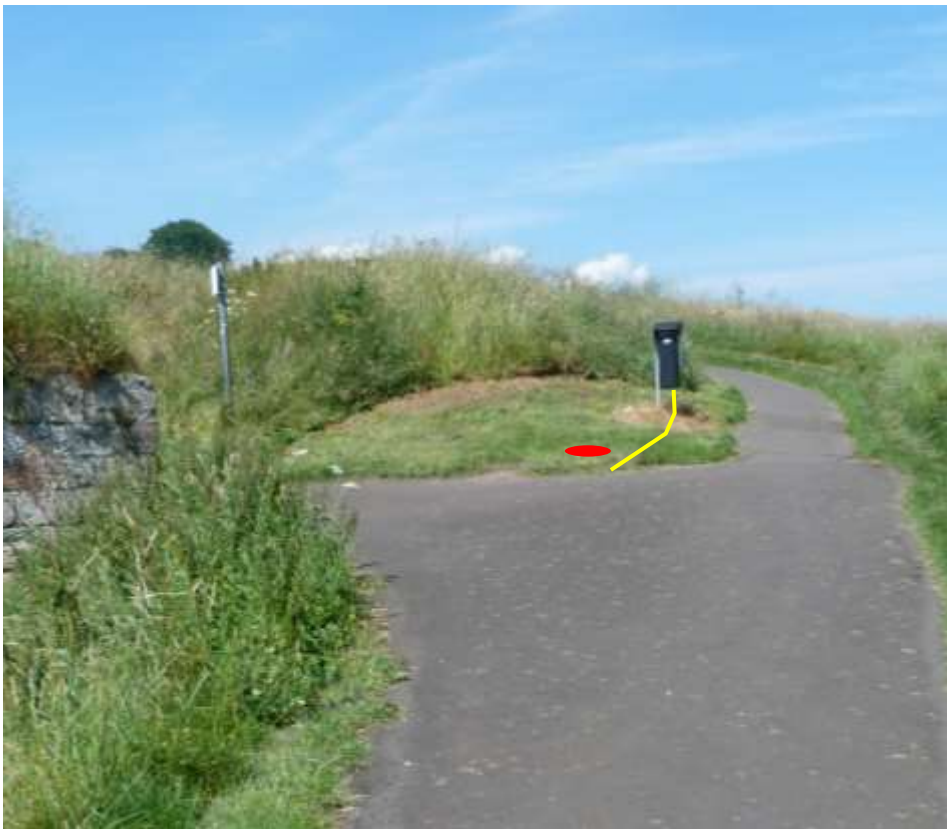
Plate H: Existing footpath. Located on figure 6. Looking north, Batardeau to left. Yellow line shows intended widening. Red disk location of finger post and pole.

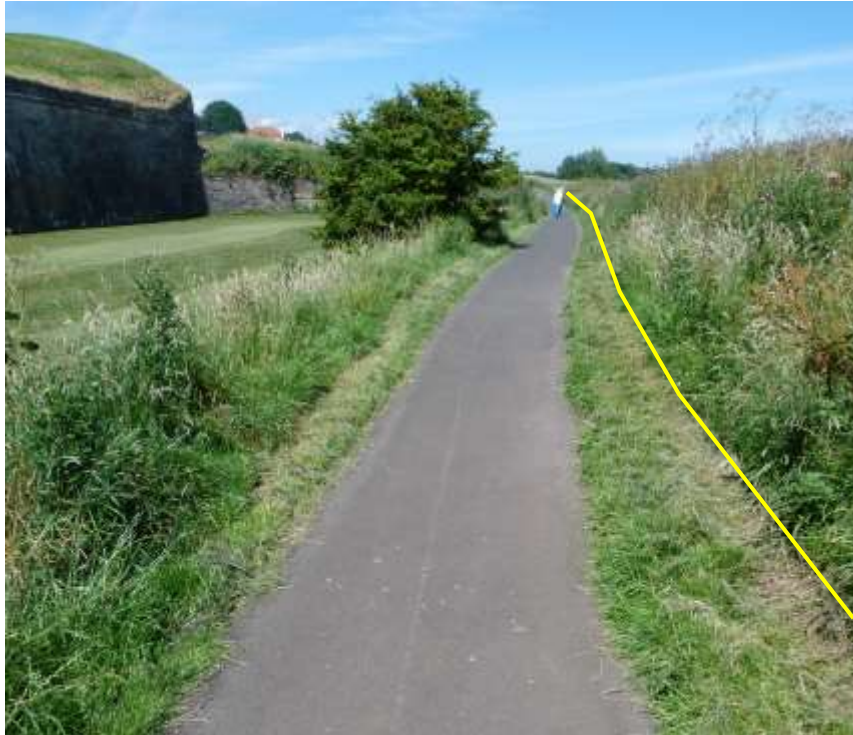
Plate I: Existing footpath. Located on figure 7. Looking north Brass Bastion to left. Yellow line shows intended widening.

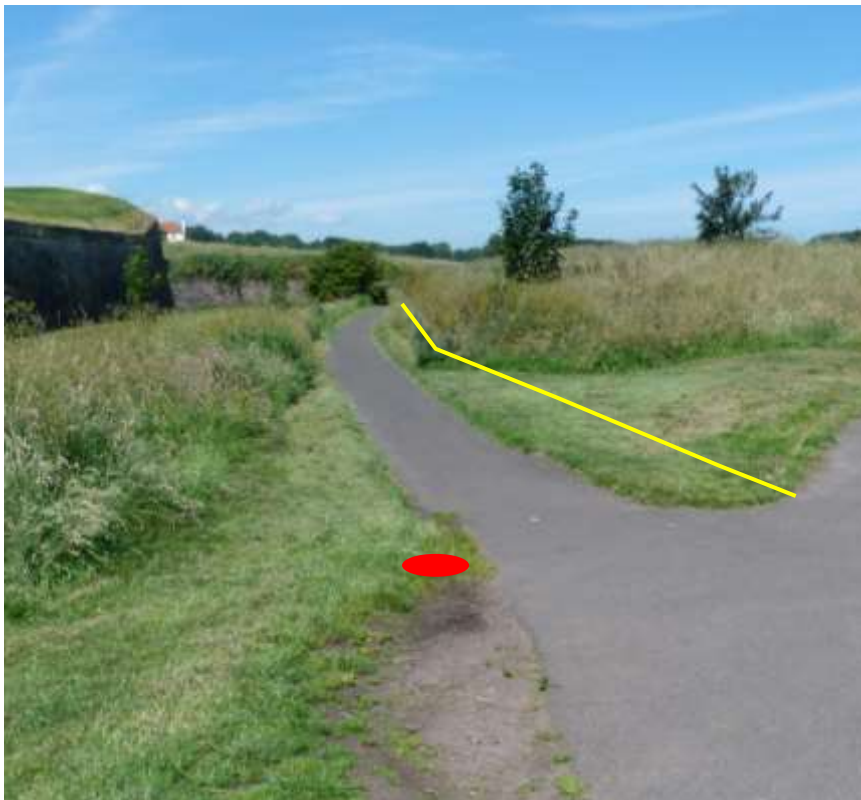
Plate J: Existing footpath. Located on figure 7. Looking north Brass Bastion and Batardeau to left. Yellow line shows intended widening. Red disk location of finger post and pole.
