STORAGE SHED AT CHESTERS WALLED GARDEN
Archaeological Evaluation

June 2018

Planning Application No: 18/00507/FUL
Oasis Ref: alanwill1 - 320051
Grid Ref: NY 9075 7025
Site Code: CSS (Chesters Storage Shed) 2018
Parish: Humshaugh, Northumberland

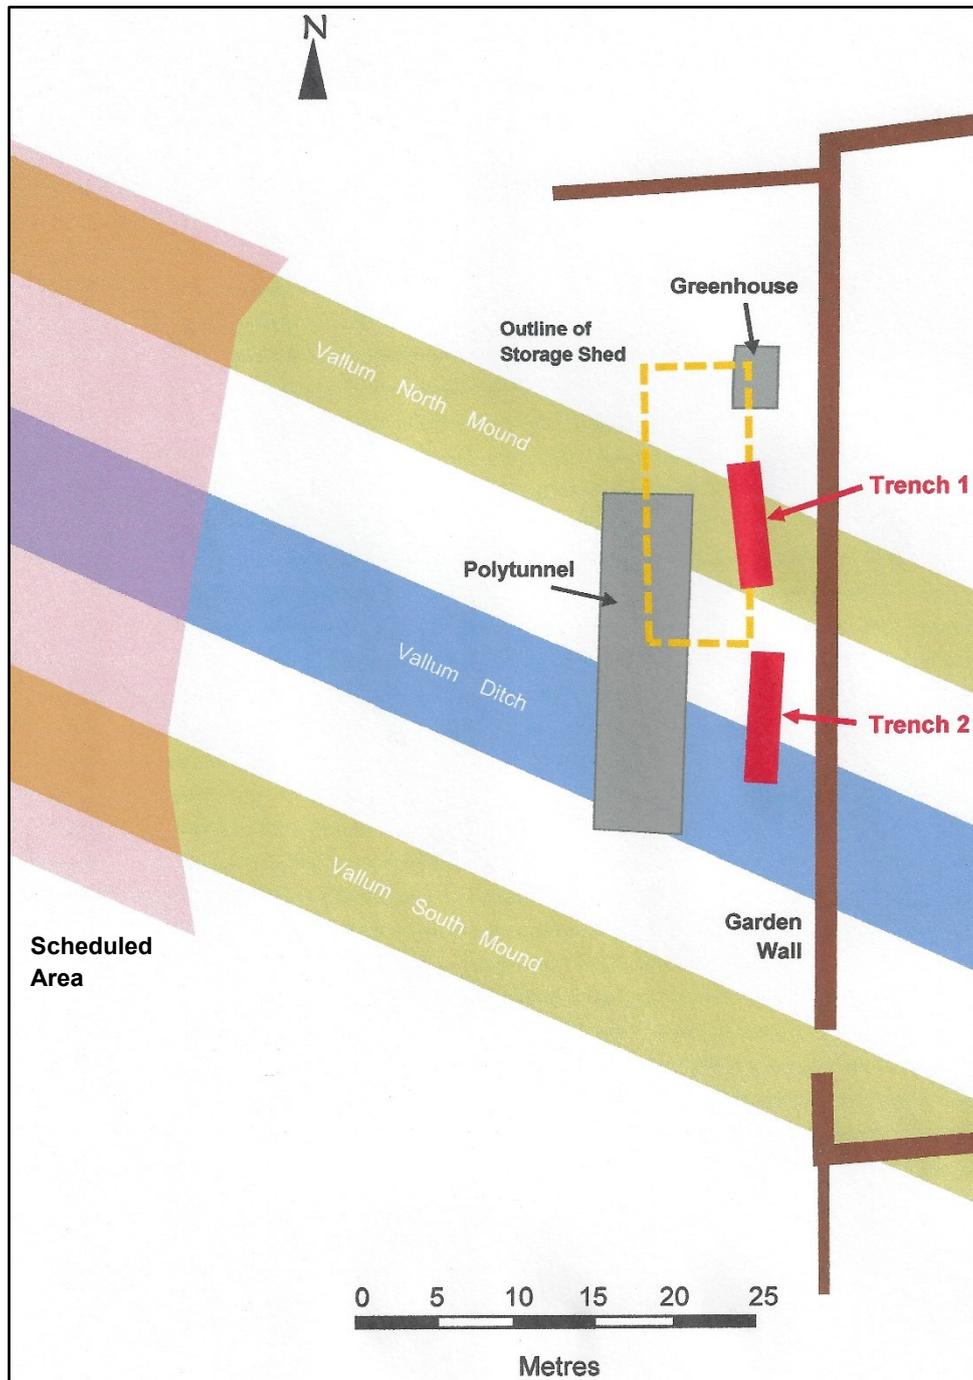
Figure 2: Trenches 1 and 2 (in red) excavated next to the walled garden at Chesters. The existing polytunnel in grey, the footprint of the proposed storage shed in hatched yellow line and The courses of the Vallum Ditch and the north and south mounds of the Vallum in blue and buff respectively

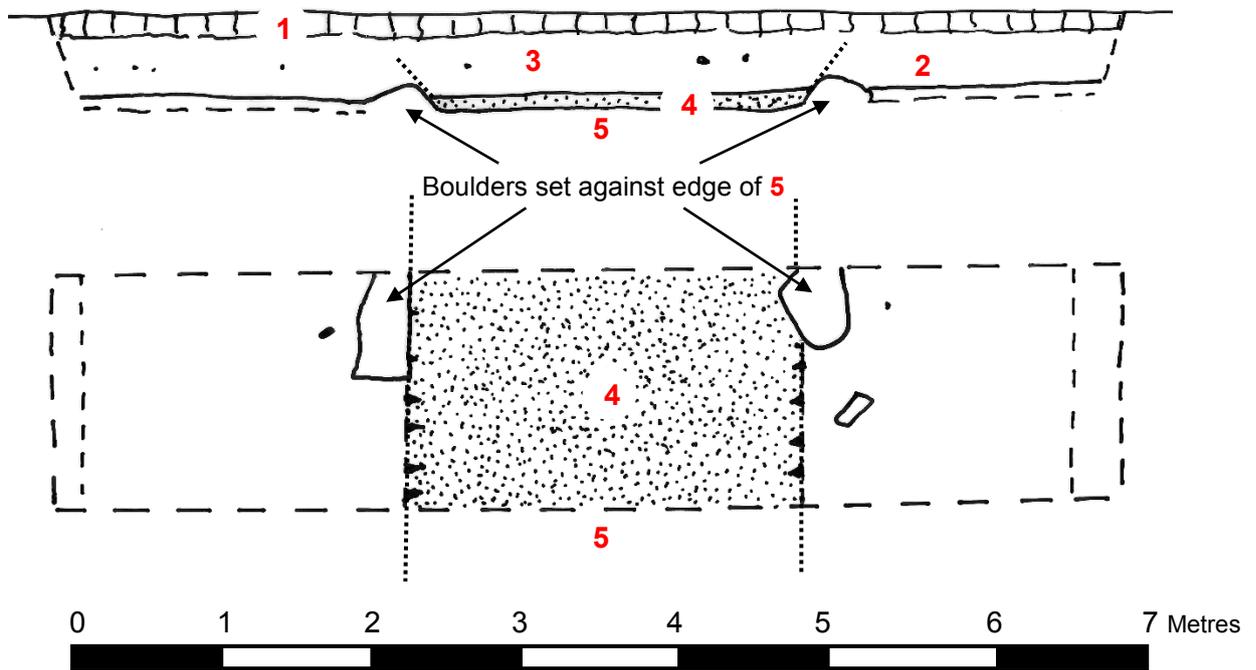
TRENCH 1

Buff-brown, stony boulder clay extended across the base of the trench at c. 0.5m aOD. Overlying this subsoil, and without any gradation from one to the other, was a medium-brown sticky clay-loam [2] which contained fairly well dispersed flecks and small fragments of lime and occasional small fragments of burnt clay. This layer was cut by a broad, east-west running slot [5], 0.10m deep with a flat base and 2.4m wide. Against the western section of the trench, the north and south flanks of [5] had been marked by boulders. The depression was filled to a depth of 0.10m with hearth ash [4] which included some fragments of coal. The remainder of the feature was filled with a very similar deposit to [2]. No secure interpretation of this feature can be offered, perhaps a cinder path. A thin modern topsoil [1] lay across the trench.

Figure 3: Plans and sections (both east-facing) of Trenches 1 and 2 (1:50)

In Trench 1, layer [2] was cut through to subsoil by a flat-bottomed, east-west running slot [5], its base filled with hearth ash and cinder [4]. Eventually, its upper area was filled with a deposit [3] very similar to (probably re-deposited) [2]. The function of this feature is uncertain, possibly a cinder path; conceivably an ash dump, the ash presumably derived from the furnace for the heated garden walls. In Trench 2, ash-filled gullies and/or pits including a drain or similar sunken structure formed of modern brick [7] overlaid [8] and faded out to the south. Both trenches were topped with thin, modern topsoil ([1] and [6]).

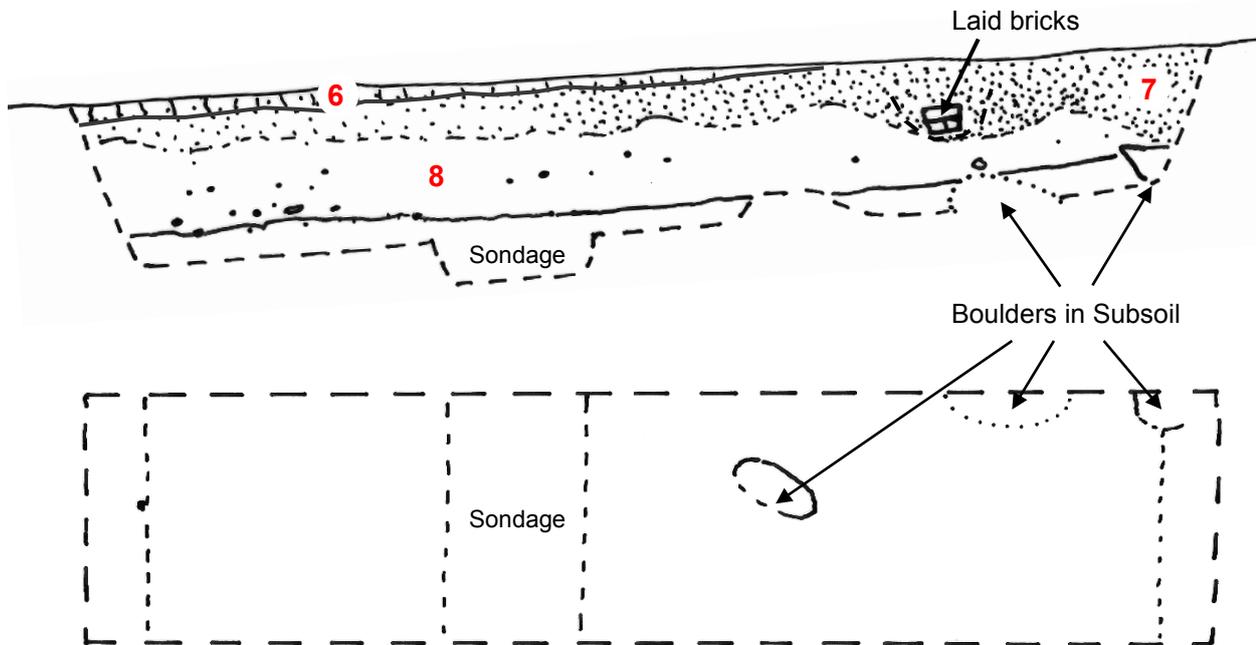
TRENCH 2

Buff-brown boulder clay with a number of substantial boulders to the north and centre of the trench was overlaid by [8] (same as [2] in Trench 1) medium-brown sticky clay loam with dispersed flecks and small fragments of lime and occasional small fragments of burnt clay. Above this were a number of ash-filled pits/gullies [6] and the terminal of a structure [7] formed of three laid bricks which did not protrude into the trench. Only at the south end of the trench was there a distinguishable topsoil [5].

Roman pottery from this area of Trench

evaluation trench would be problematic. The only indications that apparent subsoil deposits at the south end of Trench 2 (the putative location of the north edge of the ditch) may have been re-deposited were the presence of a number of very small abraded sherds of Roman pottery found in the interface between layer [8] and subsoil, and the lack of large boulders in the subsoil compared to the north part of the trench.

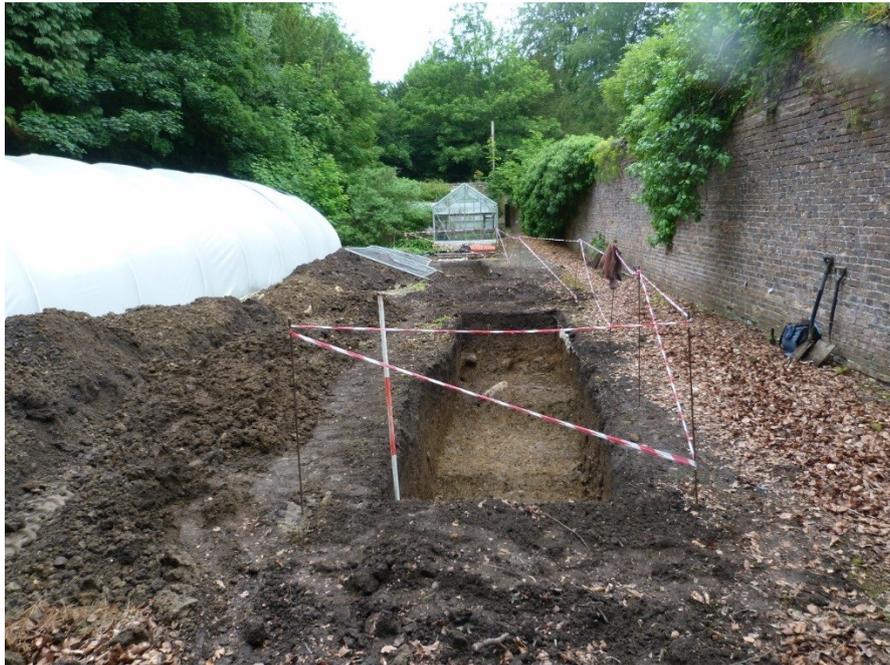
Plate 1: The evaluation trenches from the south. Polytunnel to left walled garden to the right

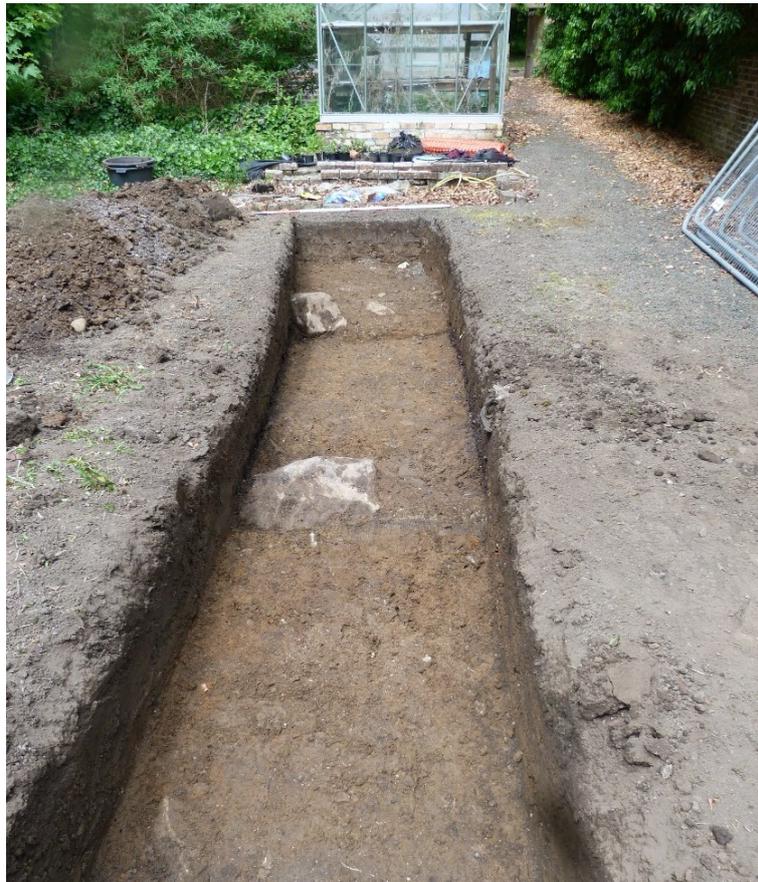
Plate 2: Evaluation Trench 1 from the south. Boulders flank feature [5].

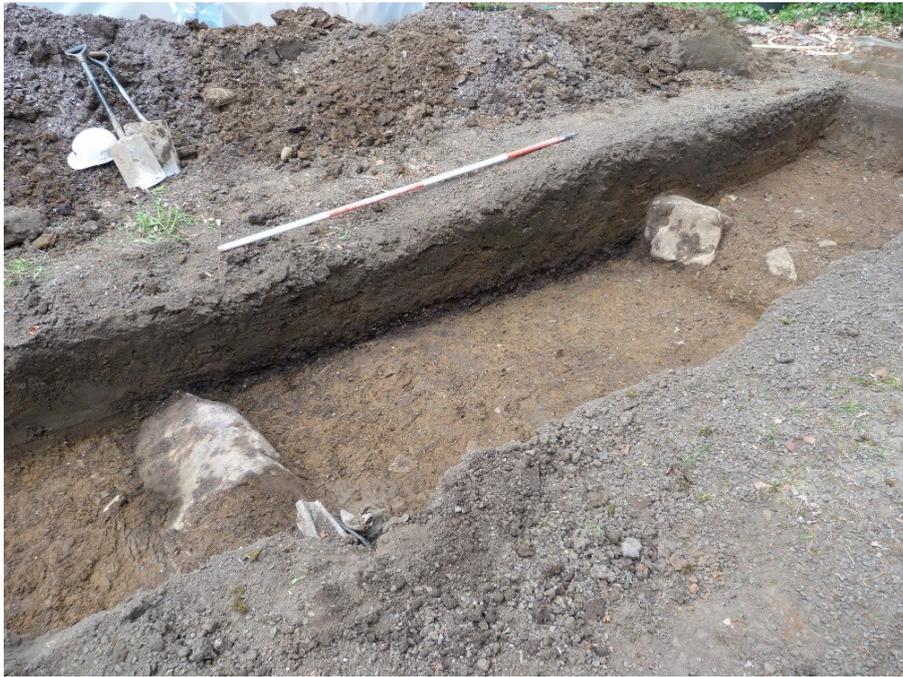
Plate 3: Evaluation Trench 1, looking north-west. 2m scale. Ash-filled feature [5] to centre

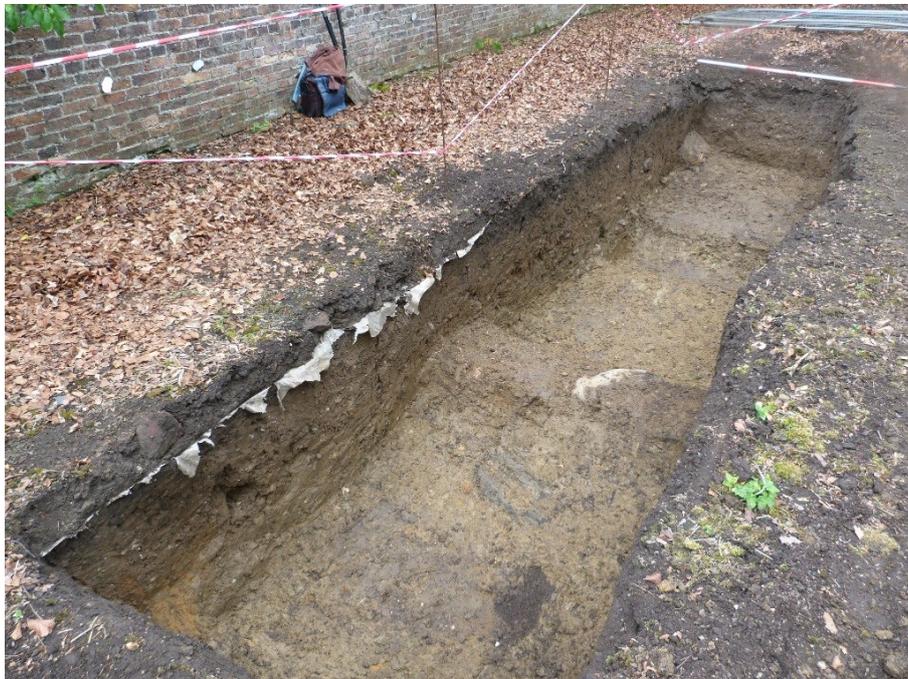
Plate 4: Evaluation Trench 2, looking south-east. 2m scale.

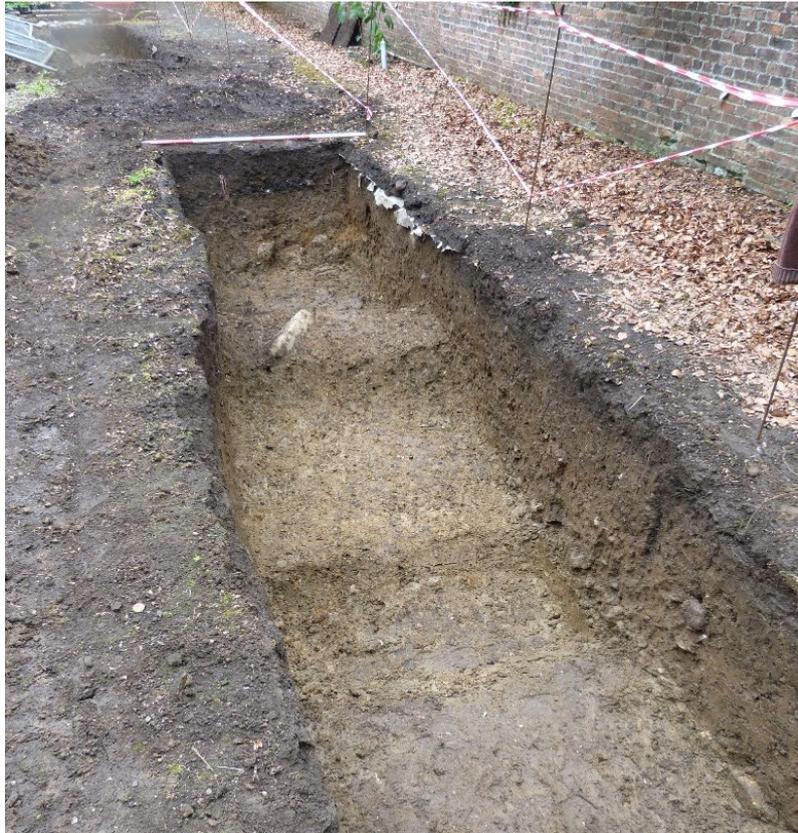
Plate 5: Evaluation Trench 2, looking north-east. 2m scale.

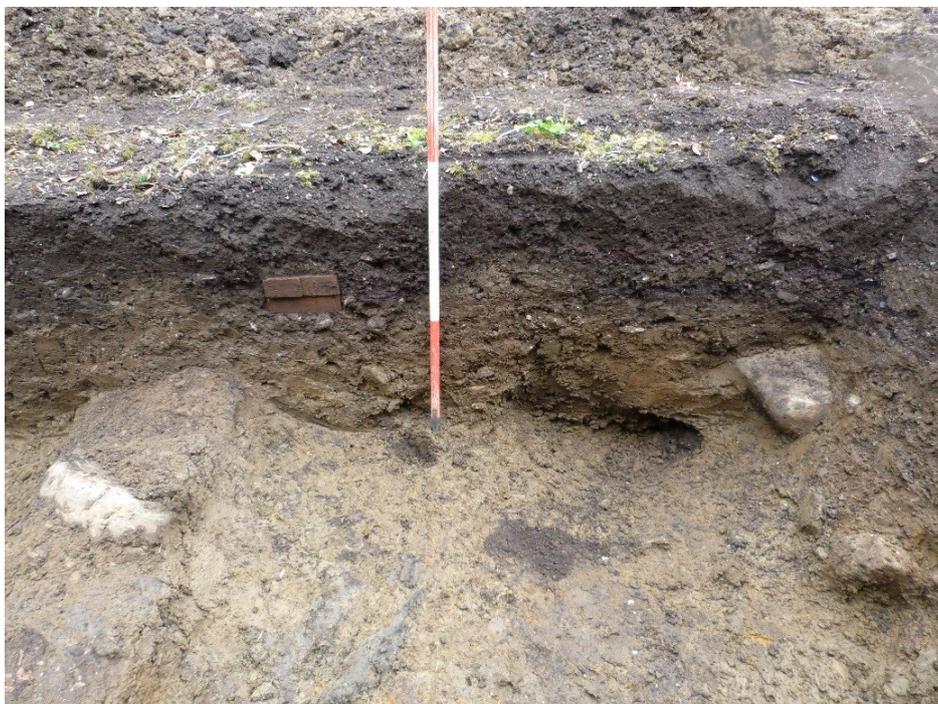
Plate 6: Evaluation Trench 2, looking west. 2m scale. Ash-filled features and brick structure [7] overlying [8] with boulder clay below.

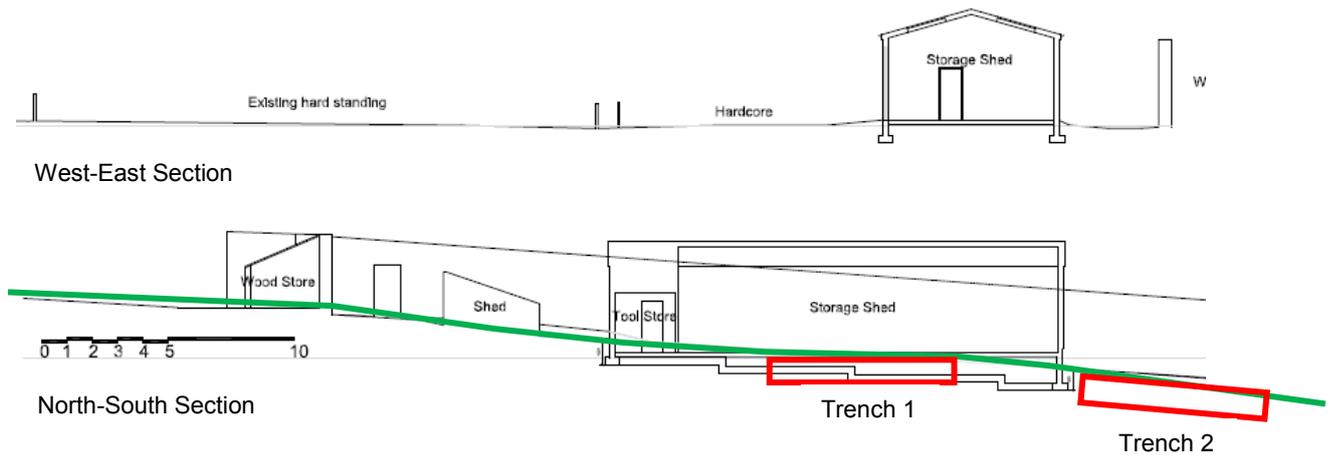
Figure 4: West-East (top) and North-South sections showing the proposed Storage Shed (as per Revision D: Doonan Architects drawing No. P01) with the current ground surface on the N-S section in green line and the evaluation trenches in red outline.

It would seem unlikely that the construction of the storage shed (as per the footprint shown on Doonan Architects Plan Revision D) would impact on surviving Roman deposits or features. Roman artefactual material recovered during the evaluation was from the south end of Trench 2 and beyond the area of development.

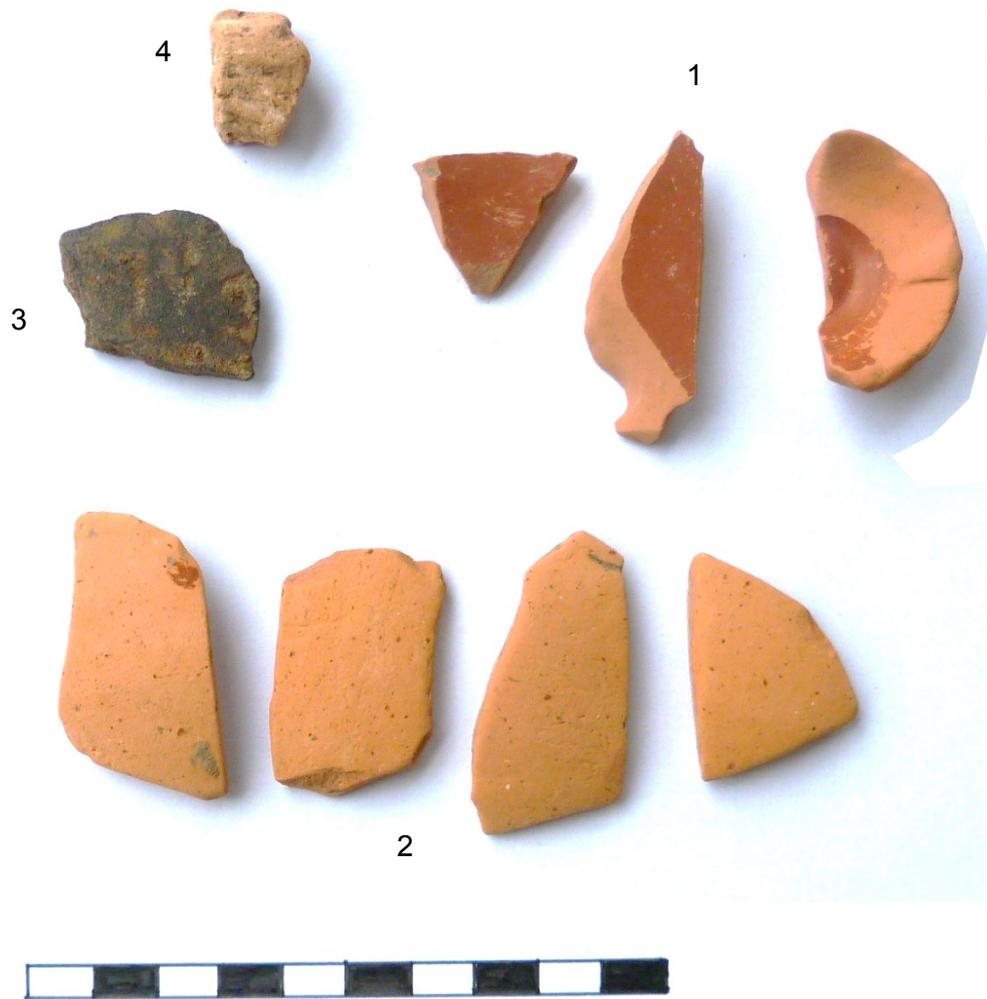
Figure 5: Assemblage of small and abraded sherds of Roman pottery from base of [8] and top of subsoil in Trench 2. Numbers keyed to text description (section 5.3).

Recovered from the base of layer [8] and the upper area of what appeared to be clay subsoil – and exclusively from the southern half of Trench 2- was a number of very small and abraded sherds of Roman pottery (see figure 5 for key) including: **1.** Three fragments of Samian (one a piece of foot ring from a cup or small bowl); **2.** Four body-sherd fragments of an equally small coarse-ware cup or flask in an oxidised sandy fabric; **3.** One fragment of reduced ware; **4.** A small fragment of an oxidised coarse-ware fabric.

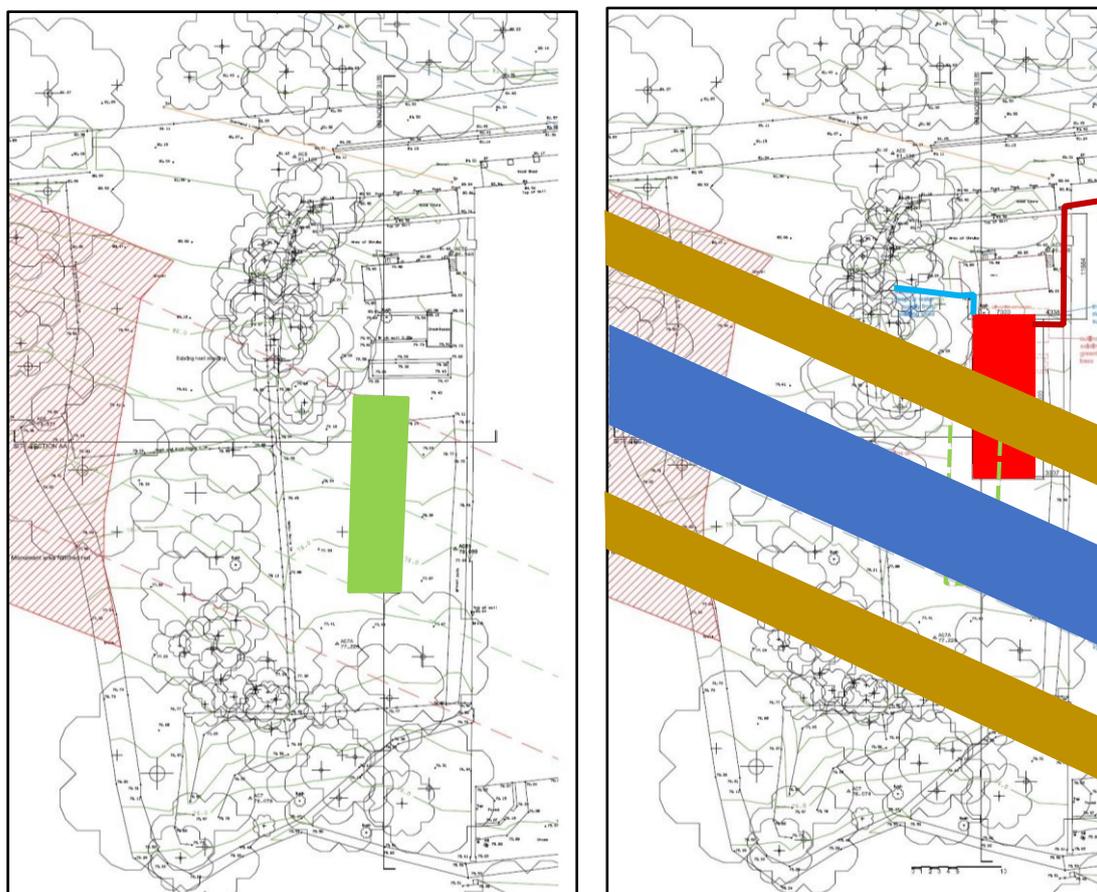
Figure 2: Drawings EO1 (Revision D) and PO1 (Revision D) by Doonan Architects showing (left) the existing site with polytunnel in green immediately to the west of the walled garden at Chesters, and (to the right) the proposed storage shed in red with the outline of the polytunnel in dashed green. Trench for electricity cable in brown; Trench for water in blue. Projected course of Vallum Ditch in green tone and north and south mounds in brown tone. Scheduled area to west hatched in red.

4.1 From the best estimate of the projected course of the Vallum Ditch and north mound, the proposed storage shed would lie immediately to the north of the ditch and straddle the line of

the mound (figure 2). No visible earthworks, negative or positive, mark the presence of either feature in the vicinity of the shed.

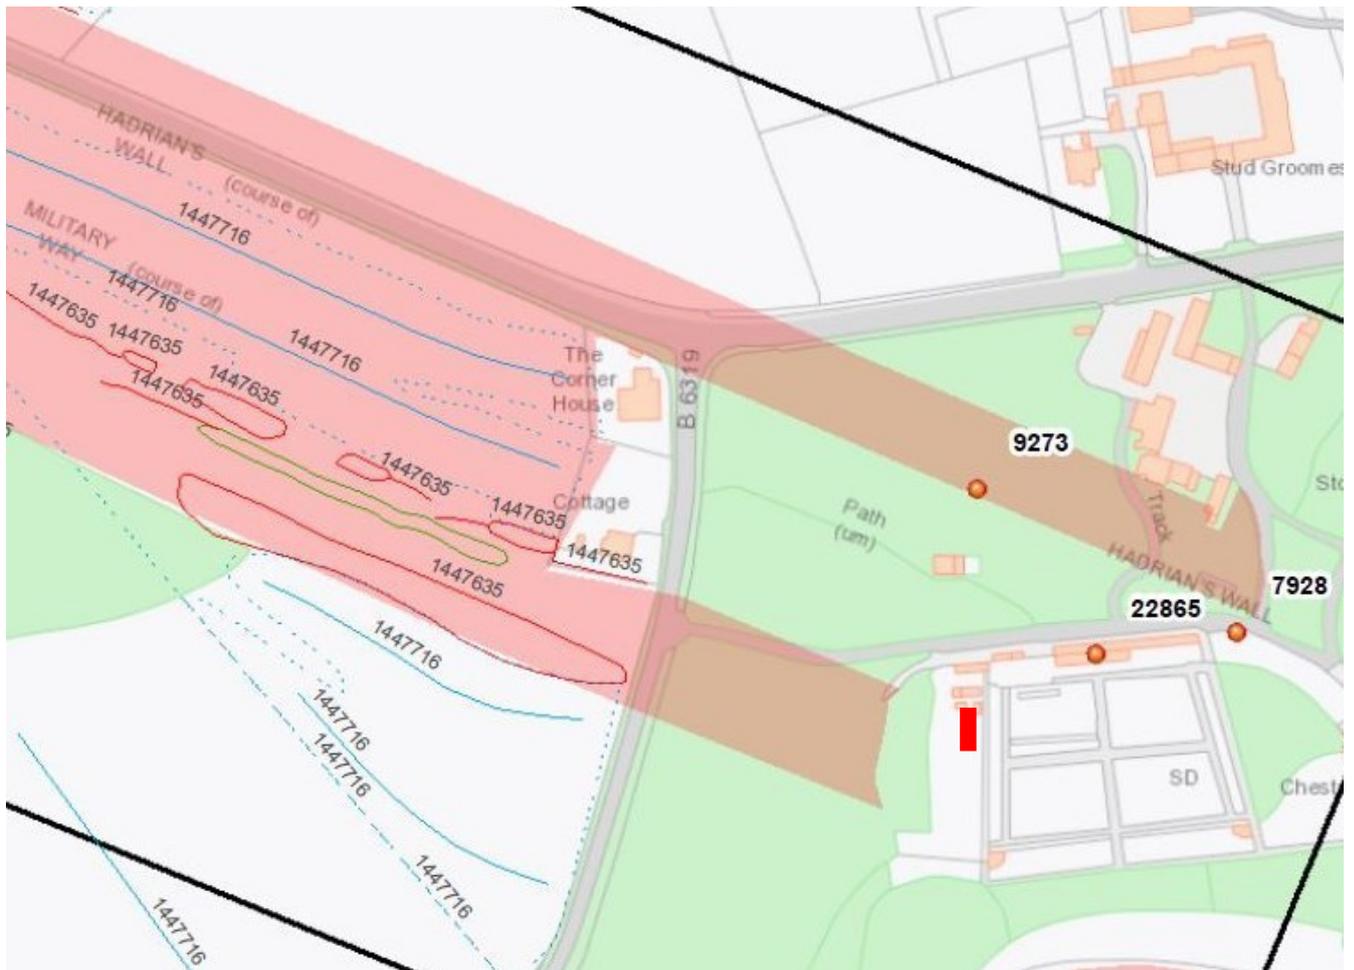
Figure 3: HER extract map for the area around the proposed development. Pink tone shows scheduled monument 26052. Hadrian's Wall National Mapping Programme features 1447635 to the west of the development area include north and south mounds of the Vallum in red outline and the Vallum Ditch, itself, in green outline. The proposed storage shed is shown in red. Features 9273, 22865 and 7928 are, respectively, Turret 27b, the walled garden at Chesters and Hadrian's Wall and Vallum.

The Vallum earthworks are shown on the HER extract map for the area (figure 3, below), referenced as features **1447635** (red outline: north and south mounds; green outline: Vallum ditch).

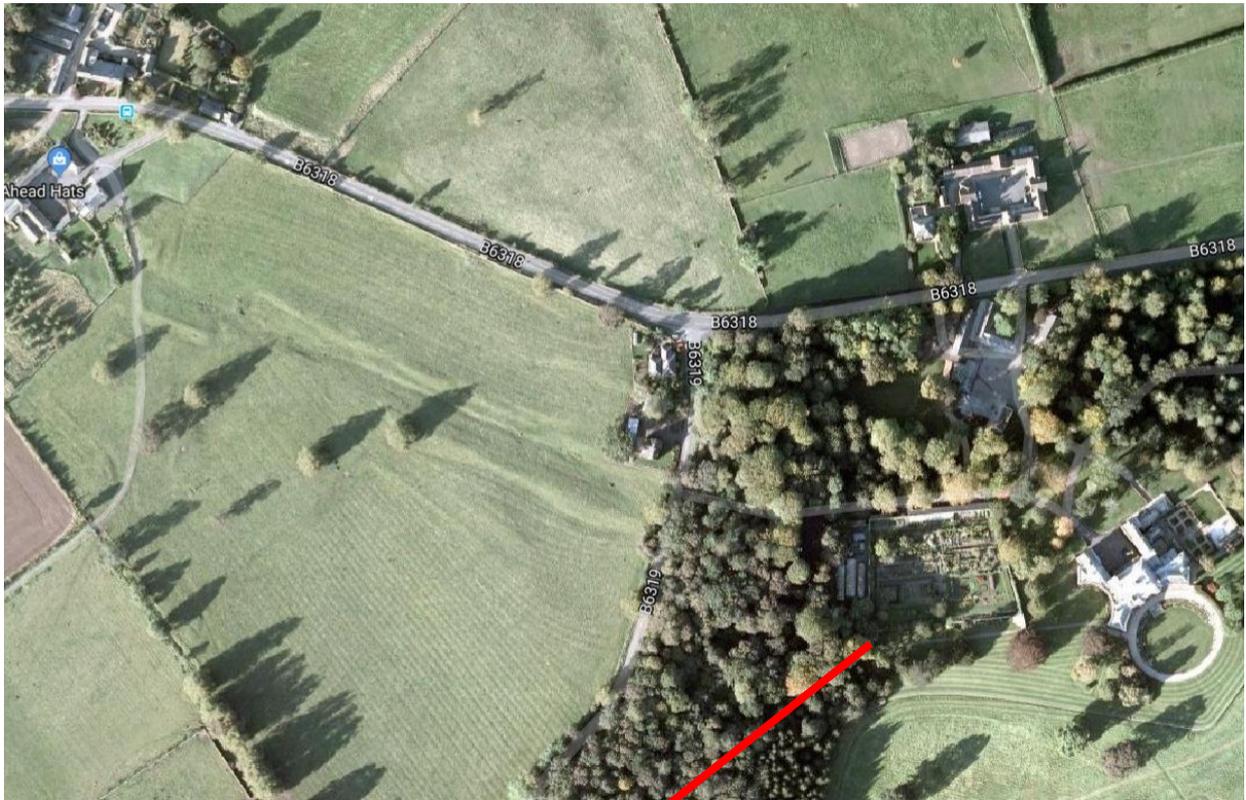
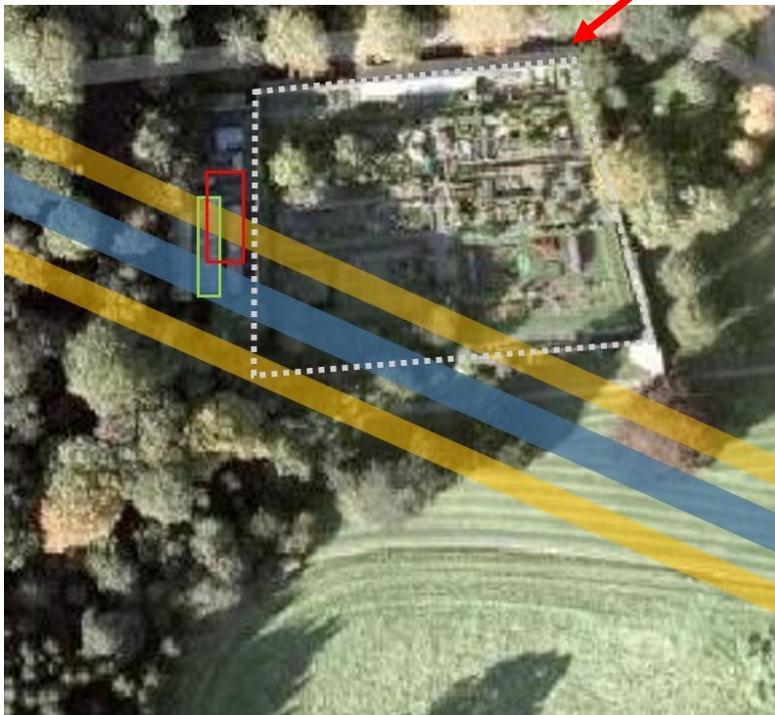
Figure 4 : Google Earth aerial photograph of Chesters House and field to the west (above) in which the eroded earthworks of the Vallum complex can be seen within the field. The enlargement of the area of the walled garden (right) shows the projected course of the Vallum Ditch (blue tone) and north and south mounds (brown tone). The existing polytunnel is shown in green outline and the proposed shed in red outline.

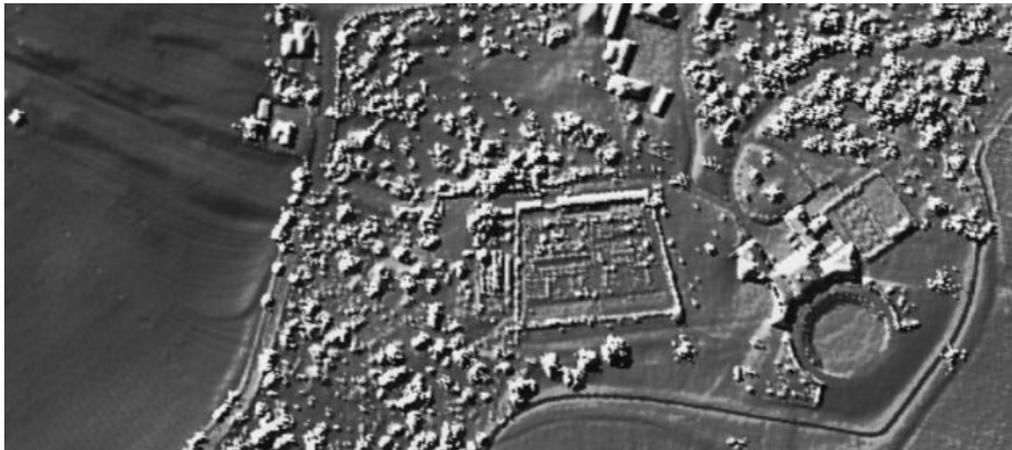
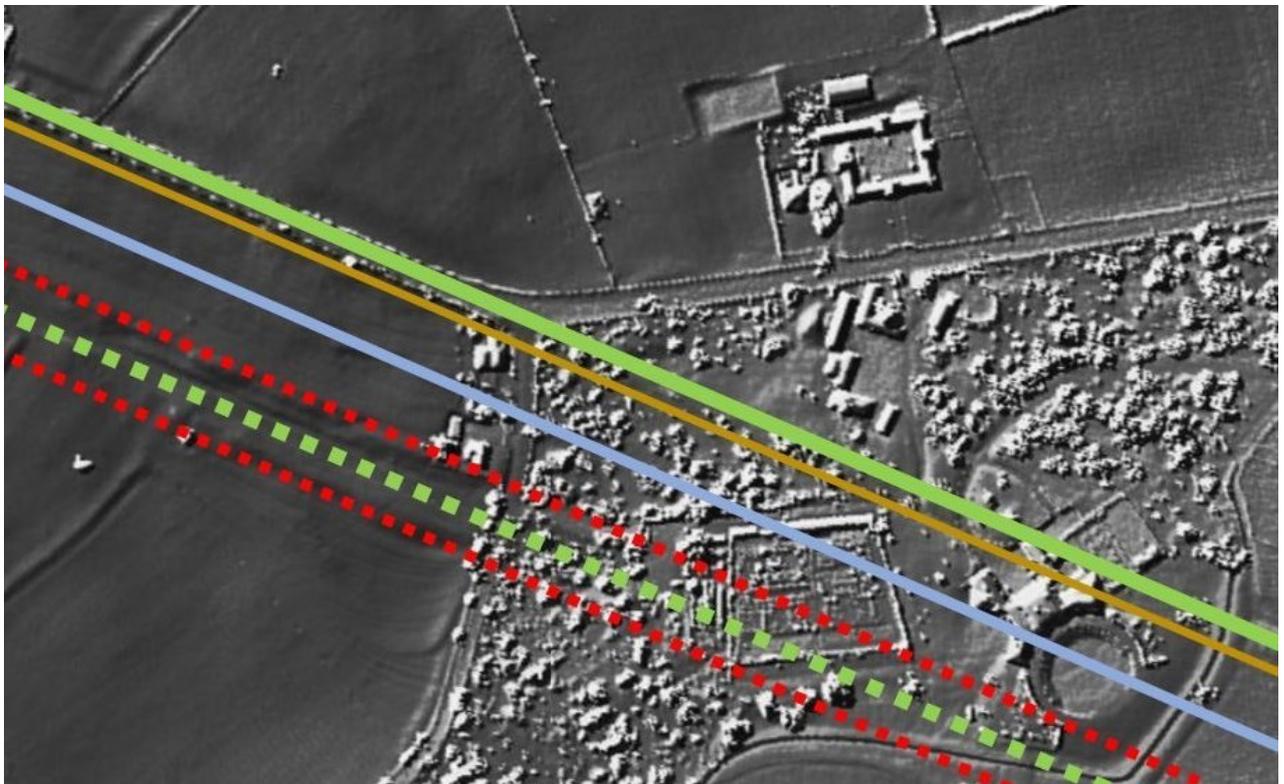
Figure 5: Two images from Lidar survey showing the area around Chesters House. The top image shows the house and its walled garden with earthworks of the Vallum complex to the west. The bottom image includes projected lines of the Vallum complex (dotted green line for the Vallum Ditch and dotted red lines for the north and south mounds) as well as the course of the Military Way (blue line); the Wall Ditch (green line) and the Wall itself (brown line) of which a short stretch survives within the gardens at Chesters House.

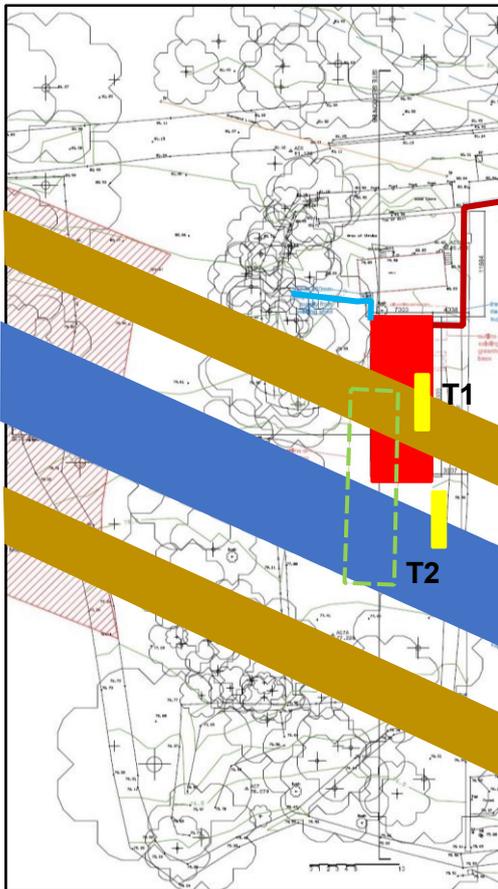
Figure 6: Proposed location of evaluation trenches T1 and T2 in yellow. Footprint of proposed shed in red; existing polytunnel in green broken line; Projected line of Vallum Ditch in blue tone and projected courses of north and south mounds in brown tone. Service trenches in red and blue line.

In order to fully establish the likely archaeological impact of the proposed development on significant archaeological remains (the area lies beyond the scheduled area of the Roman frontierworks but within the UNESCO designated Roman Frontiers World Heritage Site) and inform the planning procedure, it is recommended that two evaluation trenches (figure 6) each 6m long by 1.5m wide, should be excavated to secure the location of the Vallum Ditch (Trench 1) adjacent to the proposed shed and determine the degree of survival, if any, of the north mound (Trench 2).

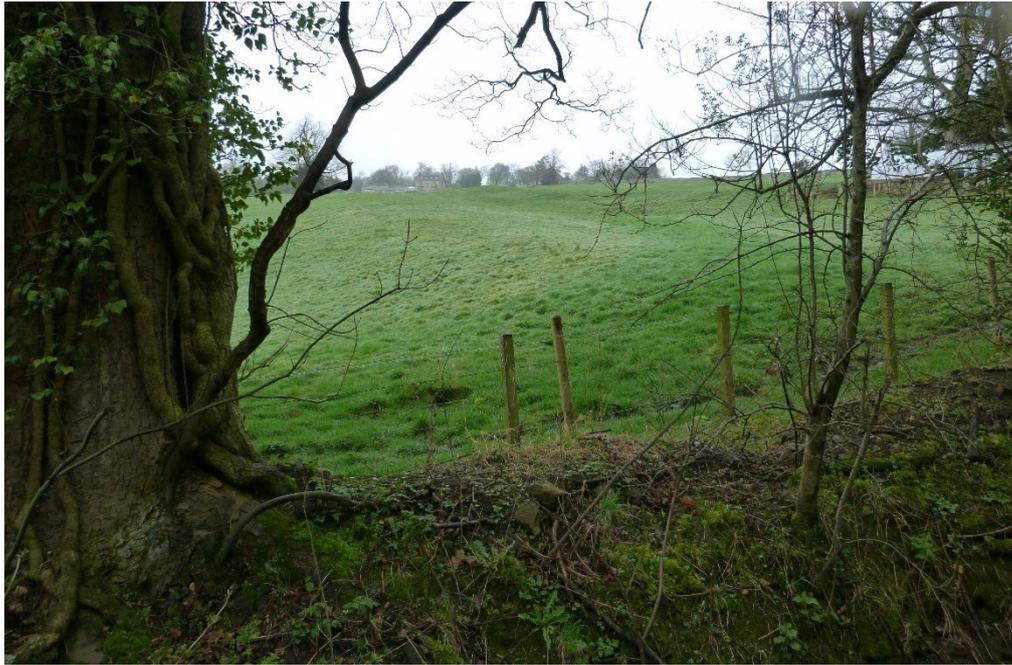
Plate 4: *Looking north-west across the reduced earthworks of Vallum Ditch and south mound in the field to the west of Chesters.*
