# BREMENIUM ROMAN FORT

HIGH ROCHESTER, NORTHUMBERLAND

## ARCHAEOLOGICAL MONITORING DURING CONSERVATION WORKS

November 2019

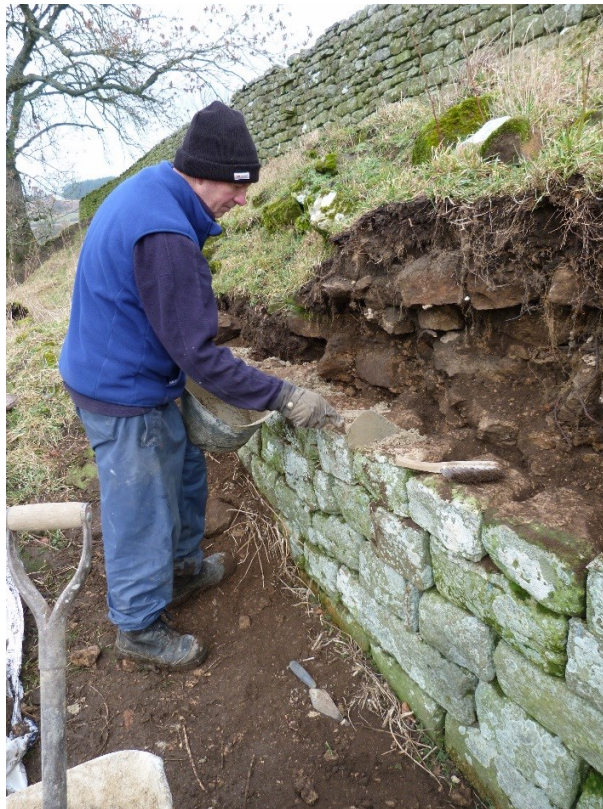
**Plate 1:** Conservation of the fort wall (Block W19) in February 2019.

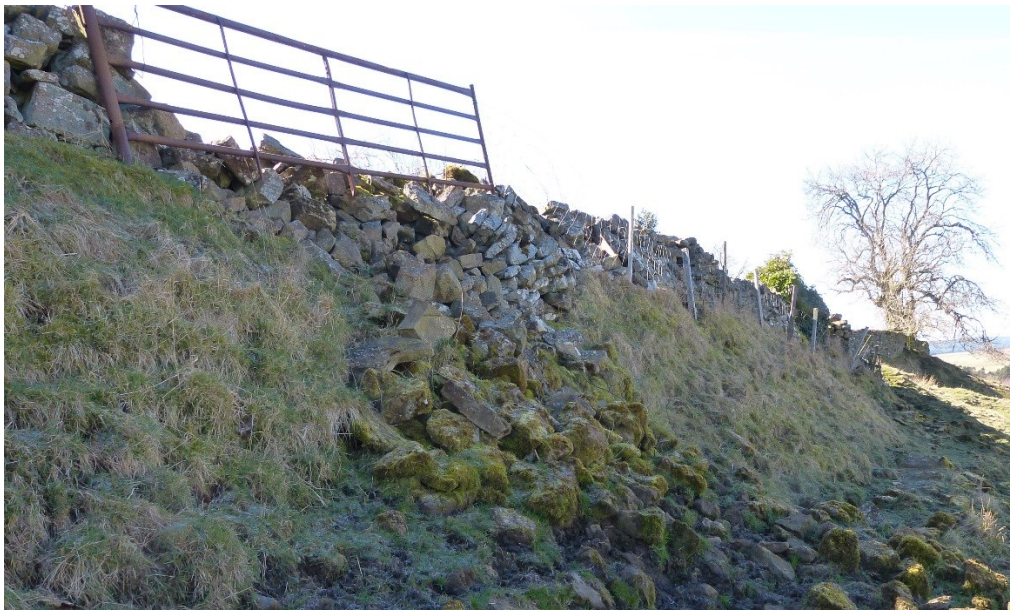
This area of walling (c 50m) runs along the crest of the northern rampart of the fort, east of the remnants of the north gate. In 2018 the wall here was in a very poor condition; intermittently tumbled and slumped, with very little coherence as a structure. All of the stretch was disassembled and rebuilt. Because there was no level ground adjacent to the wall along its north face, a platform was used to lay out and sort the dropped stones. This consisted of a framework of scaffold posts jettied out from the rampart supporting a plywood platform and was moved and built entirely manually. No *in-situ* Roman fabric was seen or impacted during the work. A number of worked stones had been incorporated in the wall, including portions of two small troughs or basins (3 and 4), one a creeing trough.

**Plate 2:** *The eastern part of the north rampart (N3) with a badly-tumbled dry-stone wall above. Looking west.*

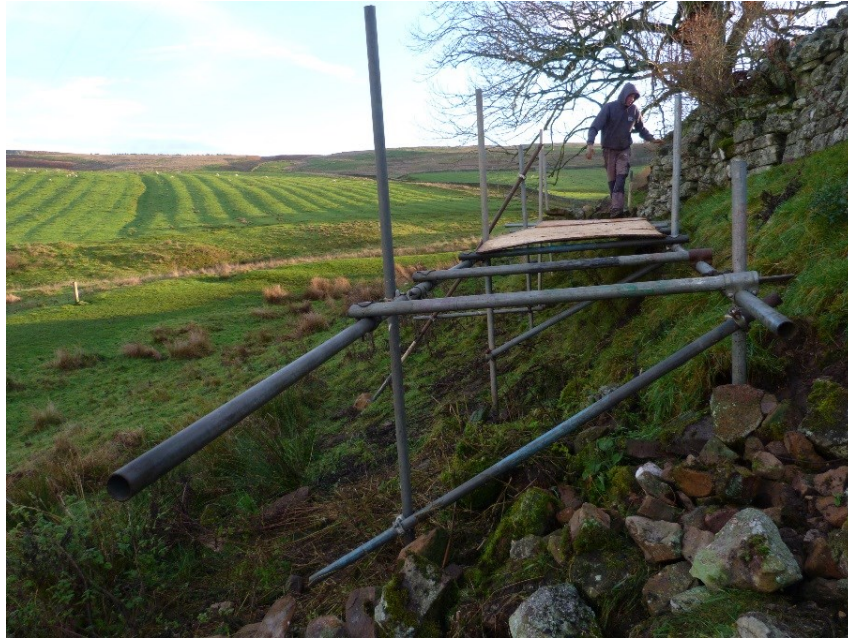
**Plate 3:** *The north rampart, looking east. Platform constructed to take dropped stones for rebuilding.*

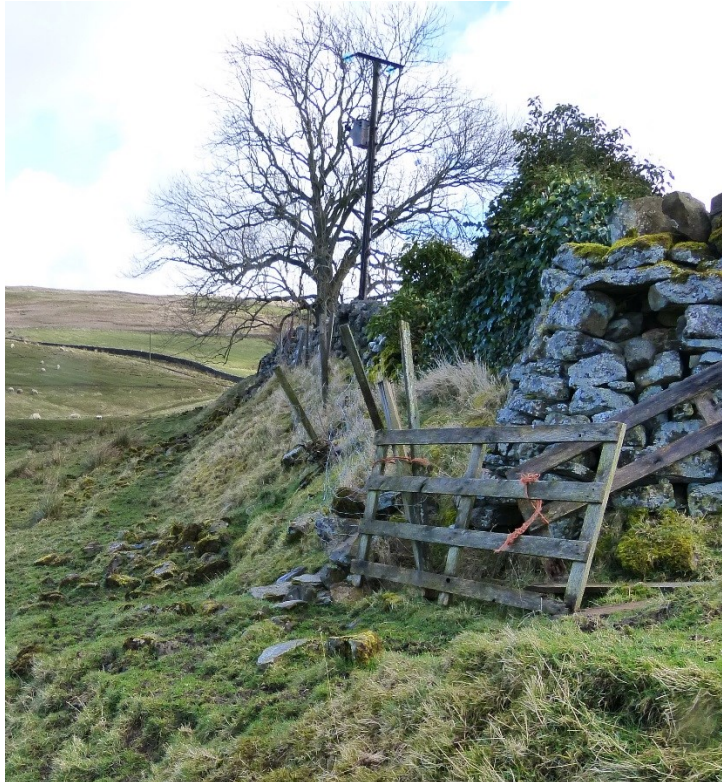
**Plate 7:** *The west end of N3 before rebuilding. Looking east.*

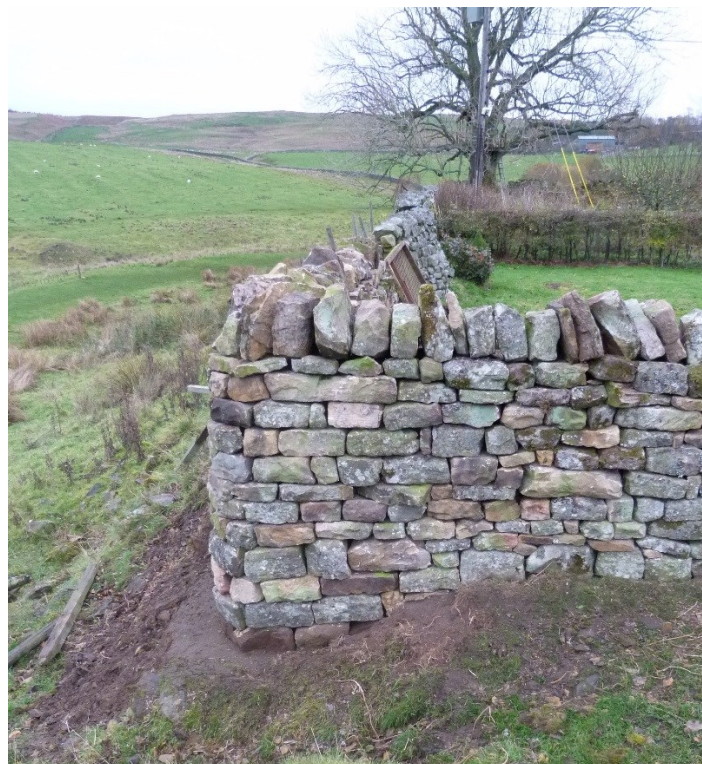
**Plate 8:** *The same area as in plate 7 after the rebuild.*

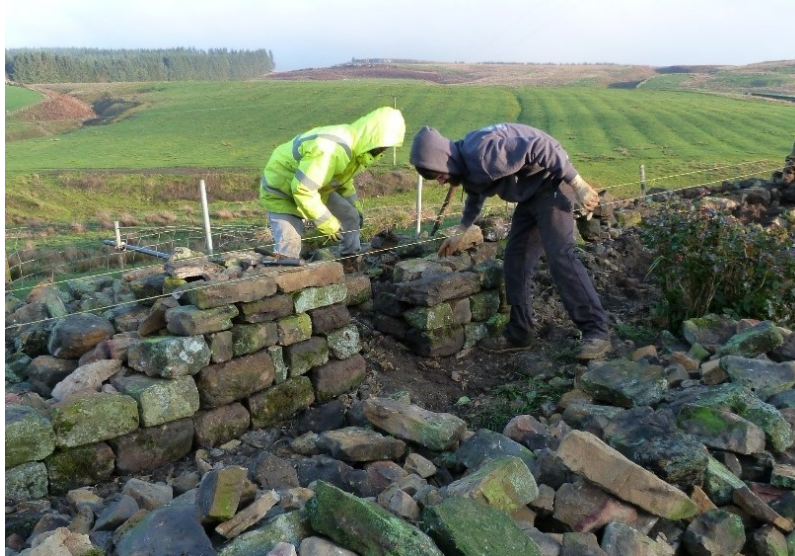
**Plate 9:** Rebuilding a sheep creep along the north rampart.  
Looking north.

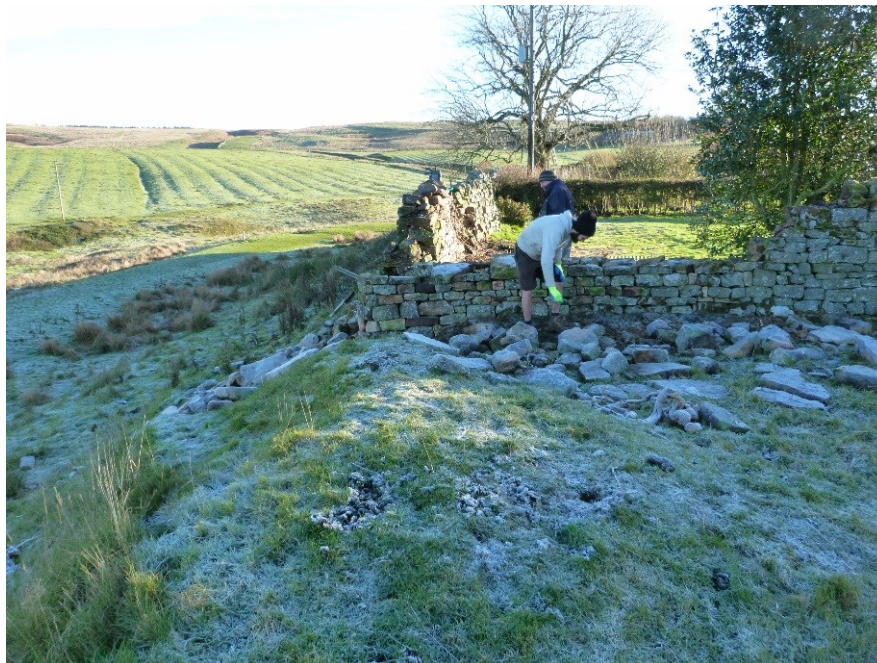
This short stretch of wall (c 20m) runs south from the western end of **N3**, flanking the eastern edge of the access ramp falling from the fort platform. This was not on the line of any Roman structure. No Roman stonework was seen during the rebuild.

**Plate 10:** Rebuilding wall N2 running in to the fort platform.  
Looking east.

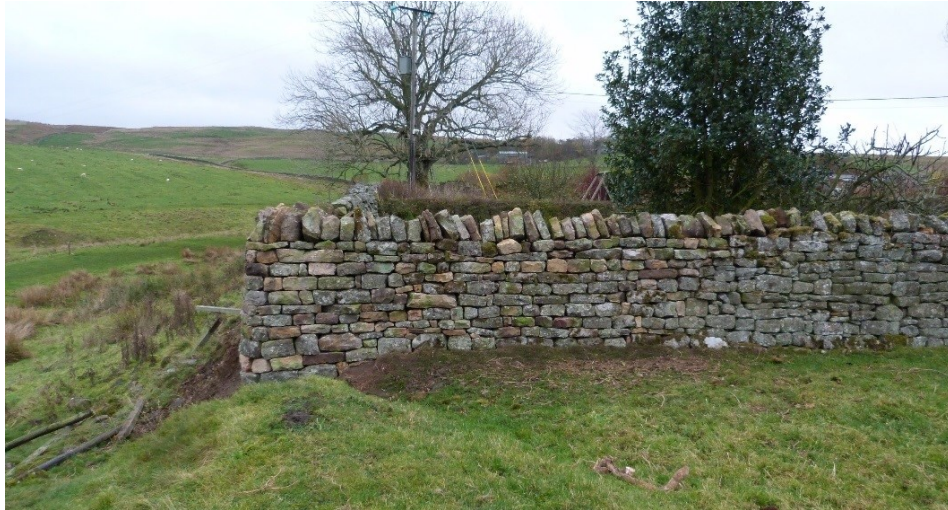
**Plate 11:** *The northern section of N2 rebuilt. Looking east.*

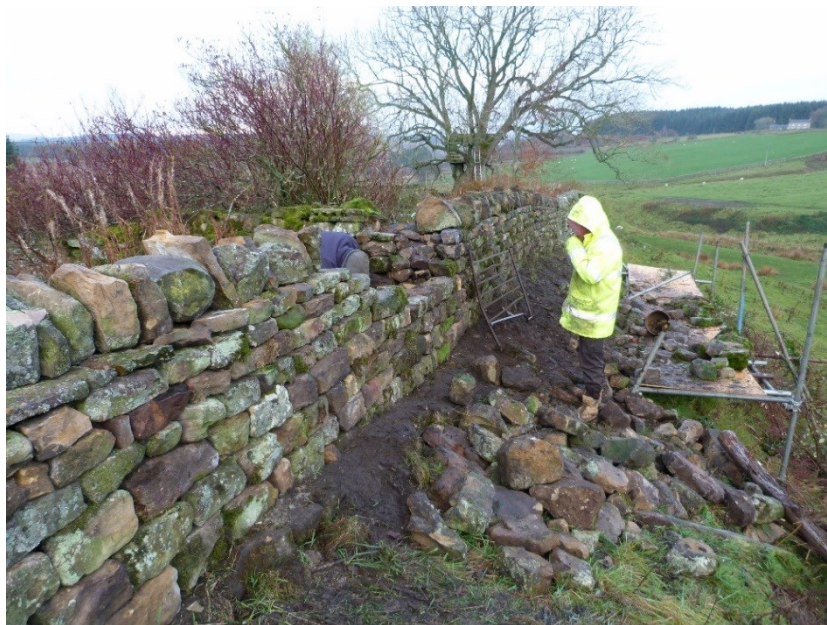
As with the eastern part of the north rampart wall, the dry-stone wall along the northern part of the east rampart (c 50m) was in a very bad condition in 2018 with long stretches tumbled and slumped. Running along the outer edge of the rampart top, it was also necessary to use a platform to drop and sort the wall stones.

**Plate 12:** *Rebuilding the southern part of E3 on the east rampart. Looking north.*

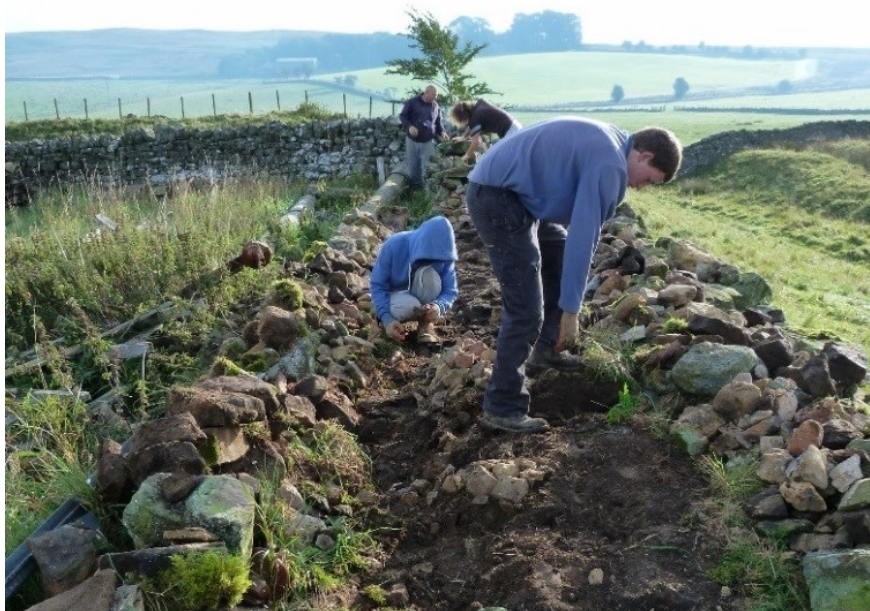
This length of wall runs from east from the access road for c25m along the line of the south edge of the rampart before turning at an oblique angle to the north-east. A part of the run is undulating. No platform was needed to hold dropped stone over this length as the wall is set slightly to the north of the crest and the rampart less steep than along the east and north sides.

**Plate 16:** *S5 disassembled. Looking east.*

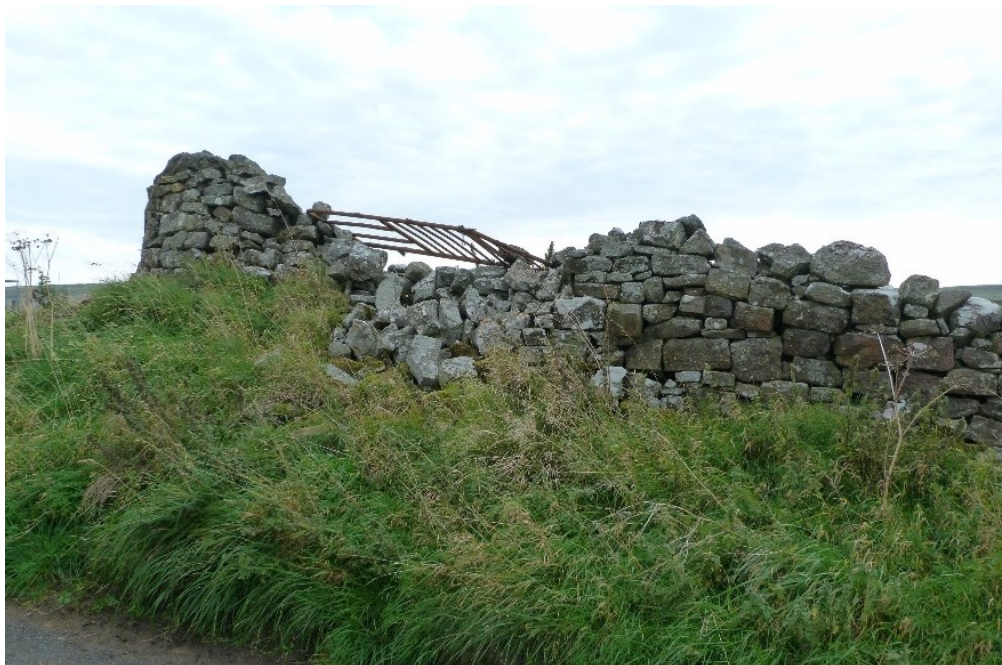
This was in a very poor condition in 2018 and rebuilt as a part of the project.

**Plate 20:** *Wall flanking the east side of the access road as it passes into the area of the fort. Looking north-east.*

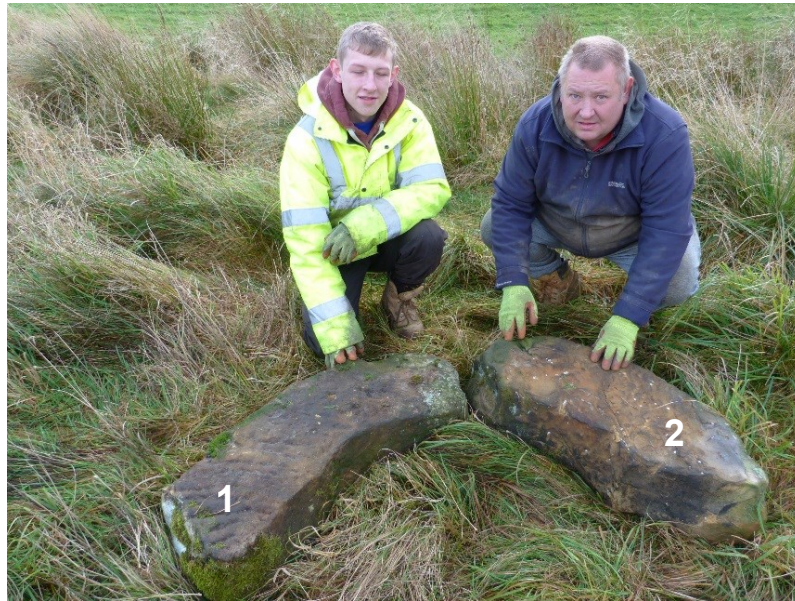
1. Two roughly-shaped blocks of yellow sandstone (1: 0.82m long by 0.30m wide and 0.17m thick; 2: 0.76m long by 0.33m wide and 0.17m thick) with part of the circumference of a circle cut in each stone. Possibly two parts of a window or door head, the form more likely of late-medieval/post-medieval date than Roman. The pieces were found together in the drystone wall immediately to the south of the fort along the access road (Plate 23 and figure 4).

**Plate 23:** Two blocks of sandstone, possibly parts of a window Or door head. They are more likely post-medieval than Roman.

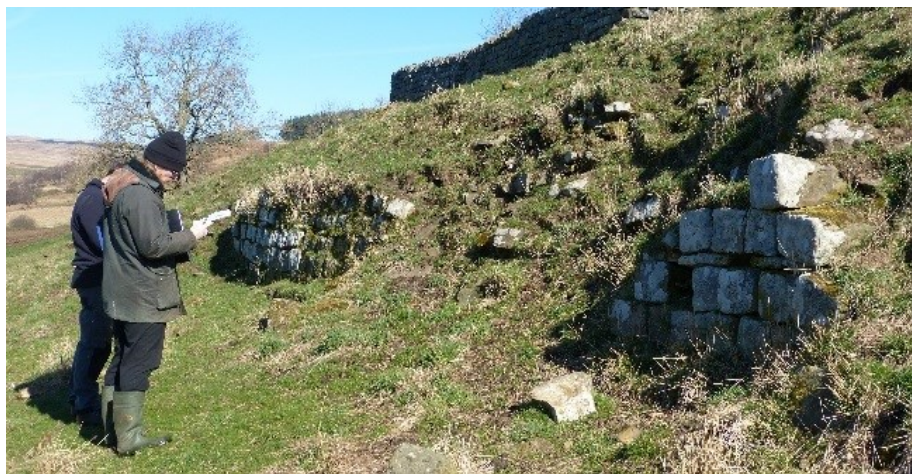
**Plate 31:** *Blocks W2-3 and 5, prior to conservation. Looking north.*

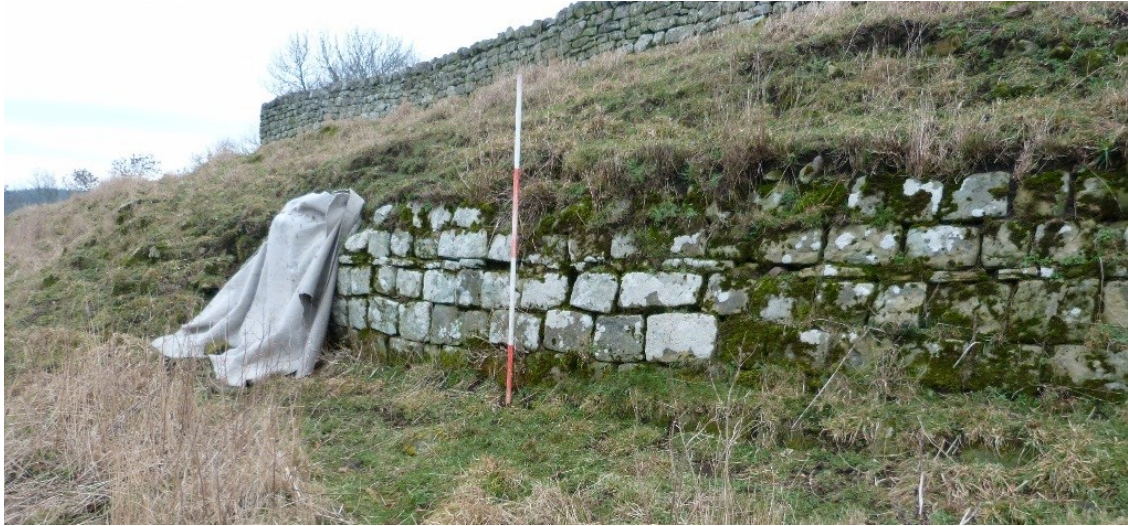
**Plate 33:** Block W5 during conservation, looking north.

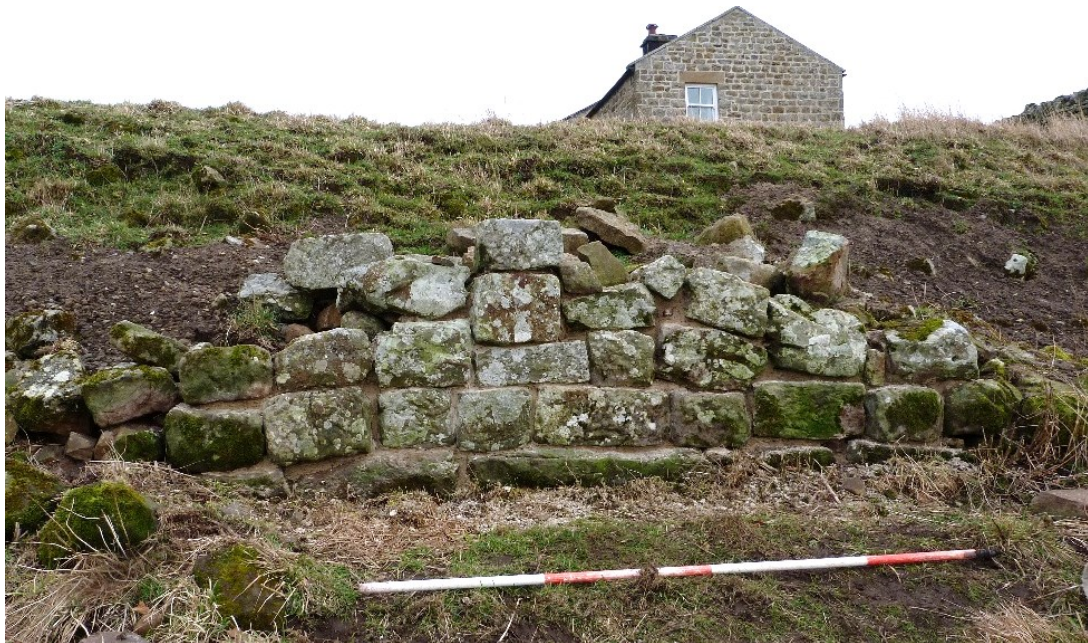
**Plate 34:** Block W7 during conservation, open joints have been deep tamped.  
Prior to turf capping. Looking east.

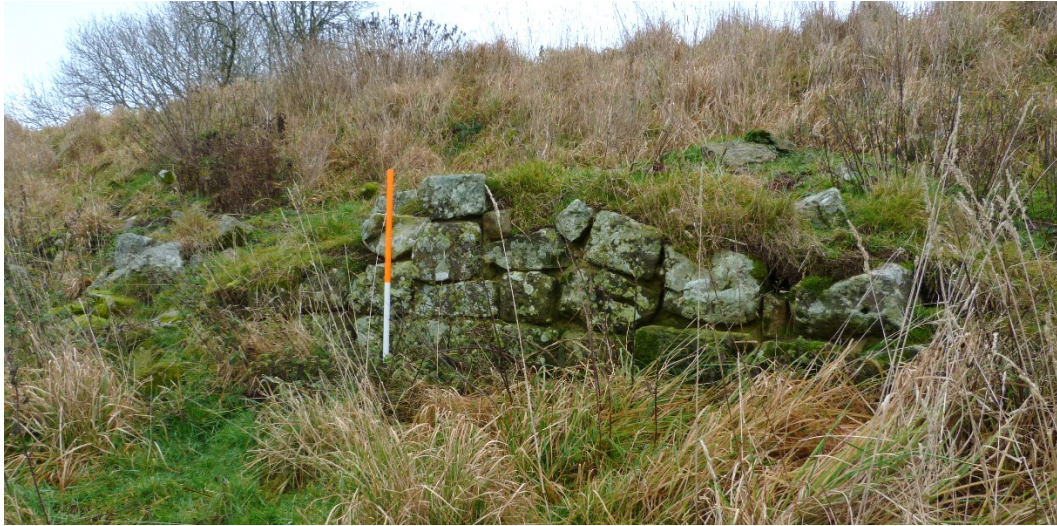
***Plate 35: Block W7 following conservation and with turf capping added.***

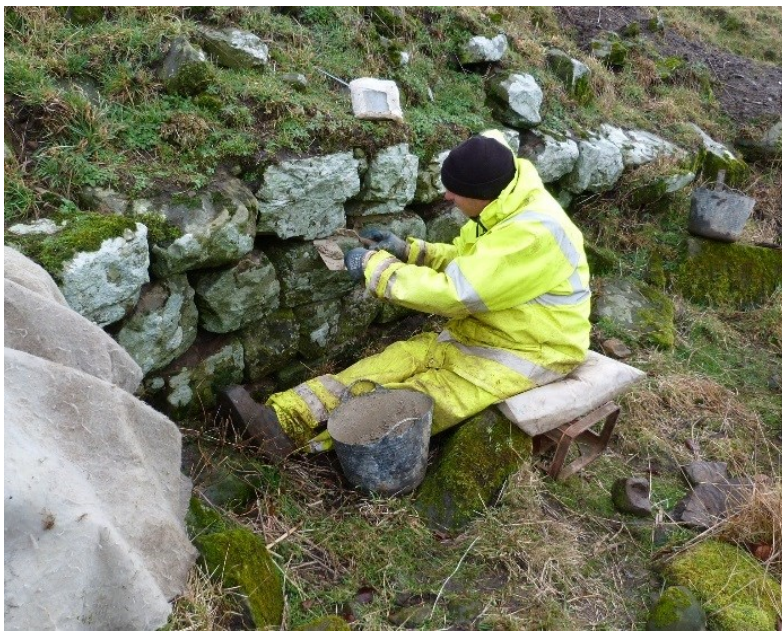
***Plate 36: Mortar work on Block W9.***

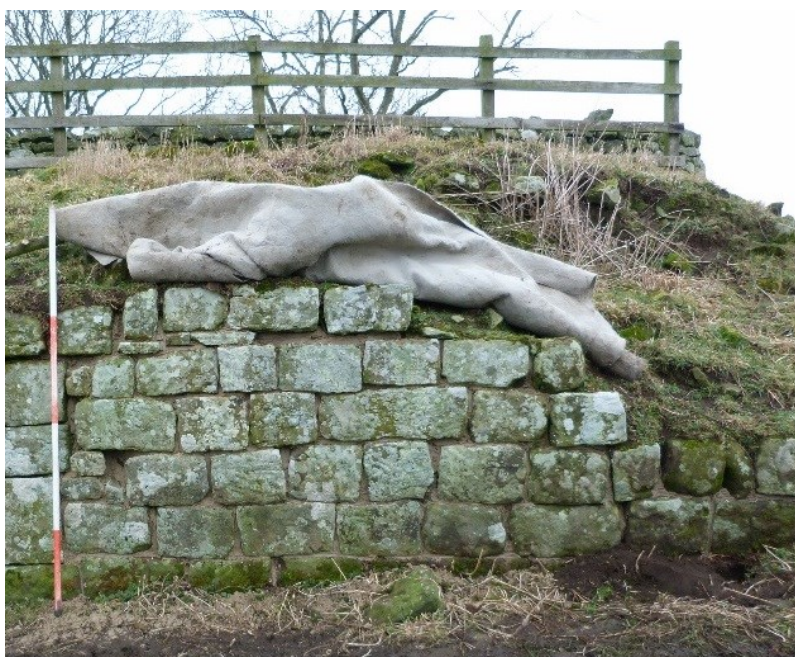
**Plate 37:** Block W13. Masonry south of the west gate during conservation. Open joints have been mortared. Looking east.

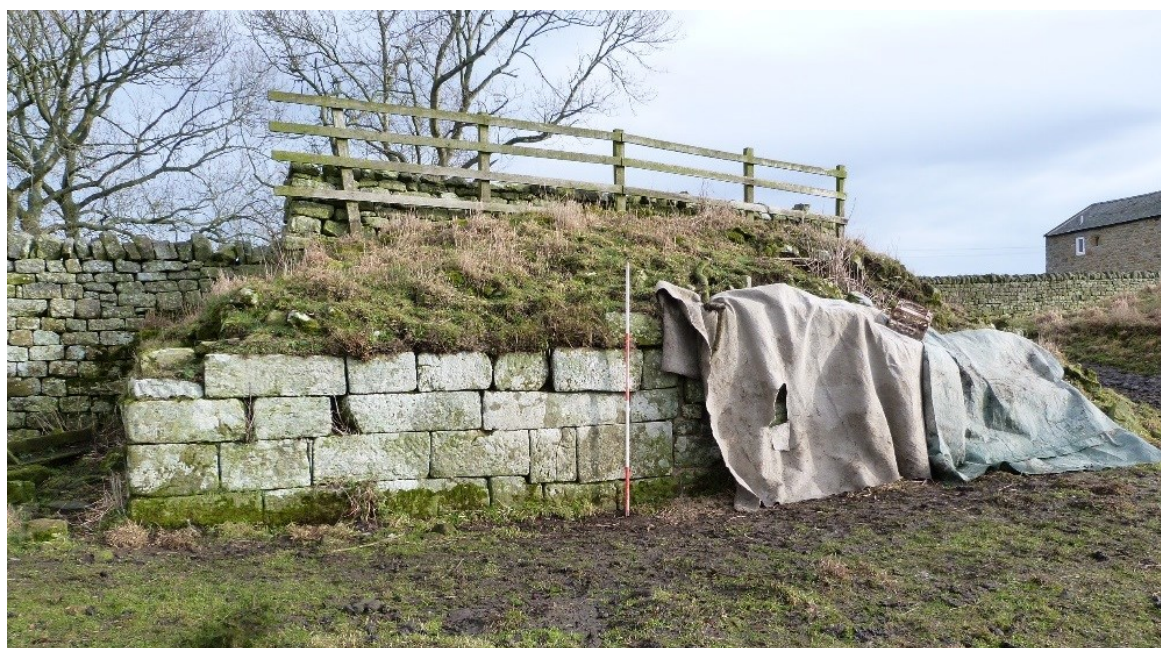
**Plate 38:** Block W14, ashlar stonework of the west gate. South of the single portal. Looking east.

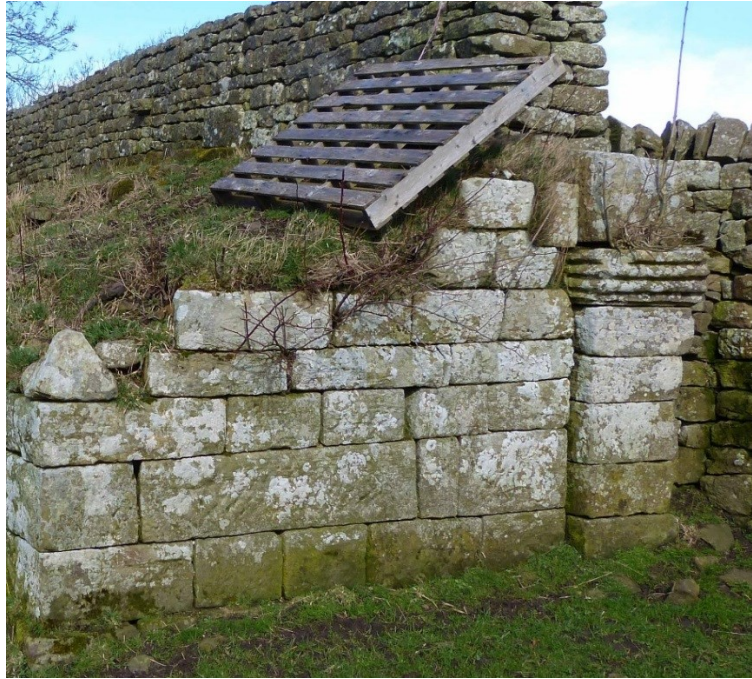
**Plate 39:** Block W16. The west gate. Pre-conservation with woody vegetation growing out of the upper courses of stonework. Looking north-east.

- **Removal of Woody Vegetation** Where brambles have established in the joints of stonework north of the west gate. (see W16 in Appendix 1) they will be cut out and deep roots poisoned. Where brambles are evident in contiguous turf capping, this will be removed and replaced. (see W18 in Appendix 1).

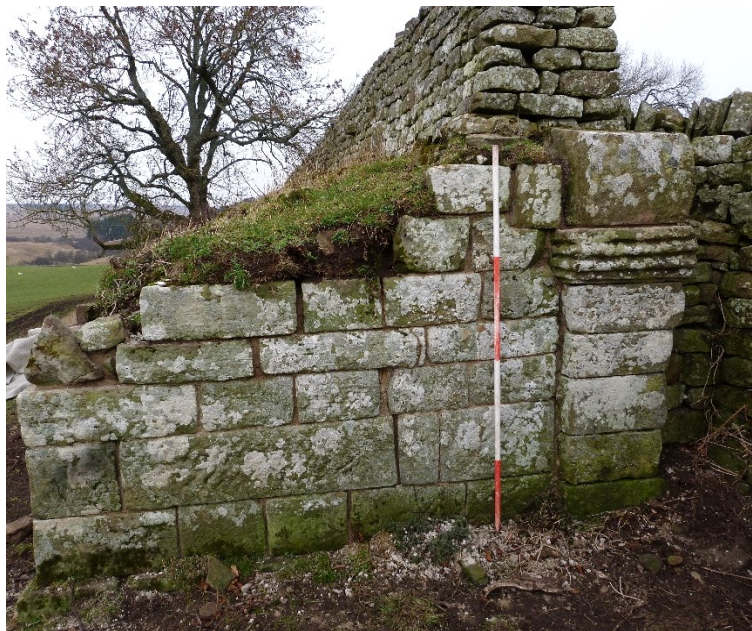
**Plate 40:** Block W16 following conservation, woody vegetation removed.

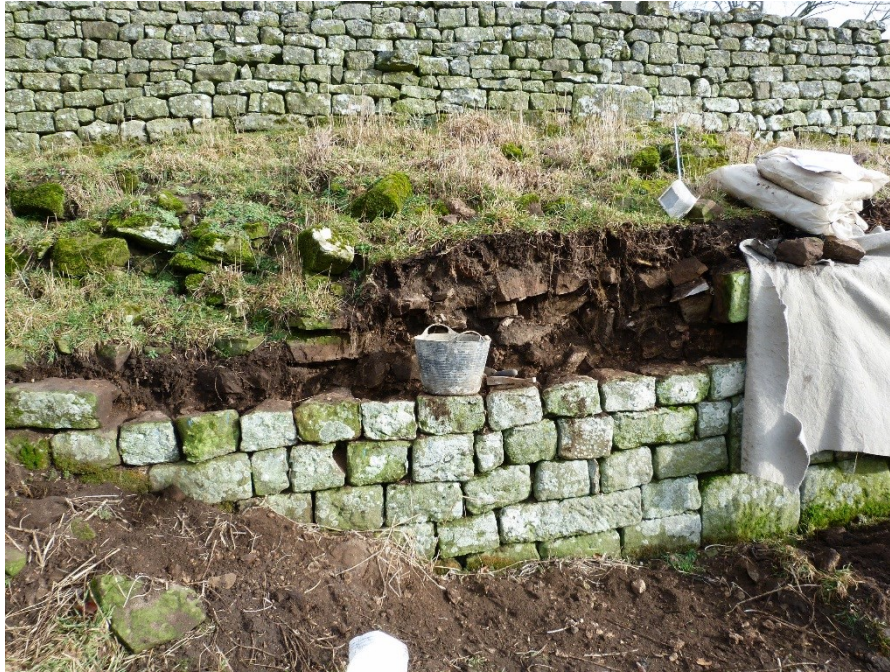
**Plate 41:** *Block W19 North of west gate during conservation. Four courses removed exposing core. Looking east.*

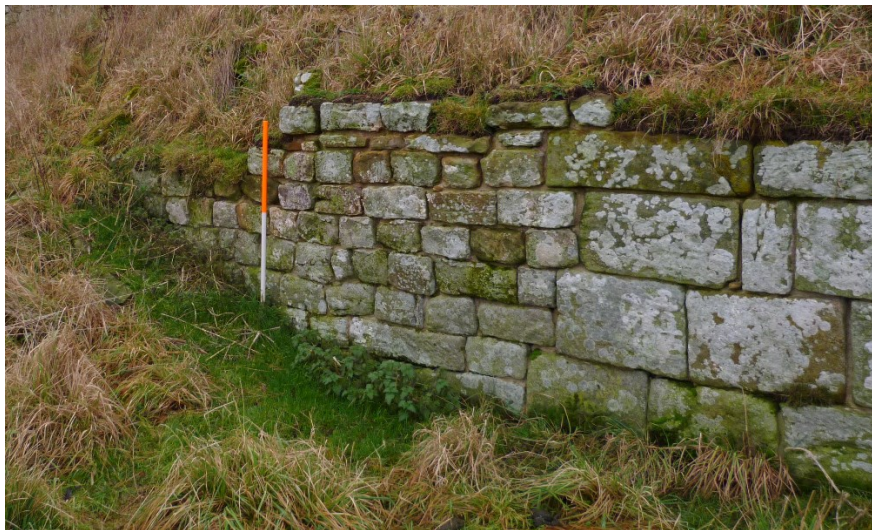
**Plate 42:** *Block W17 west gate (right) and Block W19 north of west gate following conservation. Looking north-east.*

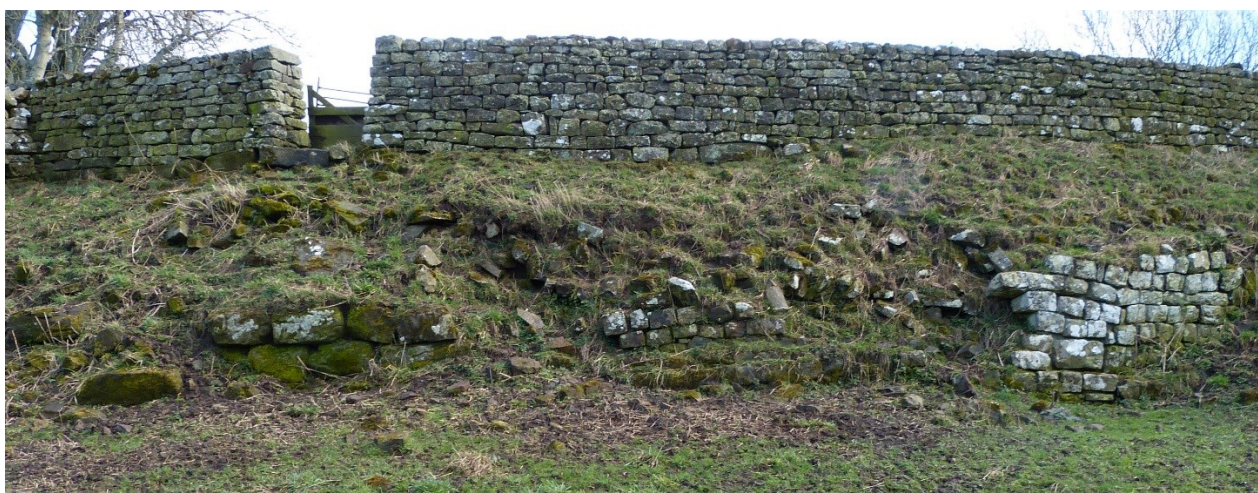
**Plate 43:** Blocks W21 (right) and W23 at the north-west angle of the fort before consolidation.  
Looking east

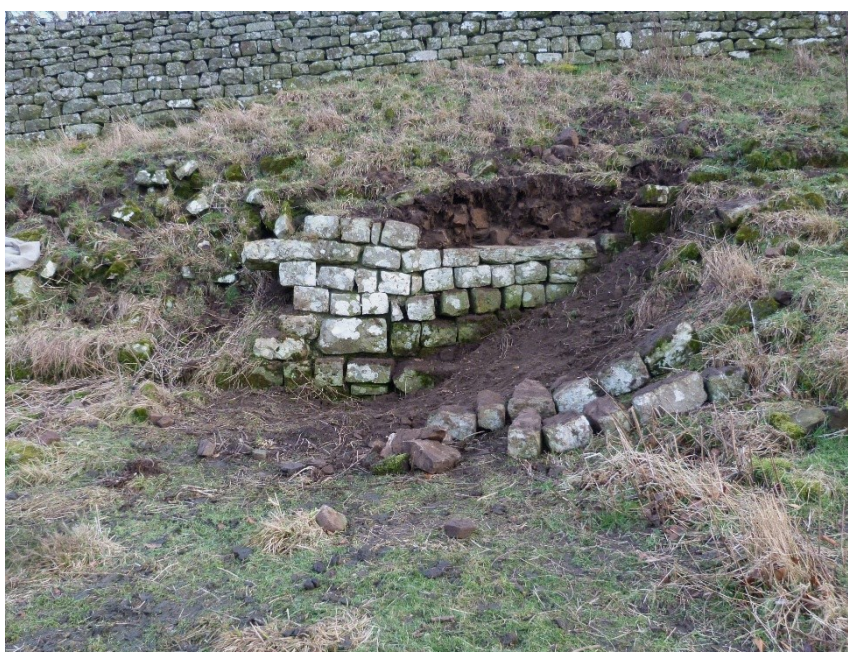
**Plate 44:** Block W21 during consolidation, a number of facing stones removed for re-bedding. Looking east.

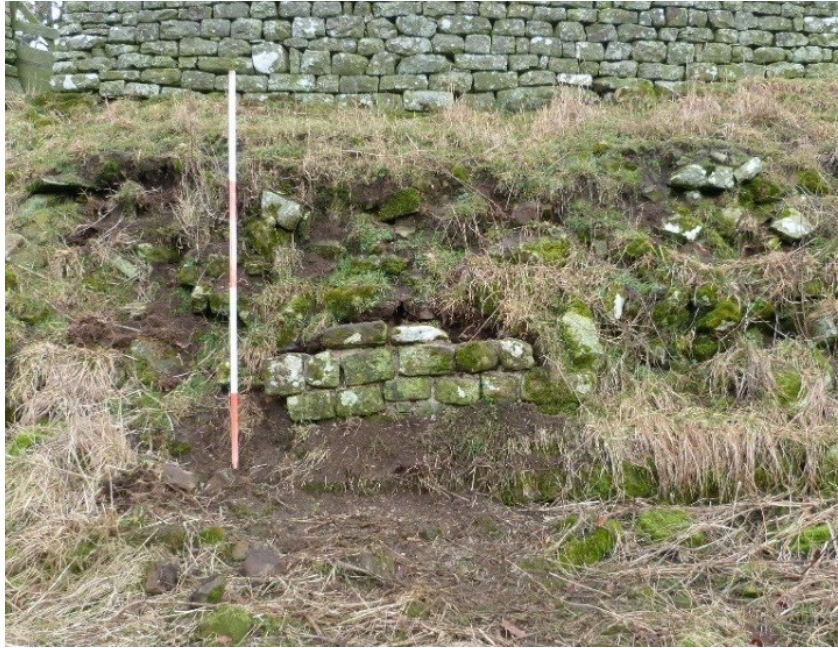
**Plate 45:** Block W23 (south) during consolidation, facing stones re-bedded and corework above and to right (W22 and W24) consolidated with turf and soil. Looking east.

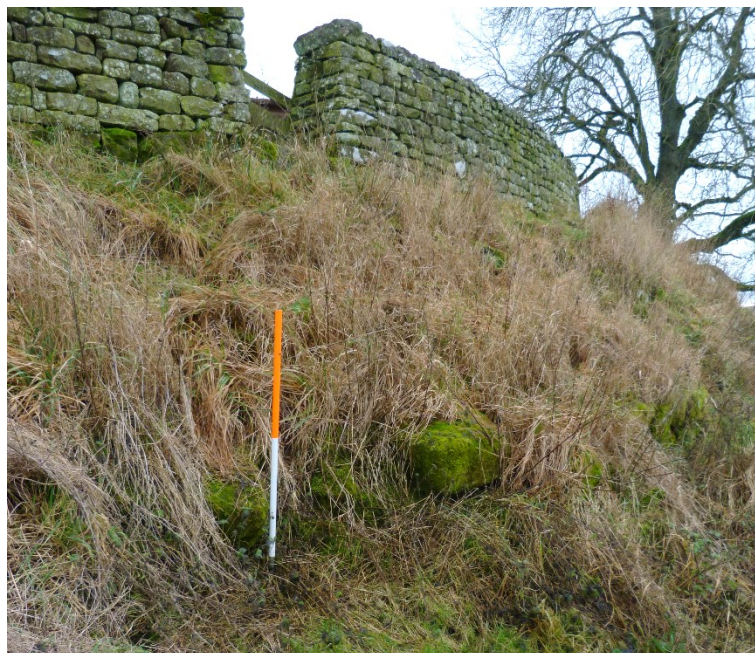
**Plate 46:** Block W23 (north) in autumn 2019. Facing stones re-bedded and corework above (W24) consolidated with turf and soil. Looking south.

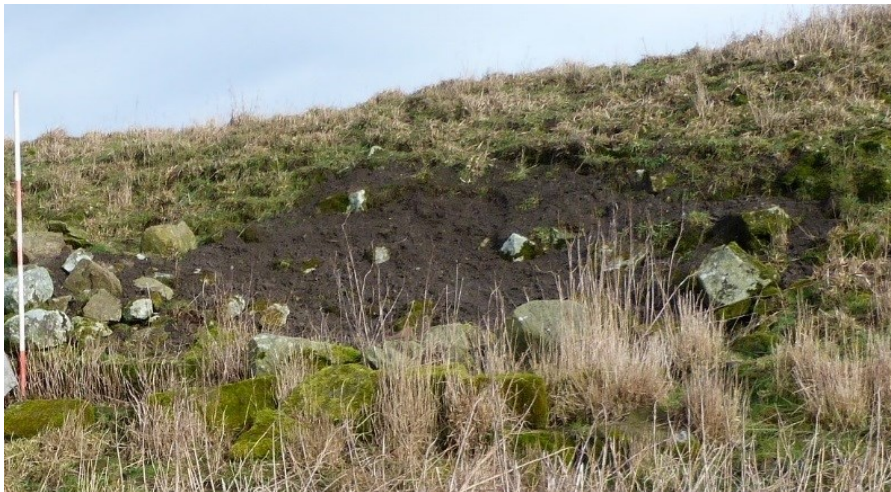
**Plate 48:** Block W6. Topsoil spread to stabilise and protect loose rubble  
with some turf clumping around exposed stones. Looking east.

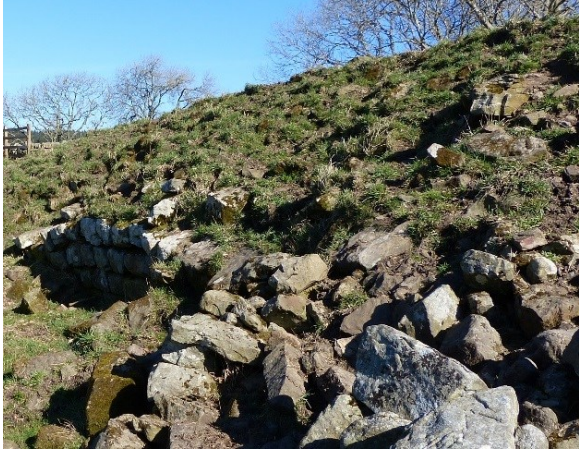
**Plate 49:** Block W6 before consolidation;

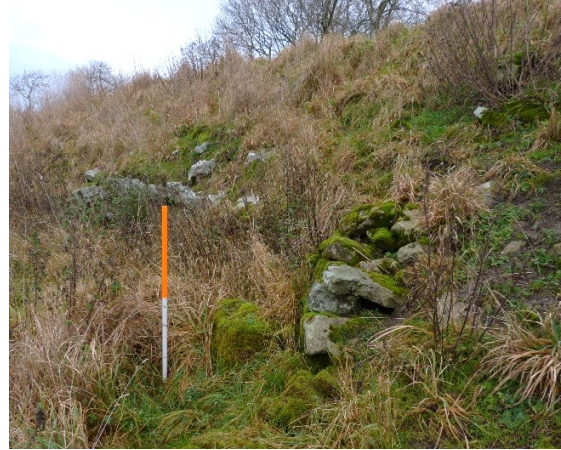
**Plate 50:** Block W6 after works in autumn 2019.

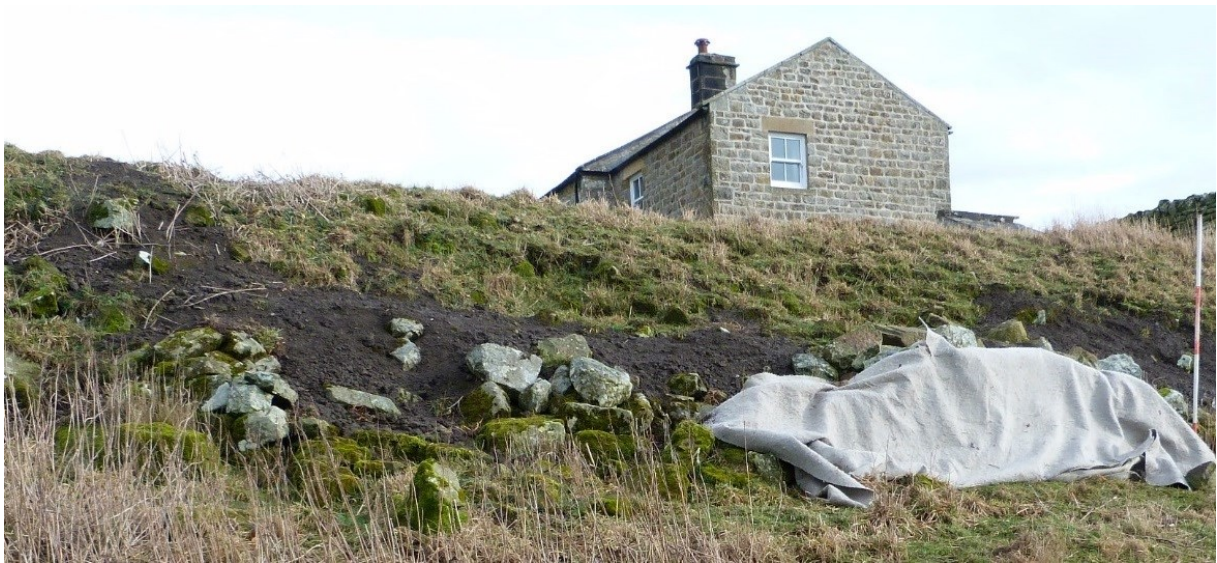
**Plate 51:** Block W8. Topsoil spread to stabilise and protect loose rubble. Looking east.

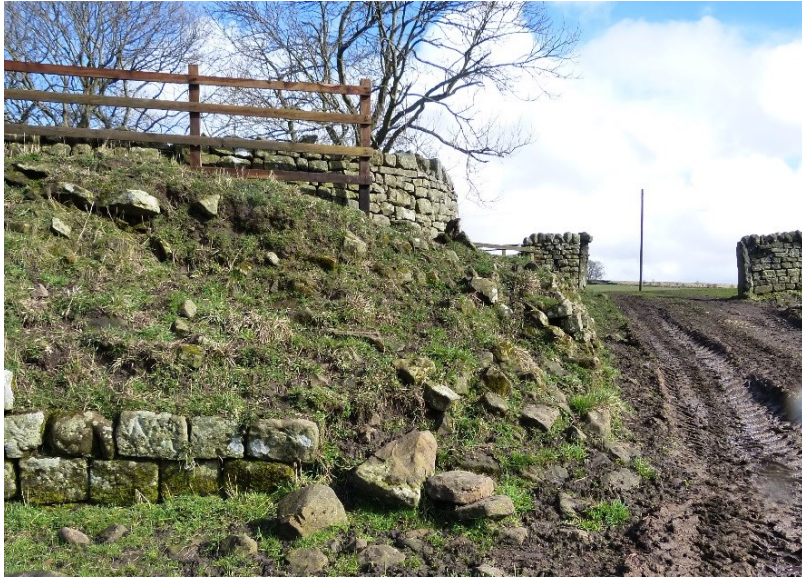
**Plate 52:** Block W12 to north of farm track through west rampart in early 2018. Looking east.

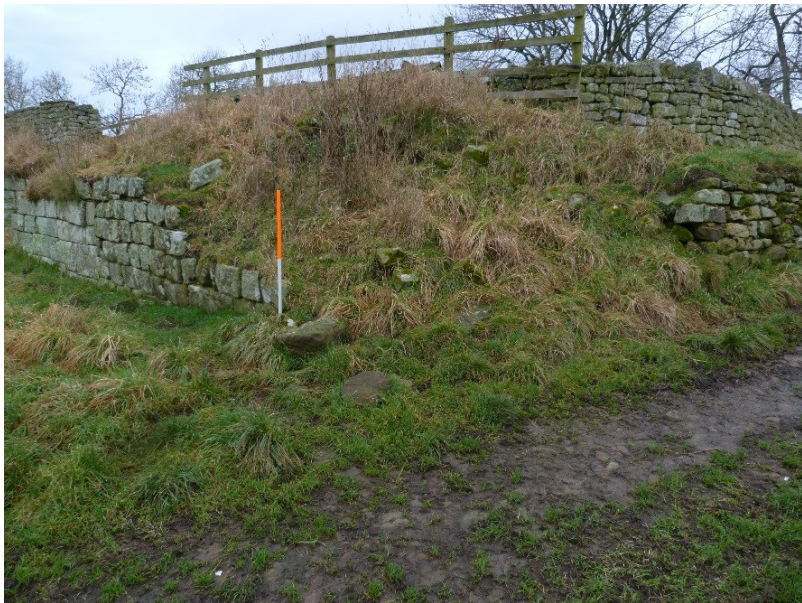
**Plate 53:** Block W12 in autumn 2019, stable following clearance and consolidation works. Looking north.

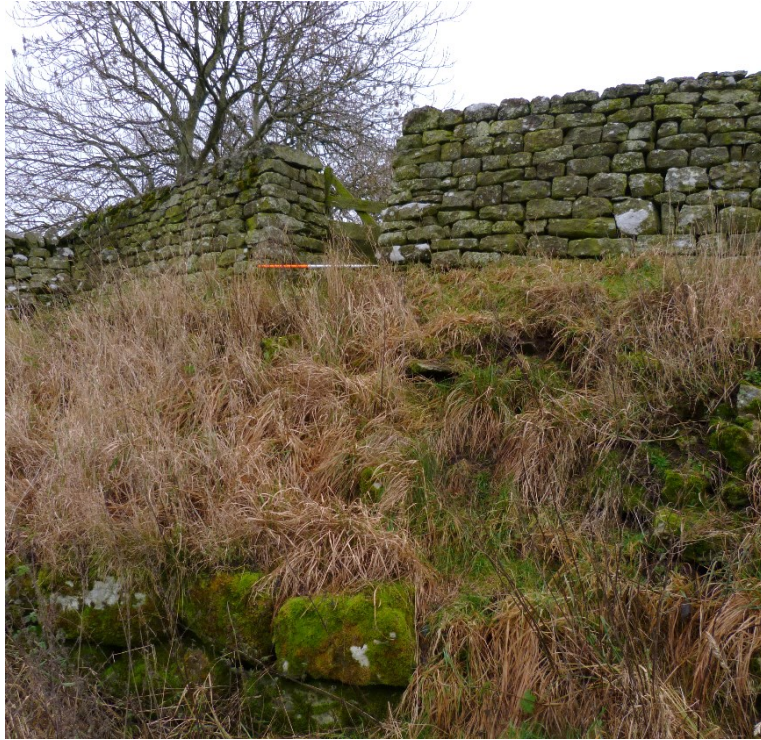
**Plate 54:** Block W24 in autumn 2019 following consolidation and stabilisation works. Looking north-east.

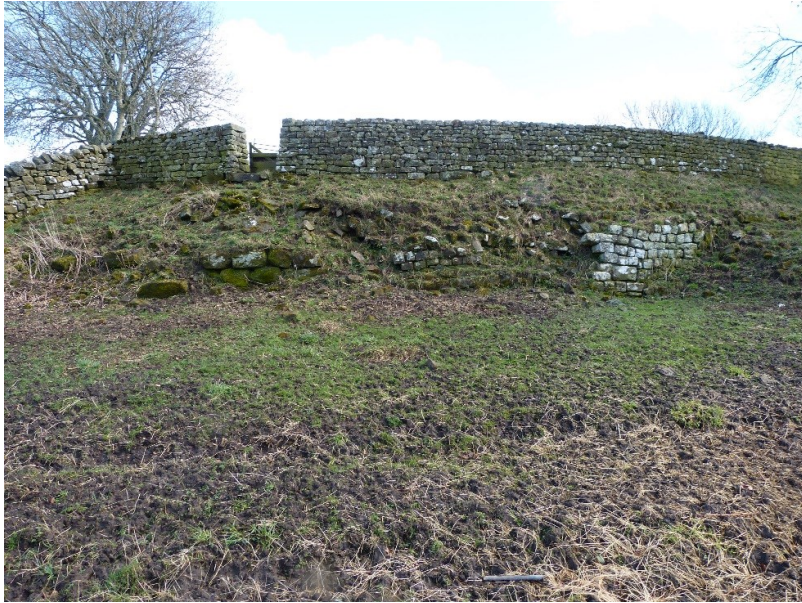
***Plate 5:*** The north-west angle of the fort with standing facework and exposed core below a modern dry-stone wall.
