Ridsdale Ironworks

CONSERVATION OF ENGINE HOUSE
AND PROVISION OF GATED ACCESS

ARCHAEOLOGICAL MONITORING
DURING SITE WORKS

January 2020

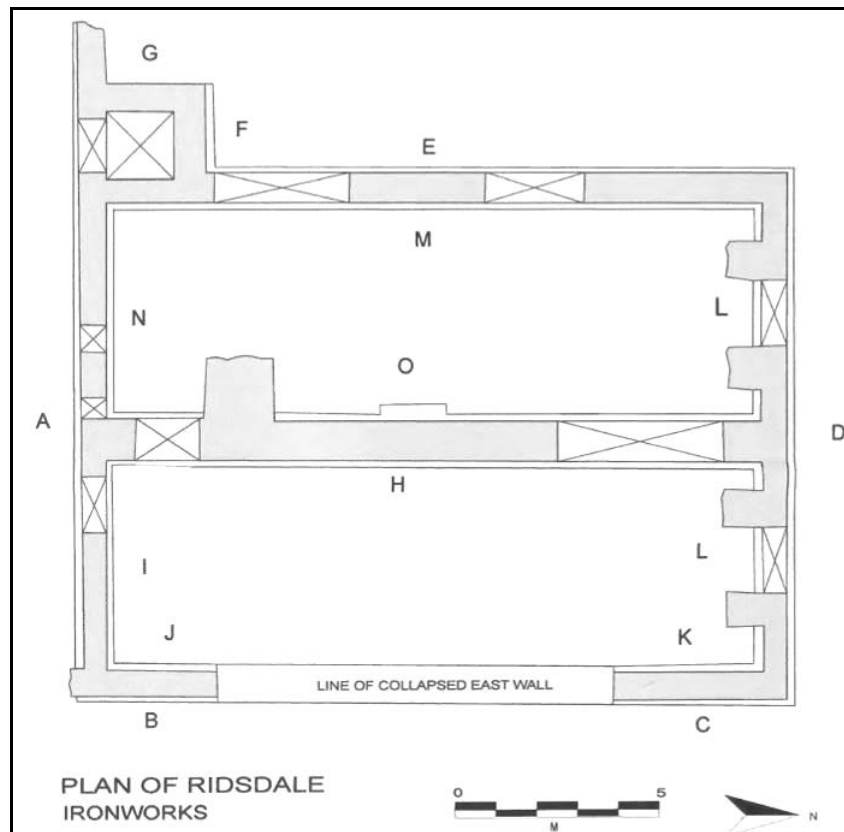
Figure 3: *Plan of the Engine House after Tylecote (1971). Elevations are each given a letter code used in this report.*

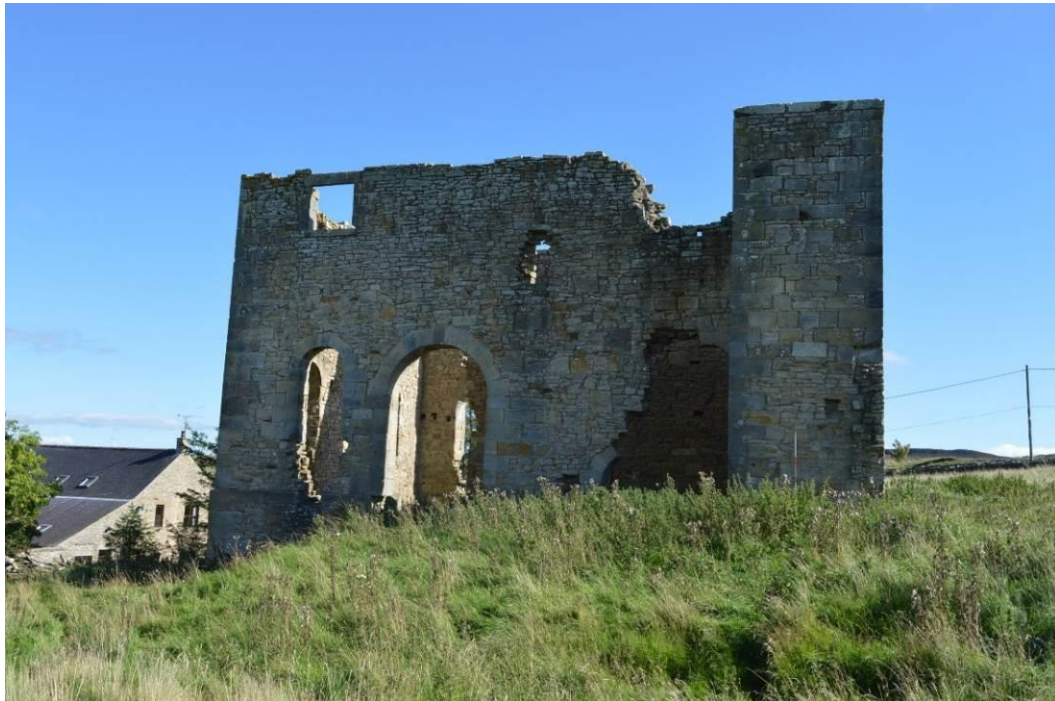
Plate 4: *The engine house from the west in 2017 showing the tumbled arches to the left of the chimney.*

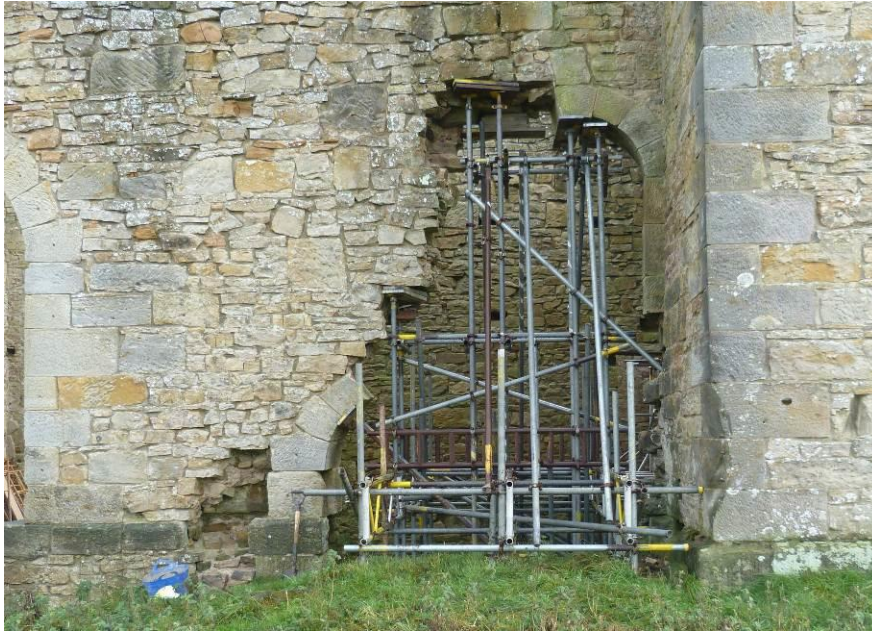
Plate 6: *The west wall of the Engine House in 2019. Looking east. Scaffolding has been added to support the surviving parts of the arches.*

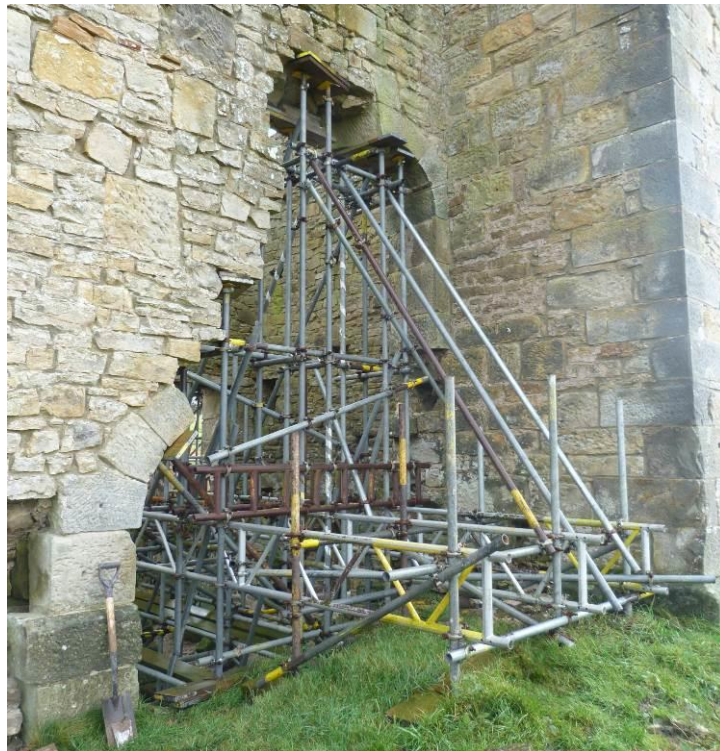
Plate 7: *West wall of the Engine House looking south-east at scaffolding supporting the tumbled arches.*

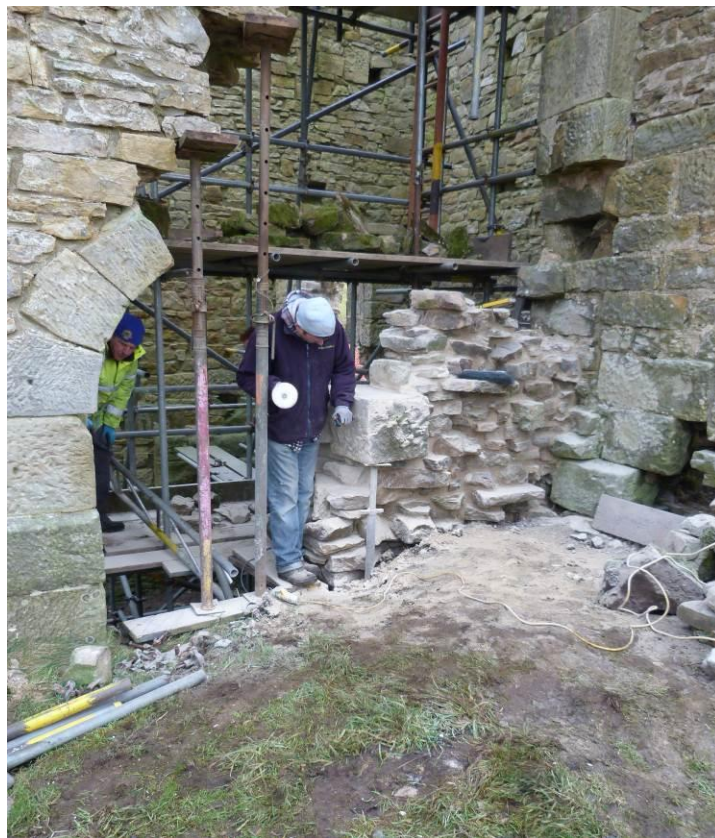
Plate 9: West wall of the Engine House looking south-east.
Working on masonry built up to the south of one of the arches.

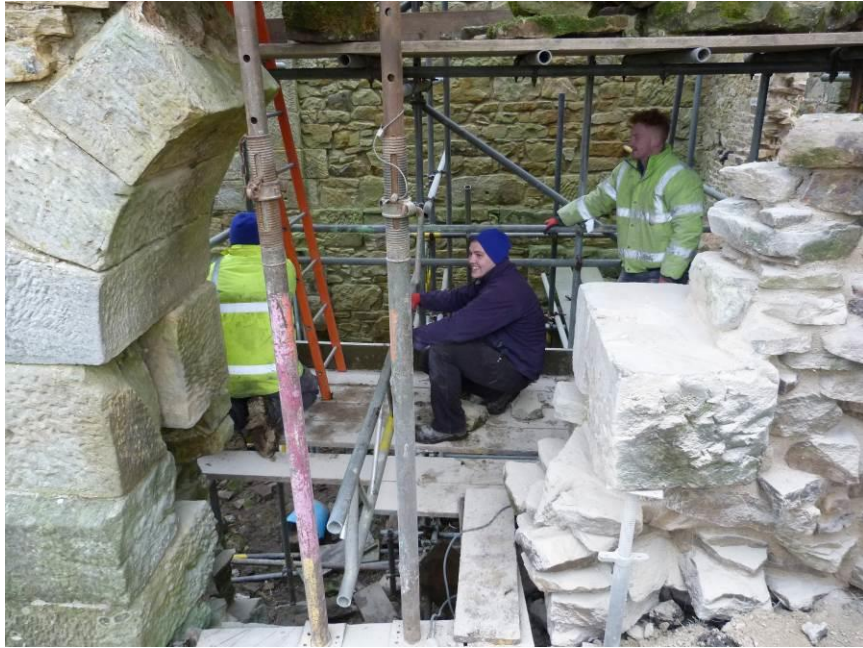
Plate 10: West wall of the Engine House, looking east.
Rebuilt masonry to right.

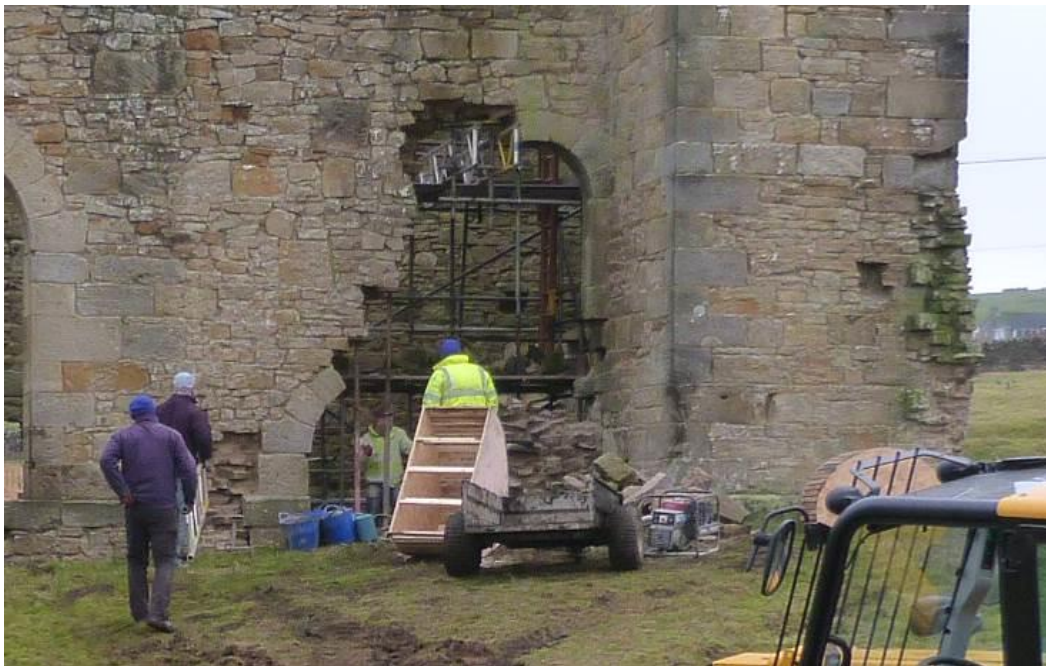
Plate 11: West face of the Engine House with timber centring being brought in to rebuild fallen arch.

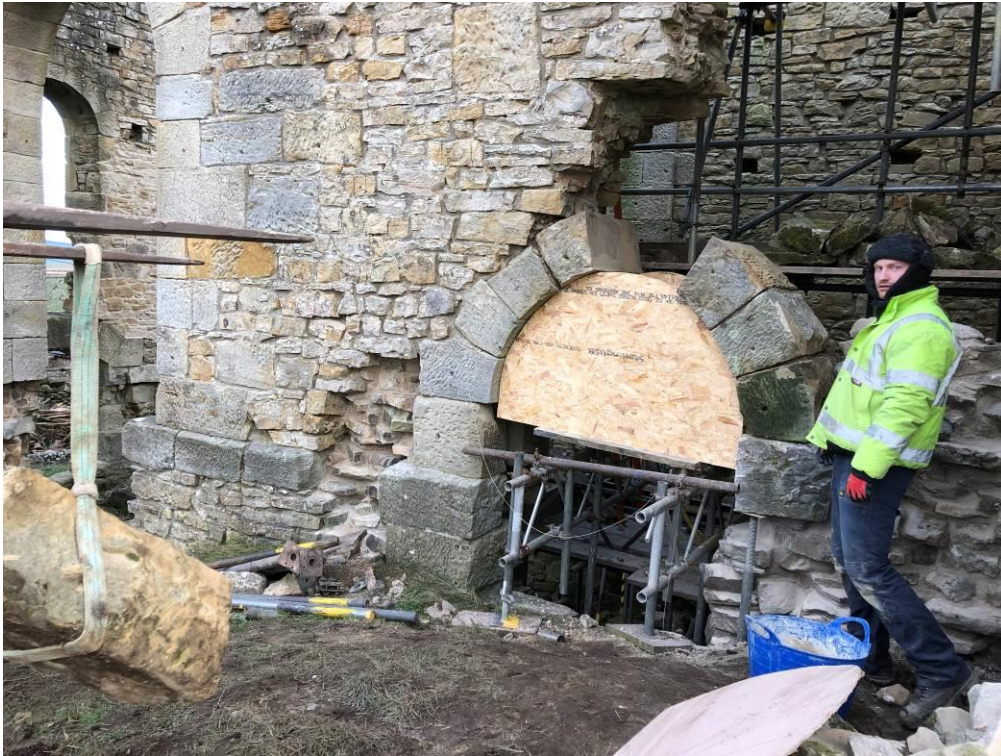
Plate 12: West face of Engine House. Centring in place, voussoirs going in.

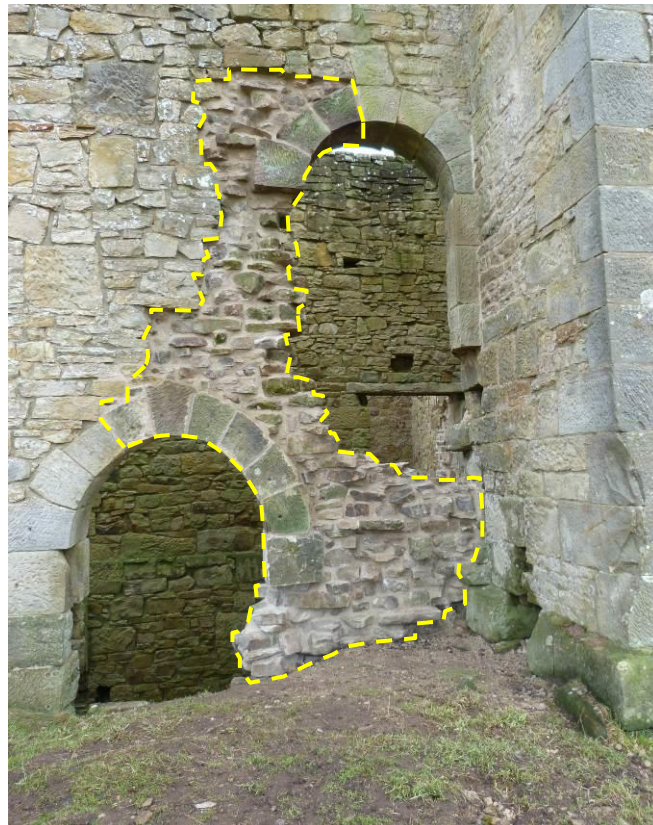
Plate 15: West face of the Engine House, both arches completed. Yellow broken line indicates rebuilt fabric.

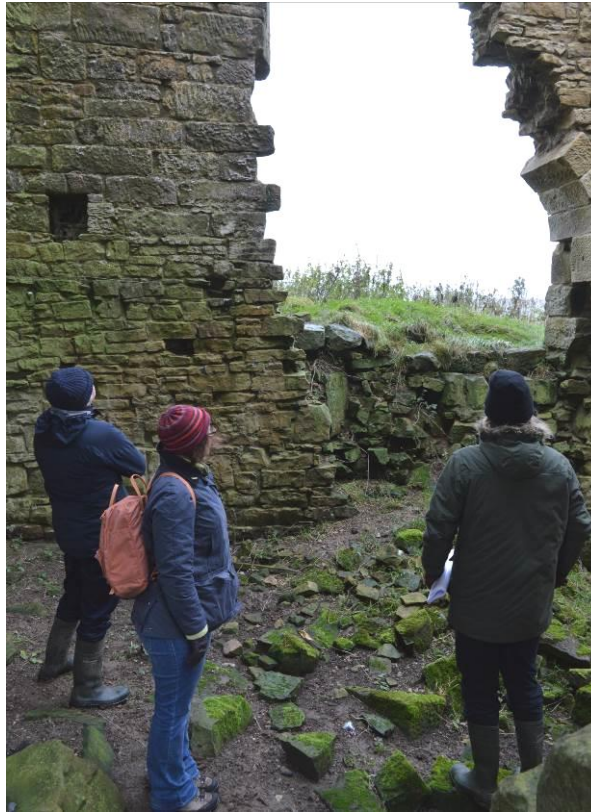
Plate 16: Inside the Engine House in 2017. Looking at tumbled arches in the west wall.

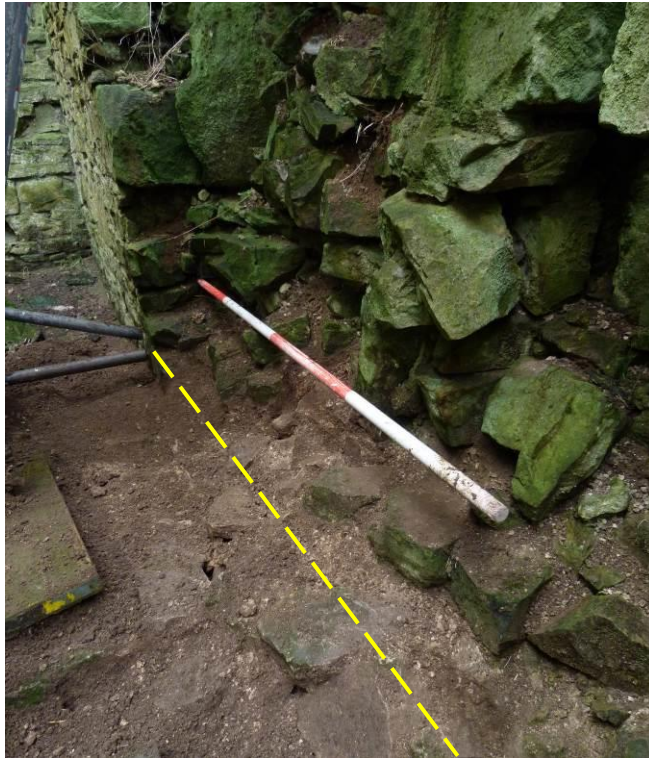
Plate 18: Inside the western half of the Engine House. The west wall following clearance of rubble down to solid core. Broken line shows line of wall face.

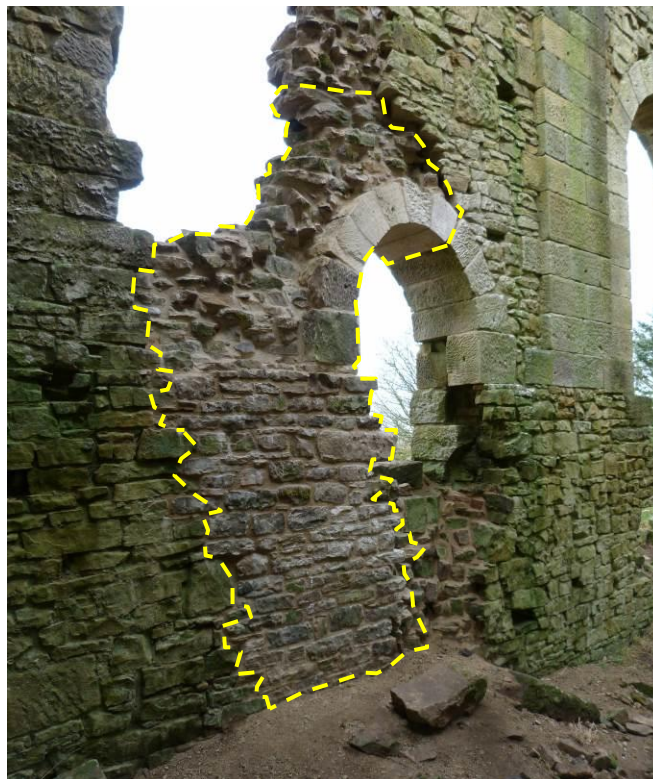
Plate 19: Inside the Engine House. Looking north-west at the west wall following insertion of new face and corework within the broken yellow line.

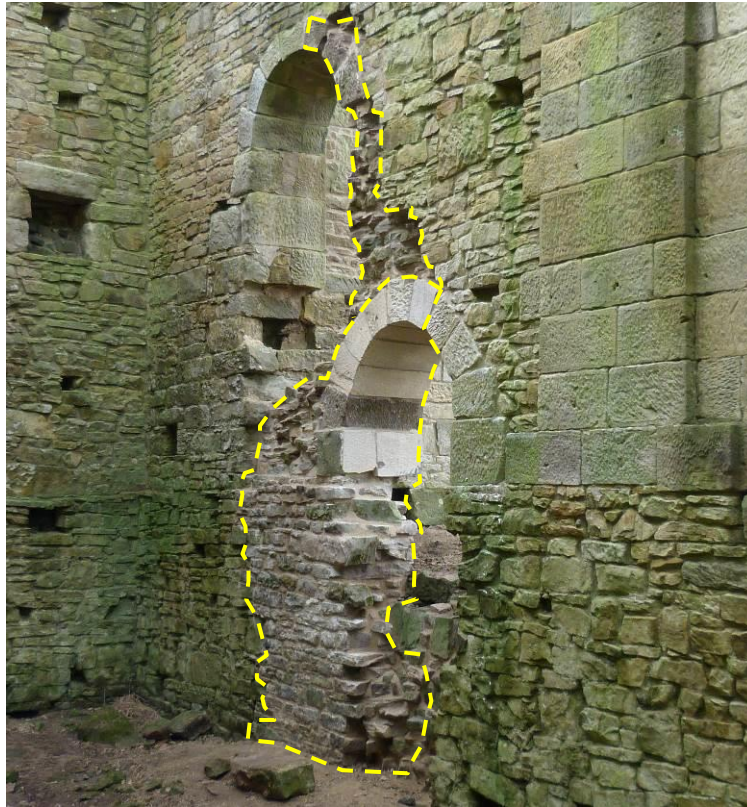
Plate 20: Inside the Engine House. Looking south at the west wall following insertion of new fabric within the broken yellow line.

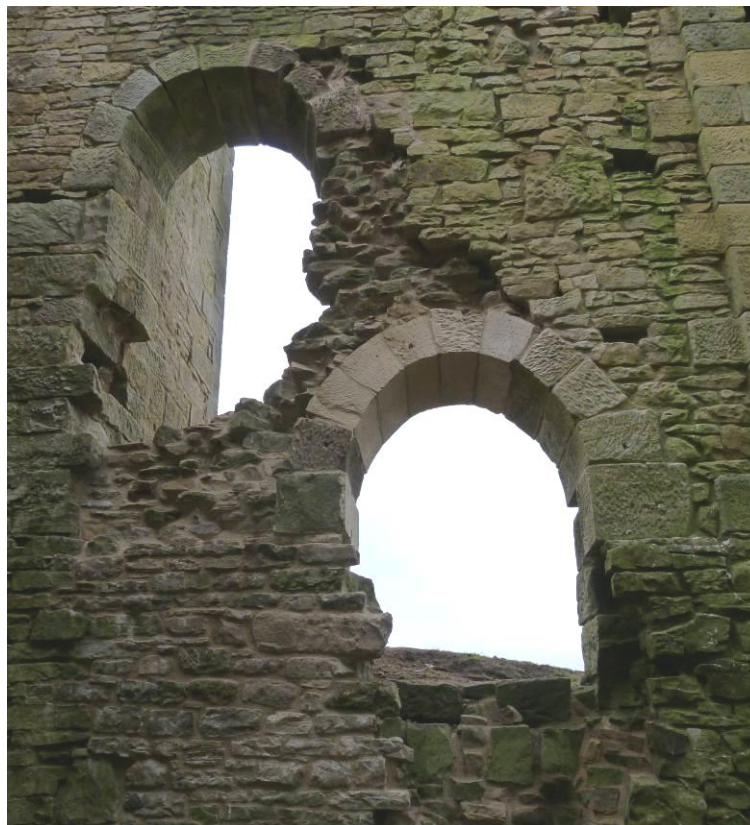
Plate 21: The rebuilt south end of the west wall. Looking west.

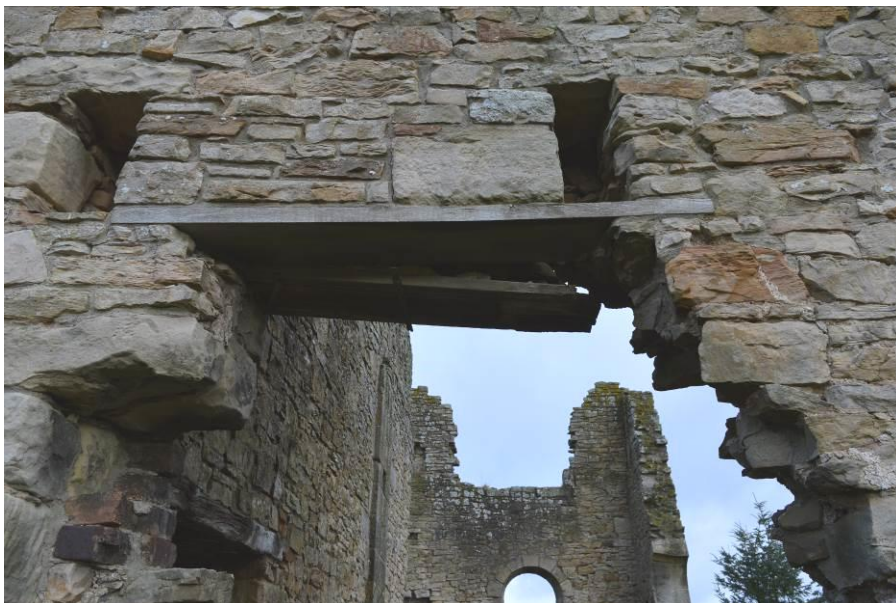
This tall opening in the south wall of the Engine House was in a very poor state prior to works commencing, the timber lintel of insufficient depth to serve its purpose and both east and west jambs tumbled and corbelling out to ground level. Scaffolding had already been placed under the lintel as a temporary measure. Works involved the replacement of the lintel with a more substantial timber of greater depth and the piecing in of both core and where necessary facework (this on the east side of the inner face), the extent of this shown on plates 31 and 32 to support the lintel at both ends. Work on the adjacent opening in the longitudinal wall involved piecing in limited core and facework. Monitoring on this work was intermittent.

Plate 26: Defective lintel in the south wall of the Engine House in 2017.

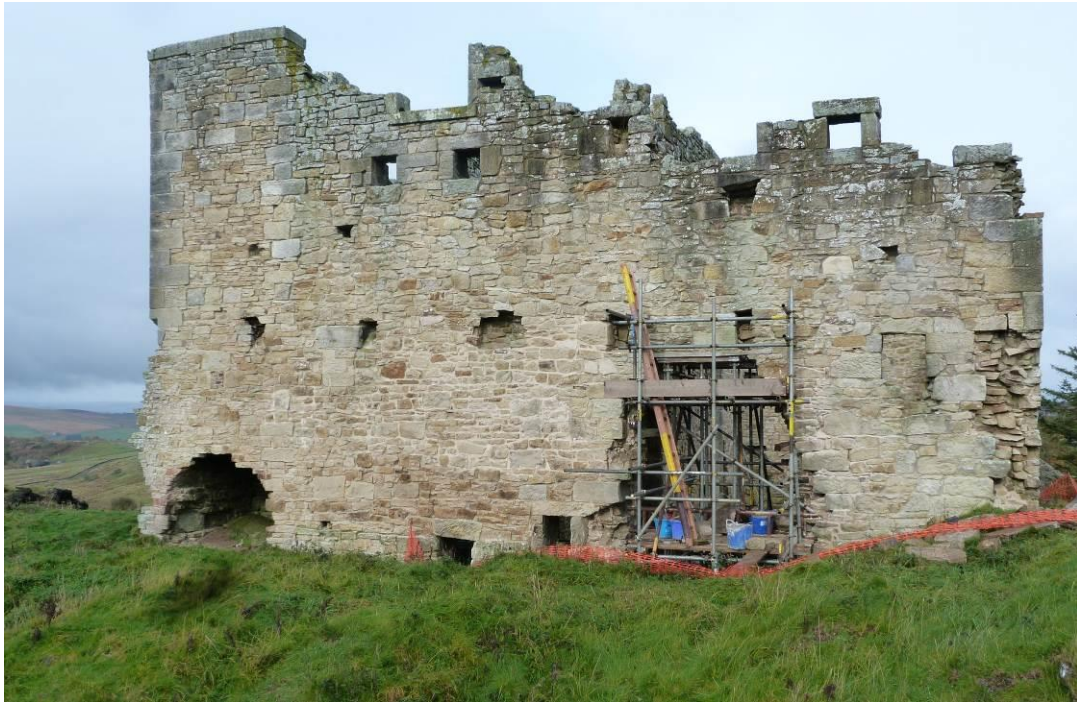
Plate 27: South wall of the Engine House. Scaffolding in place in 2018.

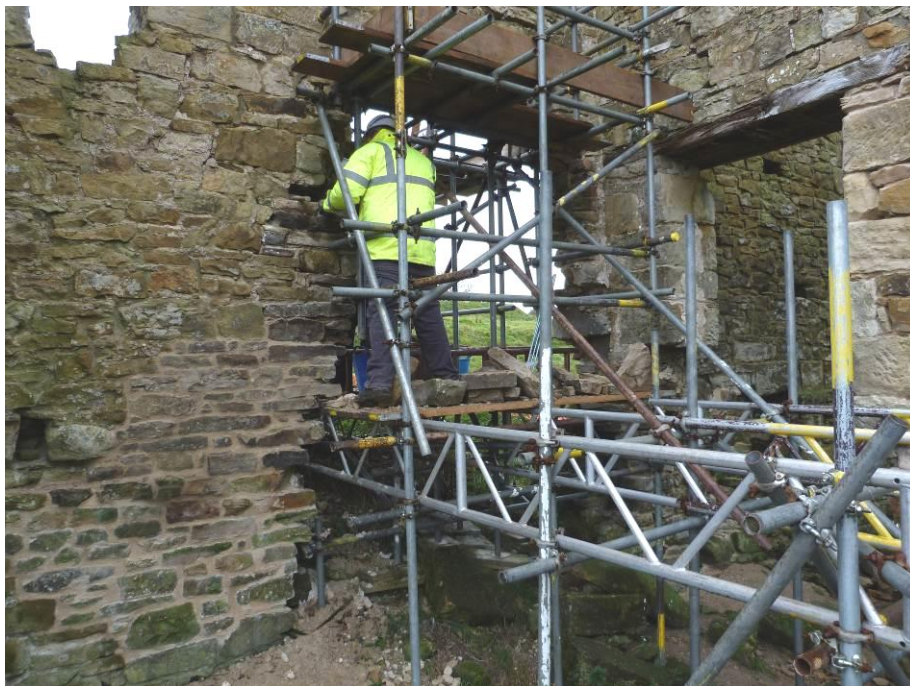
Plate 28: The opening in the south wall of the Engine House. Looking South-west during conservation works.

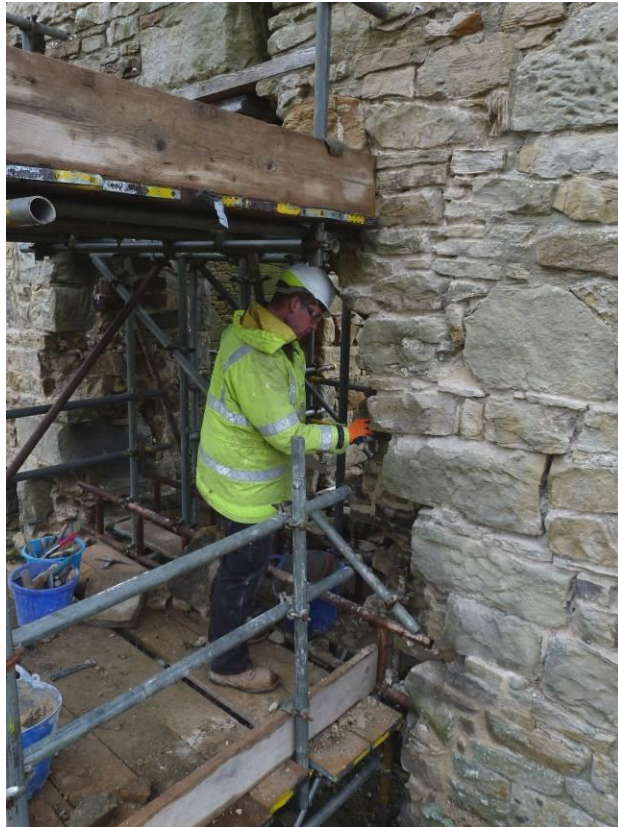
Plate 29: *The opening in the south wall of the Engine House. Looking north-west during conservation works.*

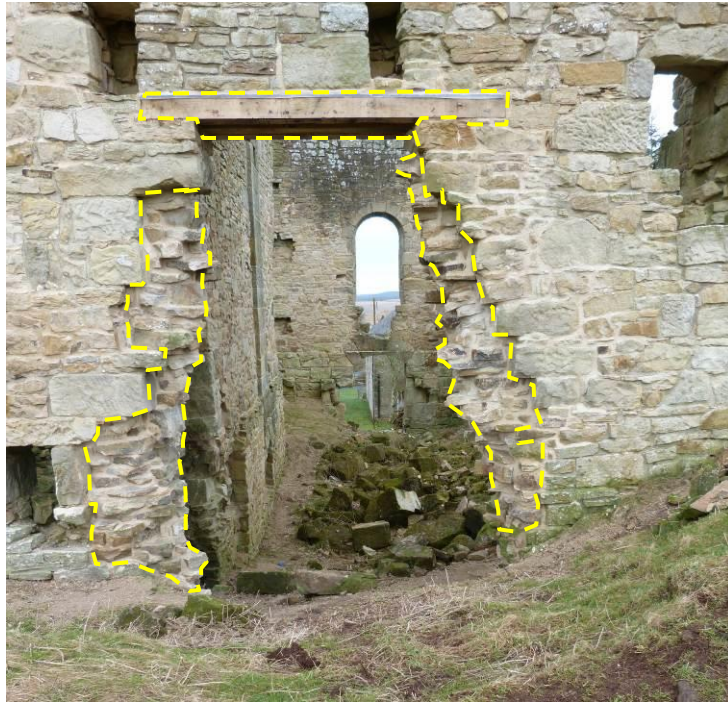
Plate 31: *Opening in the south wall of the Engine House in 2019. Looking north. Inserted work in broken yellow line.*

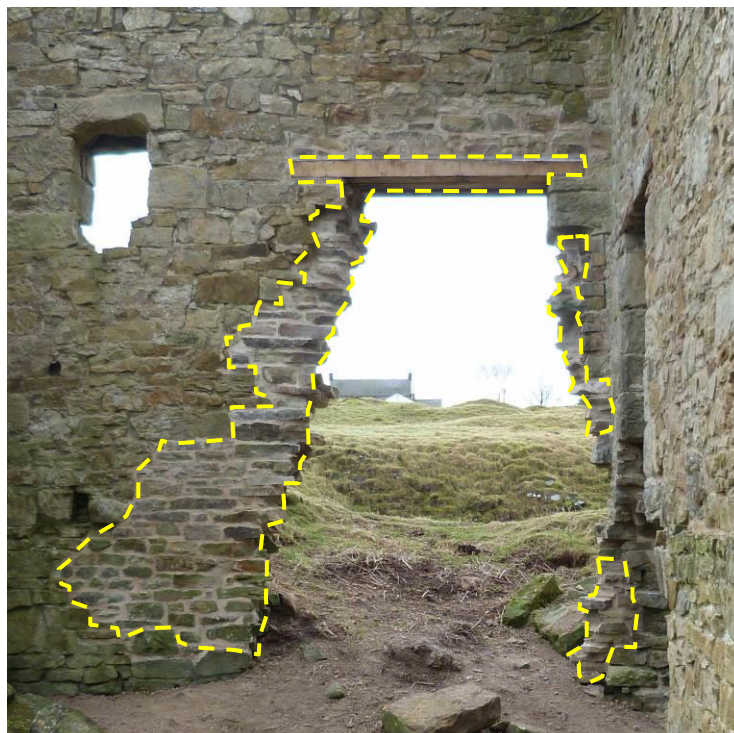
Plate 32: *Opening in the south wall of the Engine House in 2019. Looking south. Inserted work in broken yellow line.*

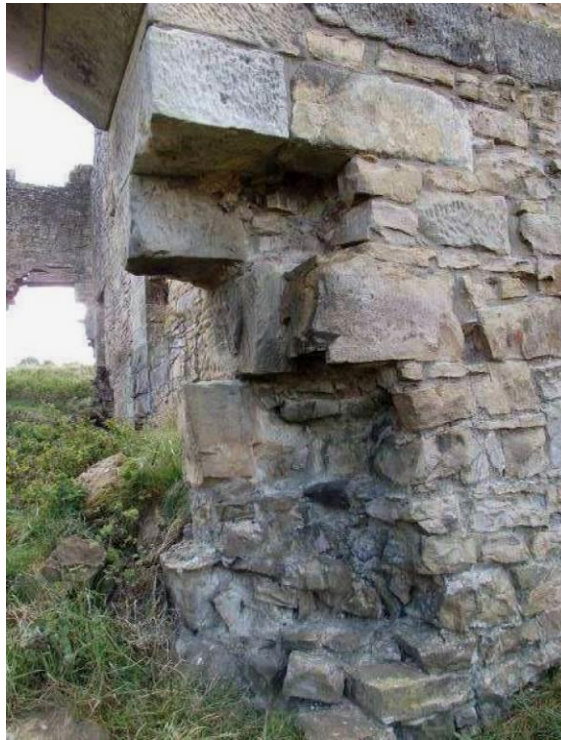
Other general work involved the raking out of defective joints and re-pointing, rough-raking of corework and minor replacement of corework at low and medium levels including work on the north wall (Elevation D plates 33 and 34) and using scaffolding if required. This work was monitored intermittently.

Plate 33: Cavities in the west jamb of east opening in the north wall of the engine house in 2017. Looking south.

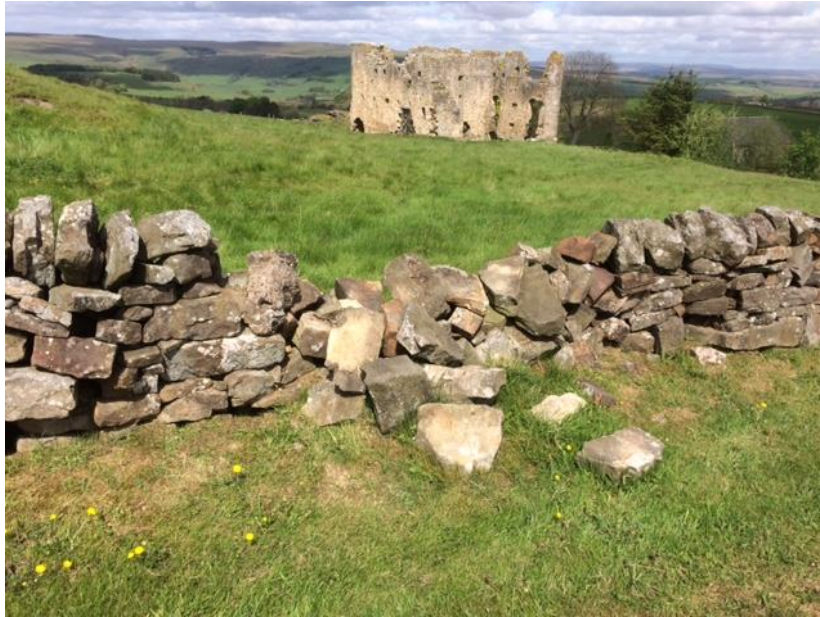
Plate 35: Ridsdale Ironworks 2017. Tumbled area of drystone wall along the A68, the location of the new gated access. Looking north-west (courtesy Lydia Speakman).

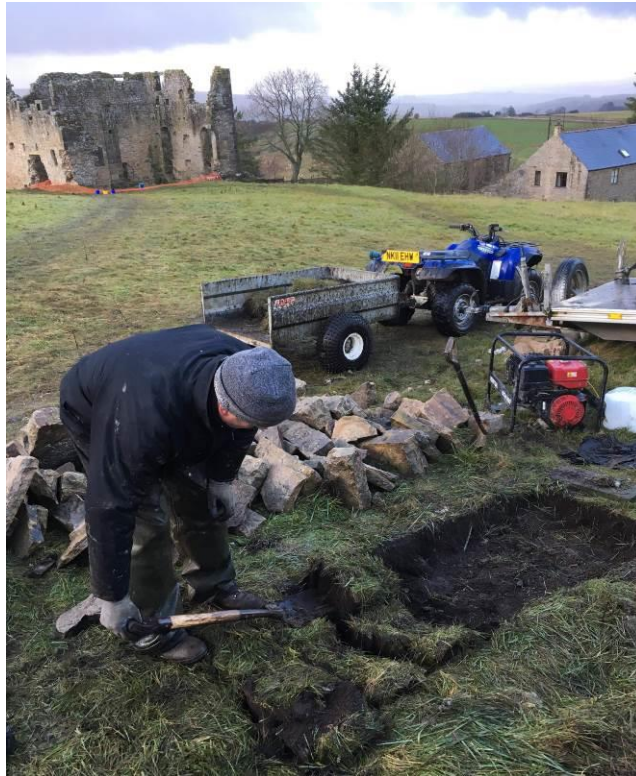
Plate 37: *Beginning de-turfing for the foundation Slot of the new wall. Looking north-west.*

As part of the project, works were carried out to allow access to the Engine House from the A68. A short section of drystone field wall to the east of the Engine House was dismantled and an entrance inserted. This involved the construction of a passage with a length of newly-built drystone wall and a wicket gate. The new stretch of wall was set above a very shallow foundation slot cut to 0.6m wide and c. 150mm deep. This was monitored but no features revealed or artefacts found during the work. Stone for the new wall was brought in to the site. Posts for the gate were driven into shallow foundation pits.

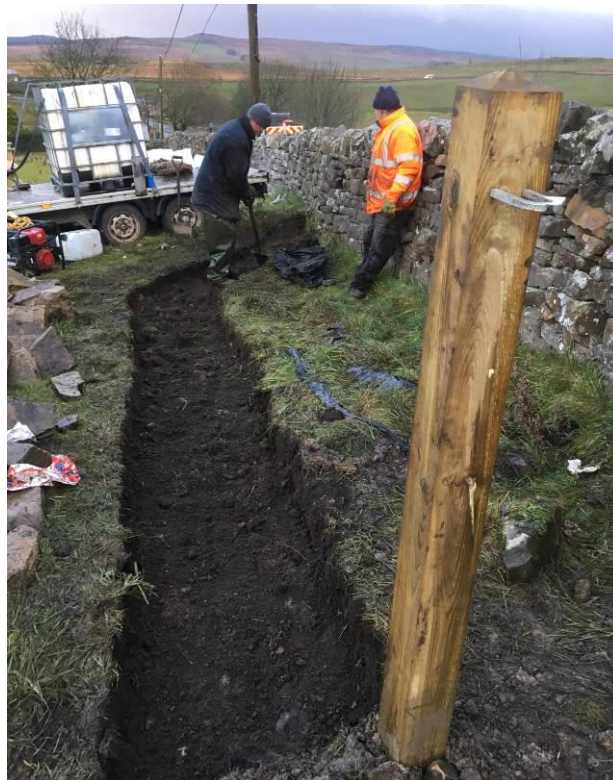
Plate 38: *The slot completed. Looking north.*

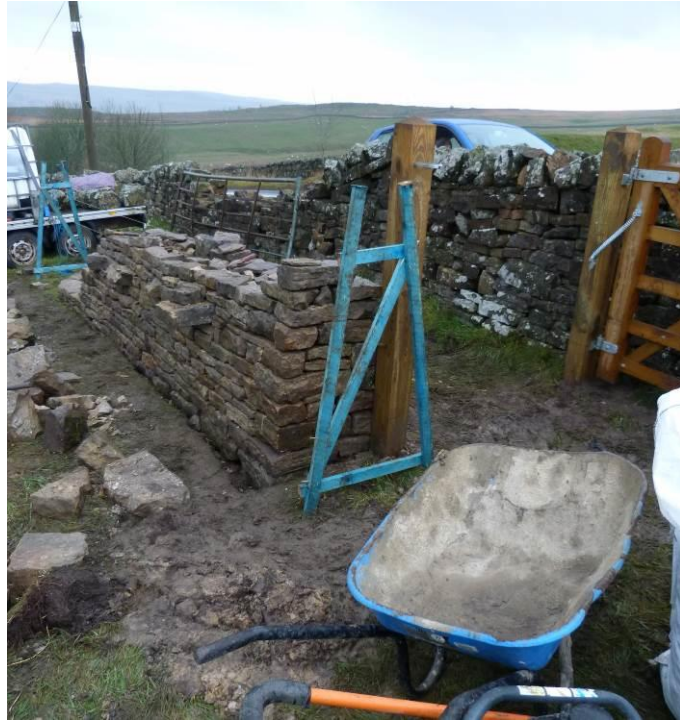
Plate 39: The new wall under construction; gate posts and gate in place. Looking north.

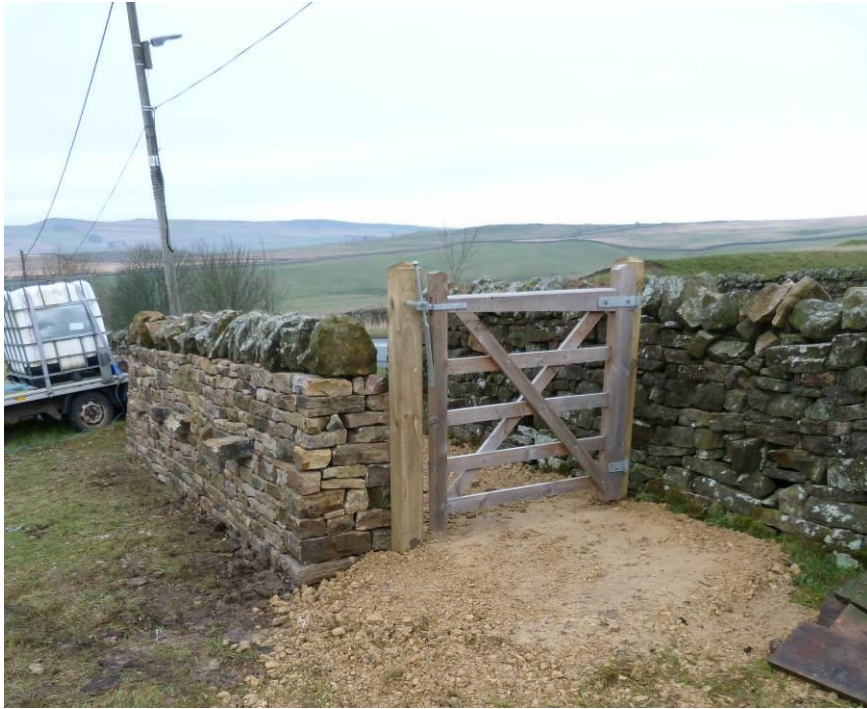
Plate 41: Entrance completed with crushed stone walkway.

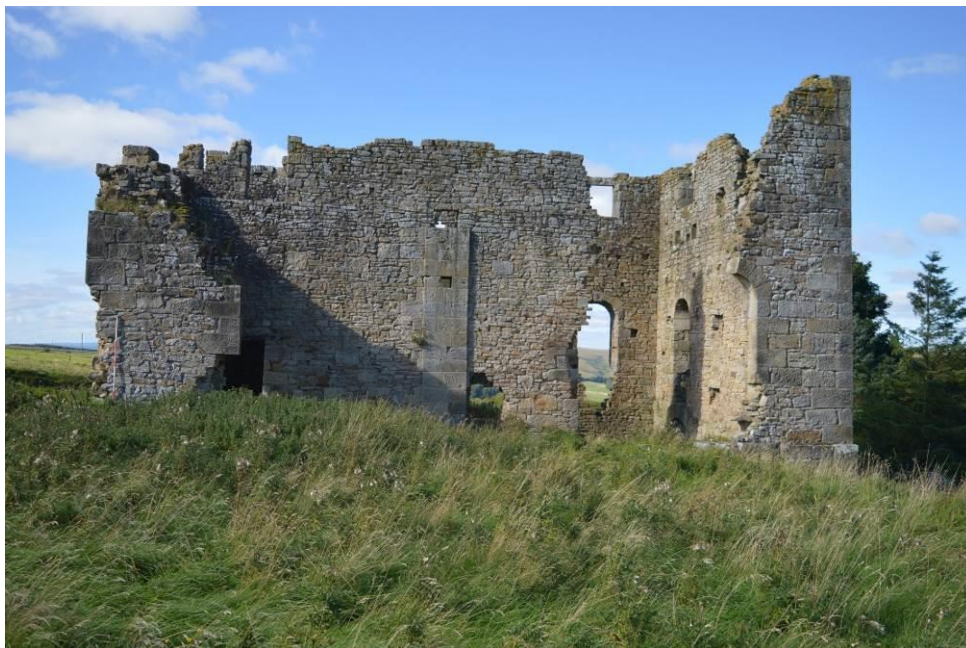
Plate 2: *The engine house from the east. Much of the east wall has fallen since the 1970s, exposing in this picture the central longitudinal wall.*
