**The Saggar-Making Shop and Drying House
at the former Sharpe's Pottery, Alexandra Road,
Swadlincote, Derbyshire (SK 29833 19507).
An Historic Building Survey**

ULAS Report No 2015-145

Planning application: **20132315**

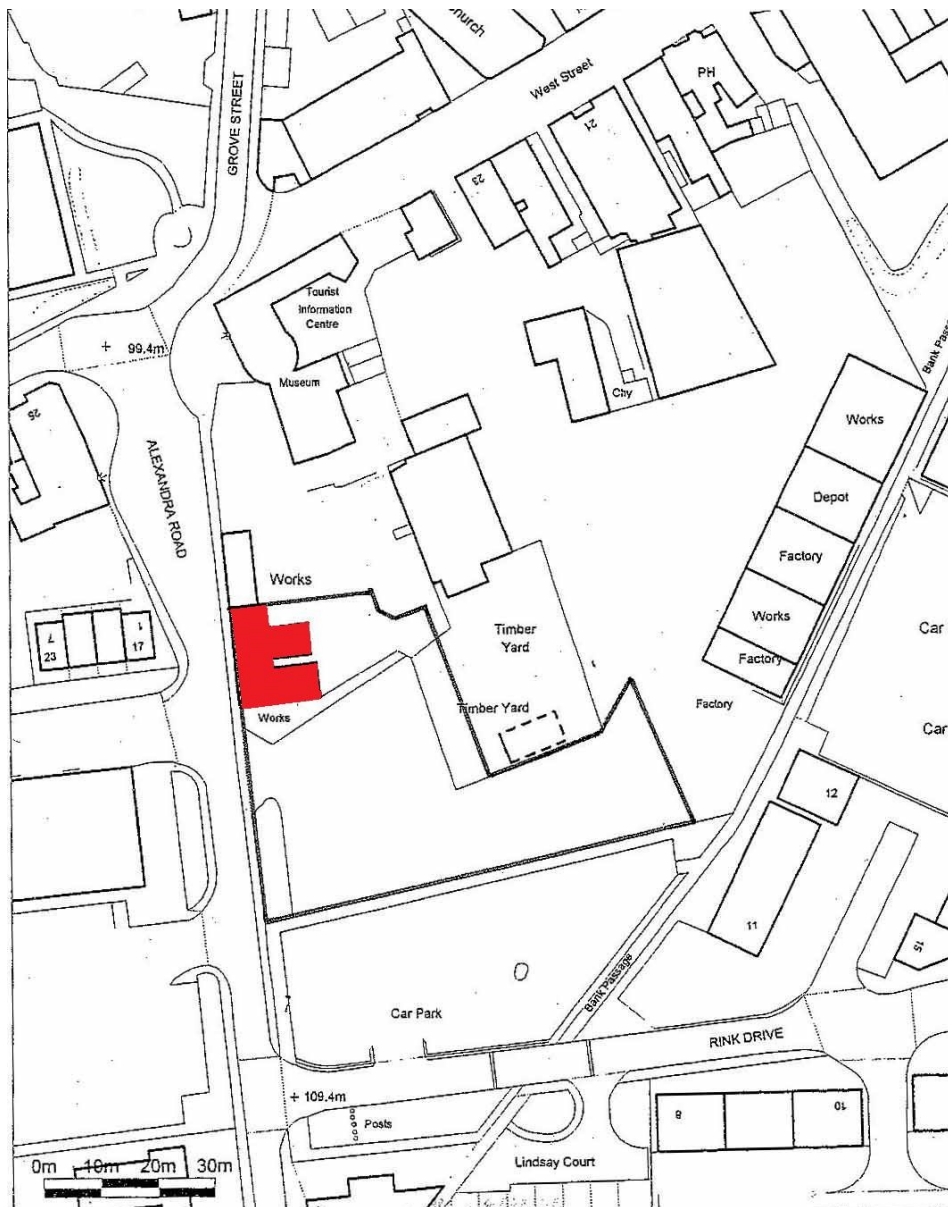
Figure 2. Location plan. The Saggar House and Drying Shed are highlighted in red.

The Saggar House and Drying Shed, with an attached Mess Room, stand on the west side of the works, beside Alexandra Road, attached to which on the north side is a later Moulding Shop (Fig. 2). The Saggar House, Drying Shed and Mess Room are surrounded by a former yard on the east and south sides, although in 2015 this has been obscured by the erection of modern fences.

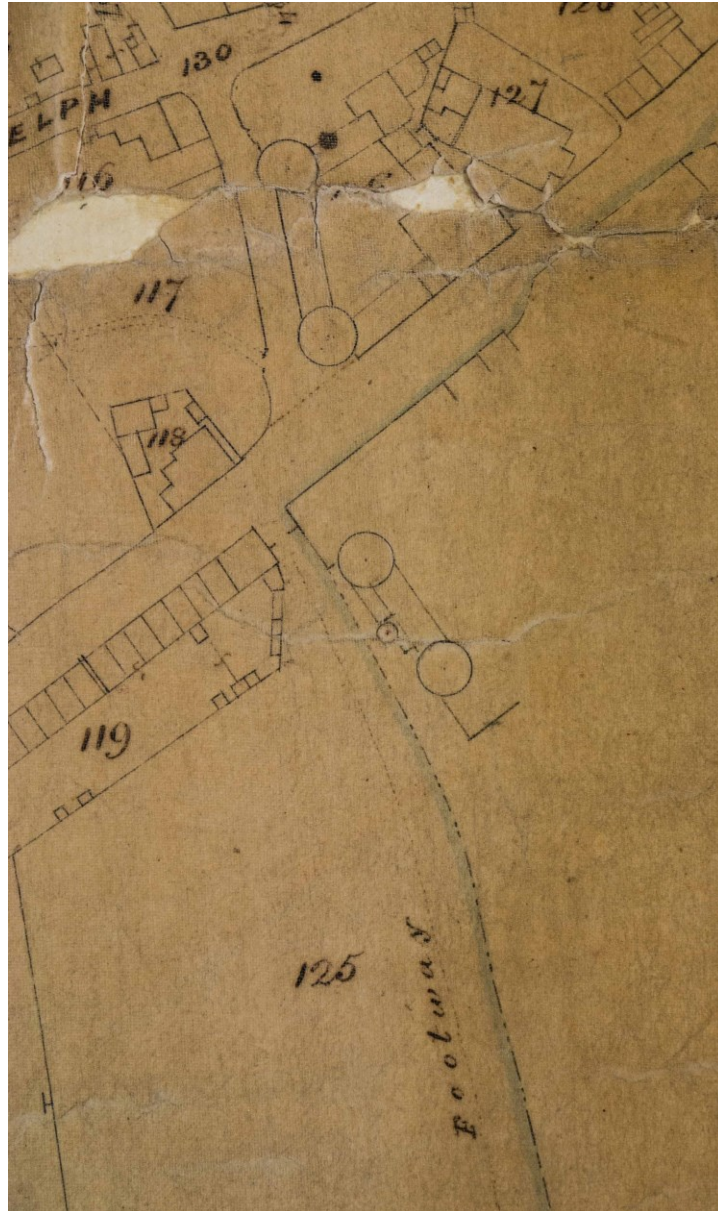
Figure 3. Sharpe's Pottery, as depicted on 'Township of Swadlincote in the parish of Church Gresley, 1856'. Not to scale. North is toward the top right-hand corner. Pottery buildings are shown on either side of West Street. The footway is what later became Alexandra Road. (Swadlincote Library M19)

A plan of Swadlincote surveyed in 1856 shows, perhaps, some of the early expansion into sanitary ware (Fig. 3). The pottery was built on West Street, which had been constructed in the early 19th century as the Moira & Gresley Turnpike Road, and occupied two self-contained sites with kilns, one on the north side and one on the south side of the road. The site on the south side of the road is where the Saggar House was later built. On the map the site is bounded to the west by a 'footway', which later became Alexandra Road. The boundary of the works is indicated by a dot-dash line.

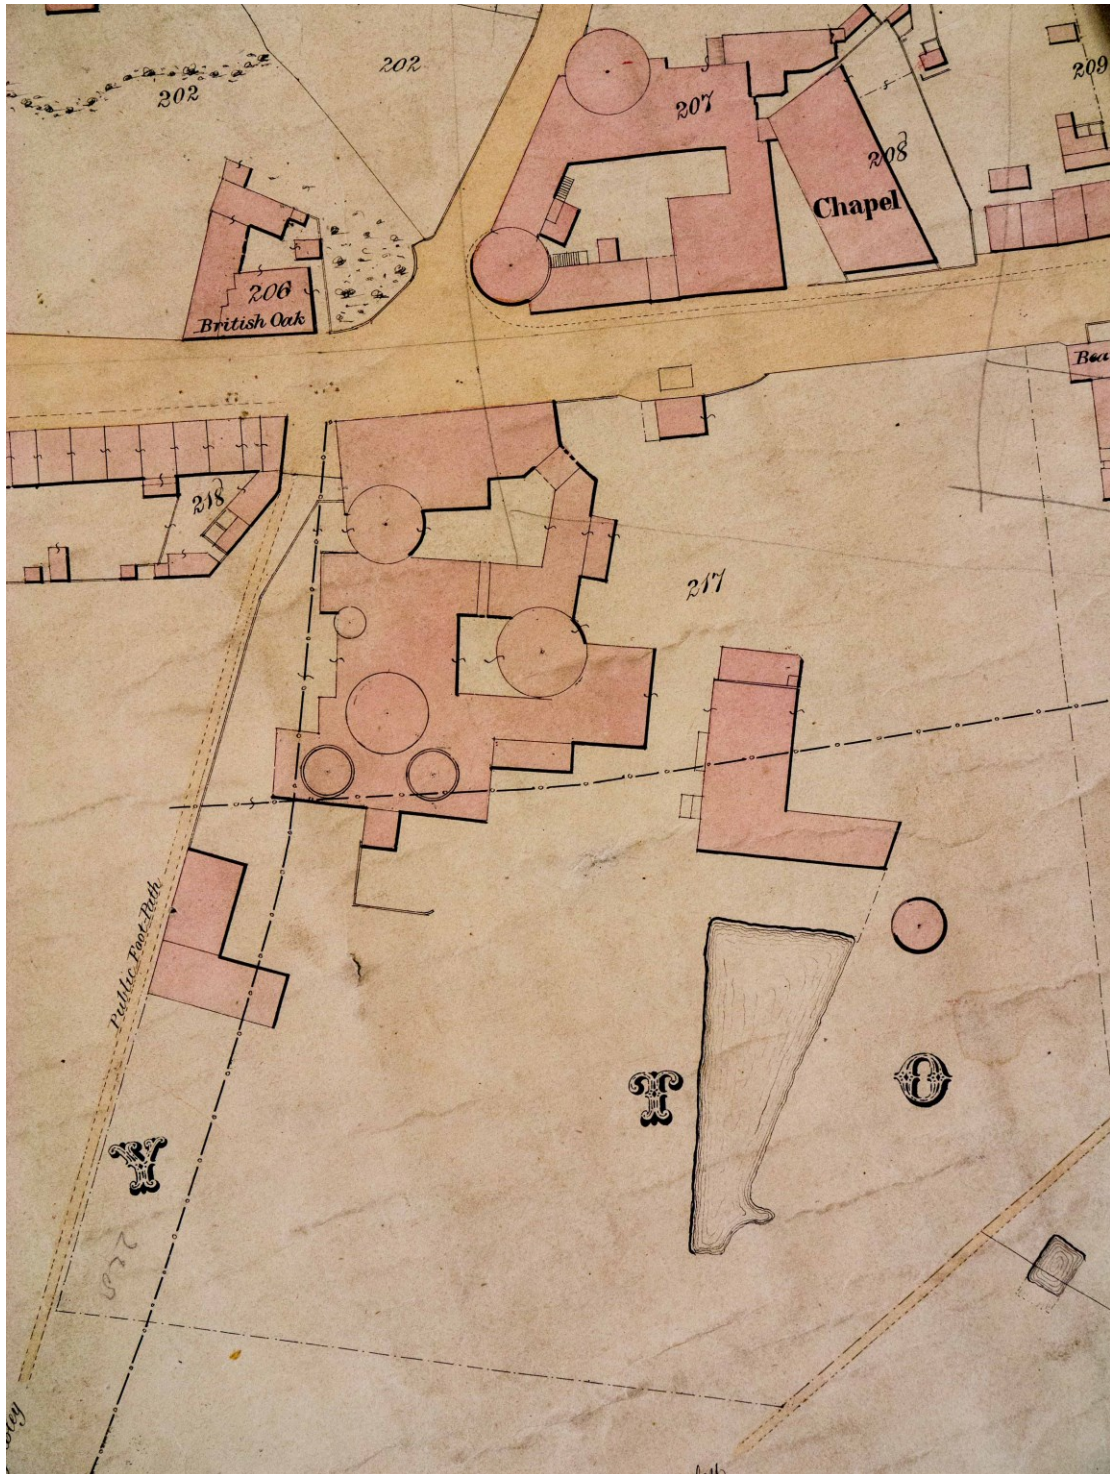
Figure 4. Sharpe's Pottery, as depicted on a map of 'Swadlincote Local Board District' in 1873. Not to scale. The map shows considerable expansion of the works since 1856. In the lower left of the picture are the L-plan Sagger House and Drying Shed, opposite the legend 'Public Foot Path'. Immediately north of the building is the solid line of a yard wall. The south and east boundaries of the works are shown as a dot-dash line, indicating that a boundary wall had not yet been built. (*Swadlincote Library M12*)

Further development of the works is apparent on a map published in 1873 for the newly formed local Board of Health (Fig. 4). The boundary from the 1856 map is also shown as a dot-dash line on the 1873 map. Outside of this line it shows the Saggar House and Drying Shed as an L-plan block beside a public footpath. The map shows two ranges, one oriented east-west, and the other north-south in-line with the works boundary. The boundary to the north of these buildings is marked as a solid line, representing a boundary wall enclosing a yard. On the south side of the block of buildings this line is not continued, suggesting that the boundary wall extended to the Saggar House only. A faint line, however, marks the remainder of the west and also the south and east boundary of the works.

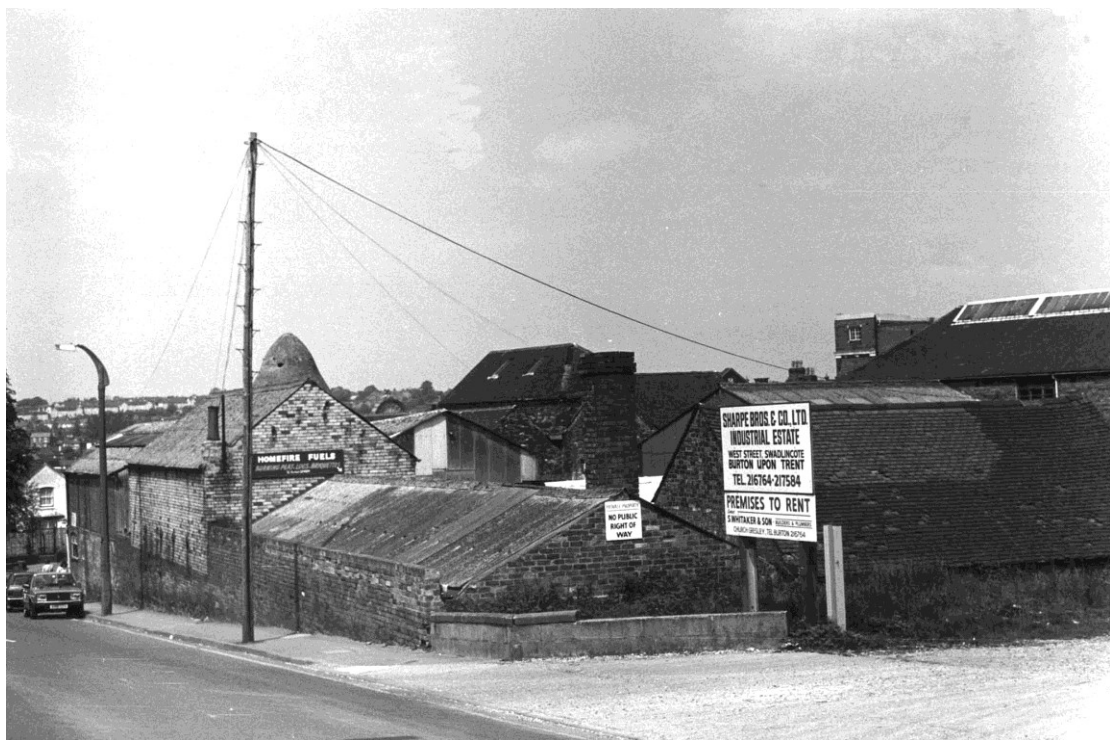
Figure 9. A photograph looking north from Alexandra Road, with the Drying Shed in the foreground and Saggar House to its right, taken probably in the 1970s. Sharpe's Pottery was closed by this time and the site was an industrial estate. The Moulding Shop, and probably also the Drying Shed and Saggar House, were let to Homefire Fuels at this time. The boundary wall uphill from the Drying Shed had been taken down to create a new entrance to the industrial estate. However the tall internal stack in the Drying Shed remained standing.

Sharpe's Pottery closed in 1968, after which the site became an industrial estate and a new entrance was made from Alexandra Road by taking down the boundary wall beyond the Drying Shed. At some period in the late 1960s or 1970s the Moulding Shop, and probably the Saggar House and Drying Shed, were let to Homefire Fuels, selling domestic solid fuels (Fig. 9). Although the Moulding Shop remains in light-industrial use the Saggar House and Drying Shed were disused by 2014 (Fig. 10).

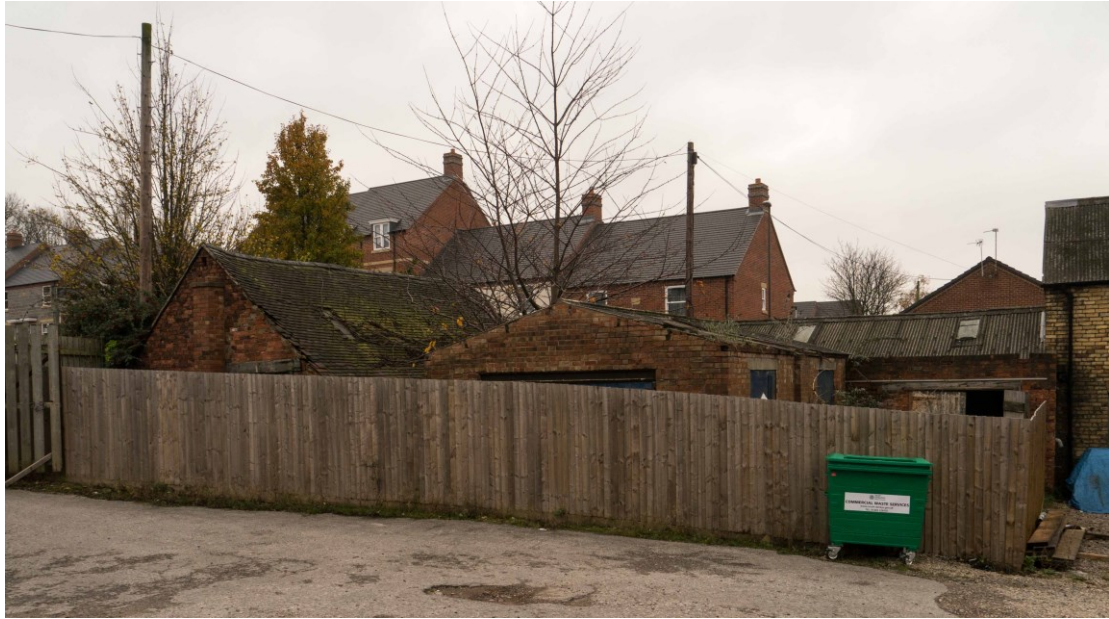
Figure 10. The Saggar House as it appeared, disused, in 2014.

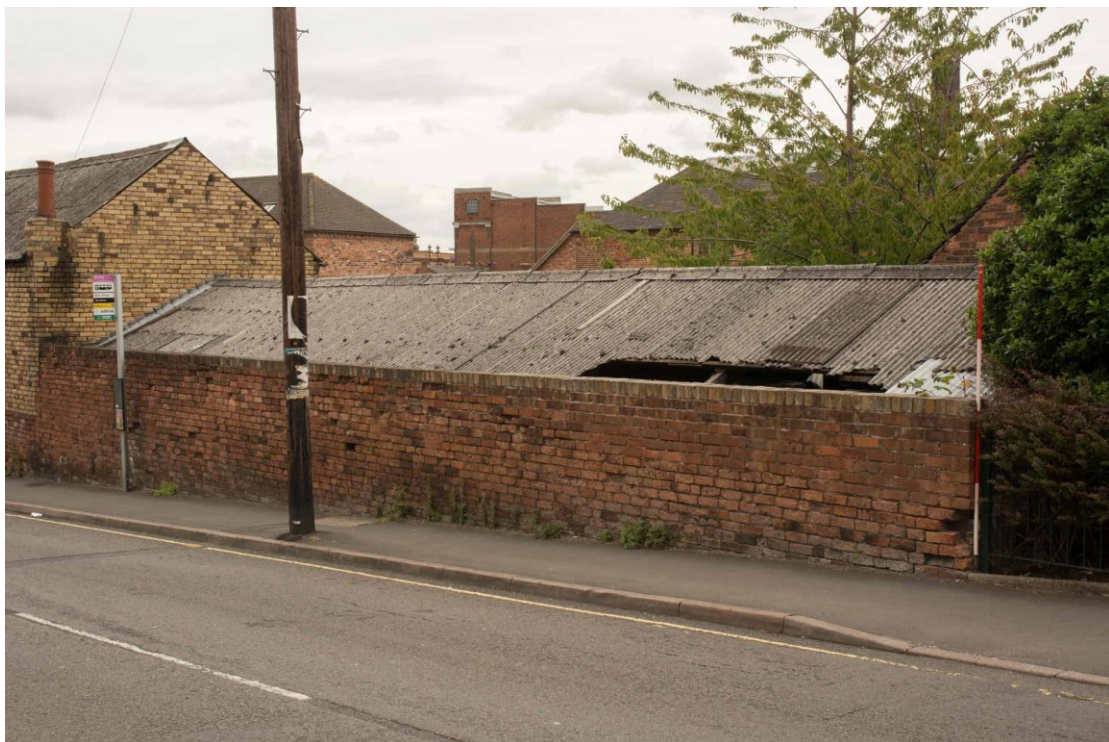
Figure 11. The Drying Shed, viewed looking north west on Alexandra Road.

The Saggar House and Drying Shed stand at the south-west corner of the block of buildings at Sharpe's Pottery and integral with the boundary wall along Alexandra Road (Fig. 11). On its north side the building is attached to a taller Moulding Shop,

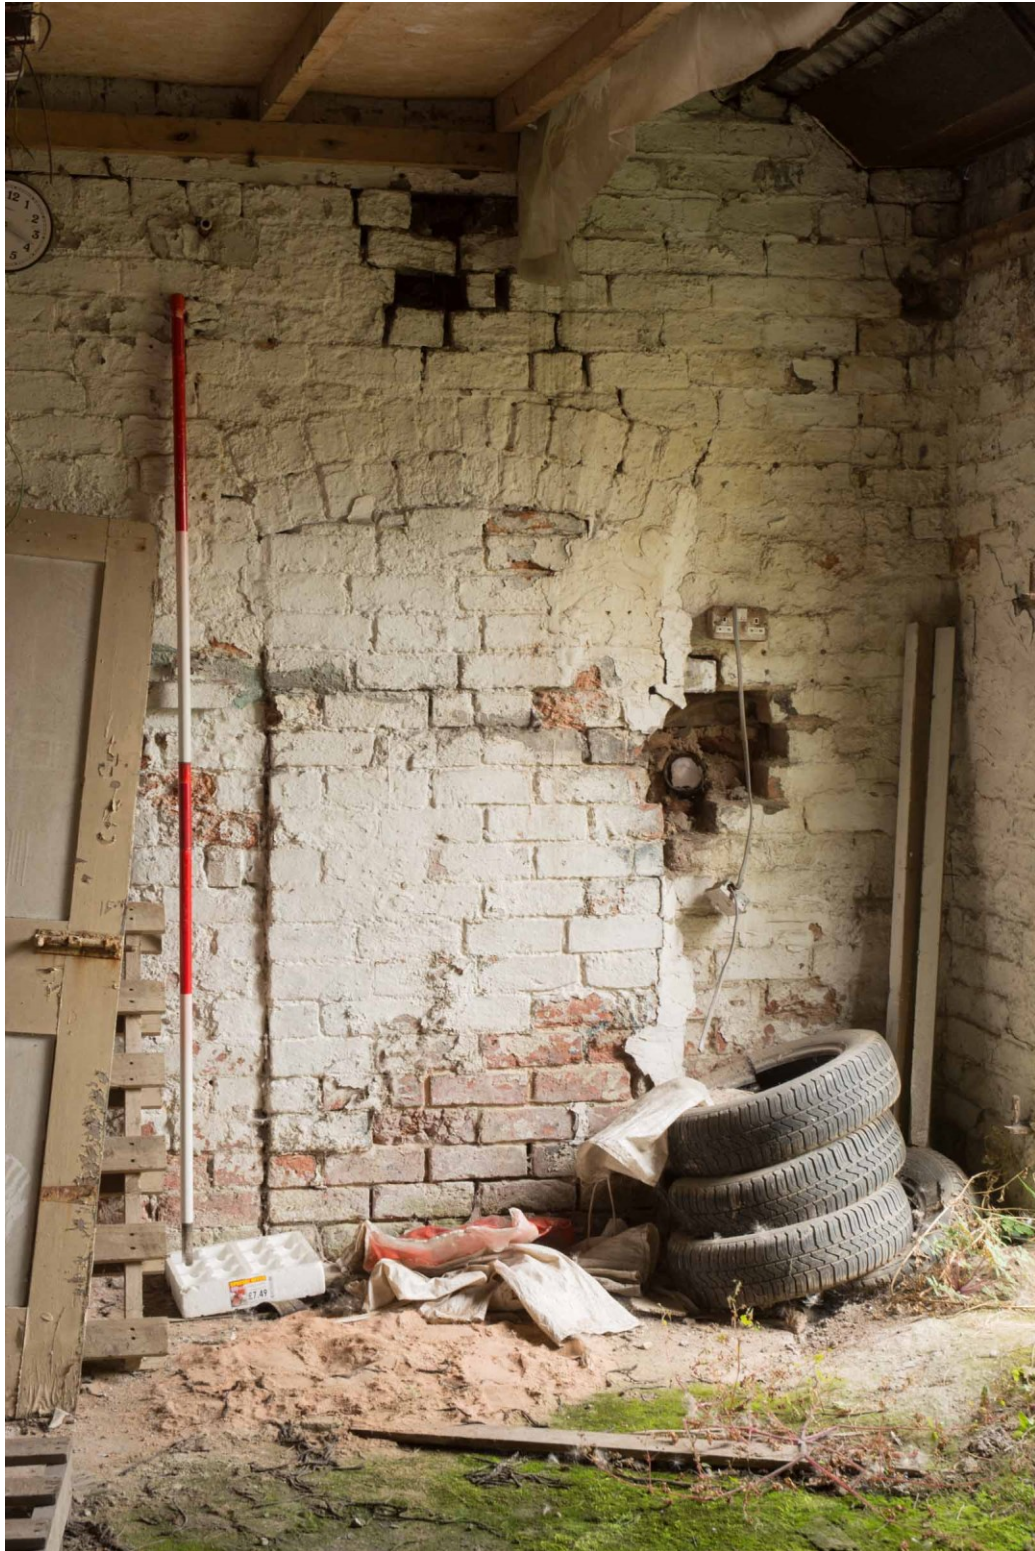
Figure 12. Blocked original doorway in the north gable end of the Drying Shed.

At the end of the 19th century the Moulding Shop was added, built partly on top of the drying-house gable end, and on to the existing boundary wall. The infill of the original Drying Shed doorway uses the same bricks as were used for the Moulding Shop.

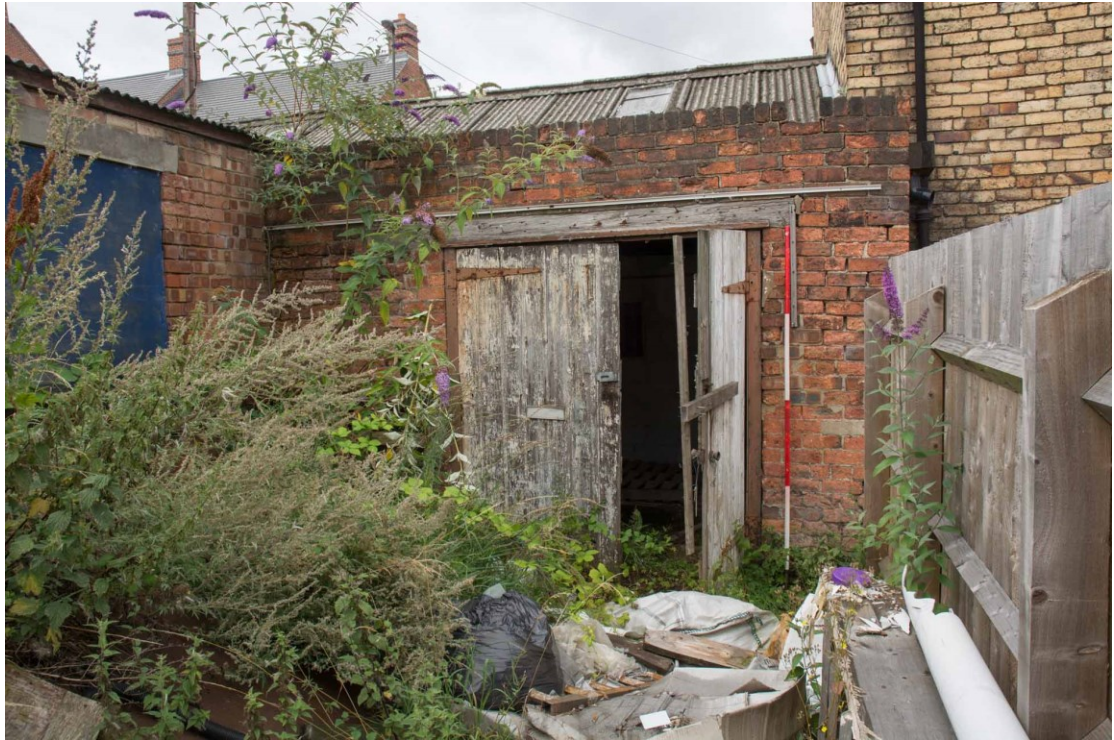
Figure 13. The Drying Shed entrance, looking west.

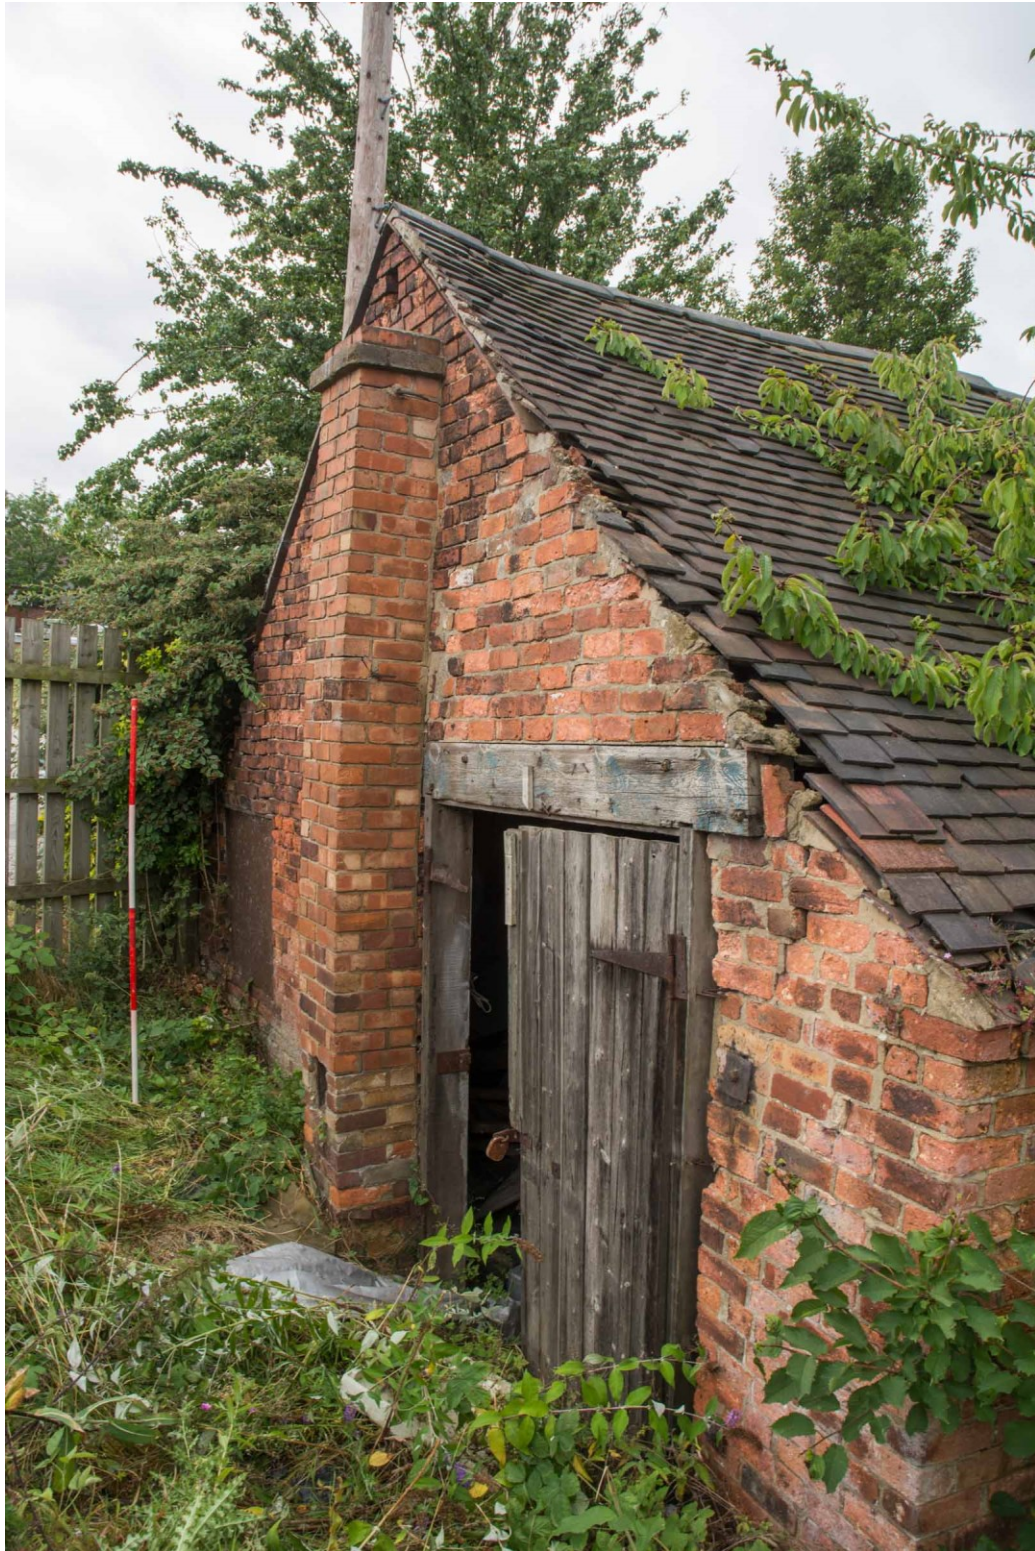
Figure 14. The Sagar House, looking south-west from the yard.

The Saggar House also underwent modifications. The doorway in the east gable end is not original, but was probably an enlargement of the original. Its lintel is too big as it extends to the verge, above which there is replacement brickwork in cement mortar. The window in the left side of this elevation is also an insertion. Of the two windows in the north wall, the larger is original, whereas the smaller blocked window is secondary.

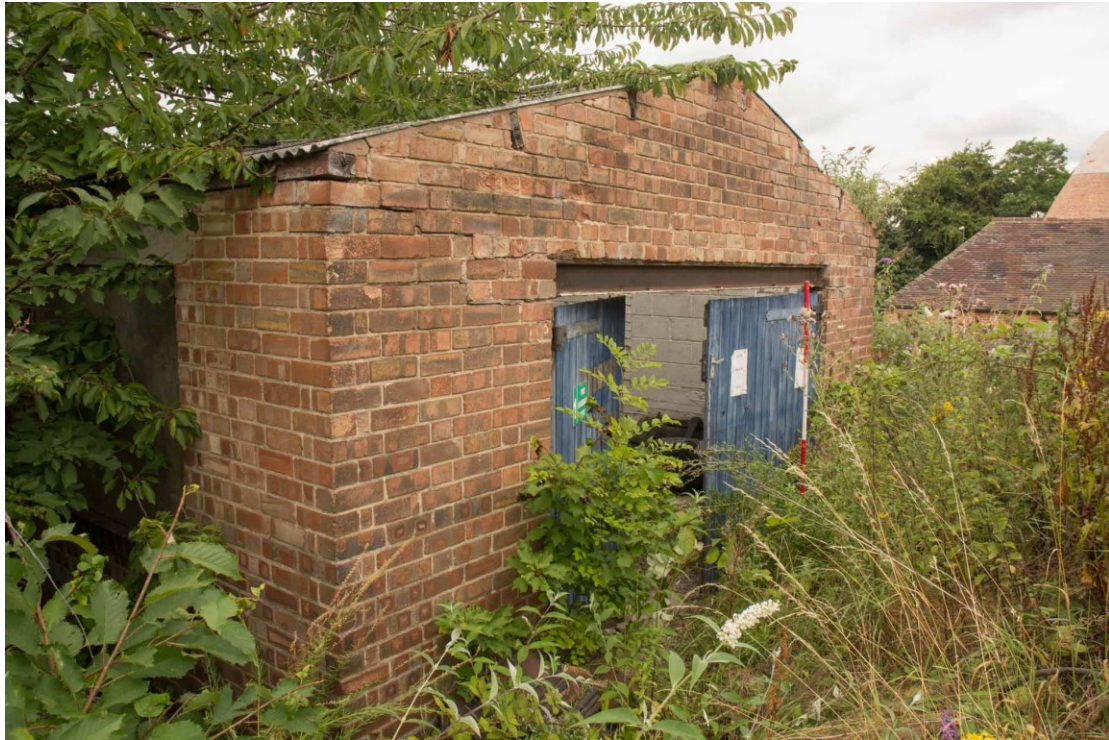
Figure 15. The Mess Room, looking north-west.

The Mess Room has a wide gable-end doorway under a steel I-section lintel, comprising double boarded doors (Fig. 15). The side walls each have two windows under concrete lintels, but all of them are infilled with blockwork.

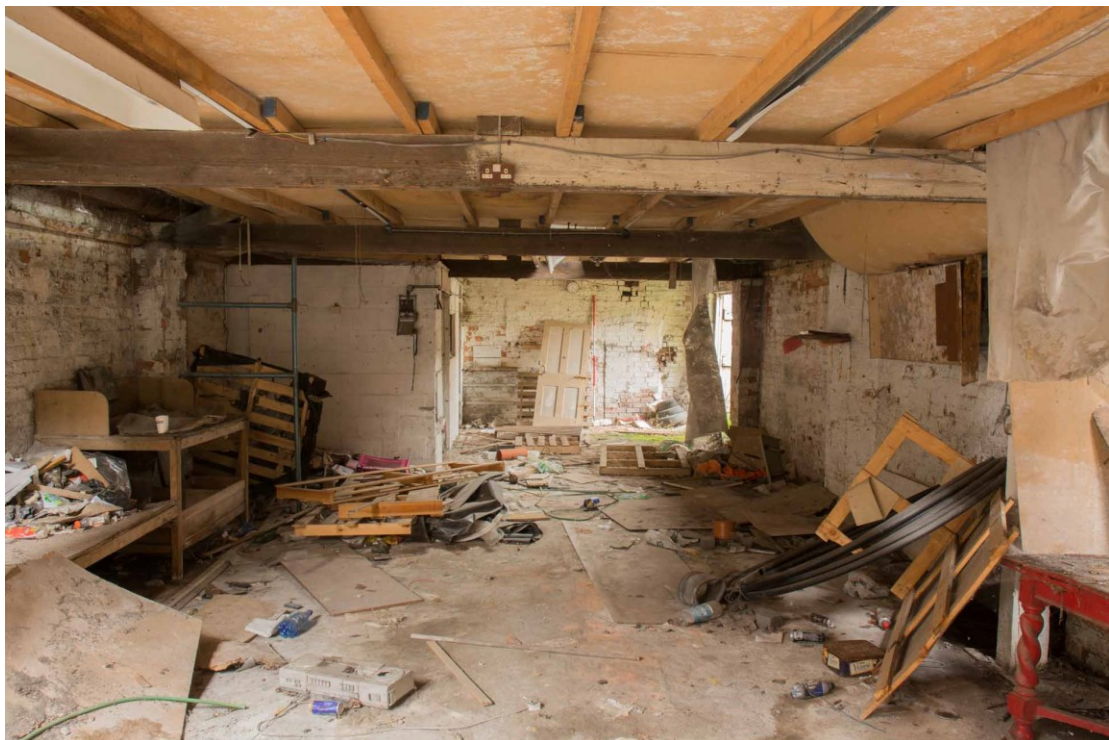
Figure 16. The interior of the Drying Shed, looking north. The blockwork partition is at the back on the left.

The interiors all have concrete floors and brick walls painted white. In the drying room is a five bay roof of machine-sawn king-post trusses (Fig 16). They are carried on wall shafts that appear to have been added separately and were not integral with the original construction of the building (Fig. 17). In the south gable end is a brick corbel similar to those in the Saggar House, which shows that the roof here was oriented at right angles to the present arrangement and was continuous with the surviving roof of the Saggar House (Fig. 18). Above the trusses a plasterboard ceiling was inserted, which was partially rotten at the time of survey. In the north-west corner of the room a two-room office was created by building blockwork partition walls (with doorways removed by the time of survey). Inside the office a door was cut into the north gable end, giving access between the Drying Shed and the Moulding Shop. This doorway, under a wooden lintel, is infilled with blockwork.

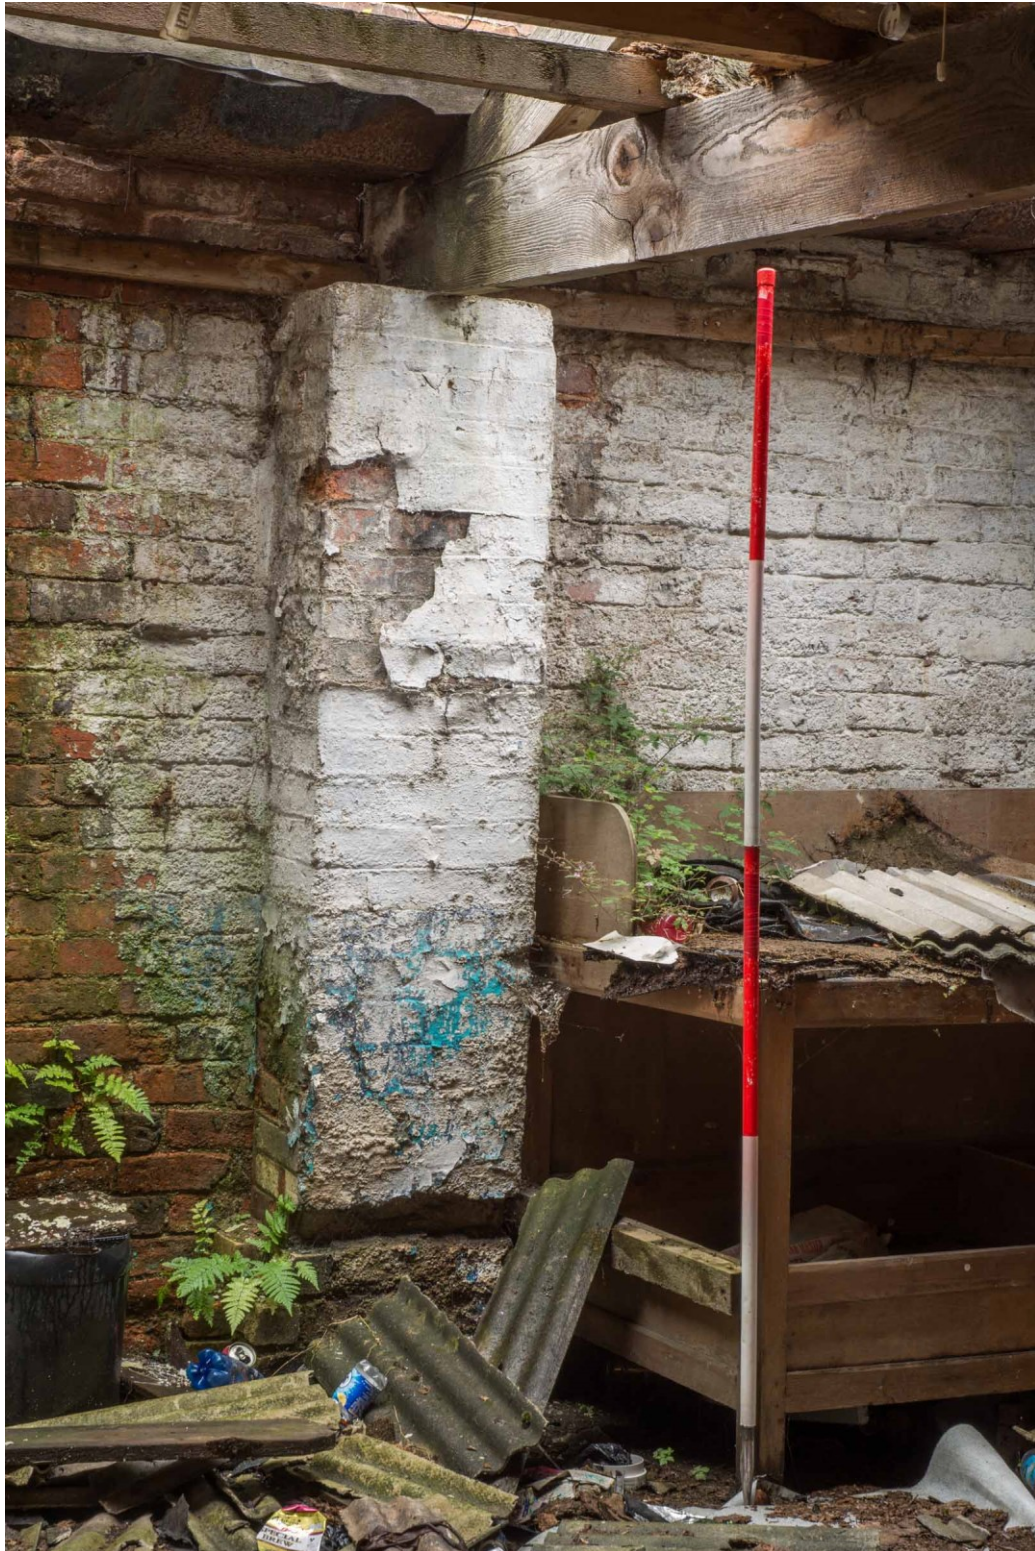
Figure 17. Wall shaft supporting the Drying Shed roof.

The original appearance of the Drying Shed is more difficult to determine. The present roof is concealed behind a parapet, which would necessitate the building of internal wall shafts to support the trusses, as is actually the case (Fig. 17). However, the wall shafts at the south end must have been added at a later stage since the Saggar House roof originally extended here. In the gables of the Drying Shed there is no original brickwork. The Moulding Shop was later built on top of the drying-house north wall at eaves level, suggesting that the gable was originally open or vented with wooden louvres.

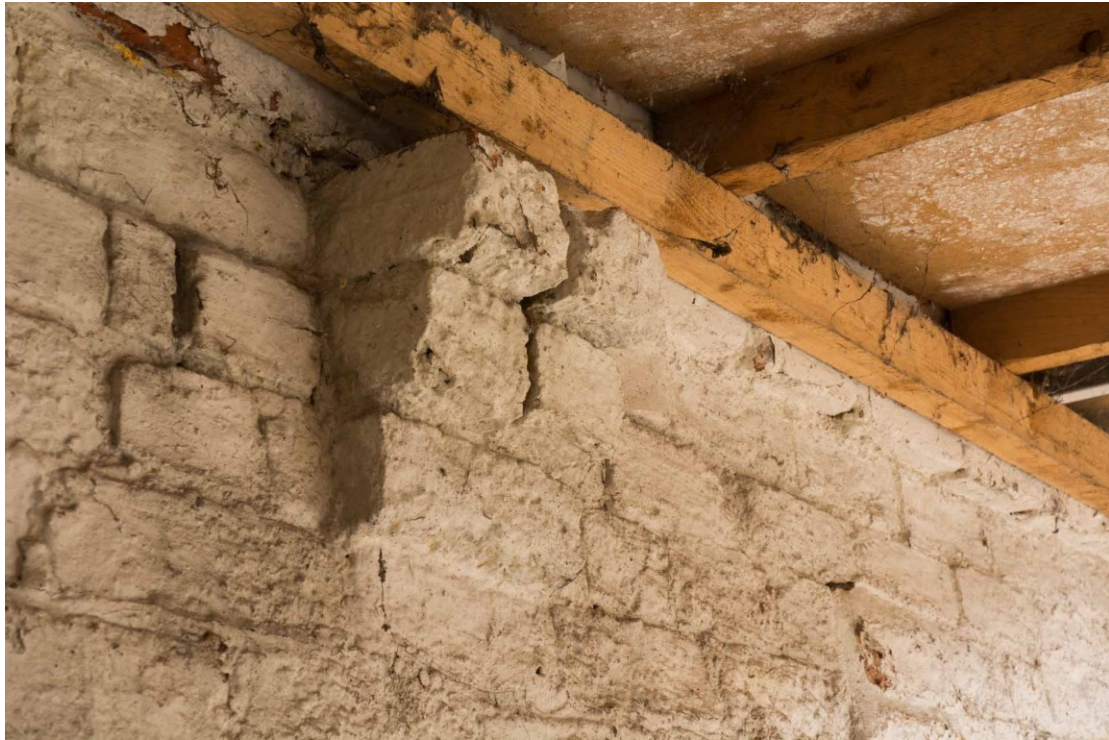
Figure 18. Corbel in the south wall of the Drying Shed that formerly carried a truss of the Saggar House roof.

part of the original Saggar House roof was taken down. Evidence of this is visible in the form of the corbel inside what is now the Drying Shed gable end, and in the wall on Alexandra Road. The original saggar-house gable end was taken down and the wall was tidied up by adding new, machine-moulded brickwork, complete with a new coping course. At the same time new gable-end brickwork was added to the south wall of the Drying Shed, which in its internal face is corbelled out slightly from the brickwork below it. Because the Drying Shed is wider than the Moulding Shop a small triangle of the north gable remained open, which was infilled at a later date using machine-moulded brick bonded in a cement mortar. This brickwork can be seen clearly to abut the Moulding Shop wall. These bricks are different from the distinct yellow bricks of the Moulding Shop and the hand-moulded bricks of the Drying Shed (Fig. 21).

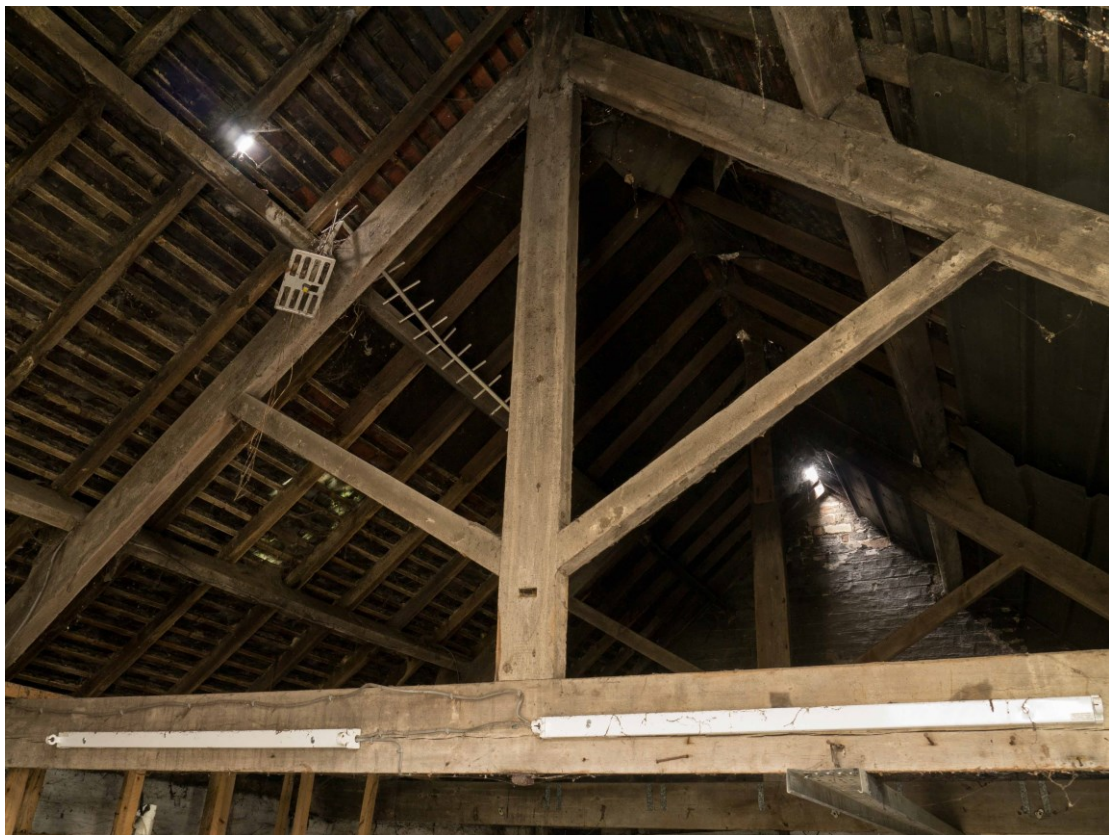
Figure 19. Roof truss of the Saggar House.

The Saggar House has a three-bay roof of machine-sawn king-post trusses with diagonal struts, carried on brick corbels (Fig. 19). The concrete floor is uneven, sloping upwards toward the east end, as does the roof line. Inside the room a small office was created by erecting a plasterboard partition in its north-west corner. At the time of survey, the office retained wooden shelves and paper files. A partial loft was created by adding joists to the innermost of the three bays. Connection between Saggar House and Drying Shed is by boarded door. Inside the entrance doors is a second, large steel door. Although it was manufactured as a door it is clearly not an original feature, or in its original location, as the door has been turned on its side, with three hinges along to the top surface (Fig. 20). New hinges were welded on and attached to a plate that was fixed to the original door frame.

The roofs of the block are no longer entirely in their original form. The Saggar House was originally a two-unit building with central dividing wall and roof extending to the boundary wall on Alexandra Road. The 1873 map indicates this, and it is confirmed by the presence of a brick corbel on the south wall, showing that the building was originally three bays on the east side of the dividing wall (which remain) and two bays on the west side (Figs. 4, 18). However, there is no evidence of a corresponding wall on the north side of the Saggar House, suggesting either that the truss was carried on a timber post or cast iron pier.

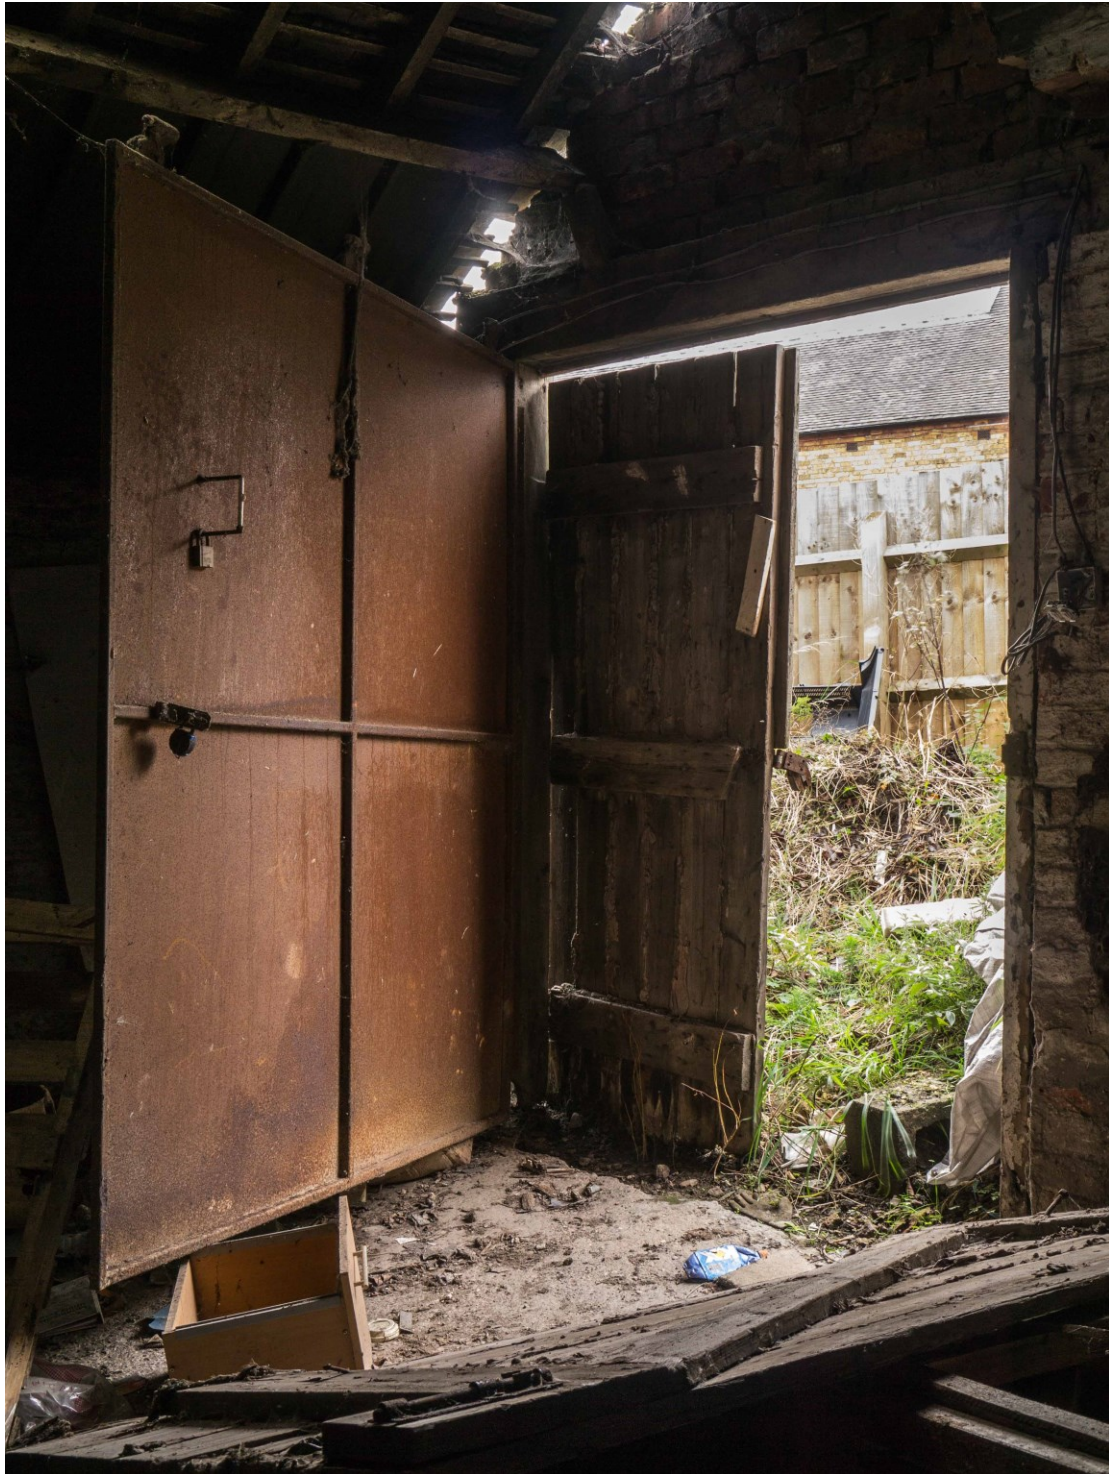
Figure 20. Steel door added to the Saggar House entrance. Hinges along the top show that it was salvaged from another site.

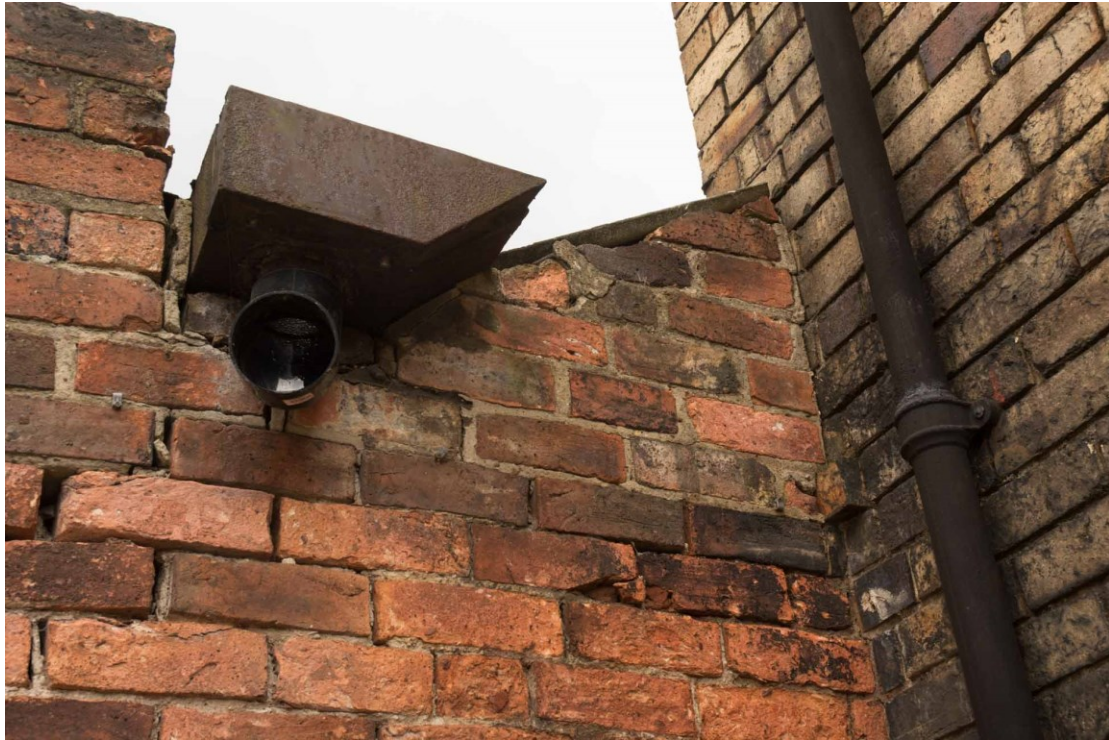
Figure 21. Part of the north end wall of the Drying Shed, showing iron rainwater goods, and cement-bonded brickwork in the gable abutting the wall of the Moulding Shop on the right.
