Southampton Archaeology Unit Report 1297

Archaeological Watching Brief at 214 Bursledon Road, Southampton. SOU 1742

2017

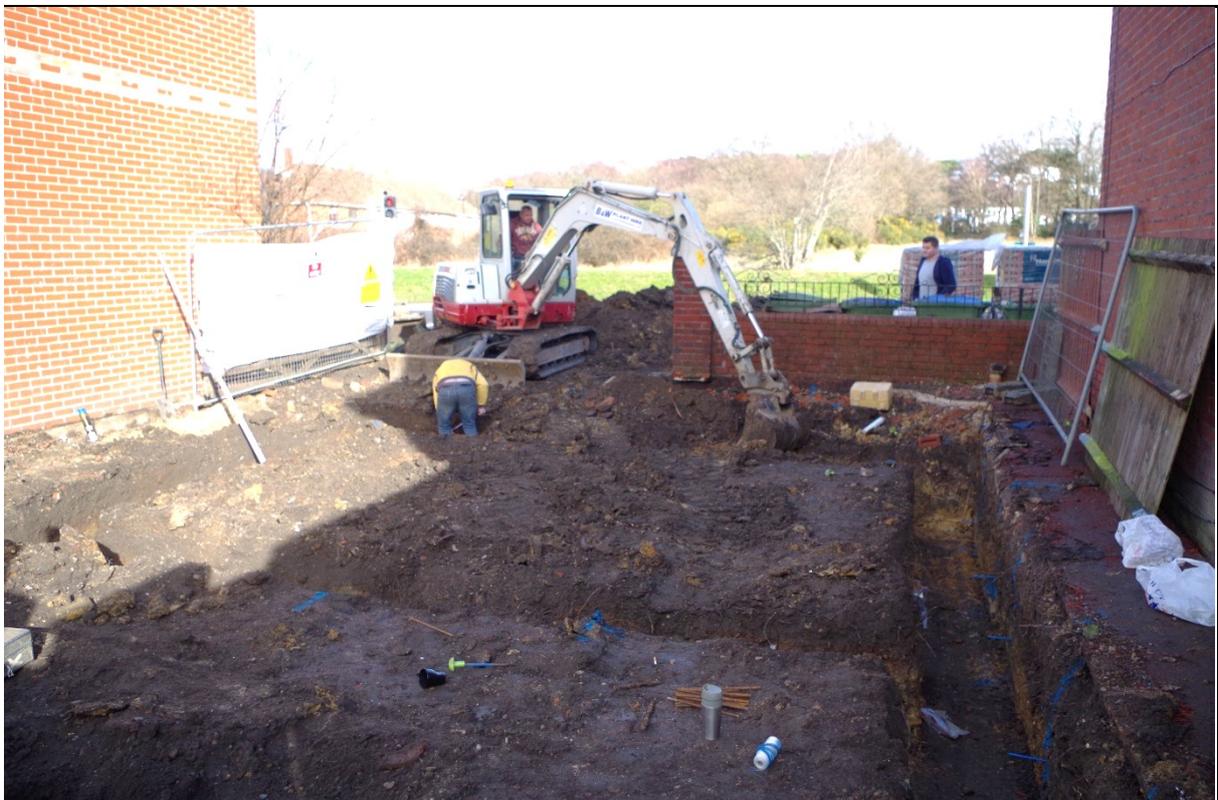
Cover photo: excavation of foundations in progress.

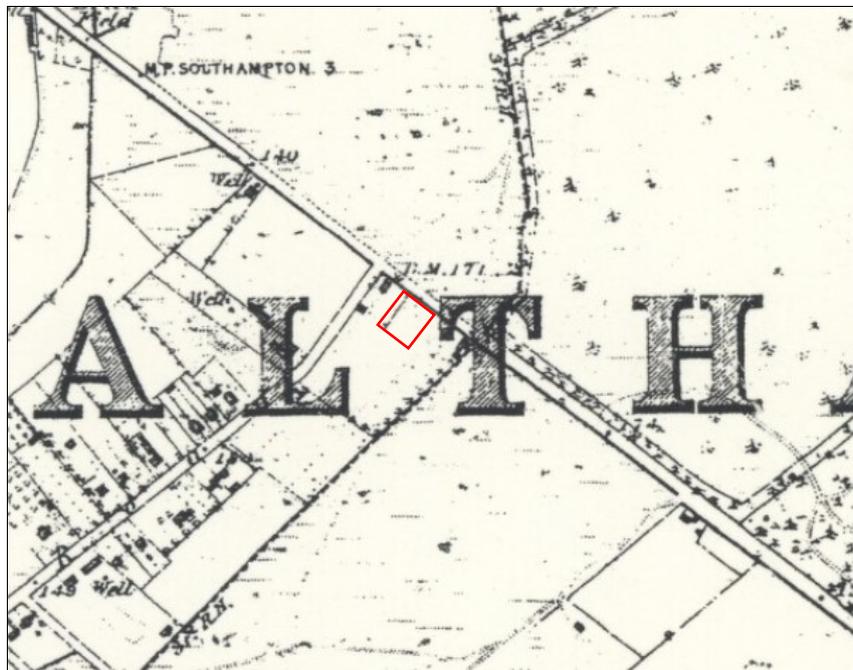
4.2 Late 19th century maps show that the site was rough pasture in an area called Sholing Common (fig 2).

Fig 2. The 1866-69 (published 1871) Ordnance Survey map showing the approximate position of the site. Sheet LXV

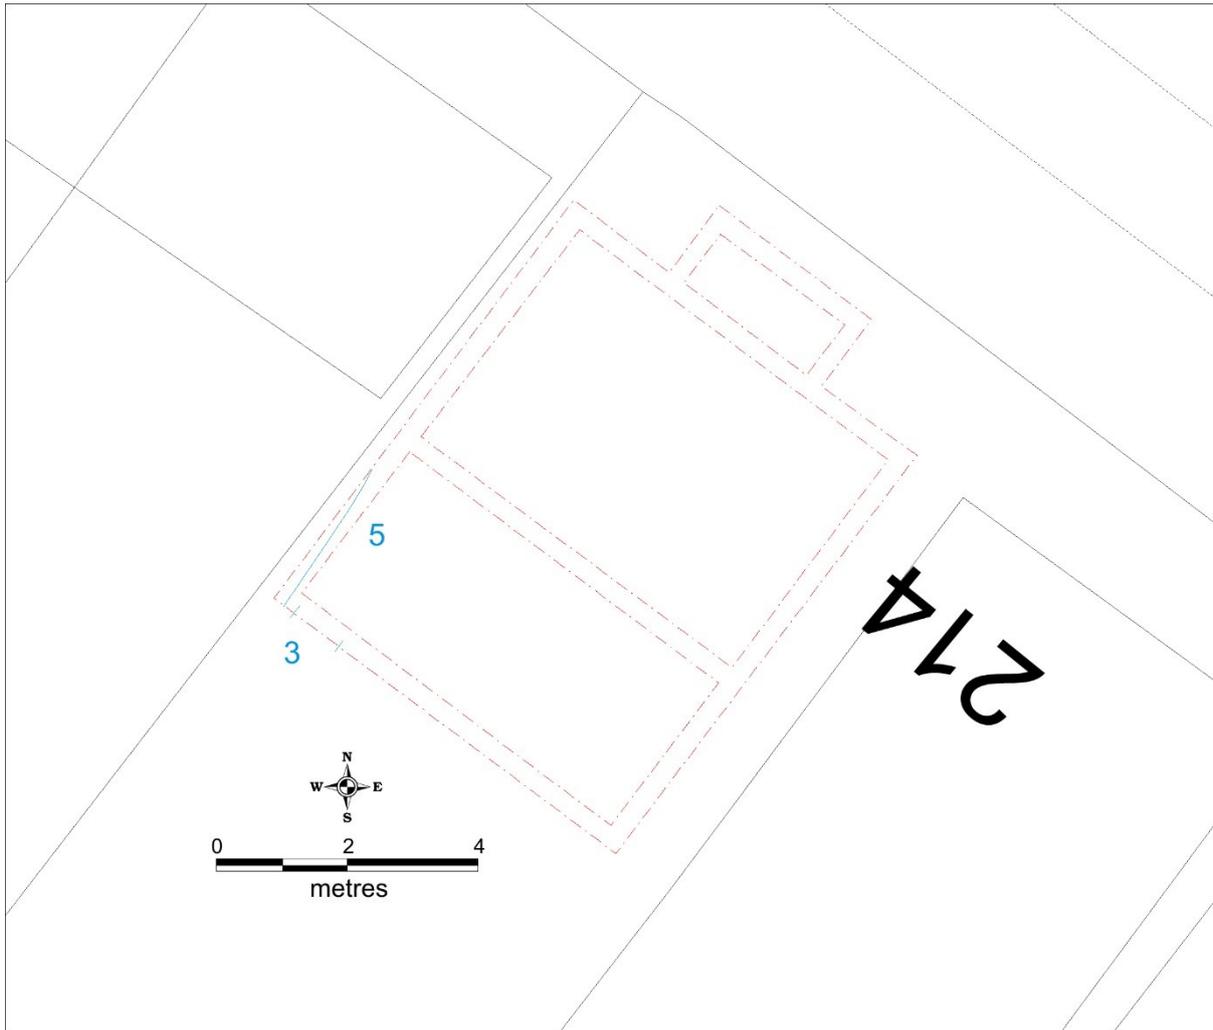
Fig 3. Outline of building foundations shown in red. Features 3 & 5 in blue.

The foundation trenches were dug with a small tracked excavator. Two features were observed in the southwest corner of the site (fig 3). The results are presented in chronological order from the oldest to the most recent. Appendix 1 lists basic details of the contexts.

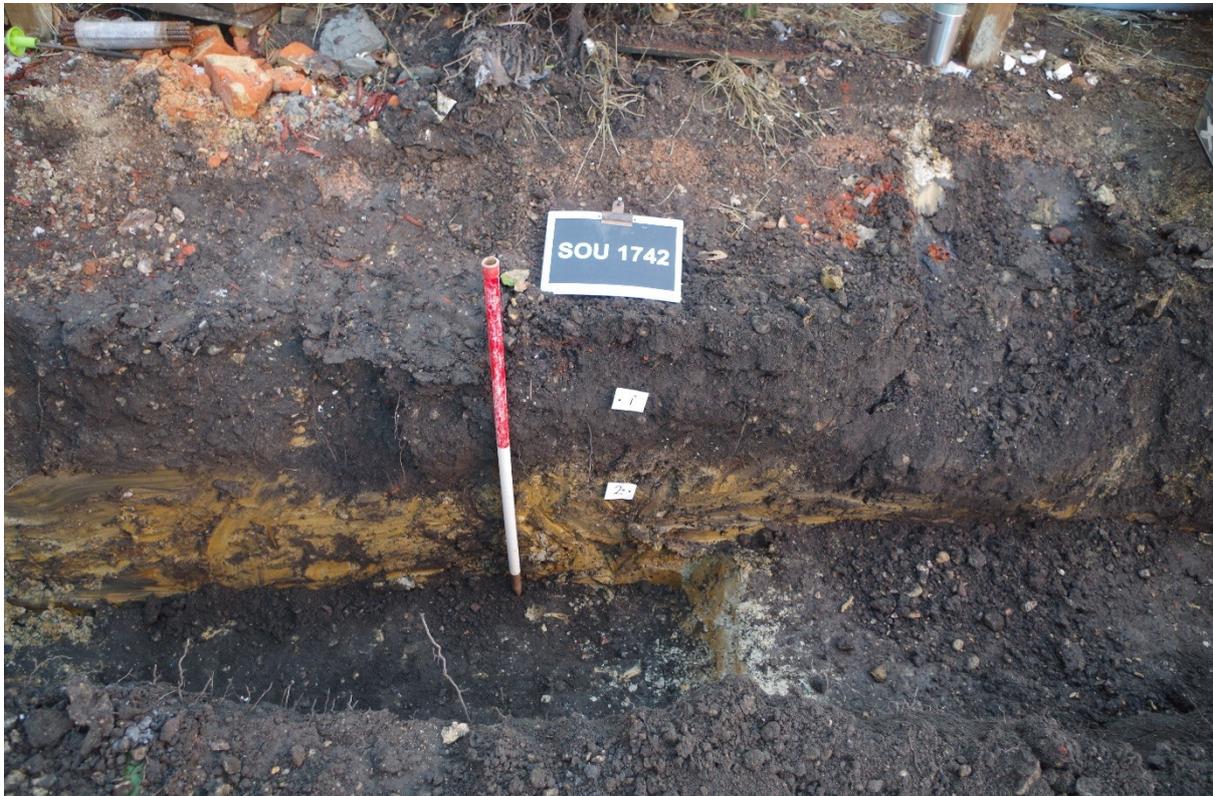
7.1.1 The natural, found some 450mm below ground level, was assigned context 2. It was a very pale brown (10YR7/4) clay mottled with pale grey sand (fig 4). The mottling could have been the result of leaching of the top of the clay.

Fig 4. North-facing section of south trench, showing layers 1, topsoil, and 2 natural clay.

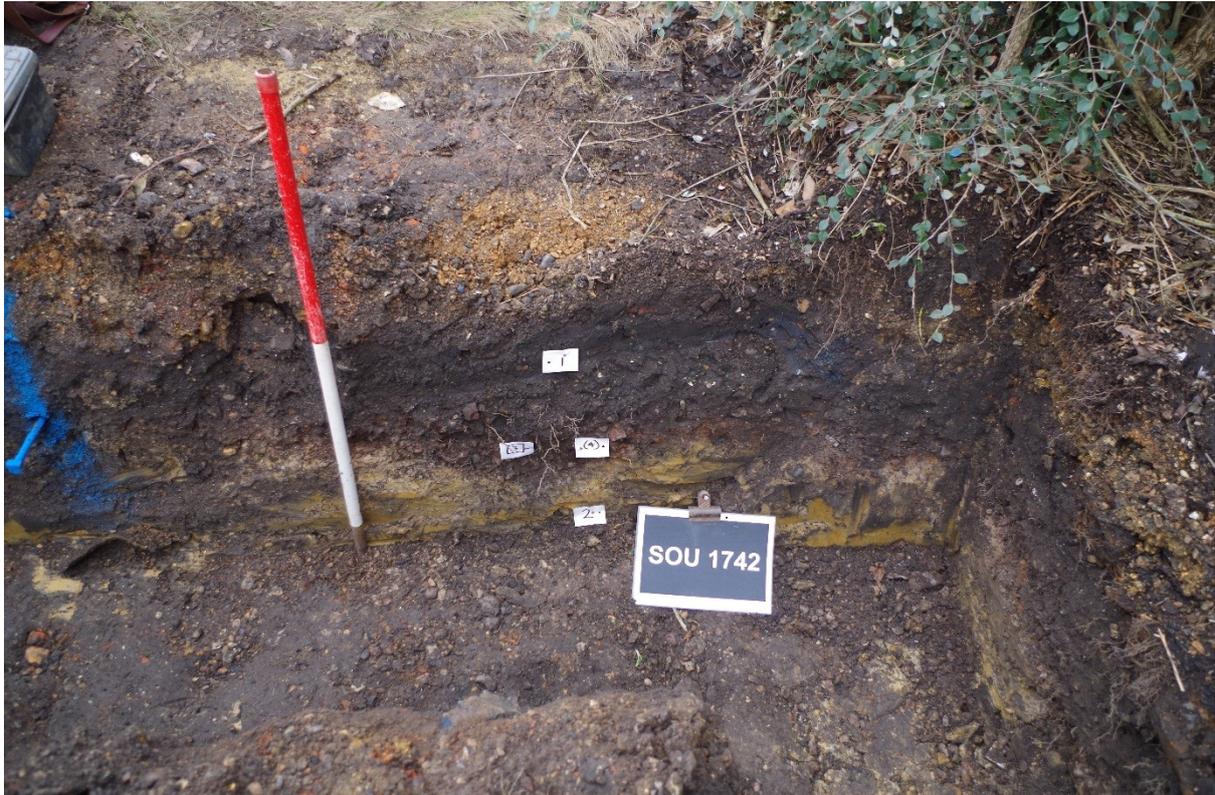
7.2.1 Feature 3 was a hollow in the natural in the southwest corner of the site. It had a gently sloping profile east to west, the north edge had been removed by the machine (fig 5). It was 0.90m long, east to west and 0.18m deep. It was filled by (4), a dark greyish brown (10YR4/2) gravelly soil with occasional burnt flints. The flints were reddened rather than shattered. There were small fragments of brick at top of of fill 4.

Fig 5. North-facing section through feature 3.

The only possible archaeological feature was feature 3, a hollow in the natural that contained a few burnt flints. The flints were reddened rather than shattered, and could have been caused by a bonfire at any date. The topsoil was checked for finds and no pre-20th century artifacts were found.

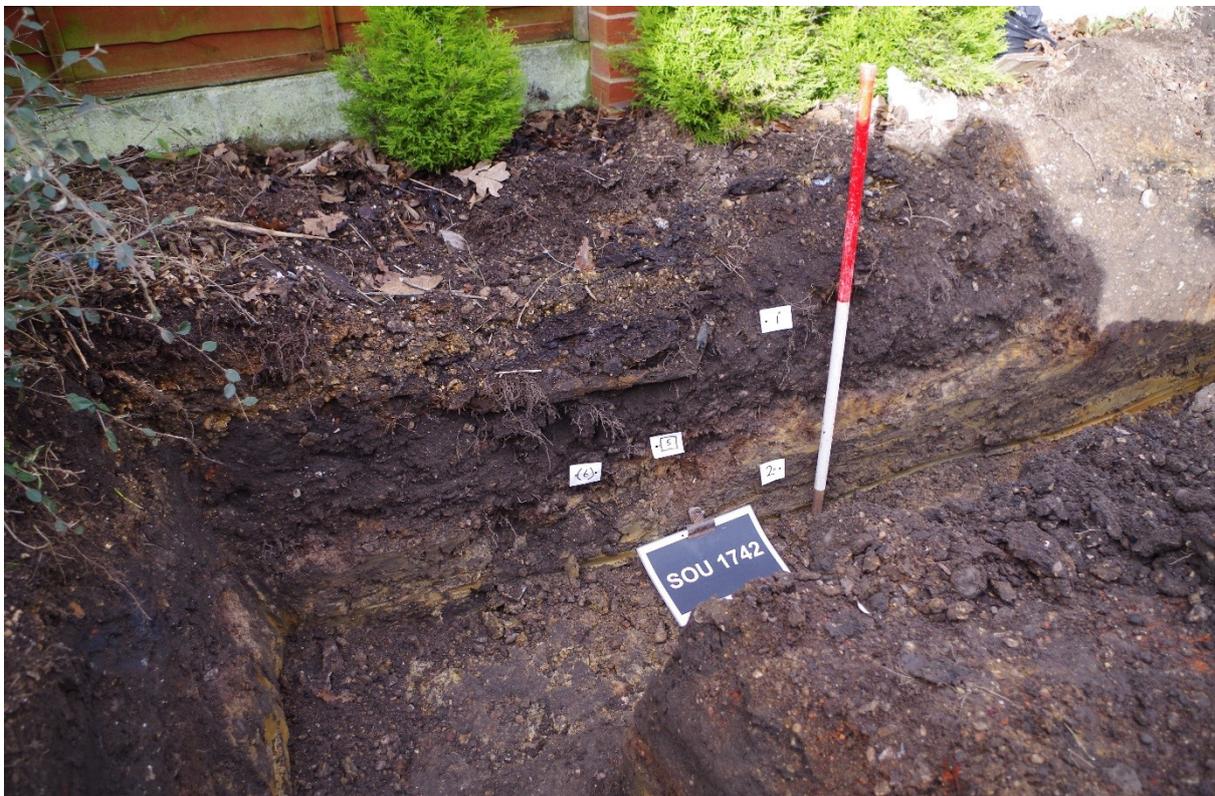
7.3.1 Feature 5 was a hollow in the southwest corner of the site. Its east edge had been removed by the machine. It was 2.55m long, north to south, at least 0.35m wide and 0.15m deep (fig 6). It was filled by (6), a dark greyish brown (10YR4/2) gravelly soil with iron panning. The fill contained abundant modern rusty iron fragments.

Fig 6. East facing section through feature 5.
