Castell Blaenllynfi, Brecknock: a Marcher castle and its landscape

By ROBERT. J. SILVESTER¹, PAUL COURTNEY² and SIAN E. REES³

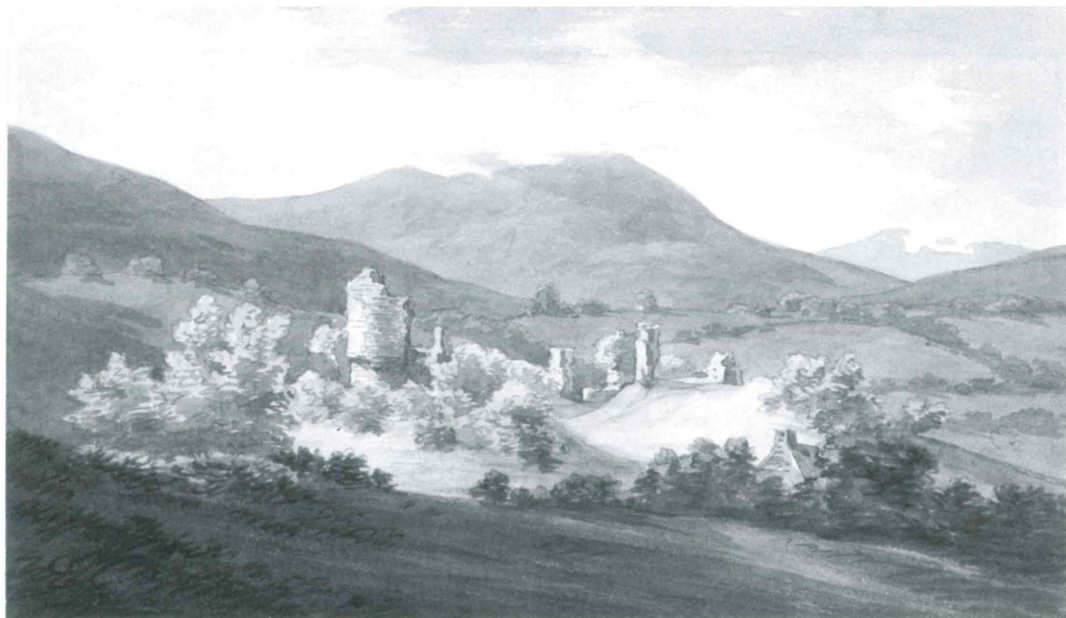
Fig. 4. Watercolour of Castell Blaenllynfi in 1790 by John 'Warwick' Smith.
By permission of *The National Library of Wales*.

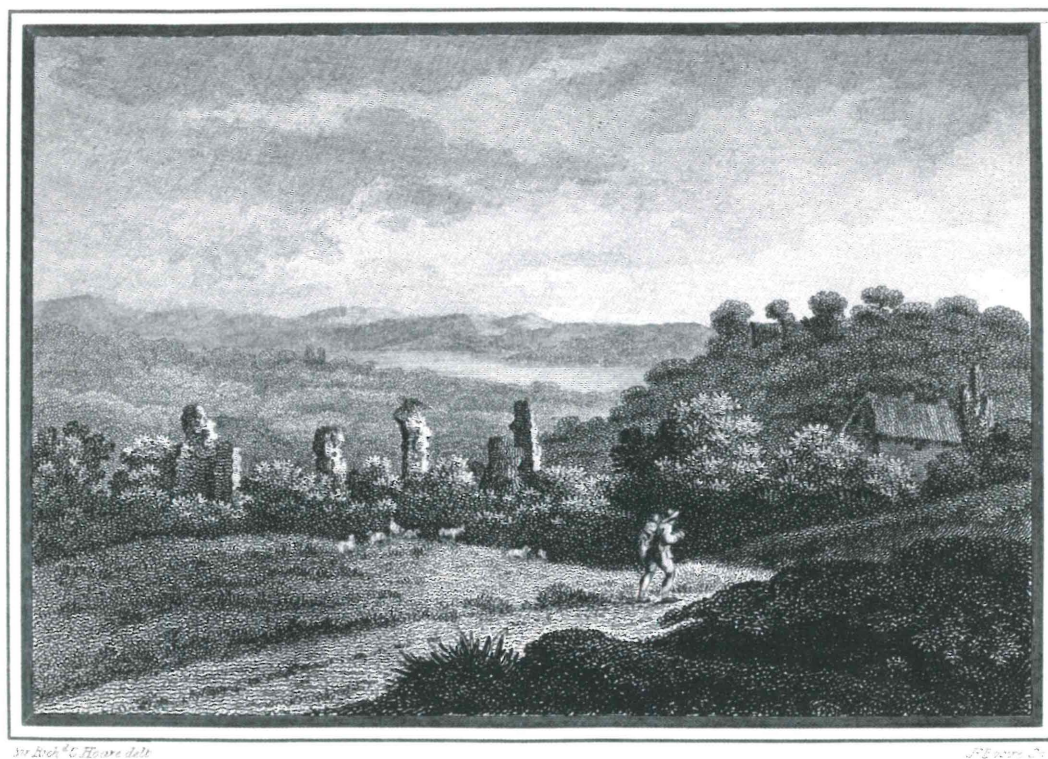
Fig. 5. Etching of Castell Blaenllynfi from a sketch by Sir Richard Colt Hoare in 1805, from Theophilus Jones' *A History of the County of Brecknock* (vol. 1, 1805). By permission of The National Library of Wales.
