5 LINLITHGOW CARMELITE FRIARY

5.2 LINLITHGOW: THE EXCAVATIONS

WJ LINDSAY

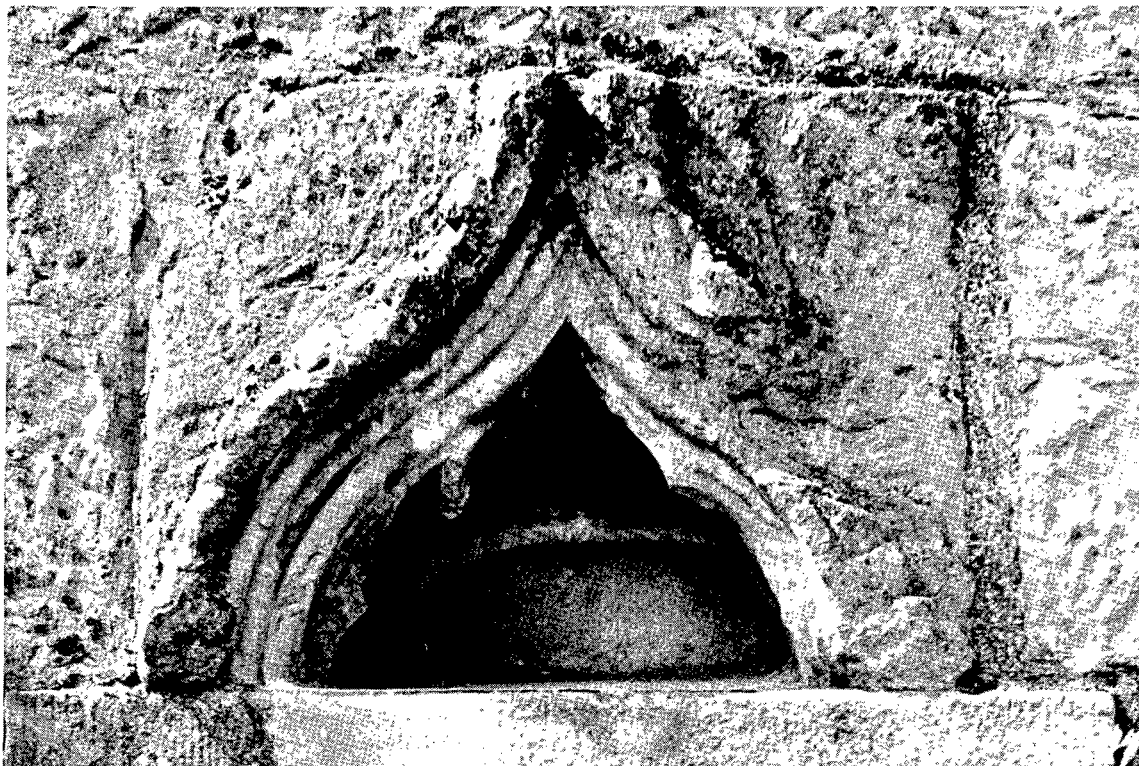
ILL. 22 : Architectural fragment probably from Linlithgow friary, built into wall of Nether Parkley House, Linlithgow, above a window lintel 0.84m long. Decorated head or canopy of an aumbry or sedile wrought from a single block of sandstone. Probably of late 15th or early 16th century date

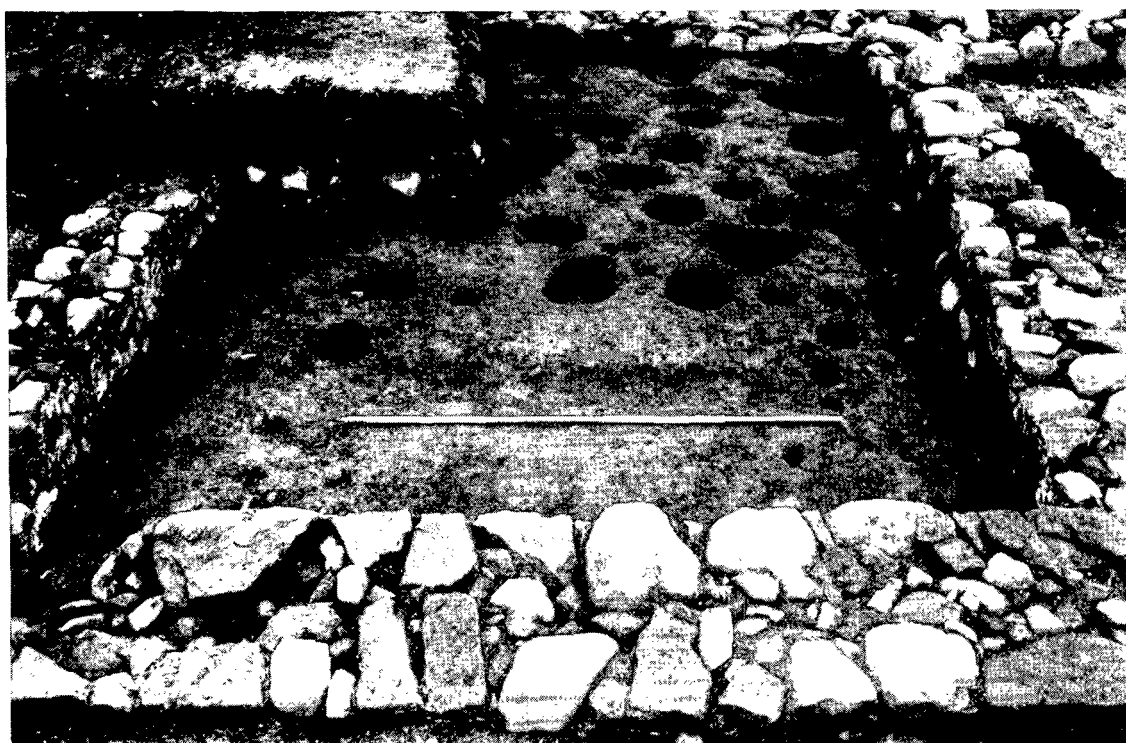
ILL 25 : Linlithgow. Some of the Period 1 cut features present within the chapter house, which was constructed during Period 3, Phase 10. Looking W

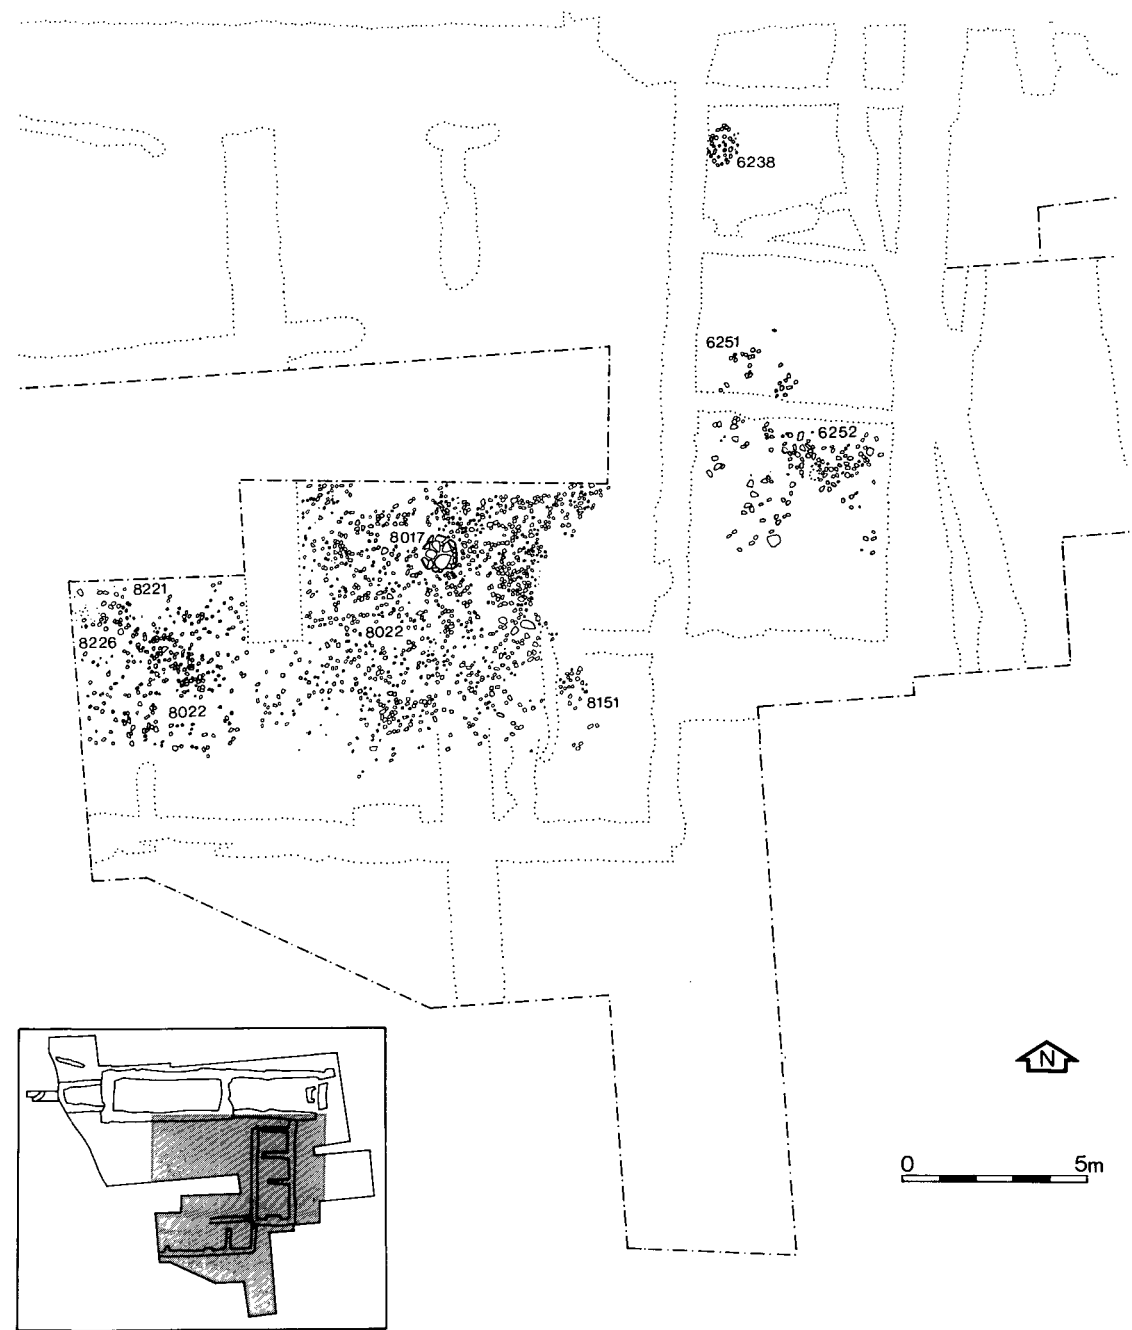
ILL 26 : Linlithgow. Plan of Period 1. Neolithic stone spreads

Apparently related to the main E concentration of cut features were overlying patches of rounded cobbles which were set in a c 0.10m deep brown soil, 6238, 6251 and 6252 (Ill 26). Parts of some underlying pits were first identified at this level although their full extents were not ascertainable until the stoney deposits were removed. It is therefore likely that the cobbled spreads had been laid as Period 1 surfaces and that stones from them had been disturbed and pulled over the cut features when the area was cultivated at a later date, probably during Period 2. The stoney spreads may originally have been more extensive but been stripped when the area was scarped in Period 3.

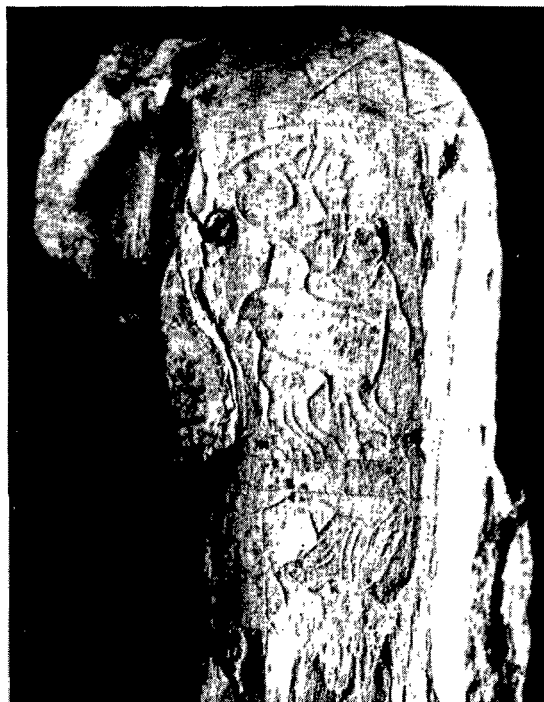
ILL 30 : Linlithgow. Detail of decorated wooden handle of knife (247) found in occupation layer within Building 1

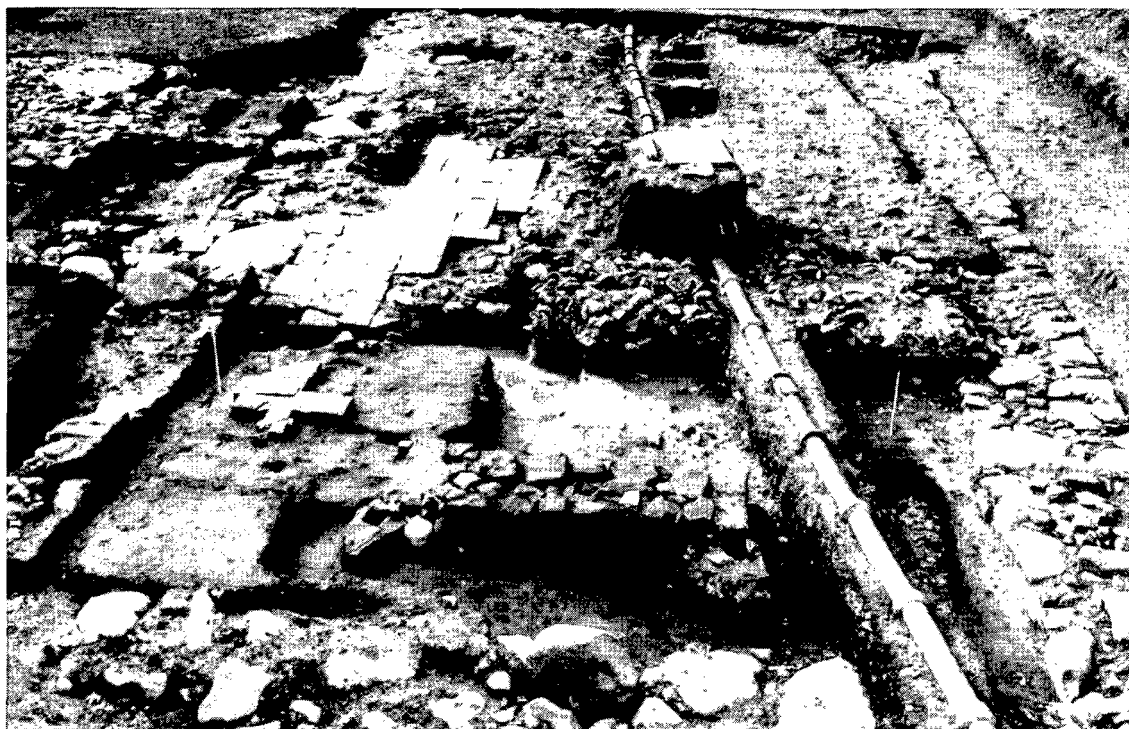
ILL 33 : Linlithgow. E end of friary church, constructed in Period 3, Phase 6, with most intrusive features removed. In the foreground is the high altar with socketed stones at NE and SE corners to support a retable. Looking W

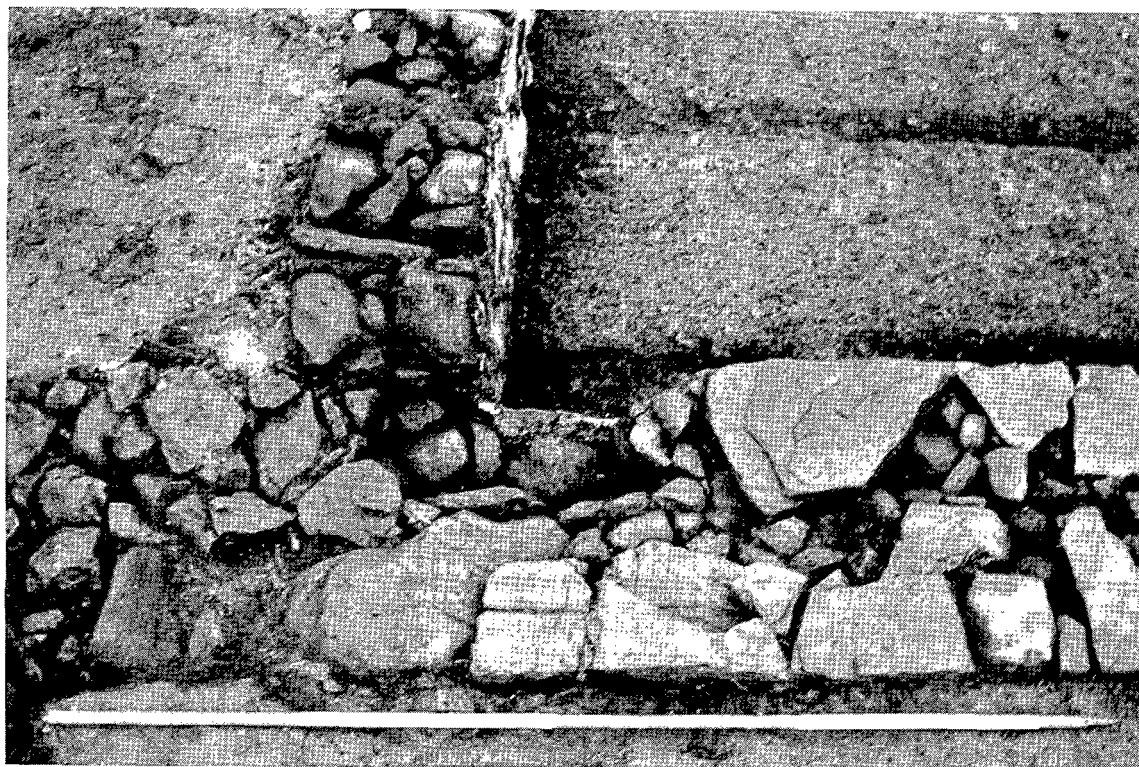
ILL 37 : Linlithgow. Detail of SE corner of chapter house constructed during Period 3, Phase 10. The S ends of two joist slots, mortar facing on the inner surfaces of the walls and a possible recess (6616) in the E wall are visible. Looking W

At the junction of walls 6005 and 6045 there was a small recess, 6116 (Ill 37), which measured c 0.60 × 0.27m and survived to a height of c 0.24m. However, it was not clear whether it was a constructional or destructional feature. The mortar facing on wall 6005 had been cut through during its creation so, should it be of Period 3 date, then it must have been a post Phase 10 addition. Alternatively it may have been a Period 4 robbing cut. Should it be of this later date it can only be speculated whether a solid feature or facings of an existing recess had been removed.
