LATER ACTIVITY POST ABANDONMENT

POST PHASE 8 ABANDONMENT

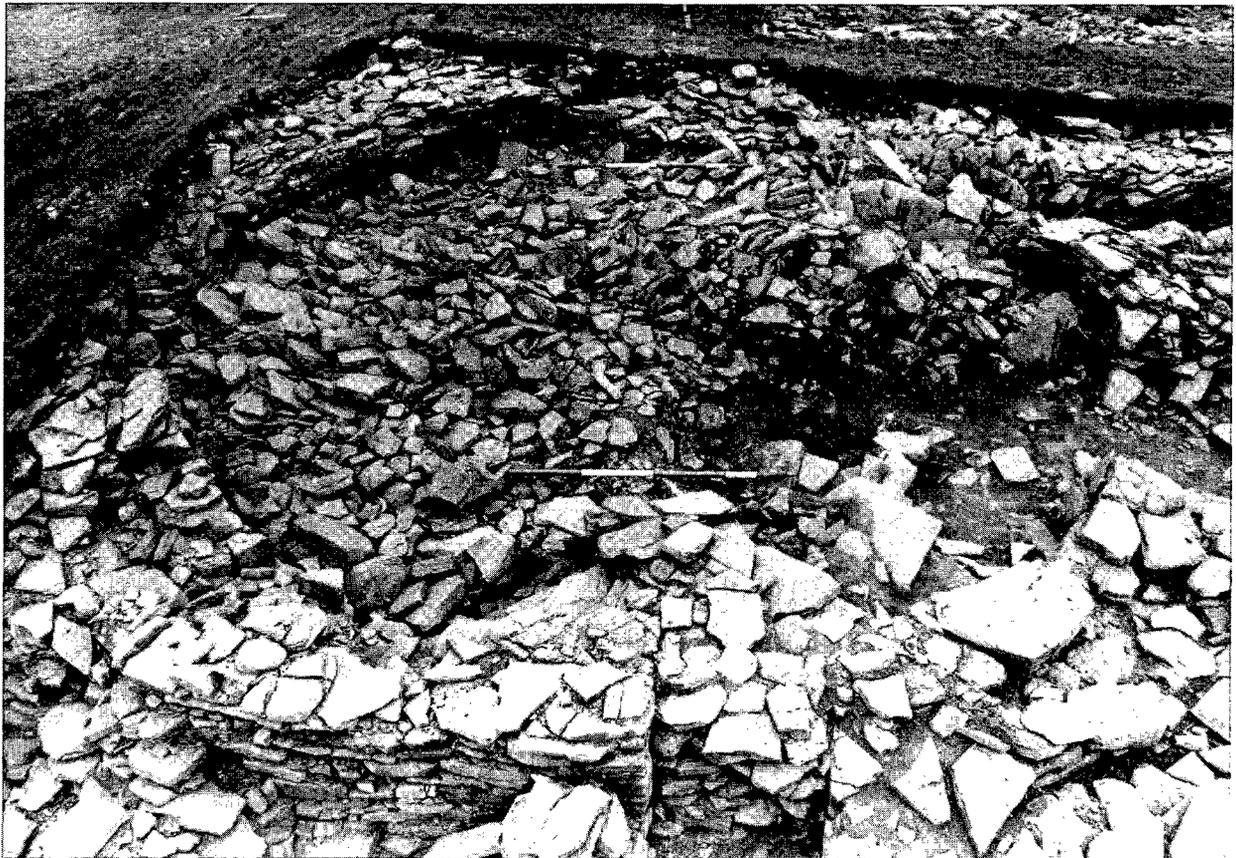
Illus 76

The top of the broch tower, shown filled with rubble after removal of turf and topsoil. The Phase 7 blocked landing is visible in the lower centre of the picture; scales – 2m; from W.

robbing of higher level structures and by 19th-century digging. In a few areas abandonment was continuous, or all but so, from the last major broch tower collapse, and a layer of weathered stone fragments built up across the site. The interior of the broch tower remained out of use from Phase 7/8, subject only to wall collapses and filling in by rubble and earth (illus 76). Stone robbing of the tower wall head did take place and the lintels from the entrance were removed after Stage 6, which allowed the passage to be filled with a stony wash.

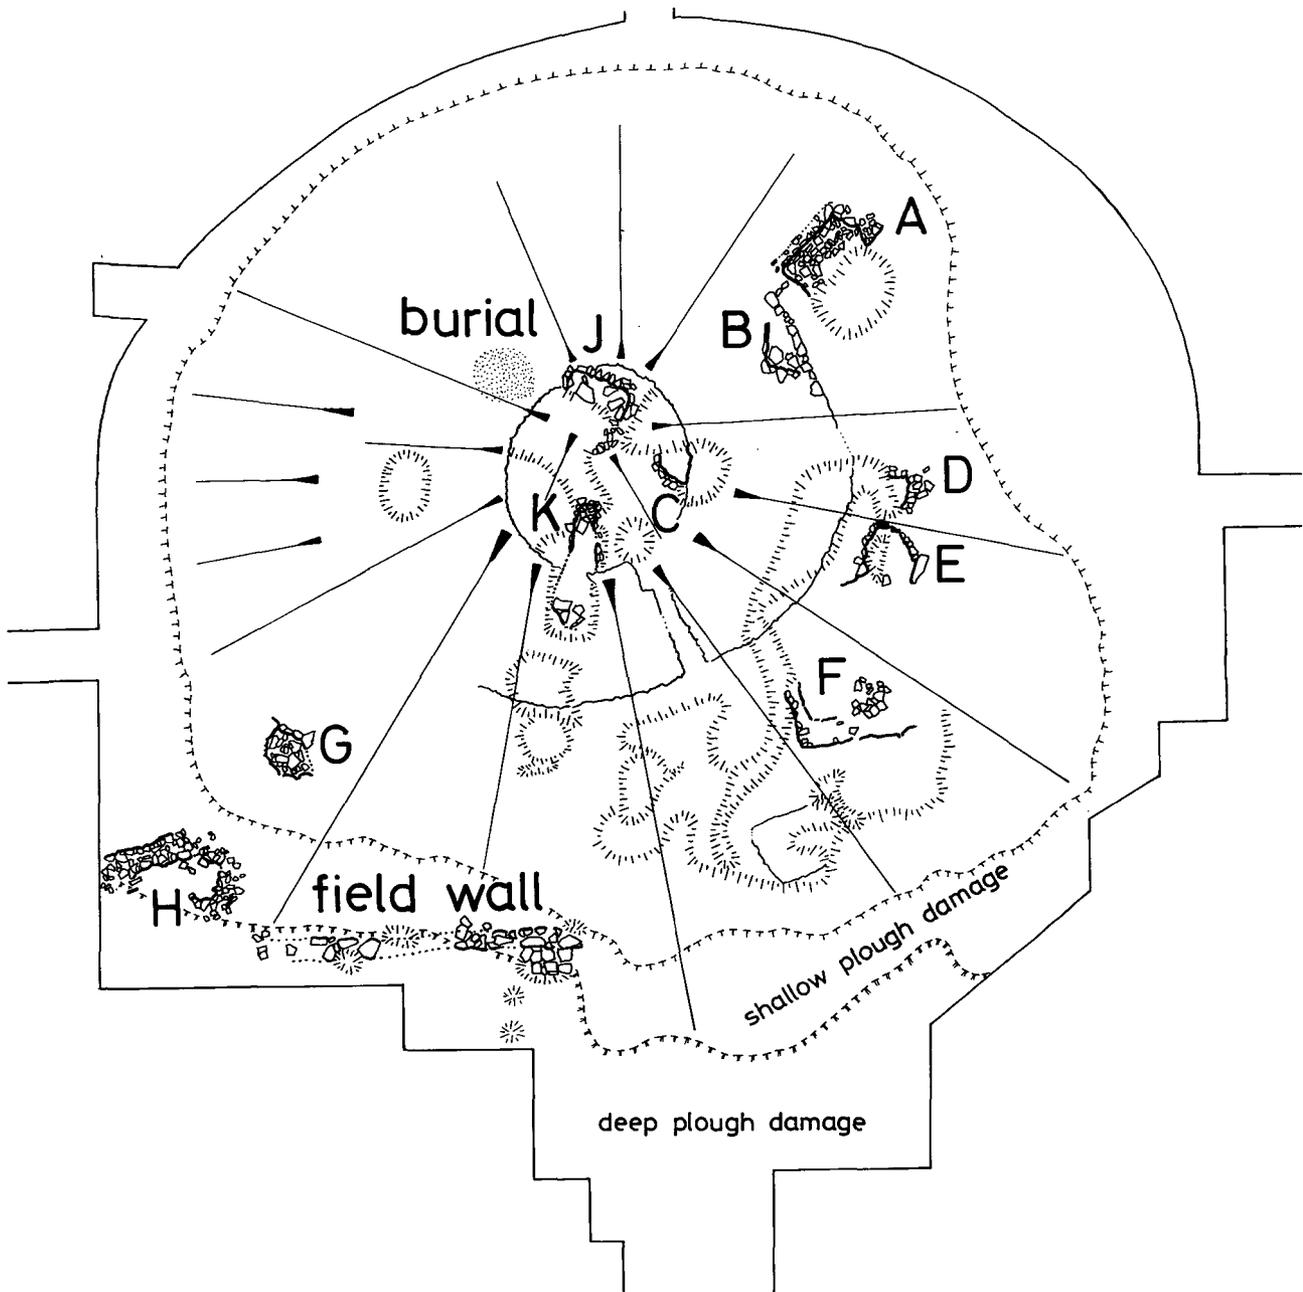
Illus 77
Phase 9 features.

UNPHASED LATE STRUCTURES (illus 77)

Parts of nine other late structures were present on the site which cannot be assigned to specific phases. These are shown together with three recent structures (18th-century or later), dated by finds, and the limits of recent stone-robbing and early archaeological investigations. Most of these structures merit little comment and are not stratigraphically linked.

Building **A** was rectilinear and lay in the upper fill of the area between the broch tower wall and the rampart revetment in the

NE. Three sides of a single-faced building survived, which cut into the abandonment rubble. The longest side, the NW, measured 2.8m, but the building was disturbed by a 19th-century excavation and only a 2m length of it survived. The walls survived to three courses in height and partly stood on stone and earth levelling. Onto the levelling was placed the flag floor of the building.

Building **B** was a tiny triangular fragment which cut the outer face of the broch tower wall at a level 1m above building **A**, and lay to the SW of it. Its wall was of upright stones and some flag flooring remained.

Building **C** was built against the inside wall of the broch tower and consisted of an arc of single-faced wall, dug into rubble. The wall survived to a height of 0.5m but was cut to the N and E by 19th-century trenches. Some flag flooring was present.

Building **D** lay to the E and consisted of a semi-circular arc of coursed stone which was cut by an arm of a Victorian trench.

Immediately below it was another semi-circular hut, Building **E**, open to the S with walls built of upright stones, and a stone chip floor.

Further S, to the E of the old broch entrance, was Building **F**, an L-shaped, 2m wide freestanding wall. It survived to only one course and lay on top of the abandonment surface. It is assumed that the flag surface to the NE belonged with the wall, but the building was cut by a 19th-century trench in the NW.

Another small fragment of a building, **G**, was located in the W within a Phase 7 rampart cell of the NW building. It was partly closed off to the N by a short length of single-faced wall and had a flag floor, c 2.0 × 1.4m.

In the SW, Building **H** overlay the upper fills of the ditch and cut the silting over the rampart. A freestanding wall, 1m wide, lay at right angles to the rampart, and a curved single-faced wall backed by rubble joined them together in the N. They enclosed an area

c 1.5m square which had an earth and rubble floor. To the S of the freestanding wall was an earth floor within which lay a hearth consisting of a fragmented base slab and an upright. Unlike other freestanding walls in Phase 8 this construction had squared blocks forming the faces with an earth infill.

From the plan it can be seen that much of the S part of the site suffered both from shallow and deep plough damage. Here the slope of the mound was shallow and allowed the plough to make incursions higher up onto the site. Evidence was found into Phase 7 levels of stratigraphy which had been ploughed away since the site had been abandoned. Evidence of the clay-cored rampart E of the entrance was missing, together with parts of buildings built over the defences in later Phase 7, and the destruction of parts of buildings during Phase 8 was much in evidence. S of the defences, beyond the settlement entrance, only scant remains were found of activities during later Phase 7, as this area was subject to regular ploughing. The survival to a higher level of the defences on the E prevented much serious damage on this side. To both the N and W, the severe slopes of the mound discouraged ploughing and again damage was minimised.
