#### AN ACCOUNT OF THE EXCAVATION OF FURTHER BUILDINGS OF THE VIKING PERIOD (VIKING HOUSE NO. II), AT "JARLSHOF," SUMBURGH, SHETLAND, CARRIED OUT ON BEHALF OF H.M. OFFICE OF WORKS BY ALEX. O. CURLE, C.V.O., LL.D., F.S.A.Scot., F.S.A.

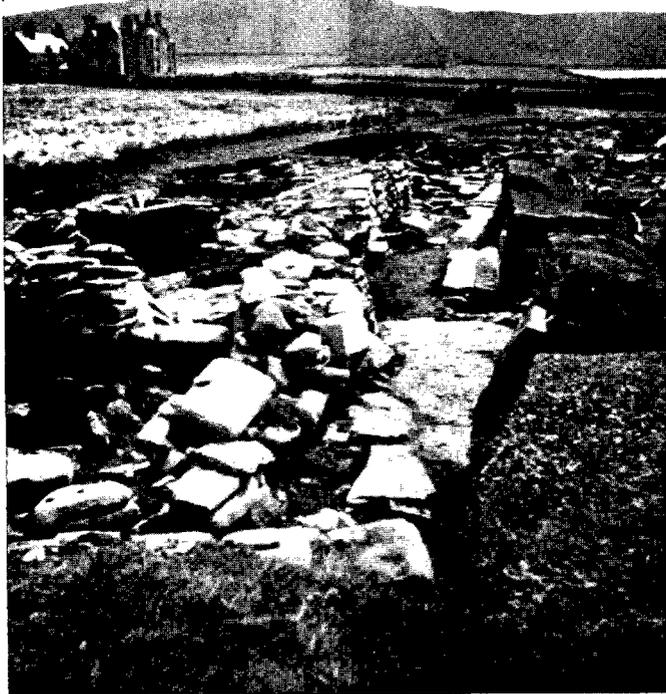
Fig. 2. North-west end, showing Reconstruction of Wall.

Seemingly the whole building had been allowed to fall into ruin and then reconstructed for secondary purposes. It had apparently been a three-roomed house. Though the outer wall on the north-east side had practically disappeared its line towards the north-west end must have passed close by the ends of the platforms indicated on the plan (Plate I) at the entrances to Rooms I and II, with the exception of the end of the platform on the left of the entrance to Room I, which had obviously been displaced. What happened eastward of that it is difficult to say. Room III had originally been some 25 feet in length, but, owing to alteration in the south-west wall, was of unascertainable width.

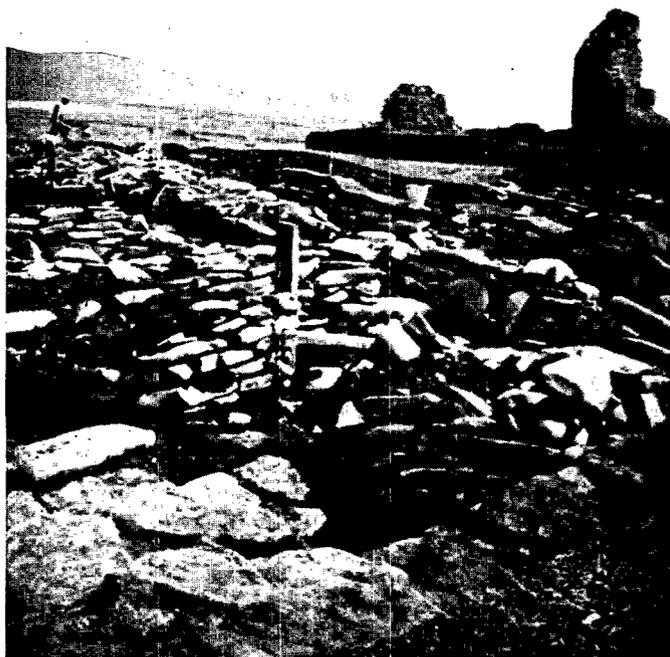
Fig. 3. Entrance to Room I, showing Platforms to right and left.

4 feet 6 inches in length, with platforms extending the length of the passage on either side (fig. 3), measuring in width about 4 feet, and, as remaining, some 2 feet in height, formed of earth enclosed with walling. In the interior of the room a single upright slab was set in the floor at right angles to the inner wall of the end platform. At the base of the partition wall dividing this room from Room II there were the remains of a flue which must have been connected with a furnace, from which came some specimens of iron slag and of bog iron.

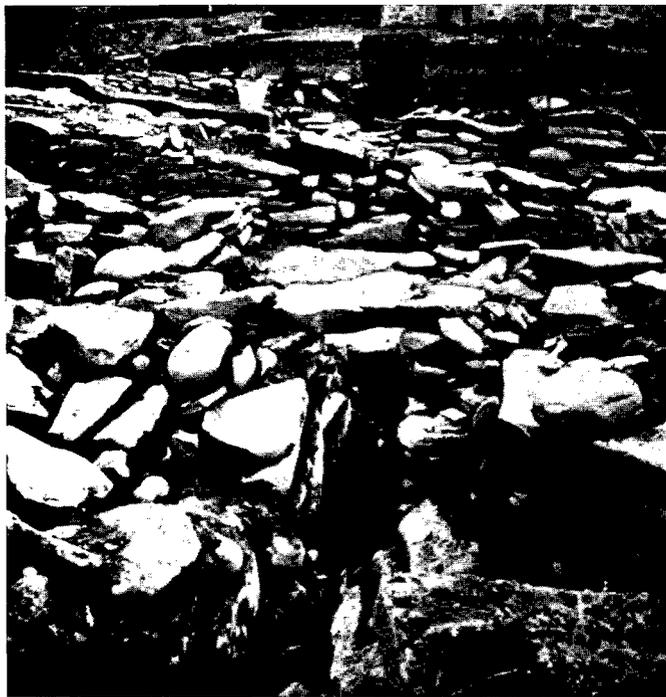
Fig. 4. Entrance to Room II, with a Lintel over it.

as if for drainage. A single lintel at the inner end covered the passage, leaving a space below such as might have allowed entrance for pigs or sheep (fig. 4). As in the case of Room I, a platform flanked the passage on either side faced with stones, and in the south-east corner of the room there were the remains of another platform in a ruinous state. In the opposite corner a recess had been formed behind a short projecting wall. Parallel, and only a few inches in front of the north-west wall of this room, there was a bench about  $1\frac{1}{2}$  foot in width, and similar in height, formed of turf or soil, with one or two upright stones on the side, and covered with flat stones like drain covers. Benches, somewhat similar on plan, are shown to have existed in Greenland, where they were

employed to support hacks to hold hay for feeding sheep.<sup>1</sup> The character of the passage as above described admits of such a possibility in the likelihood of this chamber having been used for sheep or pigs in one part of its history.

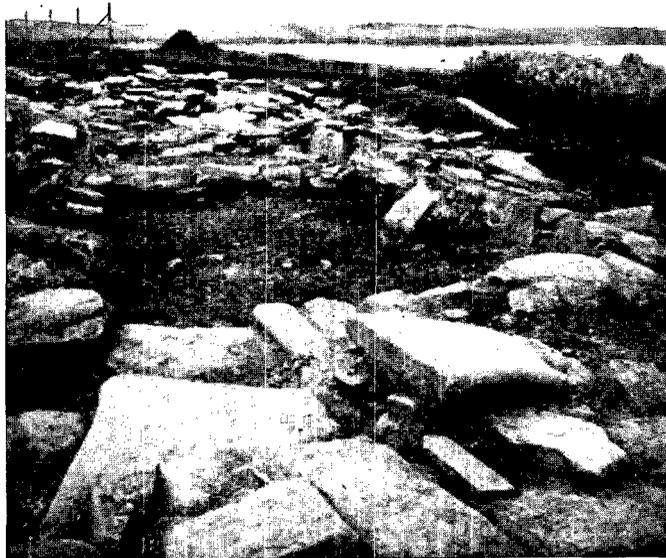
Fig. 5. Room III from the south-east.

(fig. 5). It had been an oblong chamber, measuring in length 25 feet from the end wall on the south-east to the face of the actual wall separating it from Room II, and some 13 feet in width. At a distance of some 4 feet 6 inches in front of the latter, parallel, and extending almost to the full width of the room, was another wall, in a ruinous condition, but remaining to a height of about 1 foot, in two courses, which acted as a facing to a bench of soil, probably employed as a dais. Crossing this wall at its north-east end is a single line of flat stones, which suggested the base of a later retaining wall. It was carried right forward beyond the apparent edge of the building, but could not be

followed owing to the bere crop. Again, at a distance of 4 feet 6 inches or thereby, further into the chamber and parallel with the end wall, was another facing wall of large stones, giving the appearance of the formation of yet another dais at a lower level and possibly of an earlier period. In front of this last-mentioned wall there was an indeterminate extent of compacted clay on the floor, and a similar bed of clay formed the

flooring in front of the opposite wall at the south-east end of the chamber. The wall fronting the alley had been much interfered with on its inner face, as may be seen from the plan. Originally there had been an entrance through it, blocked at a later date. Through the outer wall, on the opposite side, there was an entrance corresponding to those into Rooms I and II, flanked also by similar platforms.

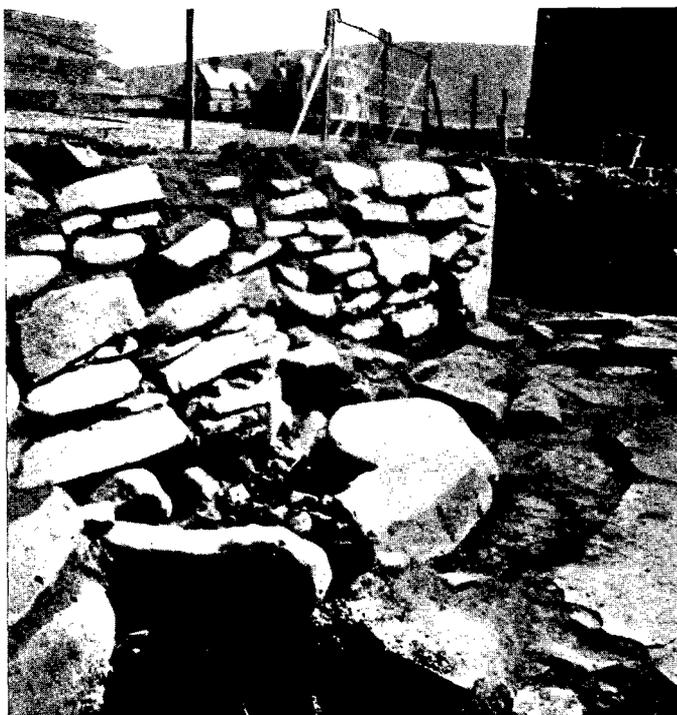
Fig. 6. Fireplace in Alleyway at Base of Wall.

In the alley against the front of this chamber there was uncovered in 1934, beneath the midden refuse, a small fireplace still filled with burnt broken stones (fig. 6). Behind this a flue passed inward through the wall, and, this season, it was met with at the base of the partition wall between Rooms II and III at the rear of the supposed dais. The deposit of peat-ash on the floor of this chamber lay to a depth of nearly 20 inches, and there was no food refuse mixed with it. From the evidence

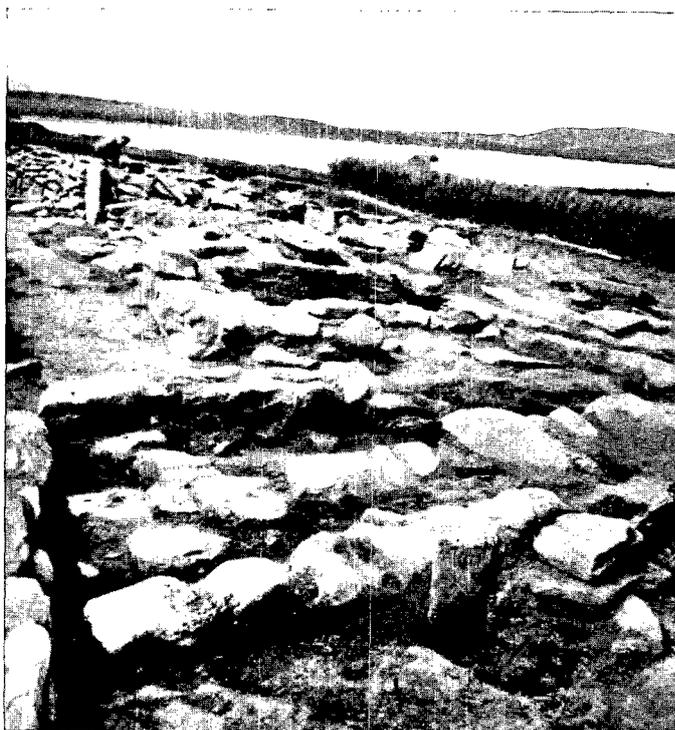
Fig. 7. View across Chambers at the south-east end.

At the extreme south-east end of Viking House No. II, and extending partially across the end of the alley, were the foundations of two other chambers which differed entirely in character from those previously described (fig. 7). A doorway, some 2 feet 9 inches wide, in the south

corner of Room III, gave access to a passage which led westward for a distance of 22 feet into the alleyway, and also to a doorway on the left into a small rectangular chamber, measuring some 7 feet by 8 feet, with a paved floor. The entrance from the passage is singularly narrow, measuring only 1 foot 3 inches in width, but in the south-west corner another entrance 2 feet 9 inches wide opens out from the end of the alley. The wall which forms the south-east end of the above chamber is carried across the alley to meet the outer face of the wall of Viking House No. I, and also forms the north-west wall of a long, narrow

chamber, measuring 2 feet 9 inches in breadth and 10 feet 6 inches in length, with an entrance through its east wall at the north-east corner. On the wall opposite this entrance was a shallow recess some 2 feet 6 inches wide. This chamber had also been paved.

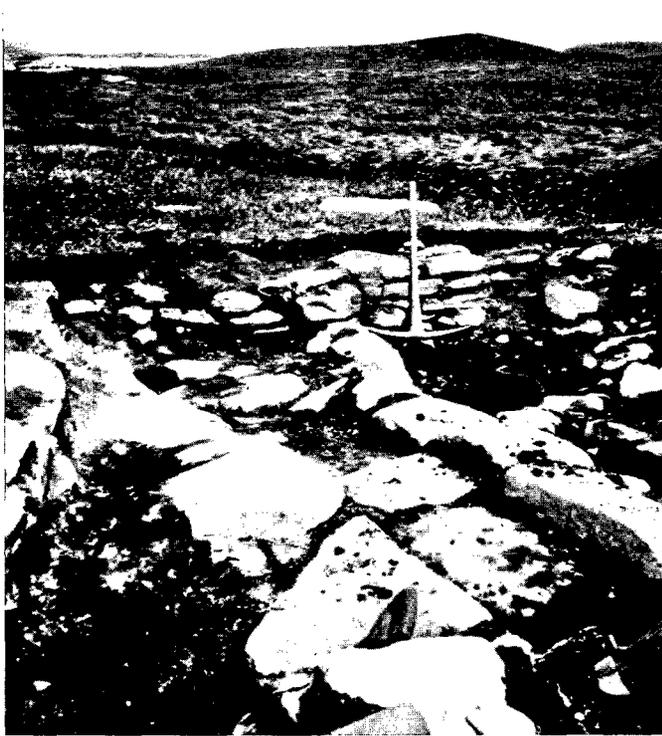
Fig. 8. Paved Passage leading out of Room I.

From Room I a paved passage (fig. 8) led outwards in a north-easterly direction for a distance of 12 feet, gradually expanding in width from 2 feet 3 inches to 4 feet, until it was crossed by a later wall. This wall was found to be the end wall of another building, measuring in the interior some 16 feet in length by 6 feet in width. The wall surrounding

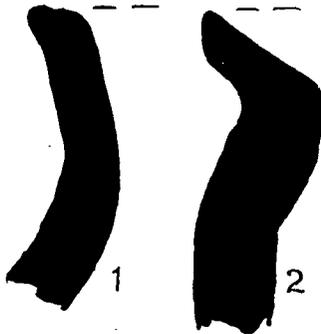
Fig. 9. Sections of Rims found to westward in the Meadow.

Excavation made in the meadow to the westward revealed the existence of other foundations in that direction. Some sherds of coarse pottery (fig. 9) showing an everted rim found among them were not similar to those characteristic of the Viking period as revealed in the excavation of the house, and were probably of later date.

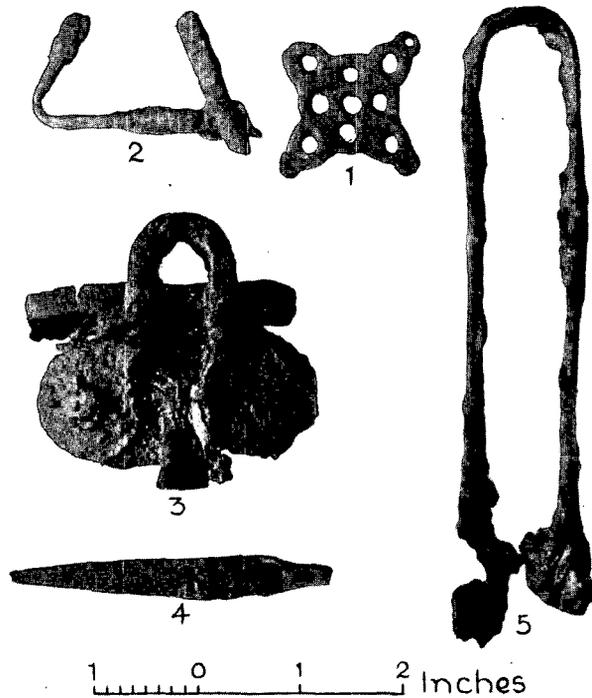
Fig. 10. Miscellaneous Objects of Bronze and Iron.

form of a four-pointed star, pierced with nine circular perforations, and small pin-holes at the end of each point (fig. 10, No. 1). It measured  $1\frac{7}{8}$  inch in extreme length and breadth, allowing for the absence of one point, and resembled a mounting for a binding. From each of the Chambers I, II, and III, as well as from the ground in front, came small

The only other object of bronze found came from the floor of the chamber excavated outside Room I towards the east. It is a broken fragment with two arms, and in appearance suggests a portion of a balance (fig. 10, No. 2).

*Iron Objects (Miscellaneous).*—An iron loop handle with thin strips of bronze attached, probably part of a bucket (fig. 10, No. 3), was found

A knife-blade,  $3\frac{1}{8}$  inches in length (fig. 10, No. 4), was found at floor-level in Room III.

The remains of a pair of scissors (fig. 10, No. 5) were found at about 1 foot below the floor-level in Room III.

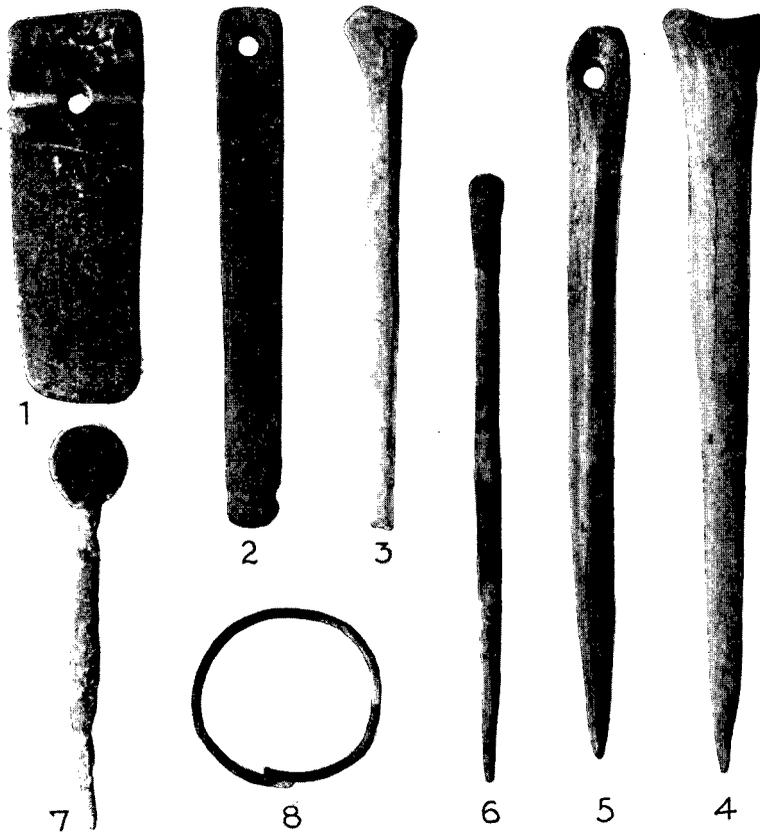
Fig. 11. Hones, Bone Piercers, Bronze Pin, and Brass Ring. (†.)

A piercer,  $3\frac{7}{8}$  inches long (fig. 11, No. 4), was found on the paving of the passage which led out of Room I.

A piercer or needle,  $3\frac{3}{4}$  inches in length and perforated at the head (fig. 11, No. 5), was found in Room III below floor-level.

A broken piercer (fig. 11, No. 3) was found outside Viking House No. I, in midden refuse referable to the Viking period.

*Brass.*—A ring,  $\frac{1}{16}$  inch in diameter, formed of thin brass wire (fig. 11, No. 8), was found in Room III at floor-level (24 feet above Ordnance datum).

*Hones.*—A small black hone, 2 inches in length,  $\frac{3}{4}$  inch in breadth (fig. 11, No. 1), and perforated at one end, came from Room I, and portions of haunched hones (fig. 12) came from Room III, the trench in front of the Mausoleum at a high level, and from the meadow. A small black hone of slate (fig. 11, No. 2), perforated at one end and notched at the other,

*Pins.*—A bronze pin,  $3\frac{1}{8}$  inches in length, circular in section, measuring  $\frac{3}{16}$  inch in diameter at one end and tapered to a point at the other, with ribs formed of fine lines on the upper half extending for about  $\frac{1}{2}$  inch down (fig. 11, No. 6), was found in the alleyway.

A disc-headed pin of bronze,  $2\frac{1}{8}$  inches in length (fig. 11, No. 7), came from the floor-level of the building in front of Room I. A similar pin was found in the Broch of Burray, Orkney, and is preserved in the National Museum of Antiquities.

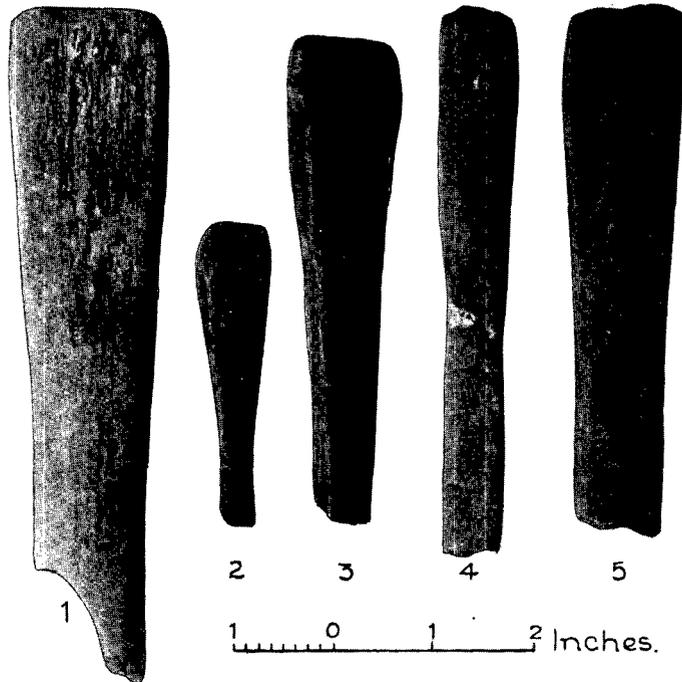
Fig. 12. Haunched Hones.

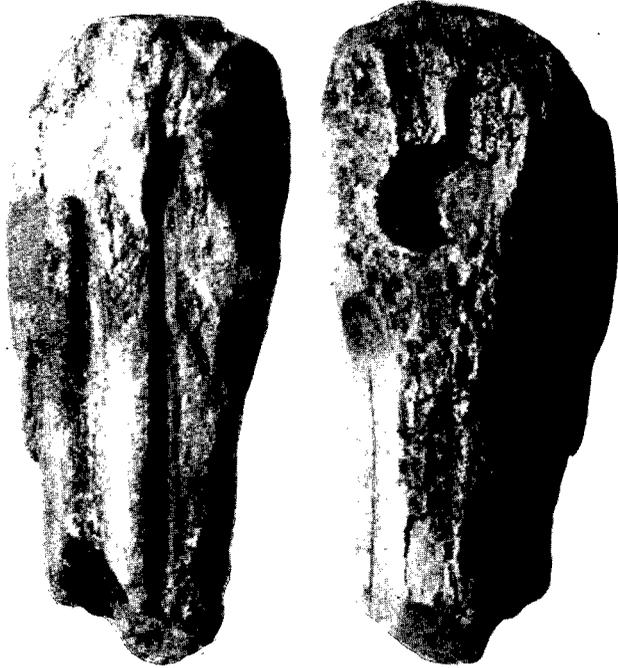
Fig. 13. Mould of Steatite.

*Mould.*—An object of steatite (fig. 13), with three pin-shaped matrices cut in it on one side, one similar on the other, and also on the latter a

cylindrical matrix, was found under a paving-stone in the building outside Room I to the east.

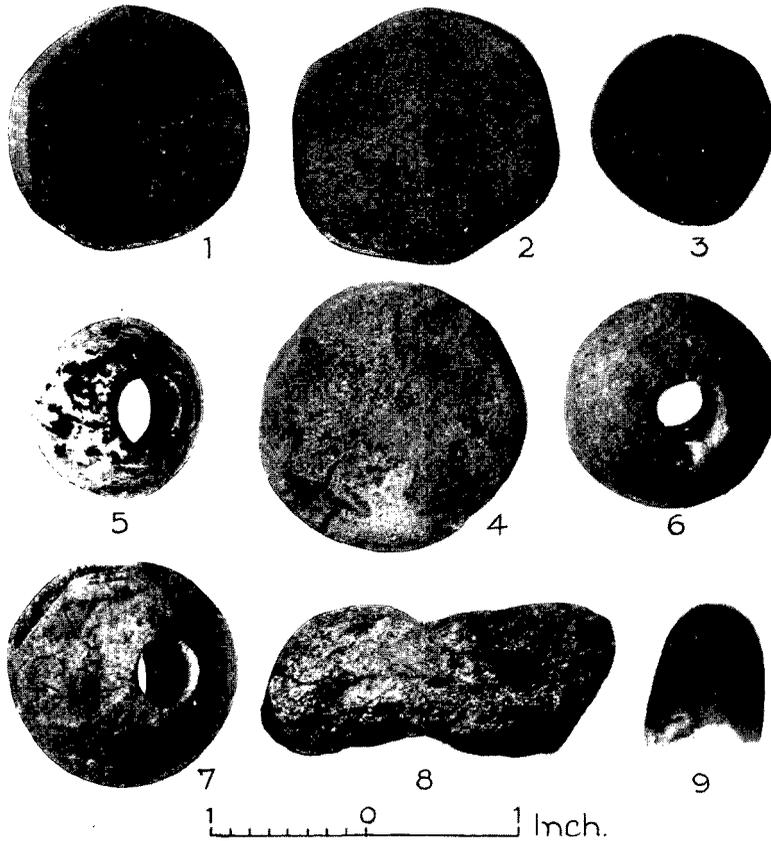
Fig. 15. Miscellaneous Objects of Stone and Perforated Femur.

*Bone Objects.*—A perforated head of a femur, measuring  $1\frac{1}{2}$  inch in diameter and 1 inch in height (fig. 15, No. 7), was found below the turf in the supposed store chambers at the south-east end. Similar objects were found in the course of the excavation of the prehistoric dwellings at Jarlshof in 1933, and as one of these came from the earth-house "h" it was presumably contemporary.<sup>2</sup> Another was found at a high level in the Viking house in 1934.<sup>3</sup> A number have been found in brochs. These objects are usually designated whorls, but such employment for all of them is not obvious.<sup>4</sup>

*Polisher of Quartz.*—A small pebble of white quartz, 1 inch in length (fig. 15, No. 9), reduced to a flat surface and highly polished at one end, was found in Room II.

*Stone Objects.*—A shaped object of steatite (fig. 15, No. 8), incompletely perforated at one end,  $2\frac{1}{4}$  inches long, and with a constriction around the centre, was found in opening out the store-rooms at the south-east end.

the store-rooms; another,  $2\frac{1}{4}$  inches in diameter, was found at floor-level in Room II. A similar disc of same dimension was found at floor-level in Room III. Another, measuring  $1\frac{1}{2}$  inch in diameter (fig. 15, No. 1), was found on floor-level in the store-rooms. Another, measuring  $1\frac{5}{8}$  inch in diameter (fig. 15, No. 4), was found outside Room I; and a sixth, measuring  $1\frac{1}{8}$  inch in diameter (fig. 15, No. 3), was found on the floor-level of the building in front of Room I. There is nothing to show what purpose these discs served, but it seems likely that they were used in a game.

*Whorls.*—Only two whorls (fig. 15, Nos. 5 and 6) fall to be recorded, and neither came from last season's excavation. Both were found on the wall-head of Viking House No. I during solidifying operations in the autumn of 1934.

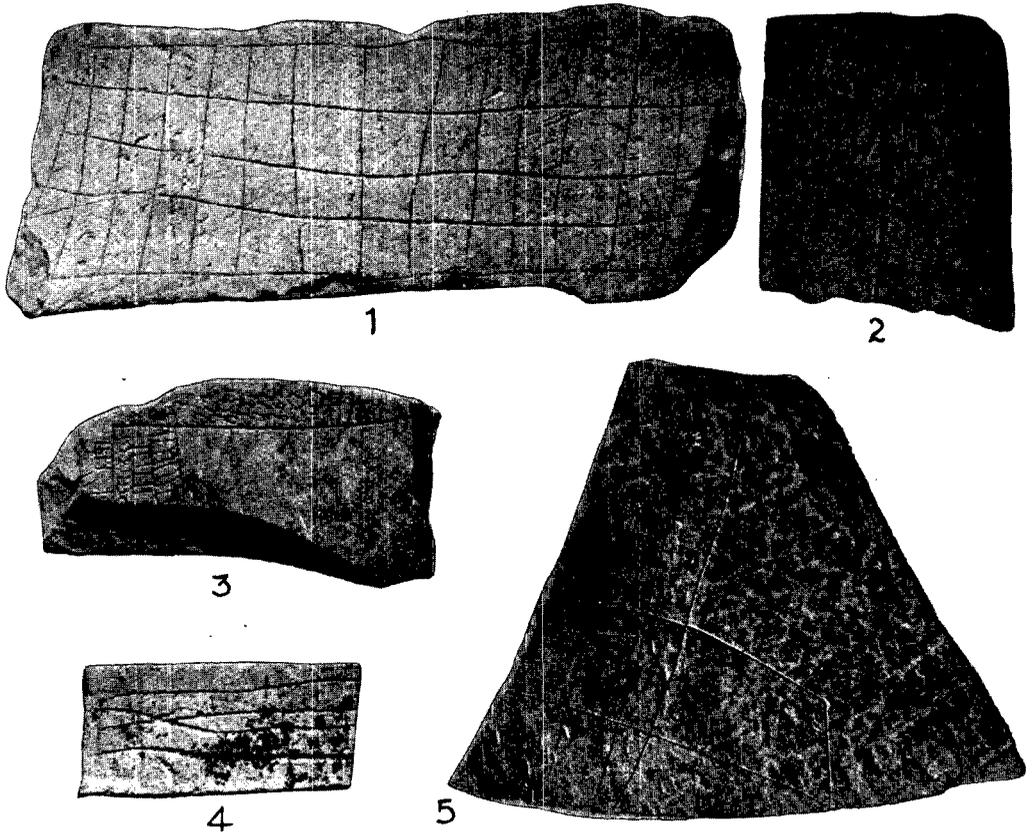
Fig. 16. Slates with Markings in Graffito. (†.)

intersecting lines seems to have been the general motive aimed at, and occasionally this has been partially scored out with cross lines (fig. 17, Nos. 3 and 4). One slate only appears to be approximately complete (fig. 16, No. 1). It is in form oblong, measuring  $3\frac{3}{4}$  inches by  $1\frac{1}{2}$ , and it

has been divided into fifty-six compartments by longitudinal and transverse lines. There are no markings within the squares.

There is one fragment (fig. 16, No. 3) on which are incised markings quite different from any met with previously. The surface has been divided into two by a deeply scored line running lengthways of the stone. The division to the right has been filled with an ornament

which resembles scales, or links, placed vertically, with a transverse band towards one end. The other division, which remains plain towards the broader end of the fragment, has been divided at the upper end into five divisions by cross lines. The lower two have been filled with

vertical strokes, that immediately above with a series of C curves; the next above with carefully cut vertical lines, with a space left between the first line on the left and the second, into which has been inserted, adjacent to the first stroke, a C curve adhering to the upper divisional line, while all that remains of the graffiti in the upper division are some portions of oblique and vertical lines. There is a suggestion in the

series of horizontal lines with their distinctive markings that this slate may be a portion of a record or tally. It was found on the wall-head of Viking House No. I during solidifying operations in the autumn of 1935. No. 2 on the same fig. as the last shows also the scheme of

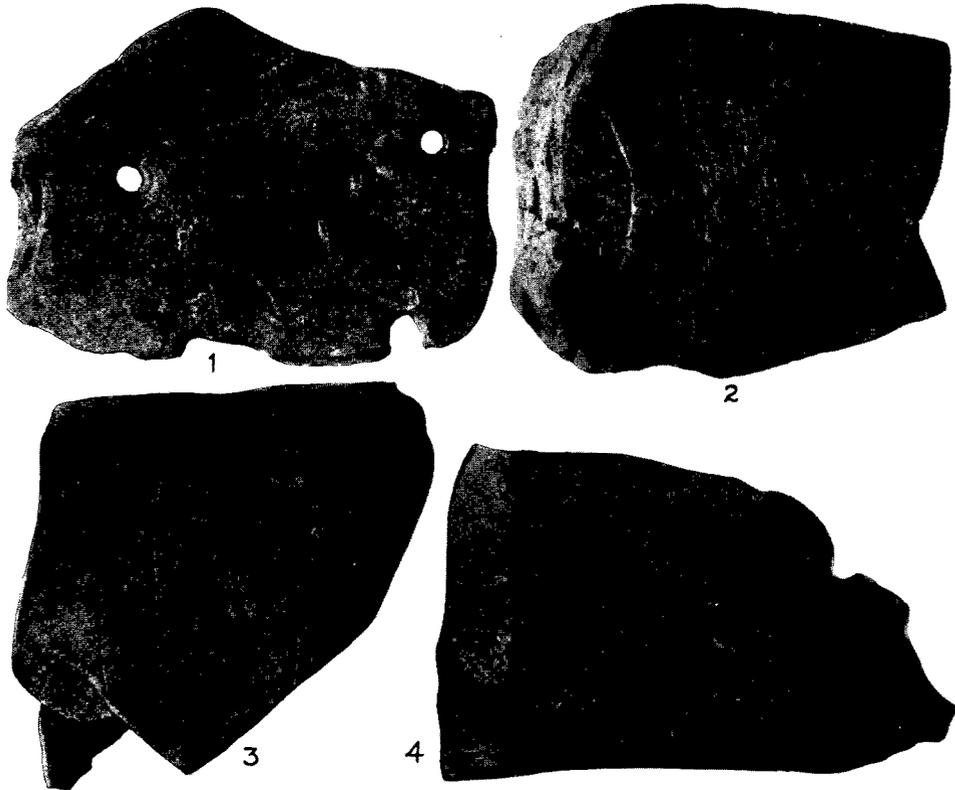
Fig. 17. Slates with Markings in Graffito. ( $\frac{2}{3}$ .)

squares. No. 5 shows a somewhat different arrangement of lines, quite enigmatical.

Two of the slates have been perforated. Fig. 18, with three perforations, has a series of graffiti apparently radiating from a point and crossed by a single stroke, in the lower left corner, and is pierced by three holes, approximately in alignment, along the opposite edge. Fig. 17, No. 1, shows four perforations of larger diameter.

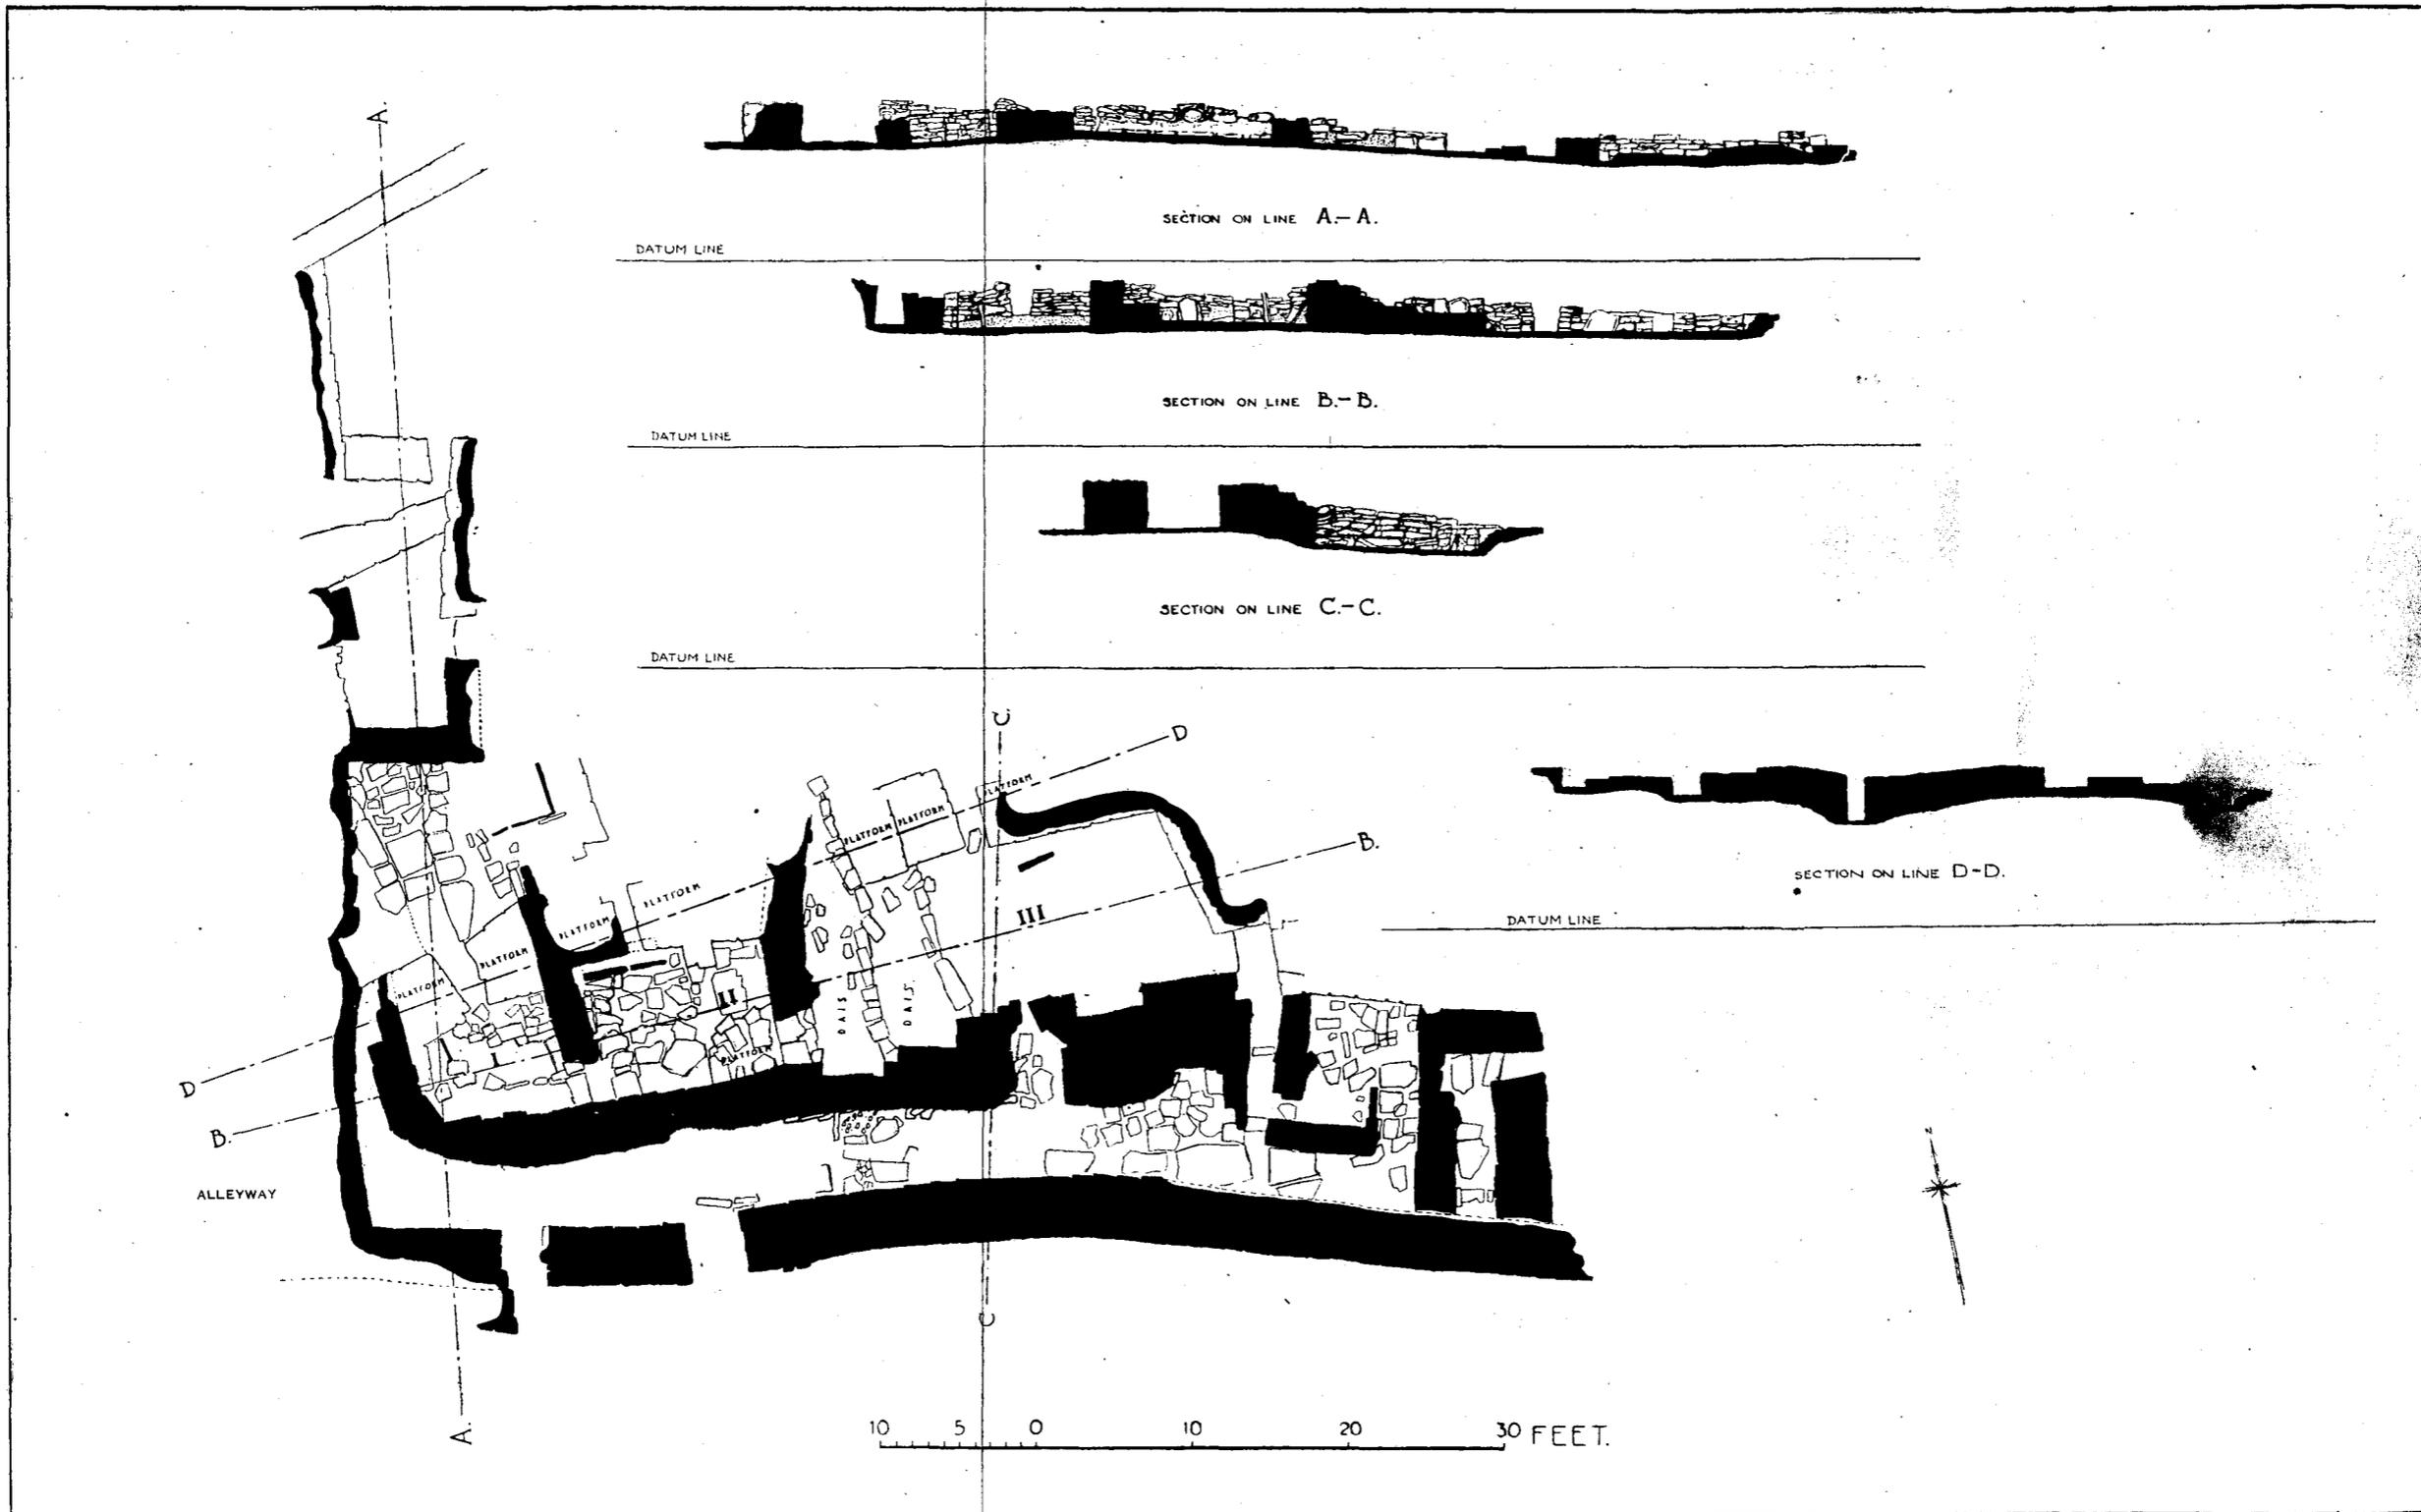
PLATE I.

PLAN AND SECTIONS OF FURTHER VIKING BUILDINGS AT JARLSHOF.

In 1935 the structure on the opposite side of the alley, and a group of associated chambers to the south-east, were examined. Unfortunately the greater part of the meadow in which the ruins were situated had been brought under cultivation, and a crop of bere prevented the complete exploration of the site towards the east. The building facing the alley was in a very ruinous condition and the plan difficult to ascertain. Originally it had been a house, possibly a dwelling, or a range of rooms or offices associated with another Viking house lying to the east of it in the ground under crop. It measured some 50 feet in length, was rounded at either end, and lay parallel to the dwelling previously excavated (see plan, Plate I). There had been an entrance 3 feet

The most interesting features discovered in the course of this excavation were the platforms (see plan) situated at the entrance to Rooms I, II, and III, and in the east corner of Room II of Viking House No. II. In all probability these were erections intended for the support of box-beds.<sup>1</sup>
