**Combined Herefordshire & Shropshire Report for an
Assessment of the Archaeological and Conservation
Status of Major Later Prehistoric Enclosures in
Herefordshire and Shropshire**

EH PNUM 5831

**Prepared by:
Peter Dorling (Senior Project Archaeologist, Herefordshire Council)
&
Andy Wigley (Principal Archaeologist, Shropshire Council)**

13 November 2012

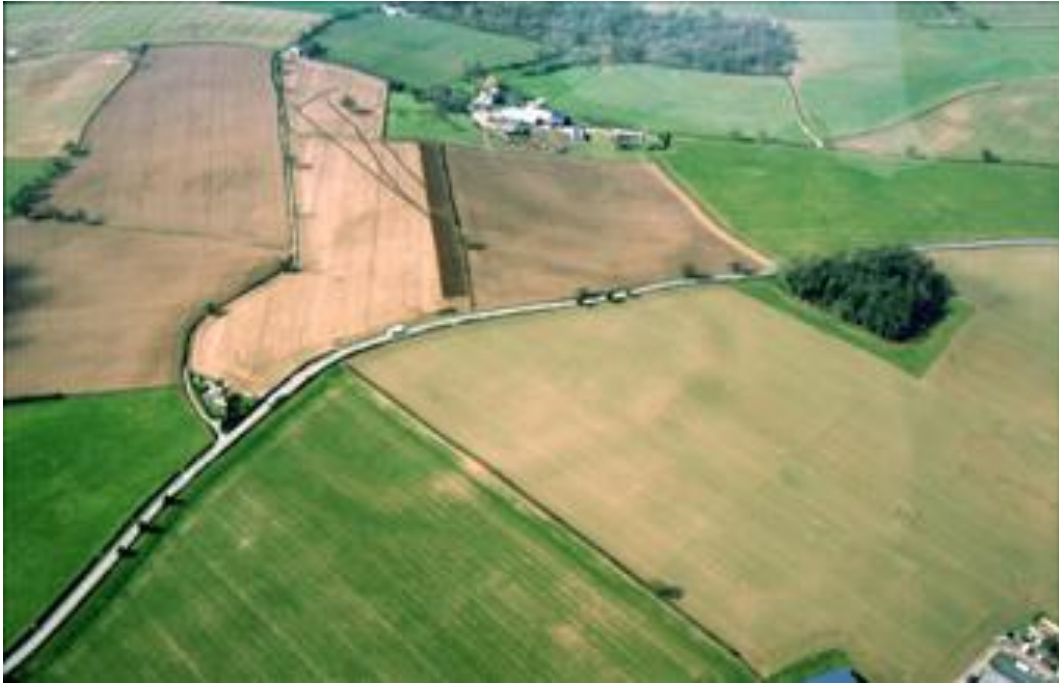
Gear Cop Hillfort, Hentland between Hereford and Ross-on-Wye. An unscheduled hillfort under ploughing

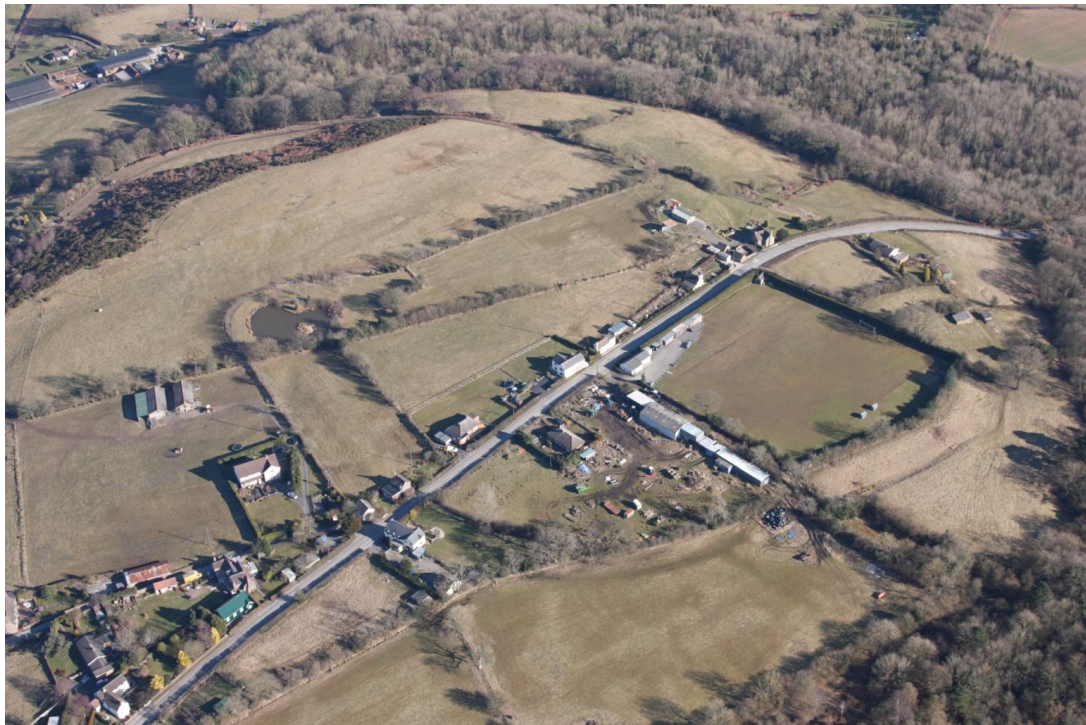
Potential new hillfort at Knowle, Shropshire, identified in 2002 during the Shropshire HLC project.

In Shropshire a potential new hillfort site at Knowle, c.9km east of Ludlow, was identified in 2002 during the Shropshire Historic Landscape Characterisation project (see frontispiece). A substantial bank and ditch are present within one field in the south-western quadrant of the site and a degraded continuation of the bank exists under a hedge to the north-west. On the eastern side of the site the bank appears to have been completely removed, although a continuation of the ditch is visible in pasture on the northern side on some vertical aerial photographs of the site. It is possible that the earthworks on the eastern side of the site have been removed by post-medieval encroachment and agricultural improvements although it is equally plausible that it represents an unfinished hillfort. The site has since been photographed from the air (see frontispiece) and a geophysical survey within the eastern half of the site would resolve the question as to whether this site is a hillfort.

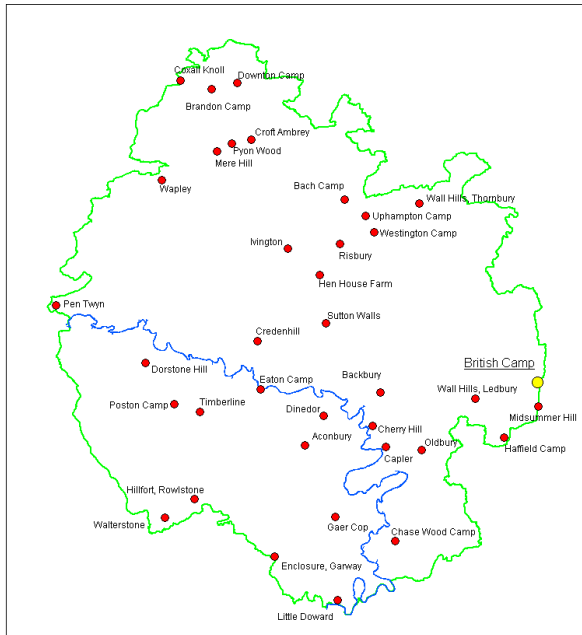
British Camp

SMR No:	932
SAM No:	HE 3
Survey level:	3
Excavation:	1879, Hilton-Price
Land Use:	Heath, rough grazing
Historic land use	Heath, rough grazing
Overall survival:	3
Conservation issues:	Recreation – erosion on paths Burrowing animals – rabbits Vegetation – bracken, gorse, scrub
Management plan or agreement:	None current
Access:	Open Access, Malvern Hills Conservators

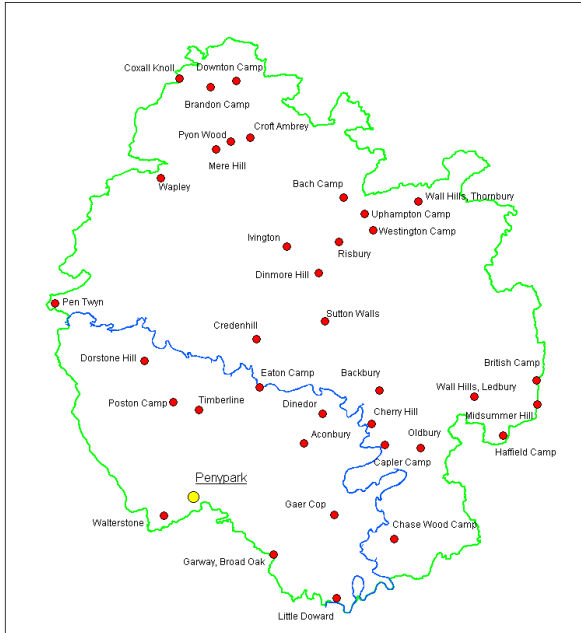
Penapark

SMR No:	10360
SAM No:	Not scheduled
Survey level:	1
Excavation:	None known
Land Use:	Pasture
Historic land use:	Arable
Overall survival:	1
Conservation issues:	None
Management plan or agreement:	Higher Level Stewardship scheme agreement
Access:	Private

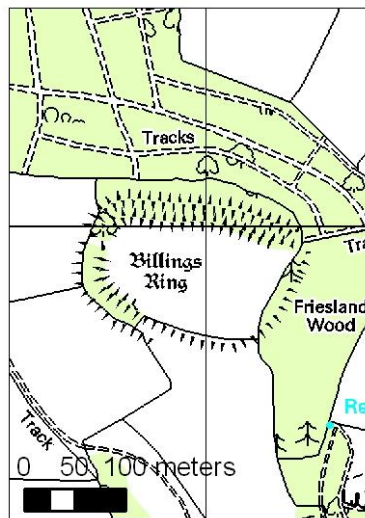
Name	Billings Ring
HER No	00154
SAM No	34940
Survey level	2
Land Use	Eastern edge of hillfort and land to the north has been in long term woodland. Interior of the site and the fields to the south and west were cultivated until the end of the 1980s, now managed under permanent pasture.
Overall survival	3
Scheduled area	Scheduled area reviewed under MPP
Conservation issues	Scrub and young tree growth has recently been cleared from the western and southern rampart under a CSS agreement leading to a marked improvement in the condition of the site. Very large and active badger set within W rampart, S of the entrance, which has exposed a large amount rampart material and is leading to collapse in places.
Management plan or agreement	Currently in CSS application for HLS in progress
Access	P
Amendments or additions to HER description	There is a distinctive break of slope along the top of the ramparts on the N and W sides of the monument. Whilst this may be a production of later 20 th century ploughing, it could also represent the remains of a post-medieval hedge bank or possibly a late phase of the defences.

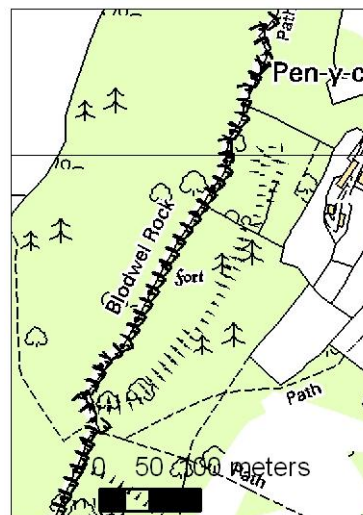
Name	Blodwell Rock
HER No	01439
SAM No	Salop 13
Survey level	2
Land Use	Woodland; Scrub
Overall survival	3
Scheduled area	It is understood the scheduling of this site was reviewed under MPP but has yet to be revised.
Conservation issues	S end of site has been densely replanted with mixed woodland and fencing is present on the W rampart (Offa's Dyke).
Management plan or agreement	No
Access	Footpath
Amendments or additions to HER description	Double rampart at the N end. No obvious entrance here, but obscured by heavy scrub and young tree growth. Single rampart on W side (Offa's Dyke?) and on E side. Multiple ramparts on S side, again obscured by vegetation. Possible causeway entrance at SW corner.
Management history and condition trend	Site is currently obscured by plantation woodland.
Excavation	None known
Select Bibliography	Fox & Hemp 1926; Hannaford H R 2007: Blodwell Rock: Watching Brief

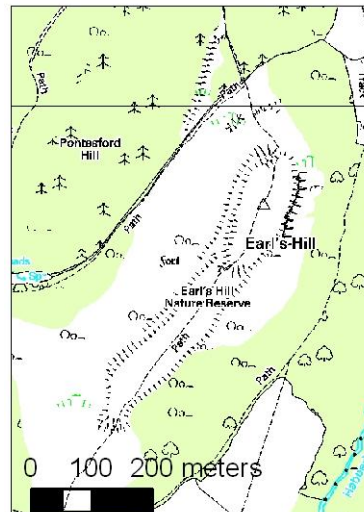
Name	Earl's Hill
HER No	01050
SAM No	34903
Survey level	2
Land Use	Pasture
Overall survival	3
Scheduled area	Scheduled area reviewed under MPP
Conservation issues	Some visitor erosion along main paths, particularly where it crosses the rampart between the main enclosure and the annex. Extensive evidence for rabbit burrowing.
Management plan or agreement	HLS application in progress.
Access	Open
Amendments or additions to HER description	
Management history and condition trend	Site is owned by Shropshire Wildlife Trust and has long been managed sympathetically.
Excavation	None known
Select Bibliography	Victoria County History 1 (1908), p368-9; Forde-Johnson 1962

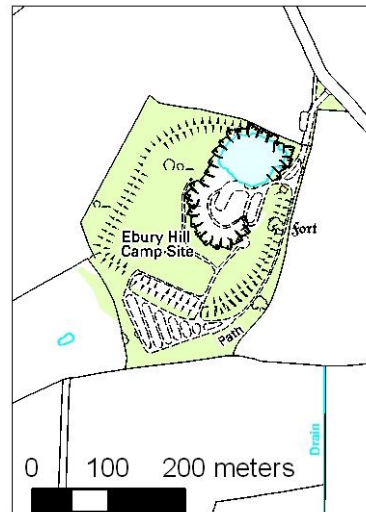
Name Ebury
HER No 00113
SAM No 35856
Survey level 2
Land Use Woodland, Other (caravan site)
Overall survival 2

Management history and condition trend The north-eastern quarter of the site was removed by quarrying in the early 20th century and the eastern and southern parts of the sites heavily disturbed by the WWII vehicle testing station. Facilities for the caravan site have been gradually upgraded since the early 1980s.

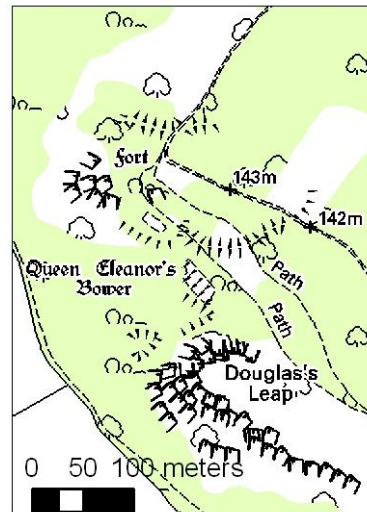
Name	Haughmond Hill
HER No	00135
SAM No	34950
Survey level	2
Land Use	Woodland, scrub and pasture
Overall survival	2
Scheduled area	Forestry Commission SM management plan
Conservation issues	There are extensive areas of successional woodland and bracken cover on the monument. Multiple trackways cross the monument, many of which exhibit evidence of significant erosion. The toposcope is located on the highest part of the monument, where there is also extensive visitor erosion.
Management plan or agreement	Site owned Forestry Commission
Access	Open
Amendments or additions to HER description	
Management history and condition trend	Haughmond Hill has been a popular with walkers and cyclists for many years and is now actively promoted by the Forestry Commission as one of their major countryside sites in the county. A easy access track was laid to the monument c. 5 years ago and toposcope has been installed within the past year.

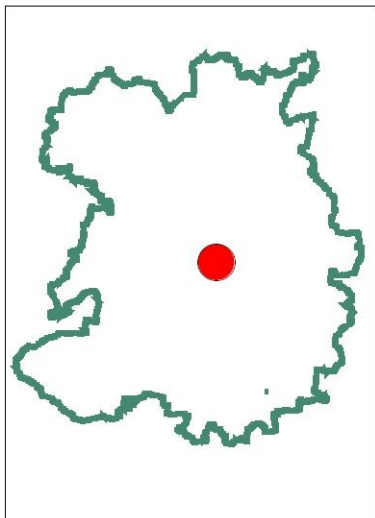
Name	Stevenshill
HER No	01438
SAM No	N/A
Survey level	2
Land Use	Arable, woodland
Overall survival	1
Scheduled area	This site is not scheduled
Conservation issues	Whole of the interior of the site is under intensive arable cultivation, which includes a potato rotation. The ramparts are managed under mature woodland, which has an understory of scrub in places.
Management plan or agreement	HLS (on arable area)
Access	Private
Amendments or additions to HER description	<p>Possible lime kiln on edge of quarried area in SE corner of the site.</p> <p>Most of the main rampart at NE side of site survives under woodland cover.</p> <p>Ramparts appear to be stone revetted.</p>
Management history and condition trend	The NW rampart was levelled in the mid-1980s, after the site was discovered through aerial photograph and shortly after the OS produced an antiquity model. Current deep ploughing and subsoiling within the interior appears to be bringing bedrock to the surface, suggesting that only deep, rock cut features are likely to survive. Arable reversion under the HLS is therefore

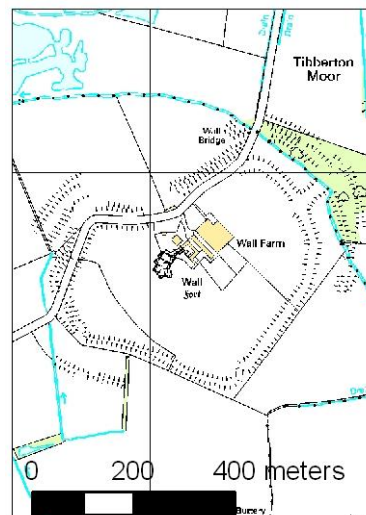
Name	Wall Camp, Kynnersley
HER No	01108
SAM No	34907
Survey level	2
Land Use	Pasture, arable
Overall survival	3
Scheduled area	Scheduled area reviewed under MPP
Conservation issues	The majority of the site is in exemplary management under a HLS agreement. There is one large badger sett along one of the boundaries on the SE side of the site. Occasional rabbit burrows are visible elsewhere, particularly within the area of very old scrub/ woodland at the N end of the monument. One small section of the NE rampart is planted with miscanthus.
Management plan or agreement	HLS
Access	Permissive access under HLS agreement
Amendments or additions to HER description	
Management history and condition trend	Parts of the site were cultivated until the late 1980s but has benefited from arable reversion under successive CSS and HLS agreements.
Excavation	Pagett 1962-5; Bond 1983
Select Bibliography	Victoria County History 1 1908, p374-5, Pagett 1965, 1967; Bond 1991; Morris 1991; Malim and Malim 2010
