Crowtrees Colliery, Quarrington Hill, County Durham

Archaeological Building
Recording

Prepared for
The Crowtrees Heritage
Group

Report No: 0061/02-10

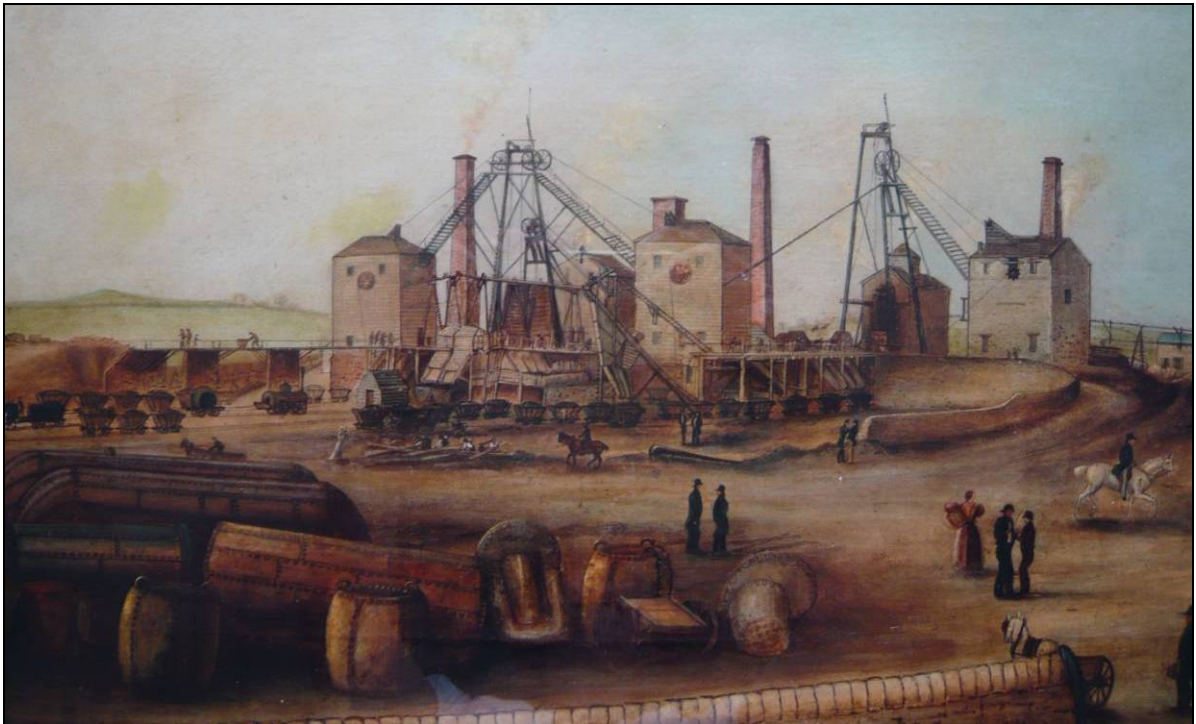
Plate 1: *a painting of Crowtrees colliery by the artist J. Wood (c. 1840) held in the Beamish Museum collection. This painting clearly illustrates the high standard of the mine buildings, stone from which may have been used in the construction of the Phase III winding-engine house.*

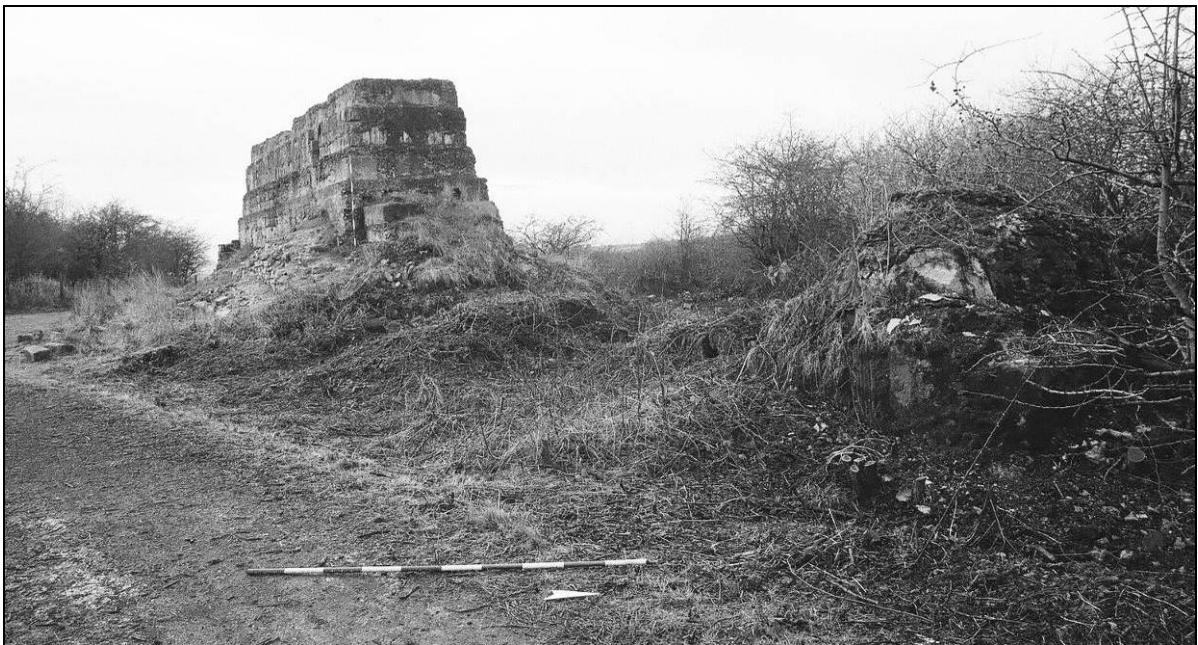
The surviving complex of structures is orientated north east to south west and measures 31.35m in total along its main axis. It comprises three separate elements: a) the winding-engine house; b) the capped pit head, and c) the east platform (pumping-engine base) (Plate 2).

Plate 2: *the winding-engine platform (100) with the capped-pit head (300) in front in the middle distance of the picture and the east platform (200) in the foreground*

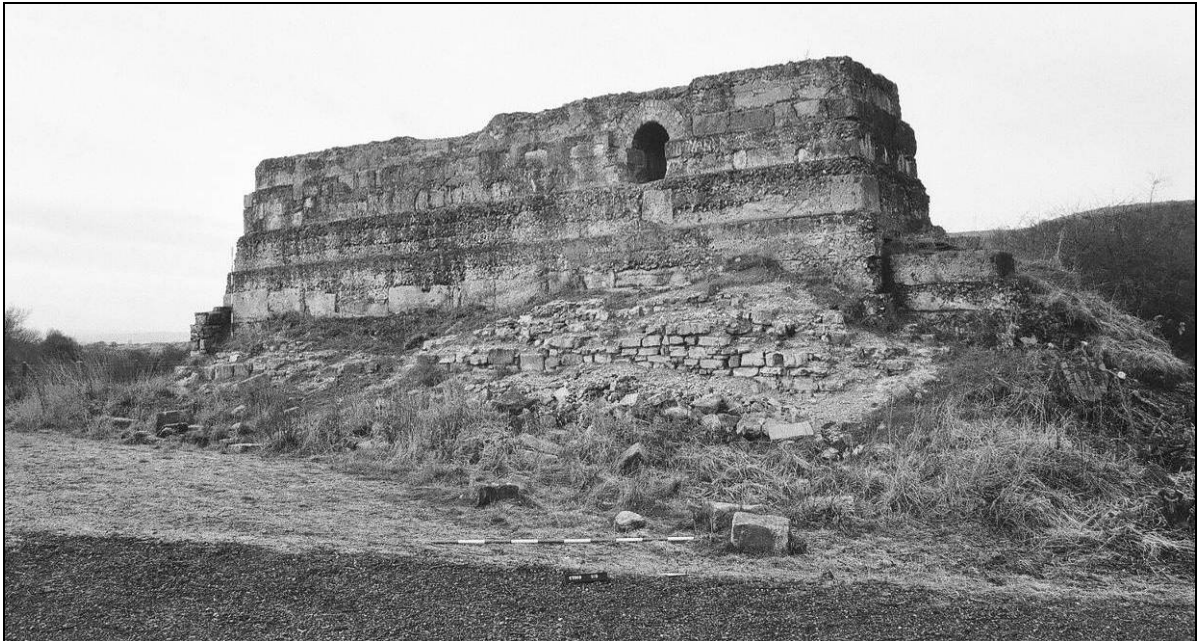
Plate 3: *South facing elevation (110) of the surviving engine platform (150) with remains of the building façade wall in front (112)*

The engine platform (150) survives to a height of 4.60m, although the north stack (160) is a little higher at 5.45m. Again, this is just what survives today but originally the building would have been much higher and included a roof. The roof is likely to have been a simple A-frame, or hipped structure like those shown in the painting of the earlier colliery (Plate 1). Around the base of the building the ground level has been raised quite considerably by deposits of fallen masonry and debris which has banked up against the structure and is now largely grassed over. A collection of large ashlars and roughly squared blocks can be seen scattered at the base of the building, particularly on the south side; these measure nearly a metre across in some cases.

The building is constructed of large masonry blocks interspersed with layers of shuttered concrete. This form of construction may have been used to absorb and redistribute some of the vibration from the engine mounted on top of the platform. The combined weight of the steam-engine and winding drum, coupled with the vibration caused by the machinery running at often 500 revolutions a minute, would place huge amounts of stress on the buildings foundations (RCAHMW 1994, 21). The courses of masonry blocks may have allowed for some degree of movement, being less rigid and prone to cracking than the concrete, whilst still providing structural support. The concrete used in the building is quite coarsely mixed, with large pieces of limestone rubble aggregate, some measuring 0.10m in diameter. The concrete would have been cast on site, the imprint of the timber planking frame still clearly visible on the surviving building. It was not reinforced, which might further account for the use of the masonry layers to provide some additional strength. Reinforced, or 'Ferro' concrete was not used extensively in British mines until the early part of the 20th century (*ibid*, 21).

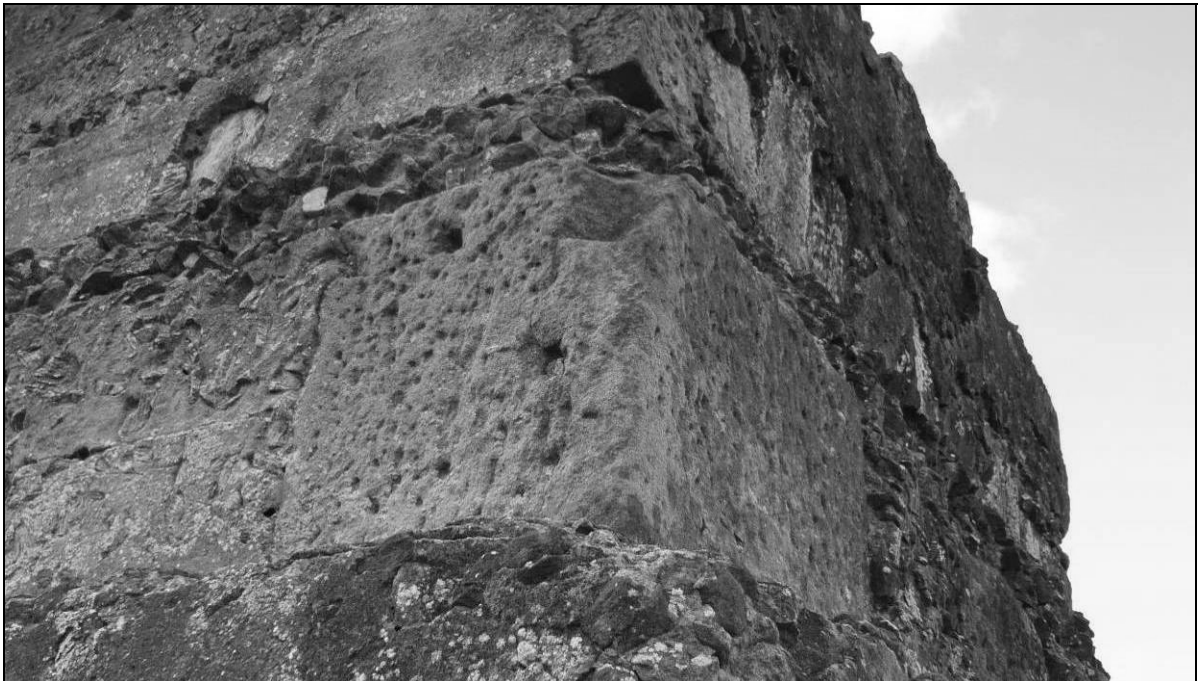
The stone blocks used in the building are of some considerable size; one of the largest being over 1.50m long and nearly a metre wide. Many of these blocks are clearly re-used from another building, and given the degree of difficulty in transporting such huge blocks any great distance, coupled with the evidence of bolt holes and mouldings on some of the stones, it seems highly likely that these were from the Phase II colliery further to the north east. The quality of the dressing and tooling of some of the blocks indicates that these original buildings may have been of some status, further supporting the idea that the earlier colliery was very much a 'showcase' project.

Plate 4: *piece of re-used masonry built into engine platform - note the hole on the left hand face of the stone near the top; this may be for a fitting of some form or could be an indentation left by the brace used to lift and transport the block (112)*

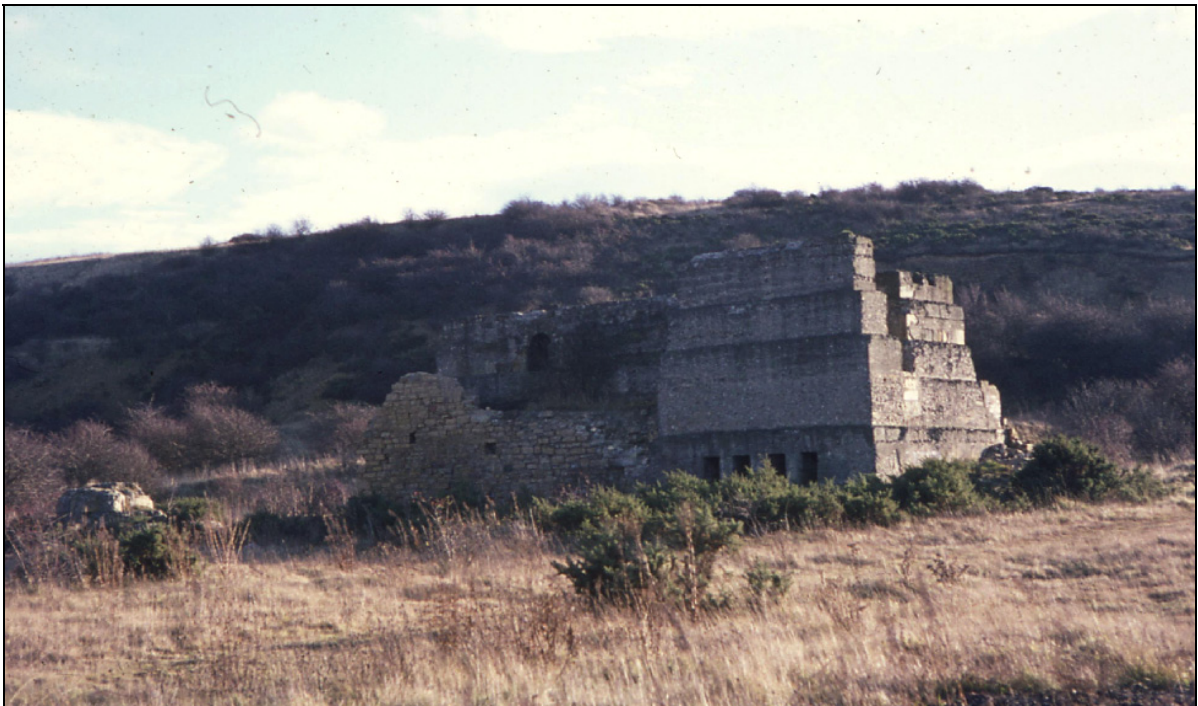
Plates 5: *photograph of the winding-engine house taken by Don Wilcox in the 1970s (c. Durham County Council). The northern exterior façade wall is clearly shown as standing to some height.*

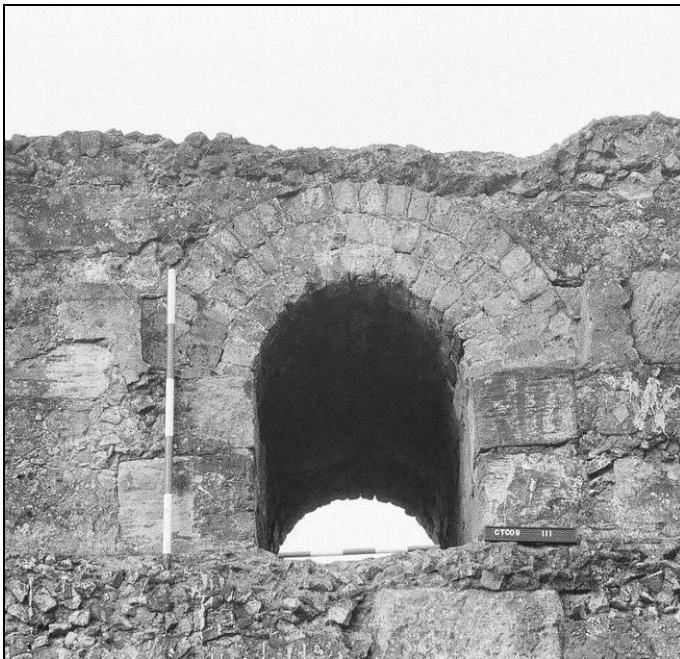
One of the most prominent features of the southern elevation is the brick headed arch at the eastern end (111). The arch aperture measures 0.20m across and stands to a height of 1.00m. It runs through the whole width of the building (2.70m) at the height of the second tier (2.50m). The arch is framed by sandstone blocks and features three tiers of red, rubbed-brick voussoirs. The wall surrounds on each side step in to form a plinth which could be a support for a platform or bearing. However, there is no indication of wear anywhere on feature and this, together with its location, would argue against it housing any type of bearing or drive shaft. On the inner face of the arch there are

two shallow slots running up into the concrete above; these connect with two of the eight bolt holes identified on top of the engine platform. The exact function of the arch remains unclear at present.

Plates 6 & 7: brick headed arch (111). The second photographs shows the detail of the slot on the arch soffit which links with the bolt holes at the top of the engine platform

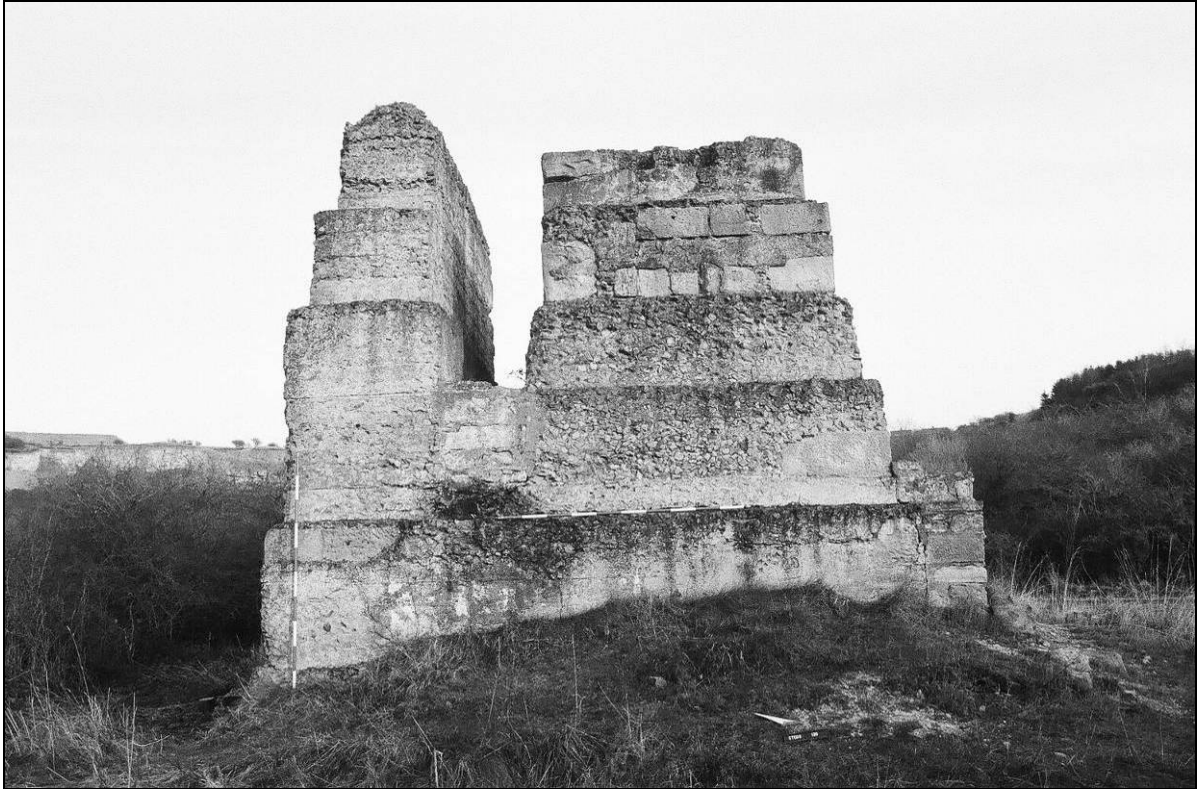
The crank arm slot (170) measures 1.00m wide and starts at a height of 2.40m above the present ground level, extending 2.20m to the top of the engine platform. At the base of the feature there is a small area of repaired masonry (121) but there are no other associated features such as mounting or bearing holes which would suggest that this was ever a void for a wheel or beam of any sort. The main function of the slot was to provide for the movement of the crank arm attached to the adjacent horizontal steam engine. The crank arm would drive the revolutions of the winding drum.

The rectangular supporting stack (160) to the north of the crank arm slot survives to a height 0.60m above that of the engine platform. It is constructed largely of shuttered concrete, although some masonry blocks are used on the lower levels. It rises in a series of stepped tiers which correspond to those of the main engine platform and the two features are obviously integrated and built at the same time.

Plate 8: West facing elevation of winding-engine base showing engine platform (150) to the right, crank arm slot (170) and stack (160) to right.

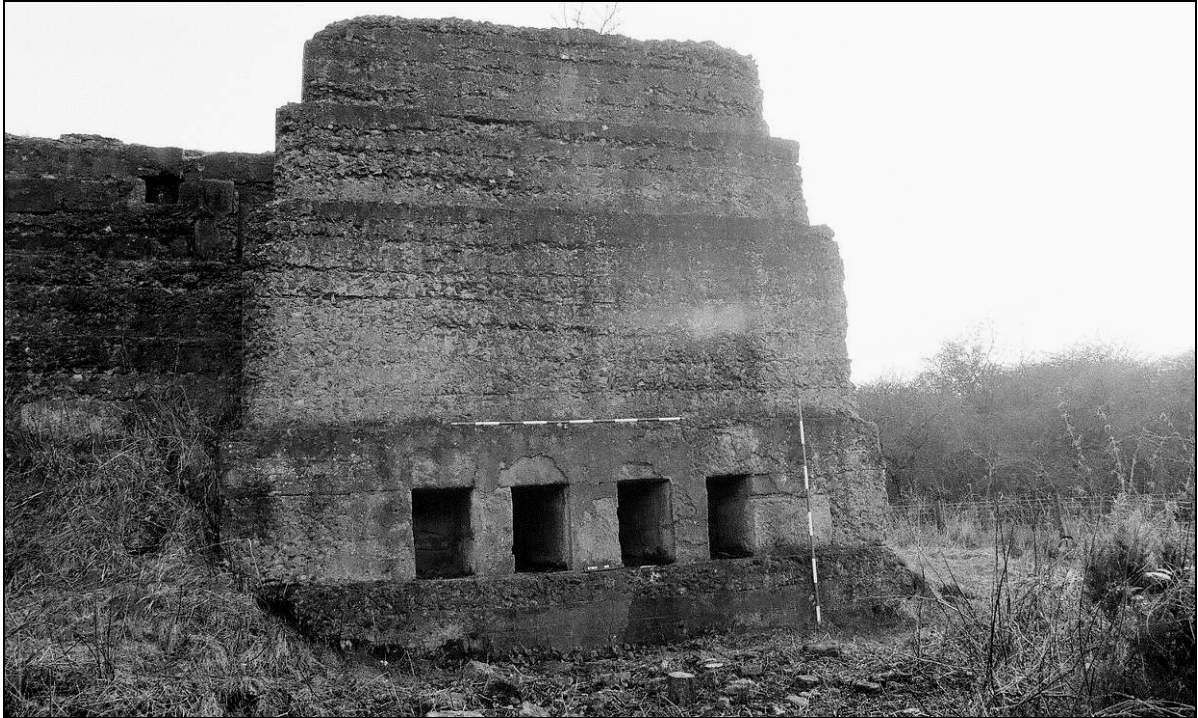
Plate 9: *North facing elevation (130) of winding-engine base showing bolt access apertures (131) in the cement stack (160)*

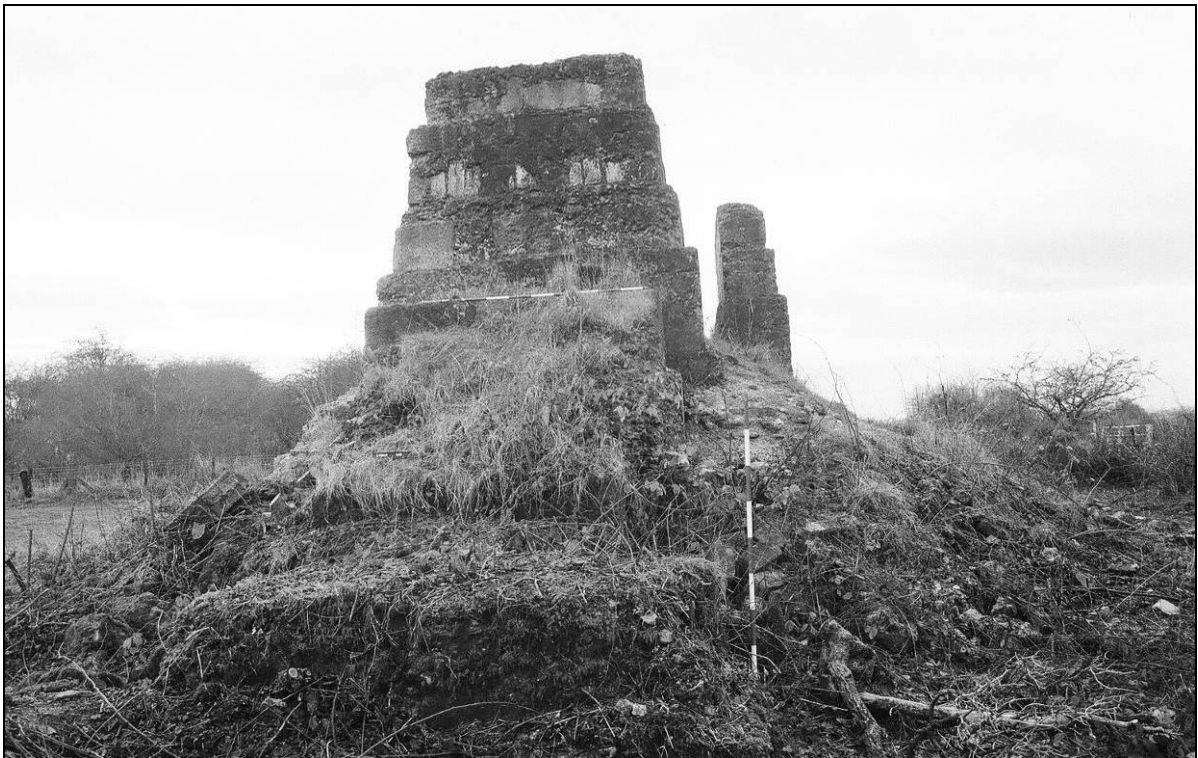
This elevation comprised the stepped structure to the east of the engine platform (180), as well as the void created by the crank arm slot (170) and the adjacent concrete stack (170). The stepped structure (180) is slightly offset to the north and is not directly central to the engine platform; this is consistent with the building originally being rectangular. Located at the top of the stepped structure (180) are the two wooden beams (181) and beam slot (183) detailed above. Just below the two beams is another bolt access aperture (184) which is partially buried.

Plate 11: *East facing elevation (140) of winding-engine base showing structure (180), probably the base support of the headframe*

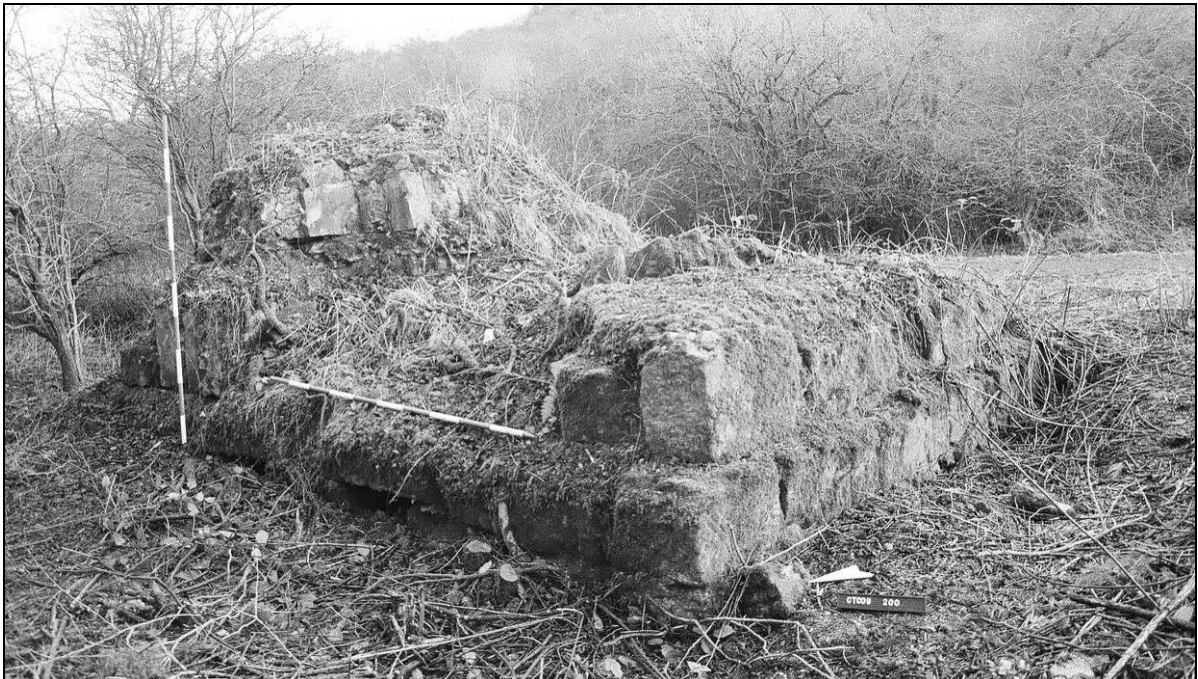
At the eastern end of the complex is the remains of a low, rectangular platform which measures 5.80m north east to south west and 3.60m across. The core of the structure is an outcrop of the natural Magnesian limestone which has been faced with re-used ashlar and roughly squared blocks. The platform survives to a height of 1.80m at the eastern end, and 0.90m at the west end where it adjoins the pit head. This difference in height appears to have been part of the original design of the building, although this cannot be confirmed absolutely. Clearance of soils and debris from the top of the structure might establish its original form and discern if any bolt holes or fitting survive; evidence for these can be deduced from the surviving bolt-hole apertures (201) on the north face.

Plate 12: East platform (200) showing north face (110) with bolt access apertures (211) just visible

The two apertures are of a similar dimension to those found on the winding engine house (131 and 184) and probably served the same function. They can be seen, located just above ground level on the north side of the structure. However, the features on the east platform are largely obscured and further clearance would be required to confirm their function.

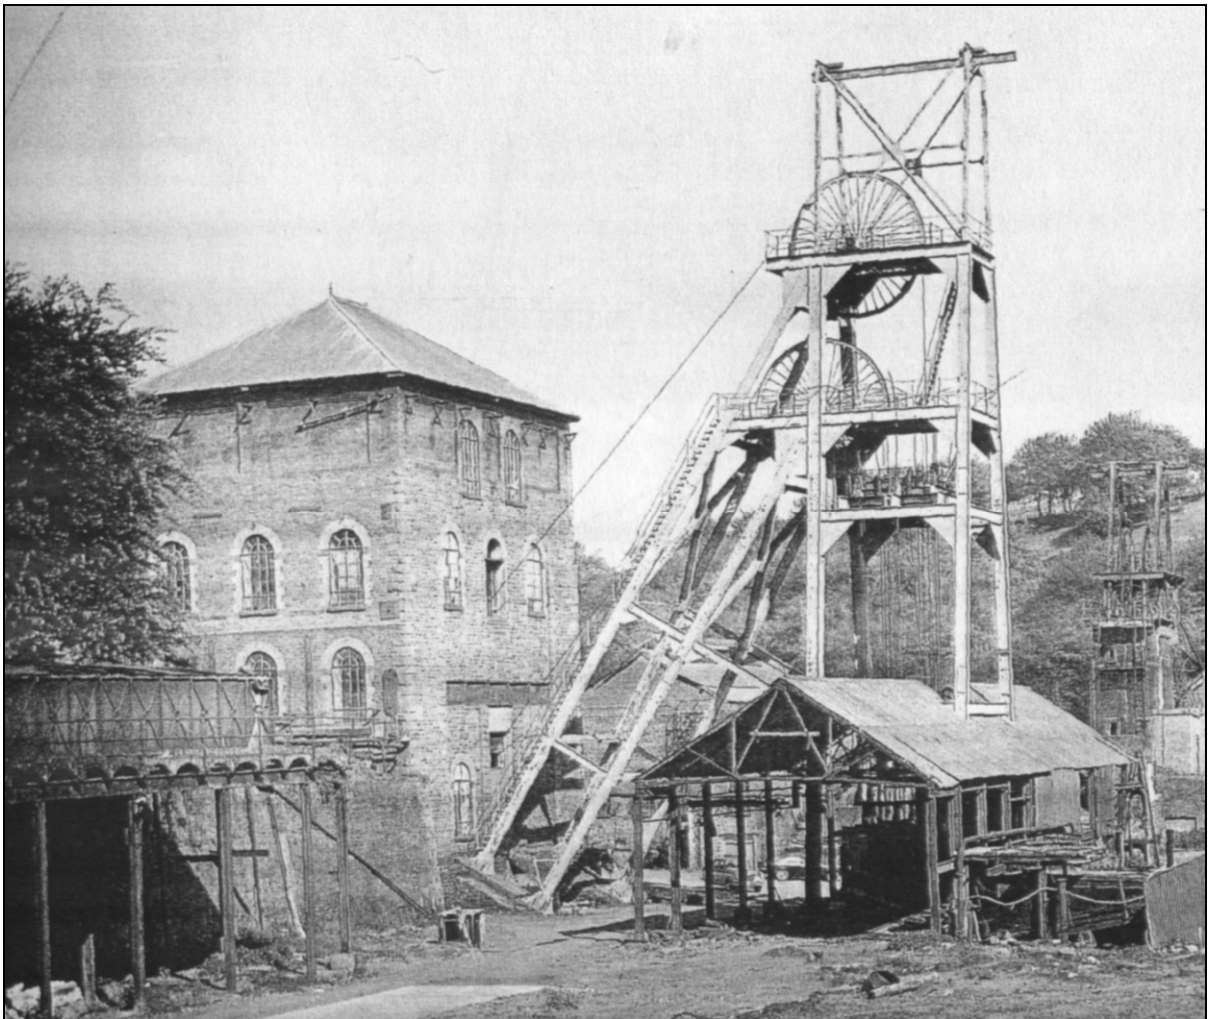
Plate 13: 19th century winding-engine house and headframe at Tirpentwys in Wales. The engine here was a vertical winder, so the building is taller than Crowtrees would have been but it does show the relationship of the various elements of the pit head.

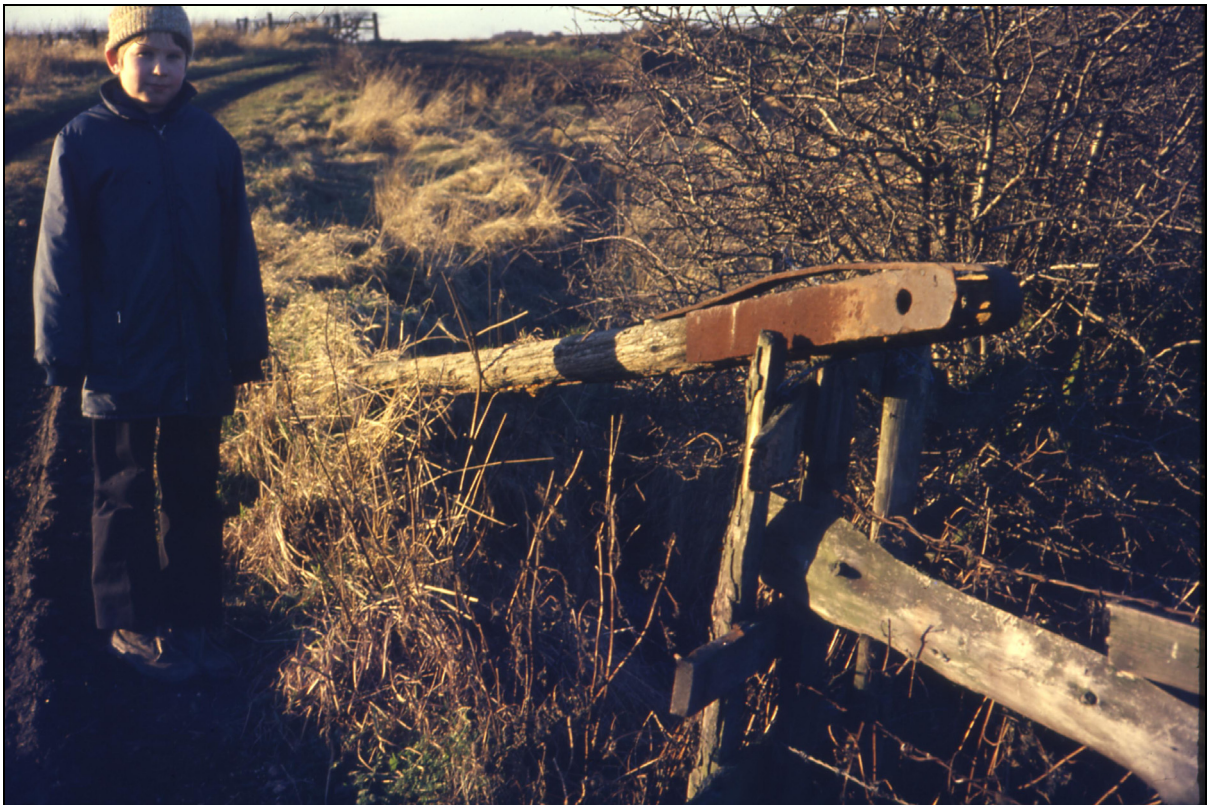
Plate 17: *photograph by Don Wilcox showing pump spears from Crowtrees Colliery used as a fence rail (not found during 2009 survey). These timber spears were joined together to form a linkage to transfer power from the steam engine to a pump at the bottom of the shaft (c. Durham District Council).*

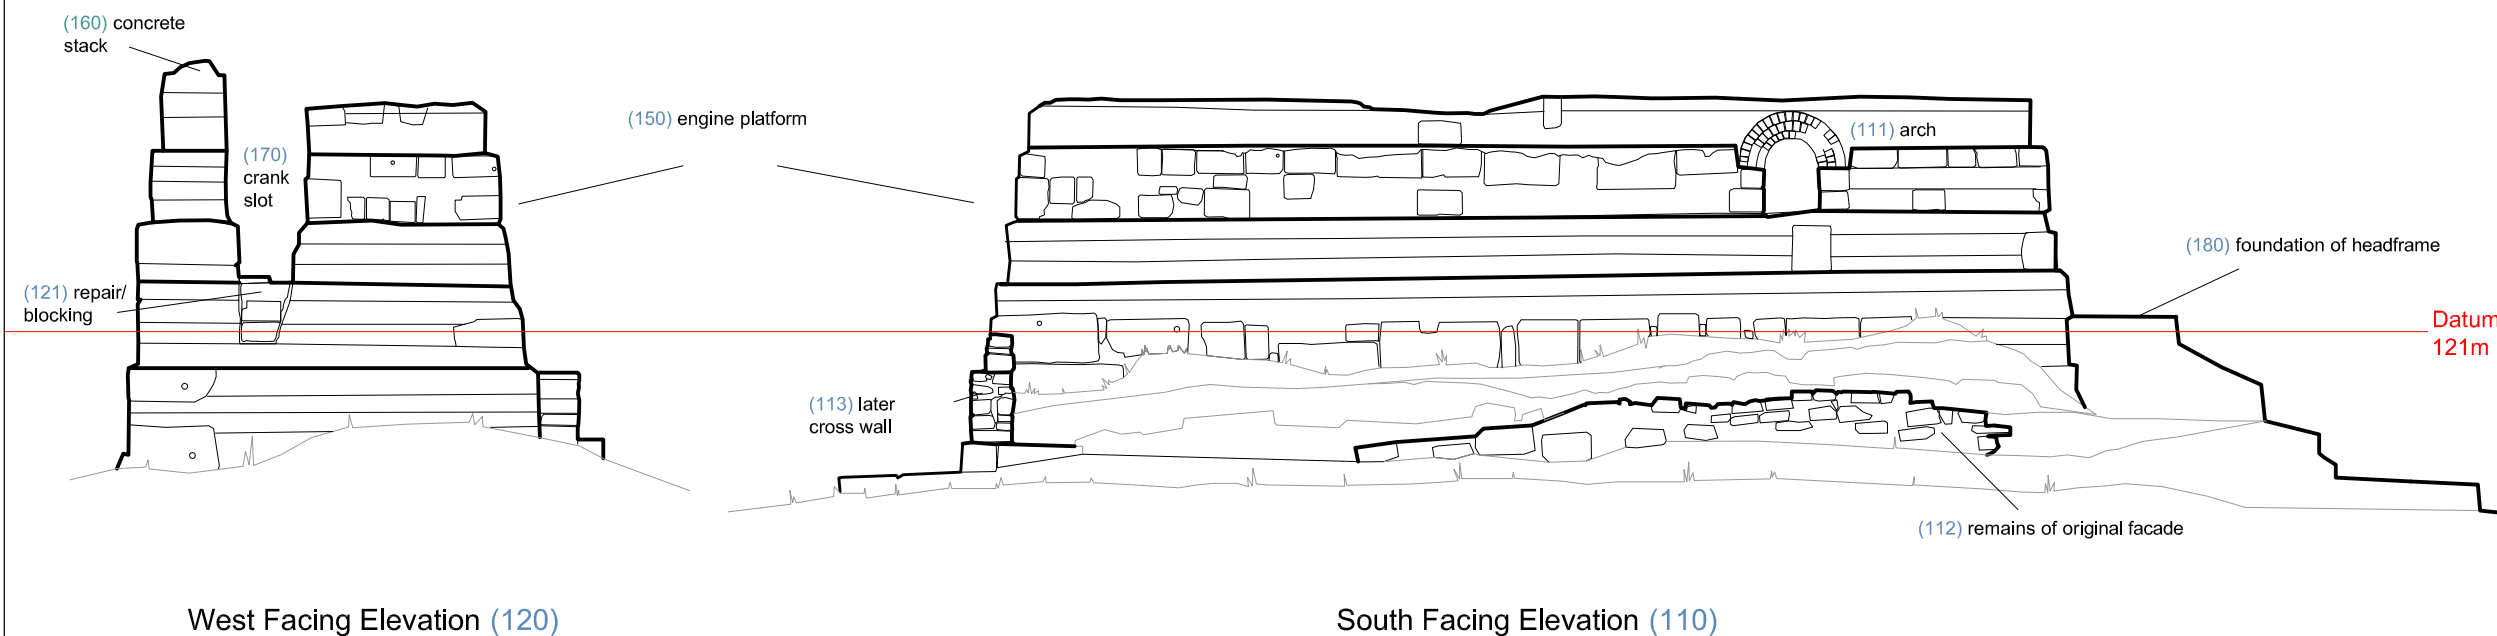
West Facing Elevation (120)

South Facing Elevation (110)

East Facing Elevation (140)

North Facing Elevation (130)

The main body of the winding house comprises five key layers (Figure 7), although the base of the building is obscured by the raised ground level. Only the top of the bottom layer is exposed above ground, the structure then steps in 0.15m to the second tier which is constructed of large reused masonry blocks. These may have been quarried on-site, although it is unlikely that the local Magnesian limestone within the immediate vicinity of the colliery was of an adequate quality to produce such large blocks. Today the exposed natural stone on the site appears to laminate and wear quite badly but this might only be the condition of the overburden. If the local stone was not of suitable quality then the original Phase II colliery freestone may have been transported along the Crow Trees railway line from a nearby sandstone quarry. If this were the case then it would have necessitated the laying of the railway line before the construction of the colliery itself.

Immediately above the masonry block course is a layer of shuttered concrete, making the exposed base of the building 1.40m in height. The building then steps in, above which is another layer of shuttered concrete which measures 0.90m in height. There is then another step and a further layer of masonry bonded with concrete and rubble; this is just under 1.00m in height. The stones in this layer are a little smaller than those in the base layer, but are still fairly large re-used stone blocks. The final tier of the building is of concrete, and measures 0.64m in height. This would have probably been the main bedding for the steam-winding engine and features eight bolt holes, each measuring 0.10m in diameter.
