Low Byre, Low Fawnlees Farm  
Wolsingham, County Durham

Historic Building Recording

# Low Byre, Low Fawnlees Farm, Wolsingham, County Durham

## Historic Building Recording

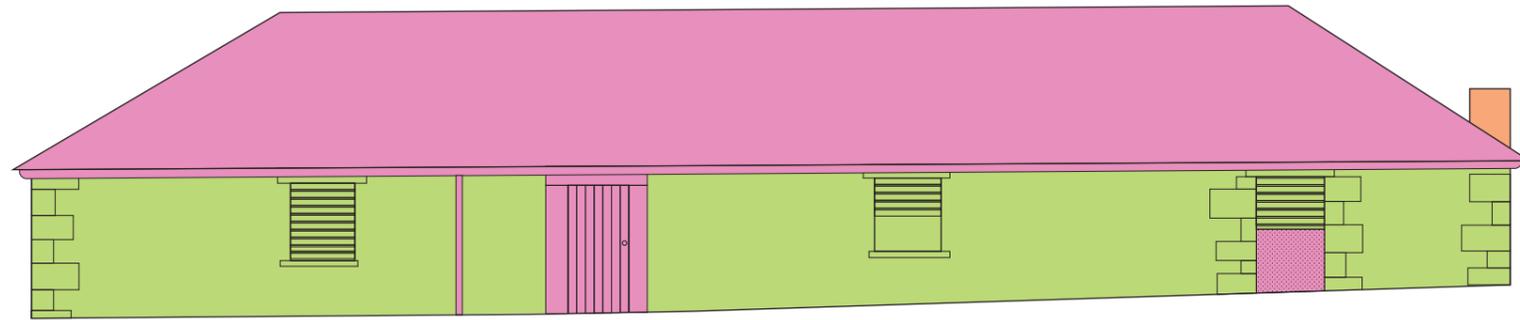
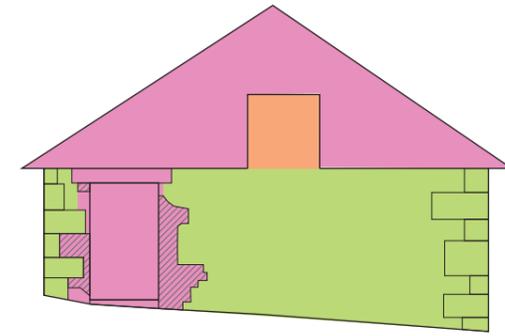
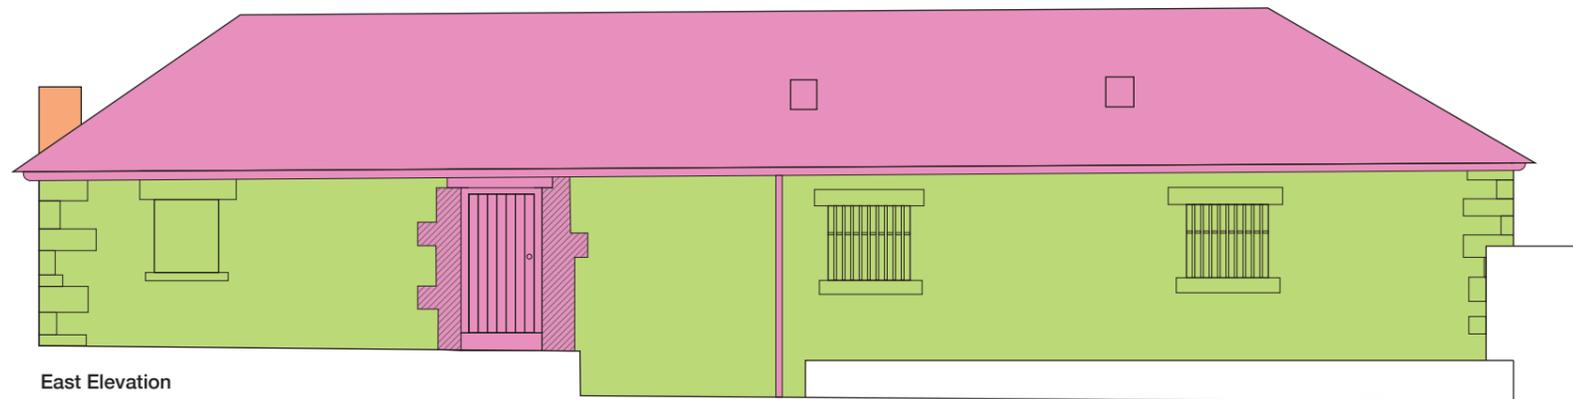
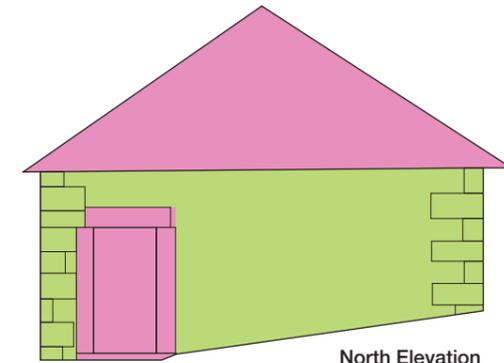
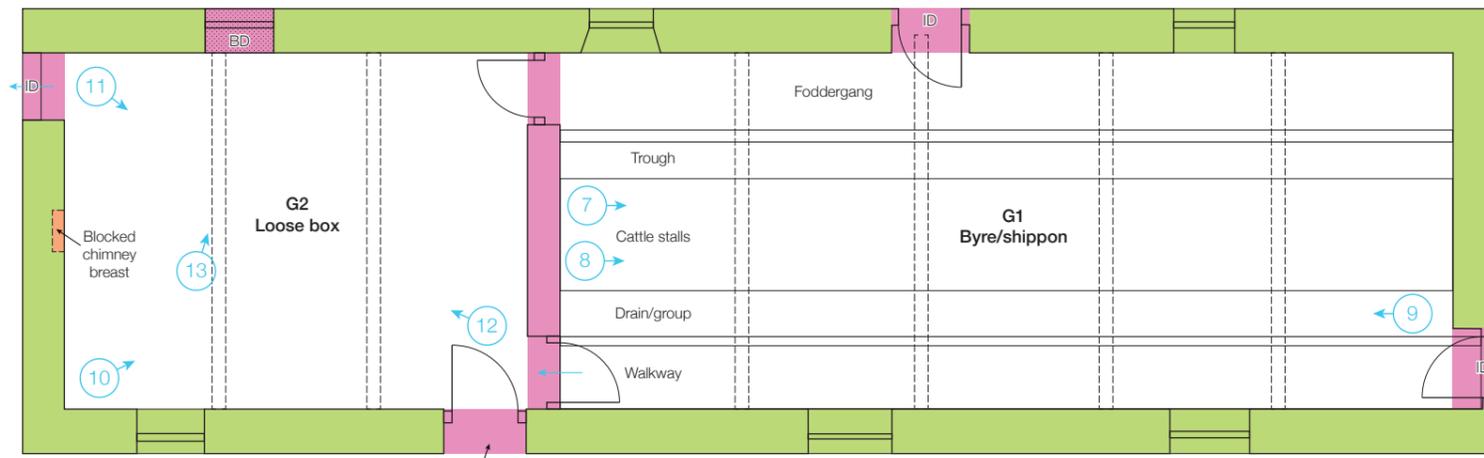
Phased plans and elevations of Low Byre

The results of the Historic Building Recording are presented, with exterior elevations described first followed by interior rooms. This account identifies all features, fixtures and fittings relevant to the original and subsequent uses of the site. Phased plan and elevations also showing the location of photographs taken for the photographic archive, derived from architect's drawings, have also been produced and are included below as Figure 2.

The byre is constructed in water shot, semi-coursed stone fabric with lime mortar and original stone quoins and has a hipped slate roof. The byre consists of two internal rooms, with the subdivision being an insertion contemporary with later renovations of the byre. These consist of:

- Renovations to the internal roof trusses and presumably replacement of some or all of the slates
- Alterations to all the external doorways
- Insertion of a dividing wall to create two internal rooms
- The potential insertion of a later chimney within G2, though this may be earlier
- Blocking up an external doorway in the western elevation.

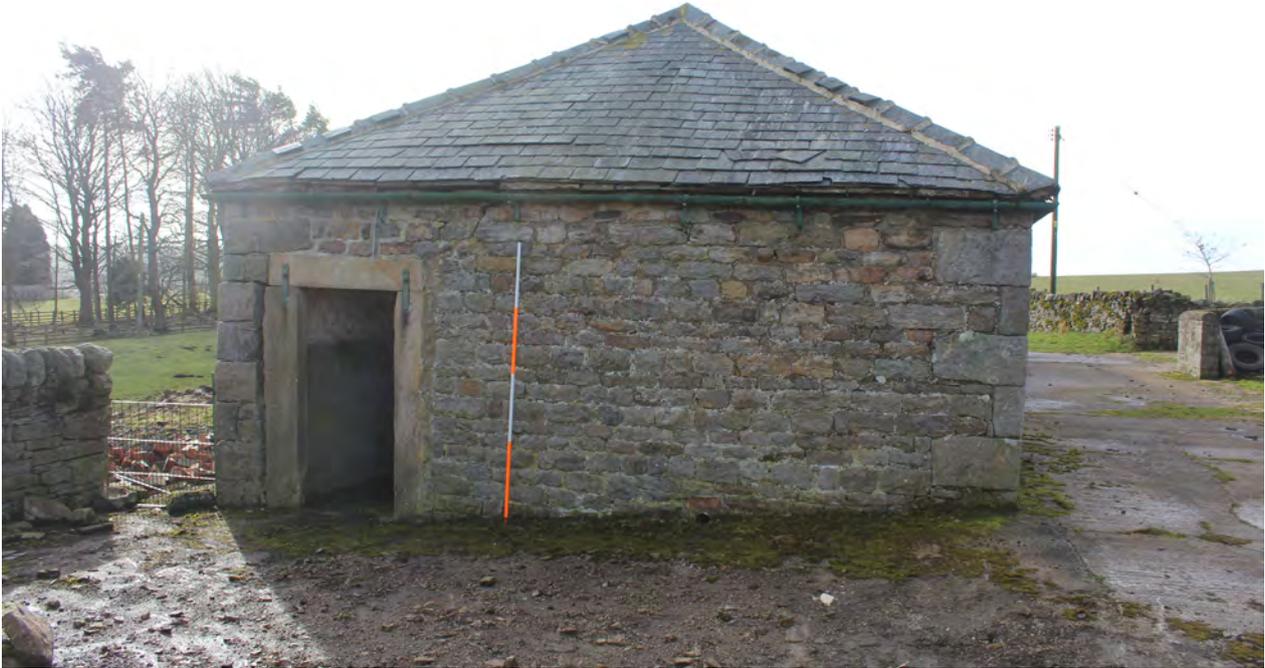
The north-facing elevation of the byre contains one small doorway into room G1 on the eastern side, with sandstone jambs and lintel. The doorway appears to have been re-used as it is not flush with the structural quoins and has cementitious mortar pointing to the surrounding wall rather than the lime mortar seen in the original fabric. The doorway is also bolted and strapped for reinforcement. There were no other features observed on this elevation (Figure 3).

Figure 3 North-facing external elevation of byre. Scale 1x 2 m

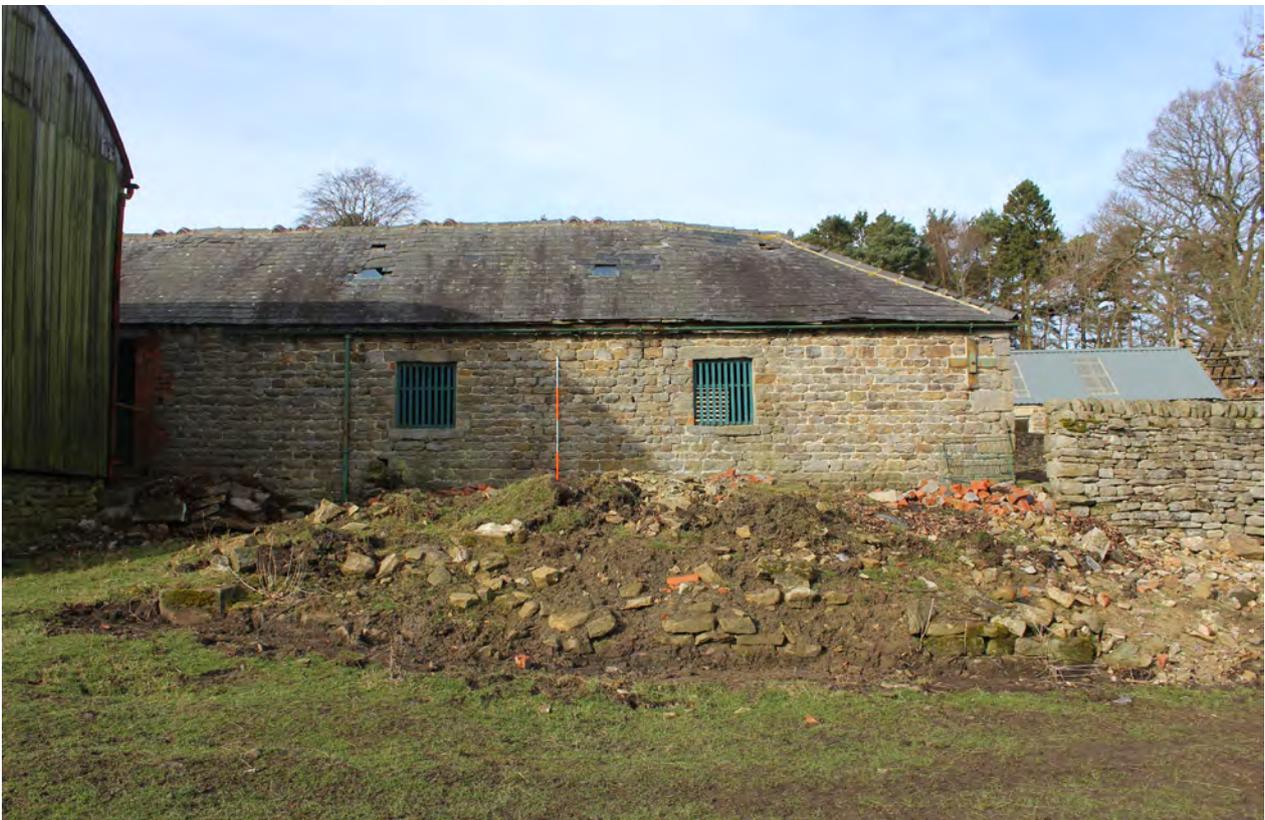
The east-facing elevation includes one metal tie-bar with pattress plate towards the northern end (Figure 4). Two original windows, with sandstone lintel and sills on both and metal bars across the windows provide light and ventilation. Towards the southern end, it can be assumed that the east-facing wooden door is in the original location; however, it has been altered, with the original quoins replaced by a surround of modern machine-made brick. It can also be assumed that the doorway was also raised as the original stonework does not fit straight with the base of the doorway. The concrete lintel is contemporary with the brick, as it does not sit flush with the original stone towards the southern end. The alteration of the doorway is likely to have been contemporary with the internal inserted wall, as it enters room G2. There is evidence of renovation of the window towards the southern end of the eastern wall in the form of inserted stone rubble at the edge of the sill with cementitious mortar repointing. Unlike the two windows towards the northern end, this window has no bars. There is evidence of a metal tie-bar close to the eaves, but no further features were observed in this elevation (Figure 5).

Figure 4 East-facing elevation, north end. Scale 1 x 2 m

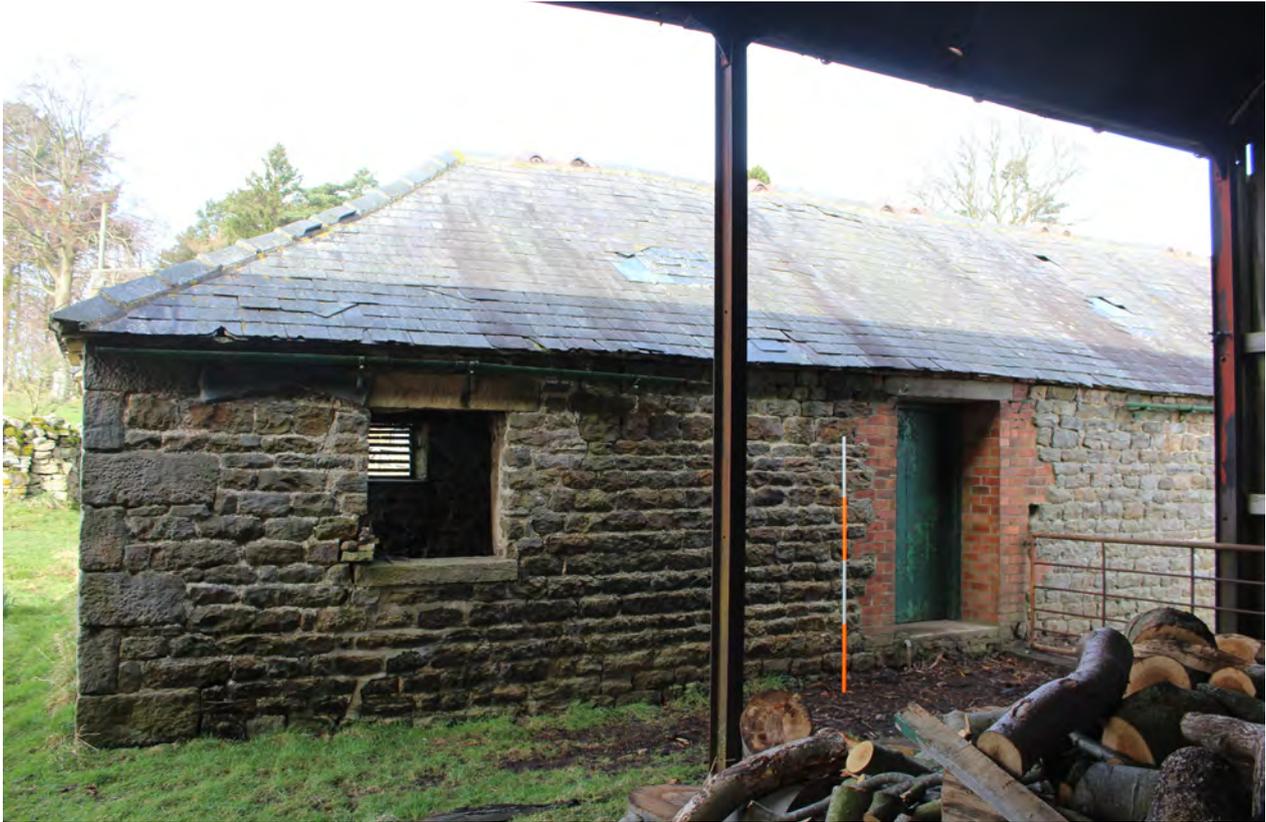
Figure 5 East-facing elevation, south end. Scale 1 x 2 m

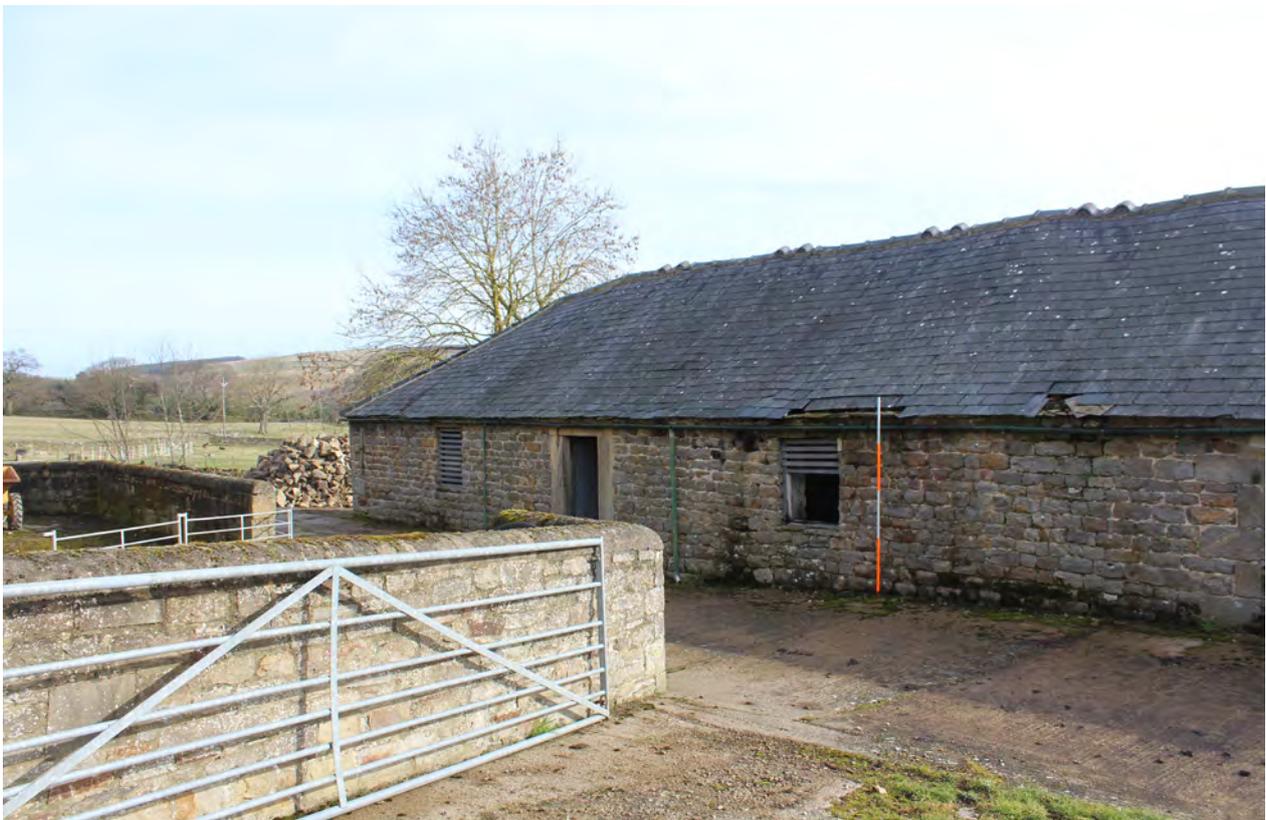
The west-facing elevation, which faces towards the farmstead, contains two original windows at the northern end (Figure 6) with original stone lintels, sills and metal bars to provide light and ventilation. The doorway appears to have a re-used sandstone jamb and lintel, with cast concrete used as the southern jamb. As such, the doorway is unlikely to be original and was probably inserted for yard access into Room G1. The doorway does not fit flush with the stone fabric and includes some brick infill around. A bolt and strap for reinforcement on the left-hand side of the lintel also provides evidence for the doorway to be a later insertion. Tie-bars with pattress plates are noted on the northern and southern end of the west-facing elevation. On the southern end of the west-facing elevation is a blocked doorway with stone quoined surround. The lower half has been blocked to create a small window. The lintel is a later insertion, and it is likely that this doorway was blocked contemporary to the renovations noted upon the east-facing elevation along with the internal wall insertion (Figure 7).

Figure 6 West-facing elevation, north end. Scale 1 x 2 m

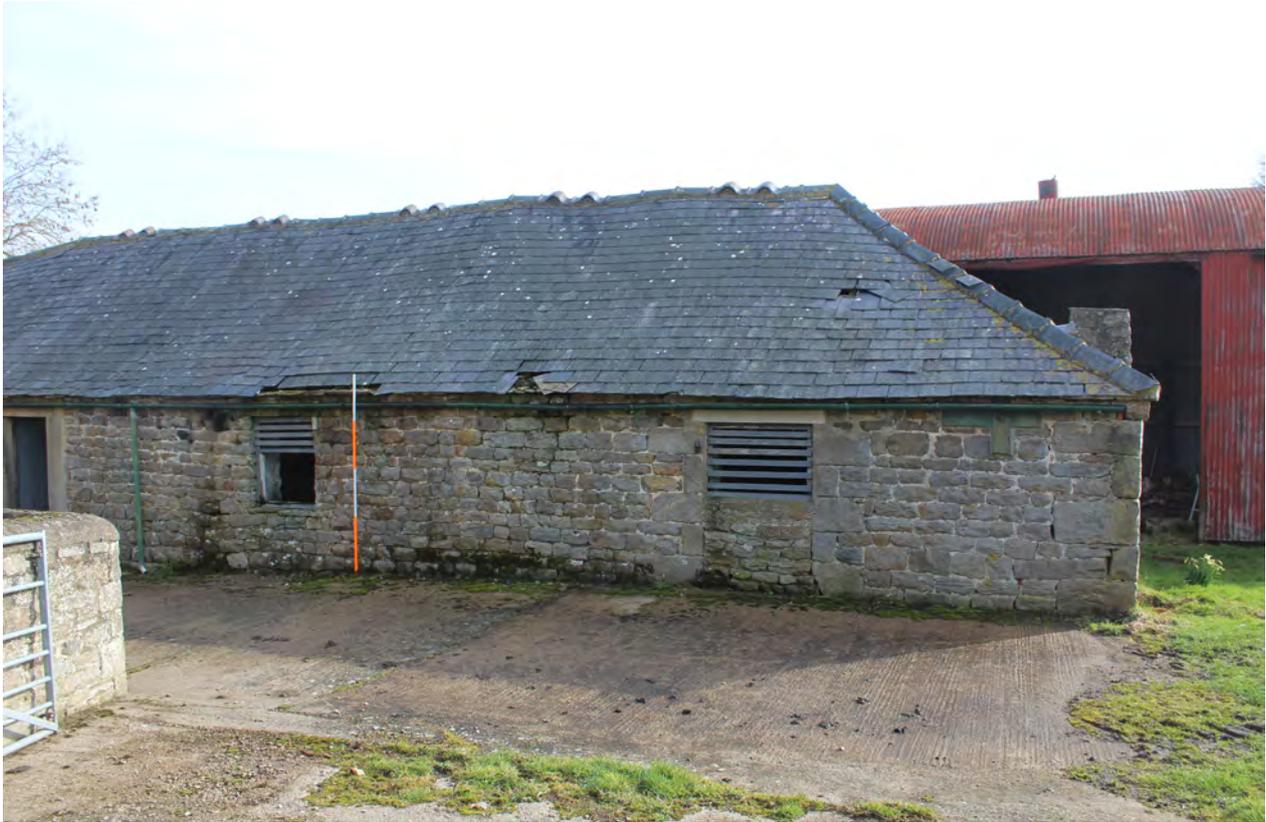
Figure 7 West-facing elevation, south end. Scale 1 x 2 m

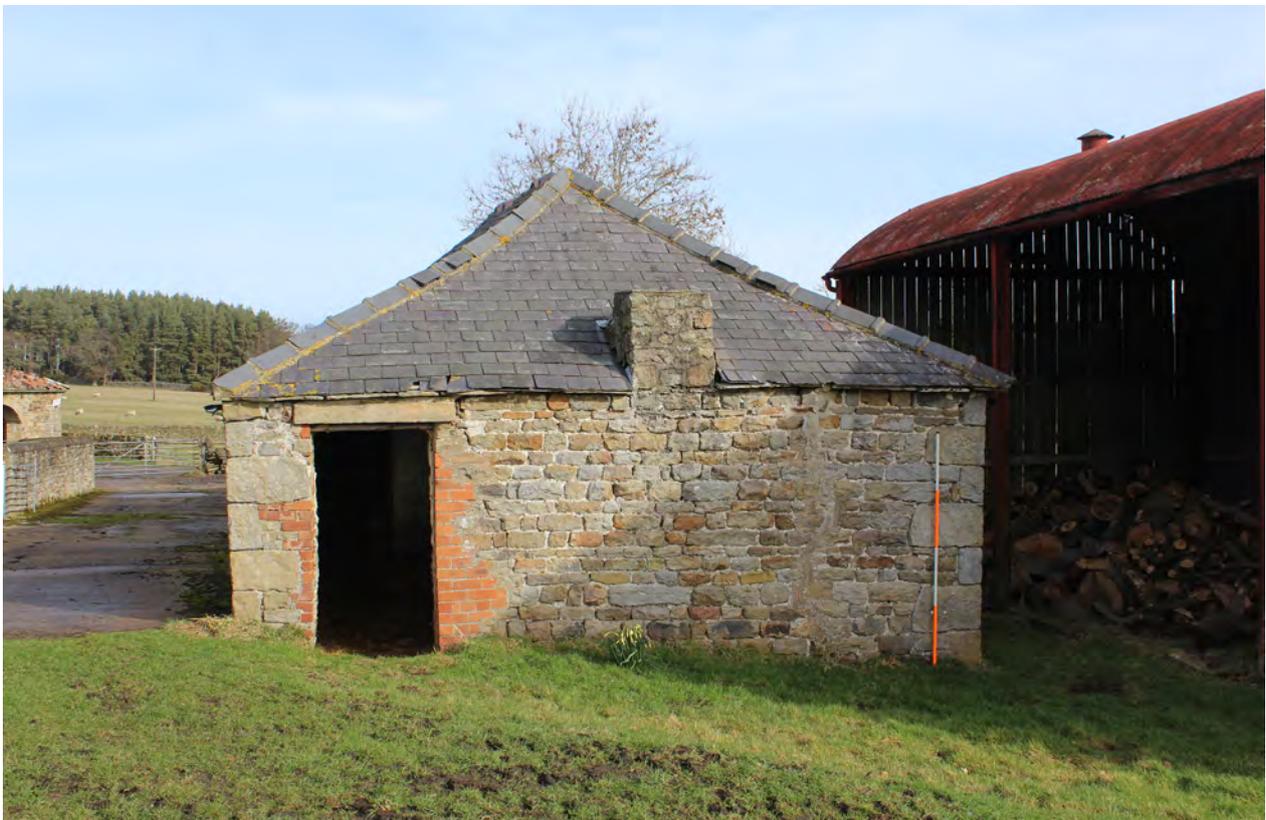
Figure 8 South-facing elevation of byre. Scale 1 x 2 m

The south-facing elevation has an inserted doorway with brick jambs and a tooled sandstone lintel with stone infill surrounding it. The doorway leads into room G2 and out into an area of pasture. This is the only elevation which has no metal guttering below the roof, yet there is a chimney stack towards the centre of the elevation at the eaves. It is likely that the chimney stack is an insertion with the later renovations and as such is contemporary with the inserted brick doorway and the modern inserted wall in the interior; however, it is also possible that it represents a phase of alteration in the 19<sup>th</sup> or early 20<sup>th</sup> century not contemporary with the other renovations. There is a structural crack on the eastern side of the elevation which has been patched with mortar.

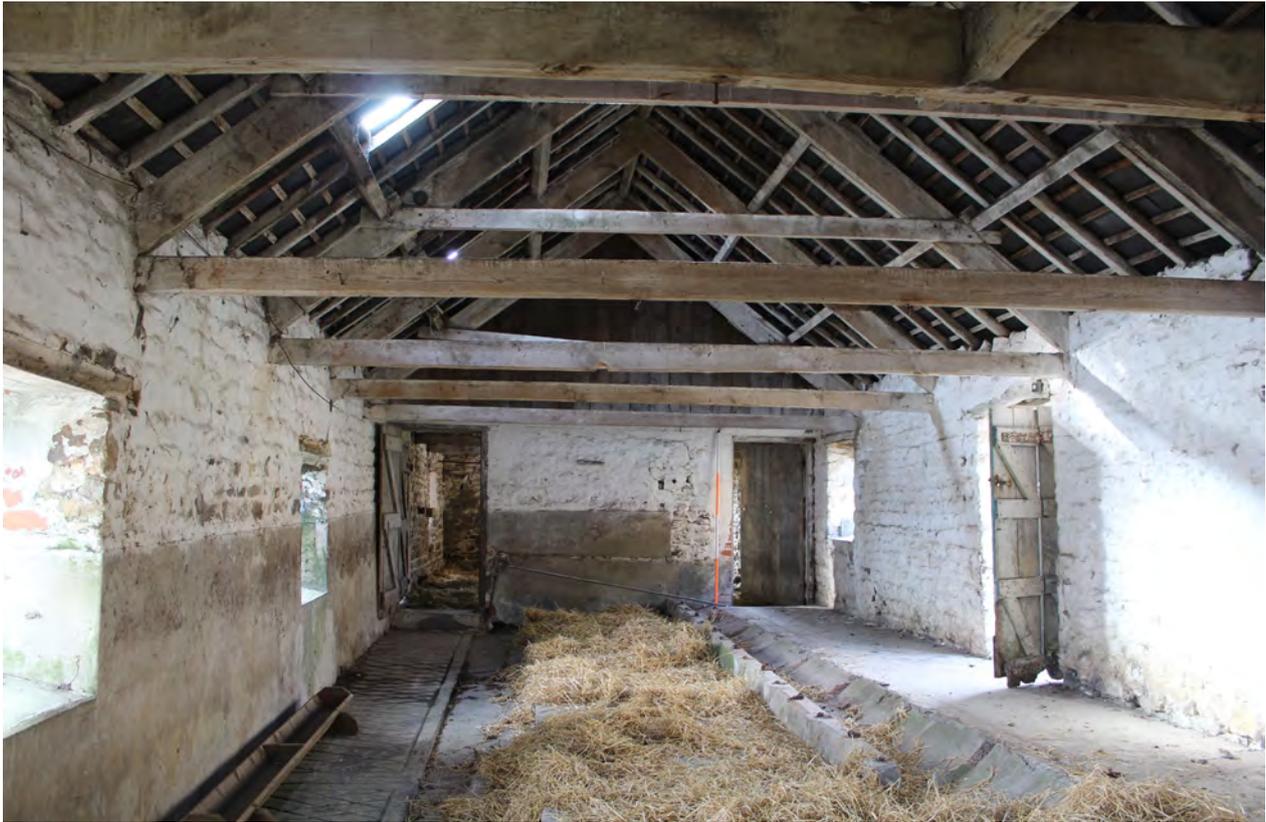
An internal subdivision was inserted during probable early 20<sup>th</sup>-century renovations which separates Room G1 from Room G2 with two doors, at the east and west sides of the room (Figure 9). These are small narrow doorways with wooden latched doors, allowing access between the rooms and keeping livestock contained. The eastern doorway sits on a raised concrete floor surface to compensate for the gradual slope towards the drain. There is no loft in Room G1, which is open to the roof. The internal roof structure in this room comprises six tie-beam and principal rafter trusses, with the principal rafters attached by halved joints. Collar beams are noted on every other truss in sawn timber, suggesting an early- to mid-20<sup>th</sup>-century date for renovations, contemporary with the insertion of the internal subdividing wall. The trusses are inserted into the external walls which were later whitewashed. (Figure 10).

Figure 9 Room G1 facing south towards the internal subdivision between Rooms G1 and G2. Scale 1 x 2 m

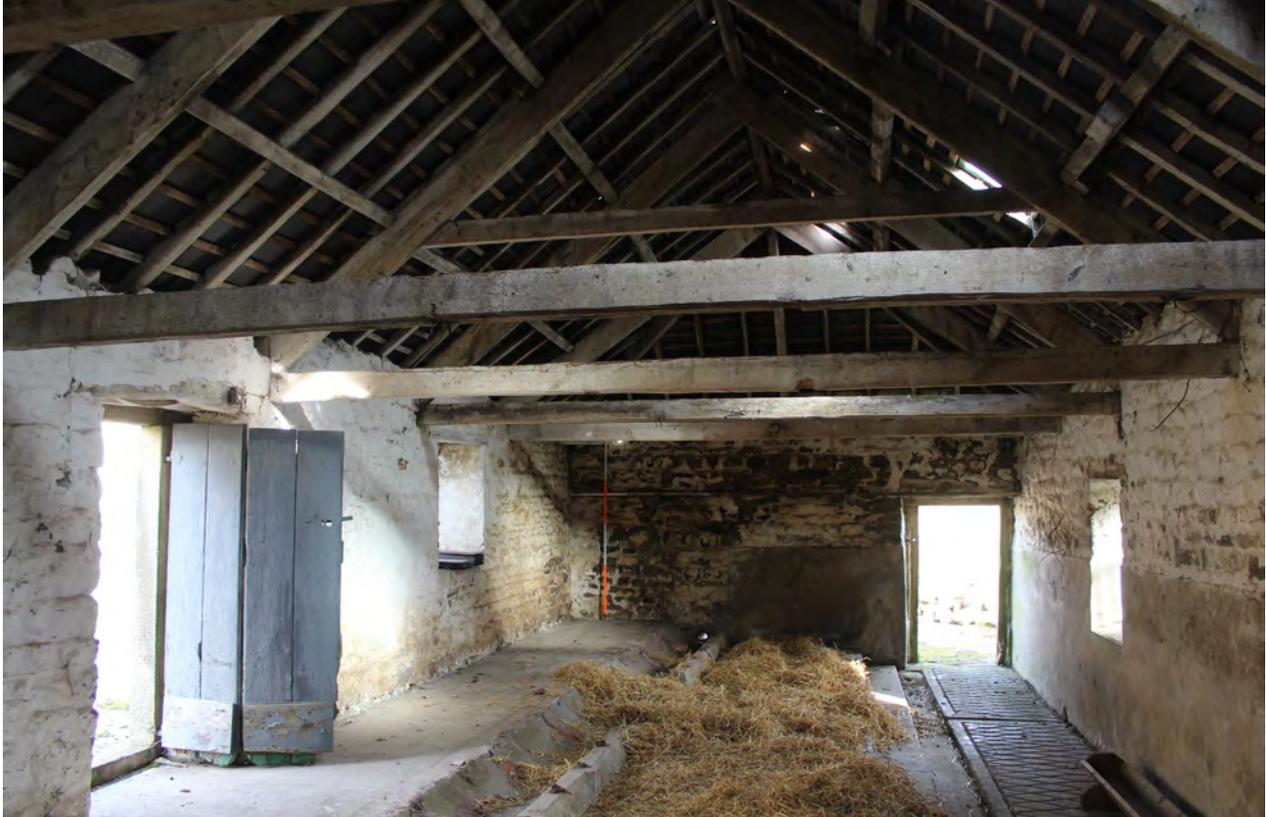
Figure 10 Room G1 facing north. Scale 1 x 2 m

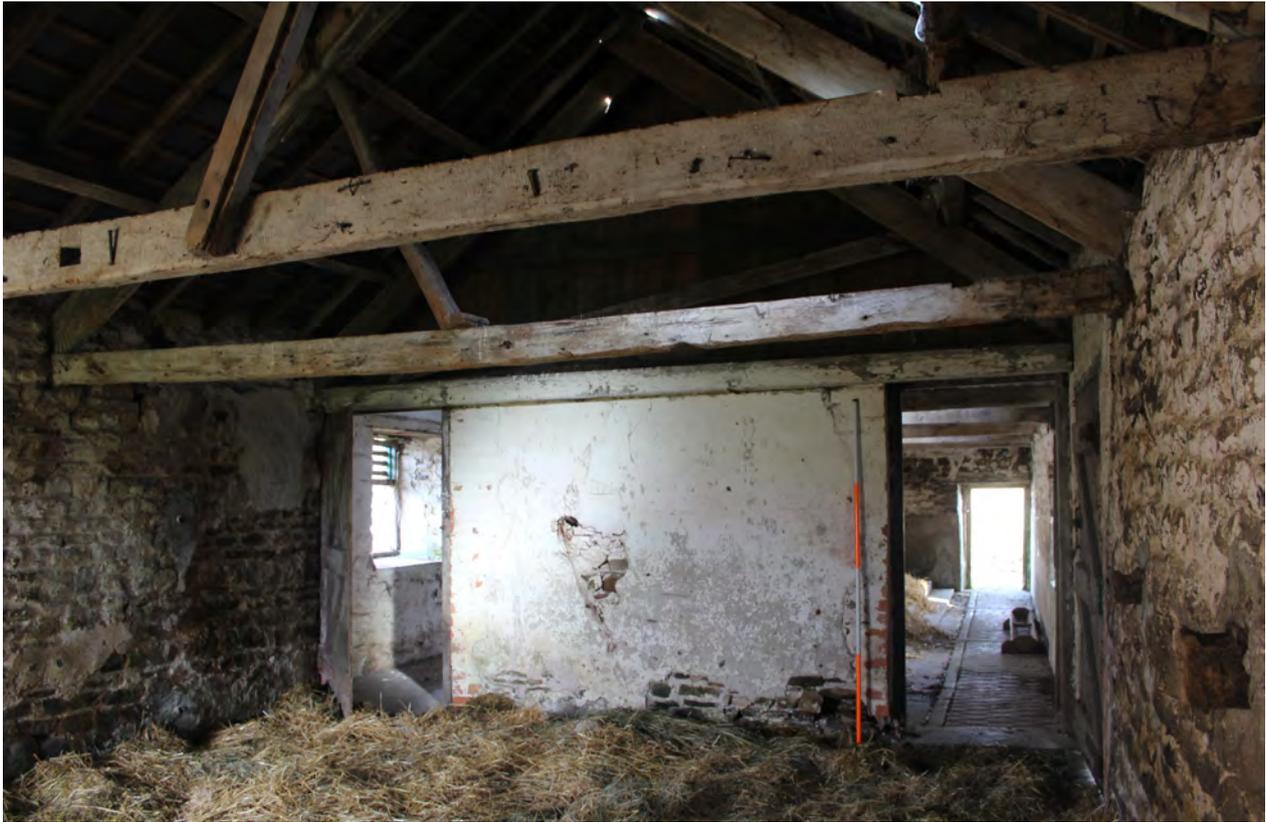
The room was previously part of the large cow byre prior to the inserted wall subdivision, with two doorways in the dividing wall. The doorway on the western side of the dividing wall opens inwards into Room G2, while the eastern doorway opens out into Room G1 (Figure 11). As well as this being a preventative measure to keep livestock separate, it could be that livestock were brought into the room from the yard, through the western doorway and into room G2. The blocked doorway as noted on the west elevation is visible on the internal wall, with the small window providing light and ventilation into the room (Figure 12).

Figure 11 Room G2 facing north towards the inserted dividing wall. Scale 1 x 2 m

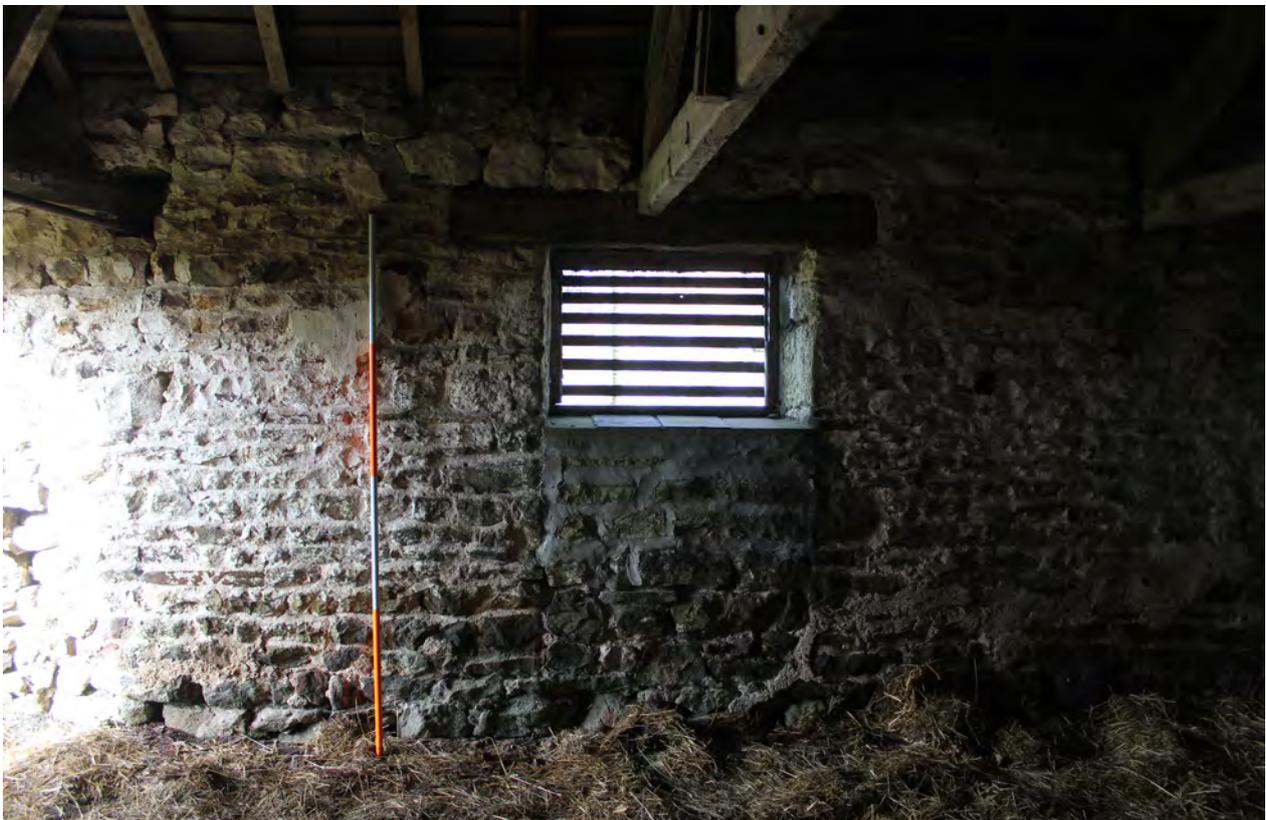
Figure 12 Blocked doorway in west wall of Room G2. Scale 1 x 2 m

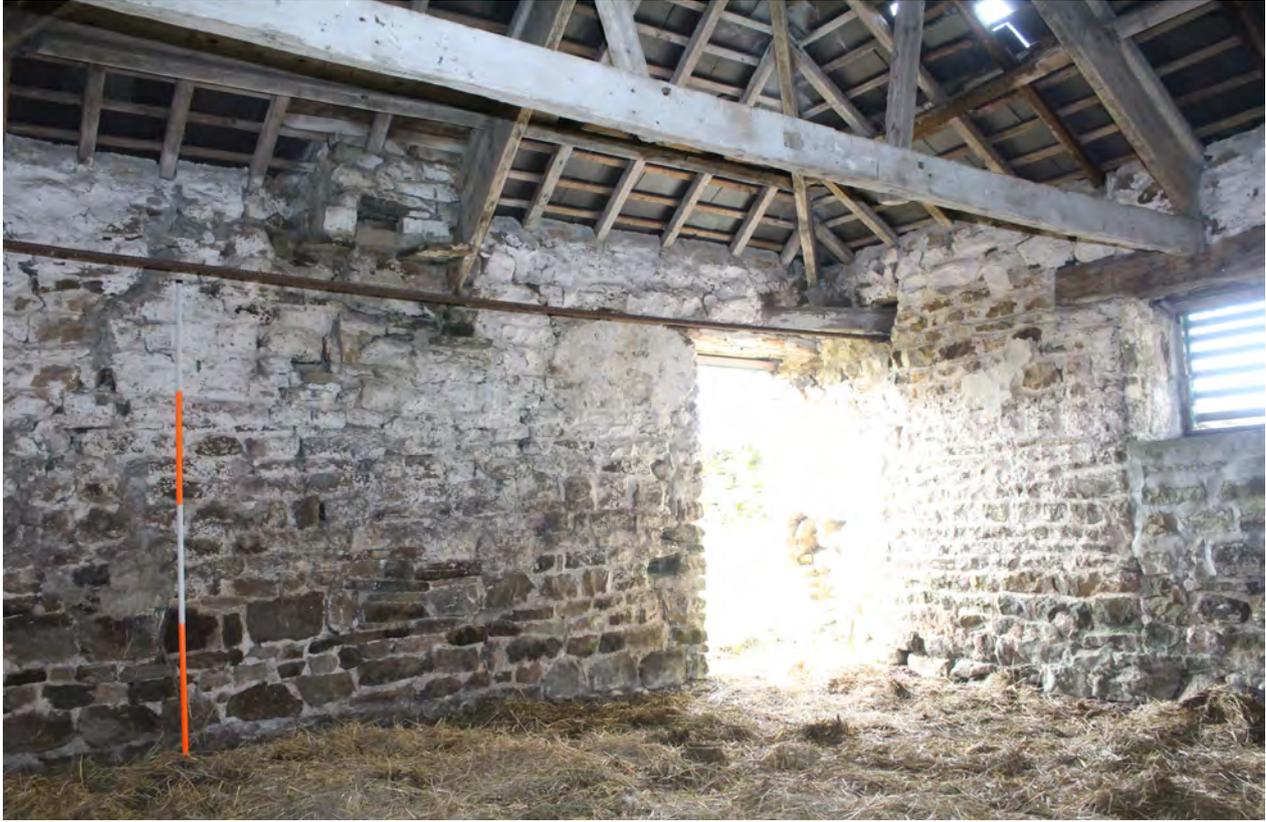
Regarding the chimney stack noted at eaves-level on the south elevation, it is considered unlikely to have been part of the original construction due to a lack of evidence for a stove or fireplace setting on the internal wall of Room G2. A small hole below the stack has been in-filled with loose brick, and it is considered most likely that the chimney was a later addition, potentially 19<sup>th</sup>-century in date. It suggests that the southern end of the building had a different purpose, or was multi-purpose, prior to the sub-division of the internal space. It is also possible that the addition of the chimney was contemporary with the early- to mid-20<sup>th</sup>-century renovations and was blocked at a later date (Figure 13). The roof timber structure is the same as observed in Room G1.

Figure 13 Oblique shot facing south-west with chimney stack shown in south wall. Scale 1 x 2 m
