**ST MARY'S CHURCH, ST MARY STREET,
SOUTHAMPTON, HAMPSHIRE**

**Archaeological Excavation and Watching Brief Report
SITE CODE: SOU1503**

Report reference: 69361.02

December 2009

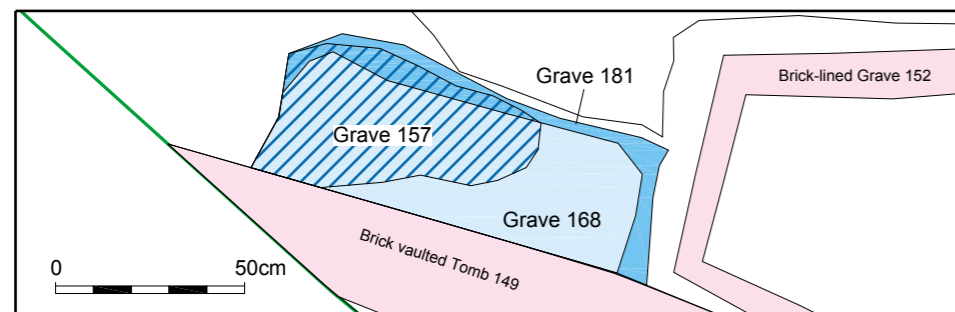
Area of evaluation and watching brief

Detail of reburial trench

Detail of Graves 157, 168 and 181

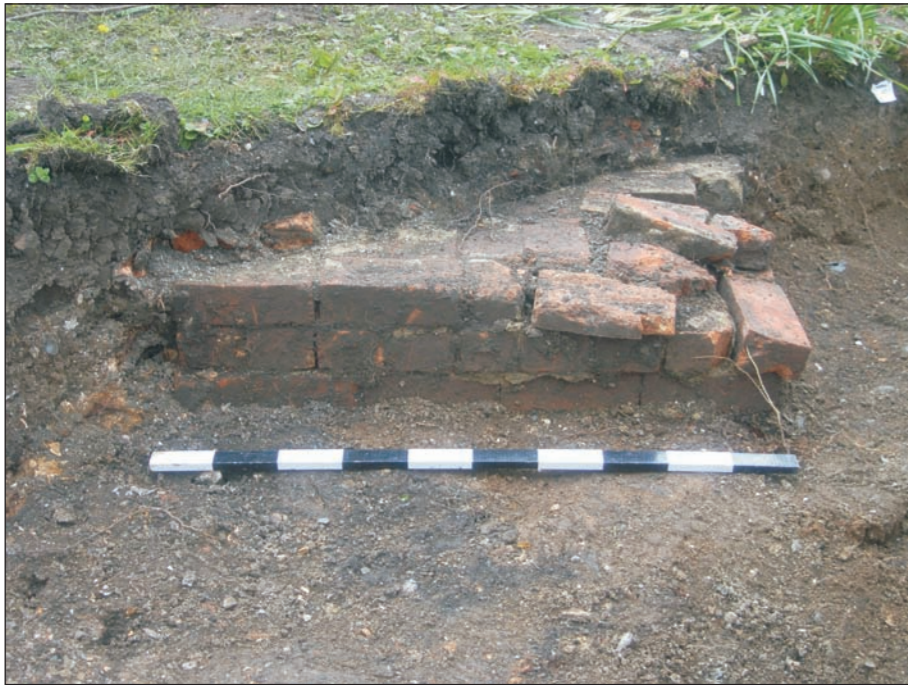
Plate 1: Structure 166, view from north-west

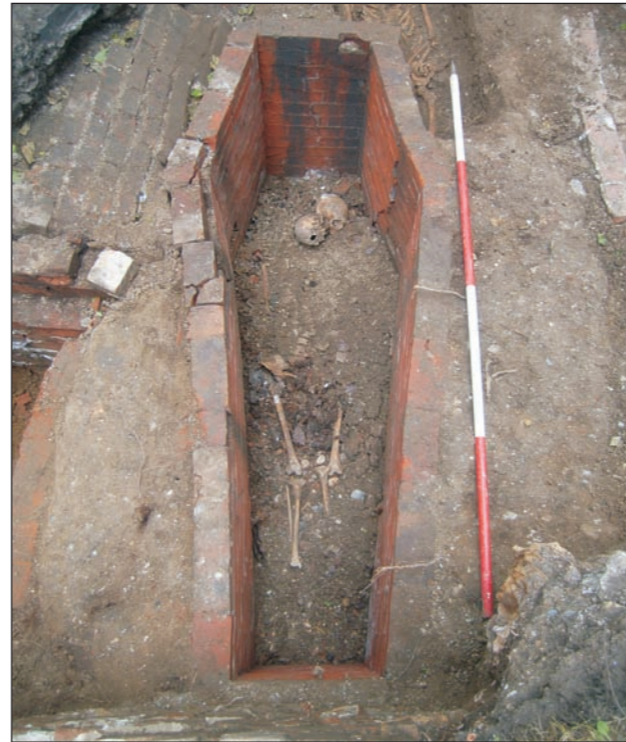
Plate 2: Brick-lined grave 152, view from east

- 5.4.3 **Brick-lined grave 152 (Plate 2)** was sub-rectangular (coffin shaped) in plan, and measured 2.60m east–west, 1.20m north–south and was observed to a depth of 0.88m. It was constructed out of at least 13 courses of handmade unfrogged bricks, in stretcher coursing, bonded with a mid grey soft lime mortar, containing coarse sand and charcoal inclusions. The brickwork was bonded to dressed limestone capping, one of which was a re-used ornate gravestone dating to 1700 / 1701 AD, giving a *terminus post quem* for this feature. The construction cut was observed in places where it truncated earlier inhumation burials, and it appears that the brick structure was not built flush with the cut, but around 0.05m clear of it, with backfill **173** deposited in the void that was left. The brick lining had four slots cut into it at a later date: two towards the head and two towards the feet ends, probably to accommodate wooden timbers for stacking coffins. It contained at least two adult inhumations **SK154** and **SK155**, separated by a small deposit of mid reddish brown silty clay loam **172**. Only the skull of **SK155** was visible, the rest being obscured by **172** and **SK154**. Both of the inhumations were within coffins. This feature is stratigraphically later than brick vaulted tomb **149** to the south, and grave **175** to the northwest.

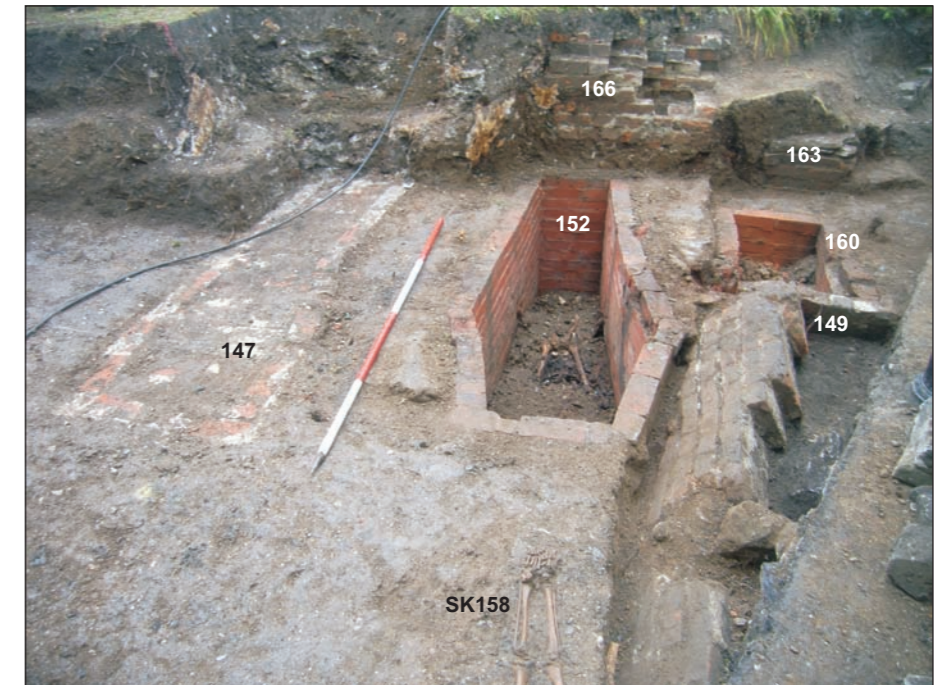
Plate 3: (Clockwise from bottom right) Brick vaulted tomb 149, SK158 within grave 157, brick-lined grave 147 after consolidation, brick lined grave 152, truncated brick-lined grave 160, (visible in baulk, left to right) structure 166, brick lined grave 163

- 5.4.4 **Brick vaulted tomb 149 (Plate 3)** This structure was only partially exposed, with the remainder extending under the existing churchyard road. The vault was truncated and backfilled during the construction of the road in the 1880s. The north wall, aligned east–west was observed for 2.50m the eastern wall for 0.88m. From the curvature of the intact portion of the vault, it is estimated that this structure was around 1.60m wide. It was excavated to a depth of 0.40m. The structure was constructed out of handmade unfrogged bricks, bonded with light grey soft lime mortar with coarse sand inclusions. The vault comprised of a partial arch of header-work, and probably is a barrel-vault, the side walls were in English bond, built flush against the construction cut. This tomb is stratigraphically earlier than brick-lined grave **152**, and road **113**, but later than brick-lined grave **160** and grave **157**. This monument is likely to be a high status family tomb.

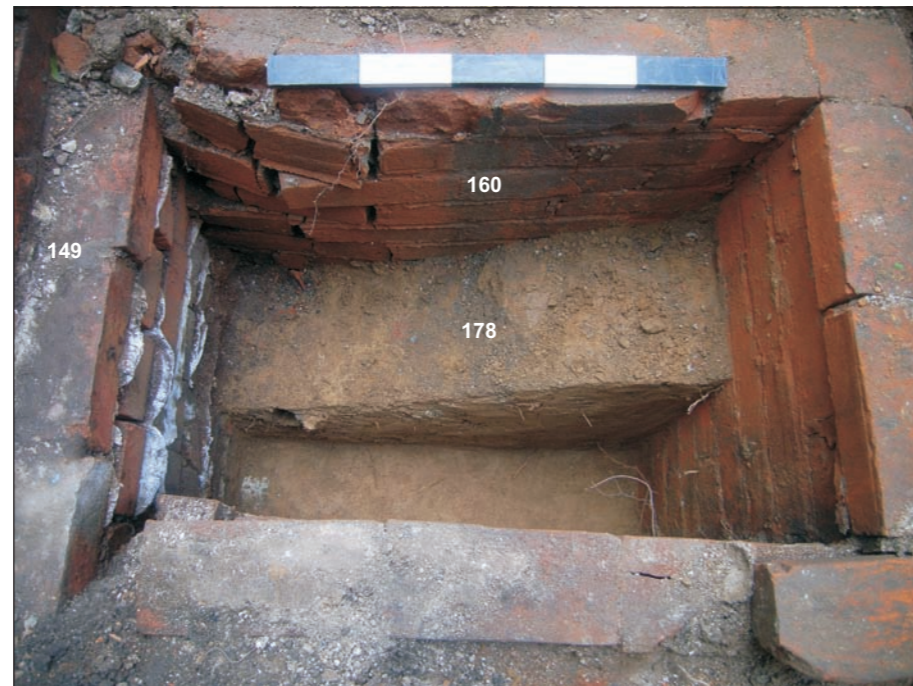
Plate 4: Truncated brick-lined grave 160, showing backfill 178, to the left of shot is the eastern wall of brick vaulted tomb 149, clearly truncating 160 when it was constructed

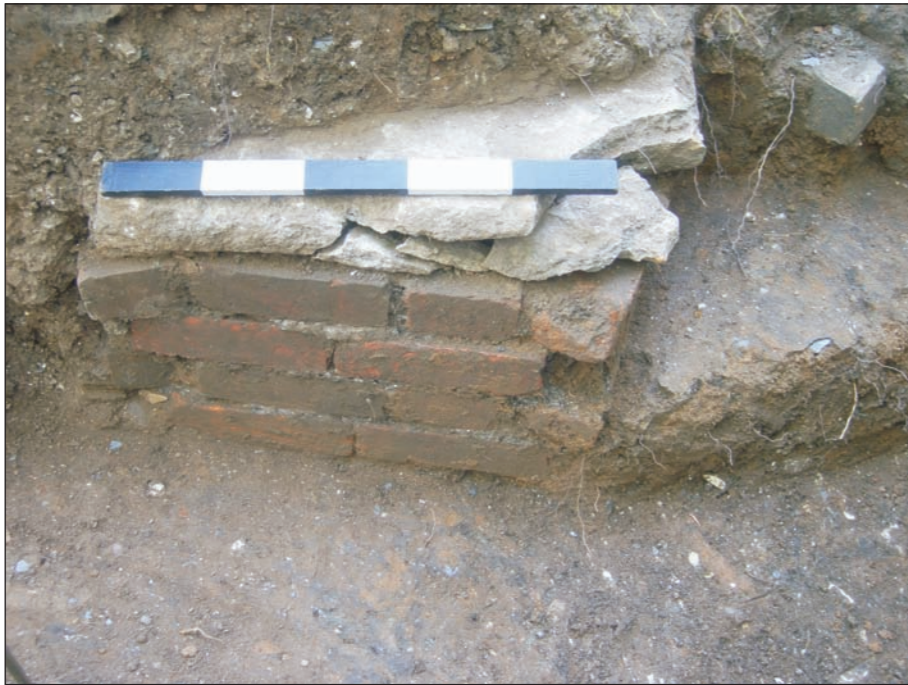
Plate 6: Brick-lined grave 163, view from north-west

5.4.7 **Brick-lined grave 163 (Plate 6)** protruded only 0.3m from the eastern baulk, and was only partially exposed during the excavation. An intact void was observed within, where a small portion of the capstone had been broken off. This brick-lined grave conforms to the same structural sequence outlined above.

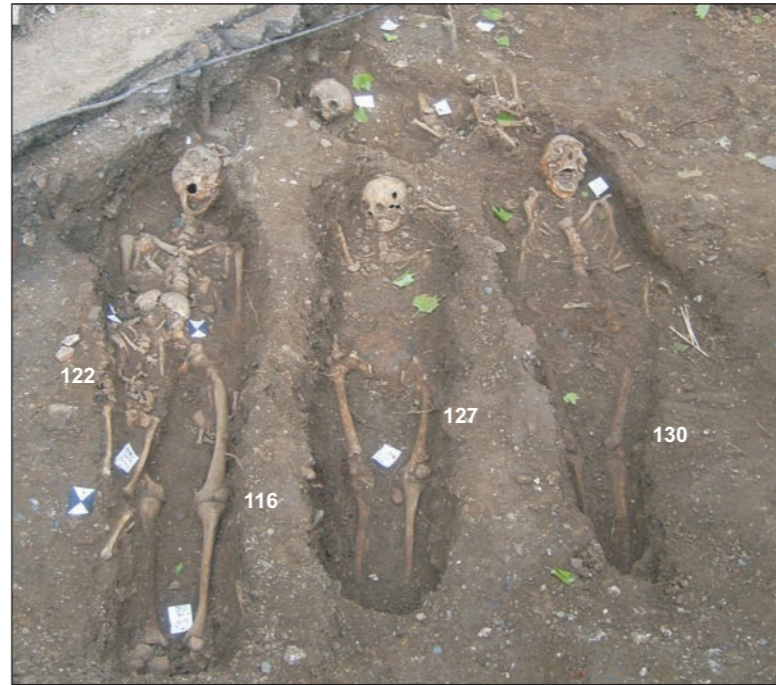
Plate 7: (Left to right) Infant burial within grave 122, overlying grave 116, grave 127, grave 130, with truncated graves 133, 136 and 139 in the background

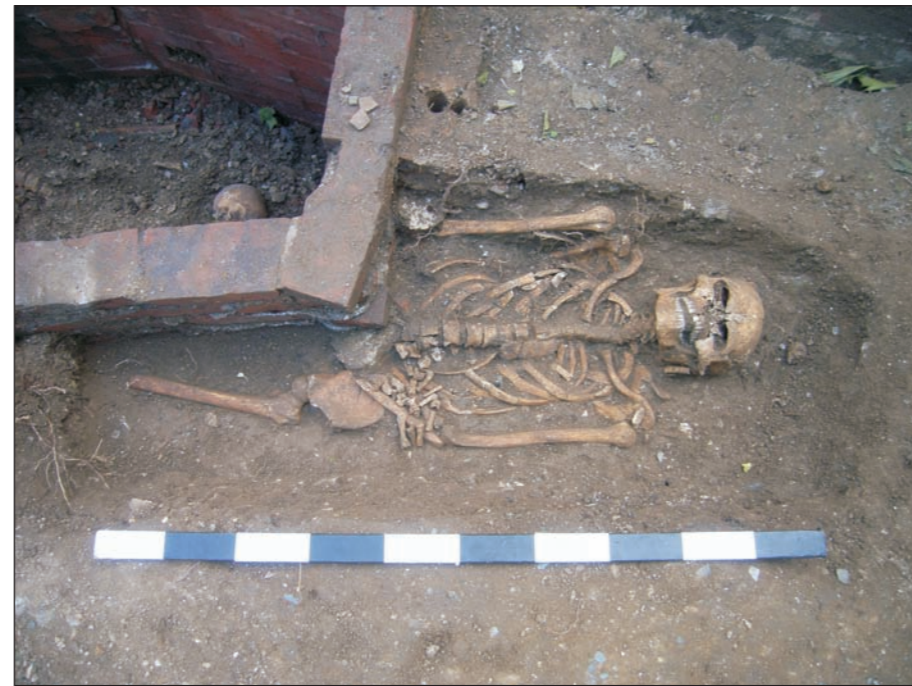
Plate 9: Grave 175, truncated by brick-lined grave 152

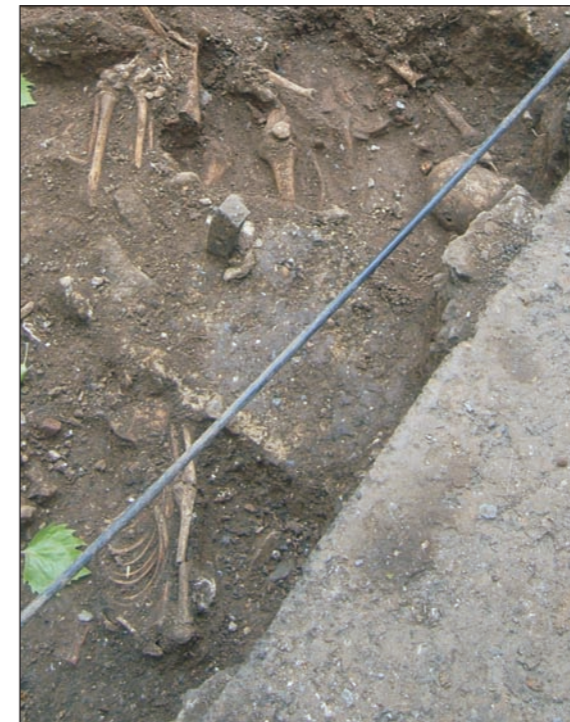
Plate 10: (Left to right) heavily truncated graves 136, 139 and 133, and concrete setting within cut 142
