Report on Archaeological Assessment
at South Tavy Head,
Dartmoor National Park

Report by: Nicola Rohan MA
Dartmoor Mires Project
Historic Environment Officer

Date: 27 June 2014

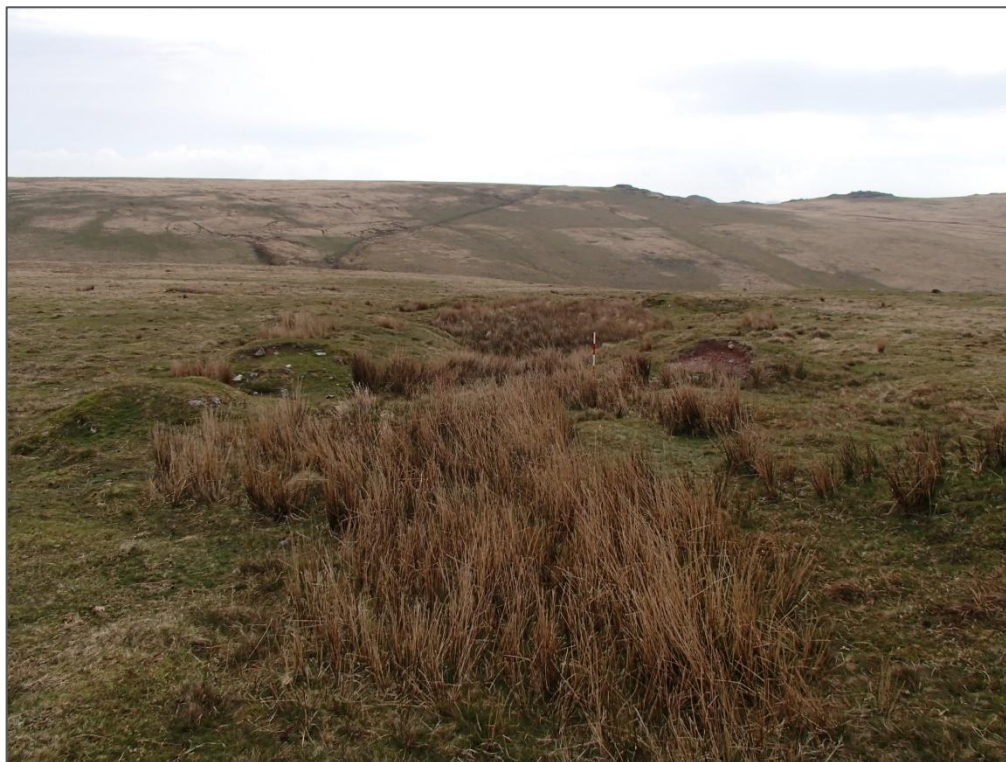
Plate 1 Tin pits along the access route, looking east towards Lydford and Beardown Tors.

- 5.1.2. The access route traverses an alignment of tin pits (EH 1065840) on the ridge, north of Black Dunghill and south of Conies Down (see Plate 1). As discussed above, the pits are the result of the exploitation of a tin lode that runs across the top of the ridge from east to west. The English Heritage Survey recorded the average diameter and depth of the pits as 5m and 1m, respectively. This feature is believed to date to the post-medieval period.

6.1 The access route was carefully selected to avoid impacting archaeological features, wherever possible. The route was subject to a walkover survey and no previously unknown archaeological remains were identified along the route. The route traverses an area of tin pits on the ridge to the south of Conies Down. It does not impact upon this feature but runs across a level area between pits. It is necessary to traverse the Lich Way but the contractor will be instructed to cross this area with caution so not to as disturb the ground in this area.

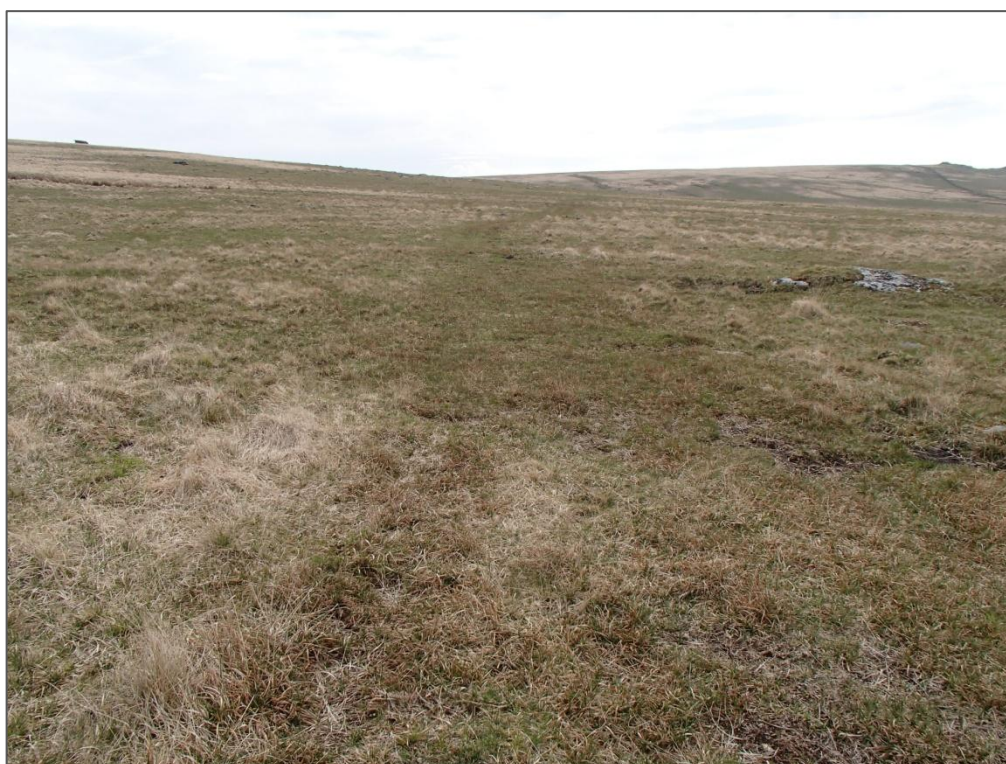
Plate 2 Lich Way looking southeast with Conies Down Tor in top left corner.

- 5.1.3 The access route traverses the Lich Way 60m west of the Conies Down stone row, on the lower western slopes of Conies Down. At this point the Lich Way is clearly visible as a level linear feature along the south and western side of Conies Down (Plate 2).

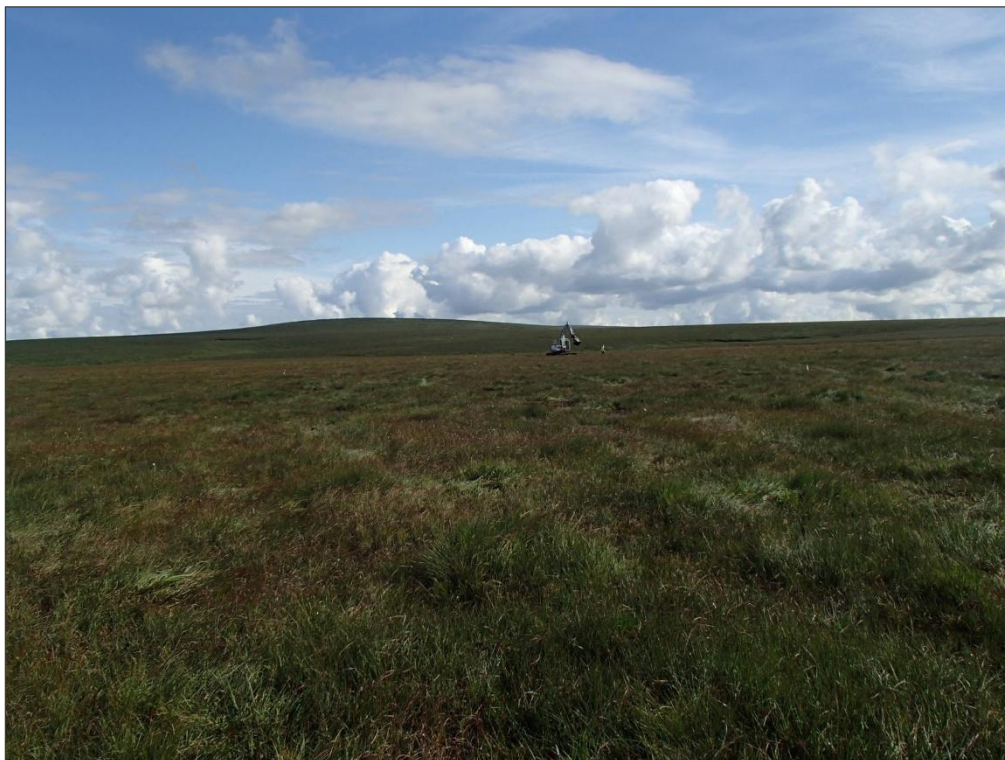
Plate 3 Restoration site from southwest corner, looking northwest.

- 2.1 The Dartmoor Mires site is known for the purposes of the project as South Tavy Head and is located on an area of relatively flat upland at the headwaters of the Cowsic, Tavy, Walkham and East Dart Rivers (OSGR SX594810) in the parish of Dartmoor Forest (Fig. 2). It is located, 7km north of Princetown, 1.8km south southwest and 1.3km north of Cut Hill and Devil's Tor, respectively. The restoration boundary encompasses approximately 5.91 ha of high quality blanket bog between 535m and 540m OD (Fig. 3, Plates 1-3).

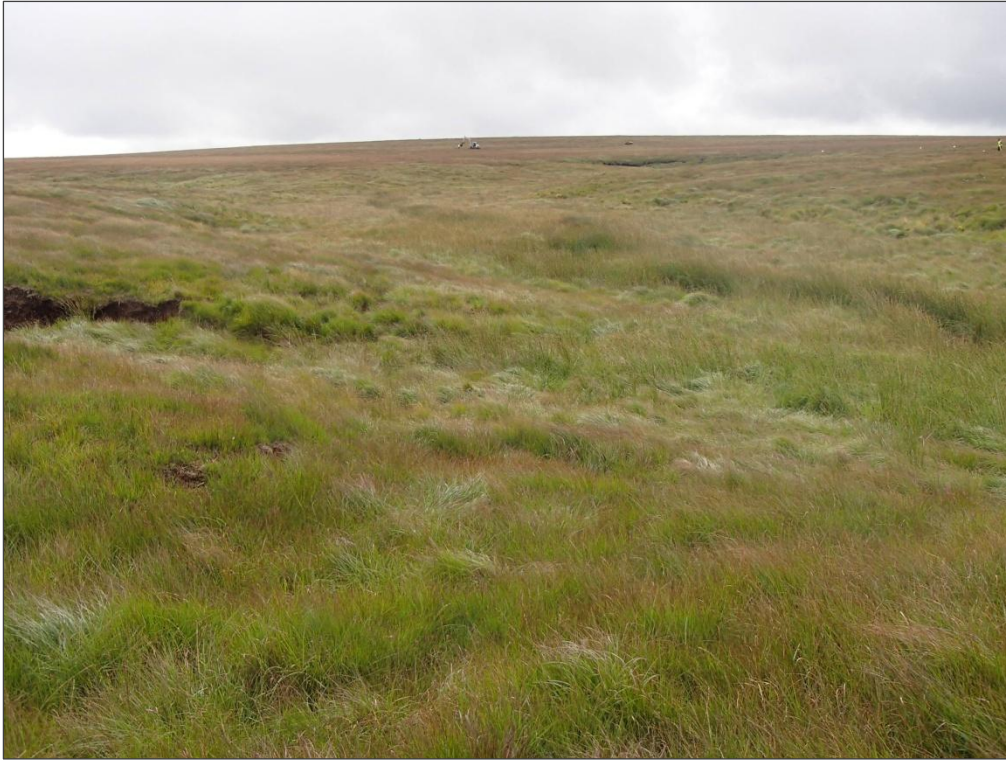
Plate 5 Depression with tributary of River Tavy that flows from the northern end of the site, looking south.

- 4.4.2 The GPR data indicates that the peat either side the large depression to the north of the site measures between 3m and 7m in depth. The depression itself drains into the River Tavy and appears to have approximately 0.50m of peat remaining at its southern end (*Ibid.*). Given the depth of peat either side of this area it may be suggested that peat was extracted from this area at some time in the past. There is extensive evidence for streamworks to the north along the River Tavy so any disturbance is likely to be related in some way to the tin extraction along the Tavy.
