Project Report 413h.1

**Archaeological Evaluation of
the Upper Loading Bay,
Castle Market,
Sheffield**

April 2002

Prepared For:
Sheffield City Council
Howden House, 1 Union Street, Sheffield, S1 2SH

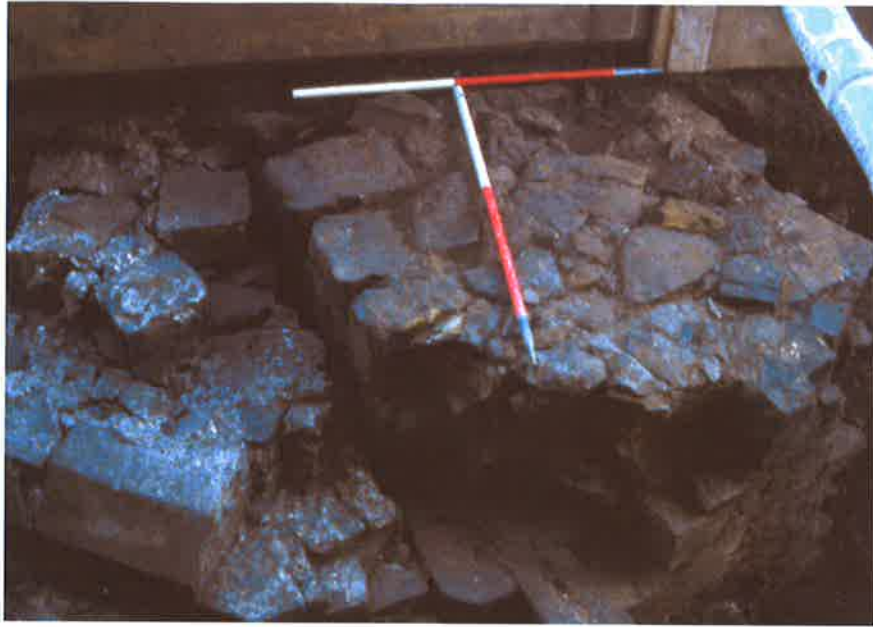
Plate a: Trench 1, wall [1012]

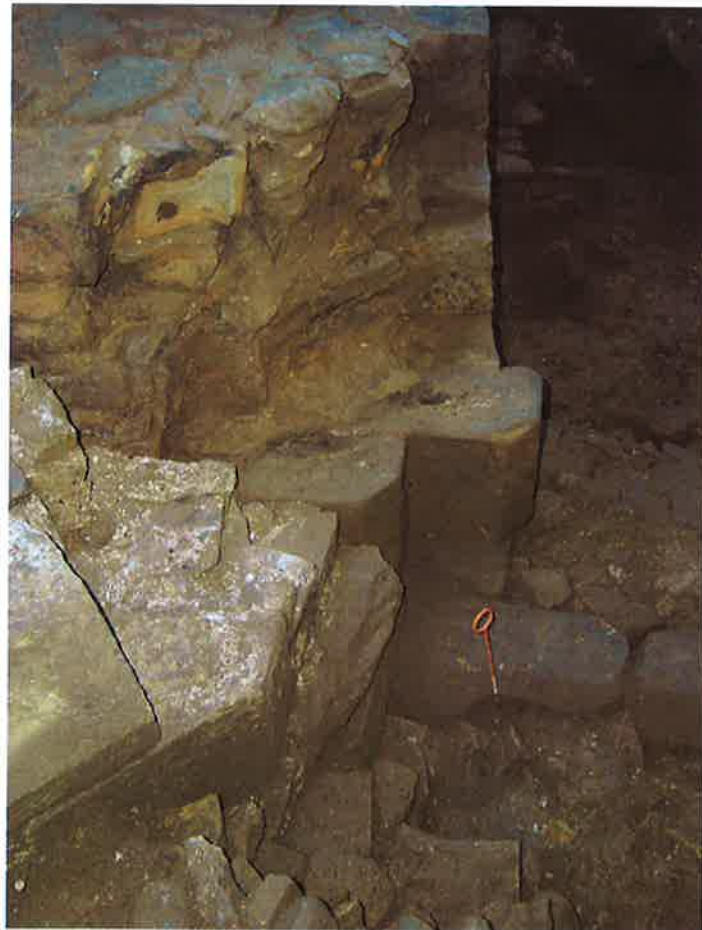
Plate b: Trench 1, chamfered surround to doorway

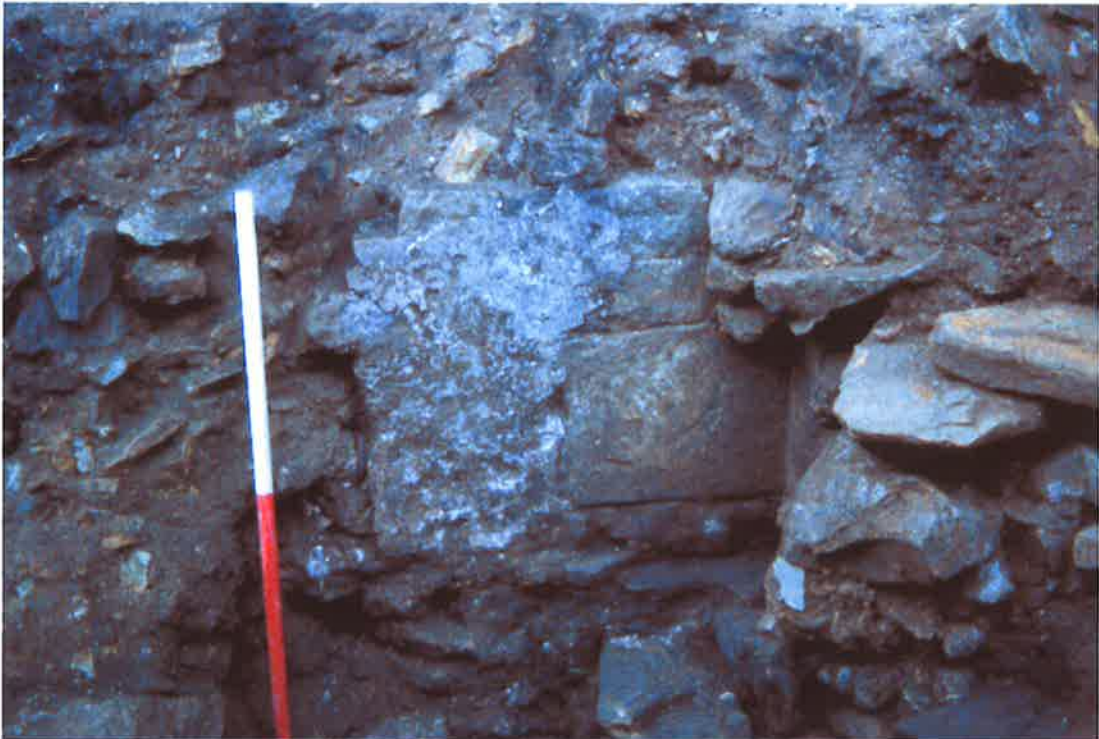
Plate c: Trench 1, plaster on the side of the doorway

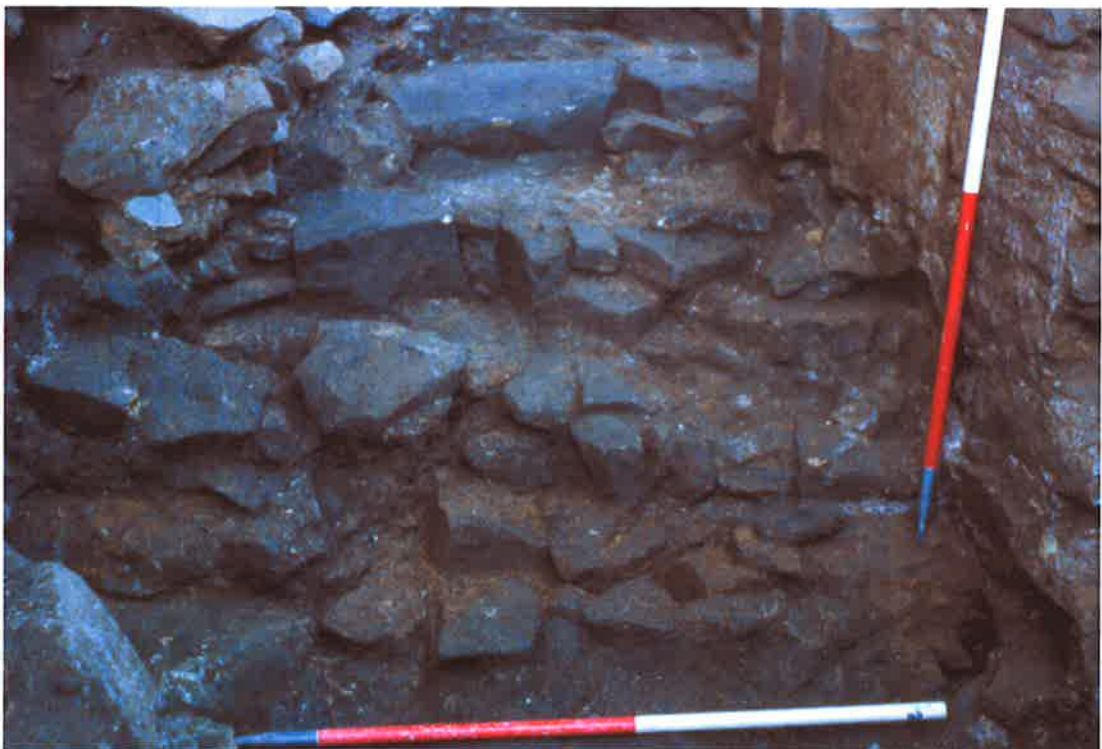
Plate d: Trench 1, robbed out steps

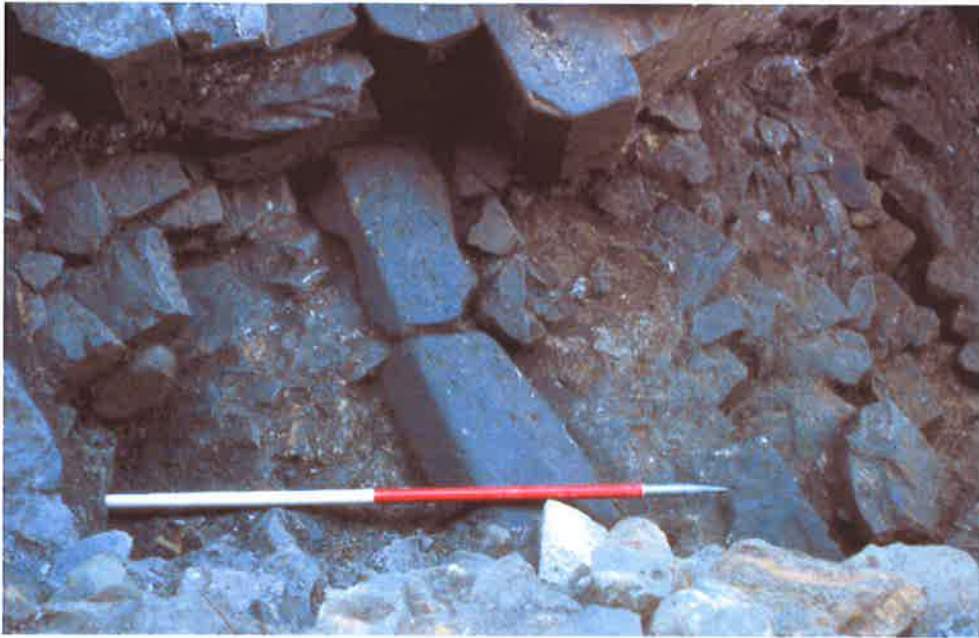
Plate e: Trench 1, buttness with former surface level

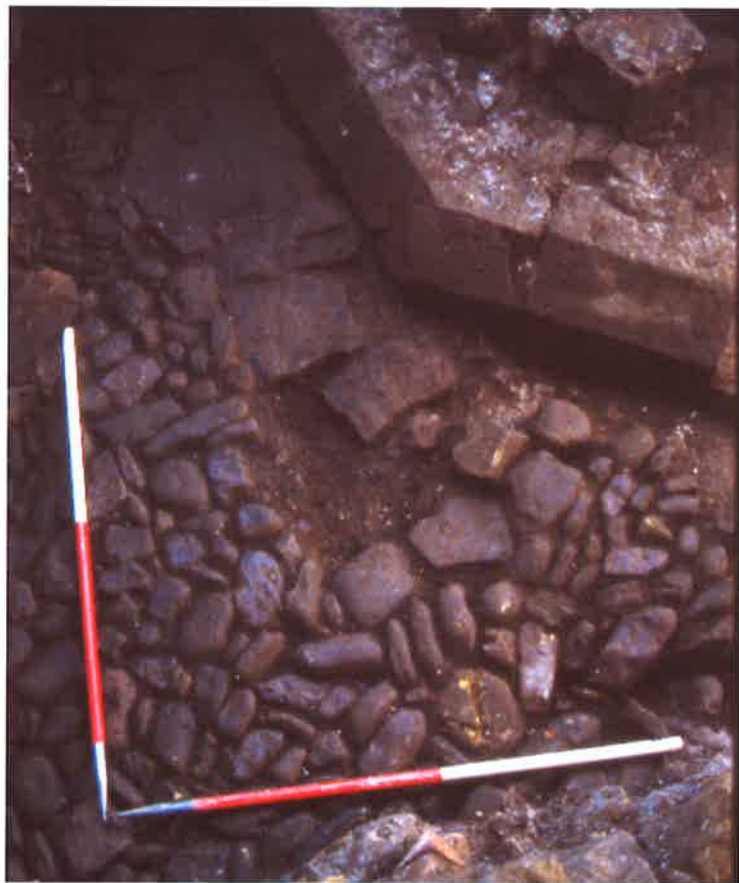
Plate f: Trench 1, cobbled surface

Armstrong (1930) noted that he observed Thomas de Furnivals courtyard in several pile pits under the castle market. Unfortunately he does not describe what he saw. In Trench 1 part of a cobbled surface was found outside the building. This was most likely the surface of a courtyard. However, it is not known if this cobbled surface extended over the whole of the courtyard, or whether there was variation in surface treatment inside the courtyard.

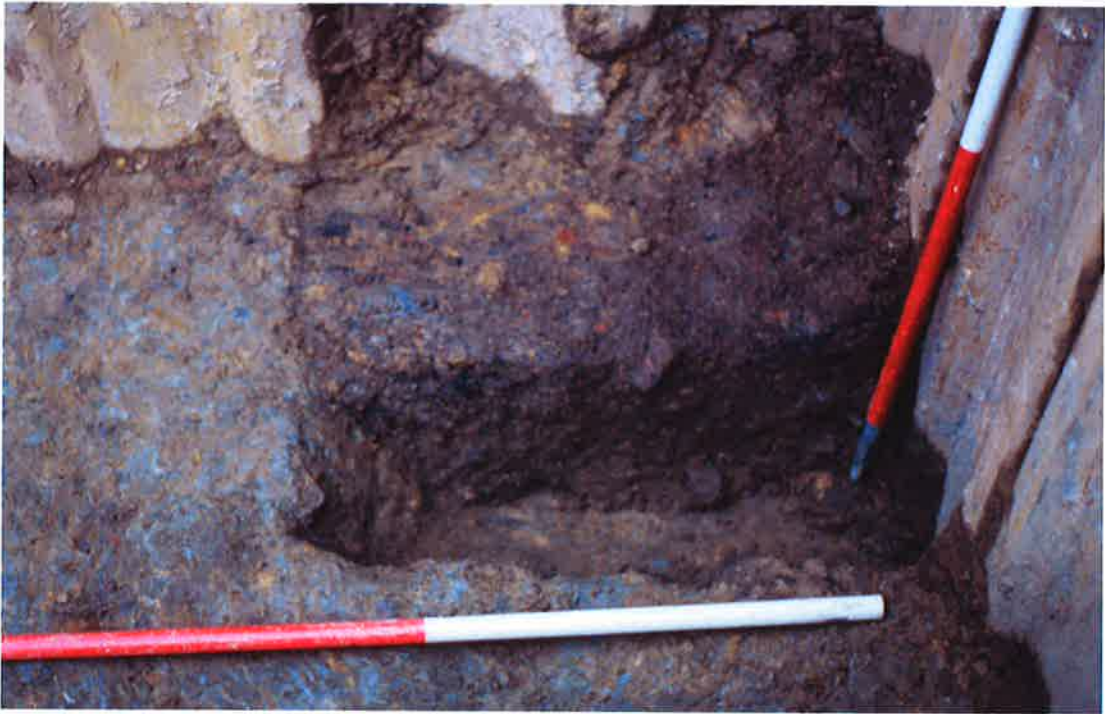
Plate g: Trench 2, pit 2015

numerous pieces of burnt stone. Immediately to the north of pit [2015] was the second pit [2022]. Pit [2022] contained a small sherd of pottery, a large jar in North Lincolnshire Shell tempered fabric. This pottery dates from the late-twelfth-century through to the fifteenth century, however, based on the stratigraphic relationship this feature must be early in the history of the castle. Pit [2022] was cut through on the east side by the shoring and had been truncated on the north side by the 'precipice'. The 'precipice' ran east west along the trench and the deposits to the north were entirely composed of modern dumping [2000]. There were several features within Trench 2 that had been truncated by the 'precipice', showing that at some time in the past the precipice has been cut back.

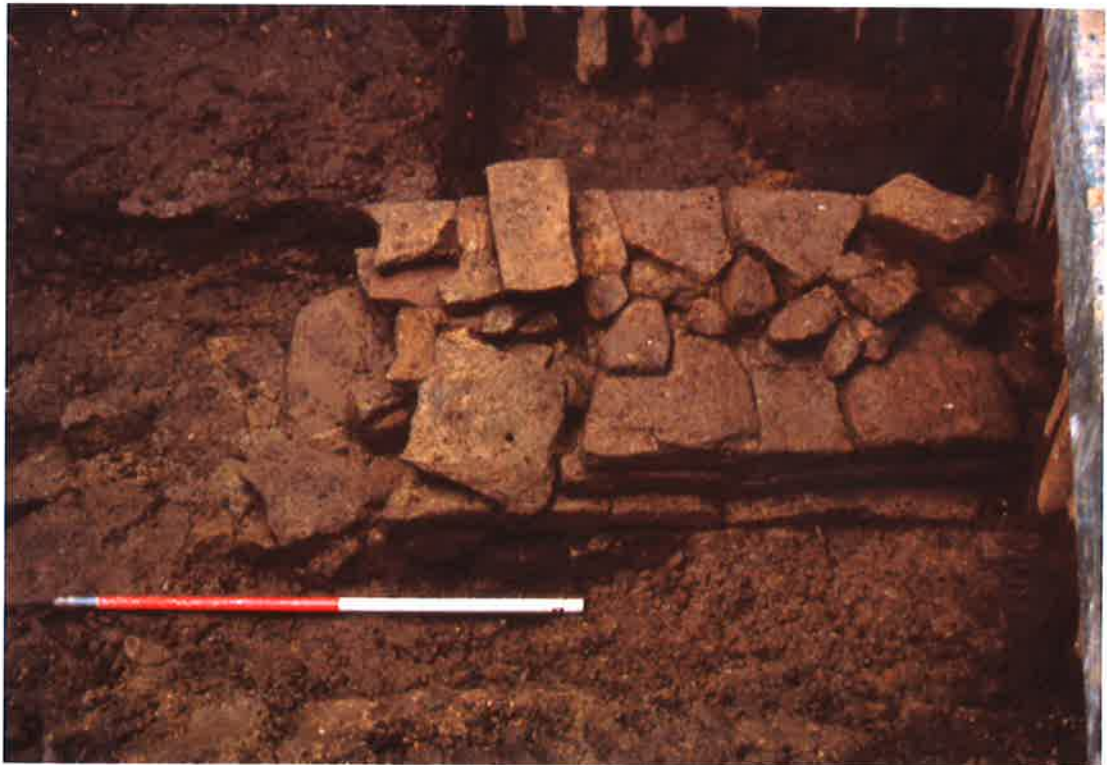
Plate h: Trench 2, wall 2007 with roof tile fragment

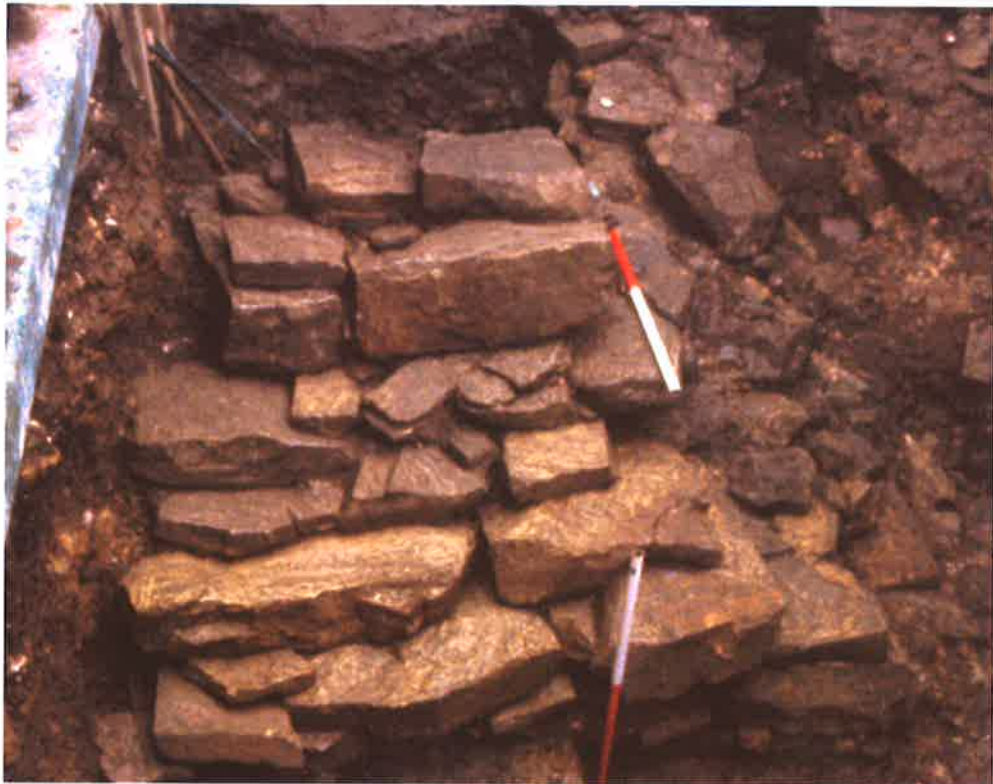
Plate i: Trench 2, structure 2017 rising in rough steps

To the west of wall [2007] and separated from it by a small gap, was a large stone structure. This was composed of three main elements [2017] [2026] and [2003] (**Illustration 14**) with a tumble of rubble [2006] over part of the structure. Although certainly part of the castle, it was not possible to determine which sub-phase of phase 2 this structure belonged to. The structure was incomplete, as a large hole [2023] appeared to have been dug through it at some time in the past, making it difficult to interpret. The majority of the structure appeared to be the remains of foundations for a large building. At the east end the exterior of the structure was constructed of a number of large blocks (**Illustration 17**) and rose up in a series of rough steps [2017] (**plate i**). This was separated from the west end of the structure

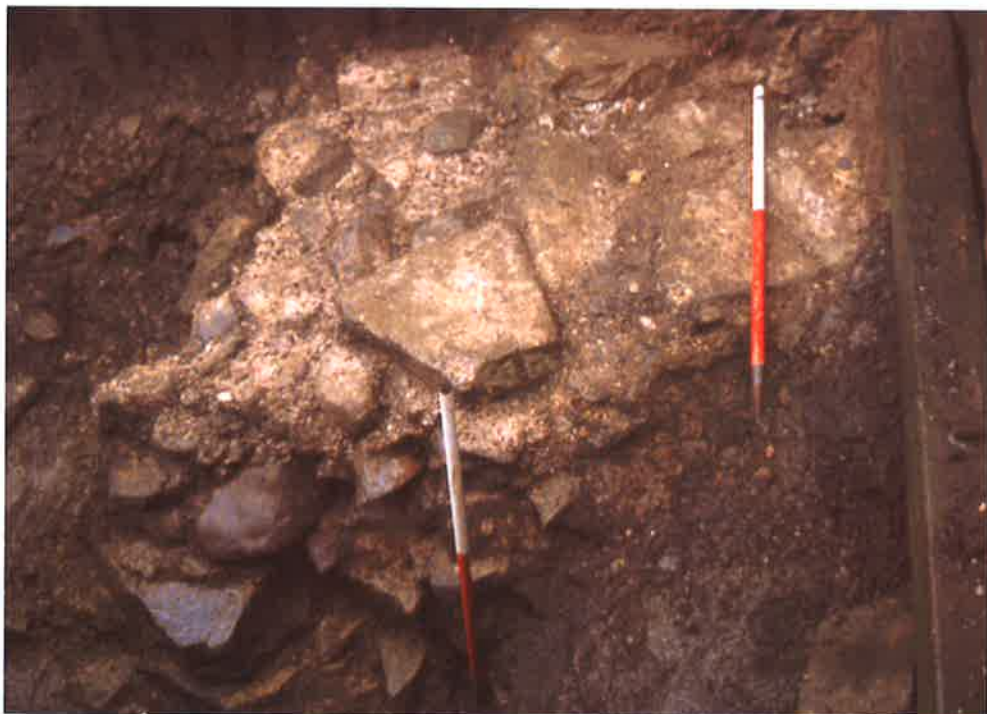
Plate j: Trench 2, flag stones on top of 2003
