Archaeological watching brief

of test pit excavation

The Red Lion, Theale

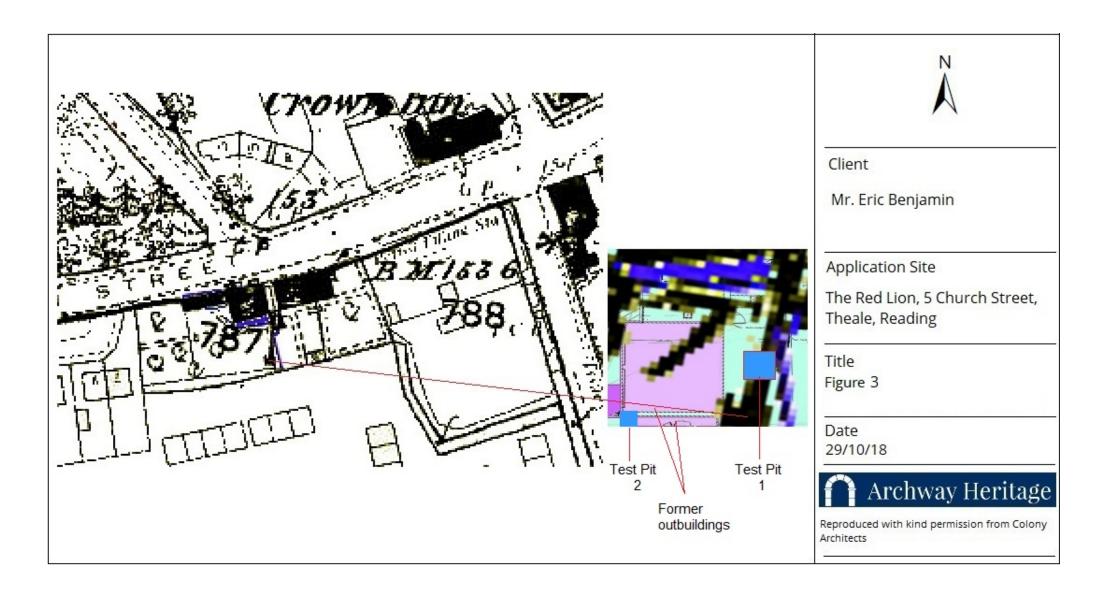
Figure 3: Overlay of Ordnance Survey maps from 1879 and 1965

- 3.1.2 Overlaying early historic maps and Ordnance Survey maps confirmed that a diagonal ditch was once located in the same spot as the test pit, which was illustrated on the First Edition Ordnance Survey map. It was the former property boundary for the Red Lion, which was realigned to be perpendicular to the road, as illustrated on the Second Edition Ordnance Survey map (see Figure 3).

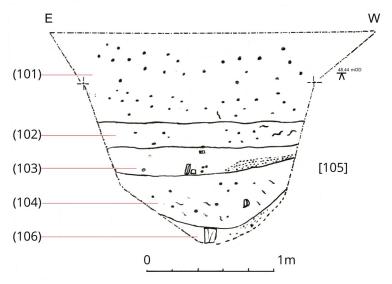
Figure 4: Section drawing of Test Pit 1

- 3.1.1 A feature was identified below the buried subsoil and spot dated by a sherd of pot as Post-medieval in date. The full width of the feature was not revealed because it was not possible to extend the test pit to the west due to the fence and services in the immediate vicinity. In addition, it was not possible to extend the test pit to the east due to need for the digger to be able to manoeuvre within this confined space (scaffolding added to dangers and restricted space). The edges of the test pit were stepped out to ensure rubble would not fall into the test pit while the Site Supervisor was cleaning the sections. The use of a ladder allowed safe access for hand cleaning and recording.

A feature was encountered in Test Pit 1. It was spot dated by a sherd of pot as Post-medieval and is interpreted as a former boundary ditch.

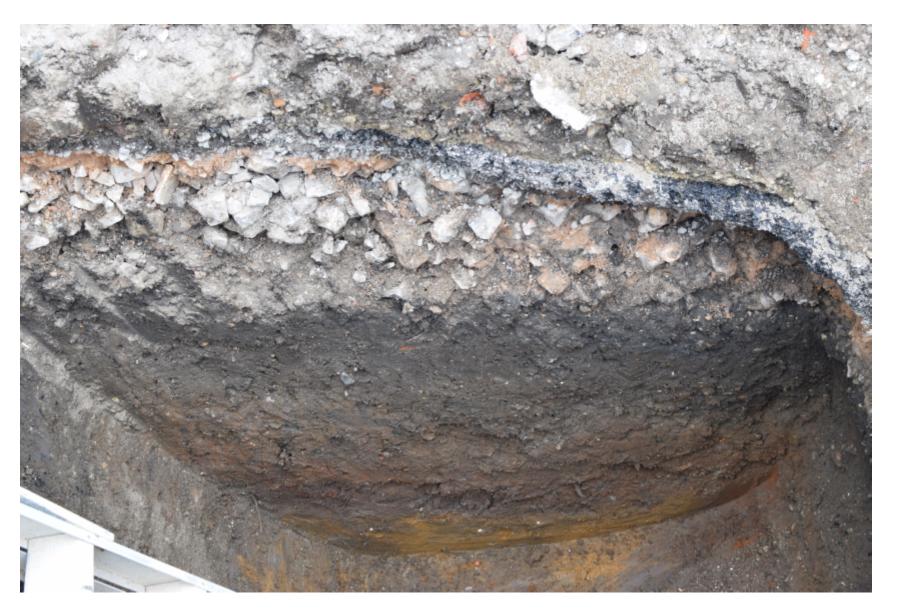
Plate 3: The north-facing section of Test Pit 3

3.3.1 Test Pit 3 was excavated down to natural, 1.72m deep, and the excavator stepped out the edges of the test pit to ensure rubble would not fall into the test pit while the Site Supervisor was cleaning the sections. The use of a ladder allowed safe access for hand cleaning and recording. As spot dating identified Prehistoric pottery sherds, the test pit was extended westwards to establish whether the edges of a feature might become evident. No features were identified and additional Post-medieval and modern pottery sherds and the broken stem of a clay pipe confirmed that the finds were redeposited and the layer was disturbed. Due to its similarity with other deposits in the same stratigraphic sequence in the non-disturbed test pits, the mottled colour and the texture, it was interpreted as buried subsoil.

Test Pit 3 contained no archaeological features or deposits but an assemblage of Prehistoric pottery sherds, Post-medieval and modern pottery sherds and the broken stem of a clay pipe.

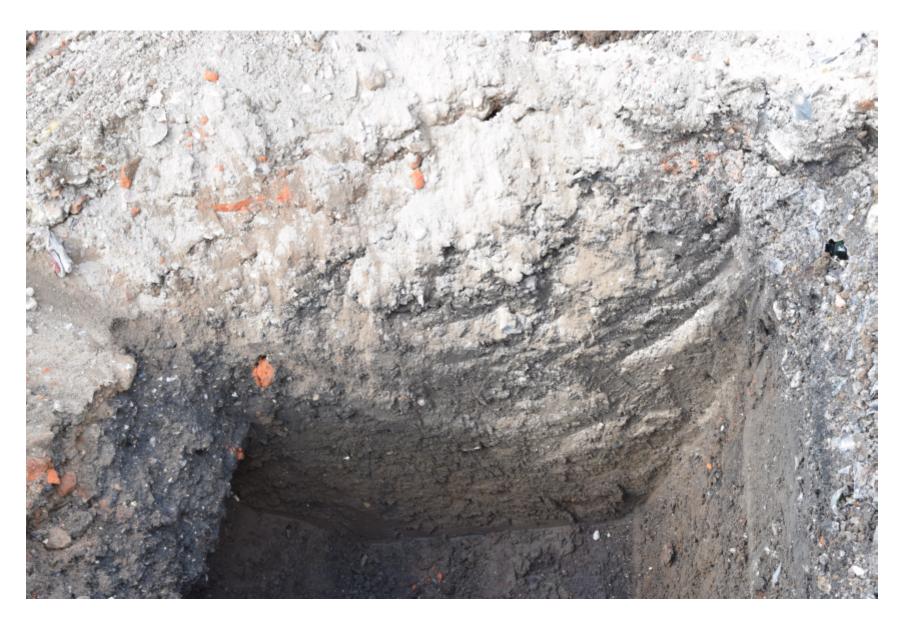
Plate 4: The north-facing section of Test Pit 4

- 3.4.1 Test Pit 4 was excavated down to a depth of 1.4m. The excavator stepped out the edges of the test pit to ensure rubble would not fall into the test pit while the Site Supervisor was cleaning the sections. The use of a ladder allowed safe access for hand cleaning and recording. There was further evidence of disturbance in this Test Pit. A clay drainage pipe was located at the southeast corner and a modern pipe protruded from the east-facing section and each section face showed a different depth or level of made ground above the buried topsoil. The section drawing shows a rubble layer jutting out from the west-facing section left in place to avoid further collapse of this part of the section.

- 3.4.2 An overlay of the 1989 Ordnance Survey map over the proposed plan, the foundations for which had been constructed at the time of the watching brief, revealed that a former boundary ditch was located at the eastern edge of Test Pit 4.
