CROSTWIGHT HALL

by Edwin J. Rose

SUMMARY

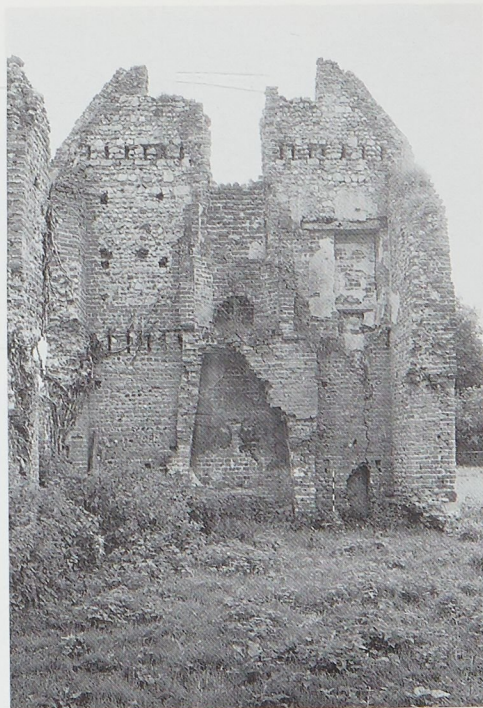
Plate V

The inner face of the south wall of the east wing. (Photo by Peter Fox)

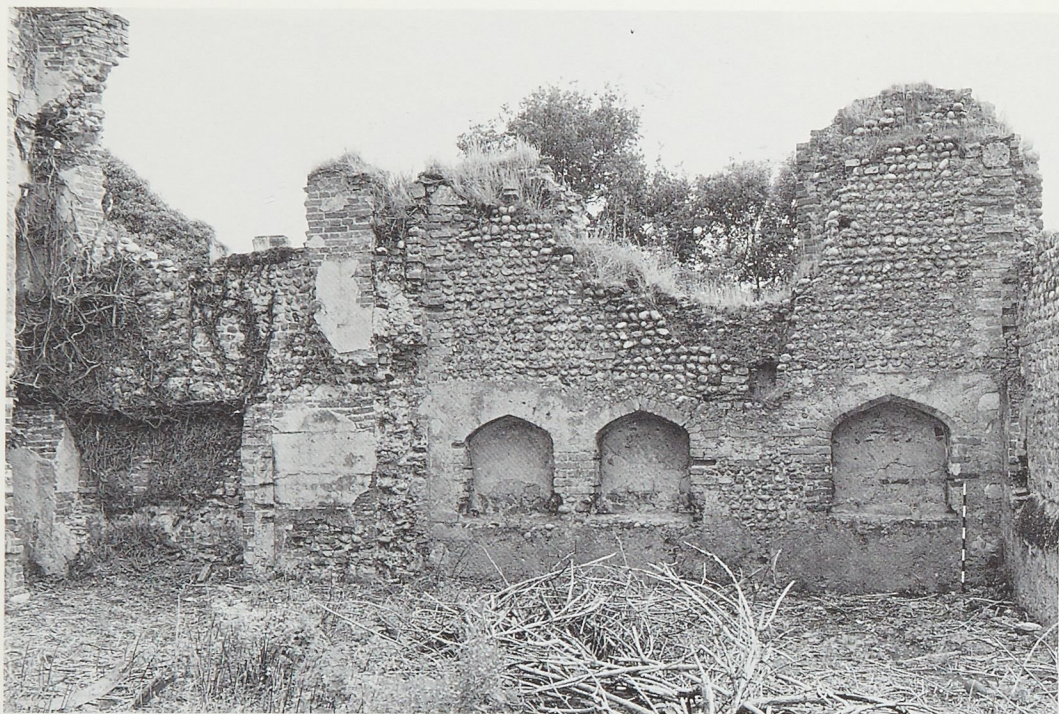
Plate VI

The inner face of the south wall of the east wing. (Photo by Peter Fox)

The wing's south wall (Plates III, VI) is composed of large flint pebbles with galletting and random bricks. The external quoins are of thick yellow bricks, unlike any others in the building, but the inner quoins are of a pale-red brick of different fabric, with some re-used stone fragments at the top of the surviving height. The outer face of the base of the wall is blank, but on the interior are three broad niches or recesses with low pointed tops.

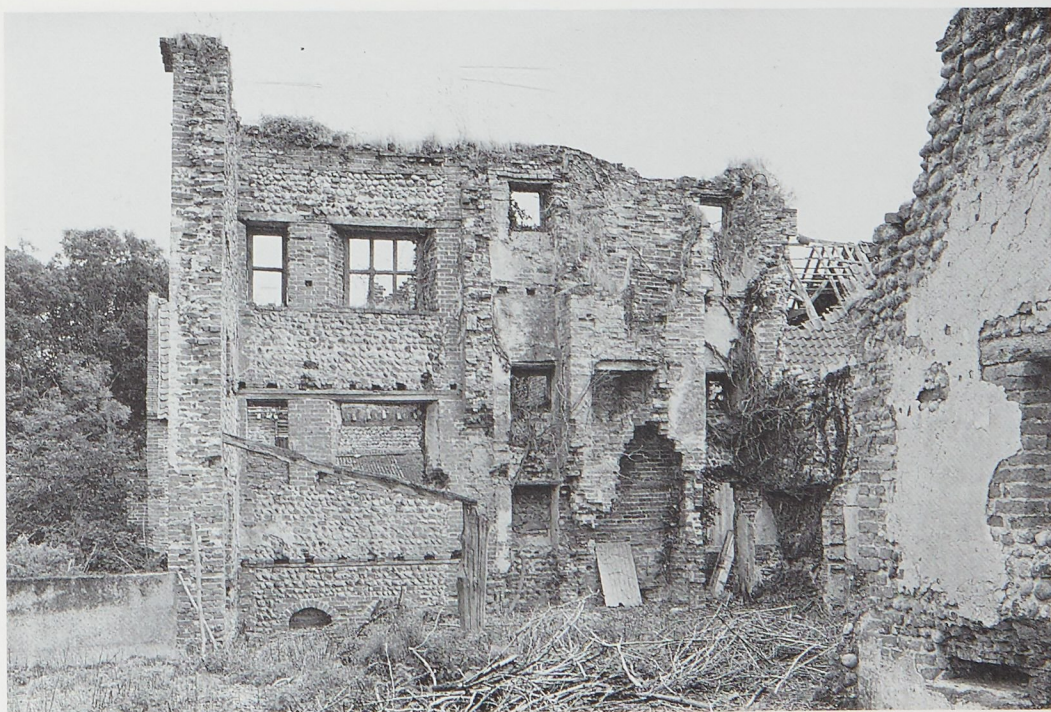
Plate IX

The inner face of the east wall of the eastern extensions. (*Photo by Peter Fox*)

The eastern extensions comprise buildings of two phases, both of rectangular plan. Both now lack a west wall, which would have been the original east wall of the east wing. The northern section had a semi-basement. The internal face of the north wall (Place VII) is of random flint and brick with brick quoins; those on the north-west are worn smooth to a height of 2 metres, indicating a doorway to the east wing. The exterior of this wall is faced in regular rows of pebble flint. The north-east corner (Plate VIII) is externally of brick, and chamfered off to first floor window level. The east wall (Plates VIII, IX) is of the same build as the north.

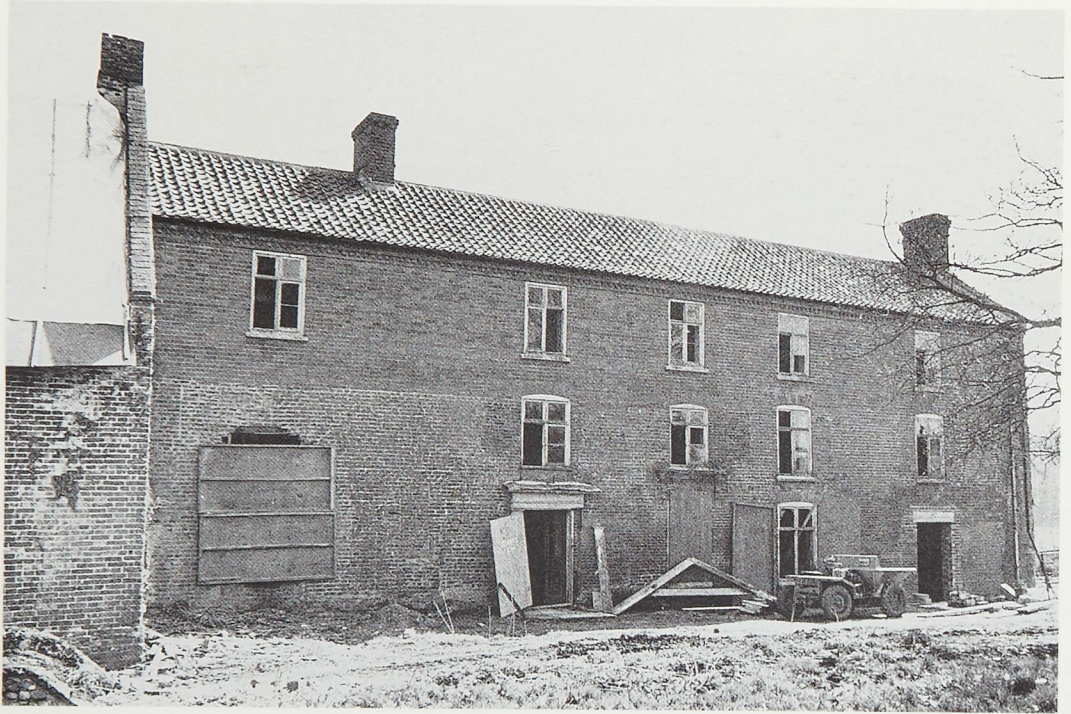
Plate X
The New Hall. (Photo by E. Rose)

Known in more recent years as the Farmhouse, this building stands to the east of the ruins and is shown on the Walpole map. It is now of three storeys; a photograph in the possession of the architects for the restoration shows the building before the addition of the present top storey, having instead a steeply pitched roof with three dormers. The walling of the lower two storeys is composed of brickwork of the 16th or early 17th century in a rough English bond. The windows are all 18th or 19th century replacements; that on the centre bay of the ground floor has a moulded straight hood.

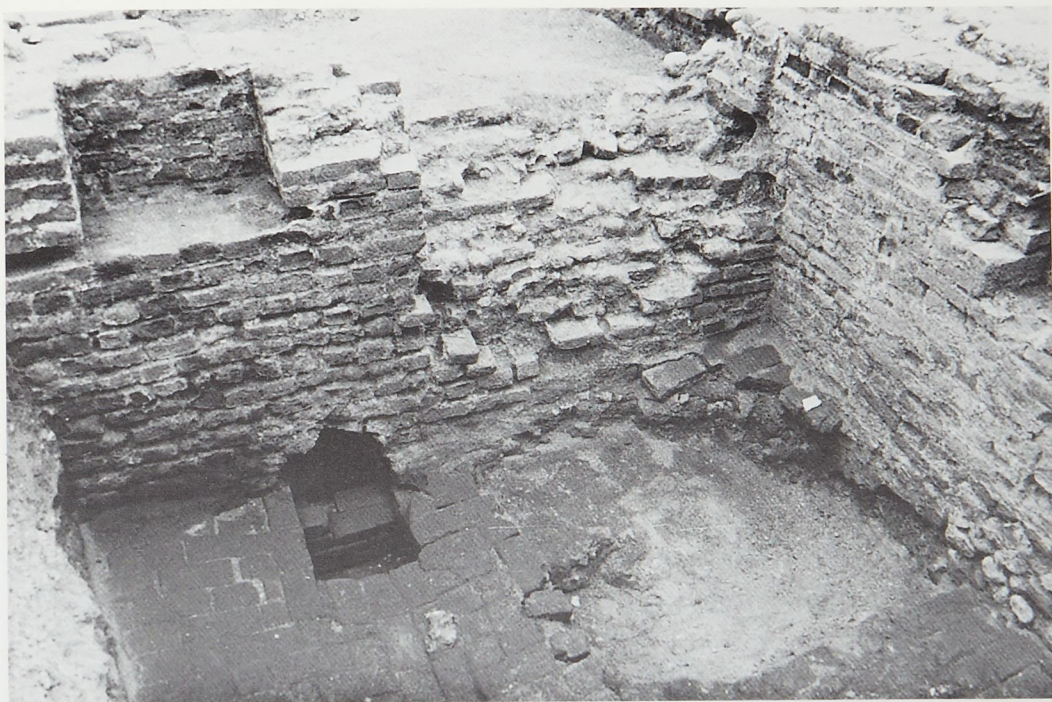
Plate XII

The cellar as excavated, looking north. (Photo by D. Wicks)

Once the topsoil had been removed it was evident that the eastern third of the block was occupied by a cellar (Plate XII), infilled with sand and portions of corrugated-iron pigsties; it was afterwards found that this backfilling had taken place within the past twenty years (2). The eastern half of the fill was removed. The north, east and south walls of the cellar were formed of brickwork, in the top courses forming a skin on the flint footings of the walls of the building. The cellar window mentioned above in the south wall served to light it. The east wall of the

cellar contained the remains of two triangular-headed niches set symmetrically, towards the top of the wall. The north wall contained the remains of a brick staircase, passing through the wall from the exterior. Adjacent on the west was a wide recess, at the level of the niches in the east wall but without any top remaining. A horizontal slot extended westwards from its base into the unexcavated area. The west wall of the cellar (Context 92) was only exposed for its topmost courses. At its north end, where it joined the north wall of the building, it abutted on a thicker portion of wall. To the east of this a facing of herring-bone brickwork had been applied against the north wall (90). This feature was interpreted by the excavators as a fireplace. Traces of the upper parts of two niches were also seen in the west wall.

The cellar floor, (211) where exposed, was not completely level but was at an average depth of 2 m below the pre-excitation ground level. It was composed of red bricks sloping markedly towards a brick culvert running north into a sink trap (211A), to the west of the remains of the staircase. There was no direct evidence that the trap connected with the brick shaft later found outside the building slightly further west. The floor was covered by a layer of fine grit, below a layer of chalky material, both of which appeared to predate the modern infill.

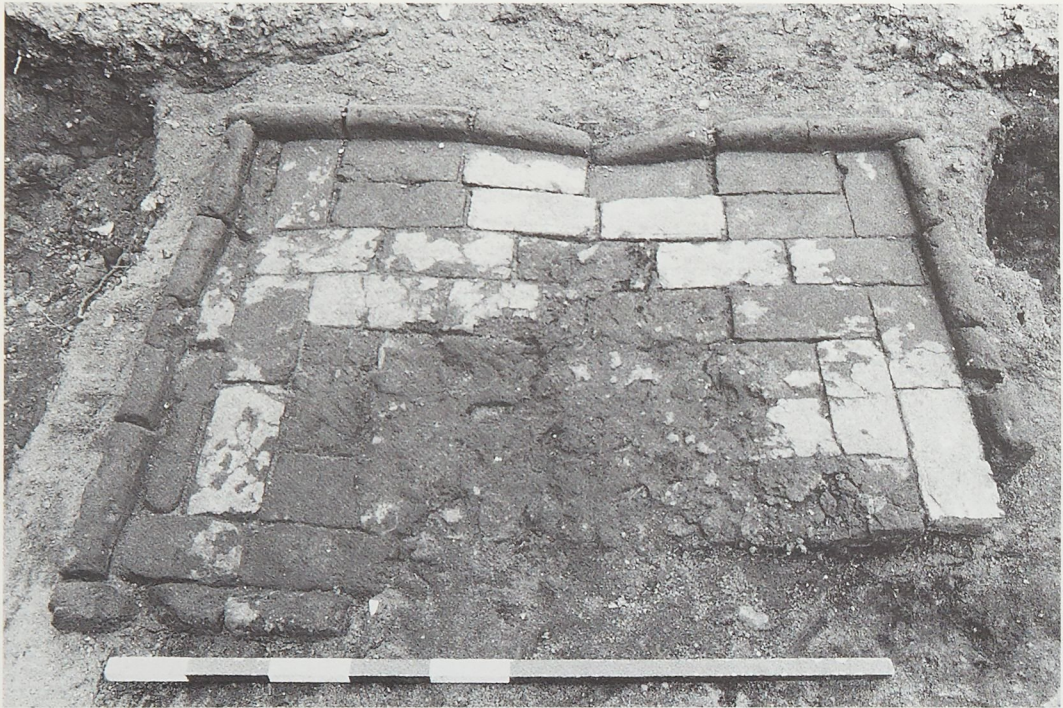
Plate XIV
The hearth. (Photo by D. Wicks)

Trench III exposed the foundation trench for the south (80) wall, cut into natural. Above the natural subsoil between the walls were two layers of sandy silt (77, 81). Set into the upper layer (77) at the centre of the building was a hearth (46) (Plates XIII-XIV), 1 m east-to-west by 1.2 m north-to-south, composed of red bricks laid flat and edged on three sides by bricks set on edge, their upper edges rounded. The unedged side was damaged and was level with the west jamb of the main doorway. The bricks bore considerable evidence of burning. Above the level of the hearth was a layer of sandy silt (75), above this burnt clay and peaty soil (32), and the topmost layer consisted of gravel and brick fragments (46), with lumps of flint adjacent to the north wall, and merging into peaty soil by the south wall. A semi-circular feature (34) containing brown soil, brick fragments and flint lumps had been cut down from this level on the east side of the hearth and may have been the cause of the damage noted.

This suggestion of a late 'medievalisation' may throw some light on a most unusual feature, the open hearth (46) set against the screens passage. Such a feature is again totally out of place in a building of this type; but it certainly does not belong to an earlier structure, for it is set into the top of two layers which post-date the foundation trenches of the present walls. The brickwork of which it is formed is post-medieval. But if, as was suggested by the excavators, this is a post-ruination feature, showing use of the ruins as a smithy or similar function in the 19th century, its central position where one would expect the hearth in a medieval open hall is a strange coincidence. The edging bricks are more carefully rounded and positioned than one might expect in an industrial context.

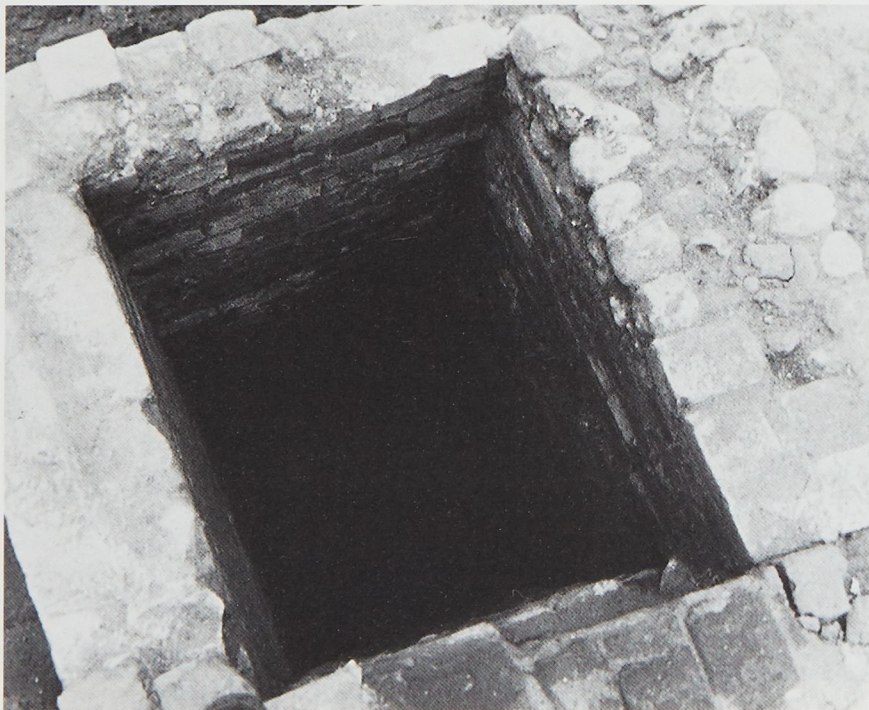
Plate XV
The brick shaft. (Photo by D. Wicks)

A much-worn brick floor projects from the north wall 1.1 m east of the flint base (93). It had an apparent brick step down to the north and the brickwork impinges on the wall of the building; the 'fireplace' (90) noted on the north wall interior above the cellar is level with its south-east corner. To the east and separated from it only by its construction trench filled with flint rubble was a square-sectioned brick shaft (281), 1 m × 0.9 m and up to 3 m deep (Plate XV). The upper courses of its east wall were of mixed bricks and flints. At its base were drain holes in the north and east walls. The main fill of the shaft, 2.10 m in depth, consisted of sand with brick flecks and a quantity of lead window comes of 17th century or later date, for diamond-paned windows (263). Above this were two layers of building rubble and large quantities of fragmentary peg tiles of 16th-17th century type (245, 246).
