## GARSETT HOUSE

by Robert Smith

*An architectural and archaeological survey of the headquarters of the Norfolk and Norwich Archaeological Society, Garsett House in Norwich, was undertaken in 1994. This revealed that the structure is an amalgam of three blocks with the earliest extant structural elements probably dating to the first half of the 16th century. The building sequence is described and an interpretation is provided.*

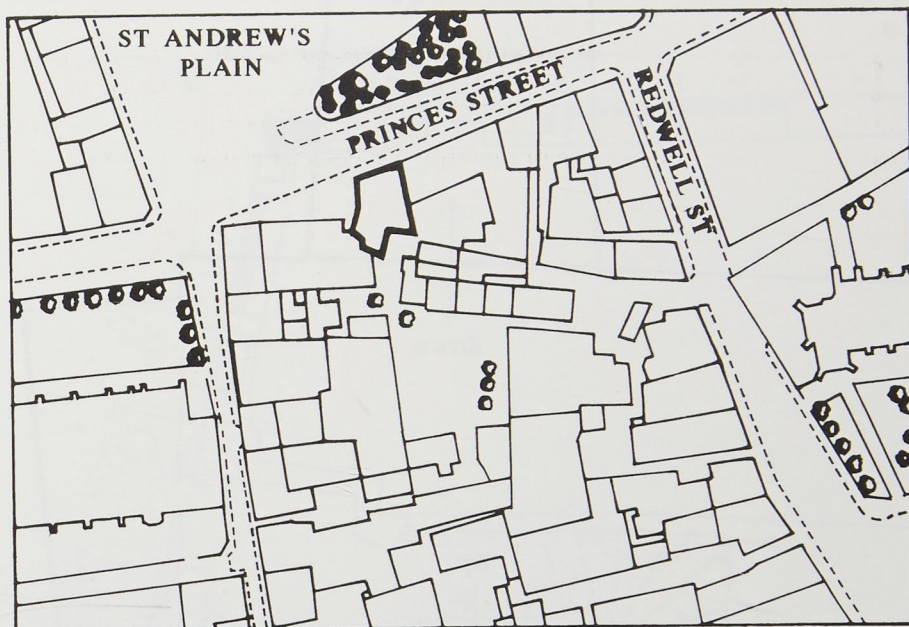
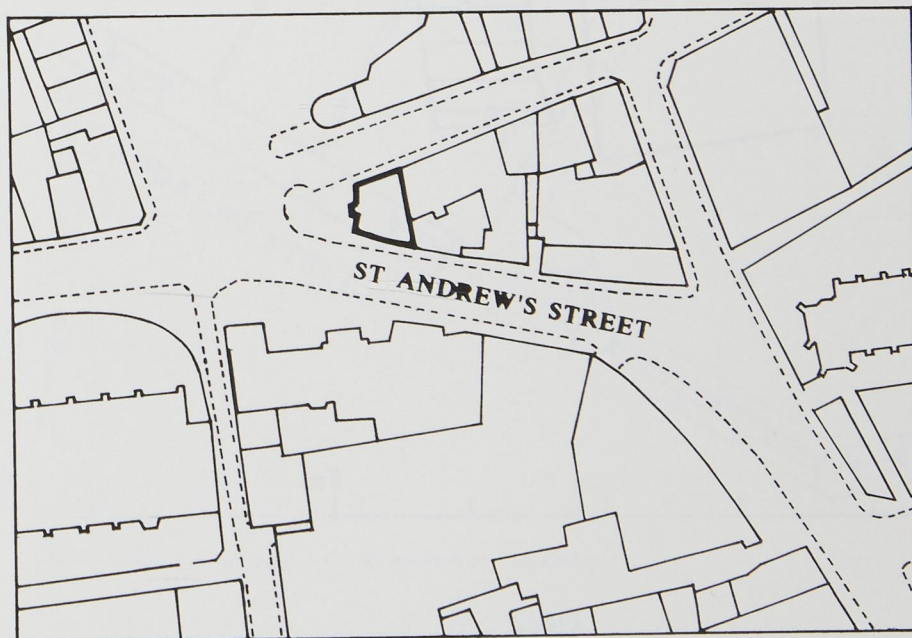
Fig. 1

1885 O.S. Sheet LXIII.II.23 Scale 1:1250

1972 O.S. TG2308NW Scale 1:1250

Garsett House, Norwich: topographical location in 1885 and 1972. Crown Copyright reserved.

Garsett House stands on the eastern side of St Andrew's Hall Plain with Princes Street to the north and the eastern extension of St Andrew's Street to the south (Fig. 1b). The building is a truncated structure, the southern part of the house having been removed in 1898 when the line of St Andrew's Street was extended uphill to Redwell Street in order to accommodate the tramway. The pre-1898 topography is illustrated in Fig. 1a.
