GEOPHYSICAL SURVEY REPORT
RESTENNETH PRIORY

RGC19342/RTP

Commissioned by: The Graham Hunter Foundation

Survey:	Restenneth Priory, Angus
Client:	Graham Hunter Foundation
Date of Fieldwork:	1 st & 2 nd June 2019
Survey Personnel:	Dr S M Ovenden and A S Wilson
Report Author:	Dr S M Ovenden
Report Illustrations:	Dr S M Ovenden
Date of Issue:	10 th June 2019

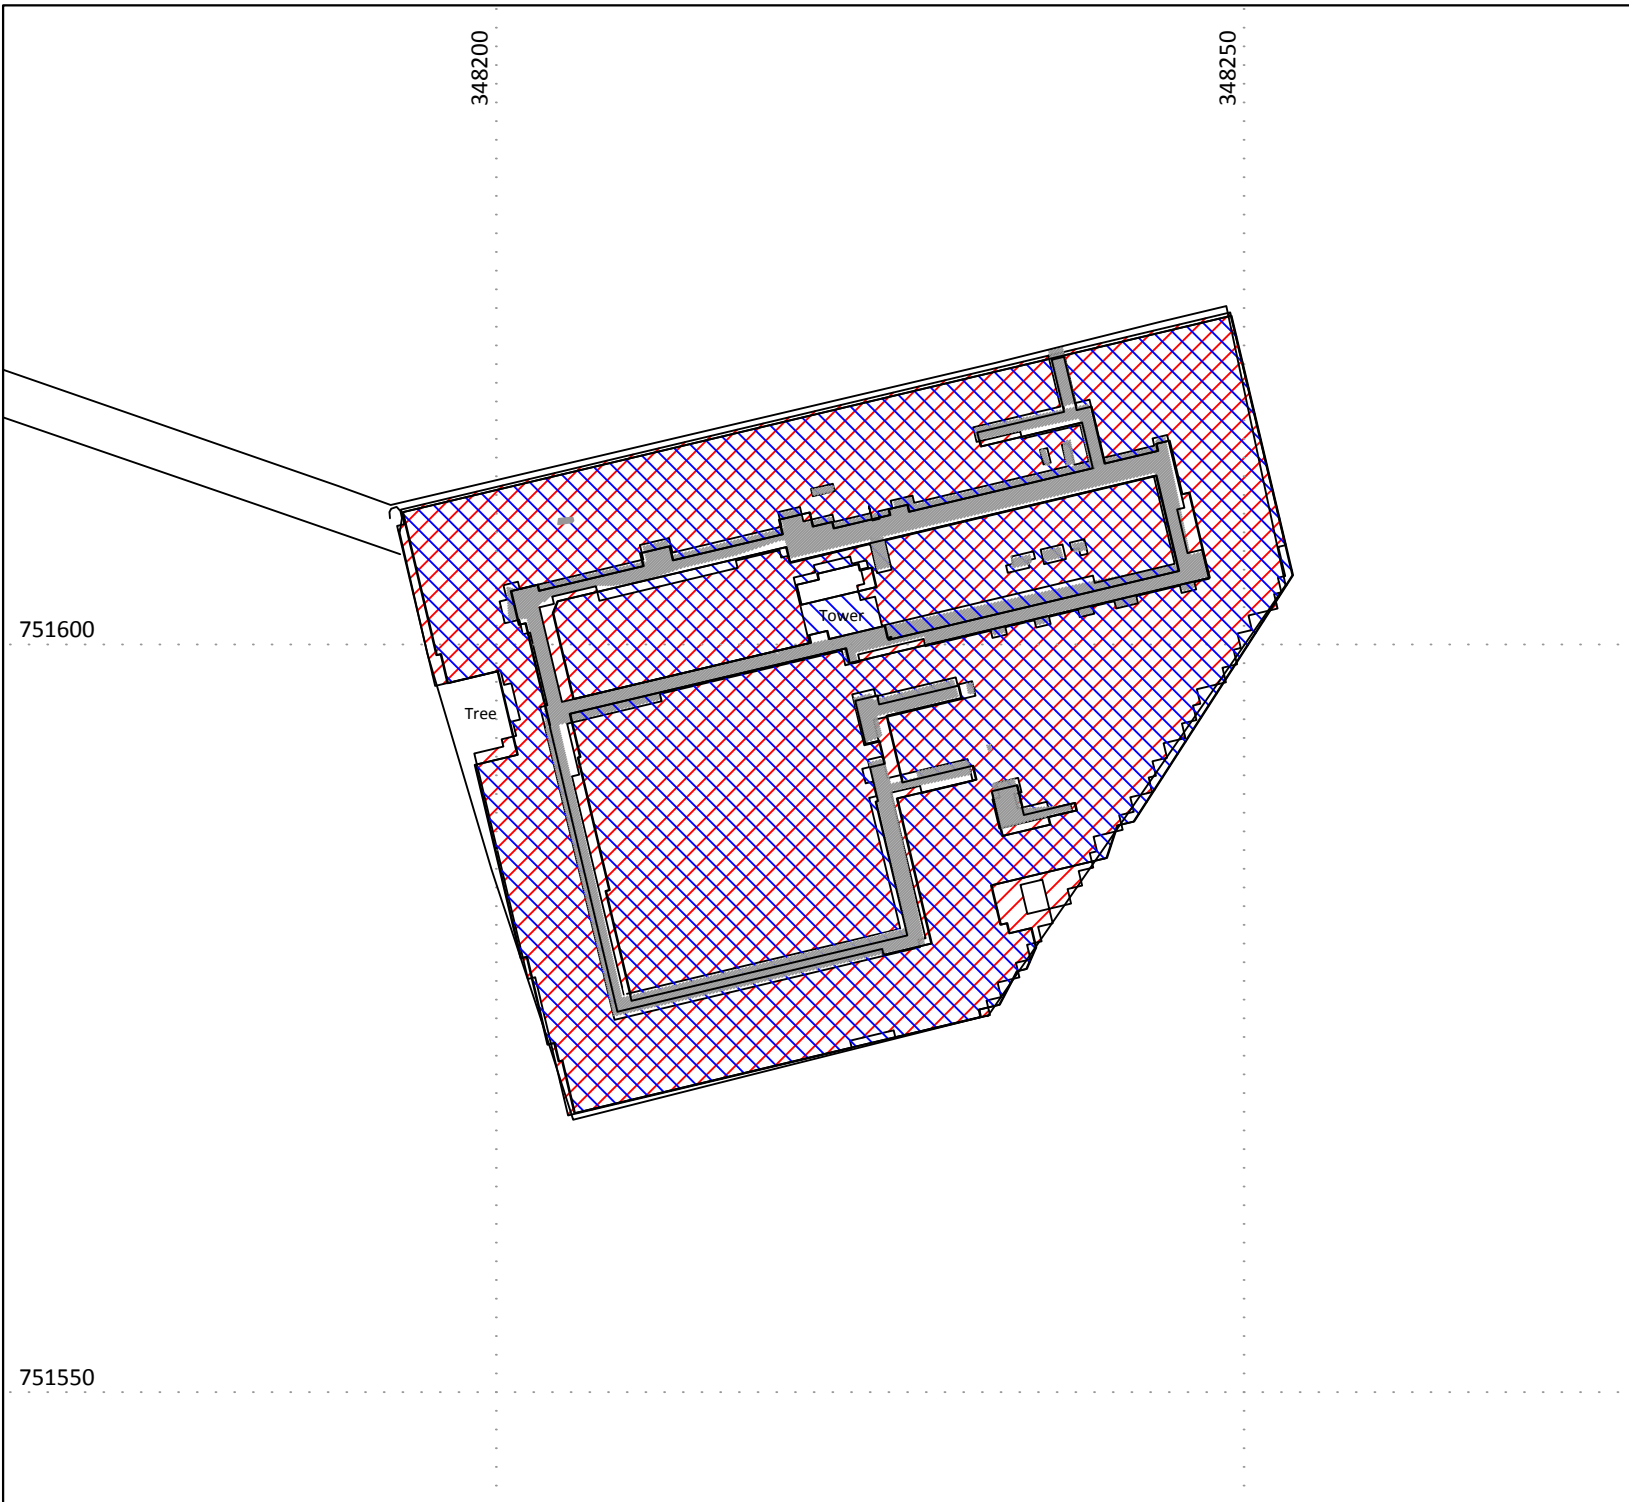
5.5.1 A location plan showing the areas investigated by the different techniques is provided in Figure 1 at a scale of 1:500.

- 5.1.1 Resistance and GPR surveys were carried out over all available areas within the PIC boundary as indicated on Figure 1, at scale of 1:500.
- 5.1.2 Resistance survey was carried out to map possible remnants of structural remains. One would normally expect walls, paths and areas of paving / cobbles etc. to produce high resistance anomalies. Occasionally they may show as a low resistance response if the feature is impeding the flow of groundwater resulting in the collection of water above the structure. Low resistance is usually indicative of a ditch type feature or a robber trench i.e. when stone foundations have been completely removed and the resulting trench has been infilled with soil. It should be stressed that the technique relies on sufficient contrast between a feature and the surrounding soil and as a result it is possible that some features may not be detected due to a lack of contrast. This could be due to a lack of sufficient material to generate a contrast or by similar materials, for example a sandstone wall in a very sandy soil. Generally resistance surveys detect features up to a depth of approximately 0.75m – 1m below the ground surface, but it does not provide any information of the depth of features detected.

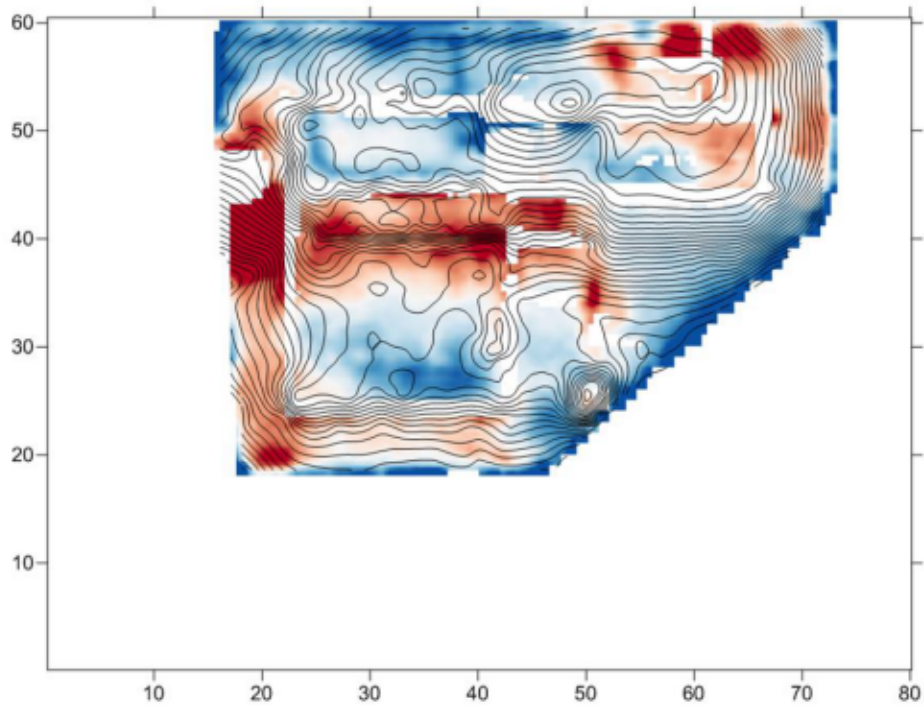
5.5.2.3 Images showing the data with the site topography are displayed in Figure 7. An interpretation diagram is provided in Figure 8, also at a scale of 1:500.

Interpolated data with contours overlaid

Interpolated data draped over site topography

6.3 There are significant topographic variations on site and as a result a coarse topographic survey was undertaken to aid interpretation of the resistance and GPR data.

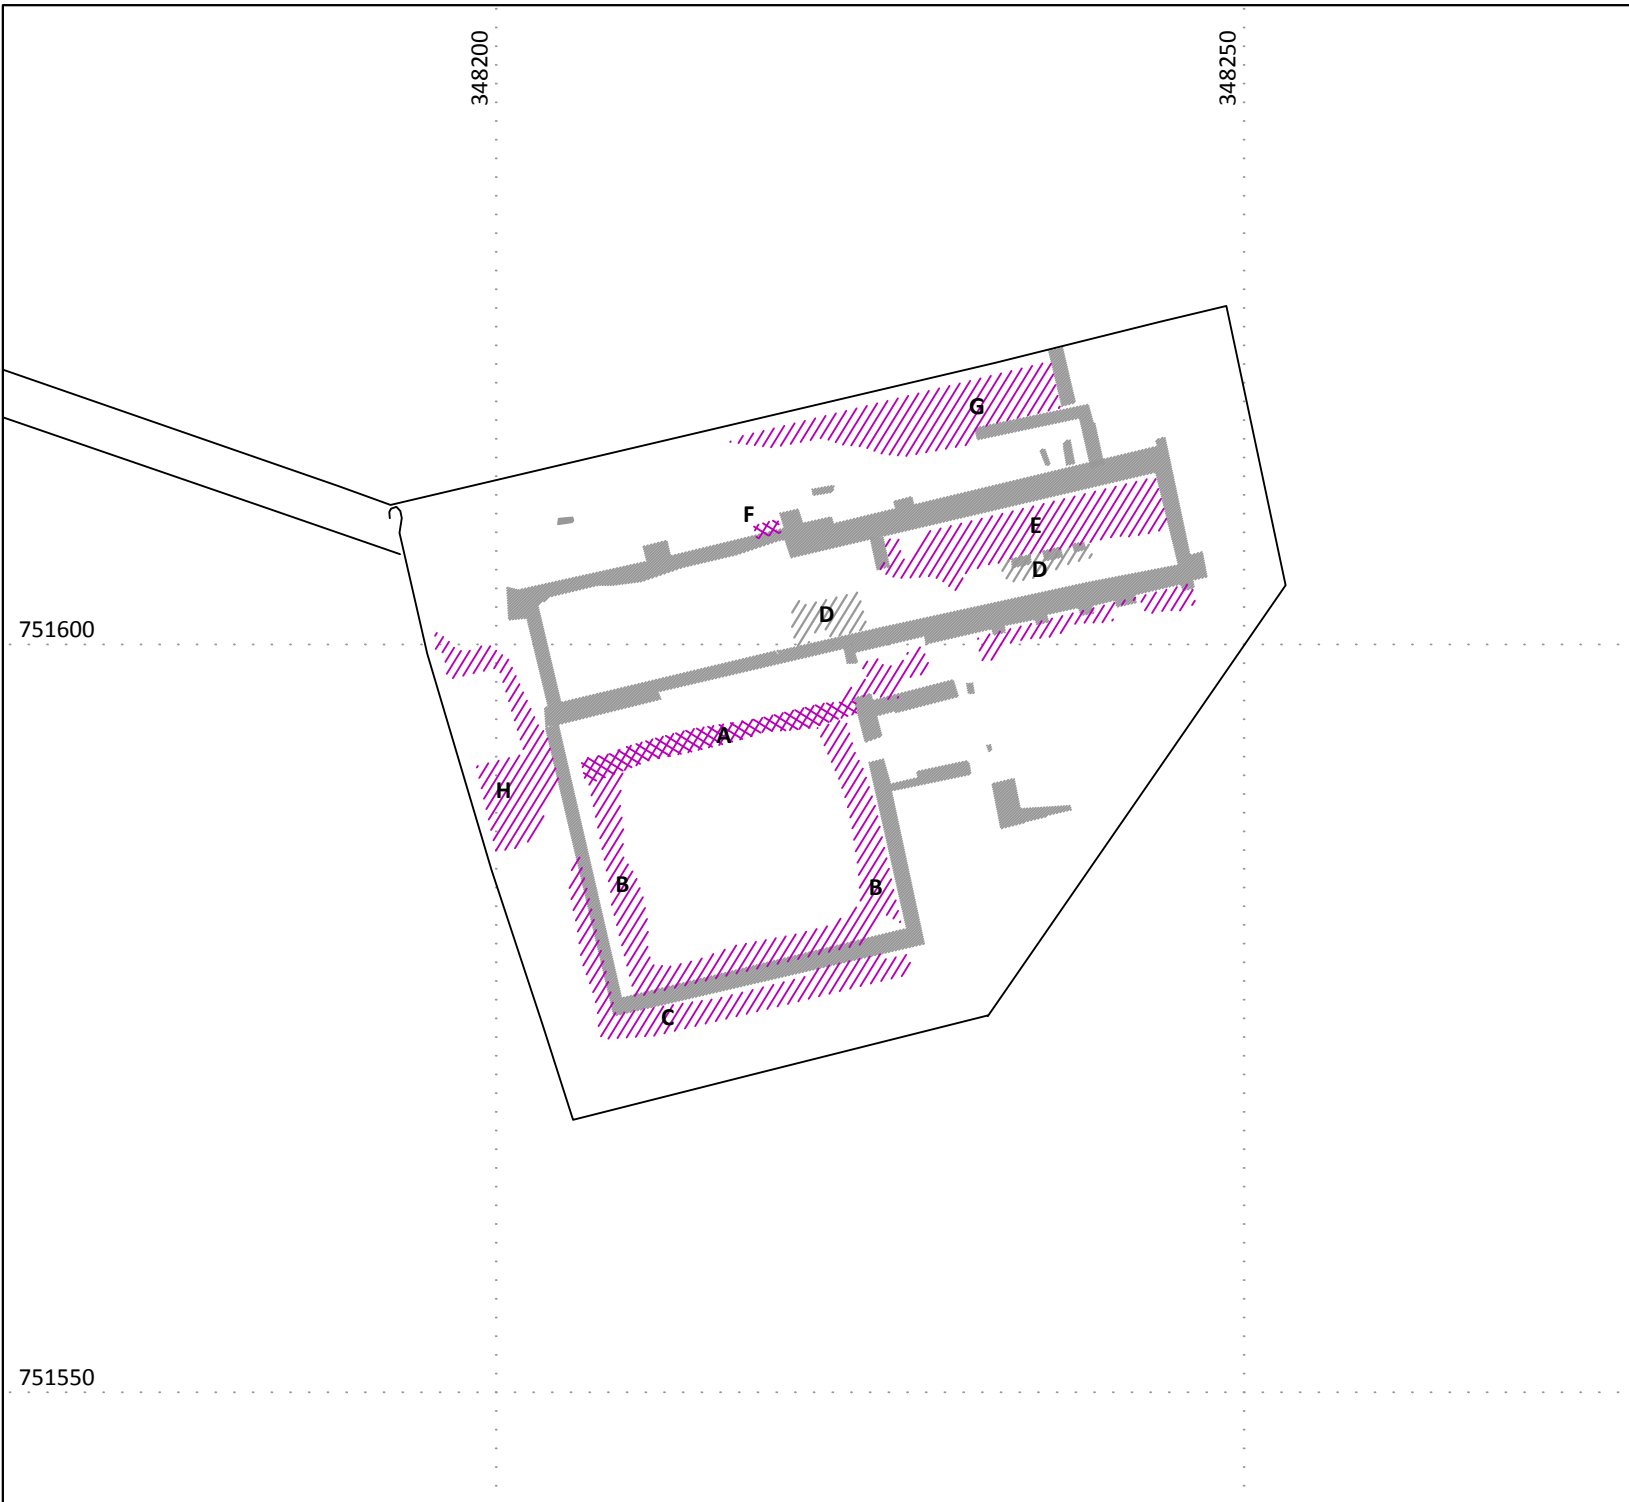
Figure 10

8.2 0.00M – 0.25M DEPTH SLICE (FIGURES 9 & 10)

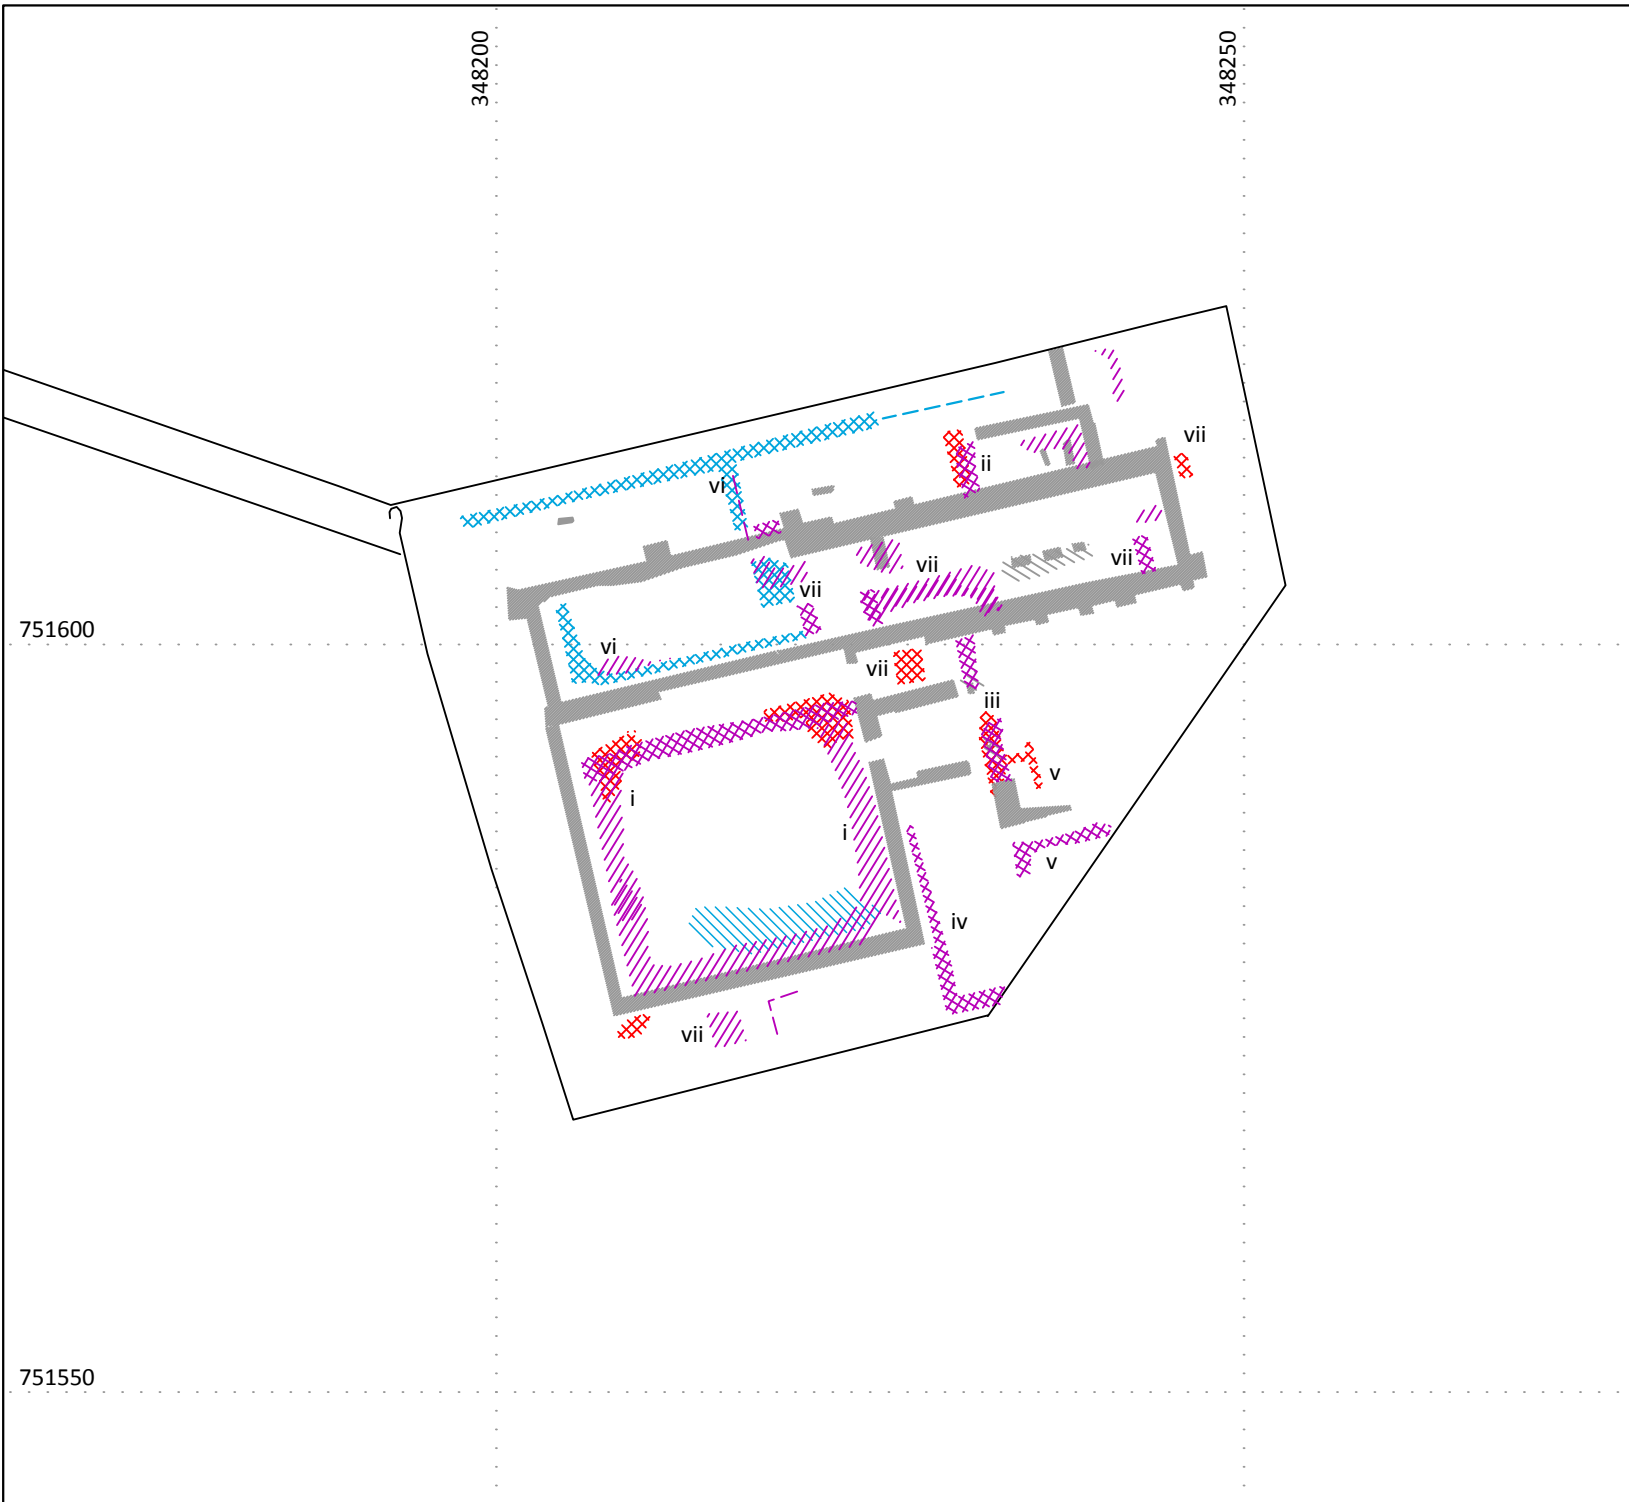
- 9.3 Both techniques have detected anomalies consistent with foundations of walls associated with the Sacristy (ii) and the Chapter House / East Range (iii). Within the GPR data a very well defined anomaly (iv) has been recorded which may indicate the southern extension of the east range. However, the angle of the anomaly is not true to the extant wall immediately to the west. It may be that the anomaly indicates an earlier phase of construction with the extant wall being later, or perhaps a more modern reconstruction which is not quite true to the original foundations. Additional anomalies (v) have been recorded to the east of the east range suggesting further structures.

- 9.6 Based on the results, additional survey beyond the PIC boundary is recommended. In particular, survey to the south of the cloister where there is a well-defined area of higher ground might help to map additional possible structures associated with the Priory.
