Towns in Transition in the First Millennium AD: York as a Case Study

FIGURES Chapters 5 & 6

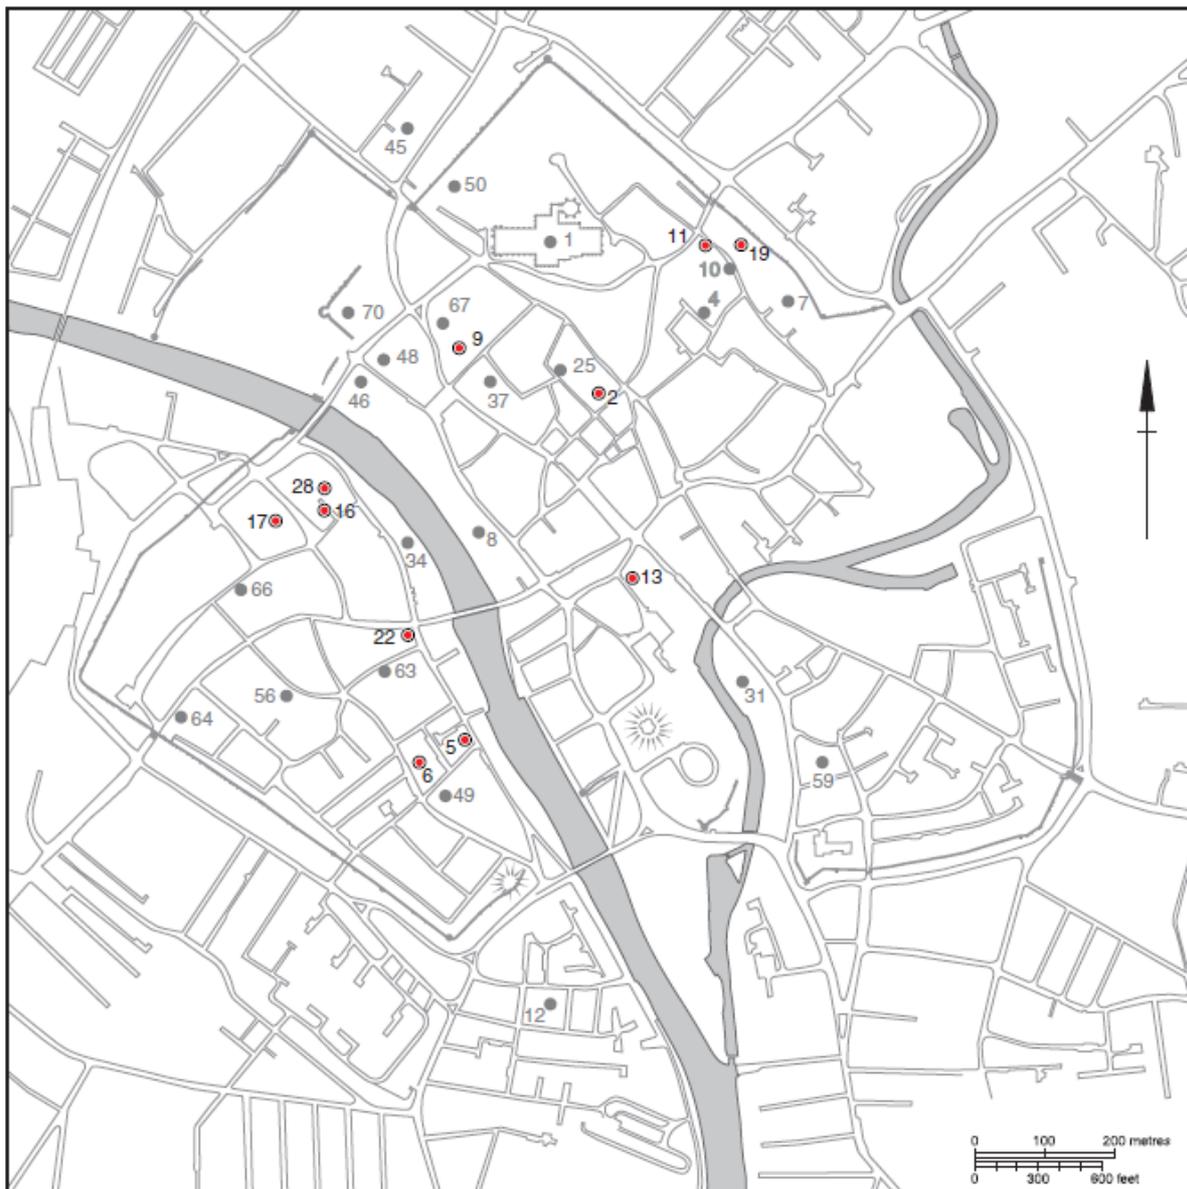
Fig.5.A

Locations of excavated sites in York relevant to the areas of research considered in Chapter 5. Those represented by red dots feature prominently in the discussion in this chapter; those located by grey dots are not referred to in the text, but are considered to be potentially relevant to the research under discussion. Sites listed alphabetically.

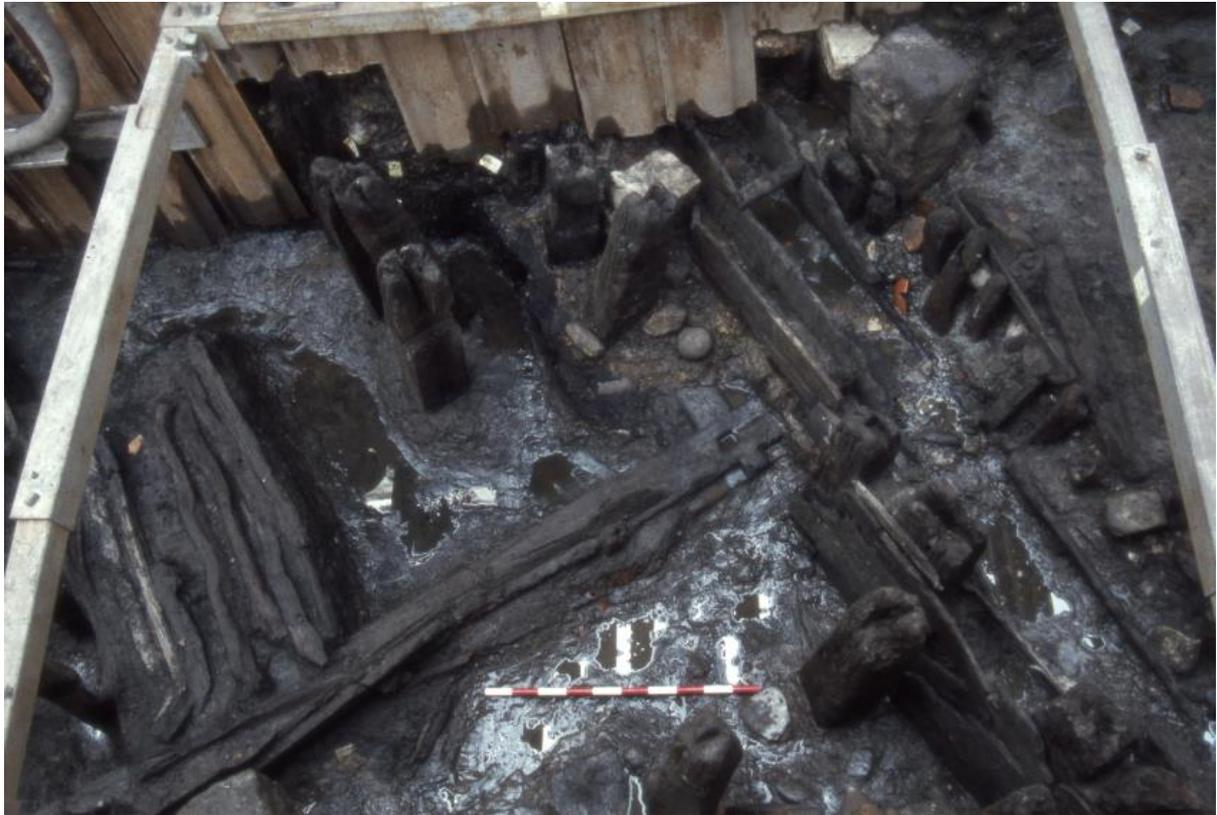
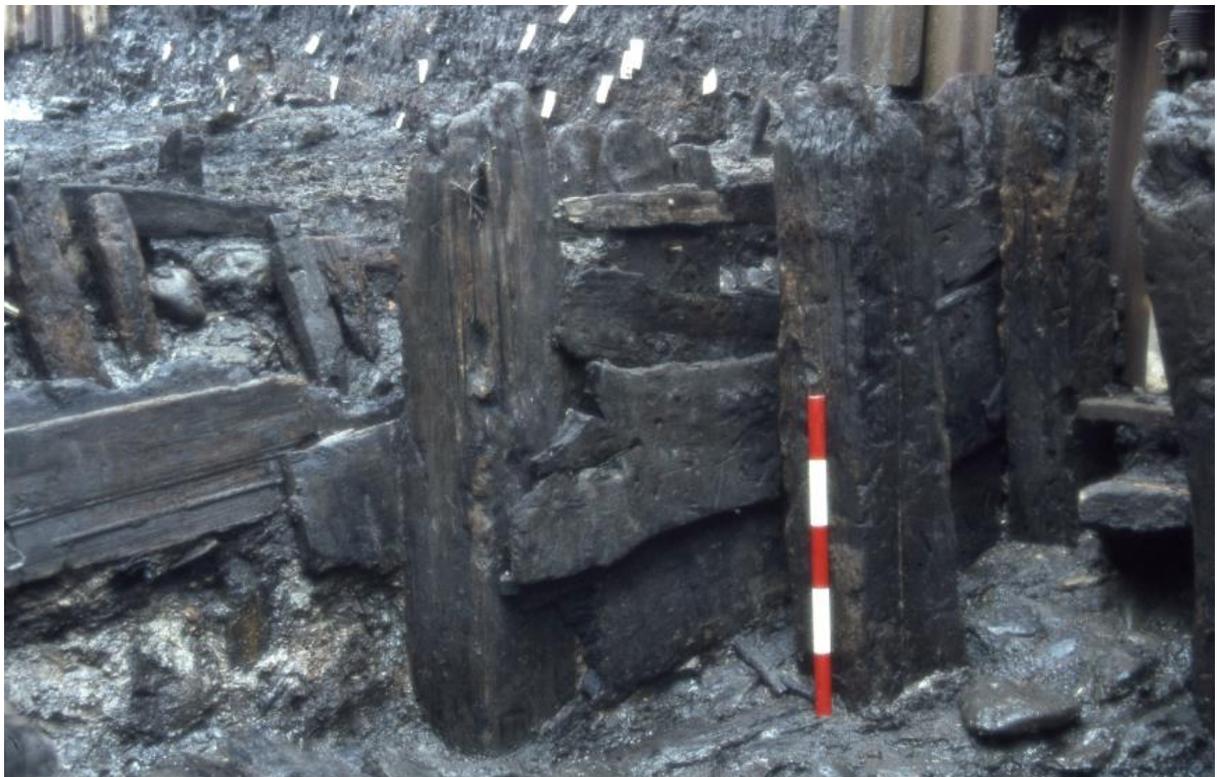
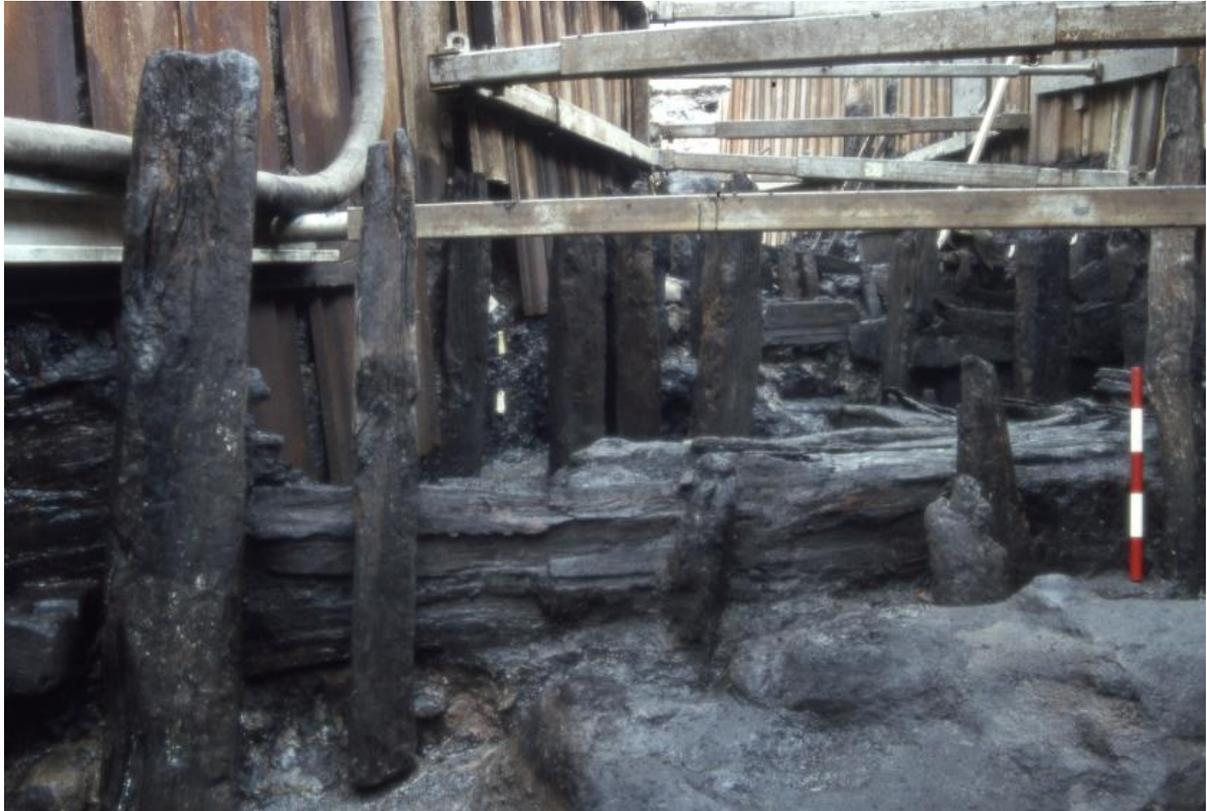
Fig.5.B

Outstandingly well-preserved Roman timber buildings, apparently of the mid- / late-2nd century AD, at 24-30 Tanner Row, on the south-west bank of the river Ouse. Built primarily of oak, many of the timbers used in their construction betray signs of their having been re-used from earlier structures, and it seems likely that their source was dismantled wooden barracks and other buildings from the legionary fortress on the opposite bank of the river. The earliest wooden structure at Tanner Row, interpreted as a revetment, employed a range of tree species in its construction, in contrast to the near uniform use of oak in the later phases, perhaps suggesting an opportunistic approach to resourcing in the early phase of the Roman occupation. The exceptional level of timber preservation in the earliest horizons at this site may be related to the suggested existence of a pre-Roman palaeochannel, whose sediments would retain large quantities of water, beneath the site (see [2.6.4.5](#); [Fig.2.E](#)).

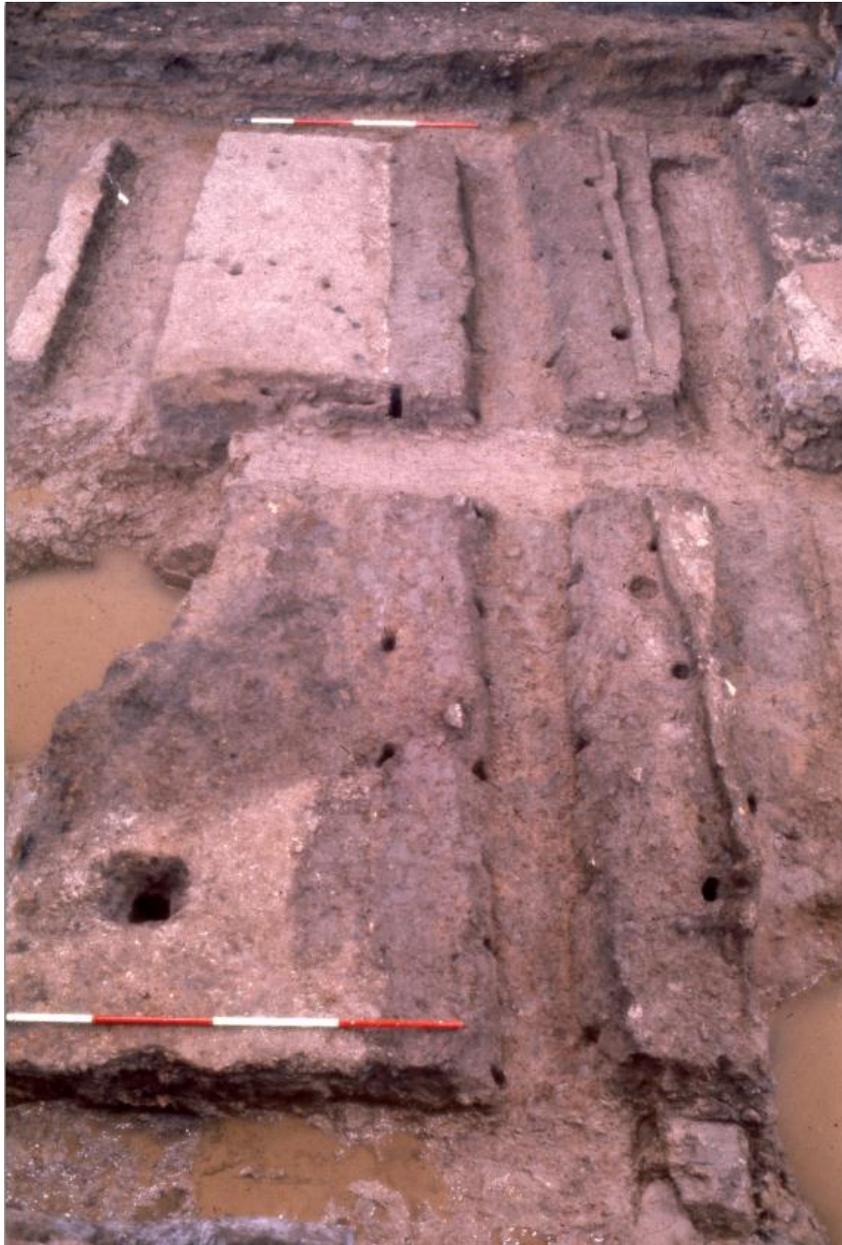
Fig.5.C

9 Blake Street – beam slots and postholes from Period 3 barracks, looking south-west; more typical archaeological traces of Roman-period timber buildings encountered in York. The broad, flat-based trenches visible in this photograph are actually the emptied-out *construction* cuts for the later, Period 4, stone-founded structures (see Fig.4.C.i, above, and Fig.5.D). The traces of timber buildings are restricted to the line of plaster visible to the right and top centre of the photograph, the former running almost from top to bottom of the frame, defined by the vestigial beam-slot and postholes immediately to the left of it. The broader linear feature visible to the left of that, with postholes at regular intervals along its edges, is the remains of a drain contemporary with the timber barracks. Contrast with the surviving evidence for probably comparable structures on the right-hand side of Fig.5.B.i.

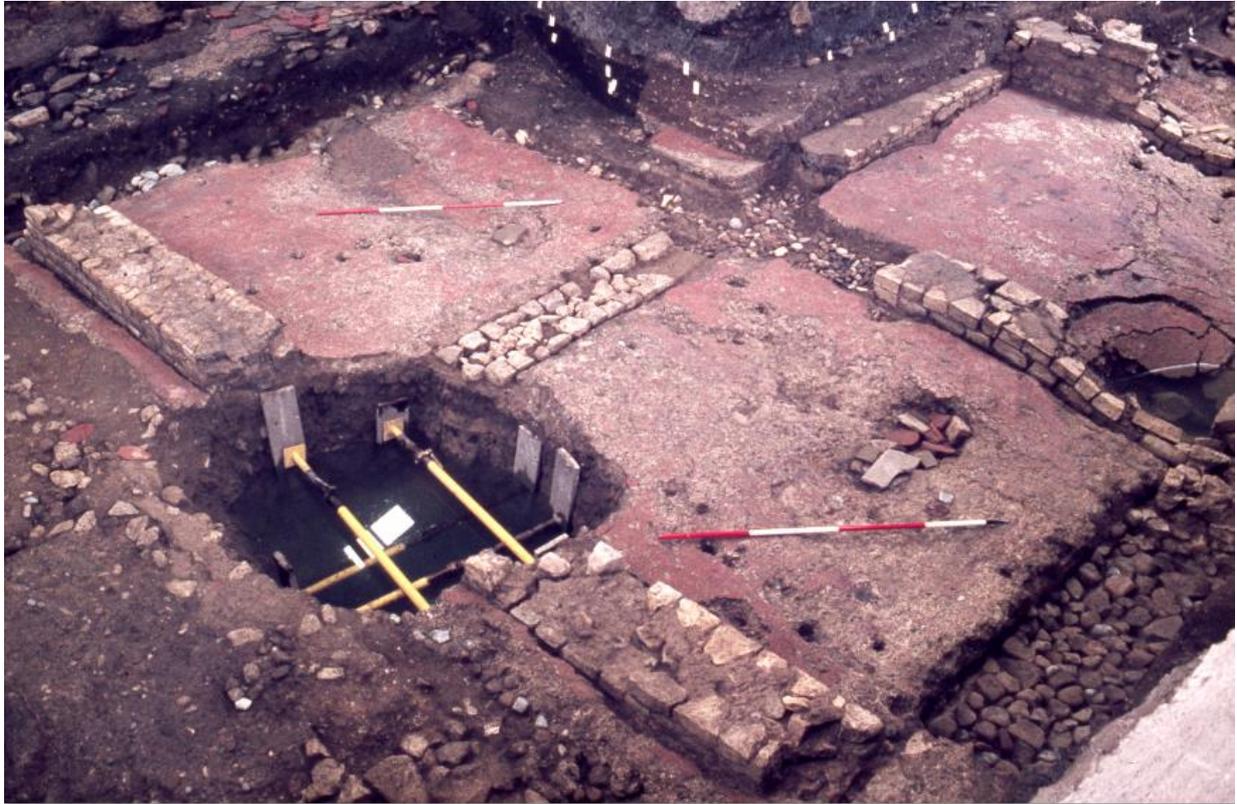
Fig.5.D

9 Blake Street – Period 4 stone footings for (modified) barrack block, original construction attributed to the second half of the 2nd century, looking towards the north-west. Originally a single room with a floor of *opus signinum*, the wall footings forming the ‘cruciform’ plan with its centre towards the centre-top of the photograph are later insertions, their construction trenches cut through the *opus signinum*. This evidence for substantial structural adaptation – which may parallel those identified in the barrack blocks excavated beneath York Minster (Phillips & Heywood 1995) is evidence of the type relevant to the issues addressed in Chapter 6. See also Fig.4.C.i.

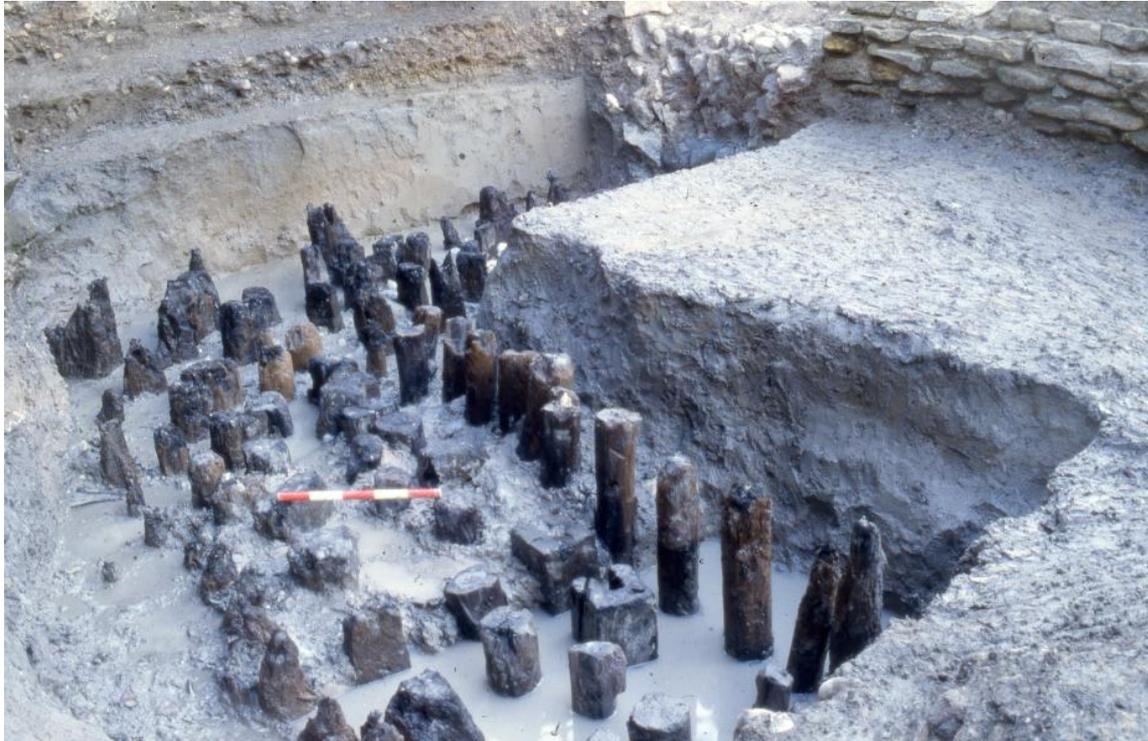
Fig.5.E

Wellington Row Area 7, oak piles beneath (robbed) foundation of major extension to masonry building (see Figs.7.B.i.b, 7.C.ii), date at present unconfirmed but probably of the late-3rd or first quarter of the 4th century. Unfortunately the 80+ roundwood oak piles were from tree which had not grown to sufficient maturity to allow dendrochronological calibration. Note the 'natural' sediments into which the wall construction trench was cut and the timber piles rammed, which could be either late-Pleistocene lacustrine deposits or early Holocene alluvium. The former is perhaps more likely, as the Wellington Row site seems to have been on the putative 'island' formed by a palaeochannel of the river Ouse flowing to the south-west of its main channel. This location – contrasting with the position of the buildings at 24-30 Tanner Row, which seem to have been constructed directly on the line of that palaeochannel – may help to explain the contrasting degree of preservation of timber between the two sites, some 80 metres apart within the floodplain of the Ouse.

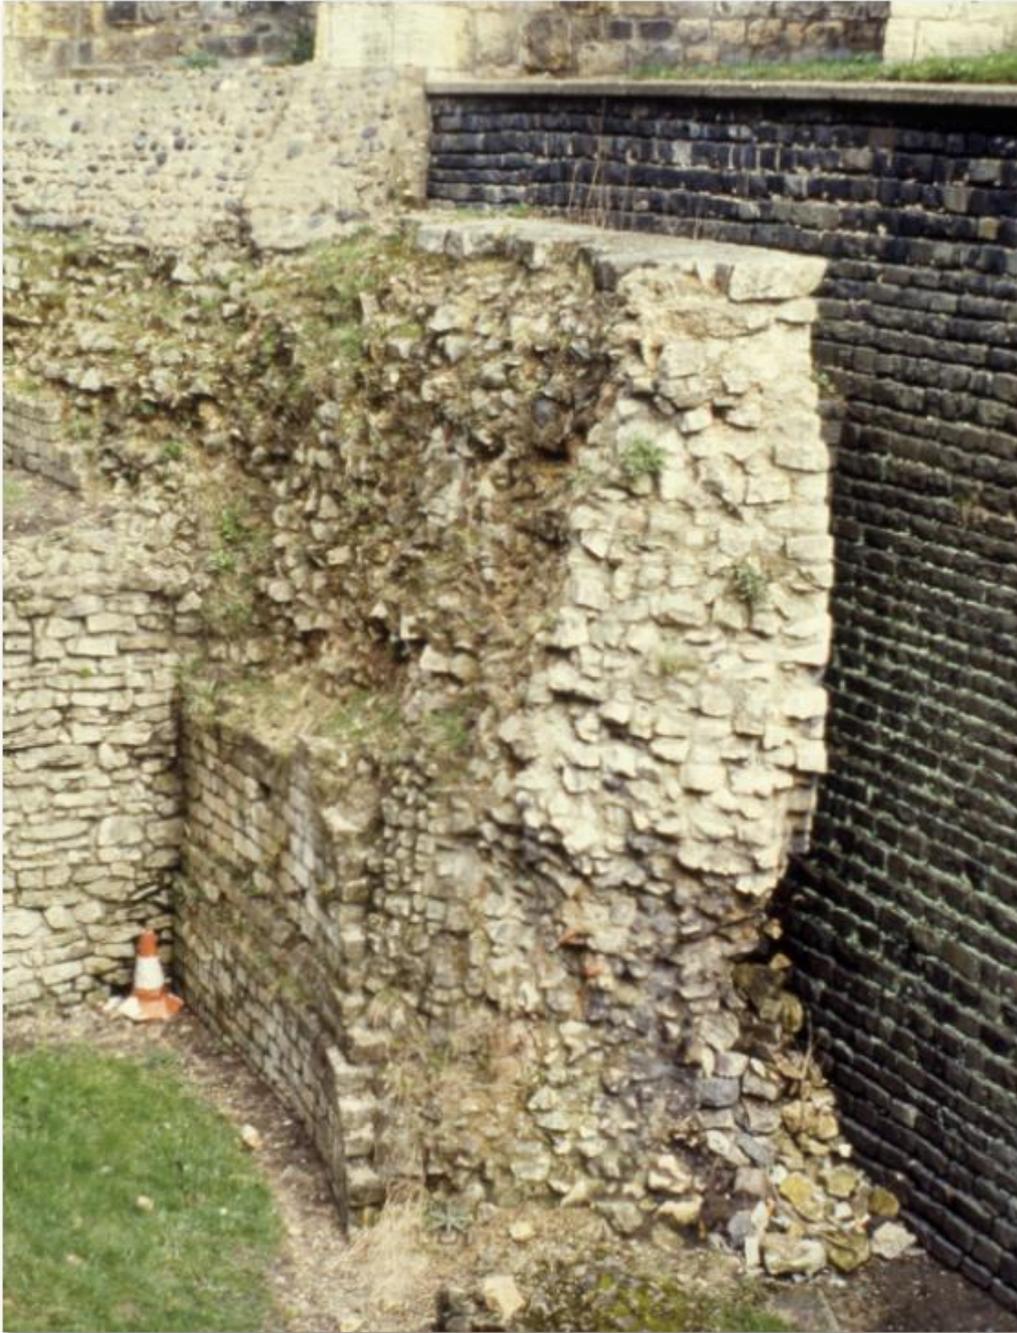
Fig.5.F

The eastern corner tower of the Roman legionary fortress, of the mid- / late-2nd century AD, looking due north; constructed in magnesian limestone procured from the extensive exposure of this rock to the west of the Vale of York, c.25 kms distant.

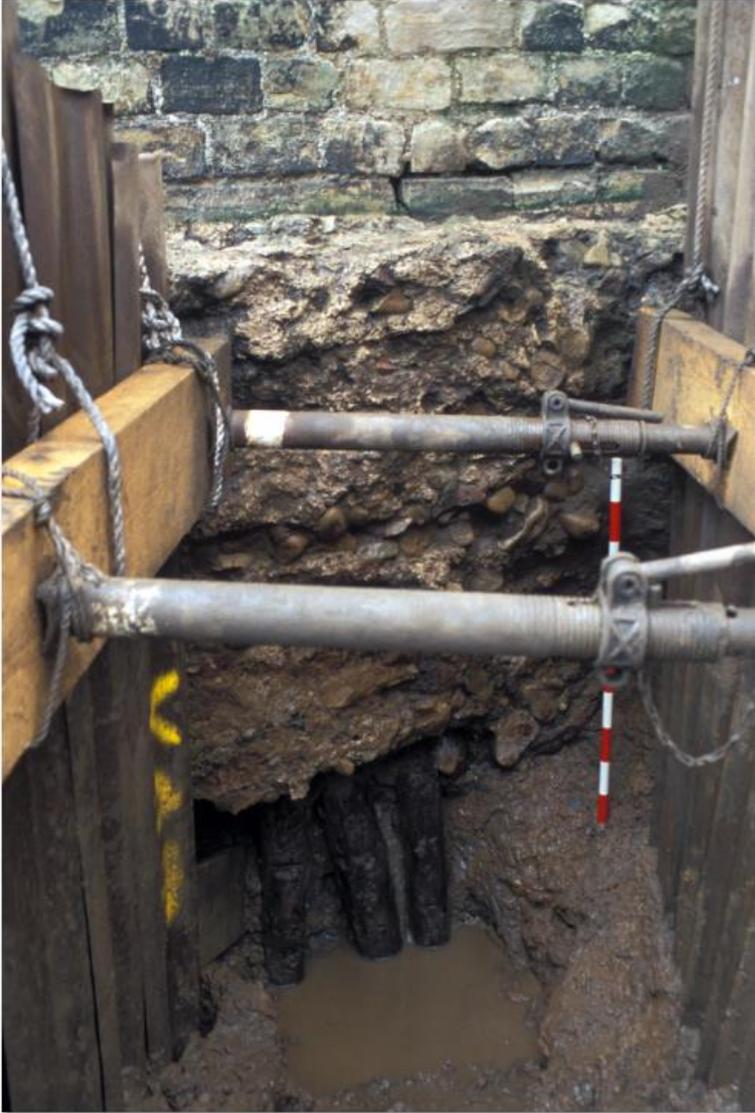
Fig.5.G

Piles made from alder roundwood beneath the southern footings of the southern tower of the Roman legionary fortress, the 'Multangular Tower', looking towards the south. The piles support part of the projecting foundation of the tower, and so are undeniably part of its construction, and not from an earlier phase of defences incorporated within a later re-modelling. The Multangular Tower was long regarded as having been constructed in the early 4th century on the strength of known parallels from elsewhere in the Roman Empire. A revision to the late-2nd / early-3rd century was then proposed. Radiocarbon determination on one of the piles produced a date in the first half of the 2nd century; given that the retention of felled roundwood alder for 50+ years, perhaps much longer, seems improbable, the case for a much earlier date than has previously been suggested for this structure, and for the elaborate south-western facade of the legionary fortress as a whole, gains strength. This re-attribution does, however, bring the use of magnesian limestone in the construction of the south-west frontage into line with what is observed elsewhere across Roman York.

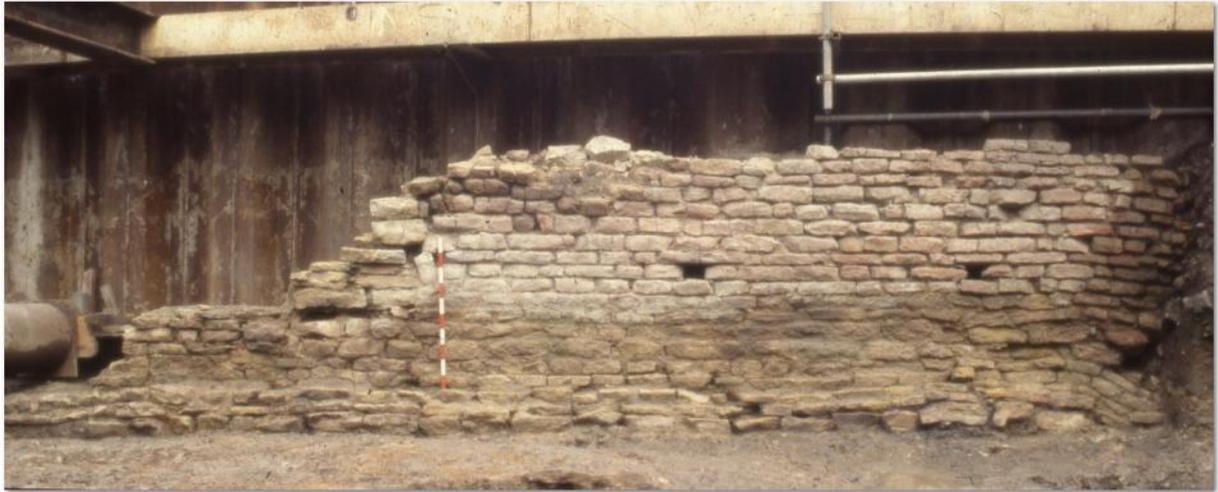
Fig.5.J

Wellington Row, Area 7, north-eastern wall of major masonry building (see Figs 7.B.i.a, 7..C.i), originally constructed in the second half of the 2nd century (although there are some indications that this wall may be a later insertion), oolitic limestone, in all probability procured from the Howardian Hills district, some 20 kms to the north-east . There are increasing hints that Roman York's entire stone supply may have switched from the western to the eastern margins of the Vale of York in the later-2nd and early-3rd centuries, in a pattern which has some resonance with ceramic supply (see 9.6a.i).

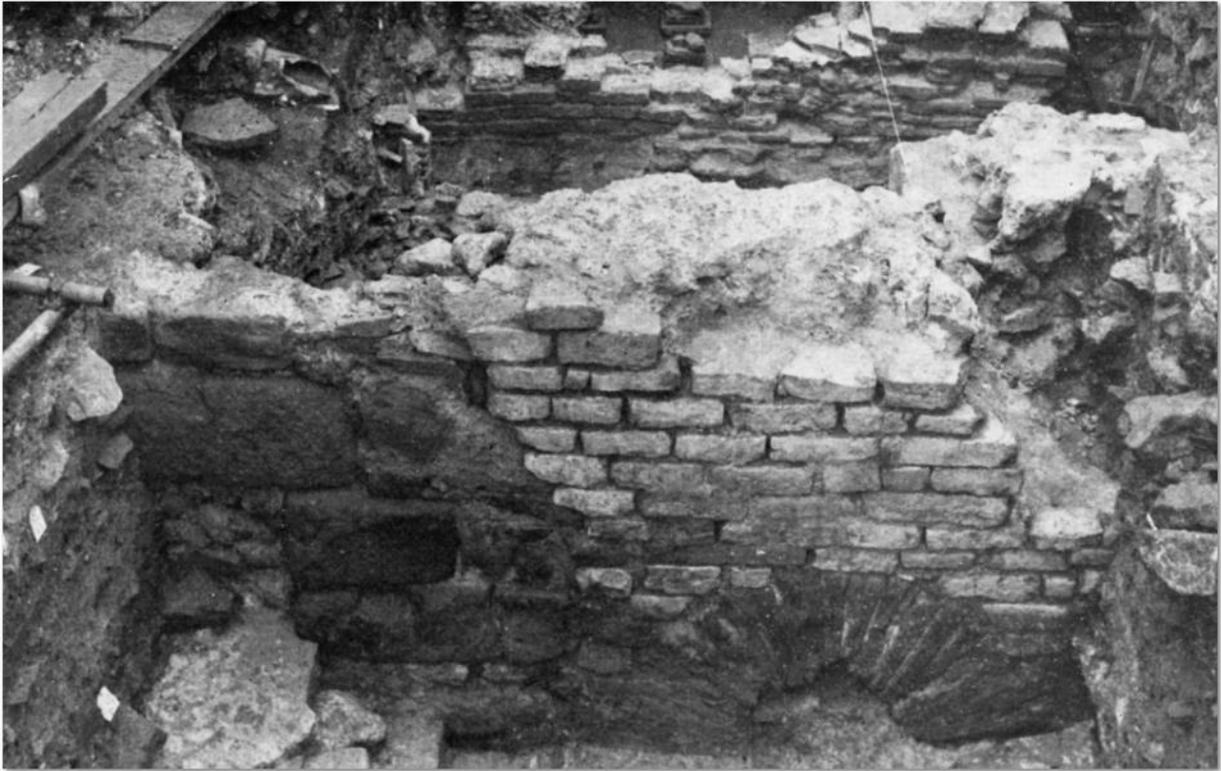
Fig.5.R

4-6 Church Street, Roman bath-house within the legionary fortress; re-use of large blocks of crudely-mortared gritstone (dark stone in left side of picture) used to infill a large void in magnesian limestone masonry, below which can be seen the tile voussoirs forming the top of a hypocaust flue. The gritstone may have been re-used from a stretch of the nearby Roman sewer, and the blocking it was employed for may have occurred when the bath complex had ceased to function for its original purpose – such a scenario has been suggested for adaptations to the nearby bath-house remains (which may have formed part of the same complex) beneath the Roman Bath pub in St Samson’s Square (R.C.H.M.(E) 1962, 43 © Historic England). For the treatment of the right-hand corner of the building as seen in this photograph, see Fig.7.J.

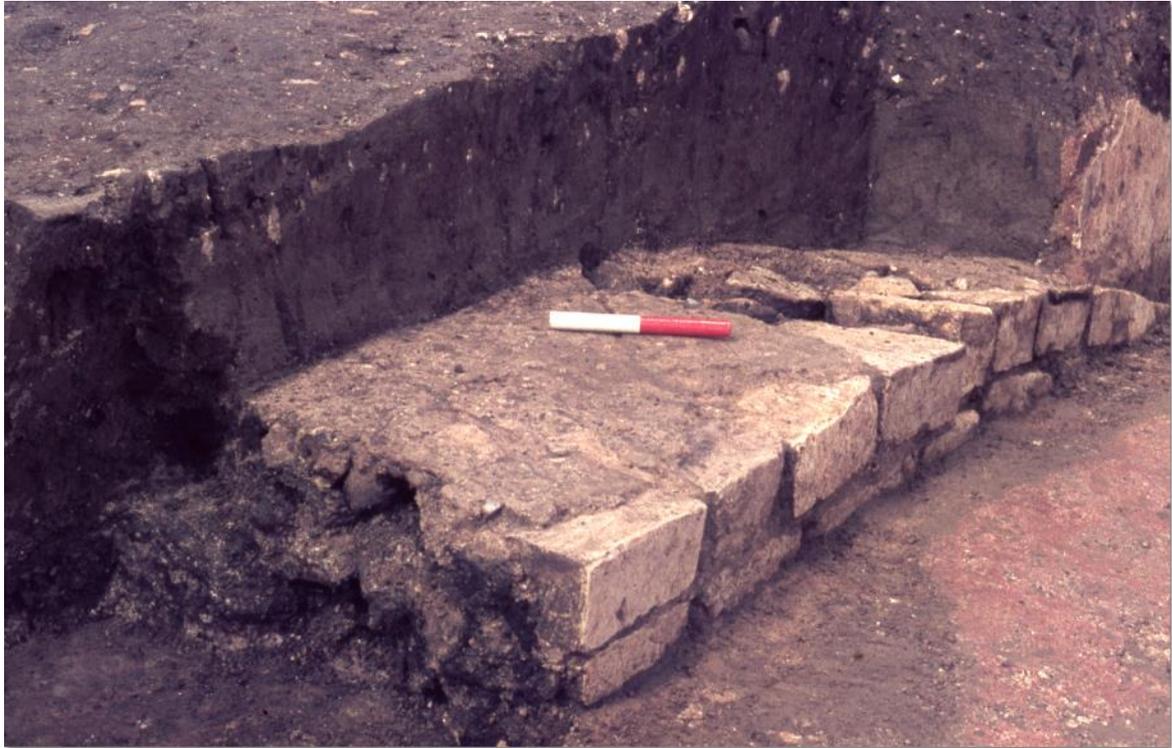
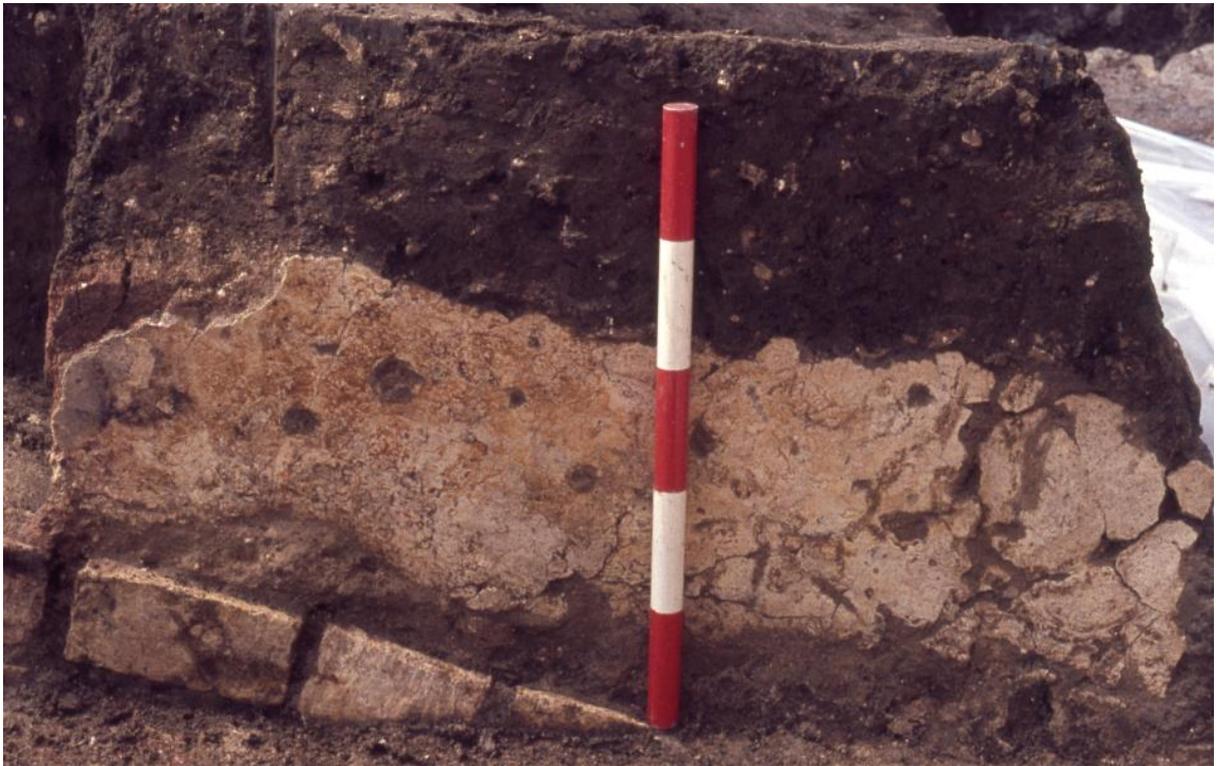
Fig.5.S

9 Blake Street; 5.S.i, possible mass walling with plaster facing, set on a mortar bedding layer on a stone footing, internal wall of modified barrack block (see Fig.5.D), ?3rd century. The footings have very evidently subsided into an earlier, underlying feature (which would appear to be the large pit 3892; see Fig.3.K.i), presumably for the most part centuries after the buildings had been abandoned, when their surviving remains were already buried. 5.S.ii shows a detail of the *in situ* plaster facing. (The soil visible *above* the plaster in this image post-dates the demolition of the wall, and is not considered part of the suggested mass walling; refer back to 5.S.i.)

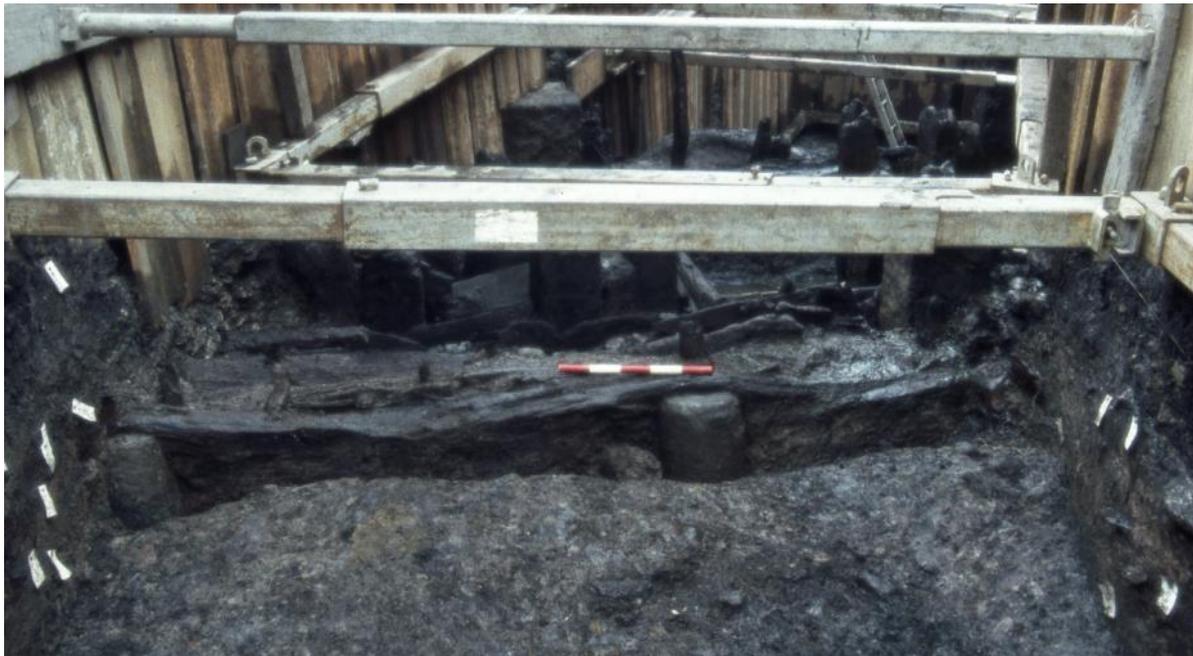
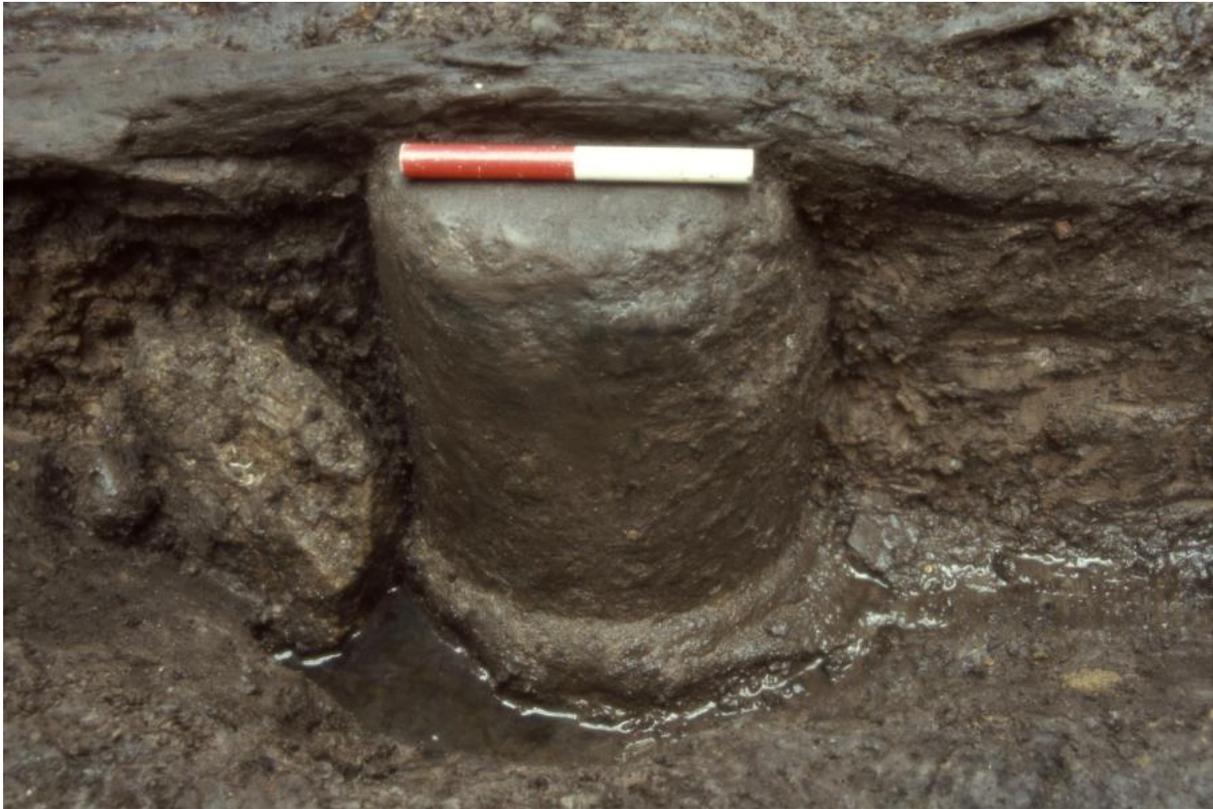
Fig.5.T

24-30 Tanner Row, the lower wattles of a collapsed ?late-2nd century wattle wall (beneath photographic scale, fallen away from the camera), set in a timber sill-beam which in turn rests on two small, re-used stone columns, set about two metres apart (5.T.i). The latter seems likely to be another aspect of the re-use of material from structures dismantled within the legionary fortress (see Fig.5.B) in the construction of these buildings in the late-2nd century. The construction technique involving the use of individual stone blocks to carry a superstructure in timber sill-beams (detail, 5.T.ii) seems highly relevant in consideration of the constructional techniques proposed and discussed with reference to the continued adaptation and re-use of Roman buildings in York into the 5th century and perhaps beyond; 5.3d.7; 7.3.3; 7.6.2-3; Fig. 7.G.ii.

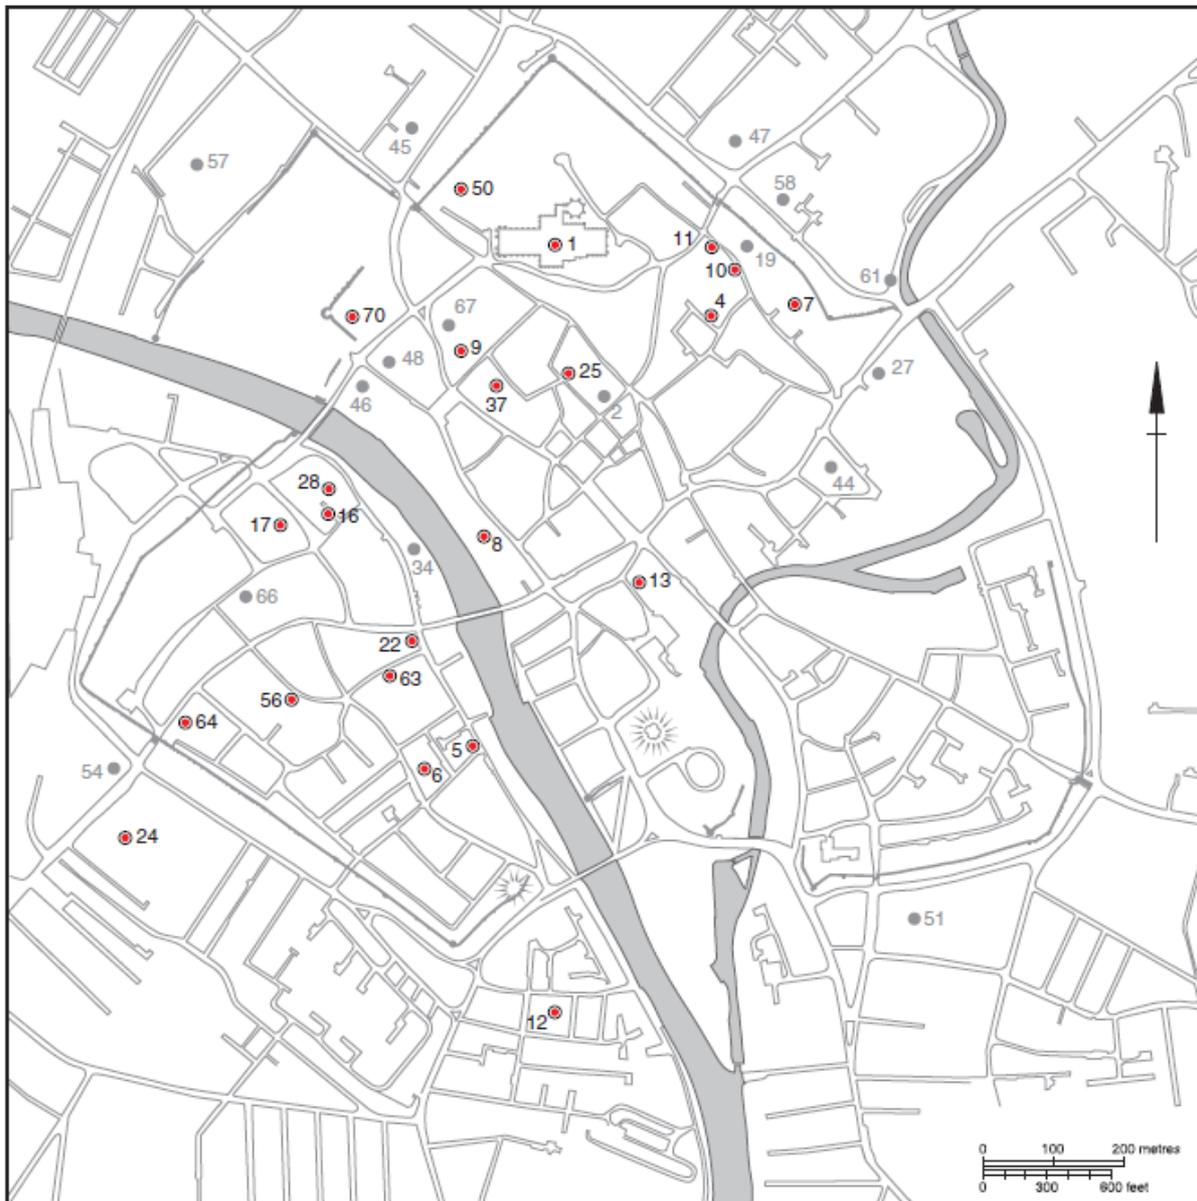
Fig.6.A

Locations of excavated sites in York relevant to the areas of research considered in Chapter 6. Those represented by red dots feature prominently in the discussion in this chapter; those located by grey dots are not referred to in the text, but are considered to be potentially relevant to the research under discussion. Sites listed alphabetically.

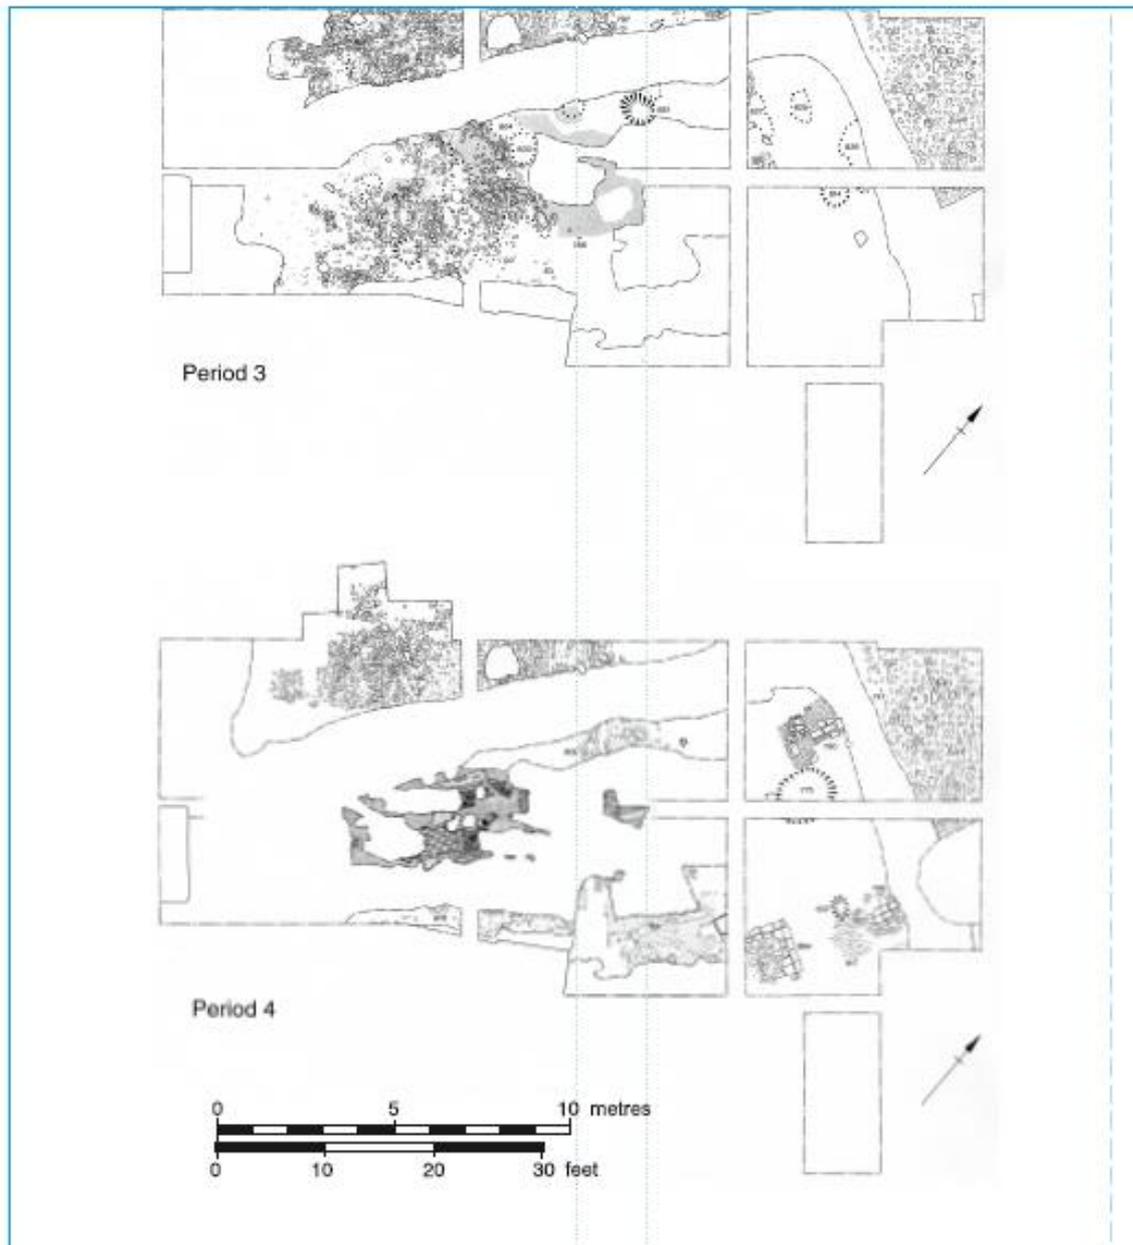
Fig. 6.C

21-33 Aldwark, Romano-British urban development in the environs of the legionary fortress. From 3rd-century (?military) manufactory (Period 3) to 4th-century town house (Period 4); 6.2.1 .

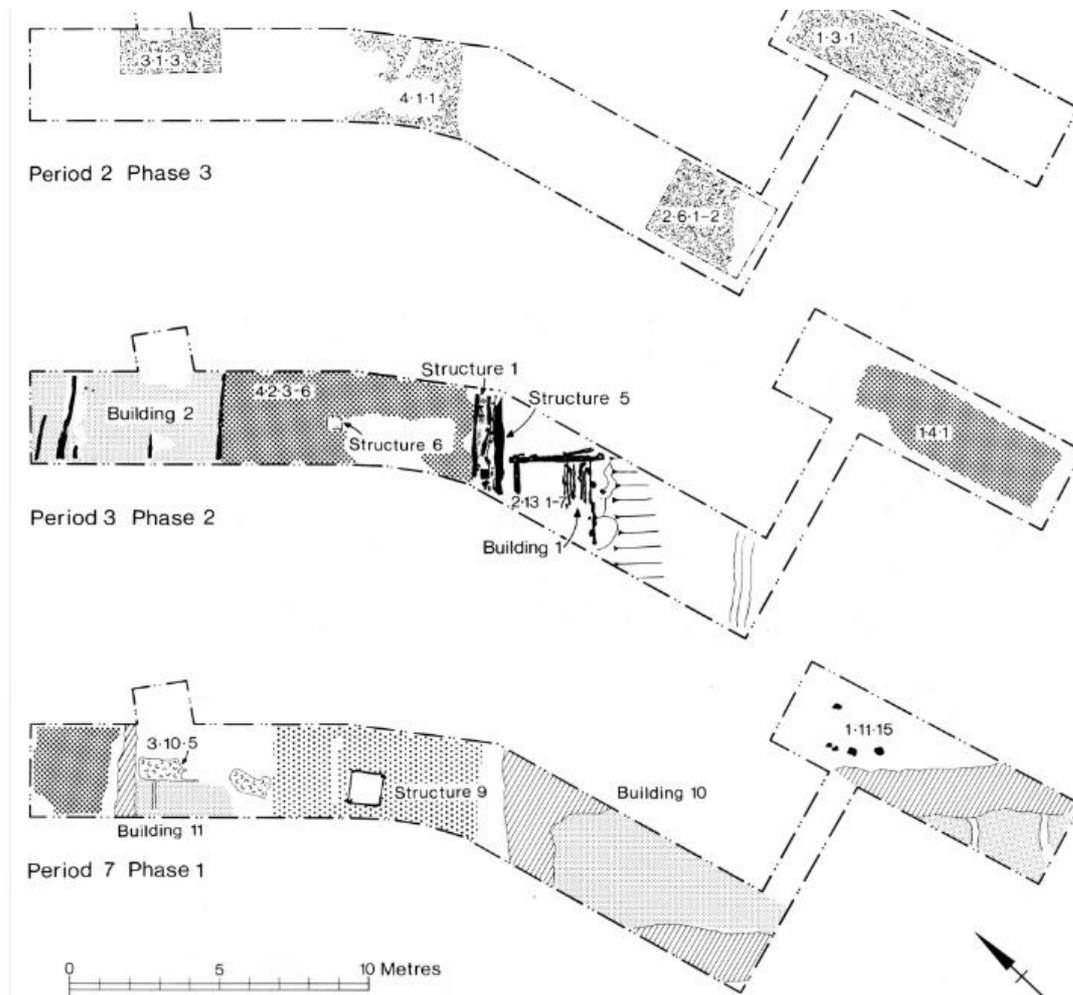
Fig. 6.D

24-30 Tanner Row, Romano-British urban development on the south-west bank of the Ouse. Floodplain sediments and 2nd-century land-reclamation (Period 2, Phase 3; 2.6.4.5-7; 4.3.1-3; 4.3.6), late 2nd-century building in timber (Period 3, Phase 2; 5.1.2, 6.2.2), ?4th-century building in stone (Period 7, Phase 1; 5.1.2, 6.2.2).
