Shene Charterhouse, Richmond upon Thames: archaeological investigations, 2009–15

ROBERT COWIE

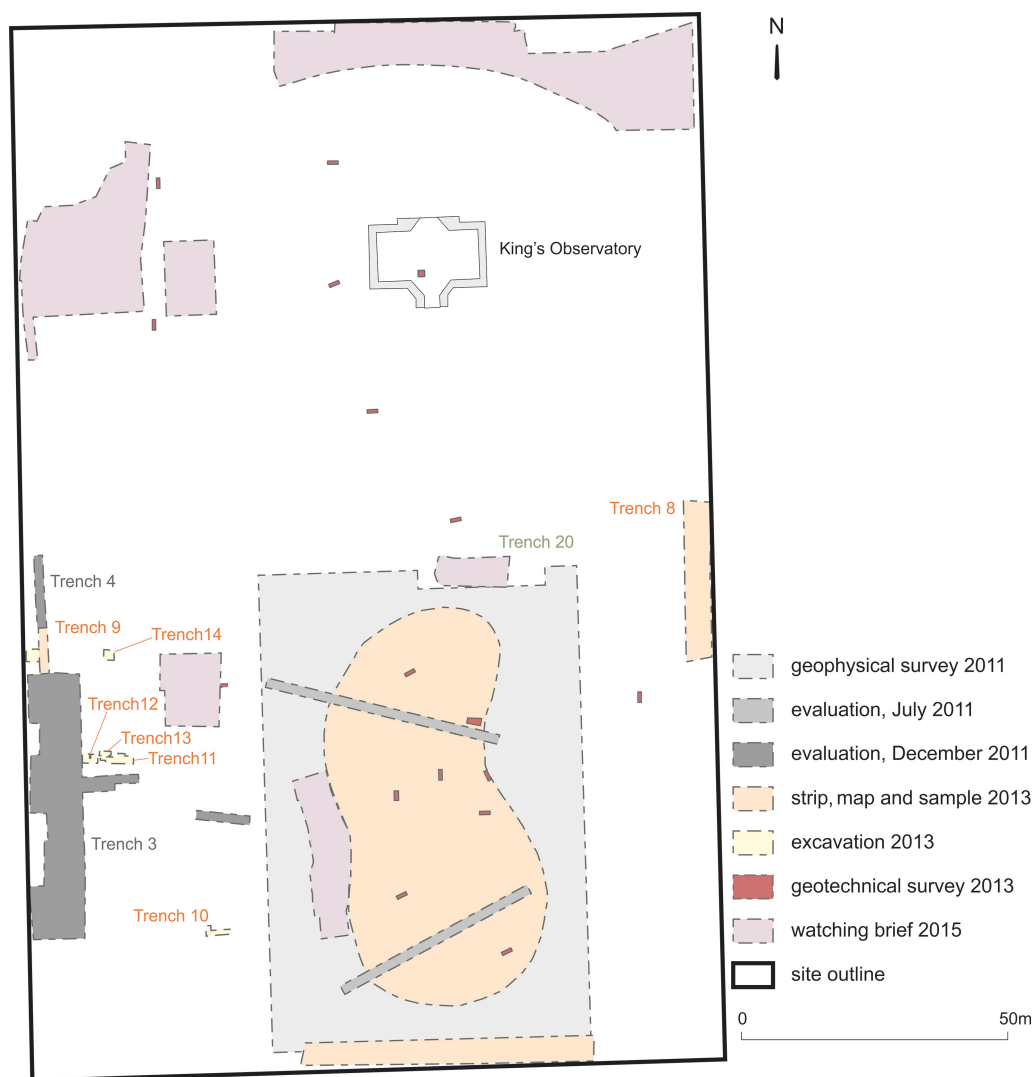
Fig 2 Shene Charterhouse. Location of areas investigated. Scale 1:1500.

The largest trenches were excavated by machine under supervision by MOLA (figs 2 and 3). Five small trenches (10–14) were dug by hand over several weekends in May and June 2013 by the author with the help of the Richmond Archaeological Society and volunteers, who also extended trench 9 to the west to expose a monastic latrine. Most hand-dug trenches were positioned to establish the extent and ground plan of a monk’s house (cell 1), and its garden and latrine.

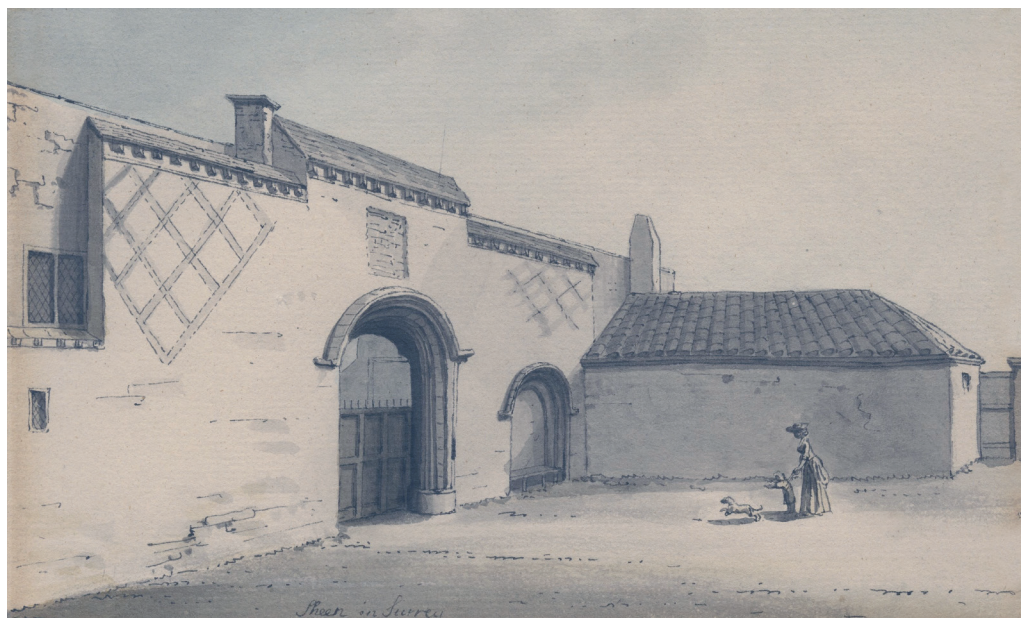
Fig 6 Shene Charterhouse. The Gateway of Sheen, c 1770. From a watercolour by Hieronymus Grimm. Reproduced with permission of the Council of Richmond upon Thames.

Two bricks have a ‘glazed’ grey coloured header end, suggesting they could have been used in diaper work. This is when grey bricks were used to form a decorative pattern in red brick walls. Hieronymus Grimm’s watercolour of the gateway of Sheen shows diaper patterns on sections of the southern precinct wall flanking the main gate (fig 6). Similarly, the precinct walls of Bermondsey Abbey are known to have had various decorative diaper patterns on their external face (Smith 2011, 199–201).

The wide base of the robber trench suggests that the wall had a broad foundation, perhaps up to 1m wide in places and probably stepped like the footings for the northern cloister walk and cell 1. This, together with possible evidence for the use of scaffolding in the construction of the wall, suggests that the precinct boundary was probably of considerable height, as shown by Grimm (fig 6).

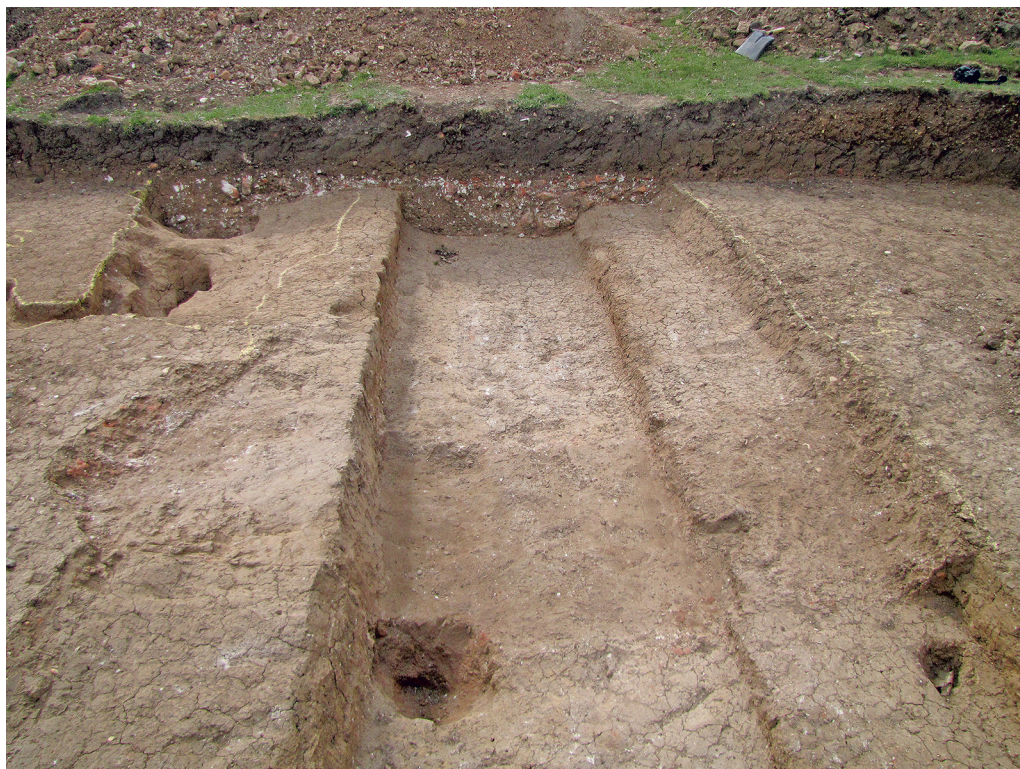
Fig 9 Shene Charterhouse. Robber trench for north wall of the priory precinct, looking west. Photograph by Robert Cowie.

The original line of the wall was delineated by a robber trench, [120, 194, 346], exposed in trenches 4, 8 and 20 (fig 8). Its course is also sometimes visible from the air as a discontinuous dark line in the turf of the golf course, as can be seen on the aerial photograph of 1929 (Cloake 1990, fig 26, points B–D). The flat base of the robber trench was generally between 0.80m and 1.00m wide, indicating the approximate width of the foundation (fig 9).

Most of the precinct wall was probably pulled down in the late 1760s. Its demolition was apparently very thorough so that even its foundations were almost completely removed. The resulting robber trench was exposed in trenches 4, 8 and 20, where it survived to depths of between 0.40m and 0.50m. In trenches 8 and 20 the sides of the robber trench were stepped (fig 9), presumably to aid levering up the masonry.

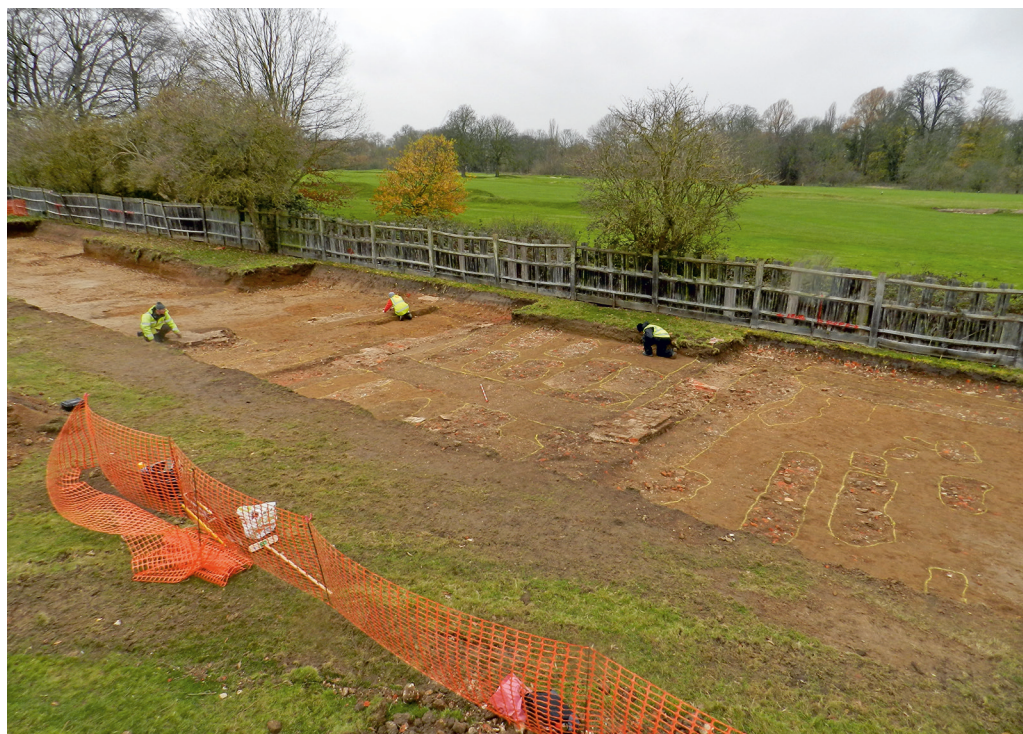
Fig 11 Shene Charterhouse. North cloister and cell 1, looking west. Photograph by Robert Cowie.

Evidence for two parallel walls of the northern walk of the Great Cloister was found in trenches 3 and 11–13 (figs 10 and 11). The inner wall of the cloister, which also formed the south side of cell 1, was represented by foundations and robber trenches. Foundations [64–65] mostly consisted of a loose tumble of brick rubble on a bed of mortar. The rubble was capped in places with a thin layer of mortar containing small to large fragments of crushed brick. Foundation [67], at the intersection with the eastern wall of cell 1, was more solidly built and comprised bonded brickwork laid in courses. Further east, in trenches 11 and 12, the line of the inner cloister wall was marked by a robber trench, [325, 328, 330].

The remains of cell 1 lay on the north side of the cloister walk and in the south-west corner of its garden (fig 11). Its eastern wall was represented by a robber trench, [62], and a wall foundation of brick rubble and mortar, [179]. The remains of its northern wall comprised foundations of coursed brickwork, [68] and [69], and loose brick rubble, [70]. The bricks in these footings were mostly half and three-quarter bats, apparently identical to those in the cloister foundations. The east side of foundation [68] was exposed to its full depth of 0.62m (ten courses), and was found to have a stepped footing. Elsewhere the north wall was delineated by a robber trench, [92].

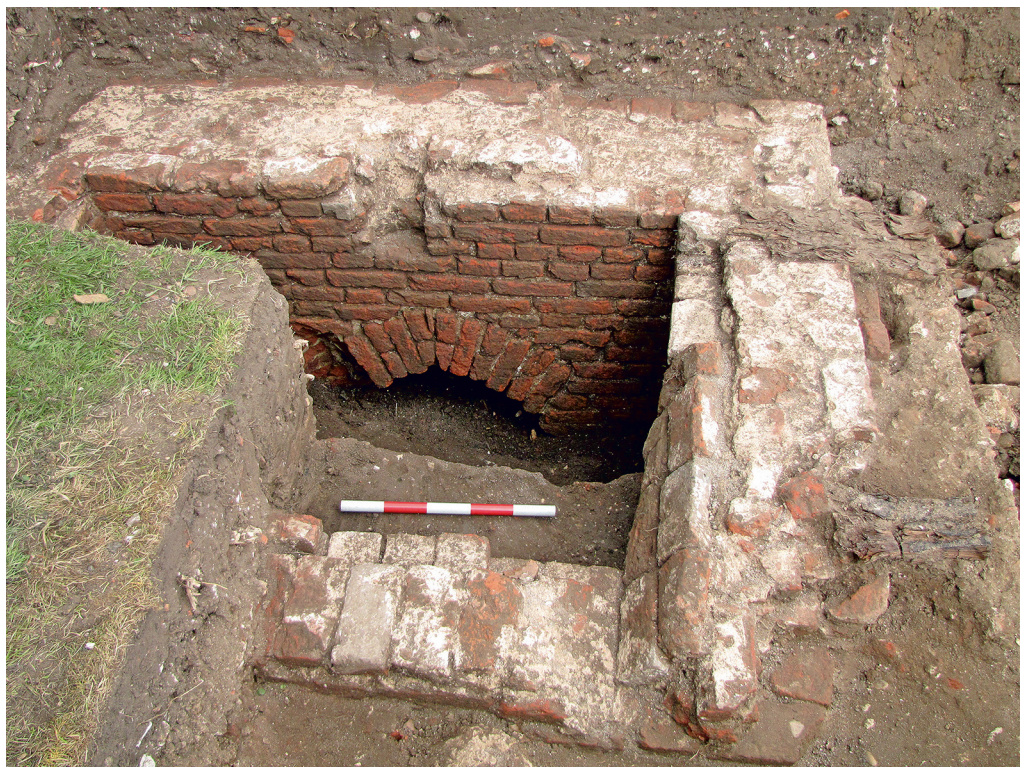
Fig 12 Shene Charterhouse. Latrine 1, looking north (0.5m scale). Photograph by Robert Cowie.

Similar bricks, some with slightly less quartz, were used in the walls of latrine pits 1 and 2. These are, however, of slightly smaller length (211–212mm) and breadth (99–101mm) but are of similar thickness (46–52mm). Other bricks were found in later rubble and ditch fills.

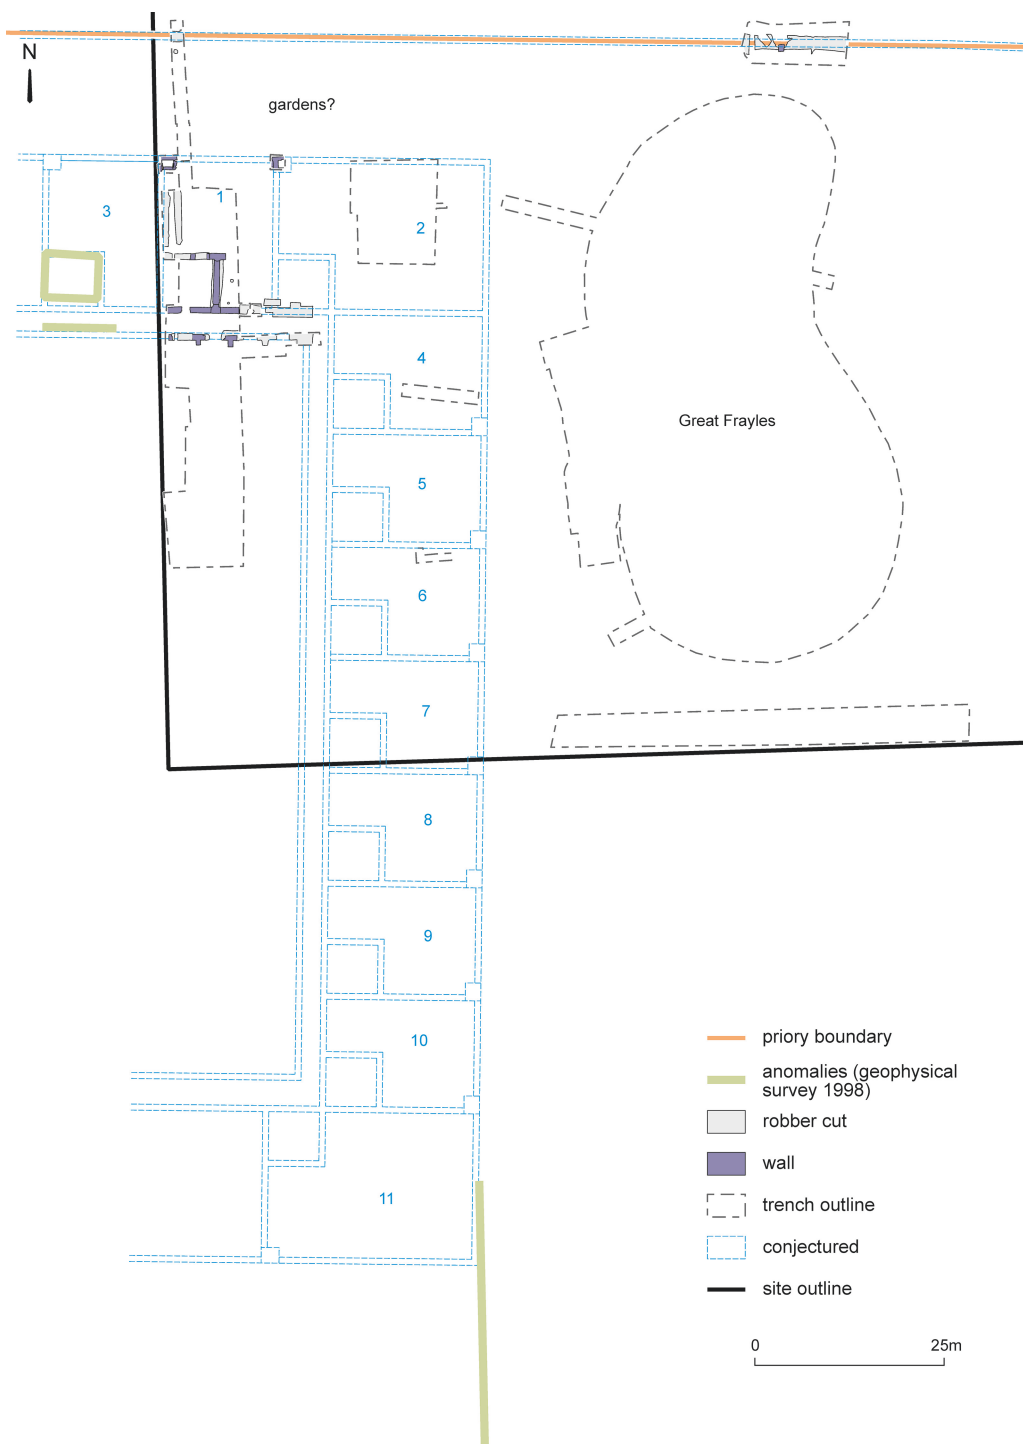
Fig 18 Shene Charterhouse. Conjectured layout of part of the Great Cloister. Scale 1:1000.

For the reconstruction presented here the modern interpretation of Worcester's description of the size of the Great Cloister has been taken to define the length of the east range. This may be problematic, however, as it is difficult to see how all 30 cells and their gardens would fit around a cloister of this size, especially as the chapter house, priory prison, wash house and access passages would also need to be accommodated. Either some cells and other elements were located elsewhere, or the cloister was larger, extending further south or west or in both directions, although only the latter would agree with Worcester's square cloister. If the cloister was larger we must question the accuracy of either Worcester's description or our interpretation of it.

In considering this problem Cloake speculated that cell 1 and the adjacent cloister may have been Marian and the original north range was built against the northern perimeter wall as first thought (John Cloake, pers comm, 19 January 2011; at the time of this suggestion the latrines had yet to be discovered). However, this solution can be ruled out, since no evidence was
