## **Excavation of a Roman tile kiln at Dockenfield, 2015**

DAVID GRAHAM and AUDREY GRAHAM

*In September 2015 trenches were excavated over the site of a late 3rd/early 4th century tile kiln close to the county boundary with Hampshire and about 1km east of the Roman pottery sites in the Alice Holt Forest. This is the first record of a tile kiln operating in or near the Alice Holt Roman pottery industry.*

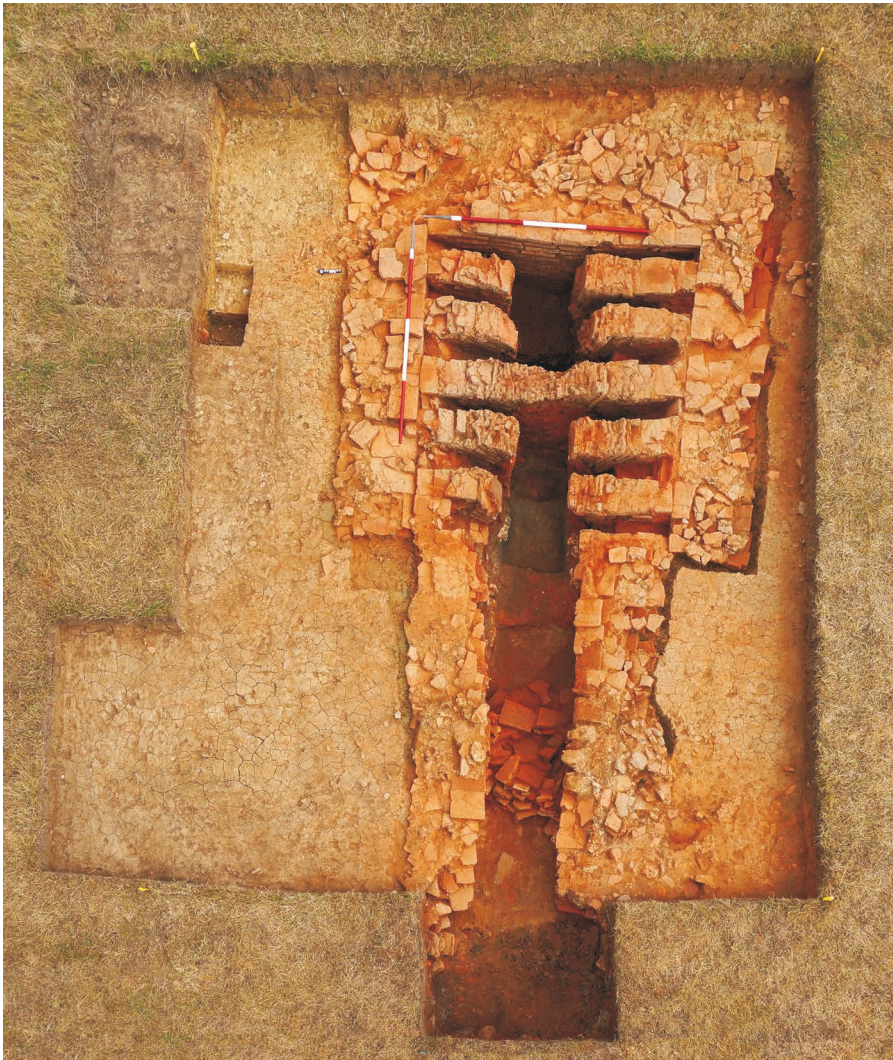
Fig 4 Dockenfield. Overhead photograph of trench 1; east is at the top.

This trench revealed the lower sections of a tile-and-brick-built kiln (figs 3–5) with a roughly square combustion chamber and five arched internal cross-walls serviced by a long, brick-built, arched fire tunnel with a stoke pit at the western end; the firing chamber and floor had not survived. The structure is very similar in design to other Surrey Roman tile kilns such as those at Reigate (Jones, in prep), Ashted (Bird 2016) and Wykehurst Farm, Cranleigh (Goodchild 1937), albeit being smaller, simpler and rather later in date than the first two examples and is a Grimes (1930) type III square updraught kiln.

This was only sampled in close proximity to the mouth of the fire tunnel and the horizontal extent of the pit is unknown. It had been backfilled during the Roman period with a 0.5m-thick layer of tile rubble mixed with a number of stones – the latter perhaps from part of the superstructure of a section of the fire tunnel (see below). Beneath the rubble/stone

#### THE COMBUSTION CHAMBER (figs 4, 8 and 9)

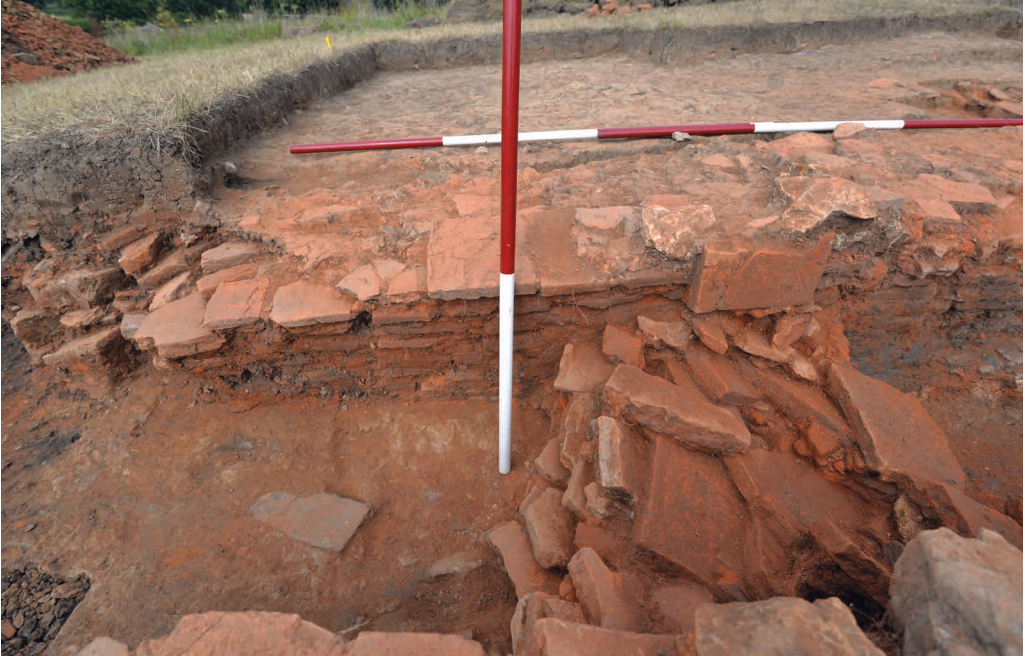
Fig 6 Dockenfield. View of the north face of the west end of the fire tunnel, showing the deliberate partial blocking of the flue – presumably a temporary part of the firing process.

Another difference was that, between the blocking band of bricks and the stoke pit, the arched walls had no obvious foundations other than appearing to be set on or level with a layer of mortar, which also formed the floor of the tunnel. In contrast, on the kiln side, the walls were set on a foundation of a band of grey tiles, which in turn had been set on a layer of stones. Where this foundation survived intact it ended with a straight edge  $\approx$  15cm into

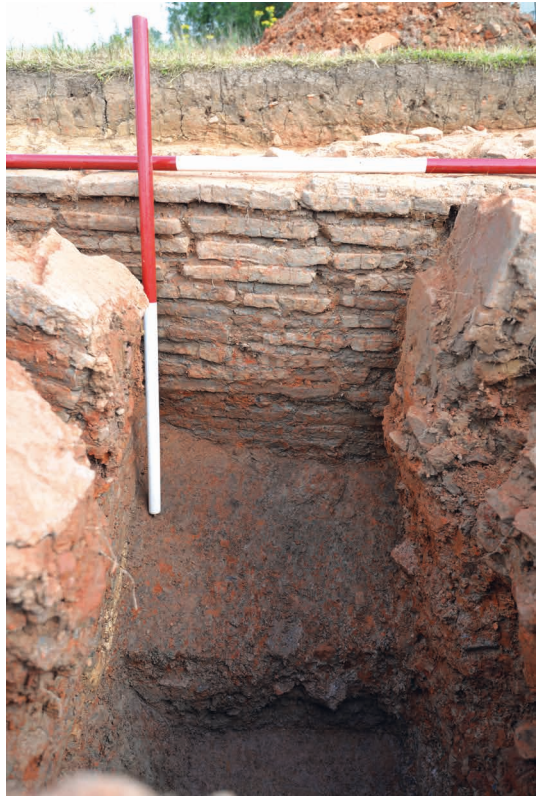
Fig 9 Dockenfield. View of the inside face of the east wall of the firing chamber.

Following the excavation of a platform cut deep into the slope, the combustion chamber walls were constructed in a single build of coursed bricks bonded with clay. These predominantly consisted of *c* 36 x 28 x 3–3.5cm-thick bricks (*lydions*), with the rear of the back and side walls infilled with a consolidated variety of tile rubble, giving an overall side wall width of 0.65m. However, the eastern back wall was thicker at 0.86m wide – presumably to take the downhill thrust of the hillslope into which the kiln had been set. This had been successful and, although the wall curved inwards, there were no signs of cracking or repairs (fig 9). The

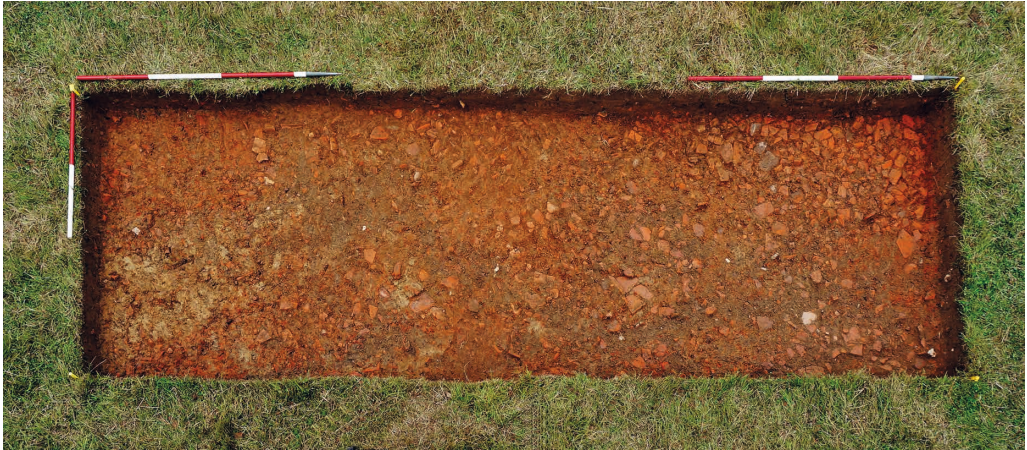
Fig 10 Dockenfield. Trench 2, surface 202, facing south.

This trench, again 6 x 2m, was laid across the top, eastern and uphill end of the second magnetic anomaly (fig 2). This had originally been interpreted as a second kiln, but none was found and, at least to the level tested, it turned out to be a laid working surface (202) of tile and brick rubble on the top of which was a thin scatter of daub (with, in one case, the

impressions of burnt-out wattle), pottery and intrusive later material. Although no postholes were noted, it seems possible that despite a slope of  $c 6^\circ$  across the 2m width of the trench, this surface might have been the site of a now undetectable timber and daub structure. If so, this would have acted as one of the ancillary buildings that must have once existed close to the kiln. An idea of the extent of the working surface can be estimated by looking at the results of the magnetometer survey. In any event the working surface and possible building must relate to a late phase in the life of the kiln as beneath the 18cm-thick layer of rubble was a filled-in pit or possibly pits (204 (fill 203), 205 (fills 206 and 207)) that contained yet more tile. These pits (possibly a single feature) were tested by a sondage to a depth of 0.86m below the modern ground surface, but continued downwards and outwards to an unknown extent. There is, therefore, still a possibility that a second, earlier kiln lies buried under this tile and brick debris. If that were the case it would suggest that the site functioned as an industry supplying tiles to a range of customers and perhaps worked over a longer period. The alternative explanation is that this feature or features represent earlier clay pits that were filled in to allow the construction of the later rubble working surface, but this is again uncertain and only further work in this area might provide answers to these questions.

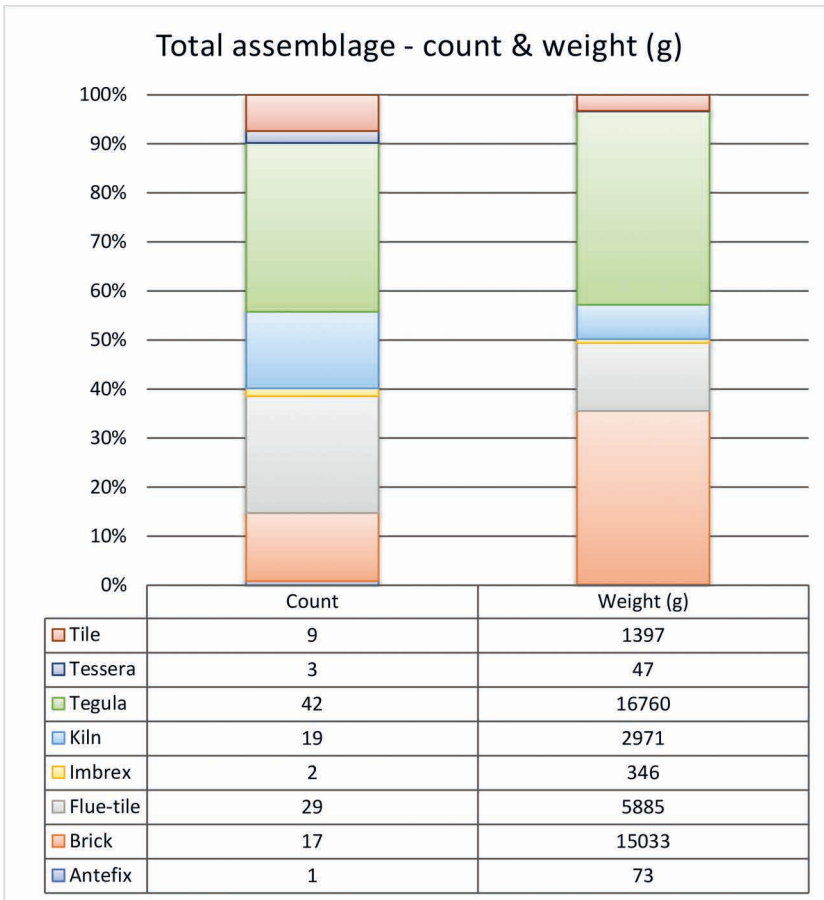
Fig 15 Dockenfield. Proportion of total assemblage of CBM by form – count and weight.

The assemblage is dominated by *tegulae*, both in count (34.4%) and weight (39.4%). Only seventeen fragments of brick were recorded (13.9% by count). However, a lesser degree of fragmentation results in a combined weight of over 15kg (35.4% by weight). Flue-tile accounts for 23.8% by count (13.8% by weight). The proportion of *imbrex* is relatively low when compared with *tegulae*, making up only 1.6% by count (0.8% by weight). As mentioned above, those fragments recorded as tile, being <30mm thick, could be fragments of *tegulae* or *imbrices*, these represent 7.4% by count (3.3% by weight). A small number of possible tesserae have been identified, which hints at preparation on site for a tessellated pavement, although these fragments could equally be tesserae-shaped fragments of broken roofing material.

There are 42 *tegulae* and only two *imbrices* in the retained assemblage. The assemblage illustrated in figure 15 therefore does not represent a typical tile assemblage. The output of

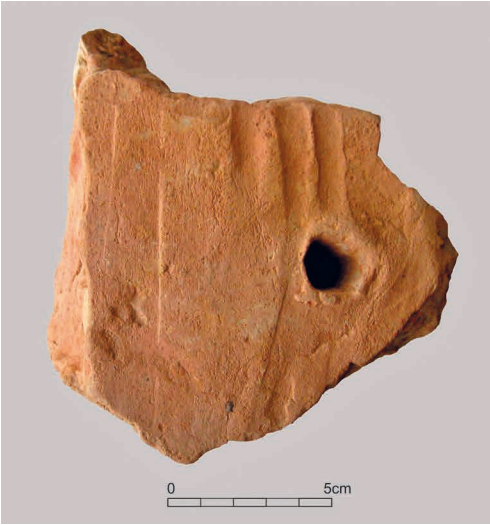
Figs 19 and 20 Dockenfield. (left) Pierced brick (105); (right) Combed brick (101).

Three of the bricks were recorded to have been pierced; this is thought to have been part of the forming process to aid the drying and firing of the brick in the kiln (fig 19). Examples of this have been noted at other kiln sites, including Harrold (Brown 1994). Two bricks, in excess of 45mm thick, were recorded as having combed upper surfaces, to provide a key (fig 20). The thickness of these bricks suggests they would have been used as flooring with the key facilitating the application of mortar for a mosaic or tessellated pavement or for the application of *opus signinum*, a coarse mortar that includes crushed brick and tile which, when polished, provides a durable floor surface.

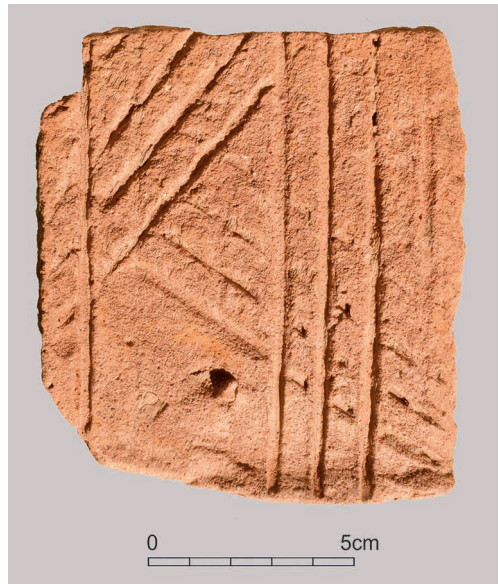
Fig 21 Dockenfield. Example of combed flue-tile (105).

Box flue-tiles take the form of square or rectangular pipes, which were built into the walls allowing the hot air to rise from underfloor voids and transfer heat to the room through the hollow walls. Flue-tiles at Dockenfield were found to have been keyed either by scoring, with a diamond-and-lattice design, or combing (fig 21). The keyed surfaces would then have been plastered with the hot air heating the room space through the plastered surface. Keying with a diamond-and-lattice pattern was an early Roman tradition, lasting only until the early 2nd century in London. Their presence at Dockenfield implies a longevity of traditional methods, or may represent early Roman tile having been dumped onto the site from elsewhere.

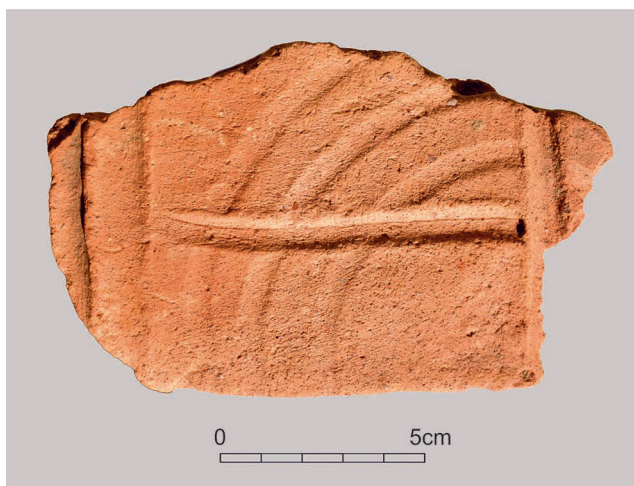
Figs 22 and 23 Dockenfield. Three finger semi-circular signature (104); cross signature (104).

Signatures were recorded on a number of forms, including bricks and *tegulae*. These were typically semi-circular marks made using one, two or three fingers (fig 22). One example made with four fingers was recorded on a brick recovered from the plough-soil (104) and a brick with a cross made by two fingers ((101) fig 23). Grooves alongside the flange, made when the *tegula* was being formed and
