# REPORT ON THE EXCAVATION, 1946-7, OF A ROMAN SITE AT FARNHAM, SURREY

A. W. G. LOWTHER, F.S.A.

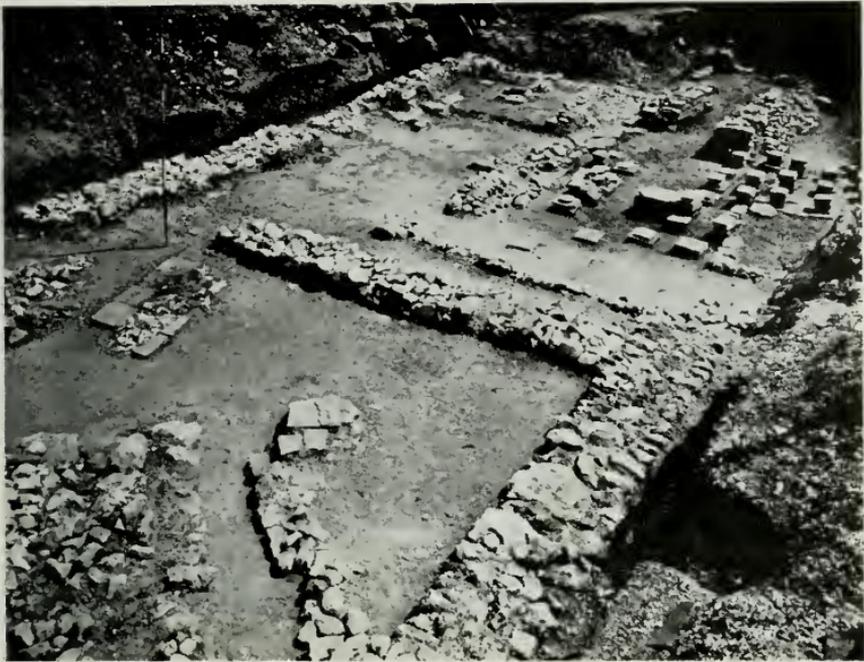
BUILDING NO. 1—VIEW LOOKING SOUTH.

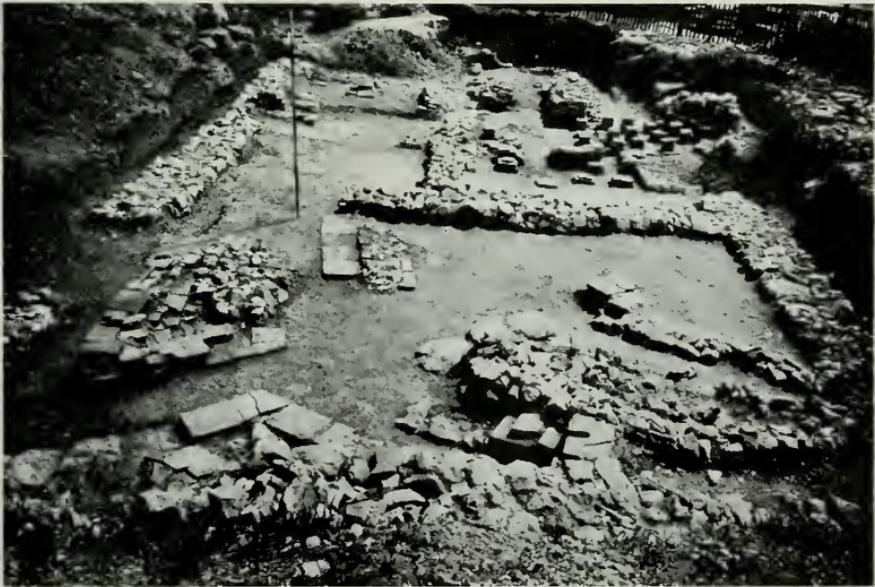
BUILDING NO. 1—VIEW LOOKING SOUTH-EAST.

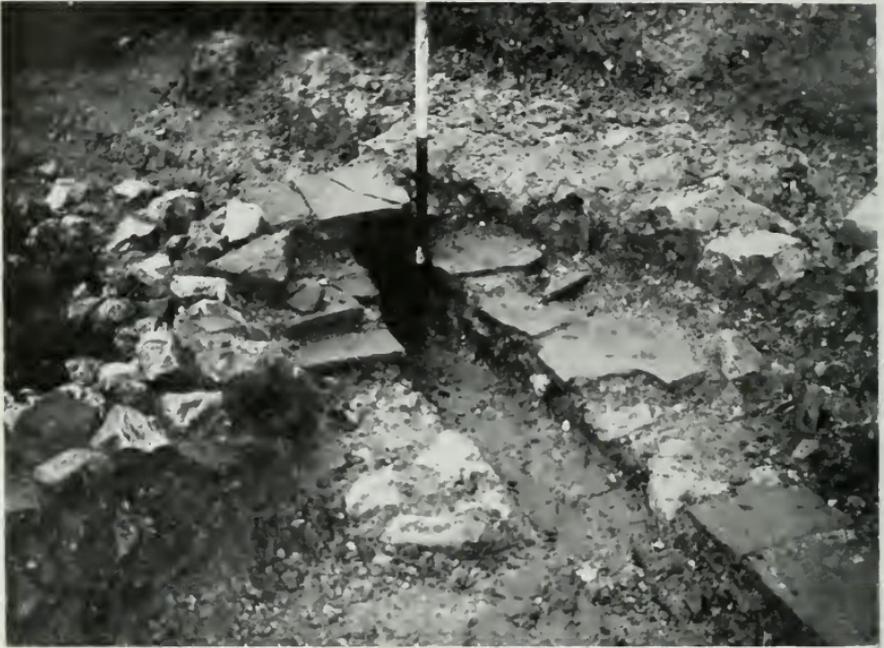
BUILDING NO. 1—REMAINS OF FLUE IN ROOM 1.

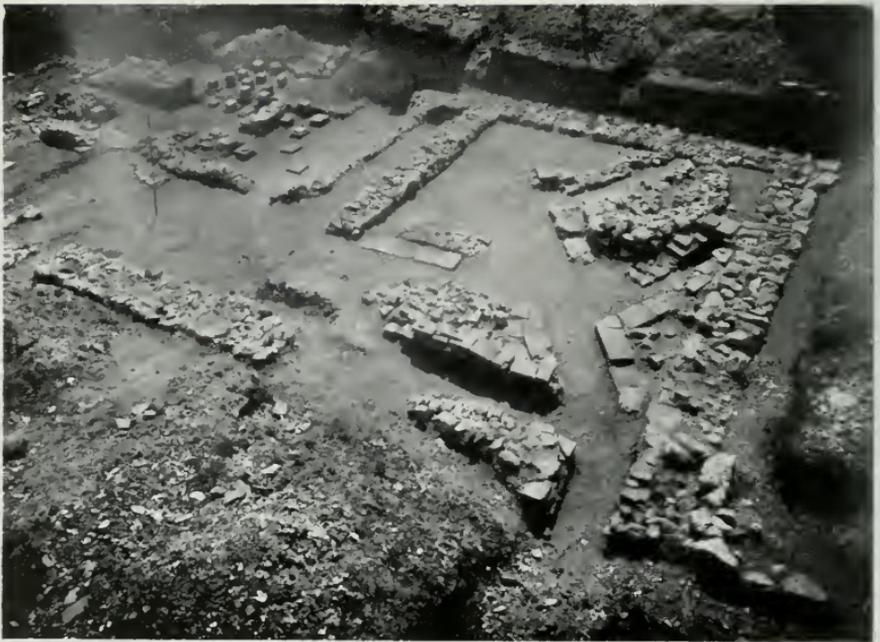
BUILDING NO. 1—NORTH END; LOOKING WEST.

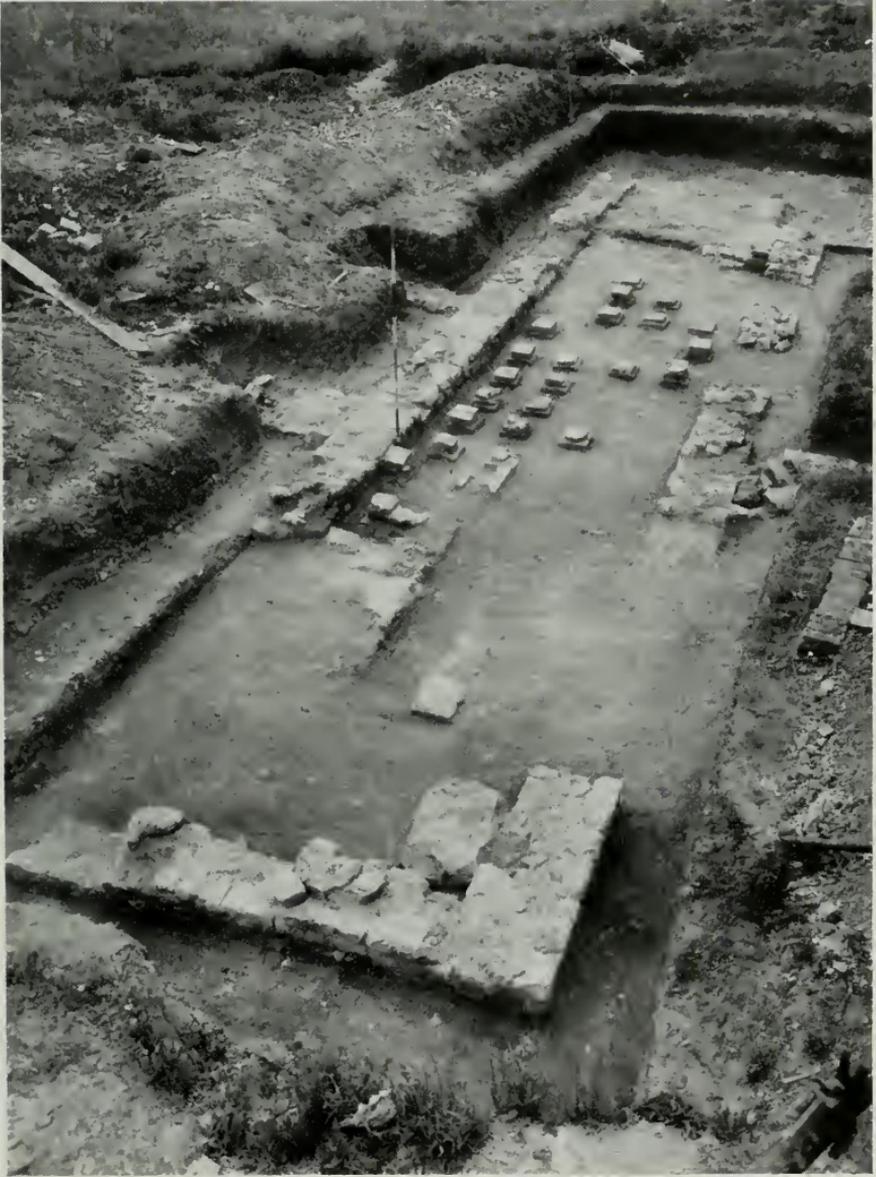
BUILDING NO. 2—VIEW FROM NORTH.

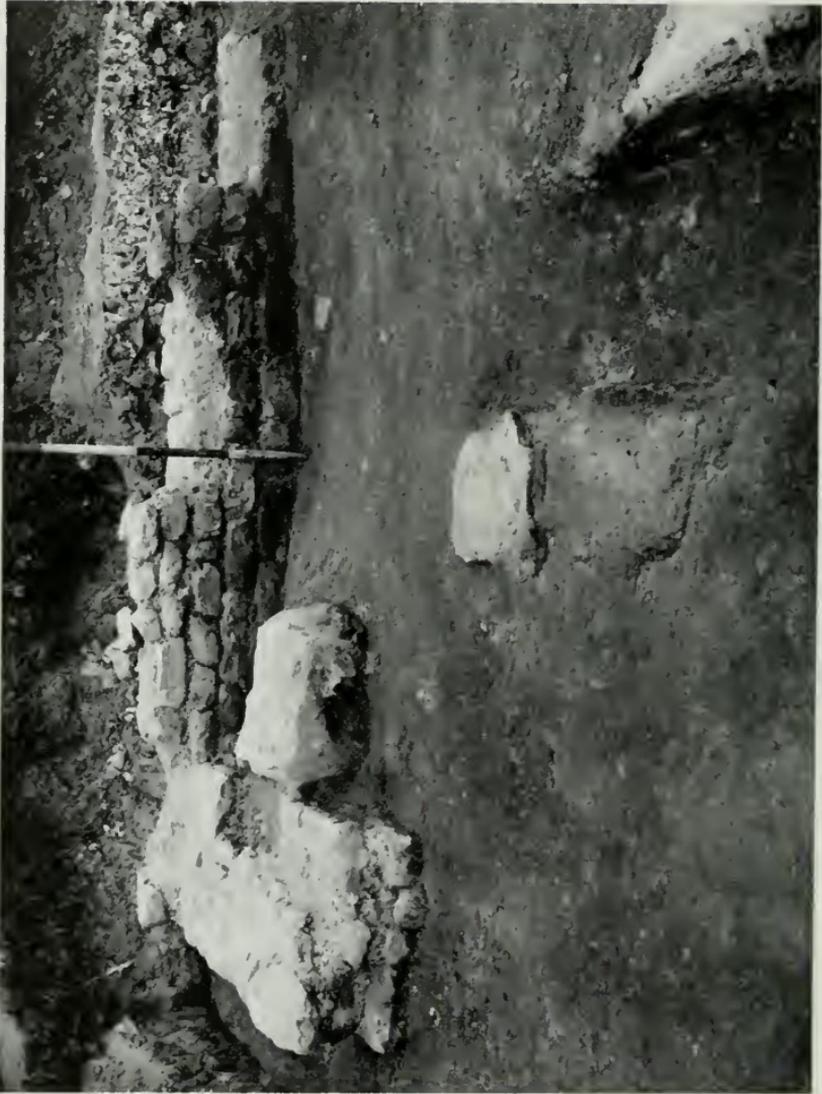
BUILDING NO. 2—REMAINS OF STOKE-HOLE AND NORTH WALL.

together with the addition of an apsidal plunge-bath at the southern end, just to the left of the entrance. Remains of the stoke-hole and furnace existed at the opposite end of the building, and the original stone step down into the stoke-hole, a single block of Greensand measuring 2 feet 6 inches by 1 foot 9 inches and 1 foot in depth, the upper surface being worn into a hollow from use. A layer of ash and charcoal, in which a few pieces of pottery of late 3rd or early 4th

century date were found, lay on the clay floor of the stoke-hole and to a depth of about 6 inches.

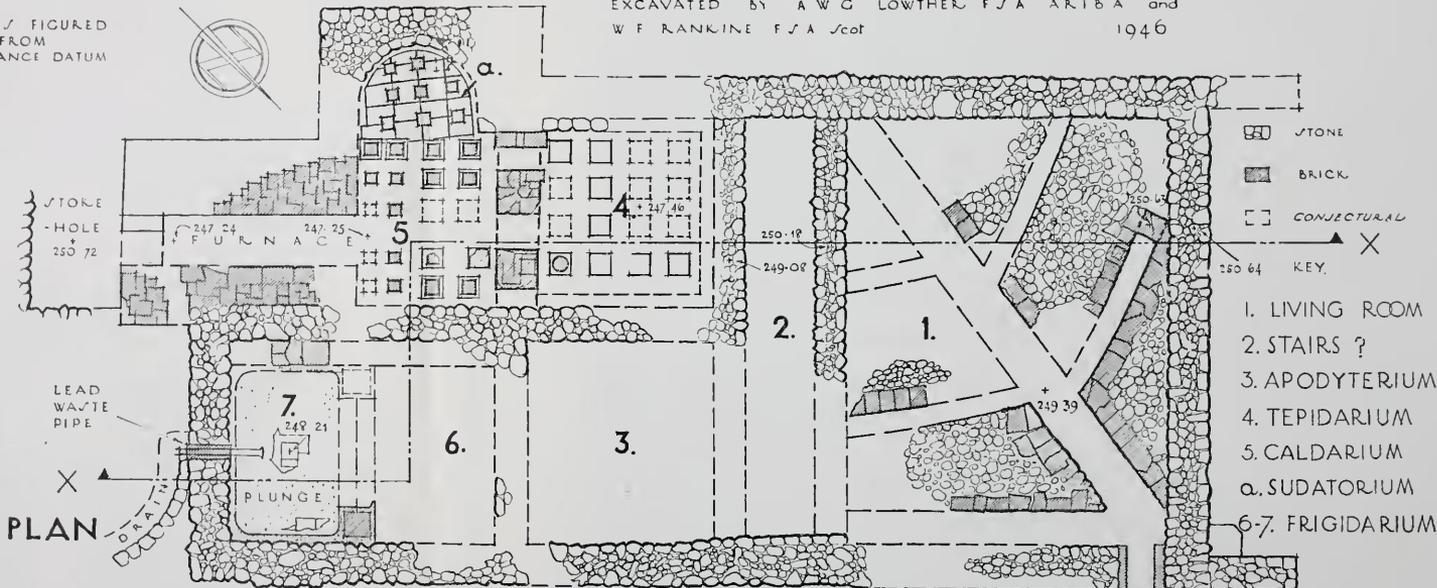
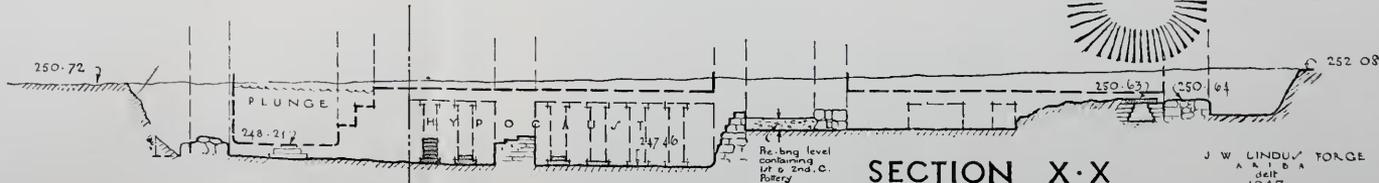
# ROMAN HOUSE

LEVELS FIGURED FROM OADNANCE DATUM

EXCAVATED BY A W G LOWTHER F.S.A. A.R.I.B.A. and W F RANKINE F.S.A. Scot 1946

The first structure located on this site (termed Building 1) proved to be a small dwelling<sup>1</sup> with a range of bath rooms (3, 4, 5, 5a, 6 and

7 on plan, Fig. 2) at its southern end, adjacent to a furnace, and with a large, warmed, main apartment at the north end, entered apparently from a verandah or porch at this end of the building.

A narrow compartment (2 on plan) between this "living room" and the bath apartments, probably originally housed a staircase leading to some upper rooms. The lower part of the hypocausts, and some of the supporting "pilae" for the floors still remained, as well as part of the plunge-bath (7 on plan) with its lead outlet pipe. A shorter length of pipe found in the débris filling the compartment, probably served to fill the bath and, from its position, it seems likely that a supply of hot water could be directed into the bath when required from a tank (possibly of the "testudo" type, as used in Pompeii) situated on top of the brick furnace tunnel at the western end of the bath. (Plate XV for illustration of pipes).

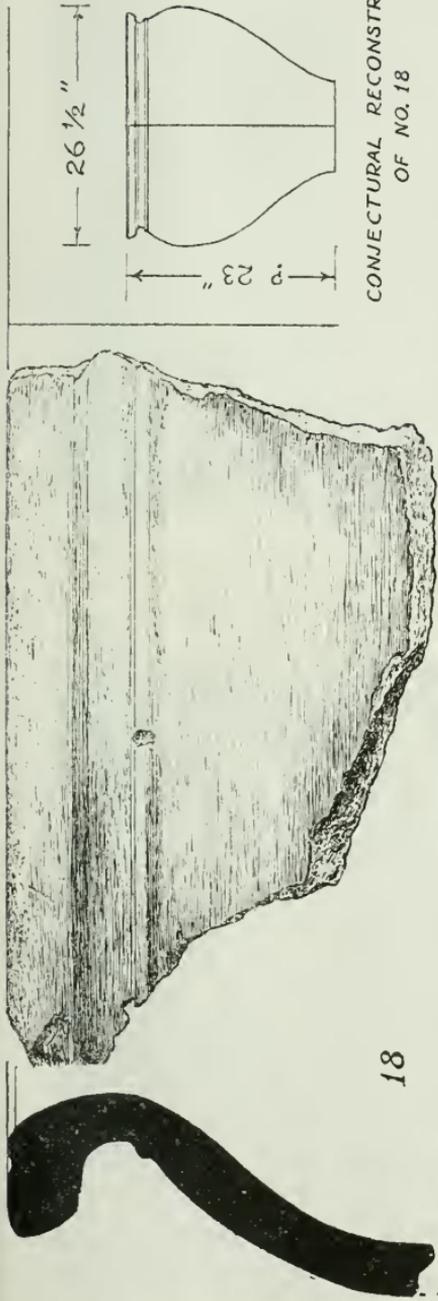
CONJECTURAL RECONSTRUCTION OF NO. 18

A small apsidal *Sudatorium* or sweating compartment (5a) opened off the west side of the *Caldarium*. In its wall, used as building material, was the fragment of the rim and upper part of an exceptionally large *dolium* or store jar (Fig. 18) which is of late 3rd century date to judge by its shape of rim and other similar, but smaller, jars from this site. This agrees with a layer of mid- to late-3rd century pottery from a level extending beneath the wall foundations of this building and, in places, cut through by the foundations. Also, the pottery, including a quantity of remains of flanged bowls, some colour-coated ("New Forest" type) red-ware,<sup>2</sup> and part of the base of a purple-coated stoneware beaker,<sup>3</sup> all of 4th century date, was found as "occupation débris" amongst the collapsed material of the building.

No. 18 is the fragment of a very large jar, or *dolium*, which was found built into the apse wall of Building 1. It is of hard, grey-coloured ware. Conjecturally, it is from a vessel of wide-mouthed type of 2 feet  $2\frac{1}{2}$  inches maximum diameter, and of 3rd century date.

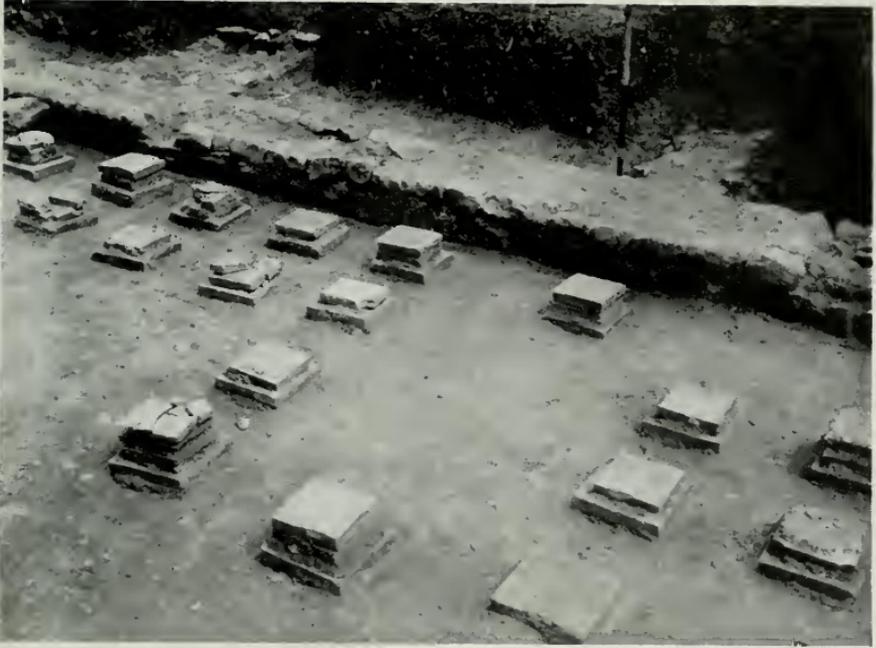
BUILDING NO. 2—CALDARIUM, LOOKING NORTH.

A trial trench cut through the clay floor of the hypocaust in the part that had served as the *caldarium* of the bath series, disclosed the fact that the building had been erected on a "raft" of rammed chalk, 1 foot 7 inches in thickness and, that the ground on which it was set had been strengthened by means of timber piling, the piles, 9 inches in diameter and only 6 inches apart in places, had decayed away completely but had left cavities, once occupied by the timbers,

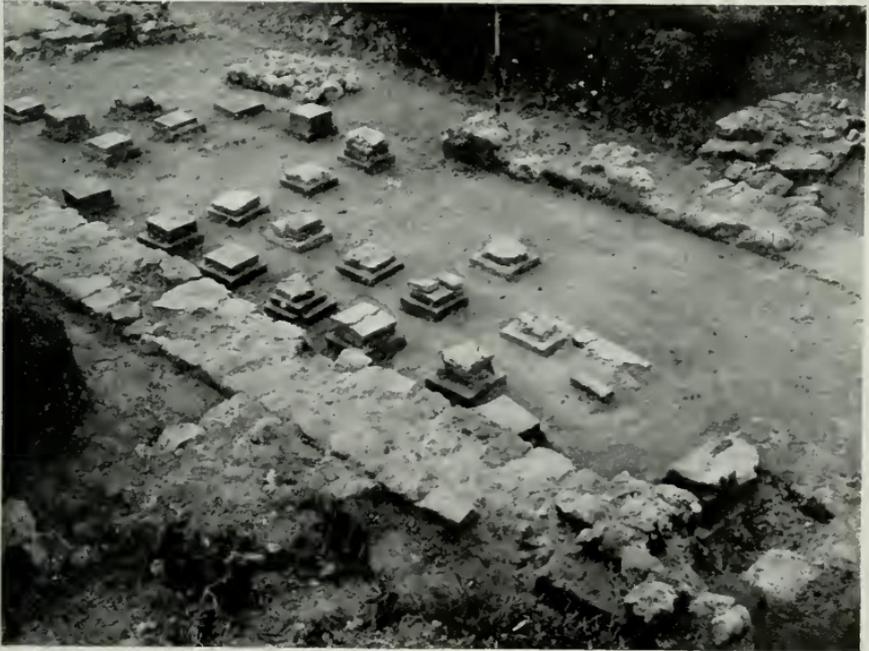
BUILDING NO. 2—CALDARIUM, LOOKING SOUTH.

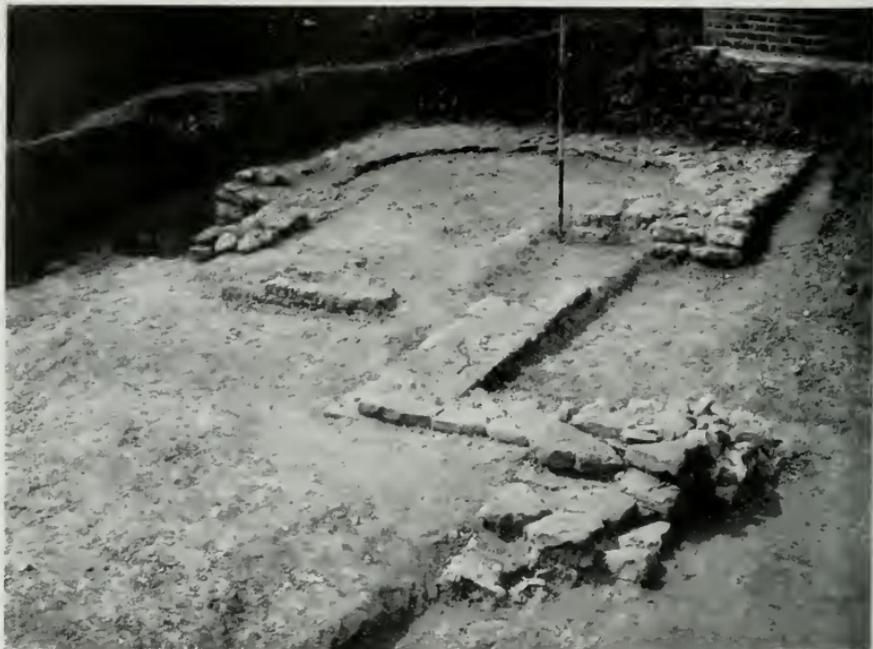
BUILDING NO. 2—SOUTH-EAST END.

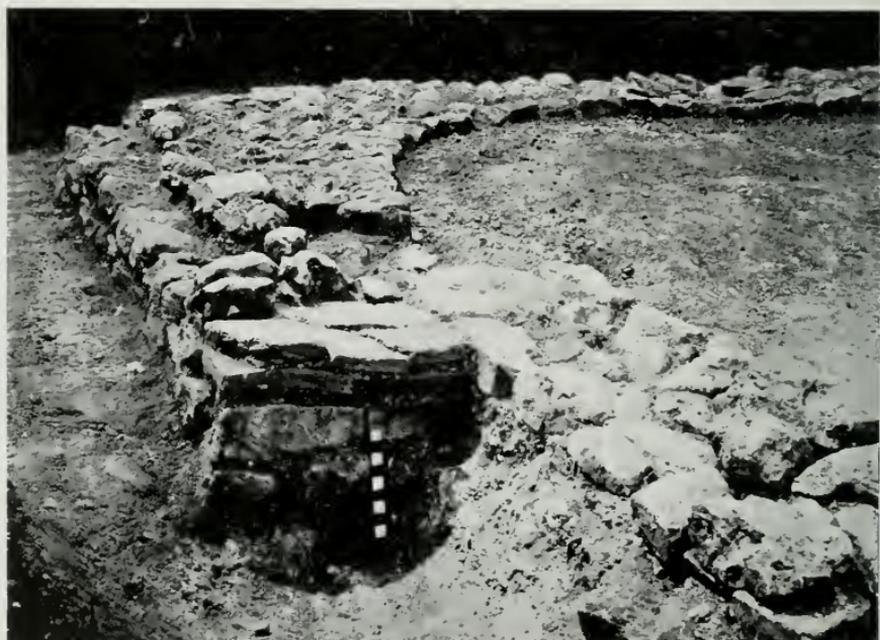
BUILDING NO. 2—OUTER ANGLE OF APSIDAL PLUNGE BATH, SHOWING JUNCTION OF WORK OF PERIODS 1 AND 2.

As to the later additions: only three of a probable six, or more, buttresses, which had been built against the outer walls, had any remaining masonry. "Robbing," apparently, from a silver farthing of Edward I which we found on top of the foundation of a robbed wall, of mediæval date, had been extensive and somewhat more so than was the case with Building 1. The apsidal plunge-bath added to the south-west corner, as well as the masonry inserted to take the steps down into this bath, were of the same yellowish mortar as that of the buttresses and of the walls of Building 1. Its foundations had been carried down to a depth of a foot or more below the level of the earlier foundations against which it abutted at either end of its

curve, and the 9- to 10-inch space beneath the *opus signinum* (red, brick and mortar concrete) floor of the bath, had been filled with a mass of pieces of painted wall-plaster, clearly that stripped from the earlier walls during the reinstatement and re-decoration of the building. Much of this plaster could be pieced together, revealing panelled designs of red, yellow and green lines on a white ground, of the usual rather crude and garish nature. Some of the bands of colour divide the rectangular (? dado) panels diagonally.

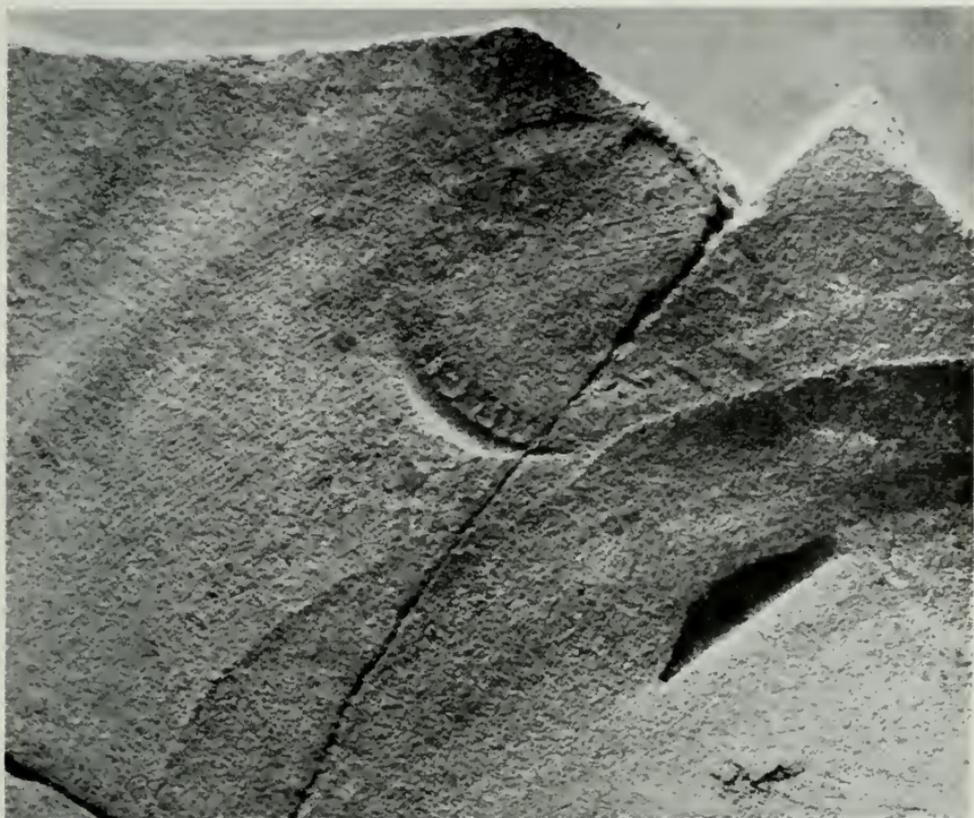
IMPRINT OF AN ANTONINE COIN (2Æ) ON INNER SURFACE FRAGMENTS OF A JAR.  
Impression of thumb-nail below. Scale:  $1\frac{1}{2} \times$  original.

A late-Antonine date for the original bathhouse was deduced not only from the types of pottery in the layer of débris into which its foundation trenches had been dug, but by the imprint of a coin (a "second brass" of which the inscription . . . T O N I N V . . . can be read) on pieces of a large jar and on its inner surface. From other imprints, and those of a thumbnail and forefinger (presumably those of the potter who made the vessel) it can be seen that the

coin had fallen on the sloping surface within the vessel (a wide-mouthed jar of hard, light-grey ware) and that the first efforts to retrieve it had only sent it further down the slope. Eventually it was recovered by the forefinger pressing the coin into the clay at one edge while the thumbnail (a fairly long one) was inserted into the clay under the opposite edge of the coin, levering it upwards (*v. illustration, Plate XIV.*)

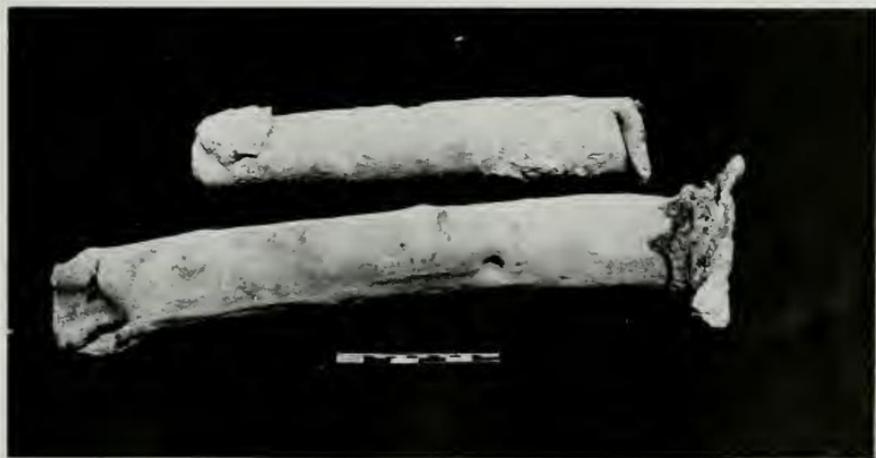
BUILDING NO. 1—LEAD PIPES FROM PLUNGE BATH.  
(Note the iron ring round end of lower pipe.) Six inch scale below.

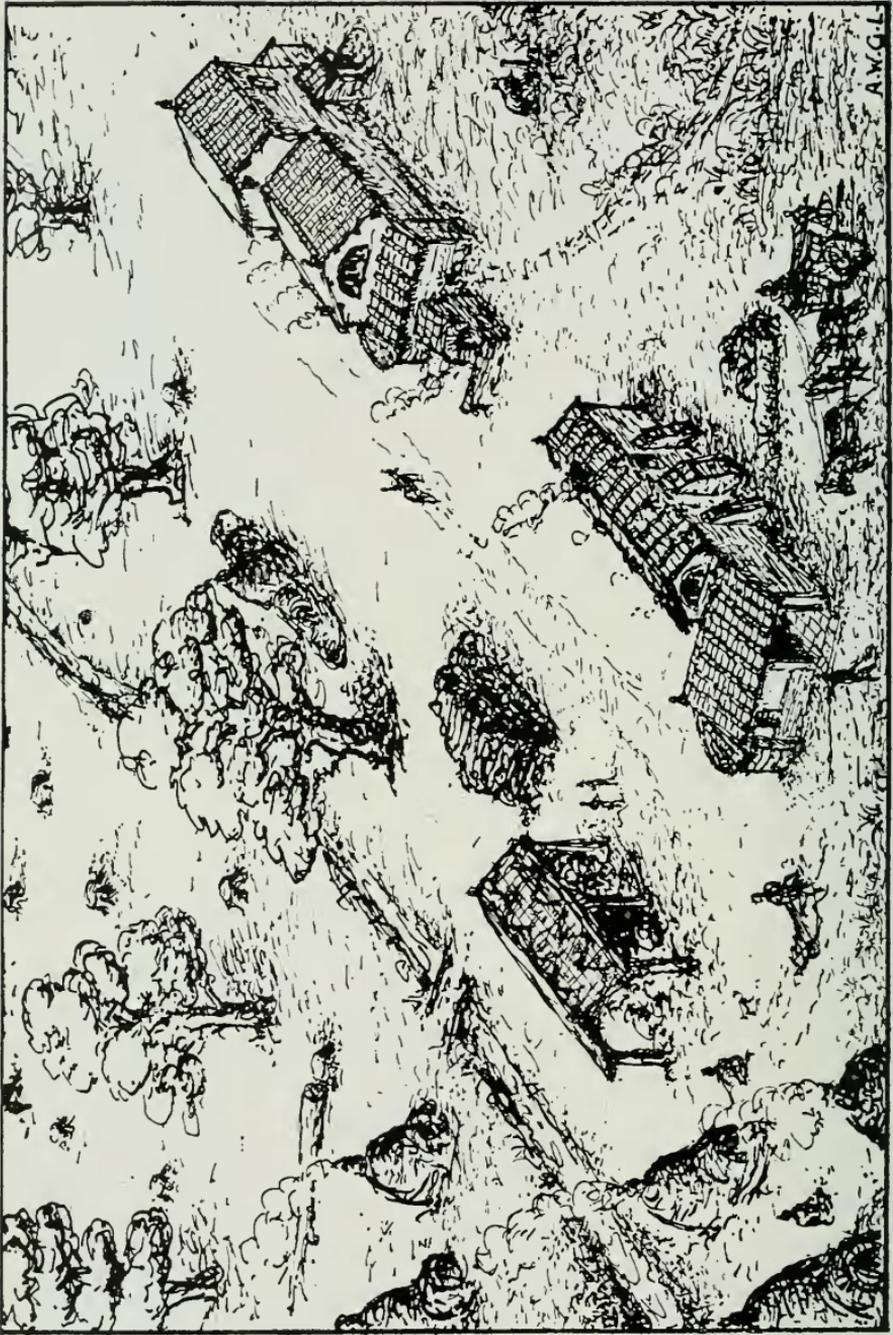
SUGGESTED APPEARANCE OF THE SITE *circa* 350 A.D.
