New light on the development of Carshalton Church

A report on archaeological observations made during partial restoration and construction work at All Saints Parish Church

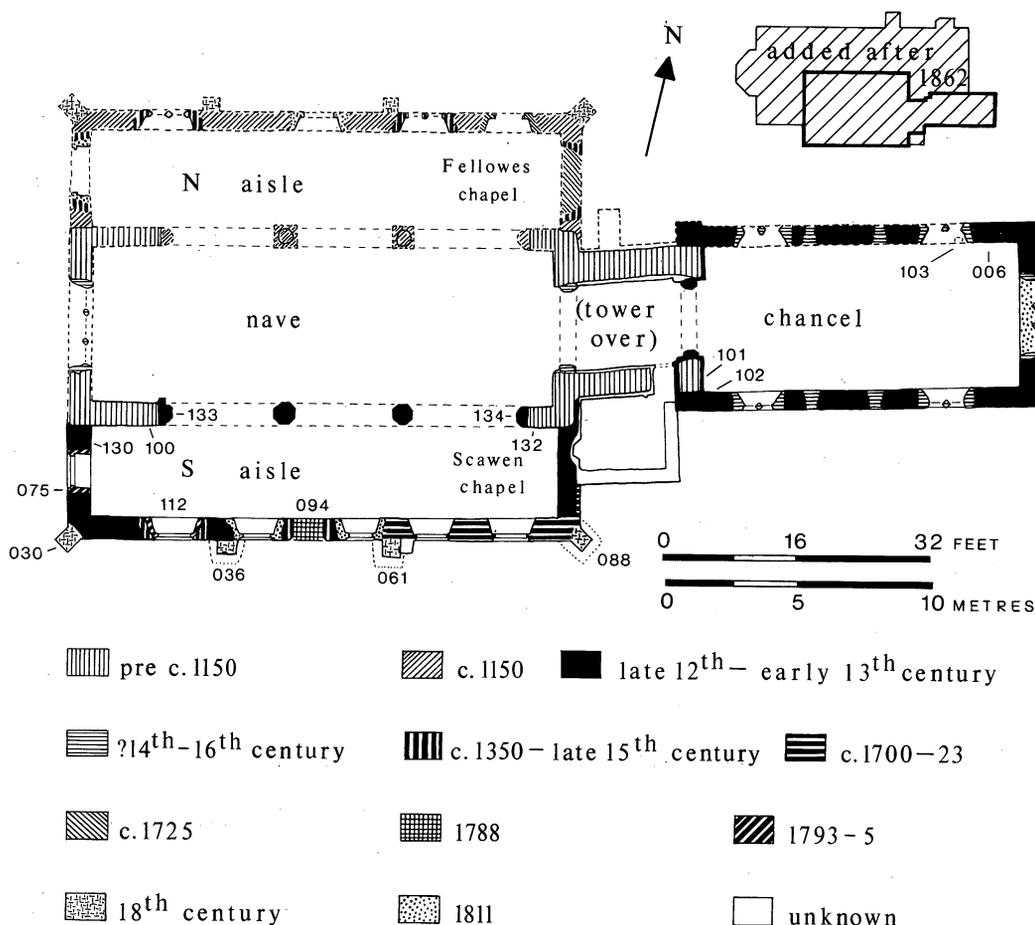
Fig 1 Carshalton Church: Plan of the church before the first Victorian restoration of 1862, showing phasing as suggested by all recent work (from a plan dated 1862). Inset shows the position of the medieval church in relation to the post-1862 ground plan.

Note: In the report, the term 'chancel' refers to the medieval chancel, now the Lady Chapel, and the term 'south aisle' relates to the medieval south aisle, now the outer south aisle. The position of the medieval church in relation to the post-1862 ground plan is shown in the inset to figure 1.

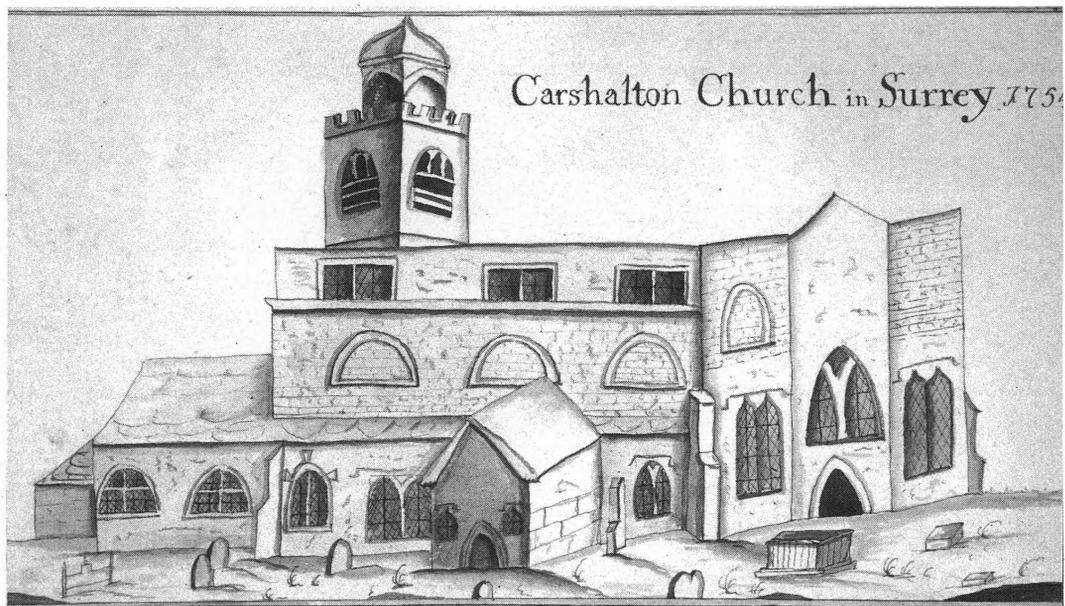
Fig 2 Carshalton Church: drawing made from the north-west, dated 1754. *Courtesy of Heritage Department, Sutton Central Library*

he agreed 'to make the north side of the said church answerable to and in like manner as the south side'. This was completed by 1726 and is shown in the 1754 drawing (fig 2). This view, in its crude but homely fashion, shows the upper storey windows blocked up, and only the lower storey windows open, together with the square panels shown above the upper storey in what was later the parapet. The 1754 artist has actually reversed the situation, as indicated by later views, although the blank arch in the west wall is accurate. It also shows an extensive north porch with a pointed doorway and windows similar in style to the aisle windows.

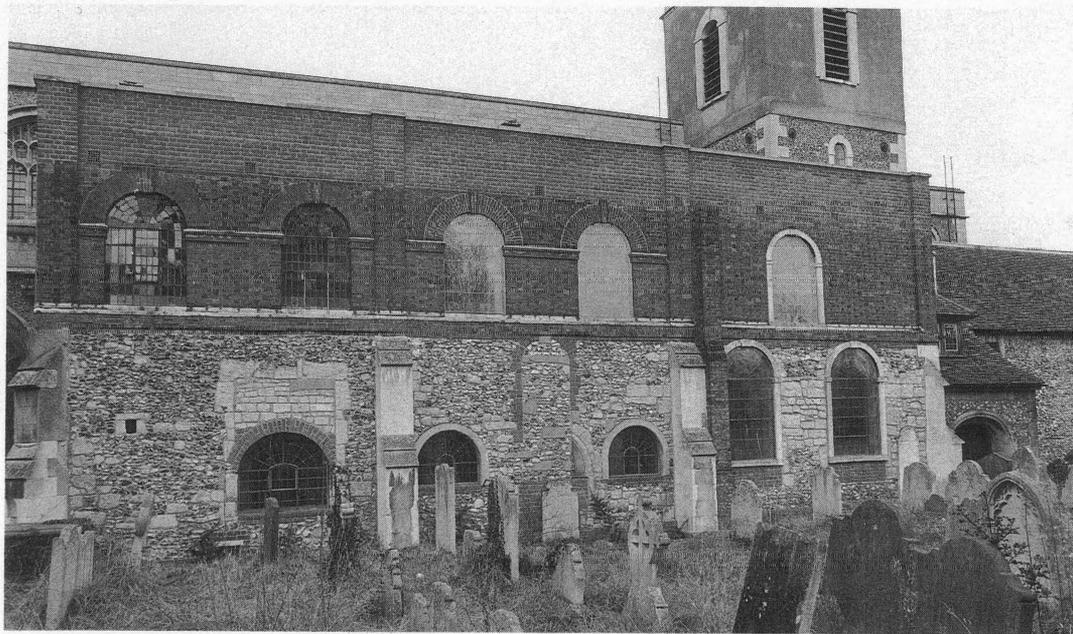
Fig 3 Carshalton Church: view of the south wall of the outer south aisle, from the south-west

In the 18th century the south aisle wall of the church was totally relit (fig 3). Firstly the eastern bay of the aisle became the Scawen family chapel. Dame Mary, wife of Sir William Scawen the lord of the manor, was buried in the church in 1700, but it is difficult to say whether the brick upper storey, with its single stone-dressed window over the medieval eastern bay, and the two similar stone-dressed windows inserted in the wall below, belong to this date or to the period up to or after Sir William's own death in 1722. It is suggested here that the whole of this east bay wall was totally rebuilt re-using materials to accommodate the new windows – it would be hard to insert such large windows without demolishing much of the wall. It is also difficult to say whether the whole upper storey of the south aisle was entirely rebuilt in the same phase (Molesworth Roberts 1973, 5). Peatling suggested that the money raised for 'ye repairing of the south Isle & beautifying the church' (churchwardens' accounts, April 1723, in Peatling nd) was used to extend the upper storey westwards from the Scawen brickwork. This may account for the difference in detail between the two sectors. Alternatively, the Scawens may have undertaken the whole of the work but had a more opulent design for their eastern bay to differentiate it from the 'commoner' part of the aisle (eg by the use of stone dressings for the windows). There is no documentary evidence to help answer these problems, and it can only be said that the improvements had taken place by mid-1725, when attention was turned to the north aisle.

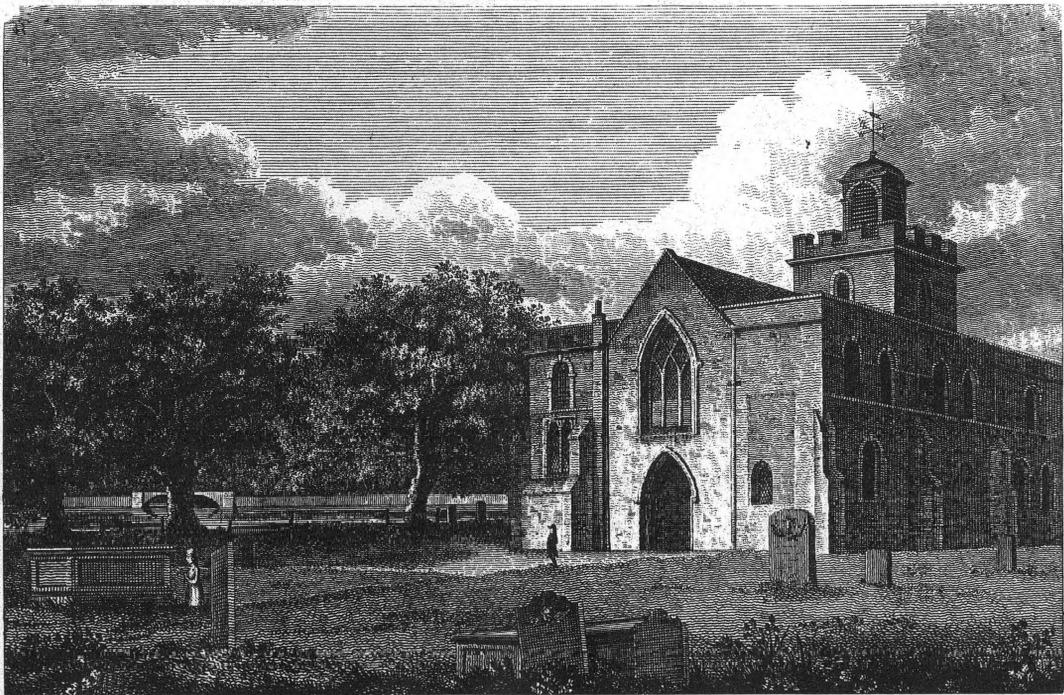
Fig 4 Carshalton Church: view from the south-west by Malcolm Somers Place, published 1799. *Courtesy of Heritage Department, Sutton Central Library*

So far, the medieval wall of the middle bay of the south aisle had remained unpierced since 1788; this is indicated by the print of 1799 (fig 4). The two round-headed Georgian windows now present in this wall belong to the final phase of re-fenestration, probably dating to 1811 when the aisle galleries in the western bays of both aisles were extended eastwards into the middle bays. In addition, access to the south gallery above was provided by 'a stone Stair Case' leading from the churchyard to a door cut high up in the medieval fabric between the two windows, and placed almost directly above the medieval doorway blocked some 25 years before, as shown in figure 3 (Sutton Library SBC LG 6/1/3 faculty document; Peatling nd). As far as is known, the north door in the middle bay was closed again and a window inserted. Doorways were cut high up through the arcade walls to allow 'staircases to pass through' (one survives in the south arcade, partly cut by Thomas Carter's fine monument to Sir George Amyand, moved here in 1891-3). At the same time the vestry was moved from the west end of the north aisle to east of the main altar, and the chancel east window was blocked up.

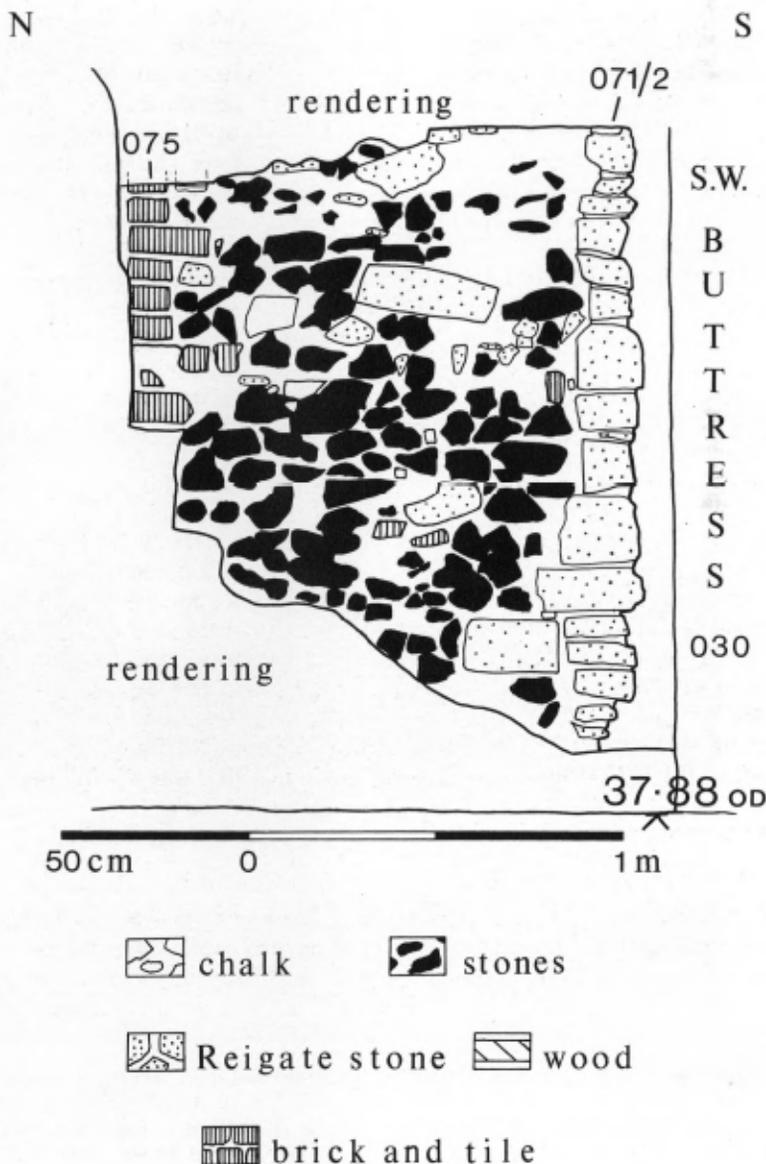
Fig 5 Carshalton Church: outer south aisle exterior, west wall, elevation. Key diagram refers also to figs 7, 8 and 11.

2.1.2 *The west wall (fig 5)*

A section of the west wall of the south aisle was exposed for a short period during October 1989; this lay to the south of the blocked late Georgian window and extended some 1.8m high by 1.35m across. The rendering was very thick in places (25mm and more) and the wall beneath was in a bad state of preservation; the original face was no longer present, and much of the original mortar had decayed for some depth, which made recording of mortar types very difficult and confusing.

The original phase, and still the present core, of the wall seems to have been represented by a flint rubble wall with some chalk and Reigate stone rubble, set in a brown-yellow mortar with flint and small chalk lumps. There appeared to have been no regular coursing of this material. Observation of other parts of this wall revealed that similar flint and mortar construction extends above the section as drawn, and that the jambs of the late medieval window exist above the section exposed (visible above the Fellowes monument). The next phase may have been the addition of Reigate stone block quoins at the south-west corner of the aisle,

represented by a white chalk mortar (071) which was found also to run along the top of the exposed section, supporting more Reigate stone which mostly lay hidden under the upper rendering. A green sandy mortar (072) underlies this mortar, but is in a similar position as 071, cementing the Reigate stone quoins into the existing west wall. It is therefore to be considered of the same phase. The date of this quoin phase is not known, but the mortar types suggest that the quoins had been added to the existing building. As noted above, there was no evidence for a medieval buttress here.

All succeeding phases appear to be of the 18th and 19th centuries, when the extensive work on the aisles was commissioned. Of these phases, the earliest would appear to be the insertion of sandy red brick 'jambs' for the now blocked window (075) which are set in a chalk mortar, with many chalk lumps. These bricks

appear to be of the early, rather than of the later, 18th century but it would seem from the documentary evidence cited above that this window was inserted at the end of the 18th century. At some stage the present Portland stone buttress (030) was set deeply into the existing west wall at an angle of approximately 45°, and the original Reigate stone quoins were severely cut back in the process.

As well as a minor brick patching episode, probably dating from the 18th century, there were some repairs to the brick jambs of the window which was finally blocked when the Fellowes monument was moved here after the demolition of the north aisle c1891. The present infill and rendering were added much later, when the original ironwork of the window was removed in 1916 (Peatling nd, note of 1916); the series of iron pins in the wall surface were set then to help secure the rendering on the wall.

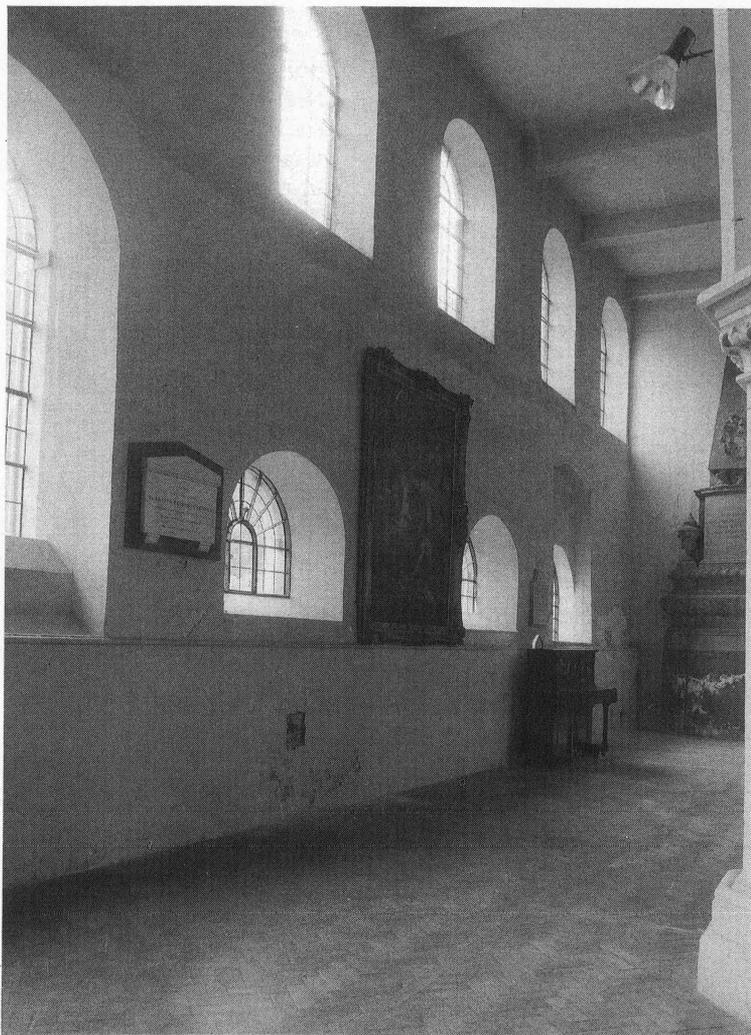
Fig 6 Carshalton Church: outer south aisle interior, looking south-west

2.2 THE SOUTH AISLE, INTERIOR (fig 6)

The documentary evidence for the development of the south aisle has already been summarized. The post-1700 re-fenestration is well documented, but the previous medieval phases are obscure. It was hoped that the removal of plaster on the interior face of the south aisle would permit some understanding of this development. Areas of wall above the dado level were exposed for a period of two weeks before Christmas 1989, and were then covered up. All areas were recorded on drawings and by photographs.

The most important features observed were a blocked archway or doorway in the middle bay, the jambs of a partially blocked window, and part of the original south aisle wall. Miscellaneous areas of the walling were also exposed, revealing some special features as noted below.

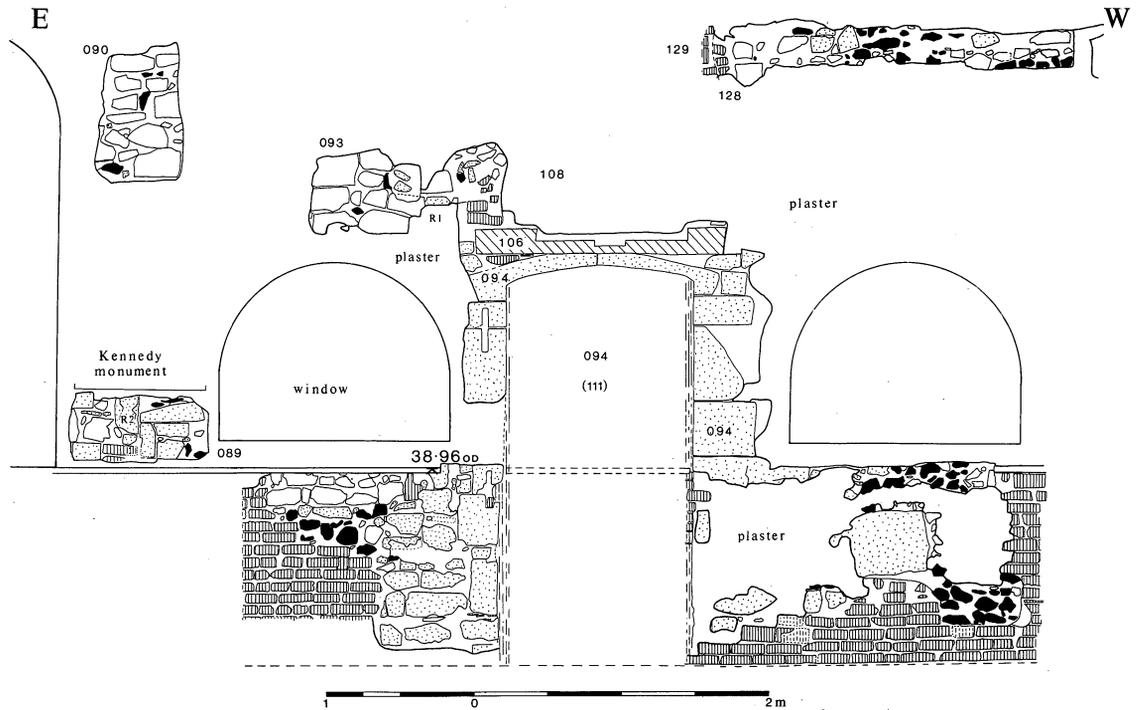
Fig 7 Carshalton Church: outer south aisle interior, south wall, middle bay, elevation. For key diagram see fig 5.

2.2.1 *The blocked archway/doorway and associated features* (fig 7)

The blocked archway or doorway (094) in the middle bay was constructed from Reigate stone blocks which, in two cases, were originally linked together with a pin or staple (now lost). The head of the arch was composed of two blocks, the junction of the two lintel stones being at the apex of this arch. Scribe- or setting-out-marks were visible on the faces of these stones. Although the opening was fully blocked, it was possible to see that there was a hollow chamfer on the underside of both blocks, disappearing into the blocking. An off-white mortar with small flint and chalk inclusions was found to have been used around and between the upper jambs of this opening. Further down below the present dado level the Reigate stone block jambs appear slightly disjointed but are otherwise as the stonework above them. This walling is overlain and built into by an internal 'apron' wall below the dado which appears to respect the position of the doorway and runs east and west of it. This apron supports the dado rail and is constructed of rough sandy red bricks, both whole and broken, in a white, gritty mortar. The brickwork used to block the doorway (111) differs from that employed in the apron and is of good quality and better laid.

Above the door lintels is a large wooden beam (106). The area above this beam had evidence of brickwork, and should be connected with area 129 which is a small exposed area of brickwork above the western jambs of the doorway. To the west of 129 was another patch of brickwork (128) which was similar to

a patch set in a corresponding position over the eastern jambs of 094, and is considered to be the jambs of a blocked doorway above the medieval door.

Further small, disconnected areas of walling were exposed east of the door/arch 094 in the middle bay (fig 7). One (093) lay above the eastern small Georgian window of the middle bay and was connected

Two areas lay above (090) and below (089) the monument to a member of the Kennedy family (fig 7). Area 090 was of chalk, Reigate stone and flint rubble walling with no special features save that two of the chalk fragments had been roughly tooled. Area 089 revealed how complicated the analysis of walling can be; in an area 0.9m x 4.5m no less than four mortar or plaster types were recorded. The area was more tightly packed than recorded elsewhere, with worked Reigate stone blocks closely set against each other. Brickwork was noted in the lowest part of the area. The most notable feature was a defaced moulded Reigate stone block (R2) which, from its position and axis in the wall, was evidently not *in situ* and had been altered. The moulding, standing proud of the whole face of the block, was a series of declining curves and recurves which became less sinuous towards the base of the block. Although identification is tentative, it appears to be a late medieval bracket or small corbel (fig 9, B).

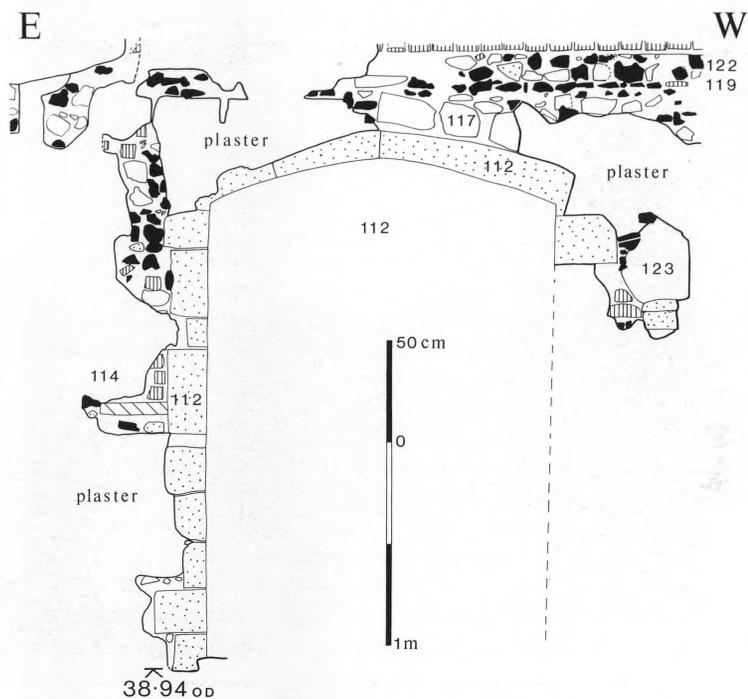
Fig 8 Carshalton Church: outer south aisle interior, south wall, west bay, elevation. For key diagram see fig 5.

2.2.2 *The west window* (fig 8)

The eastern jambs and segmental rere-arch lintel stones of the western medieval window (112) were uncovered. All are decorated, like the blocked door, with a simple hollow chamfer. The square-headed two-light tracery which existed in the window partly survives, blocked up, with a later Georgian window set in its lower half. The Georgian window (not shown in figure 8) was set in the outer half of the medieval reveal, allowing inspection of the inner faces of the inner jamb reveals. A series of wax rubbings were made of both faces for comparison of the tooling impressions. The head of the window was formed of three blocks; one block formed one half of the window head. Mason's setting out marks were observed on the corner stones of the head of the window. There were no other specific features of note. Mortar samples from the walling around the window were of a gritty off-white compound very similar to those located around the head of the blocked doorway (094) shown in figure 7.

2.2.3 (a) Around the west window (fig 8)

The largest of the exposed areas was above and to the west of the western jambs of the window to the west wall of the aisle. This was only partially recorded above the western window jamb where there was a series of three large chalk blocks (117) and above this an area of roughly coursed flint and chalk fragments. Above this a well-coursed line of flints was observed (119) which did not, however, continue at the eastern end of the area uncovered but may be again picked up in a small area of wall exposed further east. Above this was another area of un-coursed flint, chalk and Reigate stone fragments (122) on which was built brickwork forming the lowest course of the early 18th century extension. To the west of the window a horizontal deep set fragment of elm wood was found and removed from the wall by the contractors and has been preserved; this came from the large hole 123. On the opposite side of the window small patches of wall were exposed of which the most interesting was 114, where a small wooden beam supported three bricks. The bricks and the wood beam appear to be connected as one feature but it is not impossible that they were contemporary with the insertion of the window. Finally, in the south-western corner of the aisle, internal Reigate stone quoins were noted.

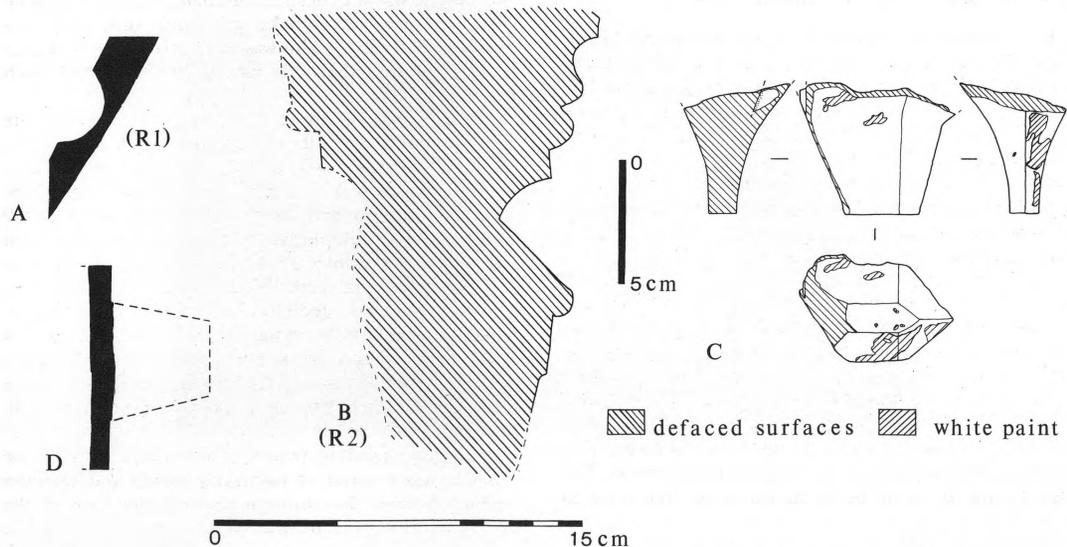
Fig 9 Carshalton Church: moulded stonework. A: from 093; B: from 089; C: fragment from 010; D: string course reconstruction (suggested)

to 108. It was a collection of chalk, flint and Reigate stone lumps and blocks, of which one (R1) was moulded (fig 9, A). This was obviously in a reused state and suggested that this part of the wall had been rebuilt.

The string course is now totally defaced but may have had a trapezoidal profile (fig 9, D). It is formed from at least two Reigate stone blocks. The western block, which terminated at about 1.45m west of the east wall of the chancel, had to be removed during the work. There was no evidence for a similar block to the west of this one, although this was positively looked for. The eastern block is an extensive piece which is in fact a westward extension of a deeper north-east quoin block, one of the Reigate stone quoins of the north-east corner of the chancel. The moulding appears to run across the south face of the quoin. The eastern block has now split (indeed, the whole quoin structure has separated from the chancel east wall by about 20mm and the gap has been plugged by Victorian cement). Traces of plaster, very probably medieval, were found to cover part of the defaced moulding, suggesting that this may have been removed during a medieval refurbishment of the chancel and not as part of a Victorian improvement.

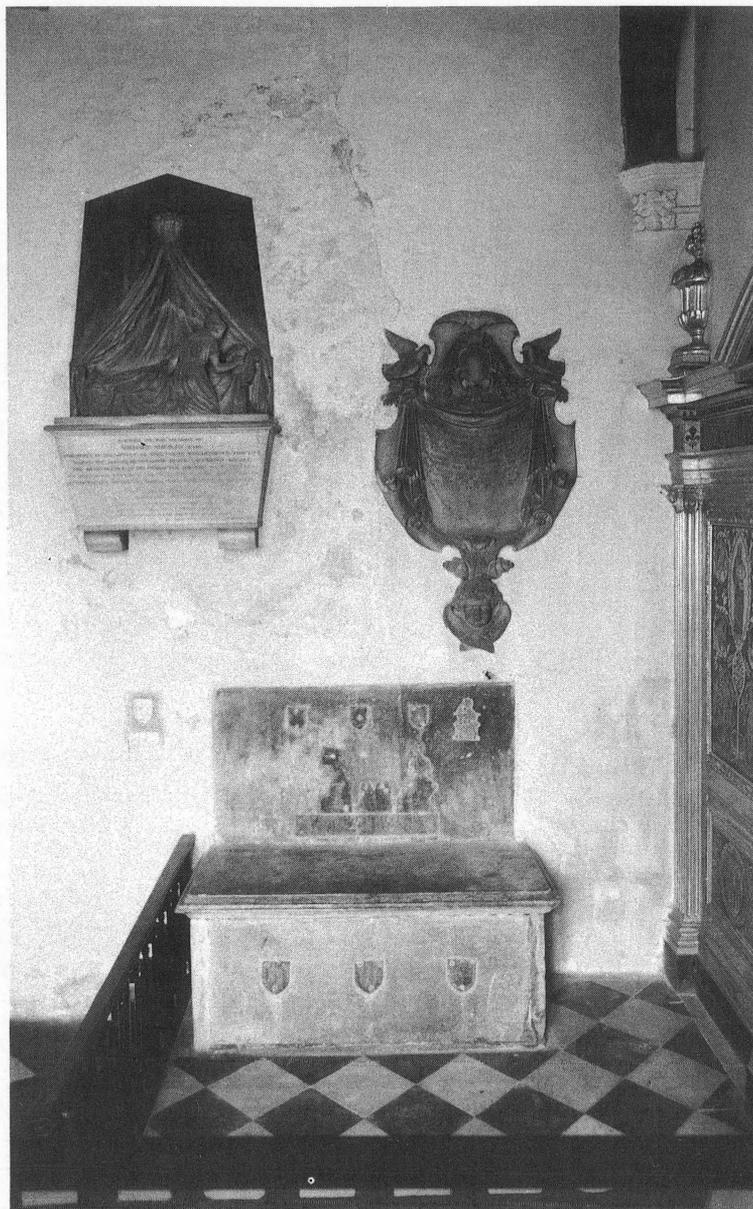
Fig 10 Carshalton Church: Lady Chapel interior, north wall, looking north

2.3.1 *The Gaynesford tombchest* (fig 10)

Investigations may suggest that the tomb was not *in situ* or was inaccurately assembled. The wall slab (008) was found to be positioned off-centre by 30mm to the east in relation to the tombchest. The west slab of the tombchest was found to have been replaced at some time, and fragments of the original slab (notably without an indent for a shield as found on the replacement) were found inside the tombchest, resting on modern debris. The top slab of the tombchest (027) was also offset with regard to the walls of the chest itself, extending 14mm more to the west than to the east. It was found to have an elaborate moulding which abruptly terminates at 18mm from the plastered wall at the eastern end. The western end is damaged, but does not appear to have such a contrived termination as the eastern end. The table top before removal was found to slope from south to north.

2.3.2 *The Burrish monument* (fig 10)

Dorothy Burrish (died 1685) lived at Stone Court, formerly Gaynesford Place. Her monument is attributed on stylistic grounds to William Stanton (1639-1705) by Rupert Gunnis (Mr Geoffrey Fisher, pers comm). It was found to be of two pieces: the first a corbel comprising the cherub's head which supported the monument at the bottom, and the main cartouche which was secured to the wall at the top by an iron staple. The reverse of the main part was heavily scored with the outlines of the actual design, but only on the left hand side. The corbel was found to have a deep 'tongue' or plug, 0.2m deep, which was set into a

2.3.3 *The Shepley monument* (fig 10)

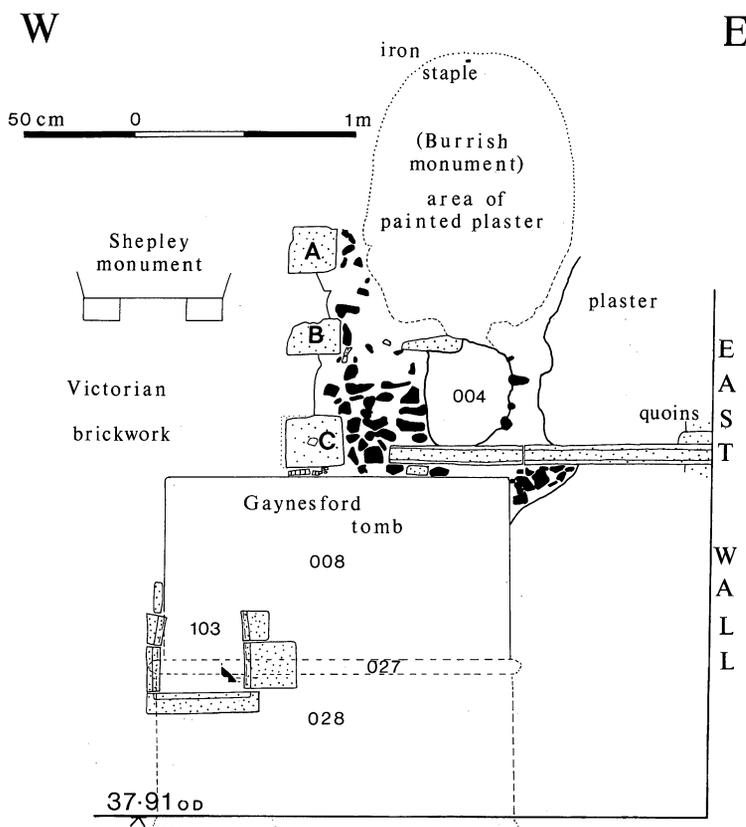
Fig 11 Carshalton Church: Lady Chapel interior, north wall, elevation. For key diagram see fig 5.

2.3.4 *The north wall of the chancel* (fig 11)

The removal of the three monuments, and the plaster associated with the wall stretching some 4m from the north-east corner of the chapel, exposed a large area of the wall for inspection.

The north wall is constructed of flint and very occasional Reigate stone fragment walling set in a yellow-brown sandy mortar, which has many small chalk inclusions and incorporates remains of a string course, internal quoins and an aumbry.

The Reigate stone aumbry (103) was rendered inaccessible by the erection of the Gaynesford tomb, thus obviously pre-dating c1497. The upper jamb had been removed by the Victorians, and there is evidence that they had disturbed the upper west jamb. The aumbry was then blocked, but the rebate moulding for the door is still visible.
