Paddington Mill, Abinger: a survey of a derelict corn mill

ALAN CROCKER

Paddington Mill, in the Tillingbourne valley near Abinger Hammer last ground grist and flour at the end of the 19th century. After a hundred years of neglect and decay very little milling equipment survived. However, a detailed survey of the derelict building, carried out in 1996, enabled the layout of the milling and associated machinery to be established and revealed several phases in the development of the mill and its site. The results of the survey are presented and discussed in terms of available information on the history of the mill.

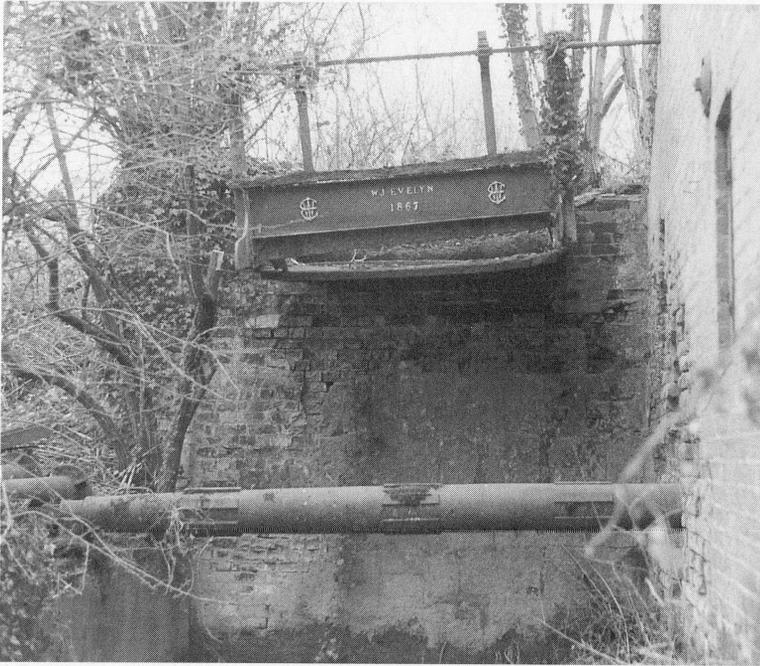
Fig 2 The wheel pit at Paddington Mill from the west, showing the pen-trough at the top and the shaft of the water-wheel at the bottom. Note the stone and brick sections of the west facing wall of the pit in the background, the eroded bricks of the mill wall at the right and the keyways for the hubs of the waterwheel spokes on the shaft (April 1996).

outer bearing of the waterwheel shaft. Of considerable interest is the vertical east wall of the pit which is built against the dam. This reveals three building phases as indicated in figures 2 and 6. The earliest of these is a section adjacent to the mill measuring 2.29m wide and 2.40m high, from the bottom of the wheel pit, and constructed from large blocks of stone. These are more likely to be from quarries in the Tonbridge or Hythe Beds than from more local sources, and are dressed in a manner which suggests a date before 1750 (Kenneth Gravett, pers comm; John Potter, pers comm). The next phase is in brick, some of which is heavily eroded. This extends the wall to the full width of the present wheel pit and upwards to a height, at the sides, of 3.15m, which is level with the bottom of the pentrough. However, immediately beneath the pentrough there are three courses of different bricks which are not eroded and these bricks have also been used on both sides of the trough. It would appear therefore that the stone section indicates the size of a pre-1750 wheel pit 2.29m wide and 2.40m deep. This was later extended, with rather poor quality bricks, to create a wheel pit of the present size. Then, in 1867, when the pentrough was installed, a new foundation for its base was created by replacing some heavily eroded bricks and the wall was raised at the sides.

All that survives of the waterwheel at Paddington Mill is the magnificent cast iron shaft shown in figures 2 and 21. This rests on bearings on the north bank of the wheel pit and on a longitudinal timber beam, supported by a larger timber beam resting on brick foundations, inside the mill (fig 17). It is interesting that the ends of the smaller beam are shaped into ogee curves which suggests that it is contemporary with the cast iron pentrough, which has similar curves at its ends. The shaft is 4.86m long including gudgeons or pivots protruding at each end and a further extension of square cross-section at the north end. The main part, which is 4.49m long, is 0.25m in diameter near the centre but tapers gracefully down to 0.20m at the north end and 0.22m at the south end. Cast on to it are four sets of iron strips or splines which acted as guides for wedge-shaped wooden keys used for tightening wheel hubs on to the shaft. These are labelled I–IV in figure 21 and, surprisingly, they are all unequally spaced.

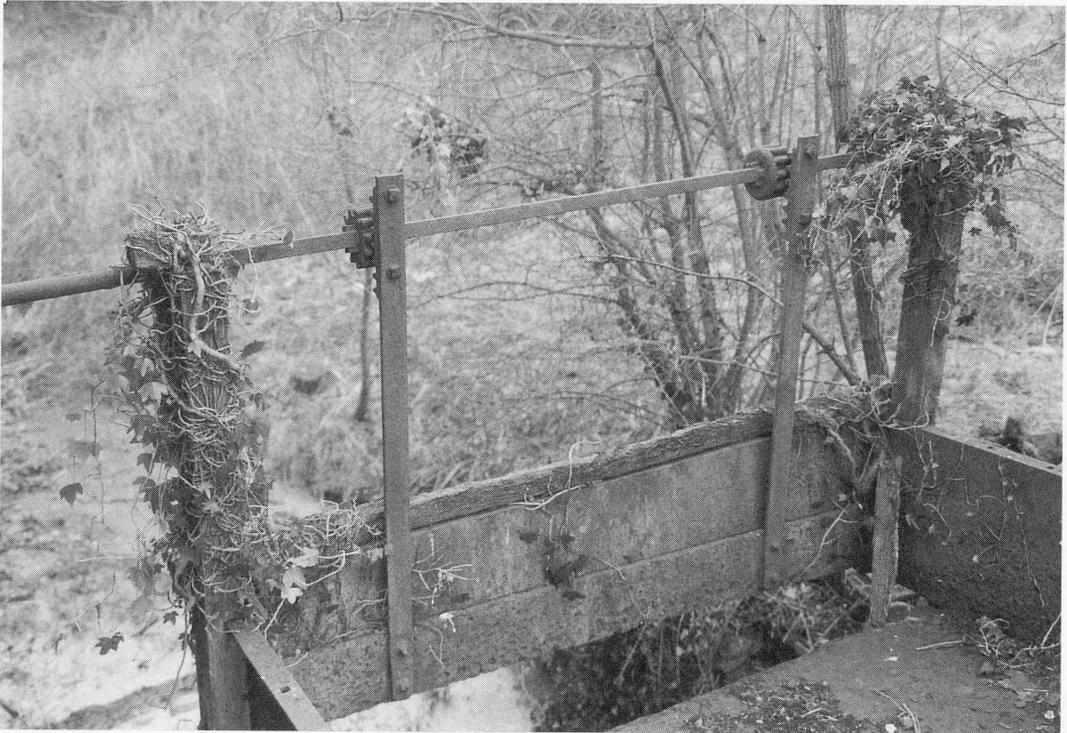
Fig 3 The control gate or penstock at Paddington Mill viewed from the south-east. The gate, which is the narrow iron plate at the bottom of the two vertical iron bars, was raised or lowered by means of the visible rack-and-pinion gearing operated from inside the mill, which is at the left (April 1996).

mill dam and it is crossed 0.55m from its end by a vertical plate 0.28m high (figs 3, 4). Beyond this plate the upper sides of the trough slope downwards in attractive ogee curves (fig 4). The top of the plate is level with the top of the trough leaving a 0.20m gap at the bottom. This gap could be reduced by a sluice gate or penstock, 0.20m high, located immediately on the inside of the plate (fig 3). The mechanism to do this consists of two iron bars rising from the gate with 0.23m long racks containing seven teeth at their upper ends. These engage with 11-cog pinions on a horizontal rod which could be turned from inside the mill. The penstock and its control mechanism are held in place by a timber framework which is in a very decayed state (fig 3).

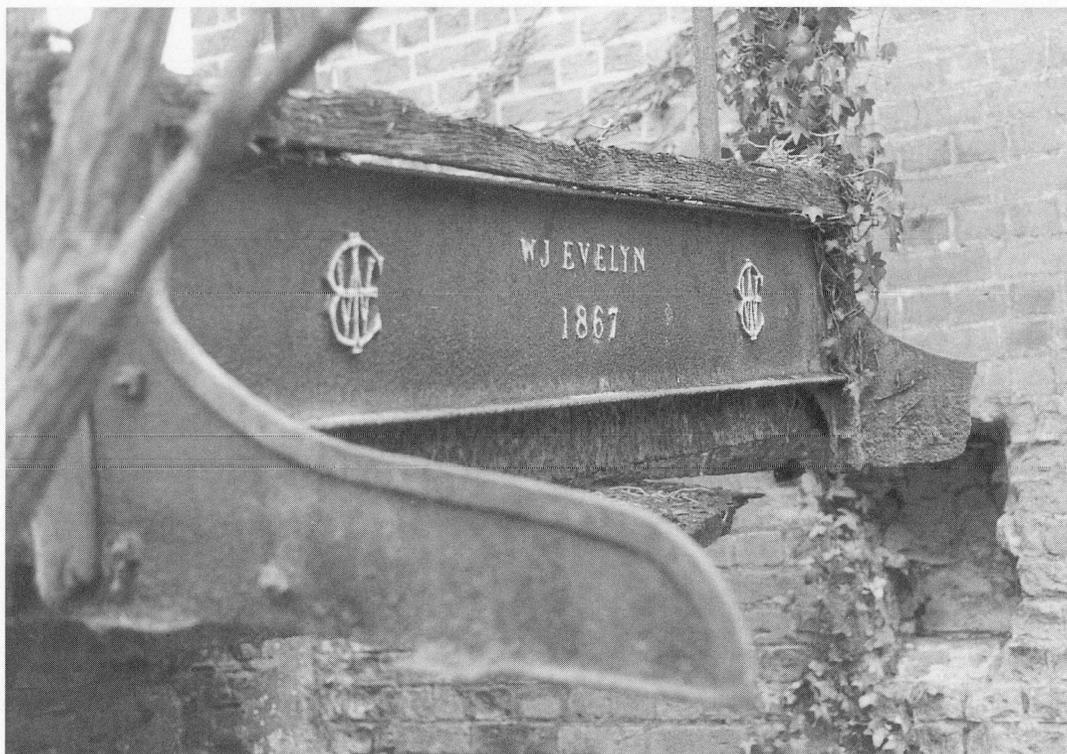
Fig 4 Detail of the pentrough at Paddington Mill from the north-west, showing the inscription W J EVELYN / 1867 and two WIE monograms, highlighted in chalk. Note also, at the bottom right the recess in the wall of the mill which held the end of the iron beam which helped to support the pentrough (April 1996).

The pentrough was supported, 0.70m from its end, by an iron structure which lies dismantled on the bank of the stream. It consisted of an H-section beam, 3.62m long and 0.15m high, fixed at its south end in a recess in the mill wall (fig 4) and at its north end on an iron stanchion 1.42m high at the side of the wheel pit. As a result of its absence, the end of the pentrough is sagging and the side away from the mill is cracked adjacent to a join in its plates (fig 5). Part of the ogee extension on the mill side is missing (fig 4).

The west facing side of the crossing-plate of the pentrough bears the inscription 'WJ EVELYN / 1867' between well designed 'WIE' monograms (fig 4). William John Evelyn was the owner of the Wotton estates which included Paddington Mill (*VCH*, 3, 156, 162). Also on the outer face of the north side of the trough, just before the crossing-plate, is the cast inscription, 'THOMAS SPENCER / MILLWRIGHT / GUILDFORD' (fig 5).

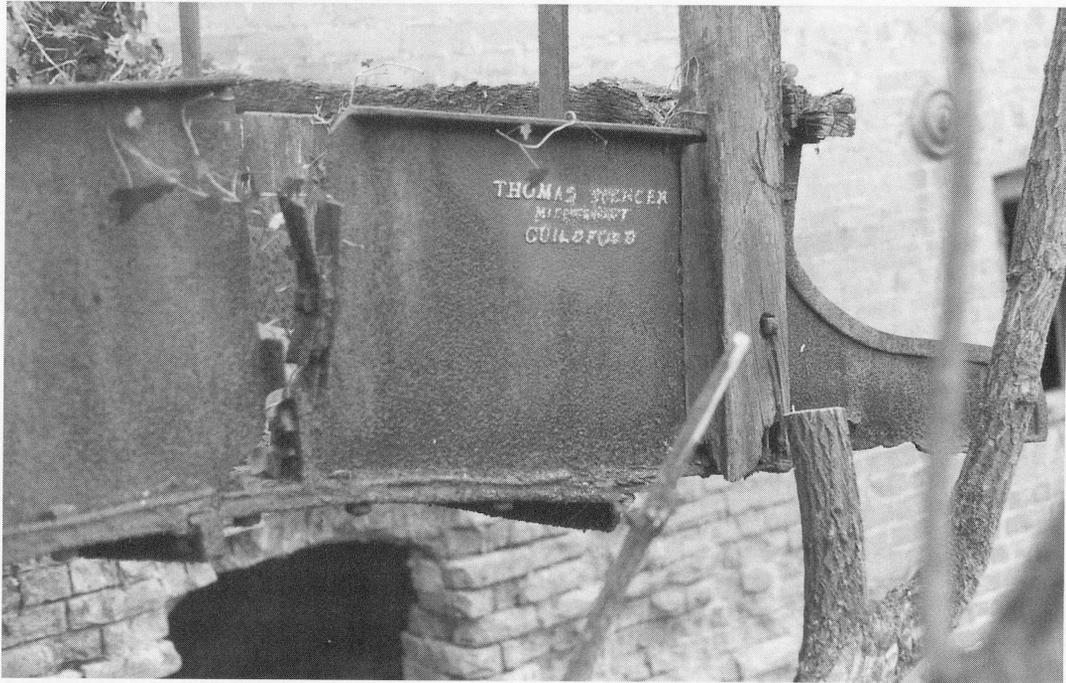
Fig 5 Detail of the pentrough at Paddington Mill from the north-east, showing the inscription THOMAS SPENCER / MILLWRIGHT / GUILDFORD, highlighted in chalk. The opening in the mill wall, which appears in the photograph to be below the pentrough, housed the shaft of the waterwheel (April 1996).

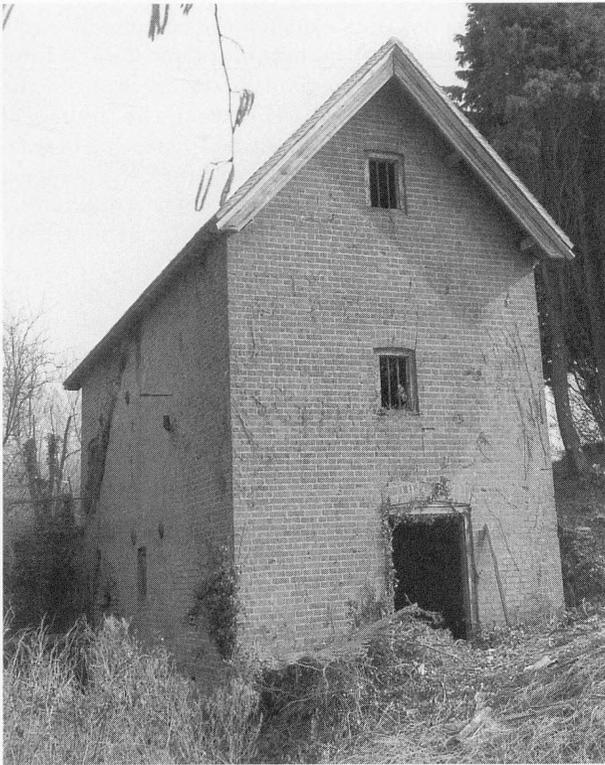
Fig 7 Paddington Mill from the north-west. The doorway is the west entrance to the pit floor, the window above is on the stone floor and the window in the gable is on the bin floor. Note on the west wall the change from English to Flemish bond above the level of the doorway. The roof has the replacement tiles of March 1996 but the bargeboards are original. On the north wall, at the left, can be seen two windows, four tie-plates, the stump of a stove pipe and a bracket to support this pipe (April 1996).

Paddington Mill is a simple, gabled, brick building of three storeys (fig 7). Most published sources (Simmons 1940s; Reid 1989, 6; Stidder 1990, 56) suggest that it was built on a pre-existing mill site some time in the early Victorian period up to 1867, the date cast on the iron pentrough. There are no later extensions. Its external dimensions are 10.85m long, 4.75m wide,

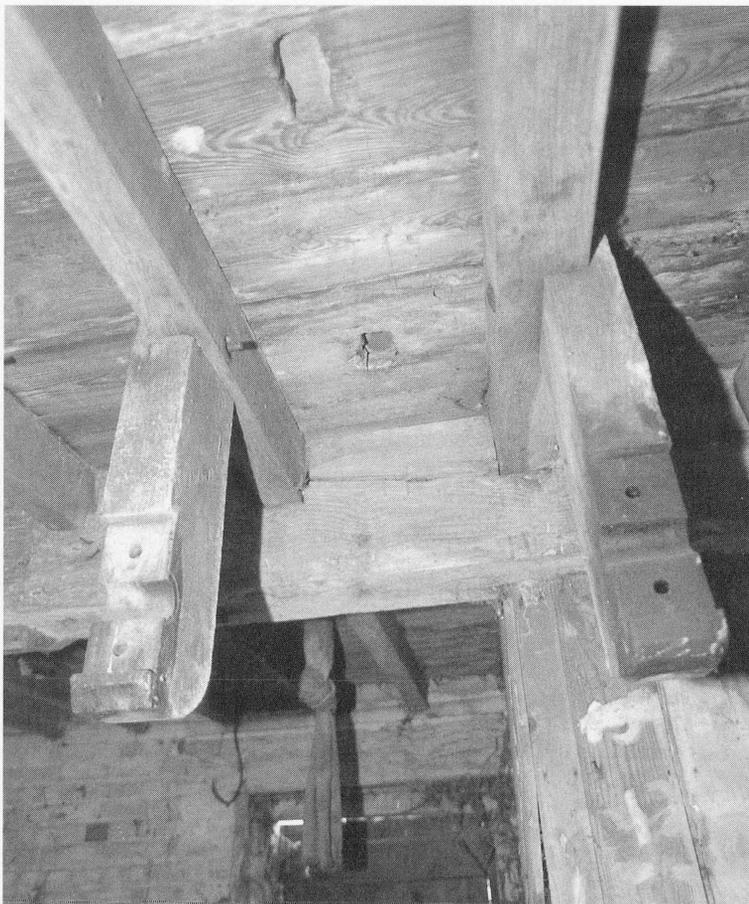
Fig 19 The pair of hanging posts on the stone floor of Paddington Mill, seen from below looking east. They supported in the grooves near their bottom ends, the lay shaft which operated the hoist mechanism. A pulley wheel turned between the posts and carried an endless rope which passed through the holes in the floorboards above and, when tight, drove a second wheel in the bin floor. Note also the tied twill sacking grain chute in the background (April 1996).

The principal clue to the mechanism for powering the hoist is provided by two vertical oil-stained timbers descending from neighbouring joists near the south-west corner of the stone floor (fig 19). These carried a horizontal lay-shaft across the mill, from the crown wheel, at the top of the upright shaft, to near the south wall. Between them would have been a wheel which carried an endless rope into the bin floor above. This wheel is lost but its position and diameter are indicated by two plugged holes in the floorboards, through which the rope must have passed. A second parallel wheel probably of about the same diameter would have been located immediately above in the bin floor, but this and its axle are also missing.

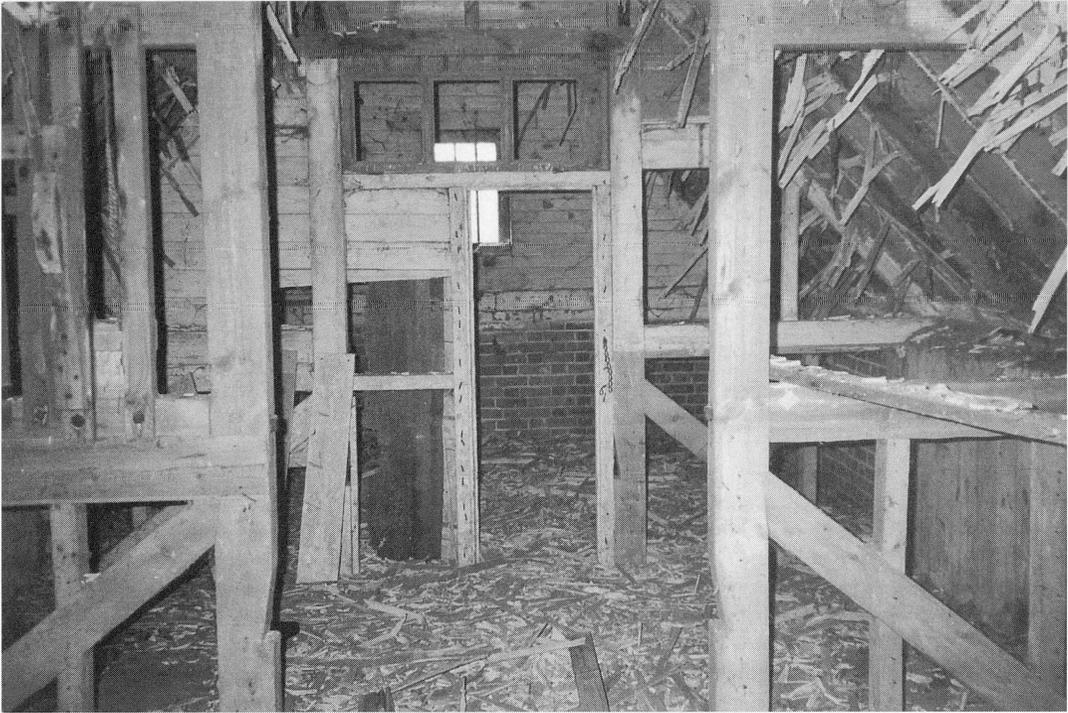
Fig 20 Photograph of the bin floor at Paddington Mill looking west. One of the interrupted tie-beam trusses is in the foreground and has notches in its posts which carried a beam to support a raised walkway. The additional posts at the left are part of the hoist control mechanism. The doorway and panels across the truss in the background were inserted after milling ceased (April 1996).

This floor (fig 20) housed the large bins used to store the grain. Its plan and principal sections are given in figures 14–16. The low side walls and the gable ends, which have small windows, are of brick. The roof has three open, interrupted tie-beam trusses (Brunskill 1985, 65, 136) dividing the space into four unequal bays and creating four compartments on either side of a central raised walkway which linked the windows. This walkway has been removed but its presence is clearly revealed by notches in the posts of the trusses, which supported beams, and holes in the end walls which supported joists and hence the raised floorboards. It enabled sacks of grain to be emptied into the bins without having to be lifted. However, it prevented high-level cross-beams from

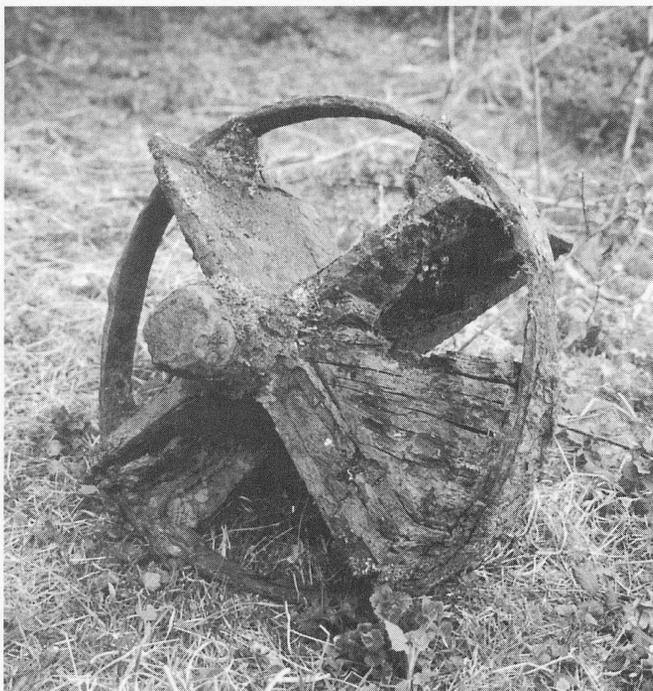
Fig 22 Photograph of the cross-head gudgeon found on the north bank of the wheel pit at Paddington Mill (May 1996).

A cross-head iron gudgeon or pivot, attached to the fragmentary remains of a timber shaft, rests on the north bank of the wheel pit. This gudgeon (fig 22) consists of a symmetric cross formed from two orthogonal iron plates, 25mm thick and 0.30m long, which were set into grooves cut into the end of the shaft. A spindle 0.12m long projects from this cross, and a circular iron band 0.51m in diameter and 50mm wide is attached to the plates. This would have encircled the end of the shaft. Three iron wedges are embedded in the small pieces of shaft which survive. Wedges were driven into the wood on either side of the arms of the cross to hold the pivot in place. The gudgeon could have been at the end of a timber waterwheel shaft which was replaced by the surviving iron shaft, presumably in 1867. Alternatively but, as discussed in the next section, less likely, it could have been one of the ends of the upright shaft which was probably removed shortly after the mill closed. In either case it is remarkable that it has remained on the site for so long.

Usually upright shafts are of timber, rather than iron, and it is almost certain that this was the case at Paddington Mill. Indeed, it is possible that the cross-head gudgeon discovered on the north bank of the wheel pit (fig 22) belonged to this shaft. However, if it did, its diameter would have been in excess of 0.51m, as these shafts are usually tapered at their ends. This is exceptionally big, the upright shaft at the much larger Shalford Mill, on the Tillingbourne near its confluence with the Wey (TQ 001 476), having for example a maximum diameter of 0.48m. It seems more likely therefore that the gudgeon came from an earlier waterwheel shaft. Upright shafts, being protected inside the mill, do not decay as rapidly as waterwheel shafts and it therefore seems likely that an earlier timber upright shaft was retained when the iron waterwheel shaft was installed. This has been assumed in figures 15 and 16 where a timber shaft 0.4m in diameter is shown.

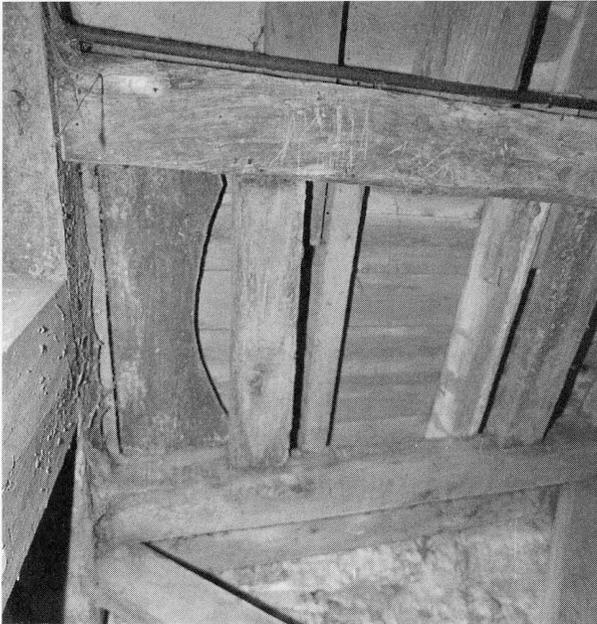
Fig 24 The section of the hurst frame at Paddington Mill which supported the bedstone of the eastern pair of millstones. The view is from below looking east. Note in particular the curved timber which helped to define the diameter and location of the stone (April 1996).

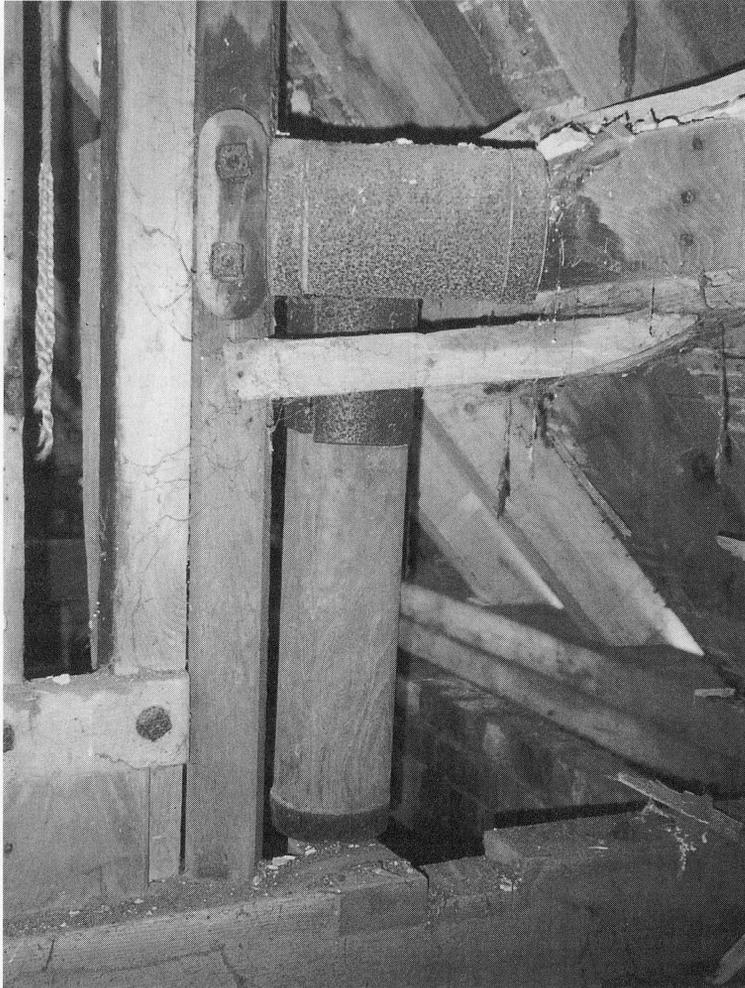
Fig 27 Photograph, looking south-east, of two of the three rollers on the bin floor at Paddington Mill which took the chain of the sack-hoist around a corner. The chain came down from the hoist pulley, under the horizontal roller, around the right side of the vertical roller, over a third roller which is missing and was then wound on a rotating drum (figure 26). Note the crude horizontal stick, just below the horizontal roller, which supported the chain if it sagged. It has a worn groove in its upper surface which indicates that this happened. Note also the frayed rope end at the top left which is all that remains of the control rope (April 1996).

side of the central truss of the roof structure (fig 27). As a sack was hoisted, the chain came down at an angle from its pulley, which was hanging from the ridge beam, around the underside of a surviving metal roller, oriented to be perpendicular to the chain, around the top iron-sheathed part of a surviving vertical timber roller, over a supporting 50mm diameter horizontal transverse roller, which is missing, and then horizontally, approximately parallel to the eaves, to be wound up on its drum. A smooth plank of wood is attached diagonally to the rafters between the pulley and the first horizontal roller and would have prevented the chain from fouling the sloping, plastered ceiling. Also, a small strip of wood is fixed horizontally just below the first roller to prevent the chain from dropping down if it became slack. The fact that this did indeed tend to happen is revealed by a perfectly located worn groove in the upper surface of the strip of wood (fig 27). As the working sections of the two surviving rollers are iron it is thought that a chain rather than a rope was used for the hoist and this has been assumed in the foregoing discussion.
