## **Three sites in Reigate: 12–14 London Road, 20–22 and 74–76 High Street**

DAVID WILLIAMS

### **12–14 London Road** (figs 1–6)

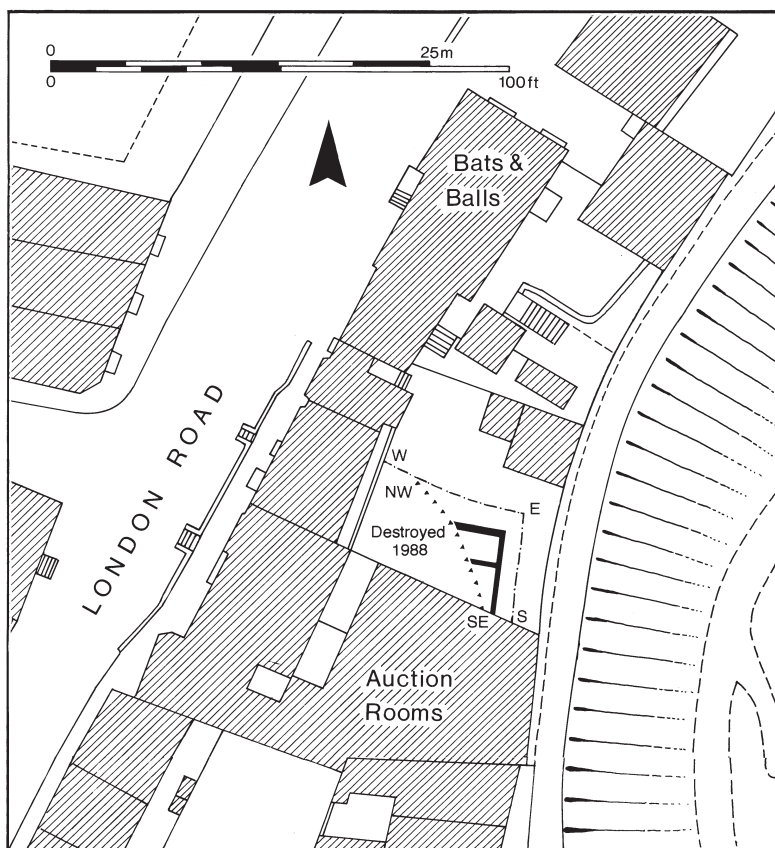
Fig 2 Three sites in Reigate. Area around 12–14 London Road showing the position of the excavated 17th century building and location of main sections. (© Crown copyright and/or database right. All rights reserved. Licence number 100014198)

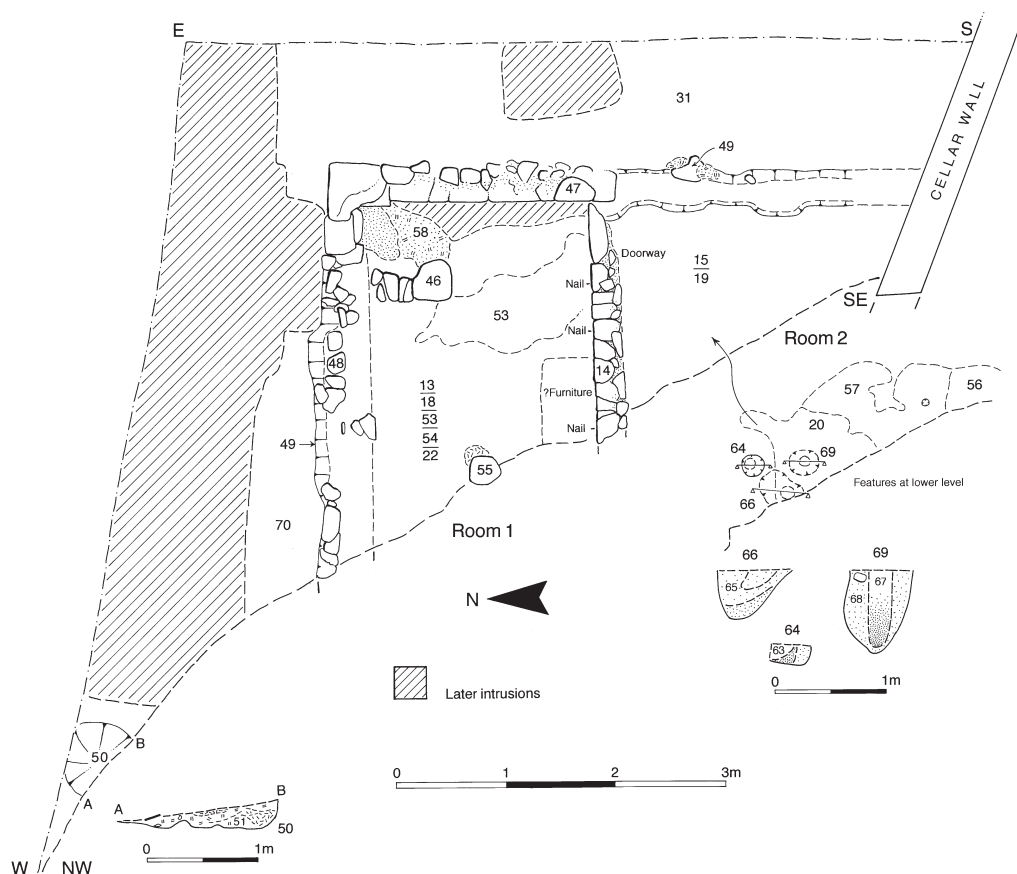
Fig 3 Three sites in Reigate: 12-14 London Road. Phase 2a and b.

At the base of the terrace, and in the area later occupied by room 2, were three postholes (69, 64 and 66). Posthole 69 was the deeper at 0.35m and this alone contained clear traces of a post-pipe filled with fibrous black matter. Sealing these features was a sequence of thin layers, the uppermost being an ashy spread (20), then a patch of mortar and stone chips (56), which in turn overlay a dark grey sandy layer (57). A layer of sand with chalk, clay and mortar fragments (24) lay beneath these above the natural sand. At the base of the deposits occupying room 1 was a spread of ash and chips of stone, mortar and lumps of chalk and clay (23) that may also belong to this sub-phase.

The surviving remains comprised the north-east corner of a building of which two rooms survived, along with a partition wall. Both north (48) and east (47) walls were originally built of stone set in a brown clayey mixture. Only that portion of the east wall from the surviving north-east corner of the building and extending south as far as the partition wall survived as a foundation. The original north wall and the remainder of the east wall had both been rebuilt at a later date. The partition wall (14) was of mortared stone with a line of bricks overlying its eastern end, indicating the site of a doorway. Within the internal angle formed by walls 47 and 48 was the base of a rectangular structure of mortared stone (46) set onto a ramping rectangular block of sandy clay (58).

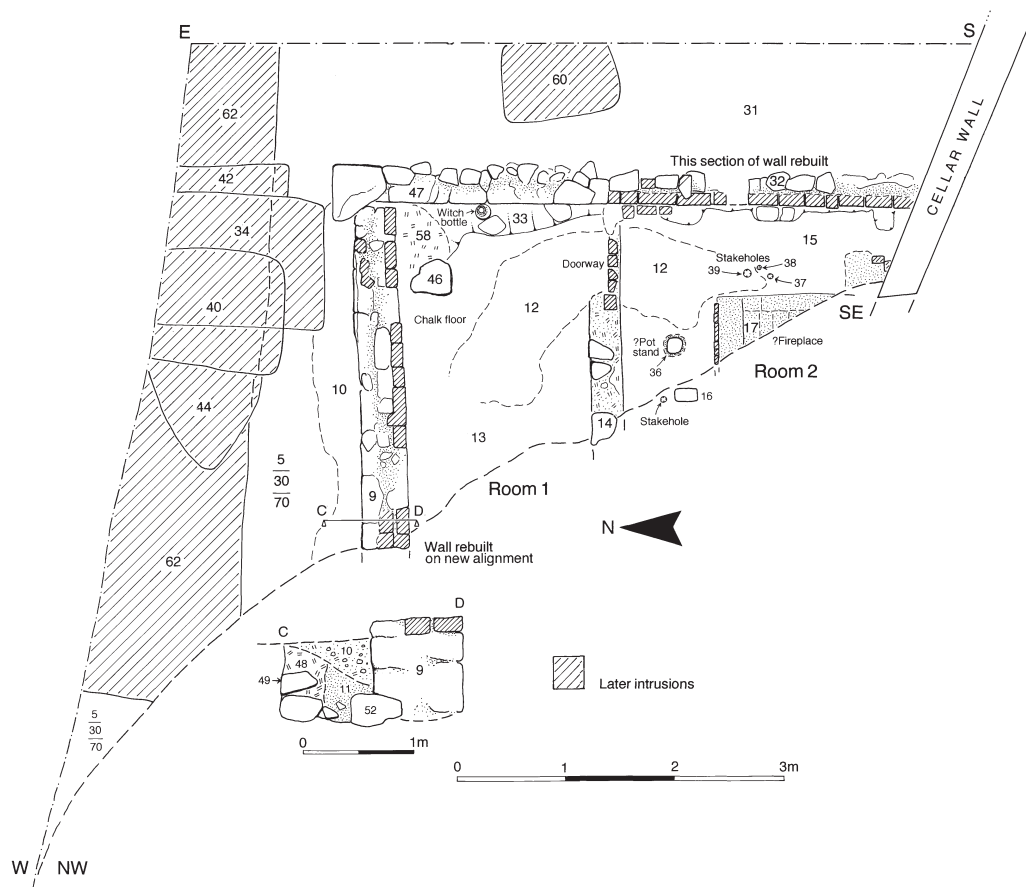
Fig 4 Three sites in Reigate: 12–14 London Road. Phase 2c.

At some stage after the laying of the chalk floor (13) both external walls of the building were rebuilt. The southern part of wall 47, beyond its junction with partition wall 14, was robbed out and rebuilt using brick (32), a socket being left at floor level to take the end of a beam supporting the partition wall. The north wall (48) was also completely robbed and rebuilt in brick on stone foundations (9) to a width of 0.4m but on a slightly different internal alignment and resting on the chalk floor (13). Both walls were faced with lime-washed plaster. Contexts (10) and (11) represent two phases in the filling of the resulting robber trench. The lower fill (11), comprised a line of stone blocks (52) running parallel with the rebuilt wall. Along the internal face of the eastern wall, slightly undercutting that wall and cutting the chalk floor, was an irregular linear hollow (33). This was deeper in room 1 and contained soil mixed with stone and brick rubble.

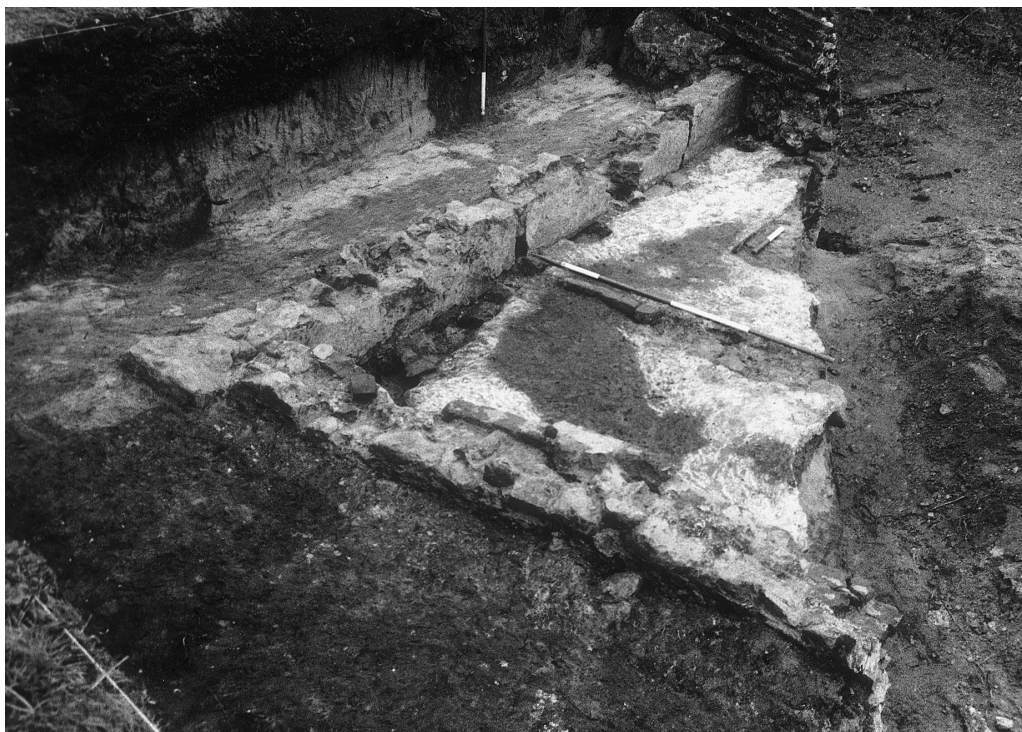
Fig 5 Three sites in Reigate: 12–14 London Road. Remains of the 17th century building. Shown here is Phase 2c.

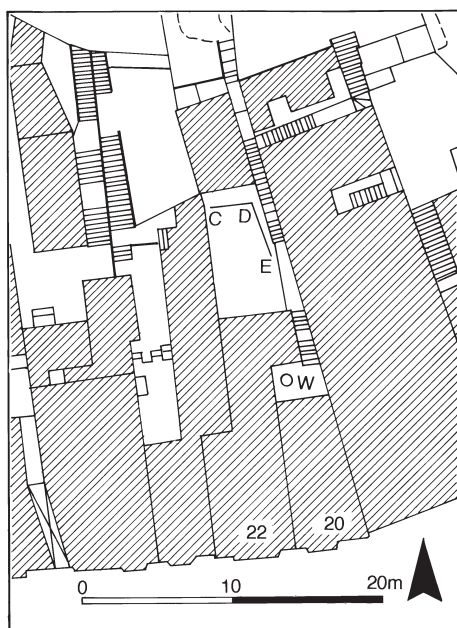
Fig 7 Three sites in Reigate. Area around 20–22 High Street showing location of section CDE and the well.  
(© Crown copyright and/or database right. All rights reserved. Licence number 100014198)

The northern edge of the well lay some 2.5m behind the timber frame of no 20. The well shaft had been dug into a hard deposit of silver sand and, below ground level, had not been lined. At the top of the shaft was a ledge which supported three remaining curved stone blocks (0.54 x 0.33 x 0.19m) bonded with red/brown clay. The well was filled with sand which contained fragments of sandstone and brick and no attempt could be made to excavate it. From the use of clay as a bonding material, which seems common in Reigate in the 16th

Behind the building two sections (fig 7) were exposed; an east–west section and, at right-angles to it, a second, less well-preserved section was exposed below the steps leading up to the garden. Over 1.5m of deposits were exposed in the east–west section. In ascending order the more substantial layers comprised: the natural silver sand (17); brown and grey sands (6–9), and a charcoal deposit (11). Contexts 6 and 7 were not clearly differentiated and yielded a small amount of medieval pottery. Above these was a layer of fragments of sandstone and ironstone and fewer fragments of Upper Greensand (5) and a substantial deposit, 0.7m deep, of yellow sand with a few ironstone fragments (4). Both were sterile of finds. The latter layer was cut by a 19th century brick structure (2–3) above which was garden soil (1). In the second section, two east–west horizontal cuts or terraces were observed. Above these was a grey sandy soil which probably equates with contexts 6 and 7. Contexts 12–16 were minor lenses of chalky mortar, sand and tile. A pocket of yellow sand above these deposits may represent the base of context 4.

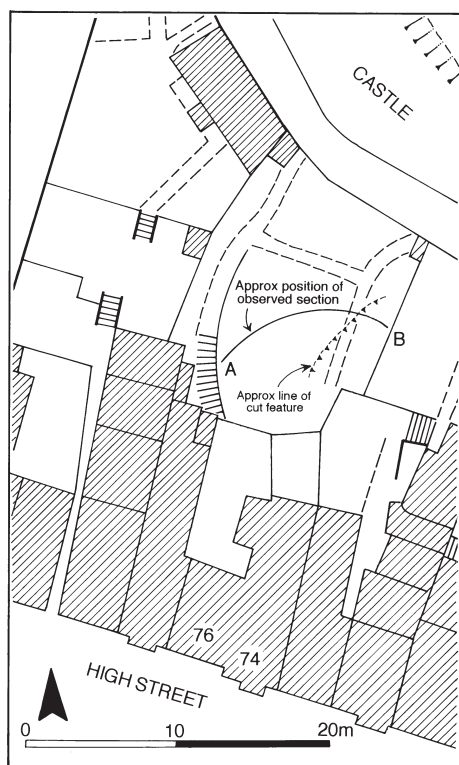
Fig 9 Three sites in Reigate. Area around 74–6 High Street showing location of observed section AB and position of edge of possible sand quarry. (© Crown copyright and/or database right. All rights reserved. Licence number 100014198)

The construction of an extension resulted in the unintentional creation, through landslip, of a semi-circular section through the slope behind the property and which extended across the width of the tenement. The circumstances surrounding the limited archaeological work which was possible on this site in 1998 have been published elsewhere (Williams 1998). As a result of the short time available, wet weather and the danger of subsidence and other peculiar difficulties of this site no formal recording was possible. A 19th century stone and brick oven that had been built into the slope adjacent to the eastern boundary of the property was destroyed without record as was a substantial revetment wall which lay just to the rear of the property. This was constructed, at least in part, of mortared re-used stone, and was probably built not later than the 16th or 17th century.

The exposed U-shaped section (fig 13, AB) was briefly examined from extendable ladders but could not be drawn. Below the topsoil (1) was a substantial deposit of loose yellow sand and broken sandstone (2). This was less than 1m deep on the west of the site but dropped to more than 4m deep on the east. This disparity in depth was because of a vertical cut (3) in the underlying natural silver sand. On the west half of the site between the dumped sand (2) and the natural silver sand (7) was a layer of grey sandy soil (6) that contained a number of well-preserved flint blades of late Mesolithic date as well as a few fragments of bone and 13th century pottery. At the base of the deeper level of sand on the east of the site was a dense layer of broken sandstone fragments (Lower Greensand) (4), which overlay a layer of grey clay mixed with chalk fragments (5) that contained pieces of Reigate stone (Upper Greensand), roof tile and sherds of 13th century pottery. The surface of this layer, which could not be examined further, was roughly level with the ground floor of the building and also with the street pavement.

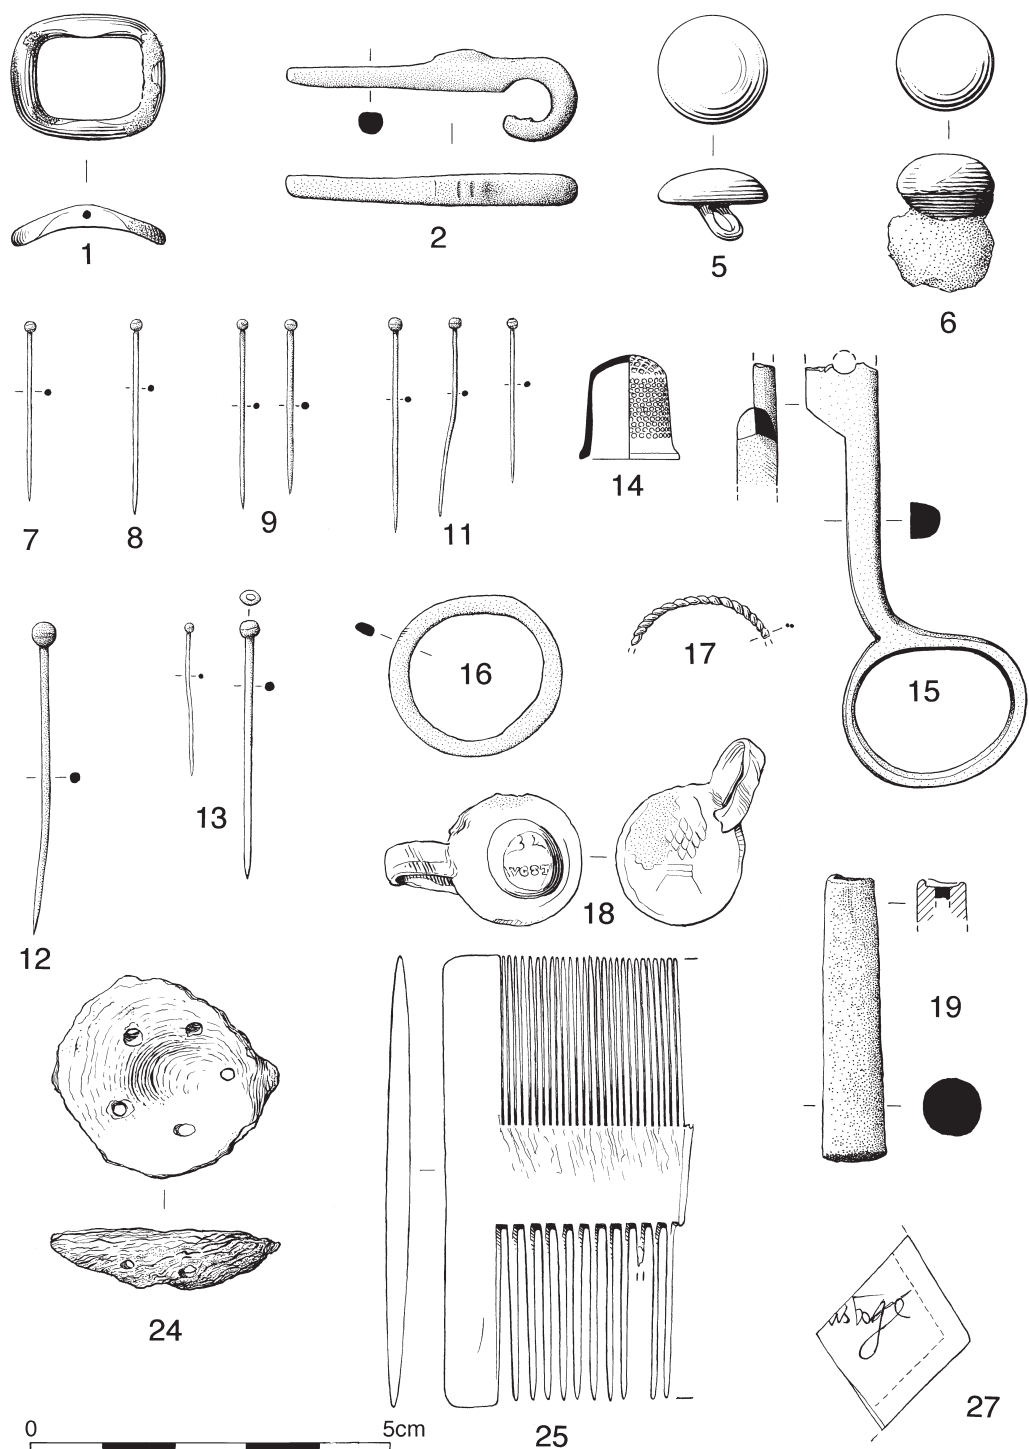
Fig 10 Three sites in Reigate: 12-14 London Road. Small finds of copper alloy, lead and pewter, bone, shell and glass from Phase 2. Scale 1:2.

- 1 Shoe or breech buckle with central pivot hole.

- 21 x 17mm. This type dates to the second half of the 17th century. Context 10. Phase 2C. SF27.
- 2 Pin from an annular brooch of late medieval date. Length 41mm. Context 18. Phase 2B. SF28.
- 3 Buckle pin. 15mm long. Context 13. SF29. NI
- 4 Lace tag. 31mm long. Context 18. Phase 2B. SF110. NI
- 5 Button, tinned with domed head. Diam 15mm. Context 33. Phase 2C. SF111.
- 6 Button, globular with iron shank. Diam 13mm. Context 30. Phase 2B. SF25.
- 7 Pin. 25mm long. Context 58. Phase 2B. SF43.
- 8 Pin. 26mm long. Context 12. Phase 2B. SF42.
- 9 Pins. 24 and 26mm long. Context 54. Phase 2B. SF47–8.
- 10 Pins. Lengths 24, 24 and 30mm. Context 8. Phase 2C. SF29–41. NI
- 11 Pins. Lengths 23, 28, 30mm. Context 33. Phase 2B. SF36–8.
- 12 Pin. Length 43mm. Context 19. SF108.
- 13 Pins. Lengths 22, 23, 21, 24 (x3), 25 (x6), 26, 30,

- 31mm. Context 18. Phase 2B. SF 45-6, 49-60, 33-4. Two are illustrated.
- 14 Thimble. Height 15mm, max diam 14mm. Context 31 (intrusive). SF21.
- 15 Handle and part of the blade from a pair of scissors. 60mm long. Context 33. Phase 2C. SF18.
- 16 Ring. Diam 24mm. Context 13. Phase 2B. SF22.
- 17 Fragment of twisted wire forming an arc  $\approx$  20mm diam. Context 18. SF112.

- 18 Cloth seal, by G Egan  
Seal from an Augsburg fustian (mixed linen/cotton fabric); pinecone on stand (city arms) // part of ox passant with (A)UGS (BVRG) on the body. Augsburg seals, of various kinds, are the most common and widespread imports in England. This example is probably of early 17th century date. Context 31 (intrusive).

- 19 Lead weight, perhaps for a clock. A tapering lead cylinder with remains of an iron suspension loop in the narrow end. Length 77mm. Context 18. SF64.
- 20 Musket ball. Diam 19mm. Context 18. SF65. NI.
- 21 Flattened sub-oval object.  $\approx$  30 x 40mm. Context 33. SF66. NI.
- 22 Solidified runnel of lead. Length 50mm. Context 12. SF67. NI.
- 23 Large fragment of lead flashing, bent and with an attached iron nail. Max width 132mm. Context 18. SF70. NI.

- 24 Oyster shell, with five drilled circular holes. Presumably this was intended for use as a crude strainer. Context 18. SF82.
- 25 Fragment of double-sided bone comb. Context 31 (intrusive). SF82.

- 27 Fragment from the right side of a diamond-shaped pane on which is engraved a word in script. This appears to read '...astage', although the first surviving letter may be an 'o'. The fragment is tantalising but incomprehensible. Context 22. SF83.

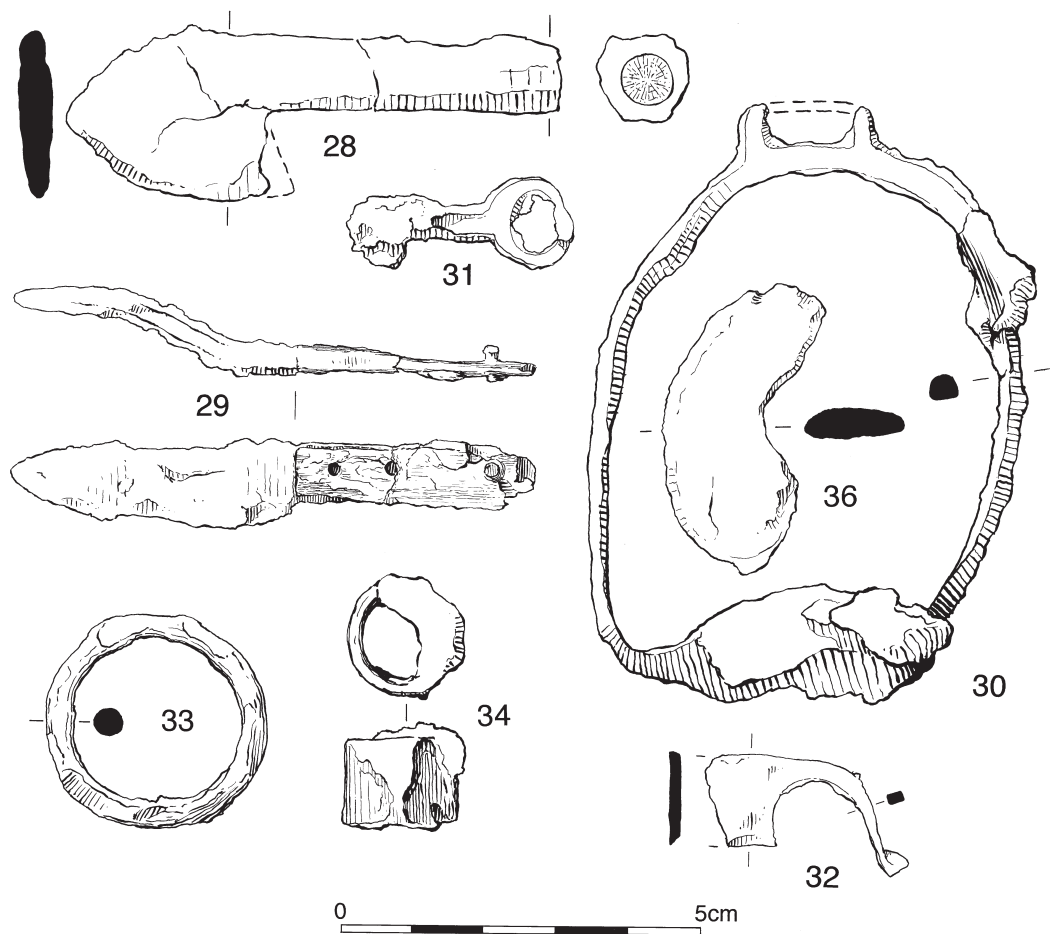
Fig 11 Three sites in Reigate: 12-14 London Road. Small finds of iron from Phase 2. Scale 1:2.

- 28 Cutting tool, with a barbed blade and remains of wooden handle still in the socket. Possibly used for leather working. Length *c*140mm, socket diam *c*140mm. Context 22. SF91
- 29 Scale-tang knife with remains of a horn handle originally held in place with three rivets. Length 145mm. Context 22. SF95.
- 30 Stirrup. Although now bent this stirrup appears

very similar in shape to those of Civil War date from Beeston Castle, Cheshire (Keen & Hough 1993, fig 99, nos 124-8). Original length *c*160mm, original width *c*140mm. Recorded as coming from the base of context 8 but is probably from the surface of context 33 below it. SF88.

- 31 Key. Length 60mm. Context 33. SF89.
- 32 Part of a blade or perhaps a strike-a-light (cf an example from Westbury, Milton Keynes (Ivens *et al* 1995, fig 170, 99)). Context 33. SF90.
- 33 Ring, perhaps for harness. Diam 62mm. Context 33. SF86.
- 34 Cylinder, perhaps a door or window pivot. Length 25mm, dia 32mm. Context 48/25. SF87.
- 35 Rectangular buckle with central dividing bar. 30 x 30mm. Context 18. SF92. NI.
- 36 Oxshoe. Length 85mm. Context 22/19. SF93.
- 37 Fragment of thick corroded sheet, perhaps a spade blade or object of similar weight. Context 53. SF94. NI.

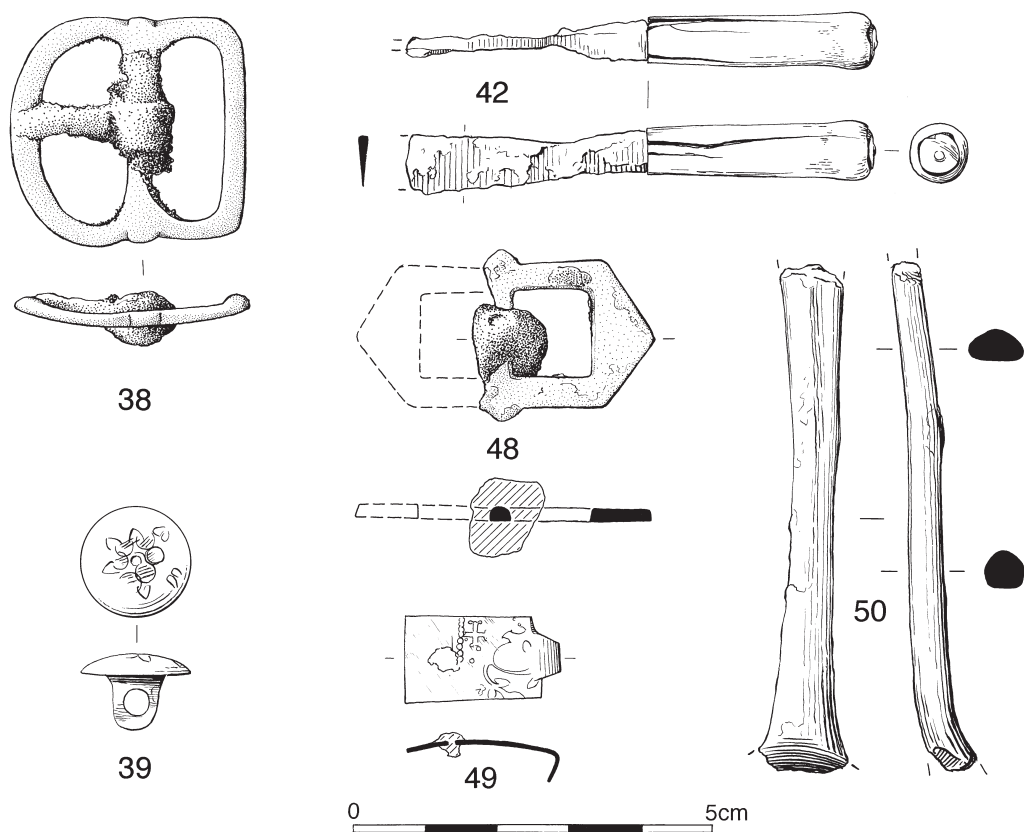
Fig 12 Three sites in Reigate: 12-14 London Road. Small finds from Phases 3 and 4. Scale 1:2.

- 38 Belt buckle, D-shaped. Copper alloy with iron pin pivoting on central bar. Traces of leather remain on the iron pin. 30 x 33mm. SF26.
- 39 Domed copper-alloy button with punched floral decoration. Diam 15mm. SF109.

- 42 Knife. Fragmentary iron blade with cylindrical bone handle and separate bone plug. A number of examples of this type of knife with separate plugs are illustrated in Mynard & Zeepvat 1992 (fig 92, nos 280–2). Surviving length 129mm. Length of handle 62mm. SF80.

- 48 Buckle fragment, copper alloy, possibly with a white metal coating, and remains of an iron pin. Width originally c 42mm. This is a common mid-17th century type often classed as a spur buckle. Context 5. SF107.
- 49 Book clasp, copper alloy. Punched pattern of floral elements, and a cross bordered on one side with pellets. Length 22mm. Probably 18th century. Context 5. SF19.
- 50 Spoon handle, pewter. Length 68mm. Context 5. SF61.
- 51 Fragment of double-sided bone comb. Width 62mm. Context 5. SF81. NI

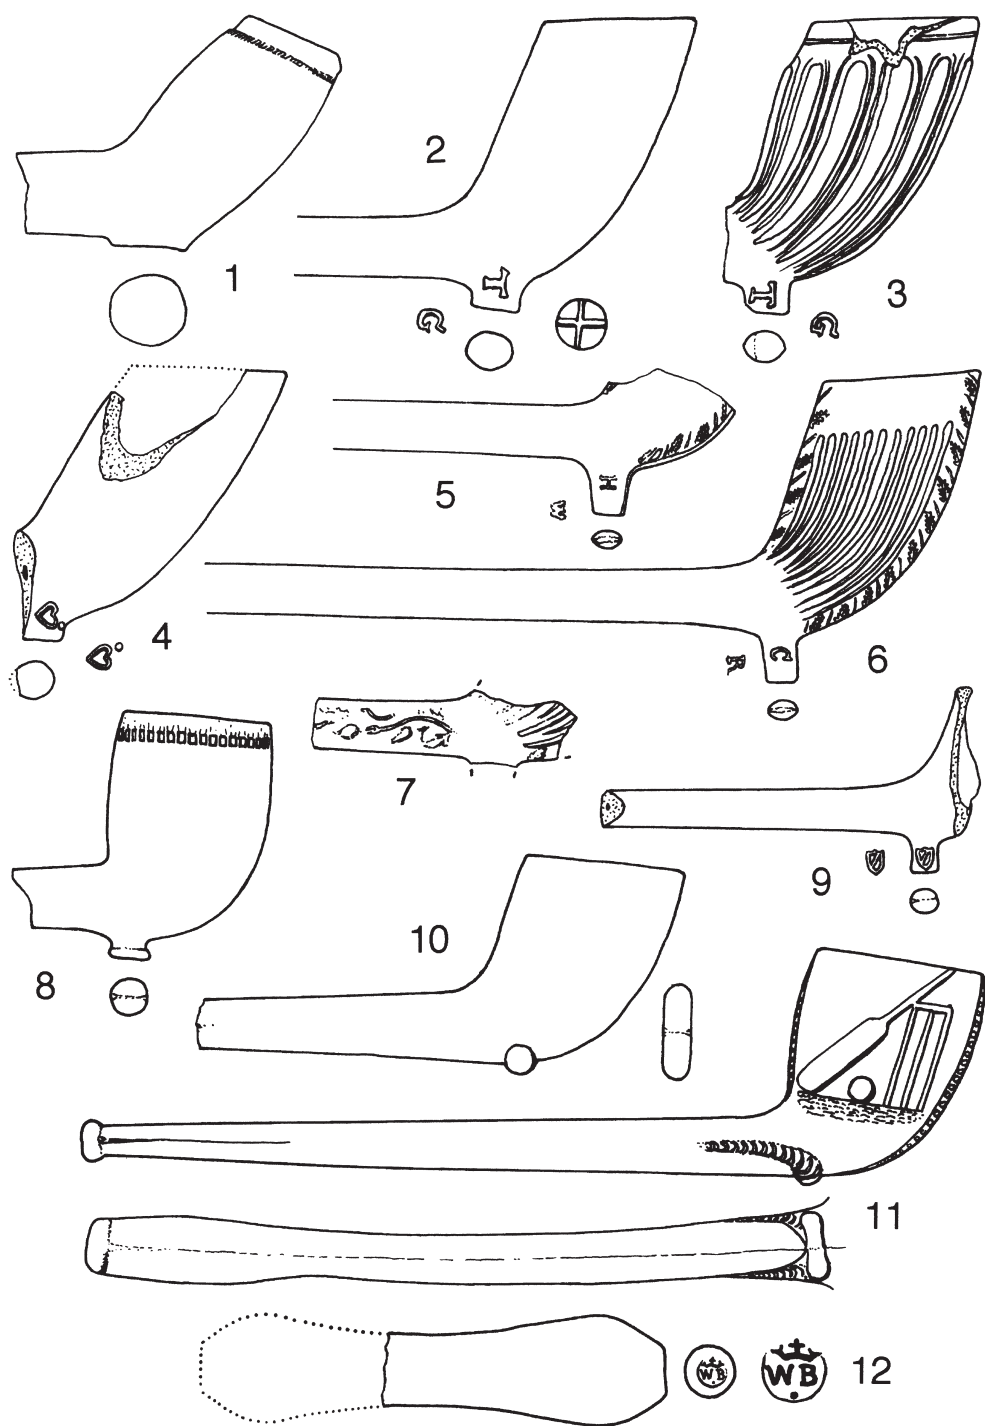
Fig 13 Three sites in Reigate: 12-14 London Road. Clay tobacco pipes and hair curler. Scale 1:1 with hair curler stamp detail at 2:1.

The 1992 excavations in London Road, Reigate produced one hair curler and 245 fragments of clay tobacco pipe comprising 70 bowl, 172 stem and three mouthpiece fragments. The full report on the clay tobacco pipes and hair curler is available on the ADS website (see *Endnote*)

- 1 Complete bowl of c 1660–80 with an extremely glossy surface. Context 30.
- 2 Bowl of c 1720–70 with the moulded initials 'GT' for George Thornton of Dorking. Context 8.

- 3 Bowl of c 1760–1800 with fluted decoration and the relief moulded initials 'GT'. Context 31.
- 4 Fragmentary bowl of c 1750–90 with relief moulded hearts and dots on each side of the heel. Context 61.

- 5 Bowl fragment of c 1800–50 with large but fairly crudely executed leaves on the seams and small, faintly moulded maker's initials 'WH' on the spur. Context 5.

- 6 Complete bowl and joining stem fragment of c 1810–80. Context 41.
- 7 Fragment, dating from c 1820–50. Context 5.
- 8 Bowl of c 1870–1920 with a 'button' heel and moulded milling at the rim. Unstratified.

- 9 Fragment of a very delicate pipe of c 1870–1920. Context ?41.
- 10 Bowl of c 1870–1920 with a wide cylindrical rest, shown in plan. Context ?41.
- 11 Complete pipe with a cricket bat, ball and stumps on each side of the bowl, c 1870–1920. Unstratified.

- 12 Hair curler made of pipe clay and with an incuse stamp comprising the crowned initials 'WB' on the surviving end.

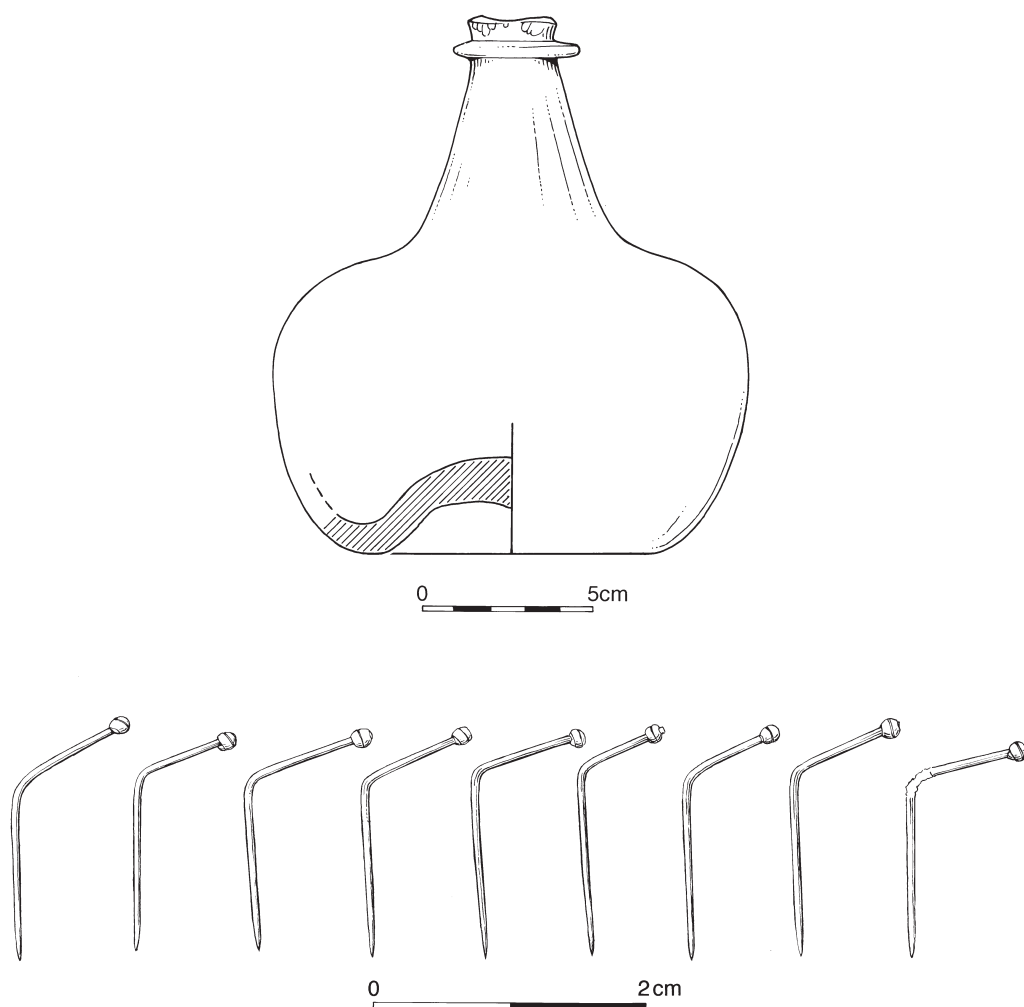
Fig 14 Three sites in Reigate: 12–14 London Road. Glass bottle used as a ‘witch bottle’ with contents of bent pins.

A complete glass wine bottle was found in context 33, upturned, corked and still containing liquid. The bottle form dates to the last two decades of the 17th century (Dumbrell 1983, pl 10, shows two sealed bottles, dated 1684 and 1690, both very similar to that from London Road). The context which contained the bottle was a shallow trench of unknown purpose that ran along the inside of the east wall of room 1. This feature also contained thirteen pottery sherds of which two are of white stoneware from Staffordshire. This first appears about 1720 (Jennings 1981, 222). The feature does not allow closer dating but it may be suggested that the bottle was between 30 and 50 years

The bottle was half full of liquid when found and its use as a witch bottle was not immediately suspected. To test whether the liquid was wine the contents were examined. Upon first piercing the cork considerable pressure was released and a sample of liquid was then injected onto a gas chromatography column. The resultant analysis showed that alcohol was present only in a minute quantity (less than 0.02% vol) and that the, more or less, colourless liquid was therefore not alcohol based or similar. Following this test the cork was removed and the contents strained. This resulted in the recovery of nine bent pins. A sample of the liquid was then analysed for the presence of urea: none appeared to be present.

Following the publication of a note on the bottle (Williams 1997) the liquid contents were further analysed by Dr Alan Massey, who conclusively identified the liquid as urine (Massey 2000). A fuller report on the contents will be published elsewhere.

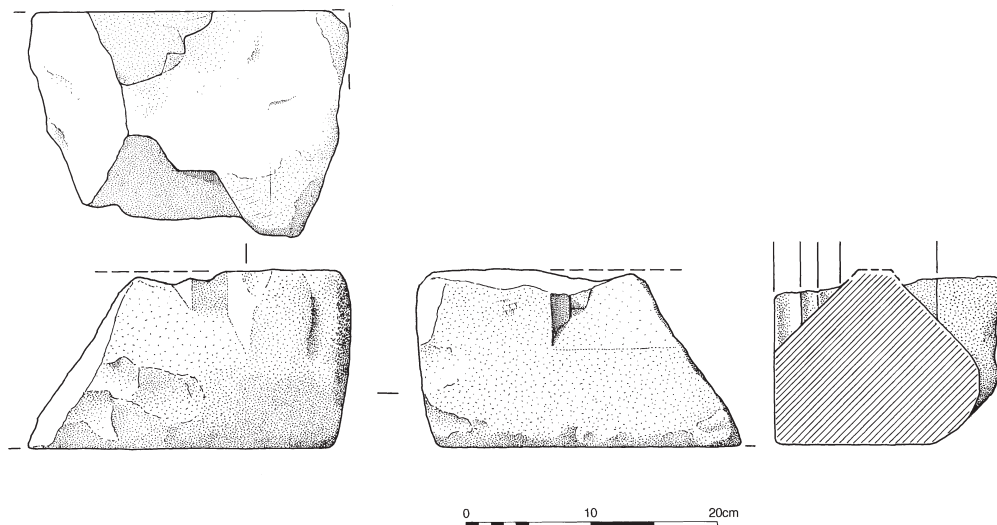
Fig 15 Three sites in Reigate: 12–14 London Road. Architectural fragment.

Dressed block of Upper Greensand forming the sill or perhaps an upper corner of a window. The rough and worn surface on one side suggests external weathering. Patches of mortar adhere to broken edges at a number of points, suggesting an earlier re-use as rubble. Despite the damage it is clear, by extending the surviving dressed face, that a groove in which a leaded window could be inserted is absent. This suggests an origin in a late medieval building, perhaps one equipped with wooden shutters. This fragment may have come from an imposing building within the town rather than the castle or priory. Context 52. Phase 2. SF103.

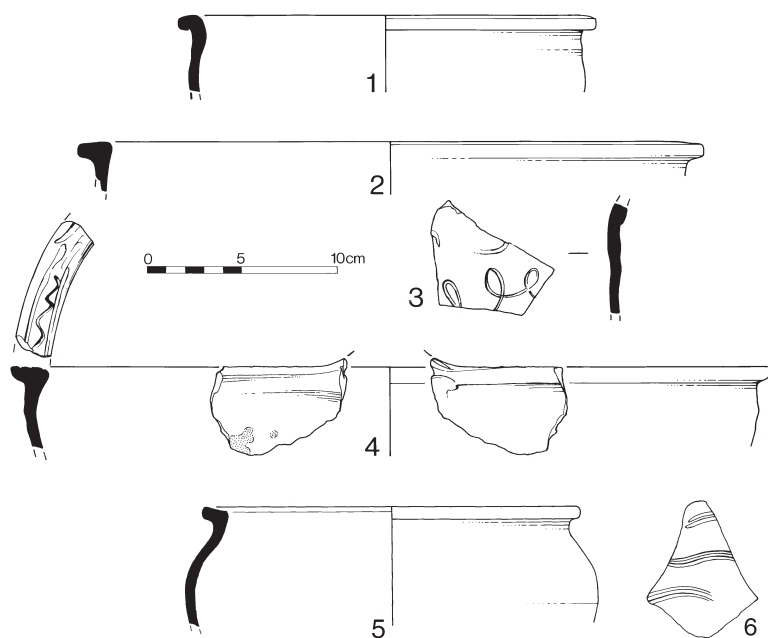
Fig 16 Three sites in Reigate: 20–22 and 74–76 High Street. Medieval pottery.

- 1 Cooking pot or jar. Orange buff ware with grey core and medium sand temper.
- 2 ?Bowl. Orange/pink ware. Fine sand temper.
- 3 Jug. Body sherd probably from near the lower handle attachment. Dark green glaze over white slip and looping sgraffito decoration. Fine sand temper.
- 4 ?Bowl. Rim with incised decoration, yellow glaze on interior and attachment for a horizontal handle.

- 5 Cooking pot or jar. Dark grey ware. Medium to coarse sand temper.
- 6 Jug. Body sherd. Buff/brown surfaces with a dark grey core. Incised wavy line decoration using a two-pronged implement.
