# The archaeological evidence for the route of Stane Street from Mickleham Downs to London Road, Ewell

ALAN HALL

*Stane Street between Mickleham Downs and Thirty Acres Barn, Ashtead is a good example of a surviving Roman road. The visible remains are so well preserved that this whole section is a Scheduled Monument that has been the subject of attention by a number of researchers over the years. The author's work, while leading a team from Surrey Archaeological Society's Roman Studies Group, revealed that there was a body of archive material that had not been published and which contained much of interest. This paper incorporates photographs and details from past excavations, aerial photographs, evidence for the use of the plough in the construction of the road, evidence for side ditches, an analysis of alignments, a suggestion as to the survey procedure originally employed, a possible source for the metalling of the Pebble Lane section and conclusions concerning the width of the road. The very clear surviving remains of the road running north-eastwards cease entirely at Thirty Acres Barn, Ashtead and the ensuing route towards the Roman settlement at Ewell has been the subject of

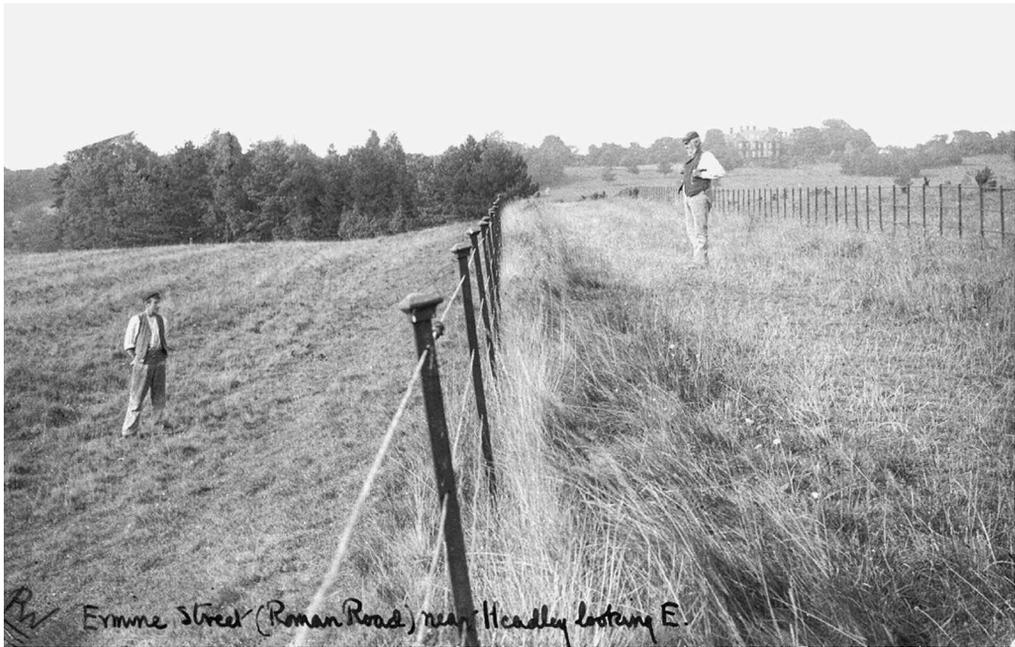
Fig 2 Stane Street. Tyrrell's Wood: 1905 photograph of embanked terrace.

In Surrey, Stane Street has largely gone out of use as a road, remaining in a few places only as a bridle path, although parts of it seem to have continued in use as a major route until the Middle Ages. The Mickleham Downs to Dorking section of the road (fig 1) was in use in the 14th century when it was cited in a deed as 'the royal road from Dorking to London' (Leatherhead Deeds 1307, Part VII, 260). The section to the south of Ashtead (Pebble Lane) was known as Pybylstret in 1358 (Gover *et al* 1934, 81) and the whole of this alignment was known as Ermine Street in Victorian times (fig 2: see handwritten caption to a contemporary photograph).

pebbles laid directly on the chalk (Poulton & O'Connell 1984, 289). In order to achieve this height, the land had been artificially raised as an embanked terrace to create a level way when the road was laid out and a 1905 photograph (fig 2) indicates that, in part at least, it stood at a height of *c* 2m above the adjacent land. Unfortunately, the ground immediately to the west (which is not shown in the section drawing) had been subject to illegal 'fly tipping' in 1988–90 that has artificially raised the level of the surrounding surface, thereby disguising the height of the embanked terrace (David Bird, pers comm). It would seem likely that the material from which the embankment is formed was taken from cutting the terrace to the south.

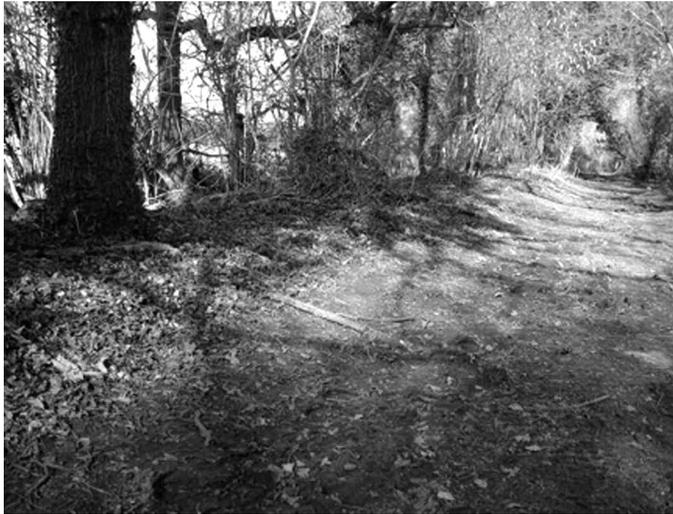
Fig 3 Stane Street. Tyrrell's Wood: degraded agger at TQ 1900 5585.

The embankment runs for approximately 500m before descending 20m to the east–west valley of Mill Way, after which the route climbs again steeply up a hollow-way to regain the previous elevation. Hereafter, the remains of the road lie immediately under the present-day bridle path. The road is much degraded (fig 3) and the remains consist of occasional raised earthworks. What appears from its profile to be the western side of the agger can be seen in the wooded margin of the rear garden of Rose Cottage at the entrance to the Golf Club (TQ 1805 5548). Similar portions of cut terraces and an apparent western edge together with traces of possible pebble metalling can be seen as far as Headley Road, notably where groundwork has recently been undertaken for an electricity sub-station to the east of Rose Cottage.

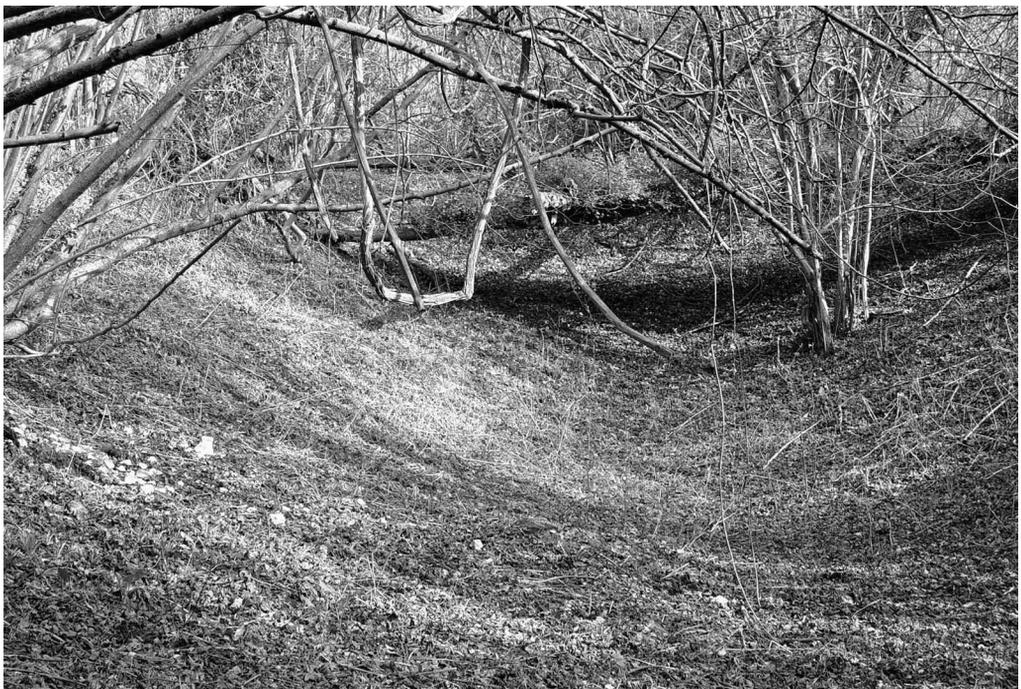
Fig 4 Stane Street. Tyrrell's Wood: roadside extraction pit.

Immediately to the north of the crossing of the driveway to the golf club there is an ancient quarry pit adjacent to the road on its eastern edge (fig 4). This contains at its base water-washed pebbles from the Reading Beds of the type seen as metalling by Poulton & O'Connell (1984) and which are visible within the surface of the road throughout this alignment. Without excavated evidence of a Roman date for the quarry there can be no certainty that this is a source of metalling for the road but, as there does not appear to be any other indication of quarrying located conveniently to the road, it must be a strong candidate.

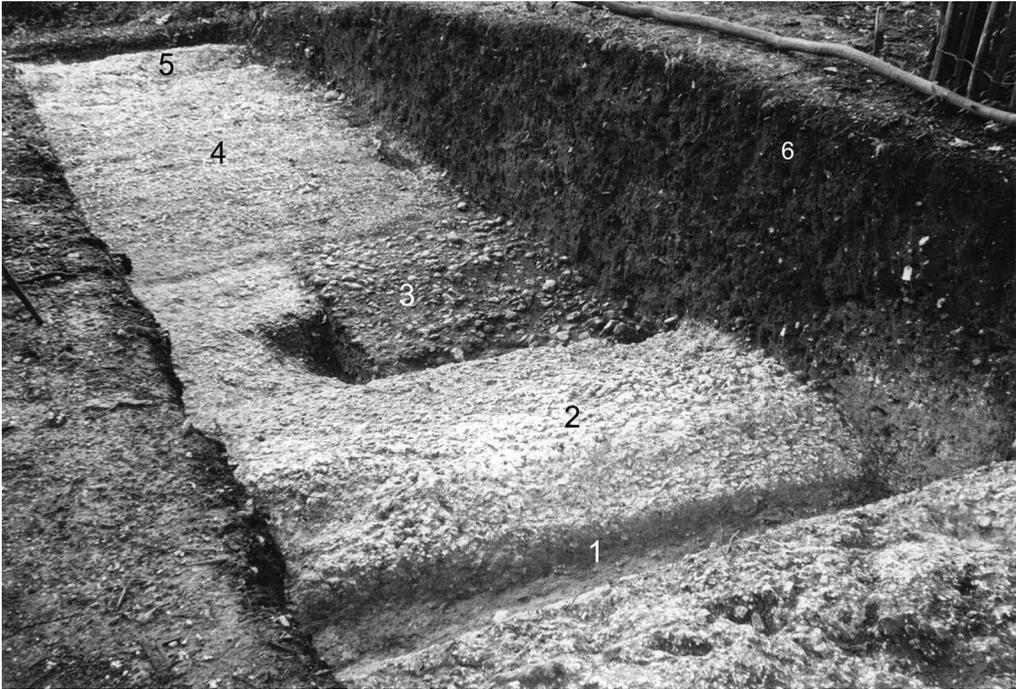
Fig 6 Stane Street. Ashted, M25 crossing: photograph of the excavation. (Photograph: Rosamond Hanworth)

The road metalling, which lay at a depth of 1m below the ground surface, was contained within two parallel chalk berms. The uphill berm had been left undisturbed in the cutting of an uphill drainage ditch and both berms had been surfaced with medium-size stones to form kerbs. Between the kerbs a metalling of small stones had been laid of which only a 3m-wide section remained *in situ*, the remainder having been removed and incorporated into the overlying boundary bank. The road was *c.* 6m wide from kerb to kerb; the features described are illustrated in figure 5 and are clearly visible in a contemporary photograph (fig 6).

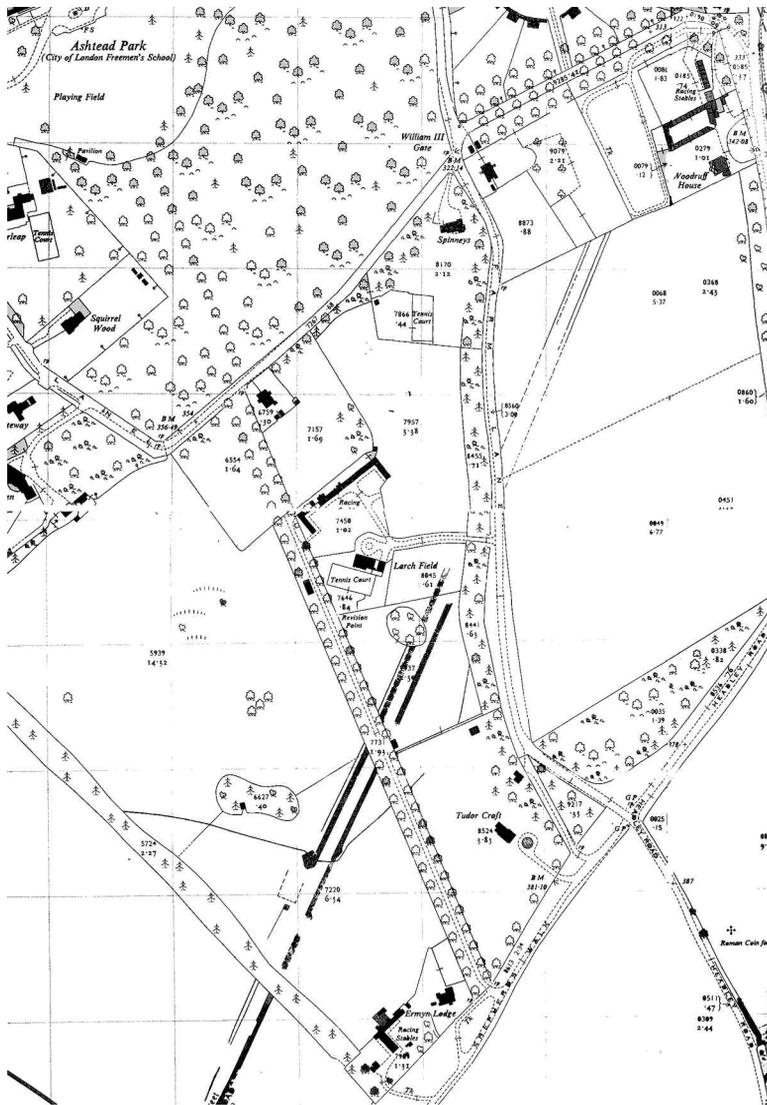
Fig 7 Stane Street. Ashted: Hampton's transcription of aerial photographs. (© Crown Copyright Ordnance Survey. All rights reserved)

Aerial photographs taken by John Hampton in September 1975, at the end of a long dry summer, show parch-marks apparently of side-ditches at two further points in the alignment (NMR: 884/346 and 886/301); Hampton's transcription is reproduced as figure 7 but his analysis questions the nature of the ditches. He calculates that each ditch measures some 13 feet (4m) across with a width of 29 feet (8.8m) between the inner edges of the marks and

suggests that they may be connected with marking out the road (Hampton 1977, 26). Another possibility is that they were quarries bounding an agger constructed from their material.

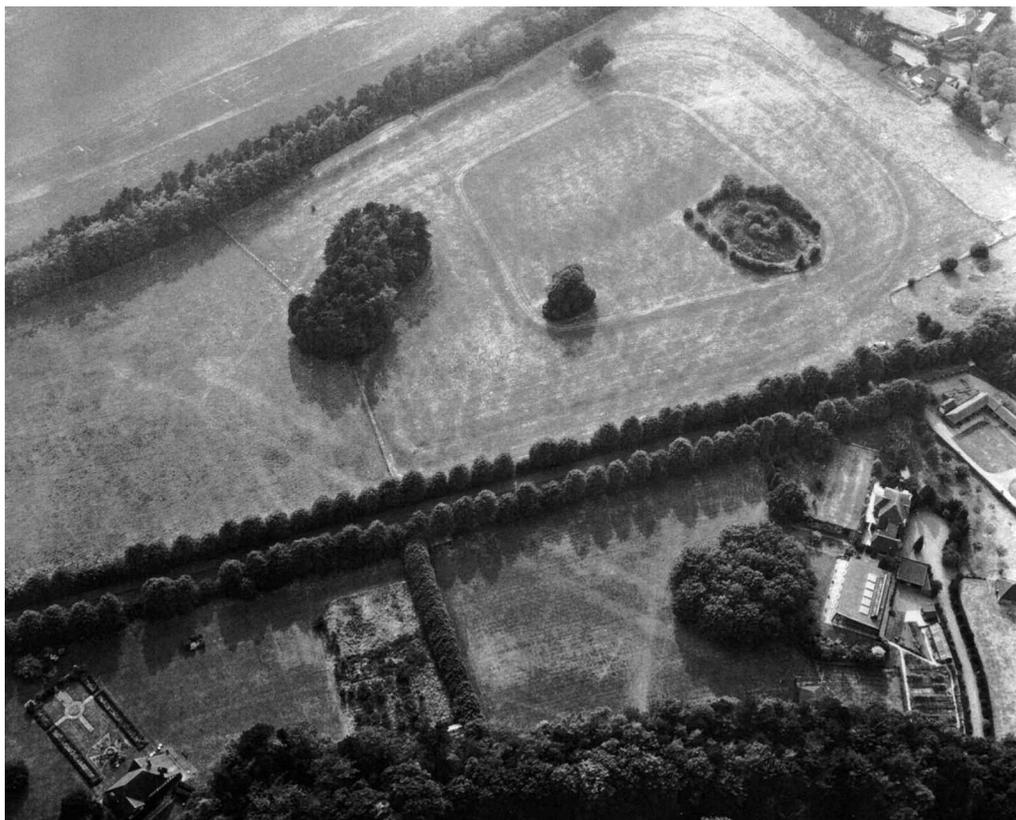
Fig 8 Stane Street. Ashtead, Tudor Croft: parallel parch marks of side ditches.

An aerial photograph taken over Tudor Croft (fig 8), shows the road most clearly and Hampton noted that the alignment of the road had shifted by  $1^\circ$  to the west at *c* TQ 1940 5680. This was the first occasion on which such minor alignment changes had been noted in this section of the road, suggesting that the continuing route into Ewell might not be as described by Winbolt.

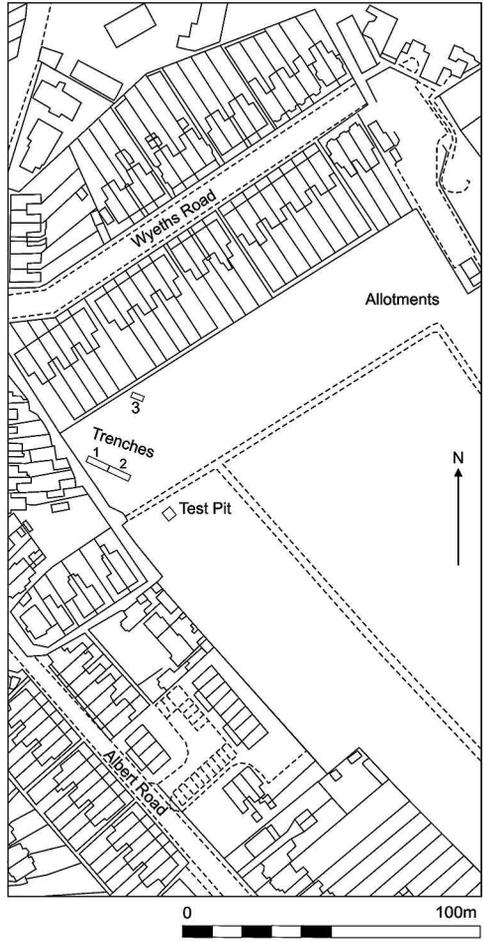
Fig 9 Stane Street. Epsom, Albert Road allotments: location of trenches. (© Crown Copyright Ordnance Survey. All rights reserved)

A further trench (trench 3) was opened 30m to the north-east and on the projected alignment (fig 9). This revealed a similar stratigraphy, with a flat layer of large packed flints at the same level below the surface as those in trenches 1 and 2, but extending across the projected width of the road for only 0.9m as it had been severely truncated at either end by two 19th century pits. The position and length of the trenches did not permit a search for side ditches or the western edge of a road so, in order to prove that the flint layers were not natural, a 1 x 1m test pit was excavated 30m away from the postulated line of the road. This revealed a 0.3m topsoil layer overlying a clean mid-brown sandy soil to a depth of 1.5m and containing only eight small pieces of frost-fractured flint. Beneath this was the natural weathered chalk. Therefore, the substantial flint layers in trenches 1 to 3 are probably the remains of Stane Street lying on the line predicted by Margary.

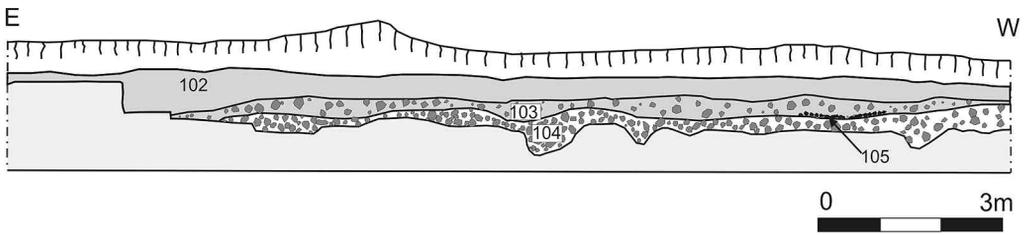
Fig 10 Stane Street. Epsom, Albert Road allotments: section of trench 1.

Beneath the topsoil, excavation revealed layers of sandy soil, which presumably originated from the adjacent Thanet Beds. At a depth of 0.8m the sandy soil contained abundant small flints of which approximately 1.5m<sup>3</sup> were removed. As these do not occur naturally in the sands they must have been brought in from elsewhere. Also within this layer were found two residual sherds of 4th century Alice Holt greyware pottery.

At 0.95m below ground level a layer of closely packed flints (some up to 0.3m across) was revealed which was, in places, up to 0.5m thick. The trench was extended (as trench 2) a further 8m to the south and the stratigraphy was found to be continuous and it was evident that the flints had been laid in a *c* 0.1m-deep cutting. Towards the western end of the trench, this layer was overlaid by a 20mm-thick layer of gravel that extended for 1.5m. As it was not possible to reach the western edge of the road, it could not be determined whether this cutting formed part of a trench in which the road had been laid or whether it was part of a terrace cut into the slope. The compacted flints were removed to reveal a natural surface of weathered and deeply fissured chalk.

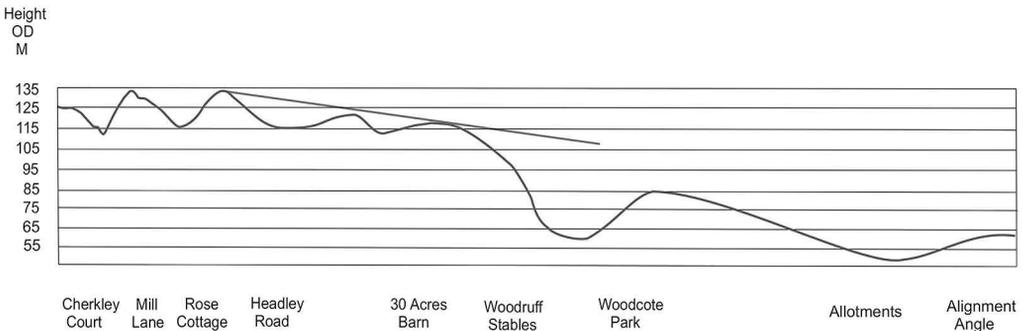
Fig 11 Stane Street. Pebble Lane: line of sight analysis.

- 1 From the southern end of the alignment the only other point that would have been visible is at the commencement of the Cherkley Court embankment (near Hargreaves' sighting point).
- 2 From this point the observer can see as far as the top of the rise at Rose Cottage, but no further.
- 3 From Rose Cottage, the route can be seen as far only as the alignment change at Thirty Acres Barn (Hargreaves' sighting point).
- 4 From Thirty Acres Barn, the alignment change at Woodruff Stables, the high point above Woodcote Park and the alignment angle near Windmill Bridge can be seen.

However, employing Hargreaves' data and the line of sight analysis (fig 11), the following survey procedure may be postulated:

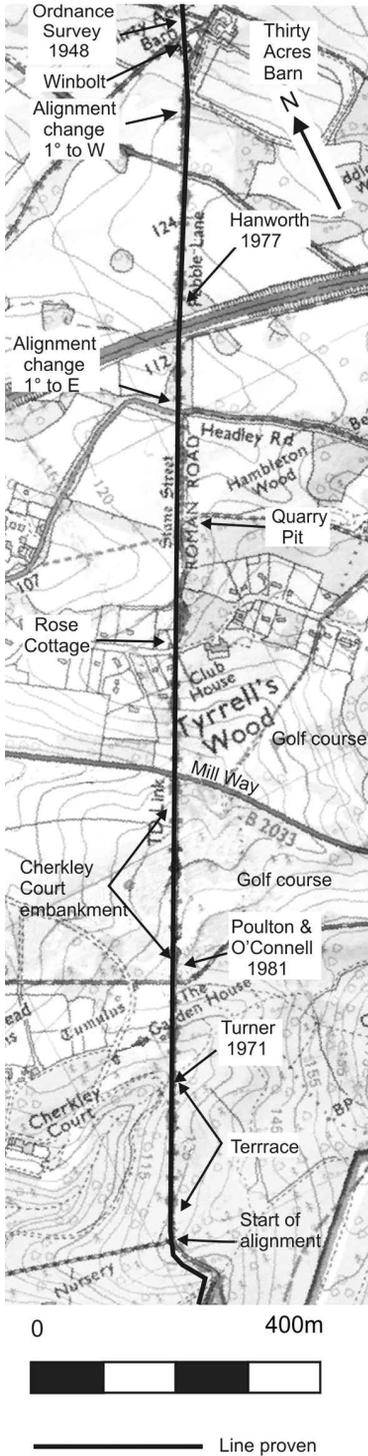
Fig 12 The route from Mickleham Downs to Thirty Acres Barn. (© Crown Copyright Ordnance Survey. All rights reserved)

### **The Pebble Lane alignment: Mickleham Downs to Thirty Acres Barn** (fig 12)

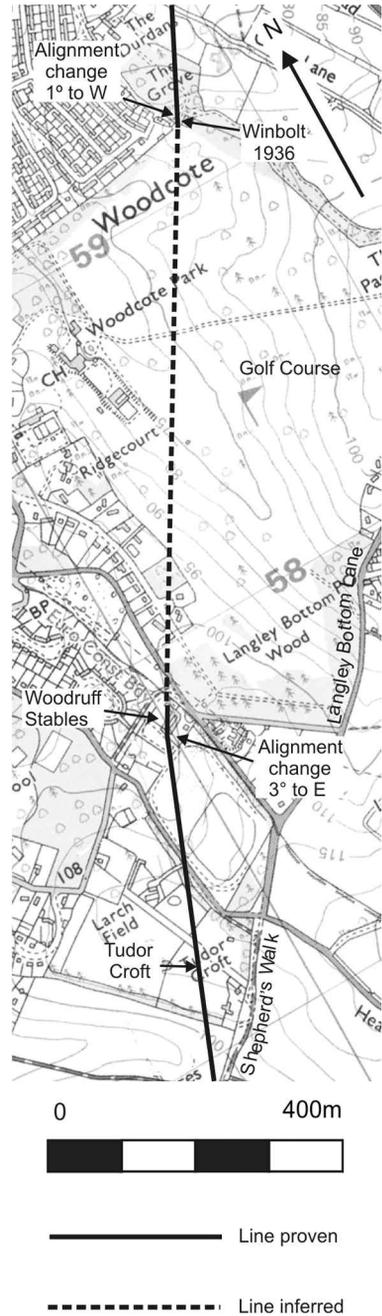
Fig 13 Stane Street. The route from Thirty Acres Barn to Woodcote Park. (© Crown Copyright Ordnance Survey. All rights reserved)

### **Thirty Acres Barn to Woodcote Park** (fig 13)

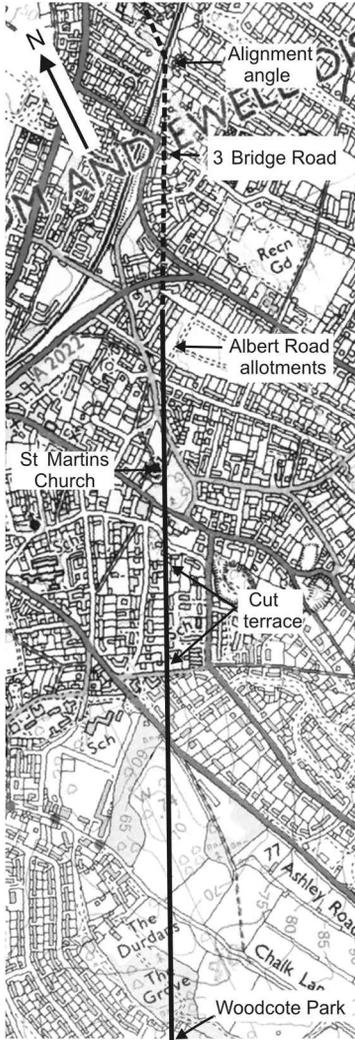
Fig 14 Stane Street. The route from Woodcote Park to Ewell. (© Crown Copyright Ordnance Survey. All rights reserved)

### **Woodcote Park to Ewell** (fig 14)

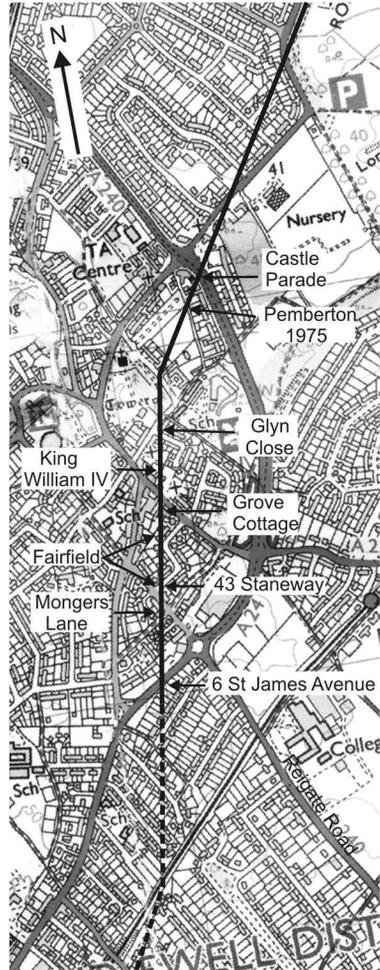
Fig 15 Stane Street. The route: Ewell alignments. (© Crown Copyright Ordnance Survey. All rights reserved)

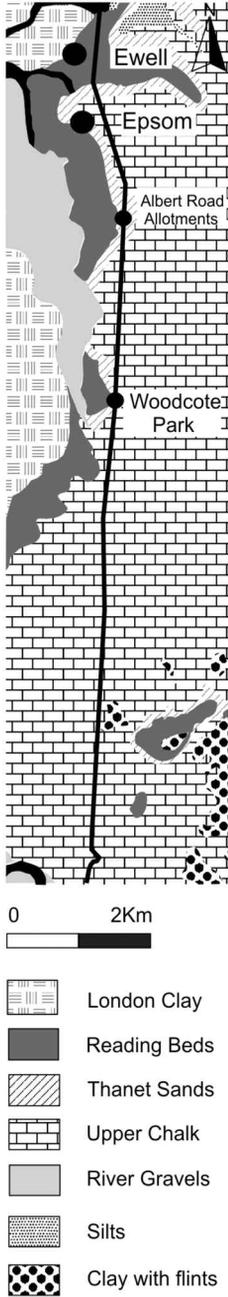
Fig 16 Stane Street. The geology of the route. (© Crown Copyright Ordnance Survey. All rights reserved)

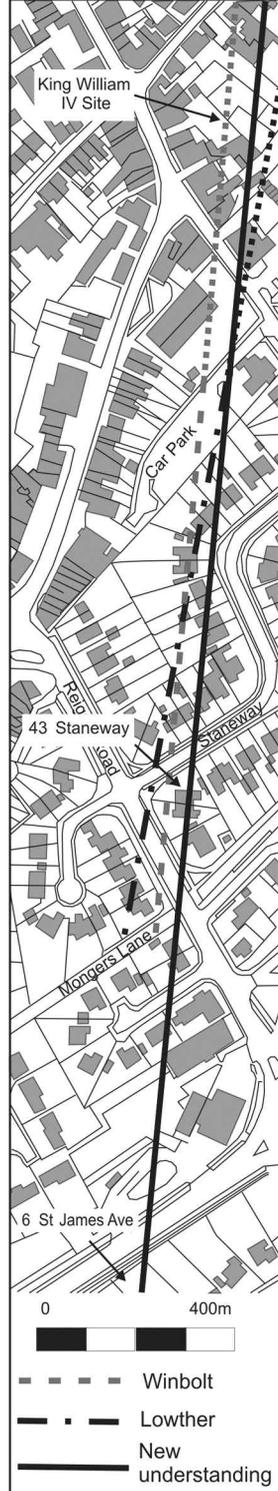
Fig 17 Stane Street. Ewell: the new understanding of the route. (© Crown Copyright Ordnance Survey. All rights reserved)

Although not shown in figure 17, a projection northwards of the newly established line passes through the Glyn Close site to form an alignment angle in Church Road with a back-projection across St Mary's churchyard of the known London Road alignment. Projection of the line to the south shows a possible intersection at the railway line with the line north-east established from the Albert Road allotments, approximately as predicted by Margary. This completes the route of the road from Thirty Acres Barn, Ashted to London Road, Ewell.

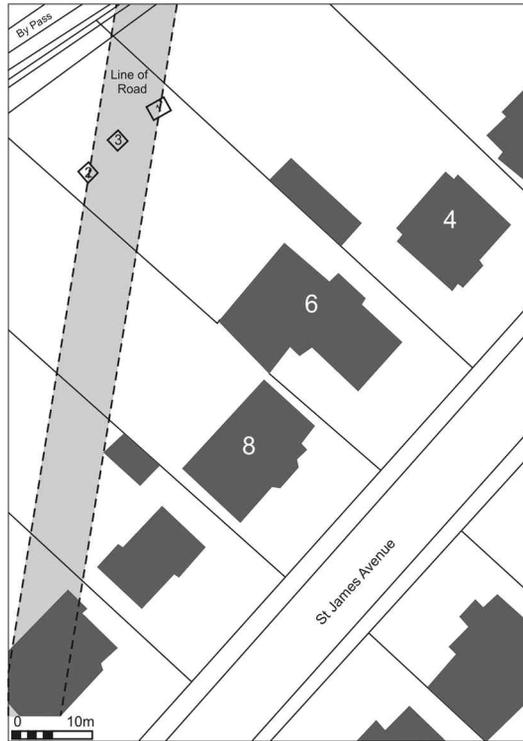
Fig 18 Stane Street. Ewell, 6, St James Avenue: location of road. (© Crown Copyright Ordnance Survey. All rights reserved)

Extrapolation of the line appeared secure and led to the rear garden at 6 St James Avenue (fig 18) where a series of three test pits revealed substantial volumes of loose flint in the subsoil and, at a depth of 0.80m, the presence of the road as a layer of closely packed flints 0.15m in depth (fig 19; Hall & Pemberton 2006, 1). The eastern test pit contained a man-made cut into the underlying chalk, which appeared to be a roadside ditch. Flints continued over and beyond this ditch but this was interpreted as degradation and spread of the original surface – possibly due to later agricultural operations. The western pit showed an edge to the packed flints, although no ditch, giving a width of 6.5m for the road at this point (fig 19). Unstratified finds from the site included a bronze nail, 4th century pottery sherds and a partial rim of a Mortlake ware vessel. The latter is important as it is the first pottery of Neolithic date to be recorded in Ewell (Jonathan Cotton, pers comm).

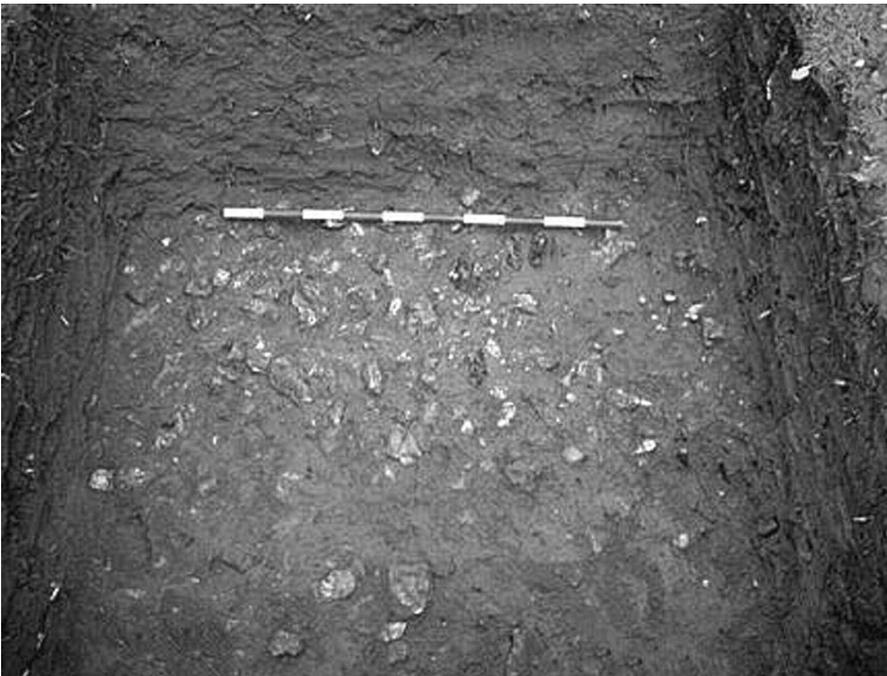
Fig 19 Stane Street. Ewell, 6 St James Avenue: road metalling in central test pit.

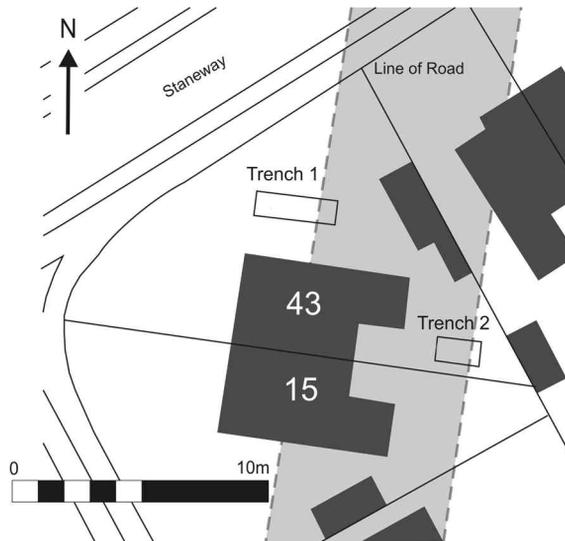
Fig 20 Stane Street, Ewell, 43 Staneway: location of road. (© Crown Copyright Ordnance Survey. All rights reserved)

Success at the St James Avenue site led to an attempt to confirm the line a short way northwards at 43 Staneway. Two trenches were excavated – one in the front garden and one to the rear of the property – each of which found the road at a depth of *c* 0.9m below the ground surface. The front garden trench revealed the western edge as a 0.15m layer of compacted flints overlying Thanet Sands (fig 20) but that to the rear, showed the road overlying, and terraced into, chalk and consisting of up to 0.30m depth of flints and water-washed pebbles from the nearby Reading Beds (fig 21). The road at this point appeared to be 6.8m wide, which compares with that seen at St James Avenue (Hall & Pemberton 2006, 2).

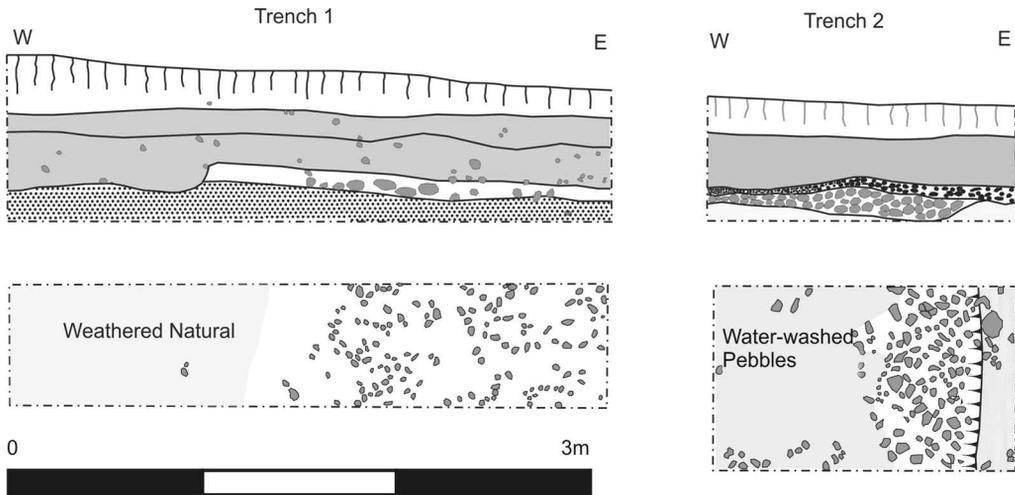
Fig 21 Stane Street, Ewell, 43 Staneway: sections and plans of road.
