Medieval embankment and post-medieval development at Bermondsey Wall West

GARY BROWN and JAMES TAYLOR

An excavation at Bermondsey Wall West revealed evidence of activity from the medieval to the late post-medieval periods. The site was crossed by a natural channel that was reinforced in the early medieval period with rammed chalk cobbles either as a beaching place for small river vessels or possibly a tide mill tail-race. Timber stakes of probable 12th century date associated with the chalk surface might have been mooring stakes or alternatively could have been the remains of fish weirs or eel-traps. The channel was later blocked with a timber revetment and wattle hurdles as the major feature on site when the 13th century riverside embankment, Bermondsey Wall, was constructed. The riverside was formalised with the building of the river defences and by the 17th century the area had been built upon as a result of the urban growth of Southwark. The remains of structures of 17th, 18th and 19th century date were revealed fronting the south side of Bermondsey Wall West and the immediate area to the south. A series of timber pipes was witness to the management of the water supply or dra

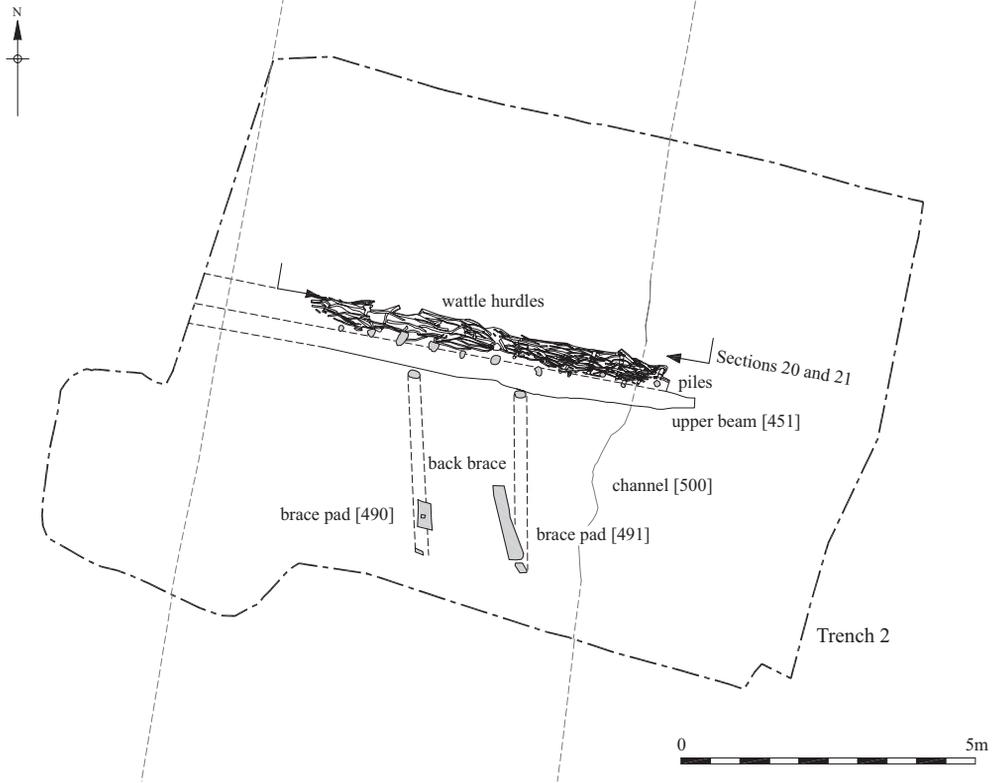
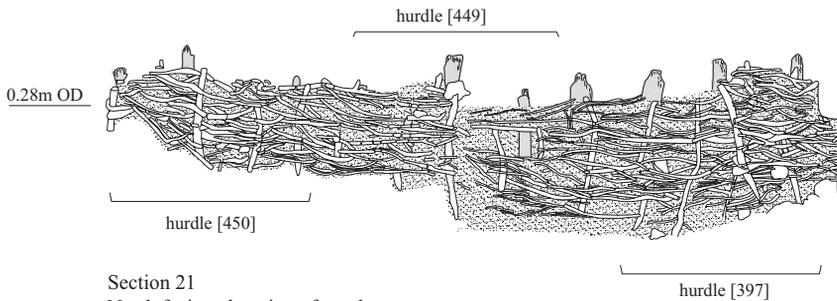
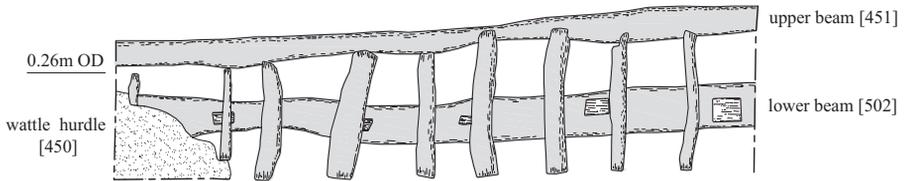
Fig 6 Bermondsey Wall West. Phase 3: wattle hurdle and revetment.

Section 21
North facing elevation of wattle revetment

Section 20
North facing elevation to show wooden bracing supporting south side of wattle revetment

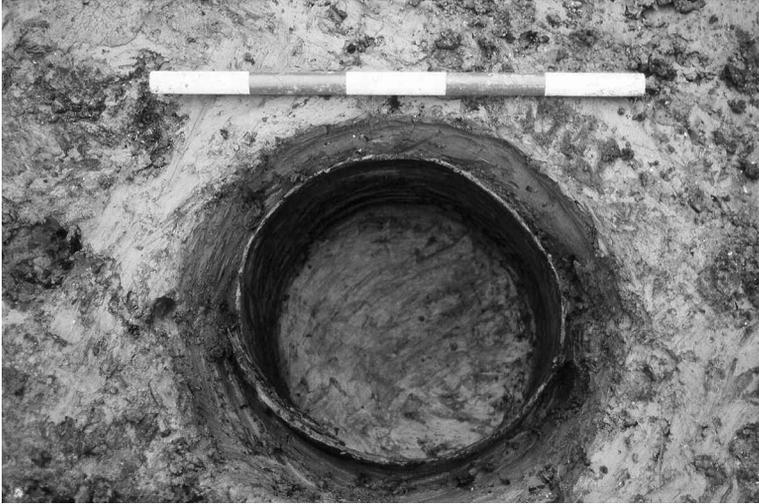
Fig 19 Bermondsey Wall West. The bentwood container.

Adjacent to the north wall, on its north side, possibly in an exterior yard location, was a small cylindrical ‘bentwood’ container (figs 19 and 29), *c* 320mm in diameter and *c* 165mm deep, which might have served as a sump (see Goodburn, below). The fill of the container included clay tobacco pipes dated to 1680–1710 and an ornate copper-alloy tap (fig 21). There was no indication that this ‘yard’ area was surfaced.

The remains of a well-preserved cylindrical bentwood container of late 17th century date was located in a yard area adjacent to the north of Building 2 (figs 19 and 29). The container was probably used as a small soakaway or sump. It was *c* 320mm in diameter and survived to a height of 165mm and had been made from a fast-grown, radially split and shaved, board of oak *c* 3–4mm thick that presumably had been bent by heat or steam. The ends overlapped and were fastened with small iron tacks. The lower edge had occasional peg holes that must have originally secured the base that was missing when found. Other bentwood boxes have been found in medieval and later deposits in London (for example at Suffolk House, City of London, Goodburn 2001) and such vessels had many uses from hat boxes to corn measures by *c* 1800.
