The Iron Age enclosure and First World War Prisoner of War camp at Felday, Holmbury St Mary, near Dorking

JENNY NEWELL, KEITH WINSER and JUDIE ENGLISH

Clearance of ground cover from the interior has allowed survey of the prehistoric enclosure at Felday and the remains of the Prisoner of War Camp within it. Documentary research on the latter site has been used to develop a context for this example of a poorly understood type of military complex dating to the First World War.

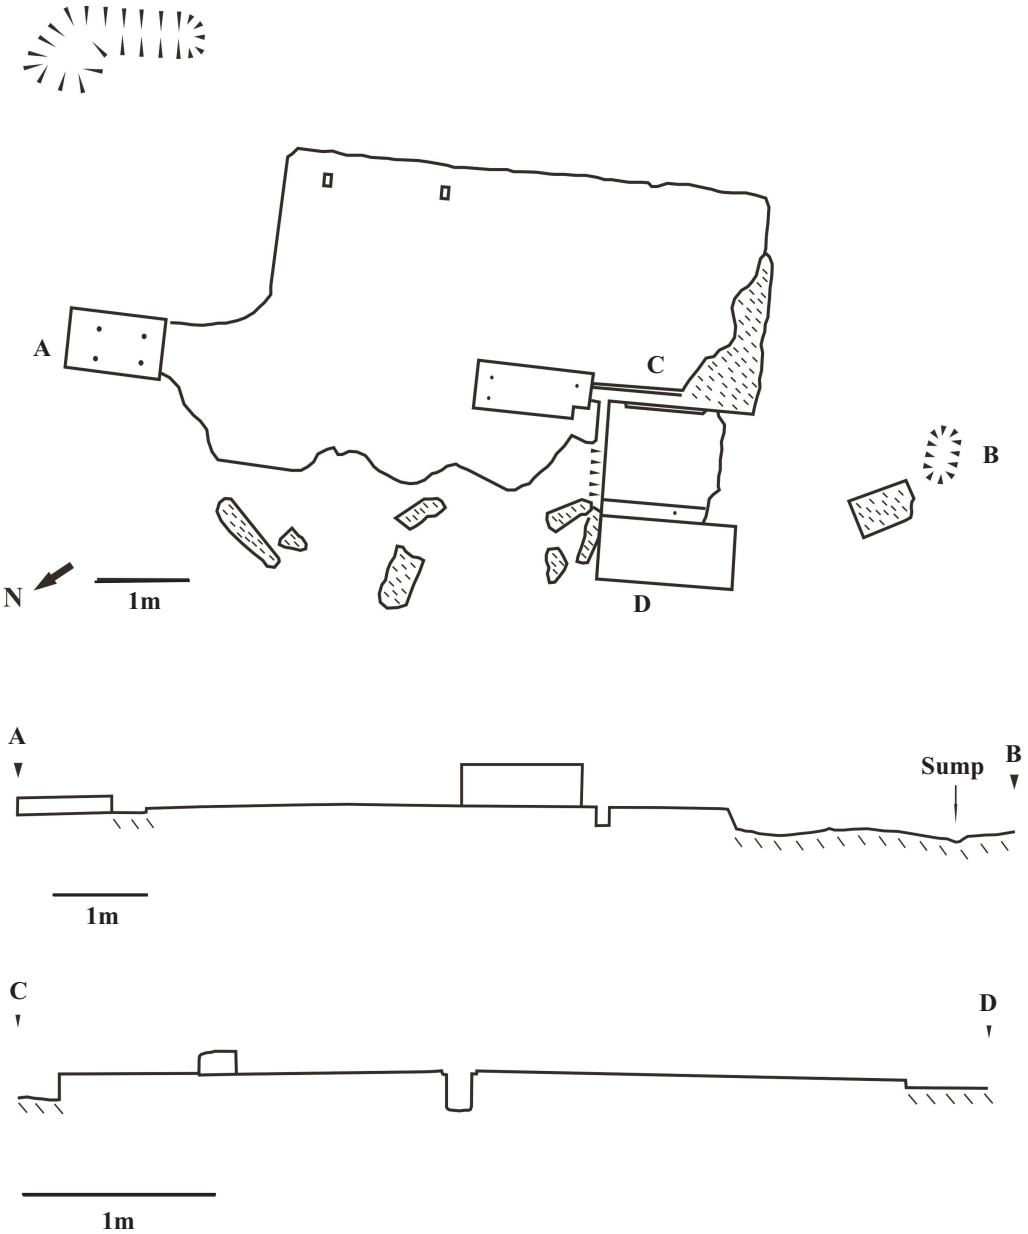
Fig 7 Felday. Plan and sections of the generator housing at the PoW camp.

b) The generator house (figs 7 and 10b)

In the north-western corner of the camp are two rectangular concrete plinths standing on a concrete base, set 3.6m apart and each with four metal bolts on the upper surface. The easterly block measures 1.1 x 0.7m and 40mm high, while that to the west is 1.3 x 0.6m and 40mm high. The concrete base measures 3.6 x 5.6m and two postholes close to its eastern edge may have supported either a roof or shelving, perhaps for batteries, or a control panel. A number of ducts or channels lead away from the western block.

The sketch by Beattie Ede (fig 5) suggests that this was the location of a generator unit. An interpretation (Tony Harcombe, pers comm) implies that a generator had been belt driven from a single cylinder, horizontal bore, open crank oil engine run on paraffin oil also known as kerosene. It would have provided a supply to a control panel, which then charged banks of batteries to provide a direct current for lighting and other uses. One of the ducts in the base would have carried the exhaust pipe outside to a silencer let into the ground to dampen the noise, and the other duct would have carried the fuel supply pipe from a tank set, probably for safety reasons, outside the building on a separate platform. A small gully in the main concrete base may have been intended to remove spillage caused while servicing the batteries.

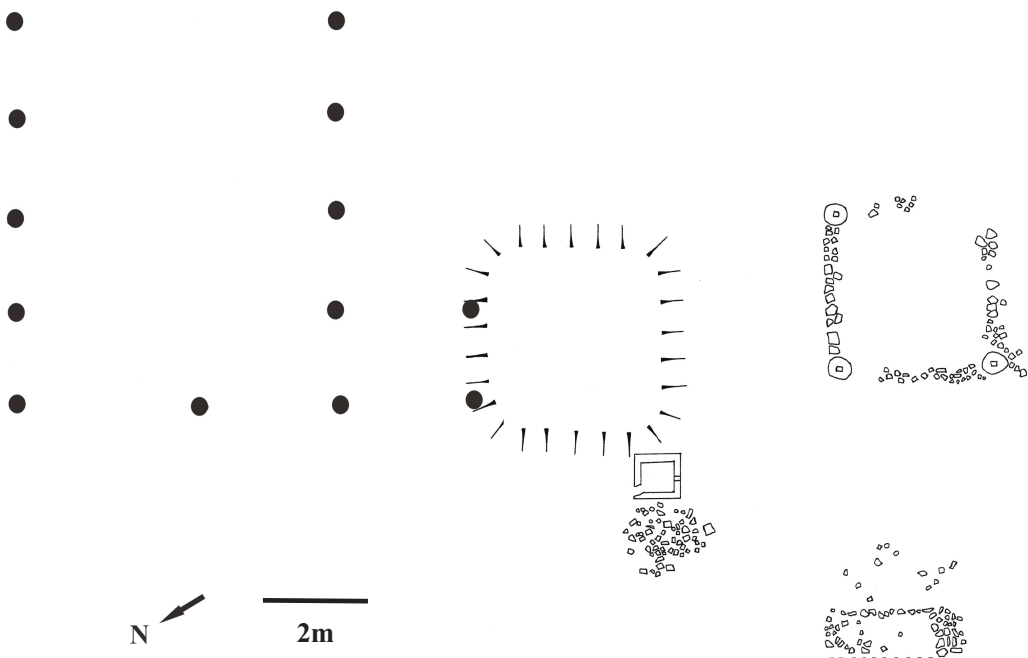
Fig 8 Felday. Plan and section of the possible ablutions block.

c) The possible ablutions block (fig 8)

In the south-eastern corner of the camp there is a series of building remains that might represent the site of the ablutions area. The inspection reports (see below) describe the earliest facilities as a shed with ten taps and a pail-based latrine system. There was concern over the lack of a bath or shower and, although additions were requested, it is not certain that the improvements were made.

A series of postholes delineate a possible building of wooden construction, *c* 6 x 7m. Adjacent to this is a 3 x 3m raised platform with a sump outside its western corner. The sump, some 0.8 x 0.8m is lined with concrete with a double catchment pit outside its western corner. The pit, some 0.8m square, is lined with concrete and appears similar to that associated with the probable kitchen area (above). The depth could not be determined owing to the build-up of silt.

Among the rubble to the west of the sump were bricks stamped with the name of the Rowfant Brickworks, based near Crawley, West Sussex. To the south are the remains of rough stone foundations of a building *c* 2.5 x 2.5m

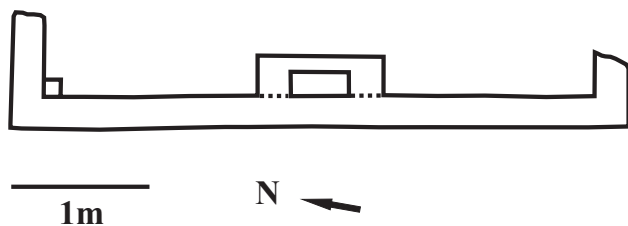
Fig 9 Felday. Plan of the possible glasshouse or detention cell.

d) The possible glasshouse or detention cell (fig 9)

Further masonry was located down-slope from the possible kitchen area but it is unclear that it represents the remains of a building. A 4.6m length of concrete, possibly the base for a timber wall, with returns at either end is set into the slope. There does not appear to have been a solid floor. The blocks central to the surviving wall and in the northern corner may have supported a superstructure.

The only reason for the tentative identification of this feature as the glasshouse or detention cell, is the presence of such a structure on the sketch by Beattie Ede (fig 5).

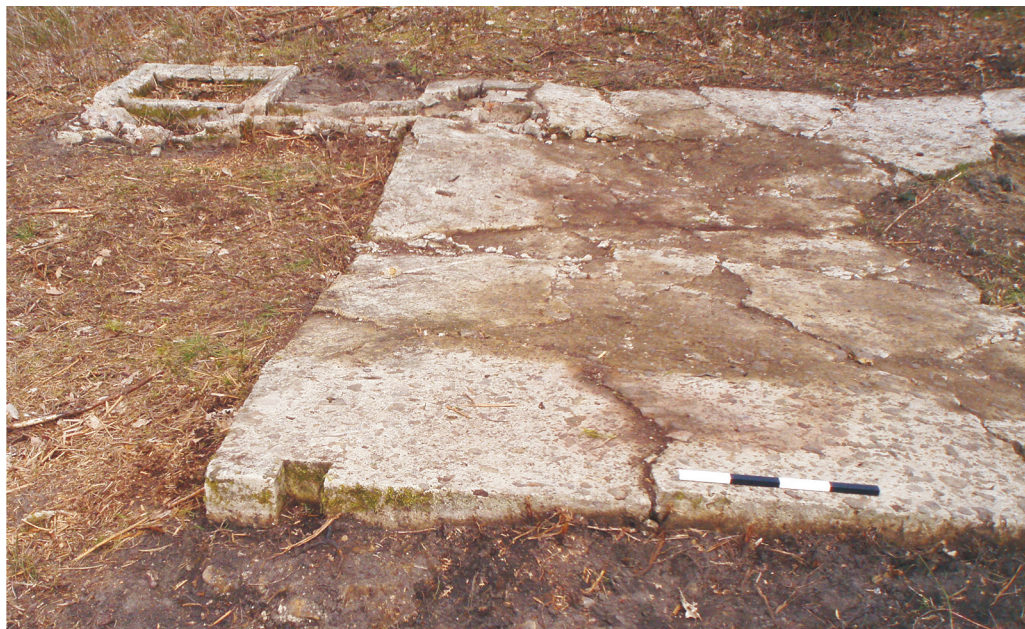
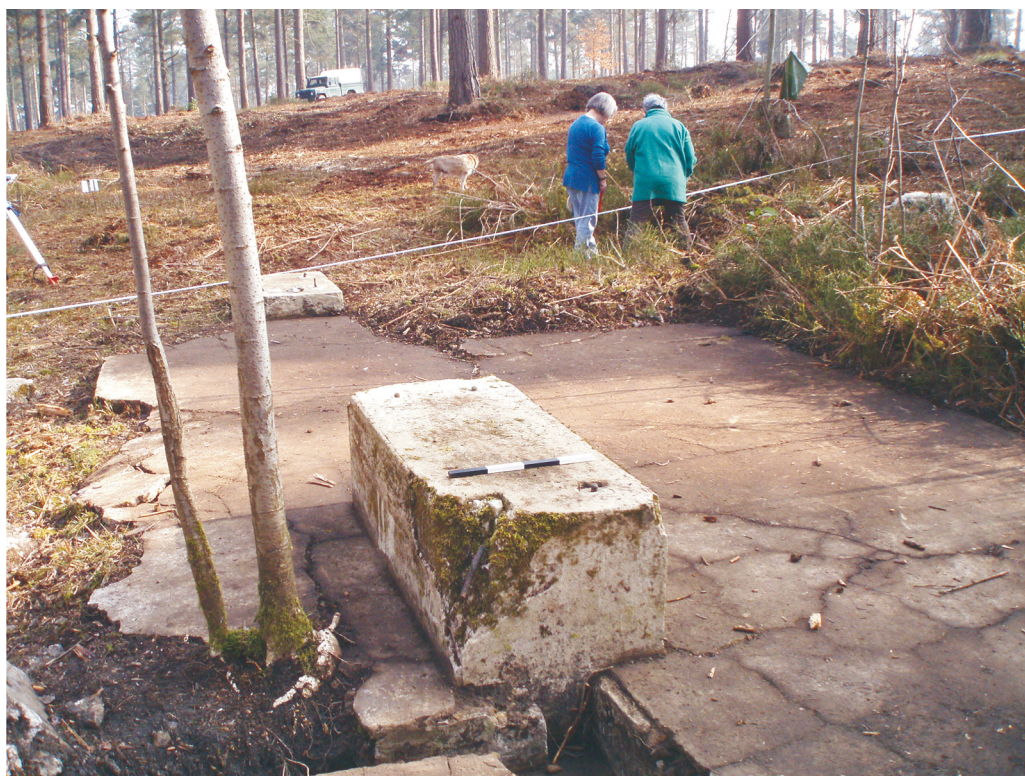
Fig 10 Felday. (a) The possible kitchen area (top) and (b) the generator area (bottom) both from the south-west.

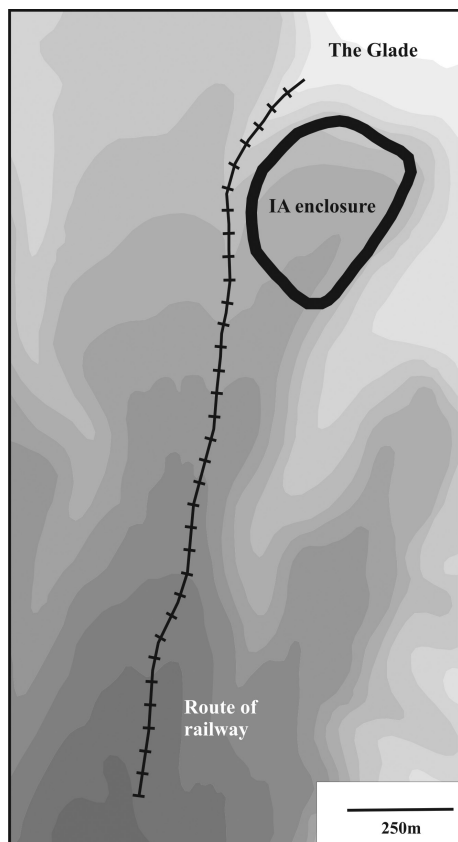
Fig 11 Felday. Route of the Decauville-type railway.

f) *The railway line* (fig 11)

In describing the nature of the work undertaken by the PoWs the inspection report (below) mentions the construction of a Decauville railway, and Beattie Ede's recollections suggest that the wagons were controlled by a chain mechanism on the descent and, when empty, pulled by horses back up the hill. The main innovation from Paul Decauville (1846–1922) was the use of ready-made sections of light, narrow-gauge track fastened to steel sleepers; this track was portable and could be disassembled and transported easily. The system became a military standard and the British and French eventually built thousands of miles of track in the trenches during the First World War.

A deep gully runs from the south, skirting the western boundary of the prehistoric enclosure at Felday and following a valley towards the site of the village sawmill (now Hurtwood car park no 9). This route may have originated prior to the First World War – stone had been quarried from Holmbury Hill since at least the 18th century and would presumably have been removed by horse and cart. However, the narrowness of the bottom of the gully, and the presence of a 'platform' visible in places running along its side, suggests that this became the route of the railway, with the horses walking along the 'platform'. The route was located by a series of points obtained from a hand-held GPS unit and runs from the plateau south of the camp (TQ 10375 43420), skirting the western side of the Iron Age enclosure before running down-slope to join the present track (TQ 10602 44678).
