WITLEY COURT

THE BOATHOUSE

A Building Survey and Partial Excavation

REPORT ON A BUILDING SURVEY AND PARTIAL EXCAVATION

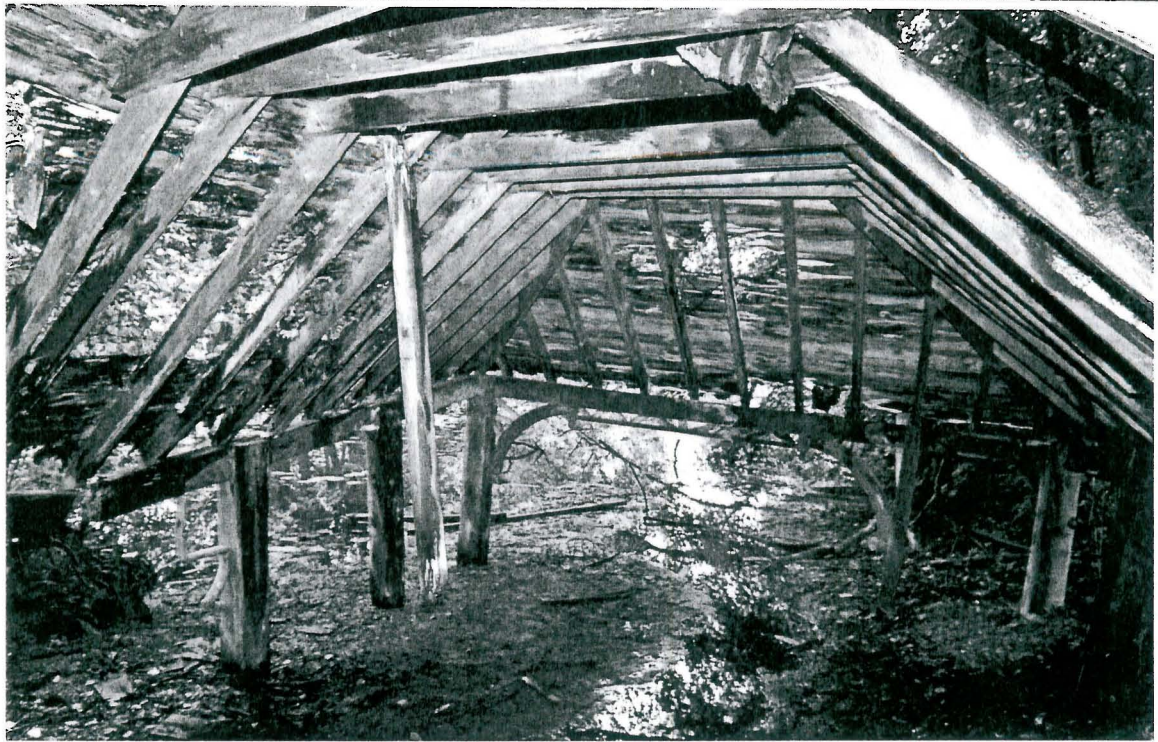
**Internal -
looking east**

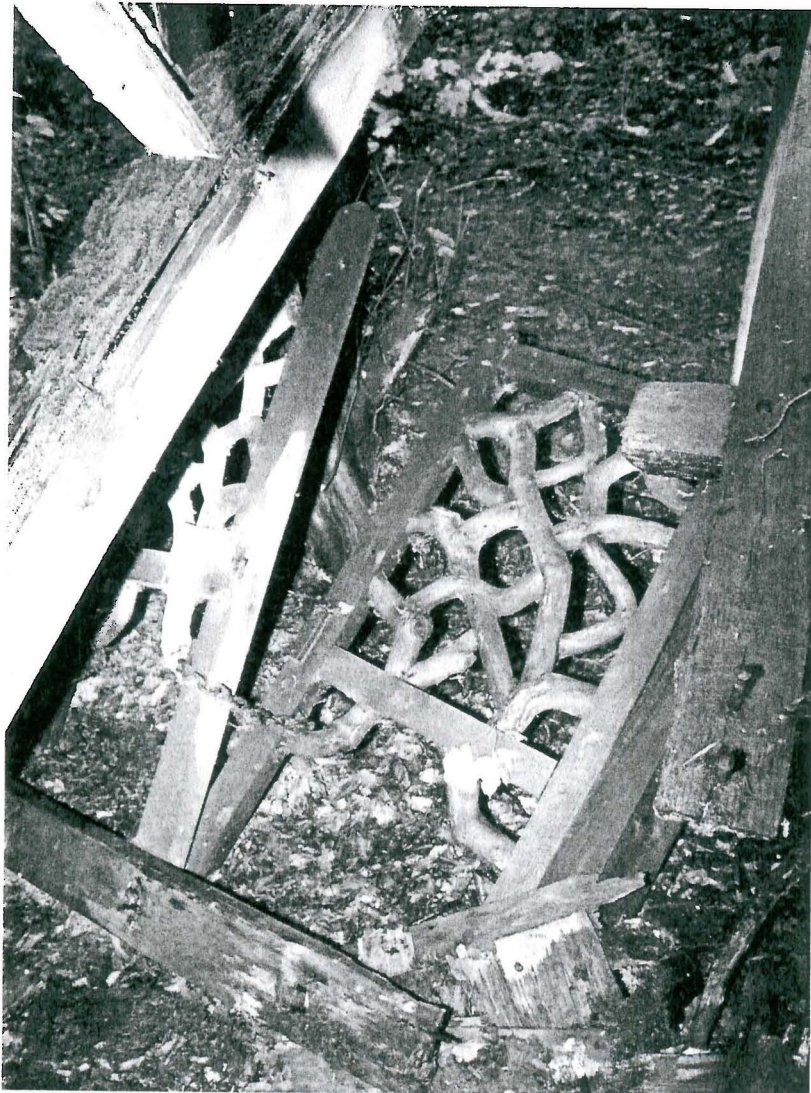
The fallen gate

The porch gates, although partially buried in the silt, were in reasonably good condition. The *cotage ornee* decoration survives fully in the upper two panels and partially in the two lower ones. The lock and hinges are also well preserved. At the junction where the gate posts meet the wall plates, the gate-posts are shallowly notched and the wall plates are tenoned. These are the only joints that are pegged, all the others being bolted or nailed. The gate-posts then rise above the wall plates giving an additional height of approximately 90cm.

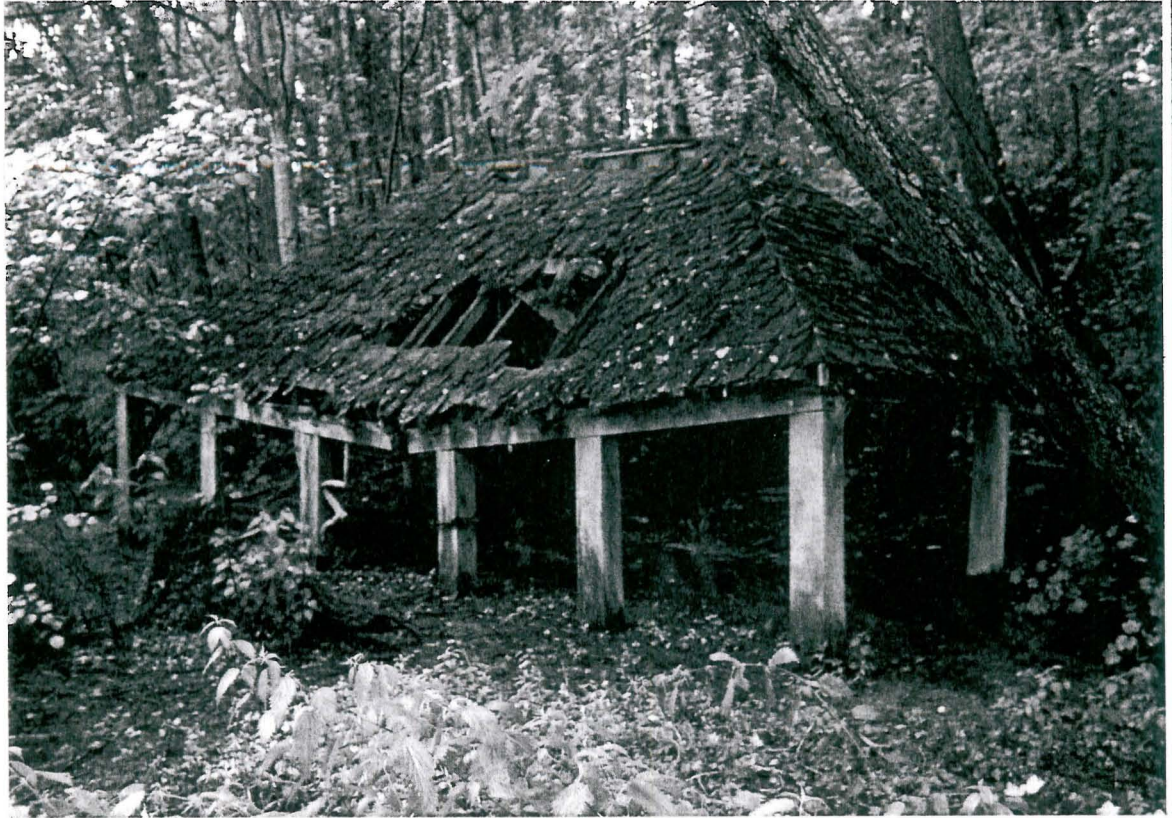
The boathouse from the north-west

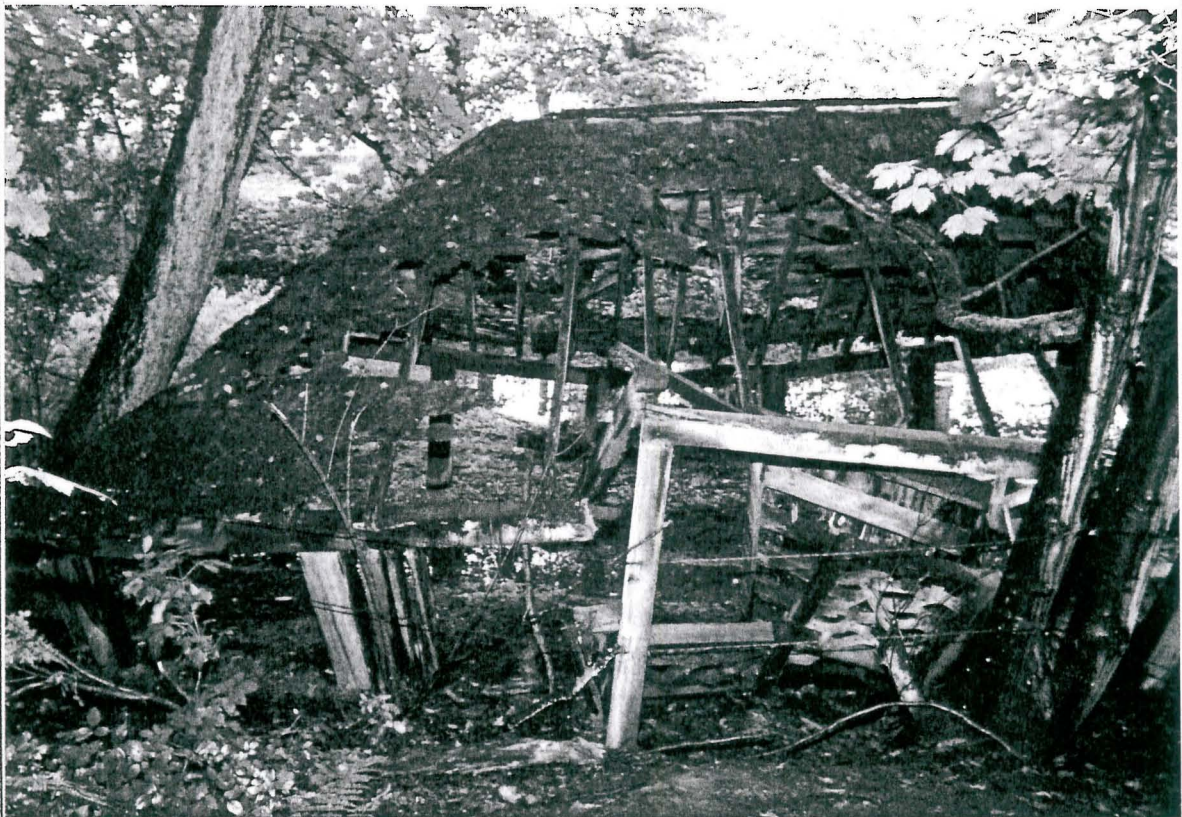
The boathouse from the south, landward side, including the collapsed porch

The boathouse is now in very poor condition and is over half buried in a thick silt which has accumulated in this part of the pool. It was about 8m long and 4m wide, built of timber and with a roof of timber shingles. The southern, landward side included a porch which has recently collapsed. However, the main structure, consisting of a series of timber posts, still stands, but it is now leaning to the south-east where it is supported by a tree. The building is of five bays on the long sides and two bays on the closed western side. The rustic decoration, consisting of curved elm branches nailed within the panels, has almost totally disappeared and most of the shingles belonging to the roof have either fallen or simply rotted away. Comparison with photographs taken in 1994 show that there has been a rapid deterioration of the whole structure in the past two years.

The design of the porch is unusual as the east and west sides were open for the lakeside path to go straight through. To the north of the path, within the porch was a pair of double doors leading into the boathouse and to the south a panel that filled the full width of the porch. Both the doors and the panel were infilled in *cotage ornee* decoration.

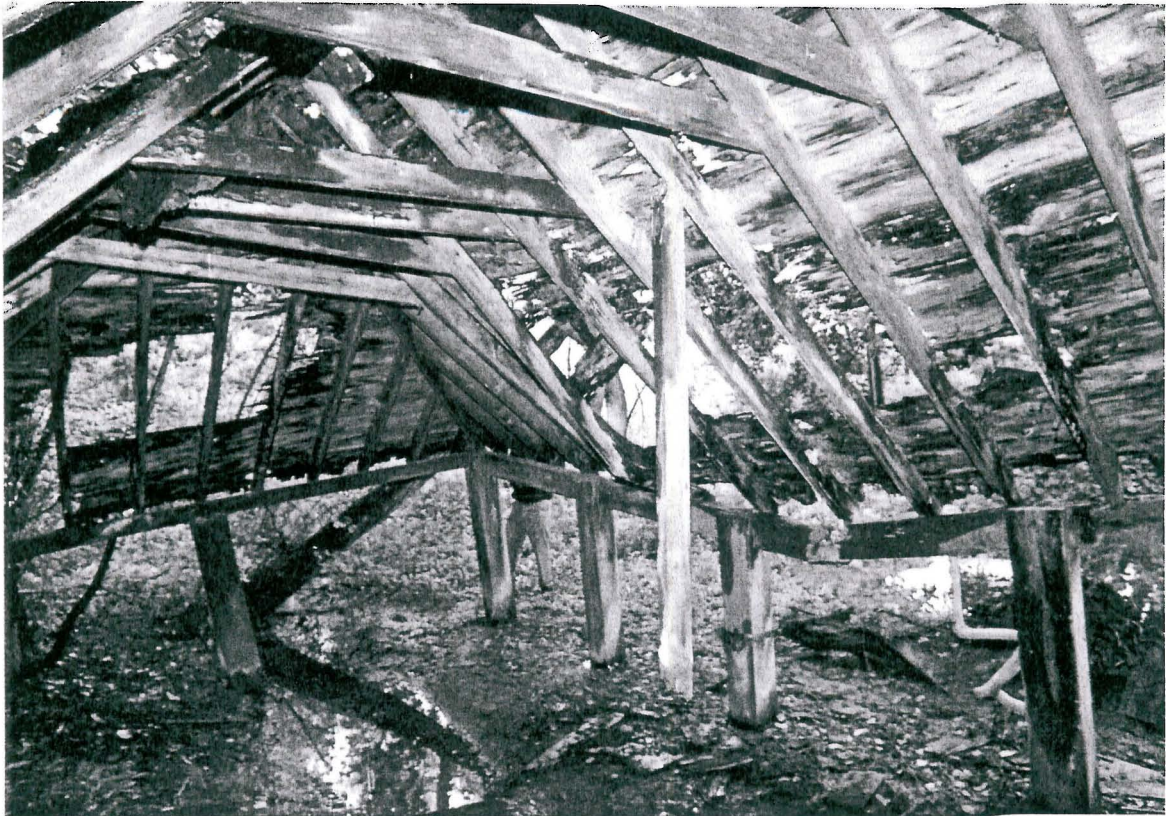
The interior of the boathouse from the south-east

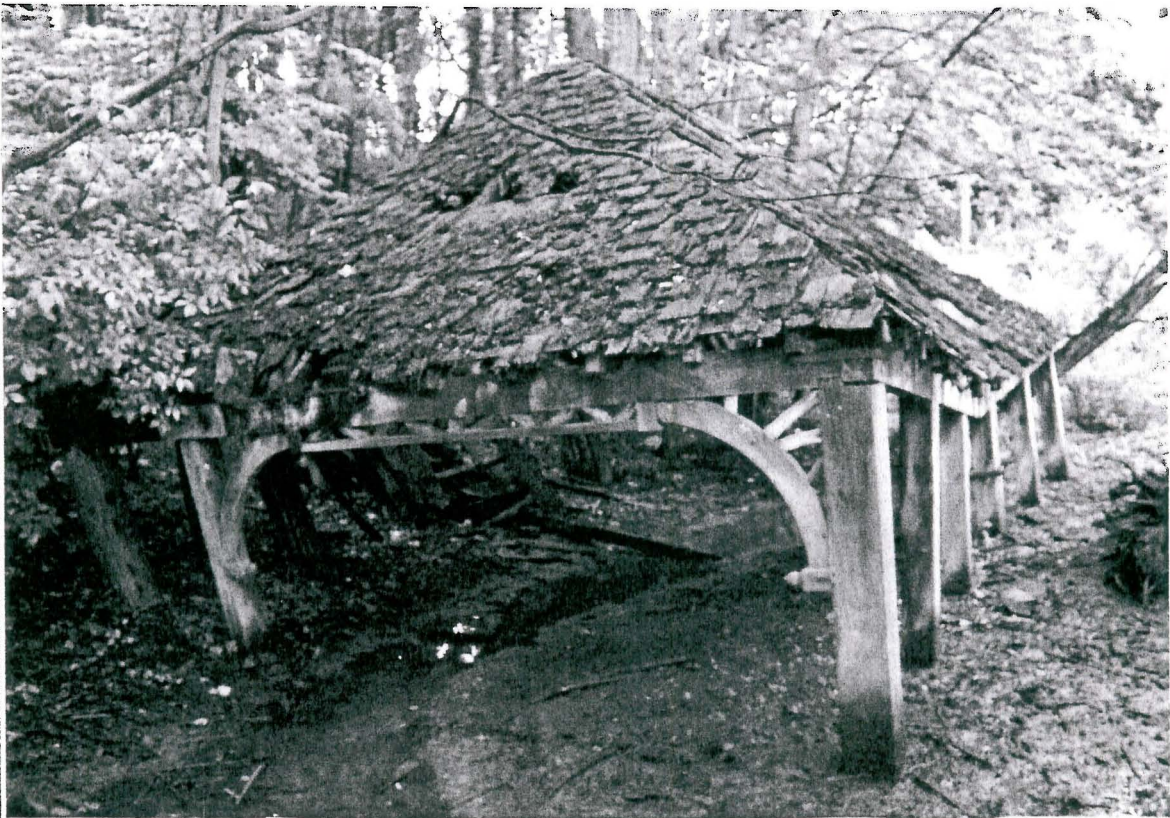
The east elevation of the boathouse

The east frame, being the entrance to the boathouse from the lake, was designed to be partially open. The southern entrance post was approximately 80cm from the south corner post. This was also the approximate width of the decking. The open part of this frame had arched braces springing from the soffit of the wall plate to the two posts. Each arch had a moulded pendant and the spandrels to the arches contained *cotage ornee* decoration.
