**Church Steps Cottage
MARTLEY
Worcestershire**

Watching Brief

Hereford Archaeology Series 525

WSM31624

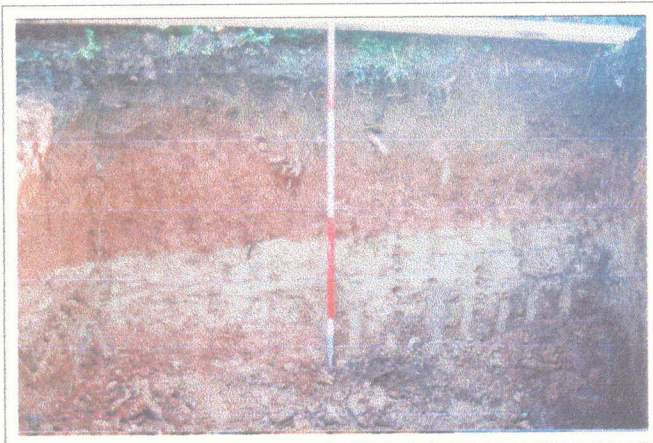
Plate 1
Showing natural deposits in west facing section of the tank trench

The bed rock itself comprised bands of reddish marl and grey/green rock (Plate 1). There was no discernible sub-soil horizon between the topsoil and the bedrock, although the upper, clayey part of the bed rock might be confused as a sub-soil where it had weathered.

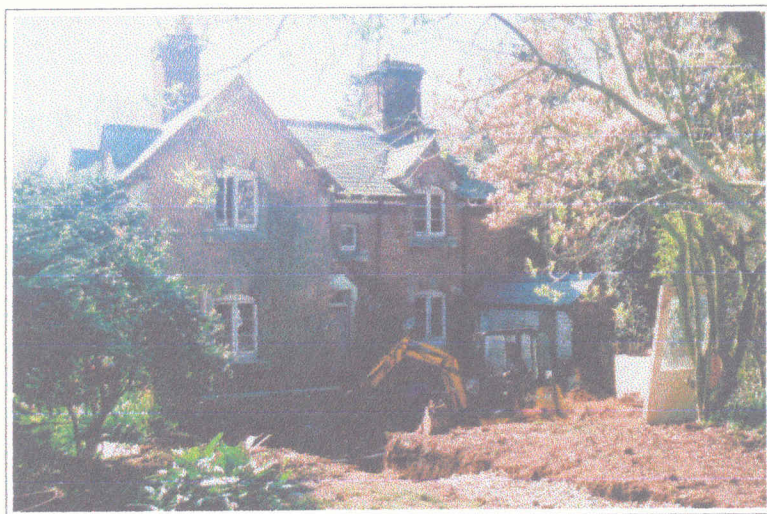
Plate 4
Showing area of excavation for foundations

The topsoil had been removed from this area prior to observations being made on site. The surface thus exposed comprised bed-rock. No features were identified in the area of the foundation trenches except for a very modern post hole containing wood. Otherwise the excavation of the trenches simply revealed bedrock similar in nature to that observed in the fuel tank hole. A photographic record was made of the foundation trenches.
