*Archaeological Recording at
Crowle Court, Crowle, Worcestershire*

*An Interpretation of Historic Fabric at
the Kitchen Range, Crowle Court, Crowle,
Worcestershire*

A Report for Nick Joyce Architects

August 2006

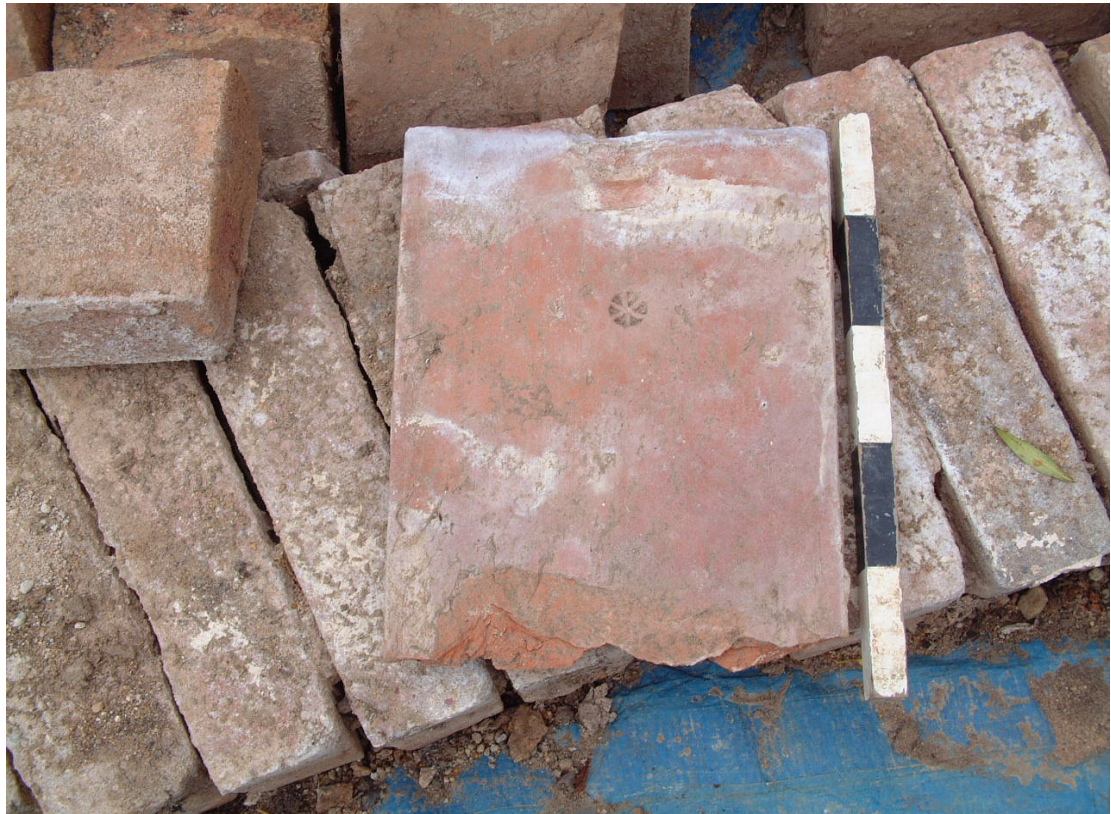
Plate 3: *Stamped roof tile (Scale 25 centimetres)*

The single nibbed flat roof tile is stamped with a circular motif with six segments. The orange-fired clay fabric is sanded on the upper face and may be categorised according to the Worcestershire County Fabric Series as Fabric 2a. The tile was probably made at Worcester after 1467, when the Worcester City Ordinance laid down rules to standardise tile making, including the requirement to stamp (Fagan 2004).

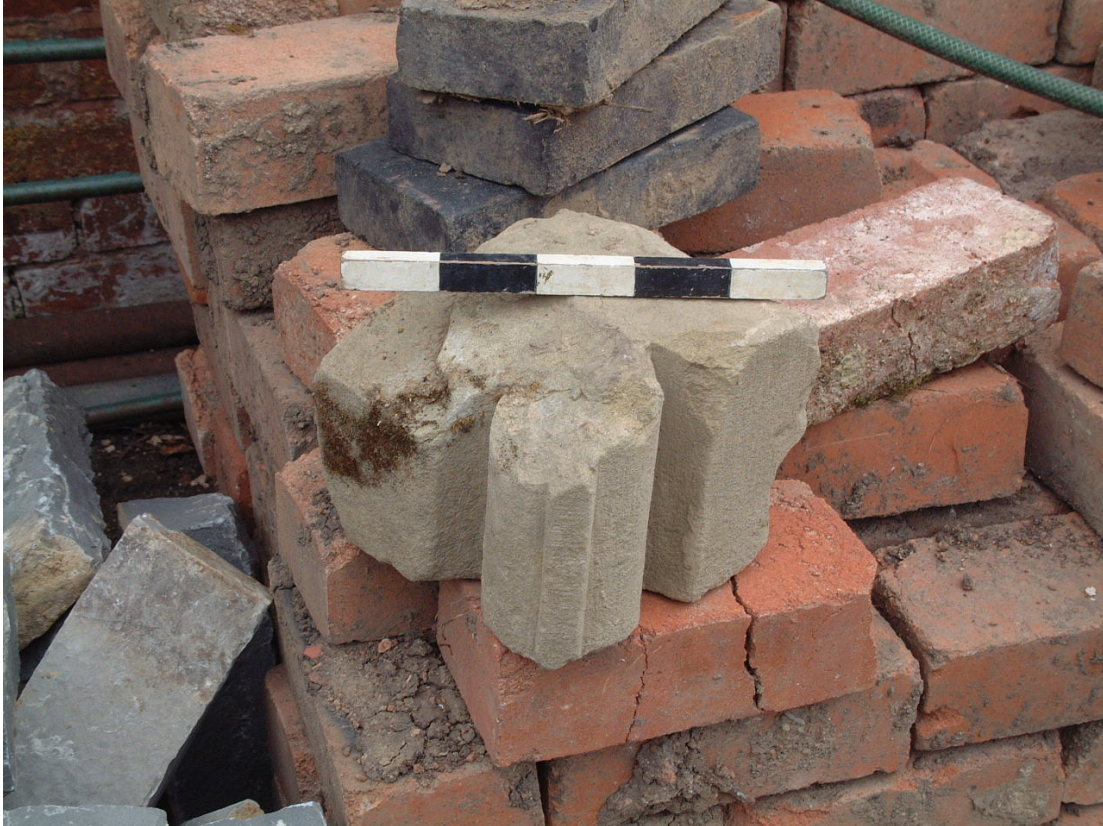
Plate 4: *Stamped roof tile (Scale 25 centimetres)*

The moulded stone retrieved from the debris that had fallen at the north-east corner of the kitchen range was inspected by Dr Richard Morriss, a specialist in worked stones, who made the following observations: -

The grey sandstone block has a roll and fillet moulding on one angle, flanked on one side by a hollow and fillet and to the other side by a hollow. This form of moulded stone was frequently used to frame a door or window aperture in the 13th and 14th centuries. The precision of the cutting of the fillet on the roll suggests a likely date in the region of circa 1220-1260.

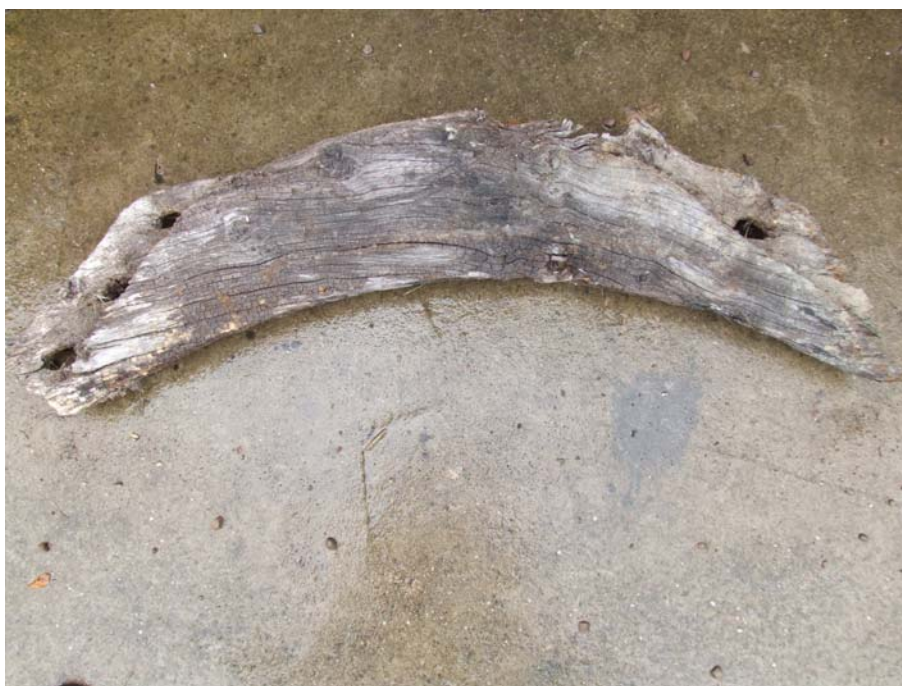
Plate 5: *Knee-brace from a timber-frame*

The section of timber-framing identified during clearance of the site represents a knee-brace, which would have been pegged between a post and the tie-beam of a timber-frame truss. It is understood that the brace is to be scientifically dated by English Heritage and the results will be presented as a separate dendrochronological report.

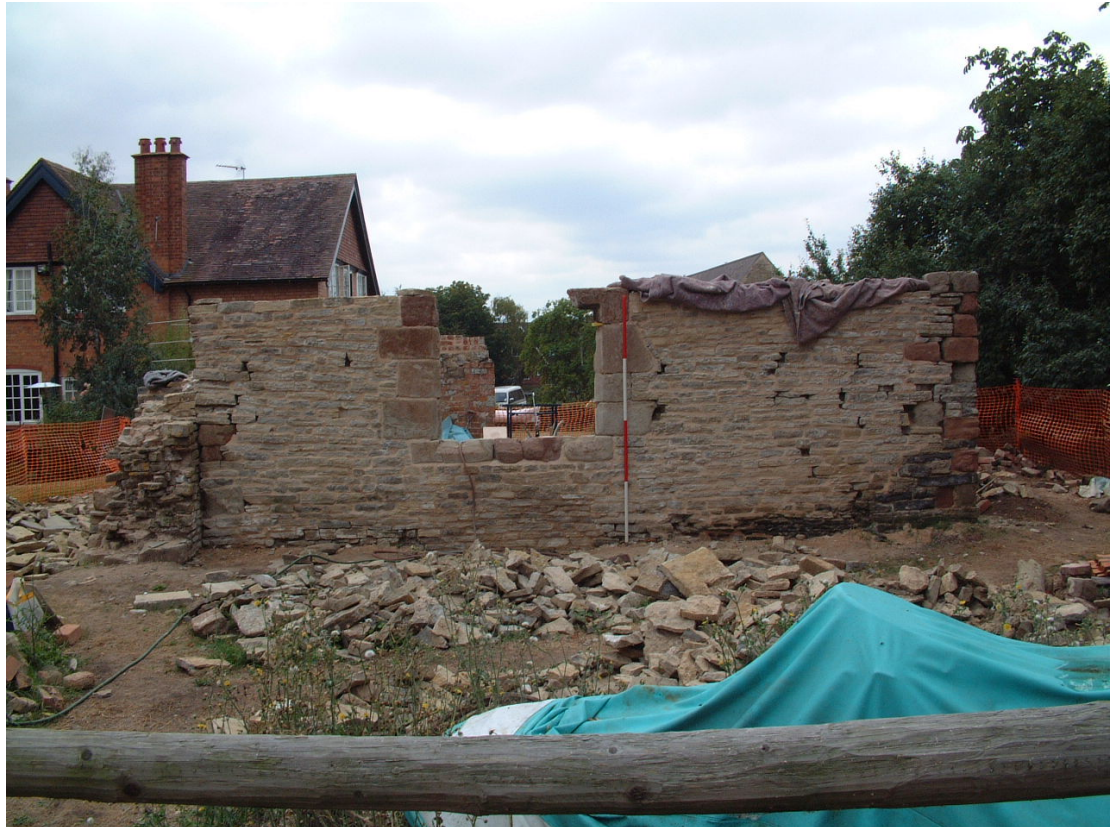
The northern elevation appears to be part of the original kitchen block structure, although its relationship with the opposite southern elevation, which is of ashlar stone blocks, is unclear. The elevation is 94 centimetres thick and stands to a height of 2-metres, although there has been some rebuilding (Plate 4 below).

Plate 4: *Northern wall (right) butted by eastern wall (left), scale 2 metres*

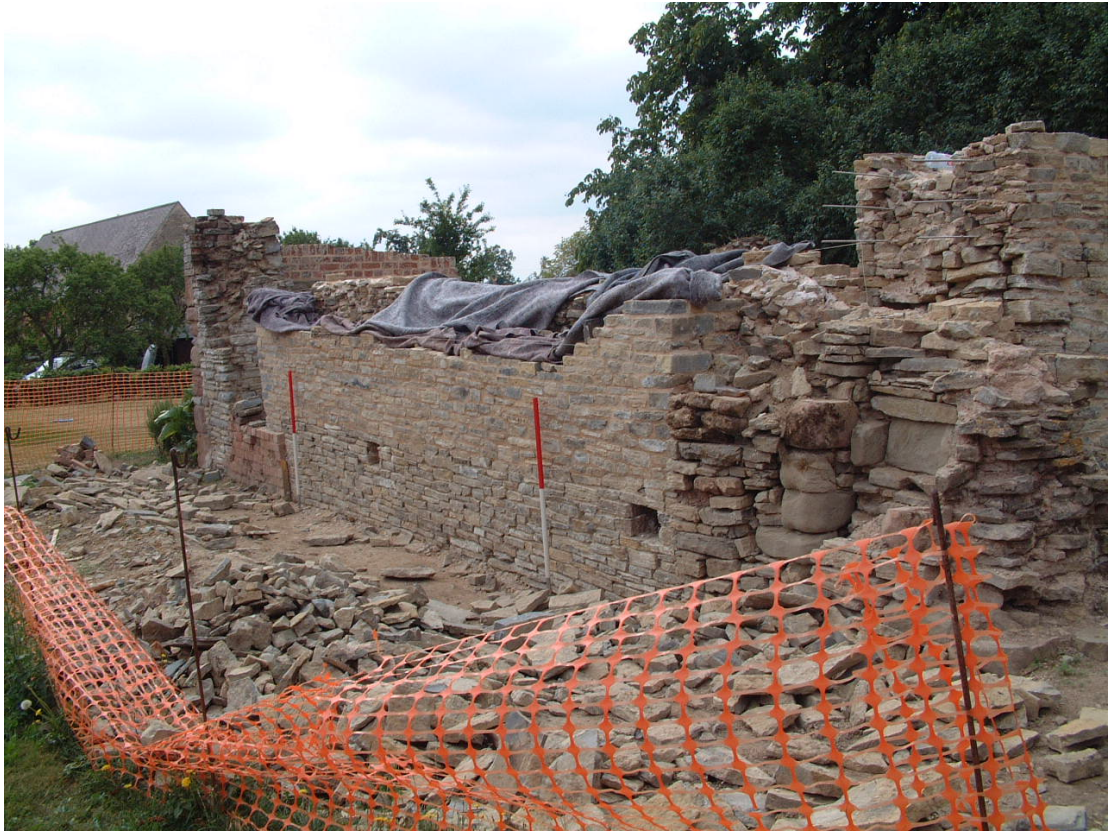
The sandstone quoins are complete at the north-western corner, tying the northern and western elevations, suggesting they are contemporary (in the main). The sandstone quoins on the opposite north-eastern corner are however, broken by a straight butt joint between the eastern elevation and the northern elevation, indicating the eastern elevation is a later wall. This is further evidenced by a pair of putlog holes low in the eastern elevation, whereas there are none corresponding within the other three elevations (Plate 5 below).

Plate 5: *Putlog holes in the lower face of the eastern elevation, scales 1-metre.*

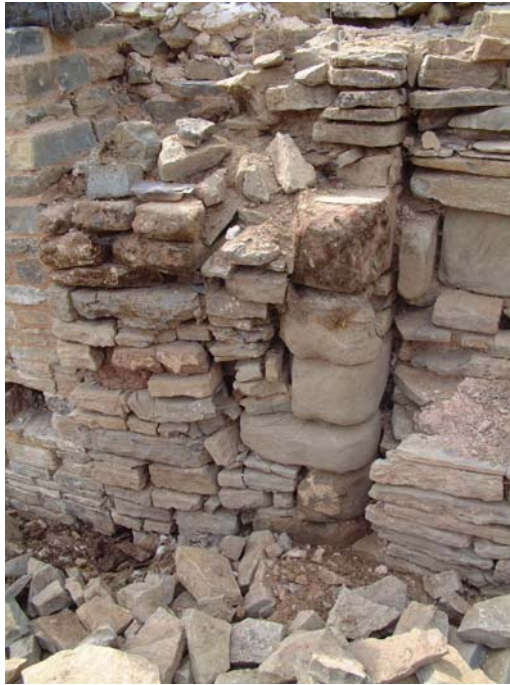
The eastern wall appears to have been cut into (rather than cut through) for the insertion of an east-west wall, with a doorway located against the eastern elevation. The quoins of the eastern door reveal can be seen within the remains of the fabric (plate 6 below).

Plate 6: *Western reveal of doorway in east-west wall, exposed during renovation work*

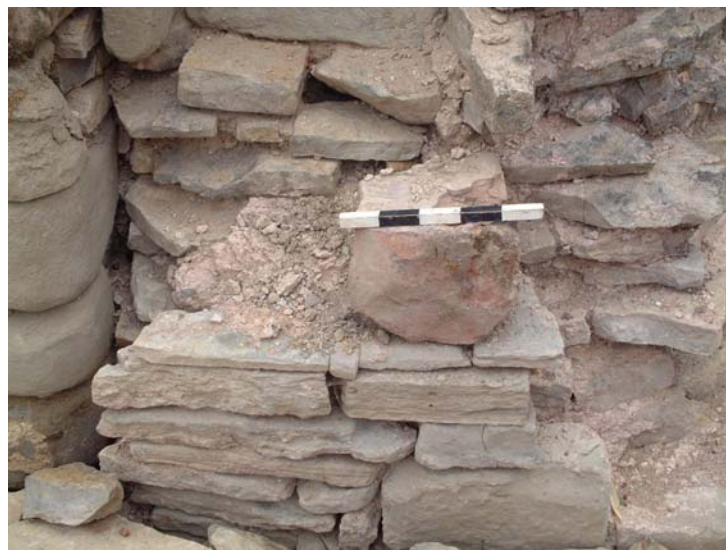
Unfortunately, the north-eastern corner has been subject to rough repair and consolidation in the past, including the re-use of stone. Three fragments of lias show evidence of burning; suggesting they came from a former hearth (Plate 7 below), other stone used includes flat slabs used on end.

Plate 7: *Burnt stone re-used in repair to north-eastern corner. The stonework below is the face of the Phase 4 repair to the wall*

The evidence suggests that when the second structure was demolished, the north-eastern corner of the kitchen, which then became detached, was repaired and consolidated using masonry from the demolished range. The face of this repair can be seen on a slightly different line to the original (2nd phase) eastern elevation.

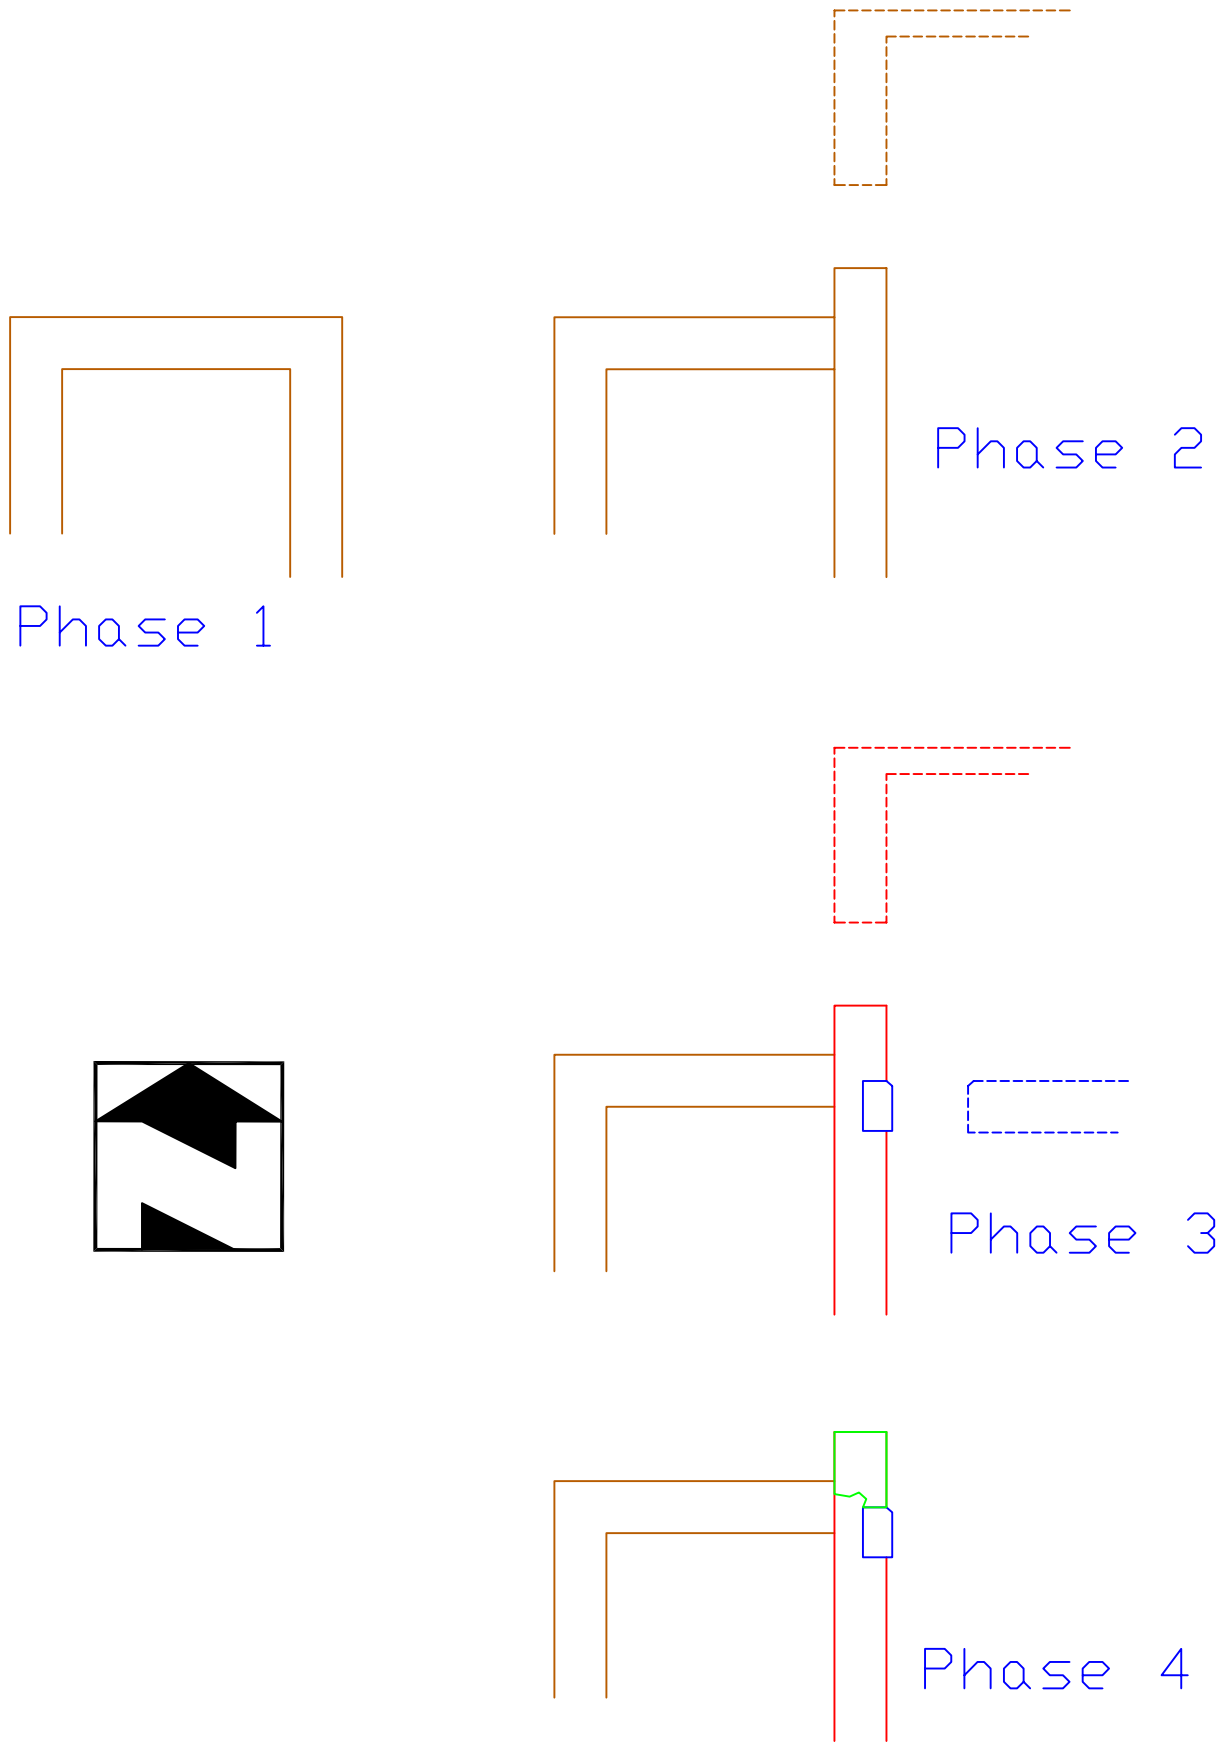
Figure 1: Sketched Phase Plan (not to scale; dotted lines - projected)

This analysis comments only on the fabric and phasing at the north-east corner of the structure. A sketch phase plan is included below (Figure 1).

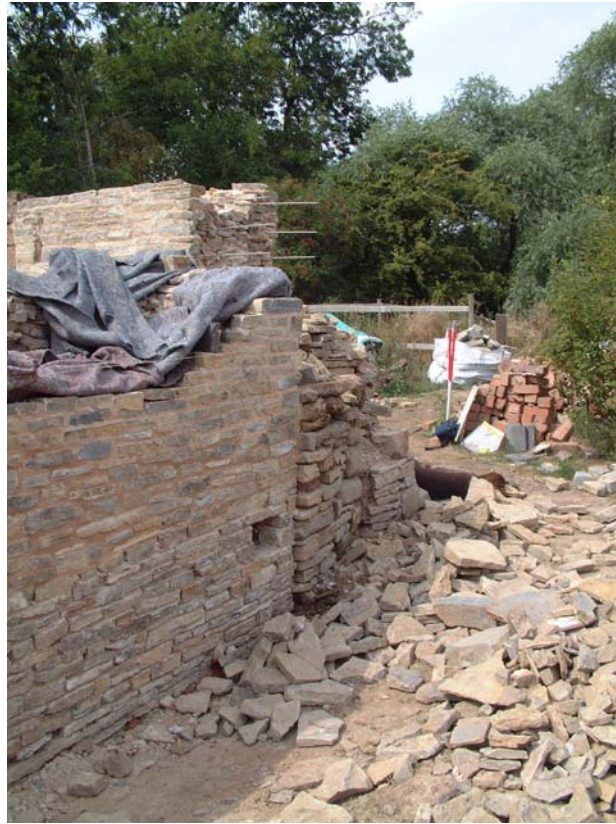
Plate 8:

North-east corner of kitchen looking north-west

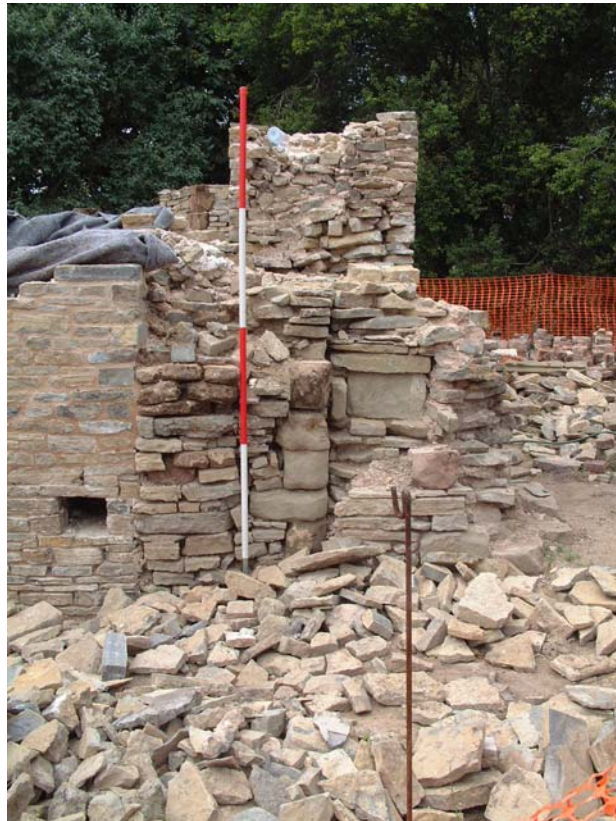
Plate 9:

North-east corner looking west (scale 2 metres)

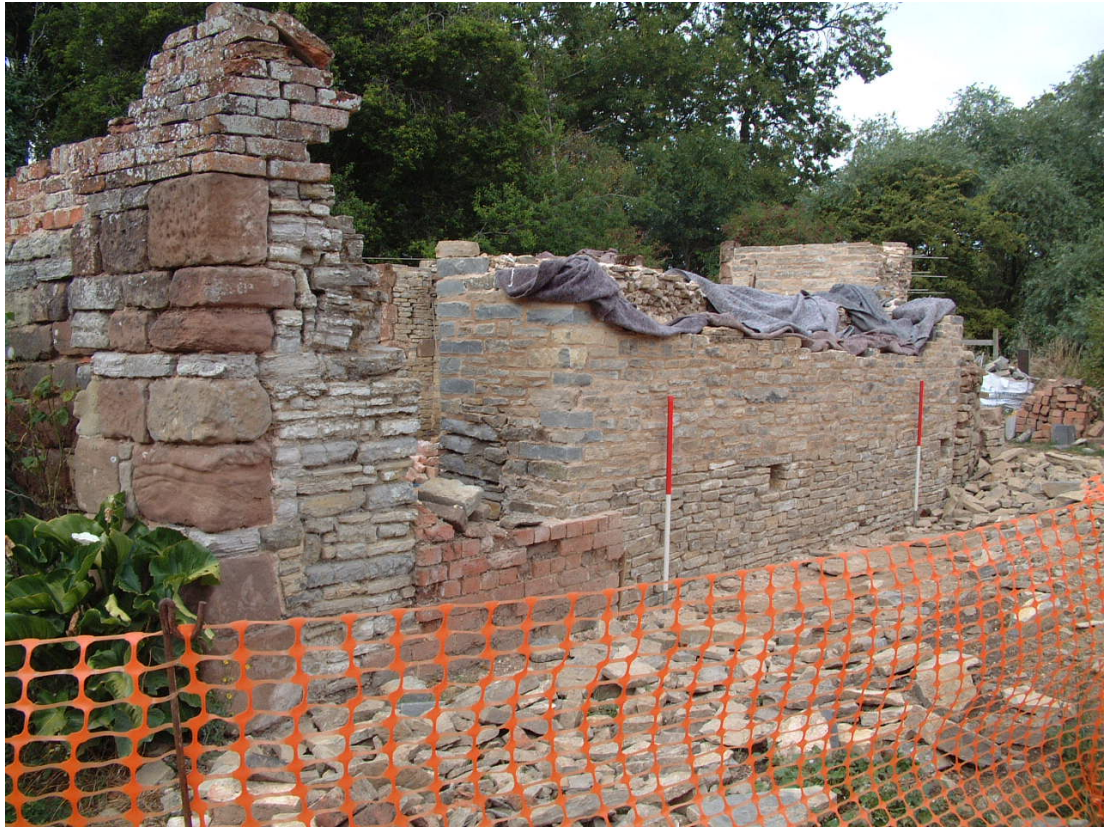
Plate 10:

Eastern elevation looking north-west

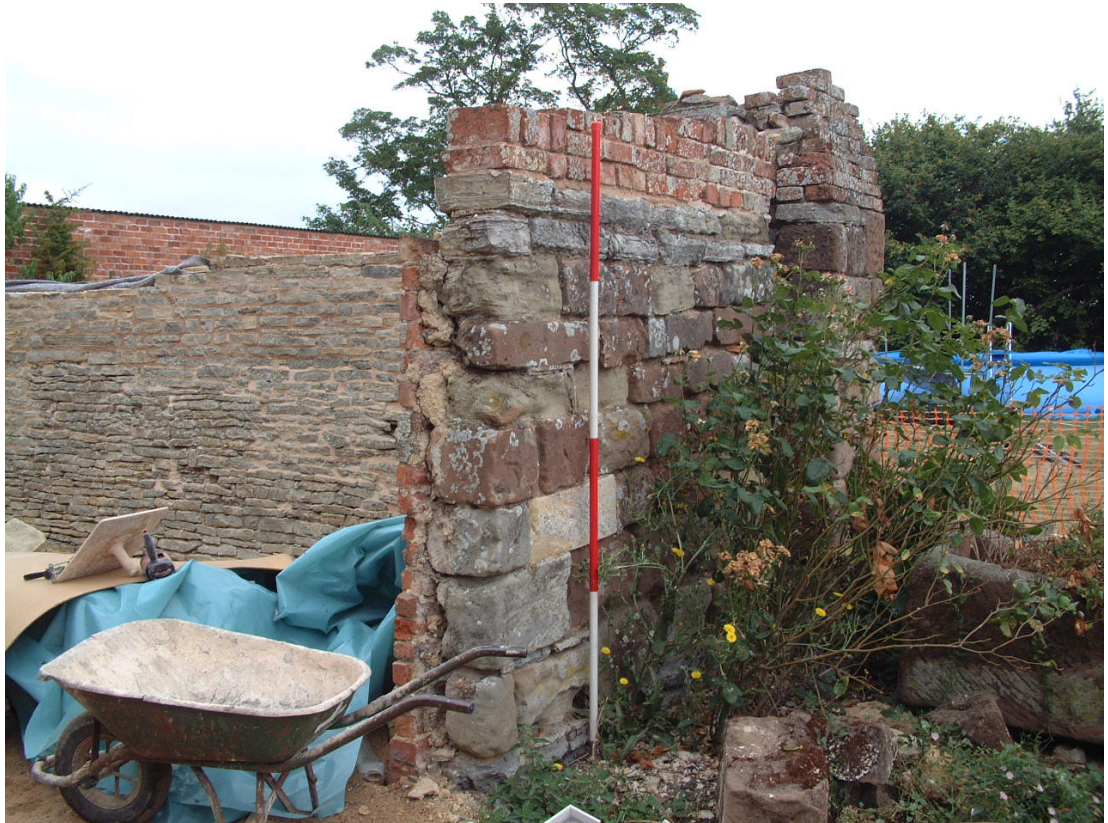
Plate 11:

Ashlar blockwork of the southern elevation, looking north-east (scale 2 metres)

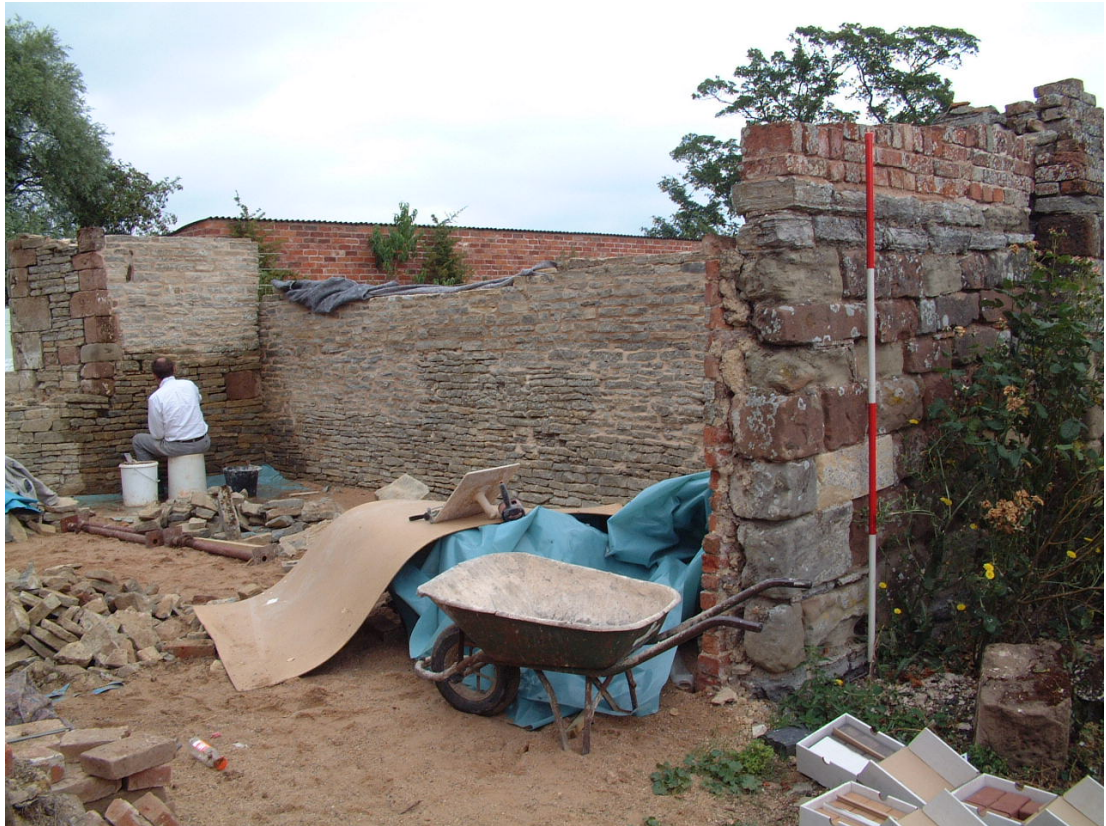
Plate 12:

Internal north-east corner (left of centre) looking north-east

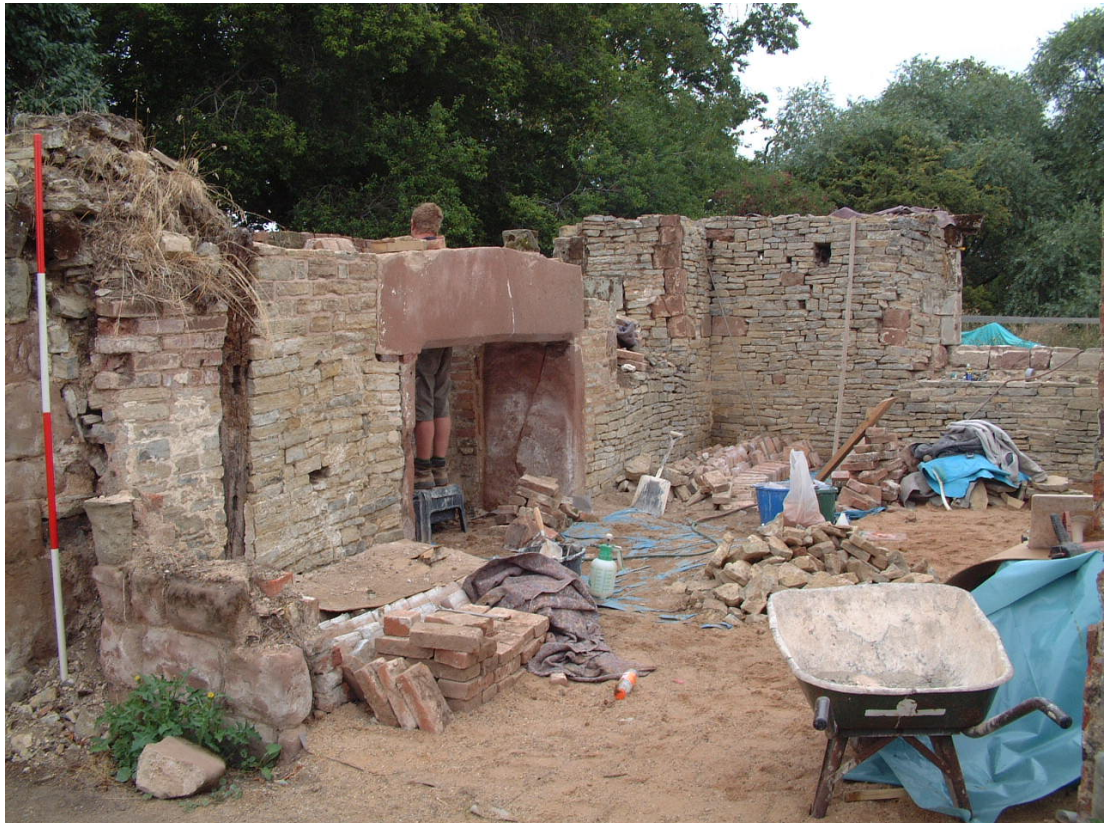
Plate 13:

Internal western elevation looking north-west (scale 2 metres)

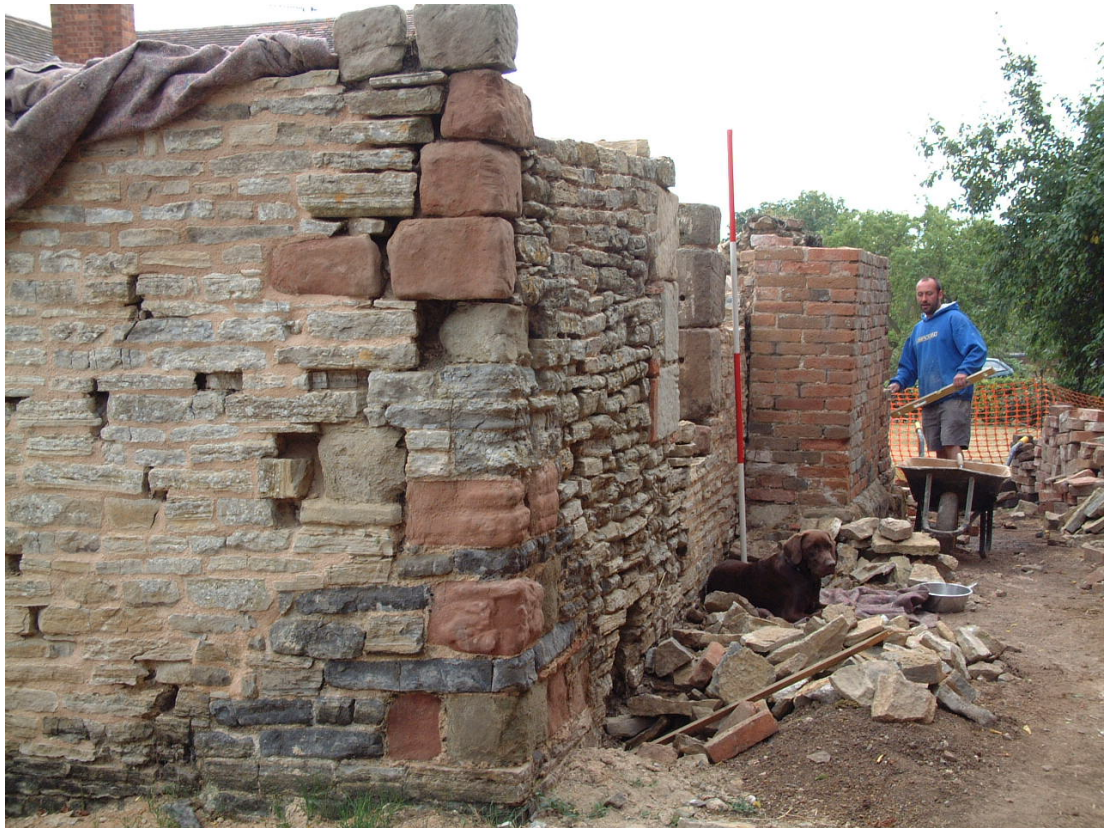
Plate 14:

North-western corner looking south (scale 2 metres)

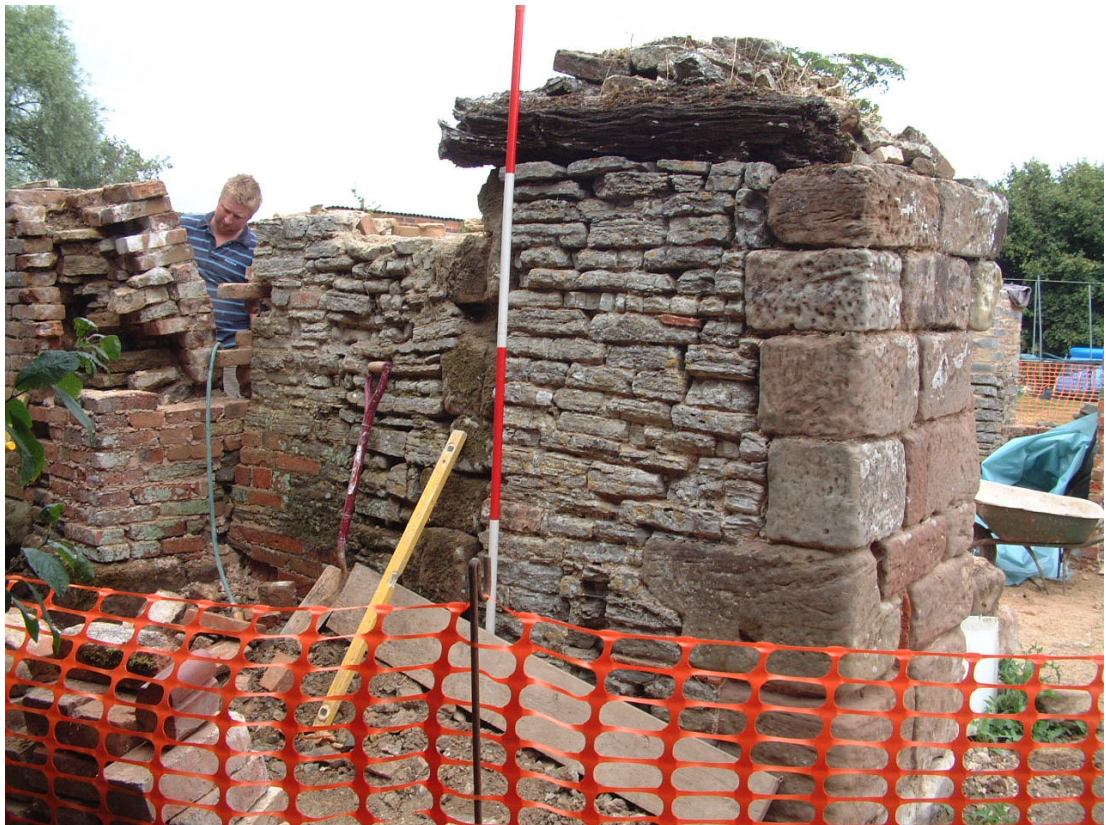
Plate 15:

The south-west corner looking north-east (scale 2 metres)
