*Historic Building Recording at Heathy Mill Farm,
Comberton Road, Kidderminster, Worcestershire*

A report for Mark and Cheryl Blakeway

September 2005

Project: PJ 146

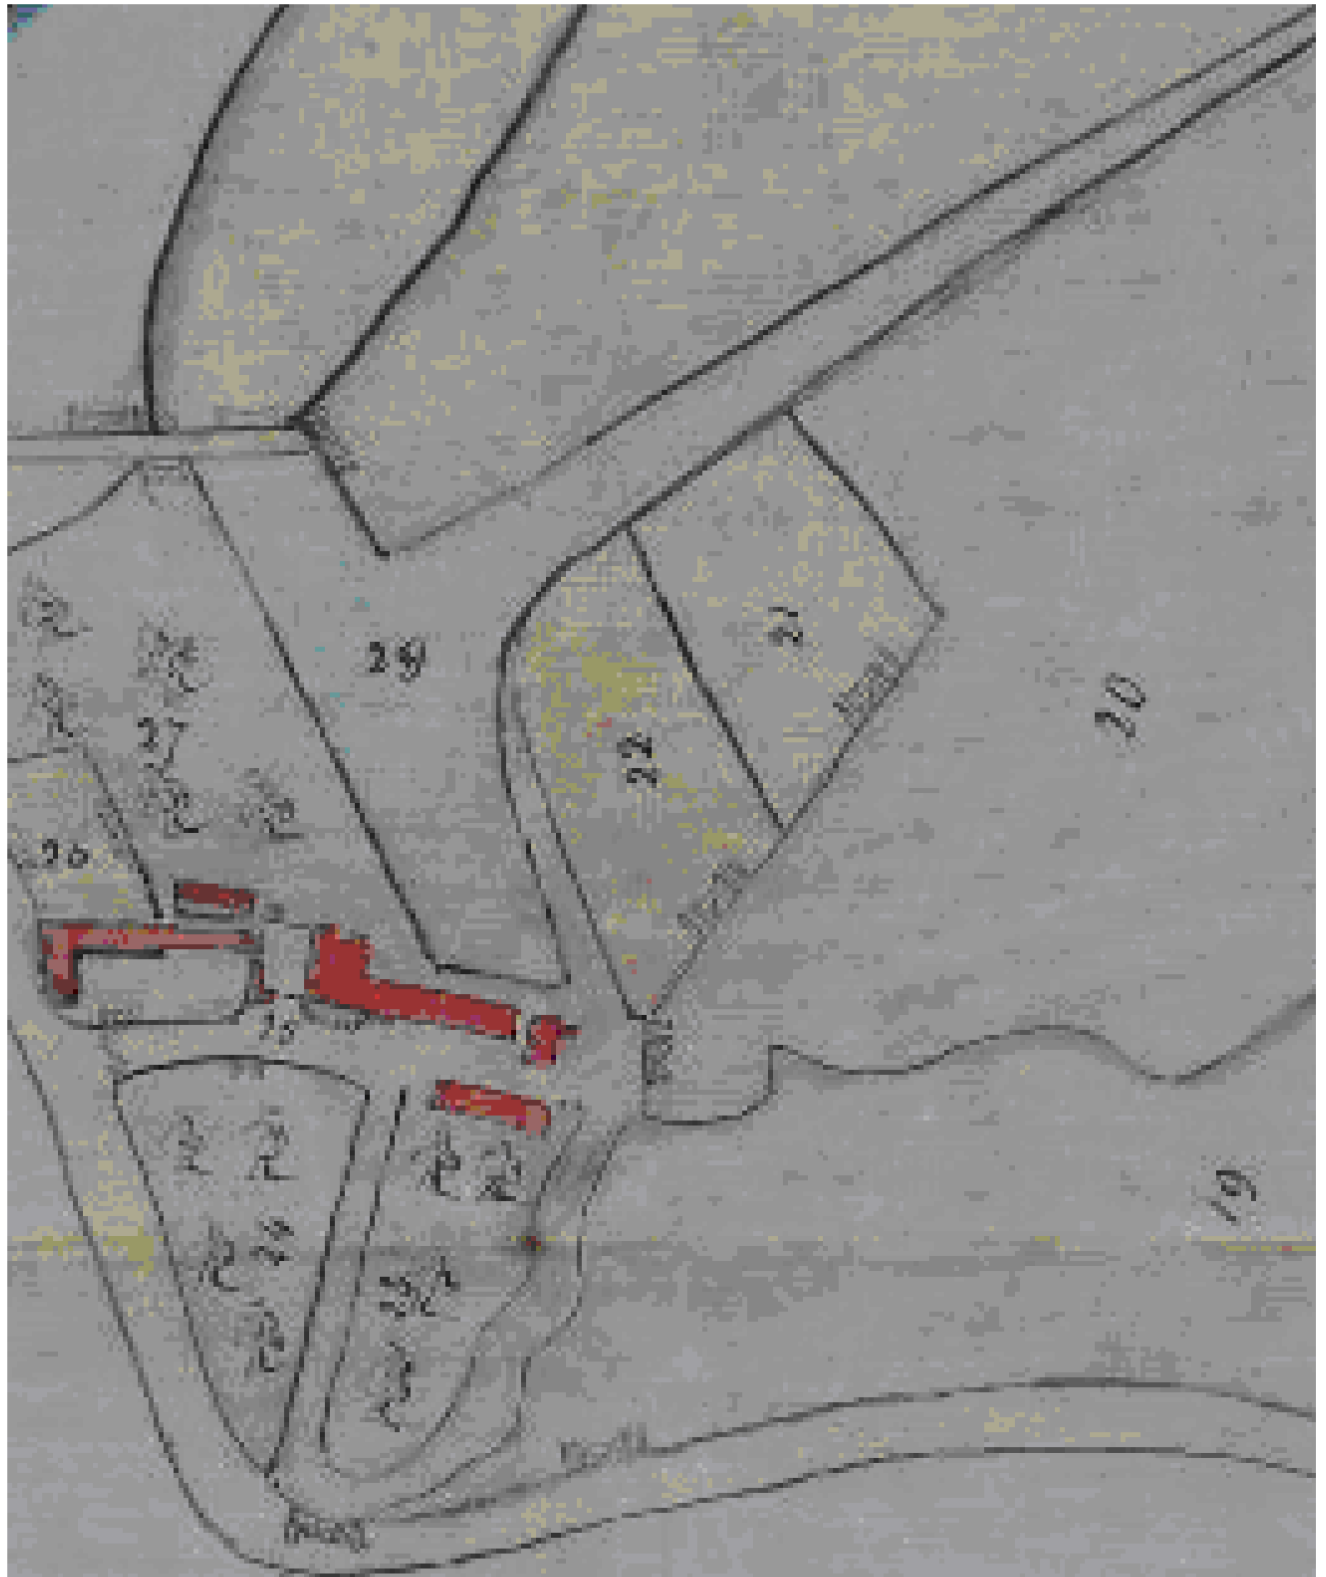
Figure 3: Extract from a Plan of Heathy Farm (1861)

The map of Heathy Farm dating from 1861 shows the mill still in its smaller form.

actually be. The 1861 farm plan clearly shows the mill as narrower than today. The 1885 6th 1st edition Ordnance Survey map shows the mill in its present configuration, with the exception that there appears to be a link building between the mill and the building lately used as a stable (Plate 19), which stands on the west; this also appears on the larger scale 2nd edition Ordnance Survey map of 1902, although now it is gone and the access drive has been routed through this area.

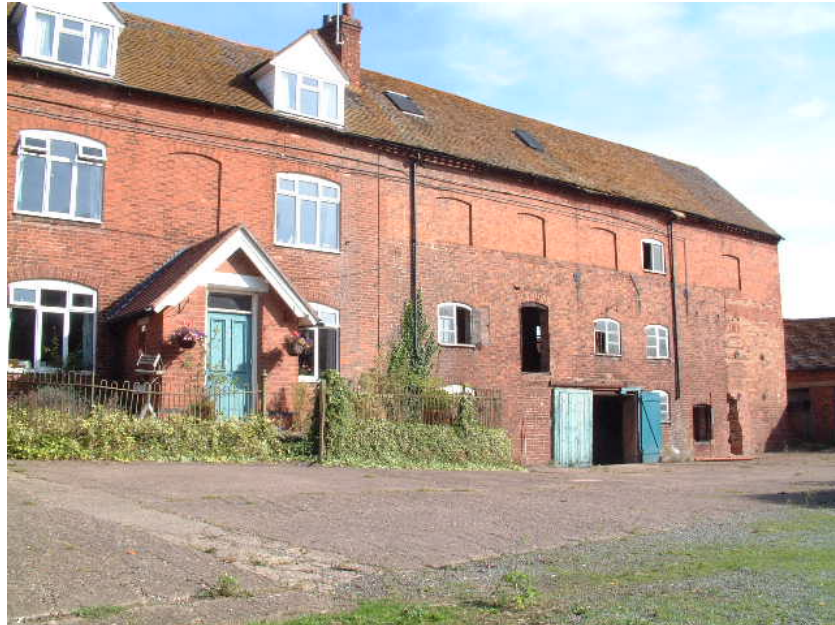
Plate 1

Heathy Mill and farmhouse viewed to the north

The roof is pitched with a hand-made clay tile cover and the gable end is embellished with stepped brickwork. The pitch is slightly higher than the farmhouse at the western end, onto which the mill butts (Plate 1).

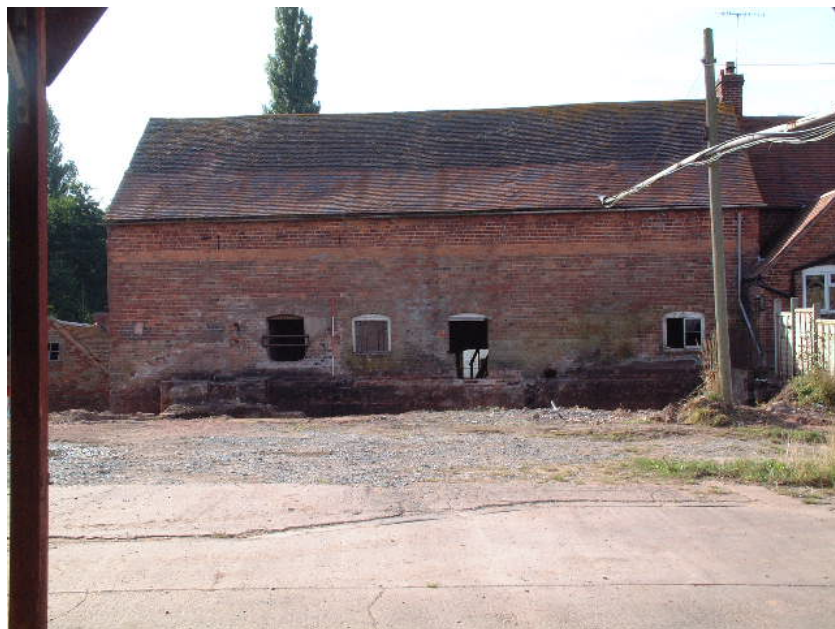
Plate 2

View to the south from the former millpond area

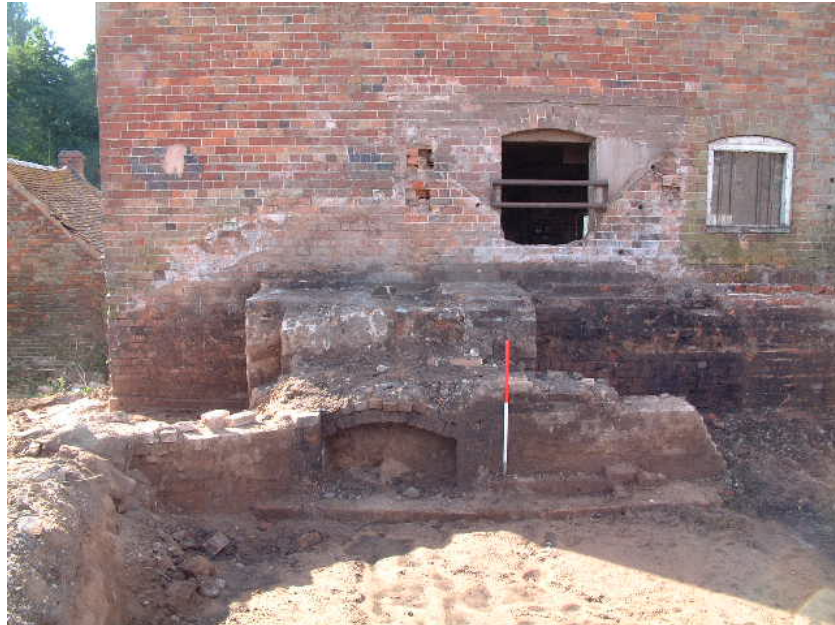
Plate 3

The inlet (penstock) to the rear of the wheel chamber (scale 1 metre)

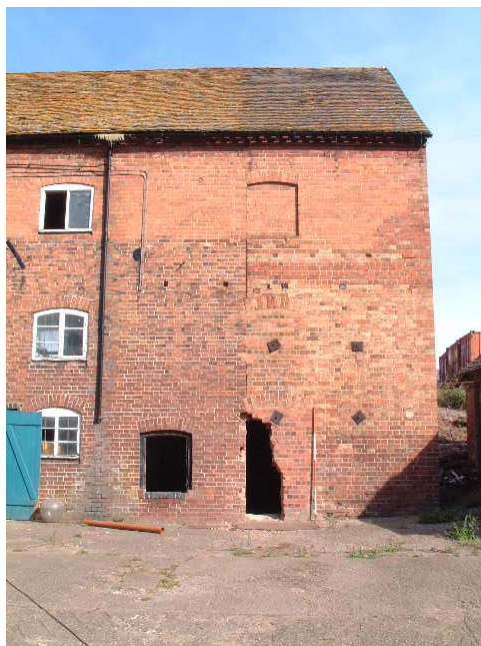
Plate 4

The low aperture marking the position of the pit-wheel, the waterwheel sat in the end bay behind the 2-metre scale

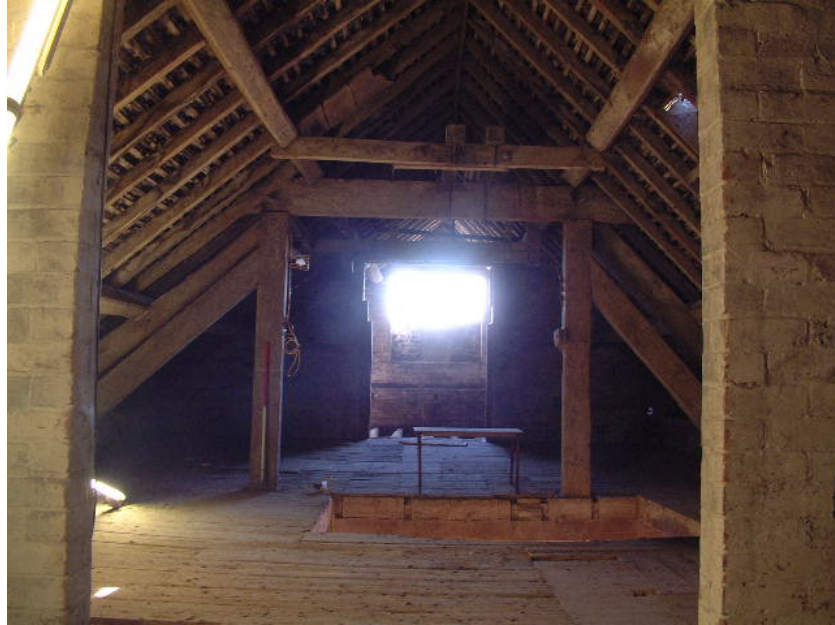
Plate 5

The central truss in the attic floor of the mill (scale 1 metre)

The roof cover is supported by two tiers of trenched purlins raised on full building height partition walls and a central truss. The twin queen struts are raised on a dropped tiebeam with an interrupted tiebeam above (Plate 5). The truss is strengthened by a pair of passing braces on either side, which do not extend past the strainer beam (collar). An 'improvised' frame of re-used timber makes use of the truss and purlins and houses the wheel of a sack hoist mechanism, which would have worked via pulleys worked off water power (Plate 6).

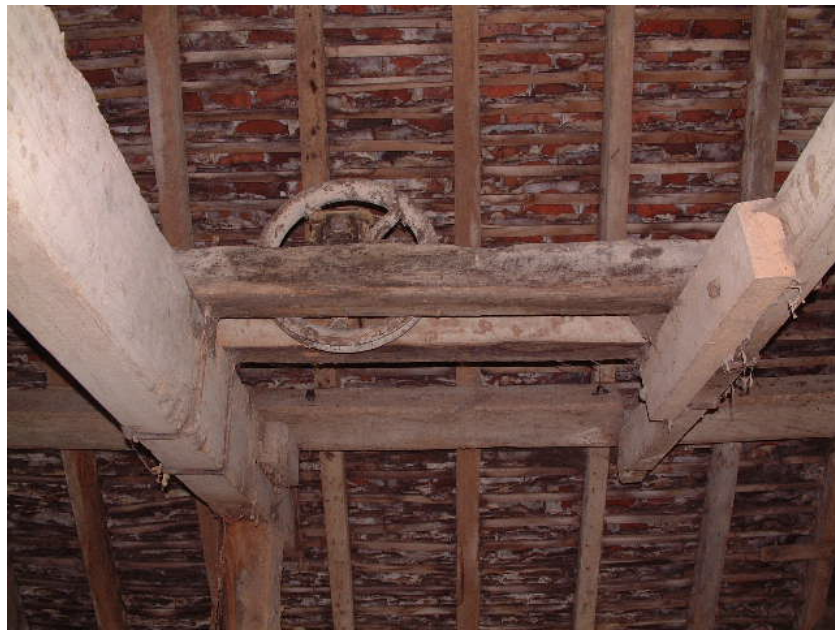
Plate 6

The sack hoist wheel

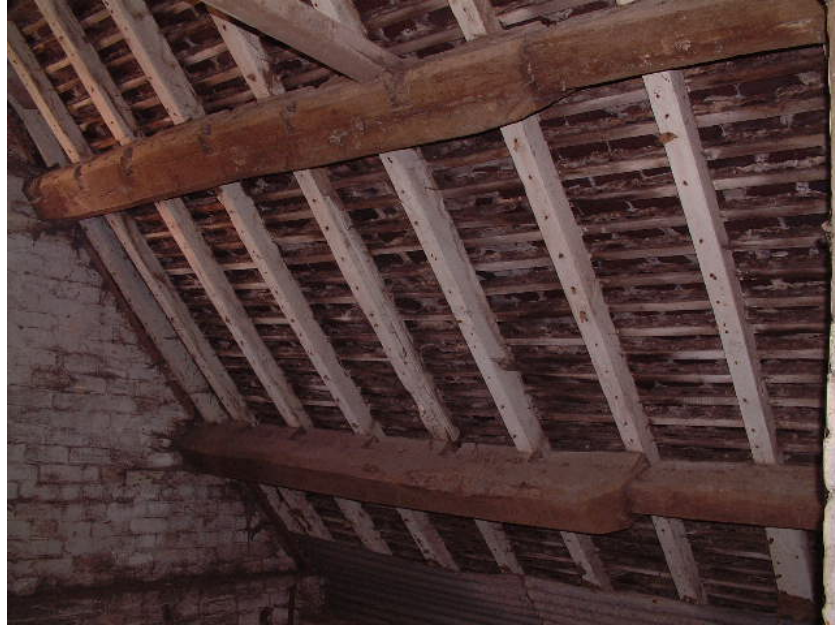
Plate 7

Re-used purlins, note the reduced timber at the ends

The purlins at both ends of the building are re-used timbers from an earlier structure(s). At least two were bridging or axial beams and have sockets cut in to take the floor joists (Plate 7). The beams are reduced at the ends, an unusual feature and the purpose for this is not known.

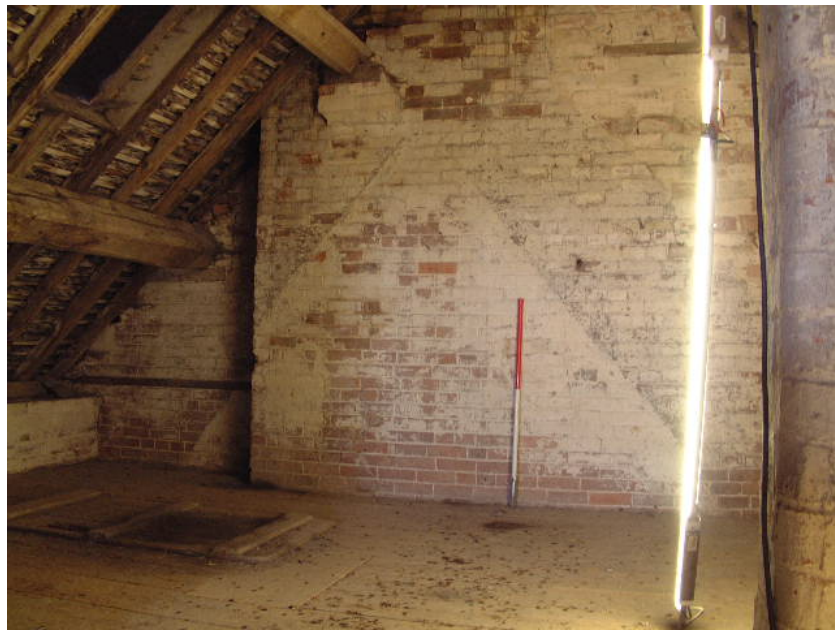
Plate 8

Roofline of the earlier phase of the mill on the gable end of the farmhouse (scale 1 metre)

The apex of the earlier roof to the original smaller mill building can be seen in shadow against the external chimneybreast of the farmhouse on the western side (Plate 8). The roof lights may be contemporary with the build, but are more likely date from the early 20th century; they are shown on the photograph of 1918 (Plate 20). The eastern end bay also has evidence of 20th century use and modification, with aluminium hopper heads having been inserted into cut slots in the floor. These were used during the post 1950 life of the building as a granary. There is an aperture in the gable end, which more likely relates to a function of loading, rather than for light, although there is no evidence of a lucam on the elevation (overhanging hoist porch).

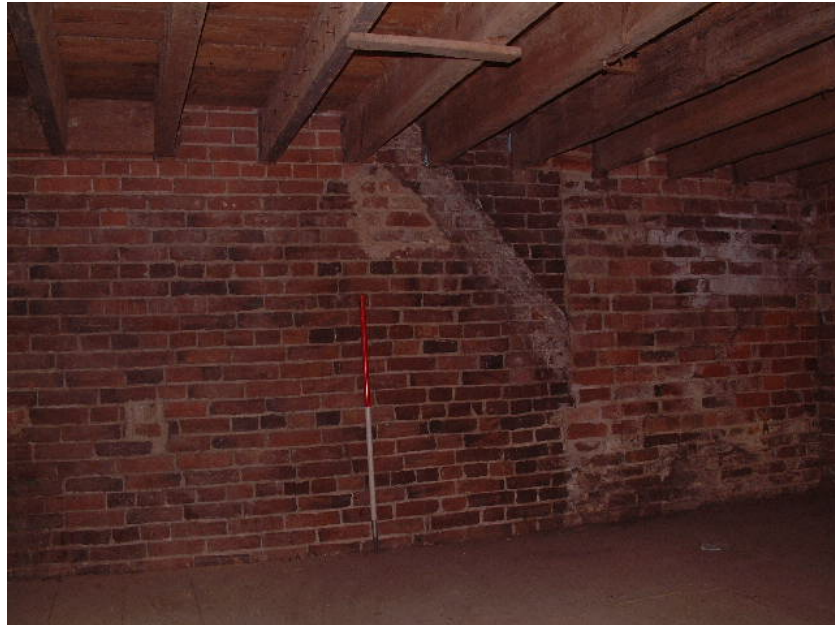
Butt joint of the mill extension to the north and former roofline at 2nd floor level (scale 1 metre)

The evidence at second floor level indicates that the building has been widened as well as heightened by a story. It also demonstrates that these modifications were carried out at the same time, Plate 9 shows the shadow of the former roofline at this level and also the later brickwork of the extension butted onto the northern side. This is not visible externally as the

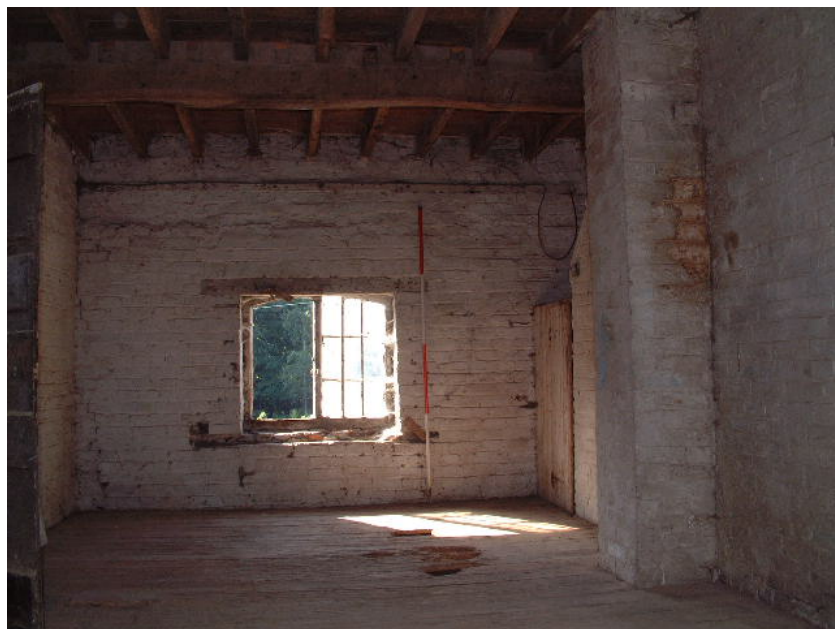
Plate 10

Western end bay of floor 1 (scale 2 metres)

A chimneybreast that serves the fireplace at ground floor level at the western end (see below) can be seen butted onto the chimneybreast of the adjoining farmhouse (Plate 10). This does not extend to the second floor and so must be punched through the wall to share one of the flues in the farmhouse chimney. This is further evidence that the mill is later than the farmhouse. Also at the western end there is a blocked in window below a rough brickwork retaining arch and a doorway (Plate 11). This indicates that the window was originally an external window to the farmhouse, which was bricked up when the mill was extended across the aperture. The doorway is below a timber lintel and must have been punched through the farmhouse wall after the extension of the mill. This door provided the only direct access between the two separate structures.

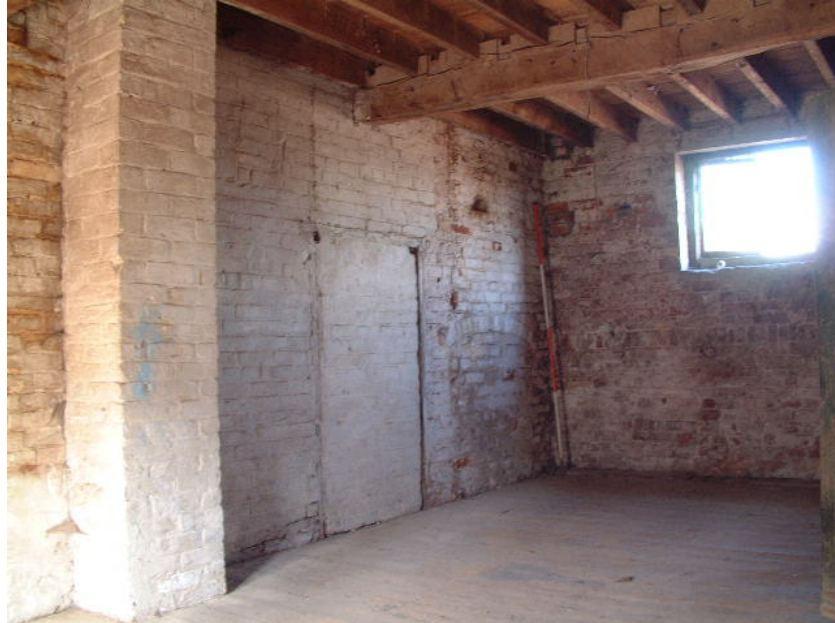
Plate 11

Blocked former window to farmhouse and blocked doorway between farmhouse and mill (scale 2 metres)

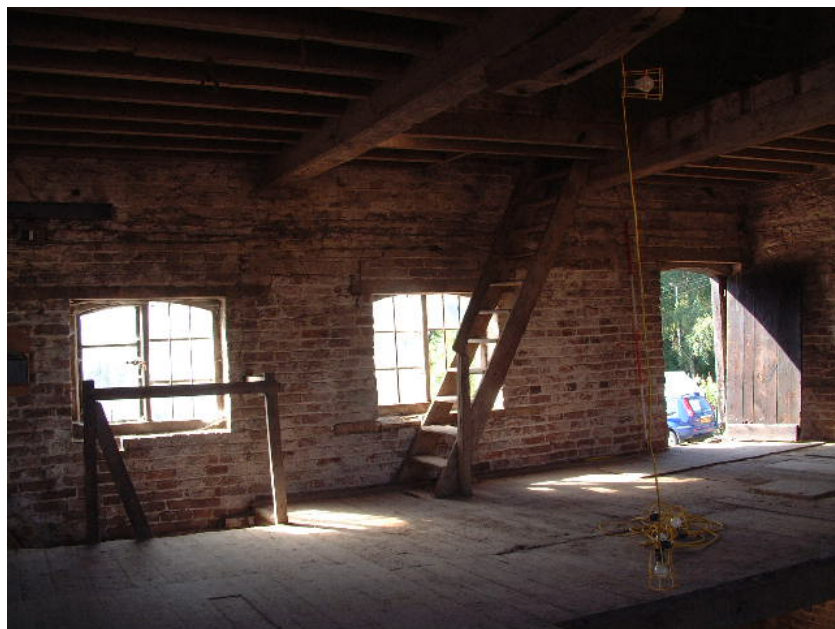
Plate 12

First floor showing steps up and down and loading door (scale 2 metres)

The floor boarding at this end has been replaced during the 20th century, probably as the ingress of water from above rotted the earlier boards. The remainder of the area is in good repair and appears original. There are steps up and down adjacent to the southern elevation and the loading door and windows are still open, giving light to the floor (Plate 12).

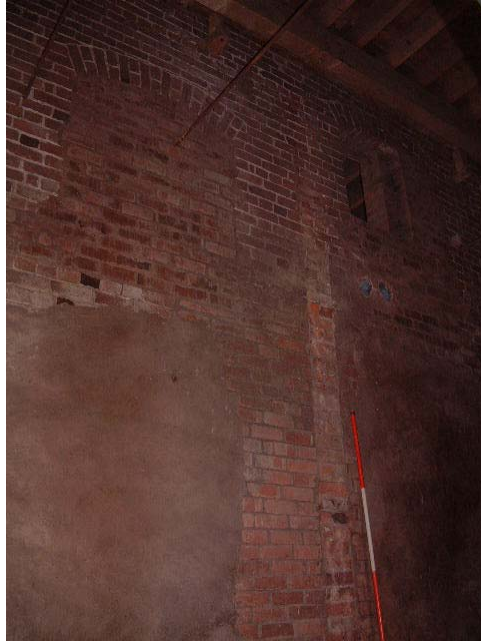
Plate 13

Blocked apertures at first floor level above wheel chamber. Wall scar is a modern feature (scale 2 metres)

At the eastern end, there is a blocked window, which would have looked out over the waterwheel prior to the extension of the building and an aperture, which suggests a doorway, although as there is not a floor at this level on the opposite side is more likely an opening that served a maintenance purpose (Plate 13).

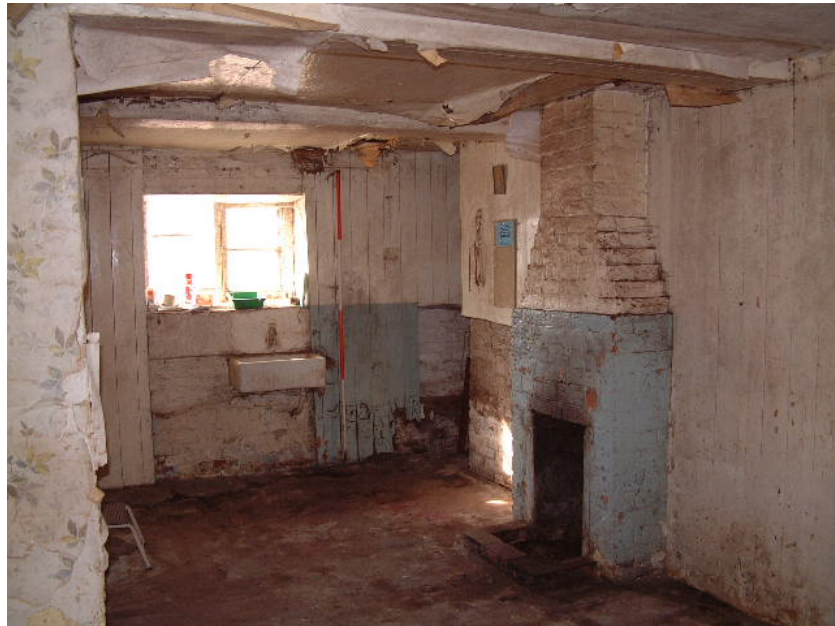
Plate 14

Room lately used as part of cottage in western end bay at ground floor. Possibly, this was an earlier overseers office (scale 2 metres)

The western end bay of the lower floor was used as part of a 'cottage' in recent times. The chimney described above (first floor) carries down to a brick fireplace and hearth. There is a small Belfast style sink in front of the window in the southern elevation. The space still had wallpaper and wood panelling, highlighting its recent use (Plate 14). Parts of the lower levels of the adjacent farmhouse walls, visible in this space, are built from large ashlar sandstone blocks (Plate 15). These must have been re-used from an earlier building, as there is brick below and above this level and the white limey mortar of the build appears to be of one phase. It is not unusual, especially in farm or industrial buildings, that handy and readily available materials from earlier buildings would be used.

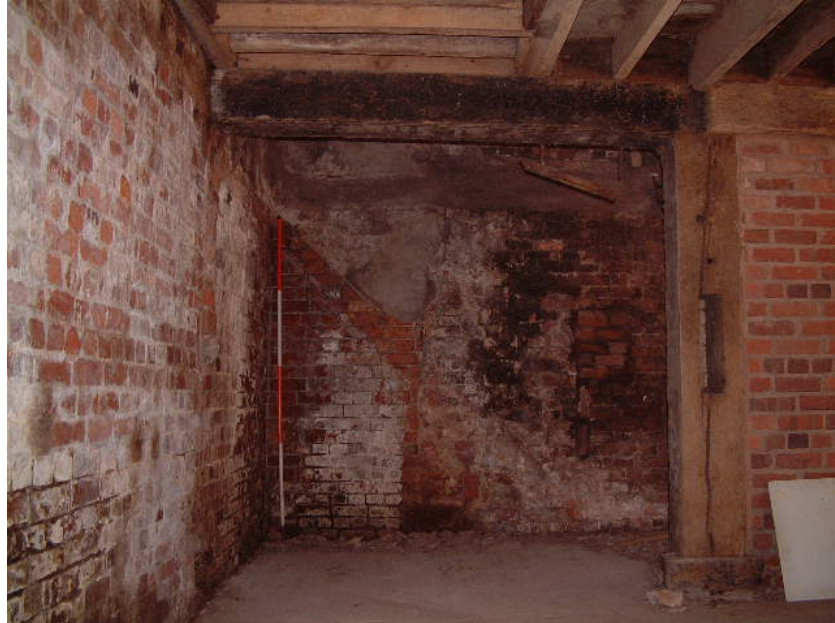
Plate 15

Alterations in the eastern bay for modern grain processing infrastructure (scale 2 metres)

The eastern end of the ground floor shows evidence of much alteration and disturbance, some relating to modern use of the space as a granary (Plate 15). Notably, the bridging beam at the far end of the space has been cut and some of the joists removed to allow a modern grain chute to be constructed inside; this has now gone. The beam has been supported by a brick pier, which is part of a modern dividing wall, which has also been partially demolished. There are two posts socketed into the remainder of the beam, each with a large rectangular rebate (plate

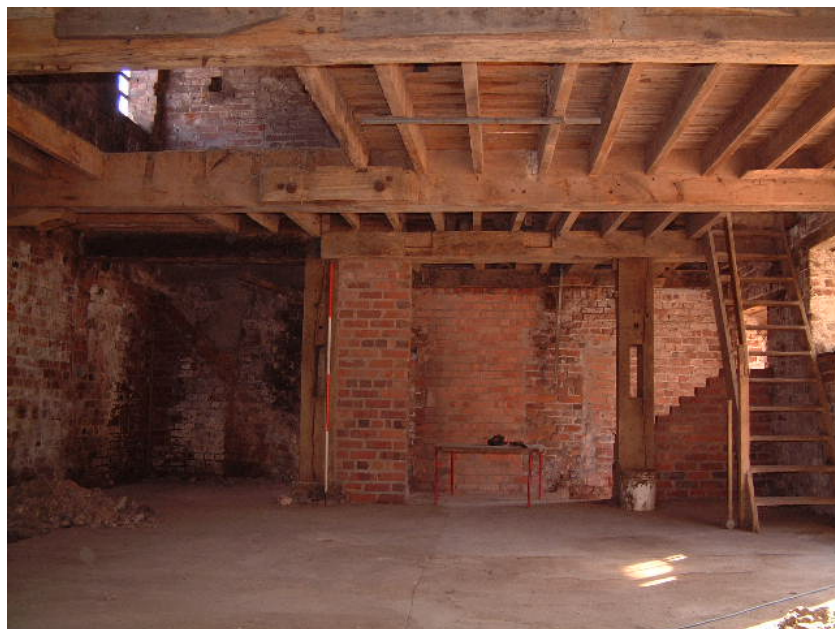
Plate 16

Timbers of the former 'hurst-frame' at the eastern end of the ground floor (scale 2 metres)

16). These are part of the remains of the 'hurst frame', which would have supported the gearing after the main waterwheel.

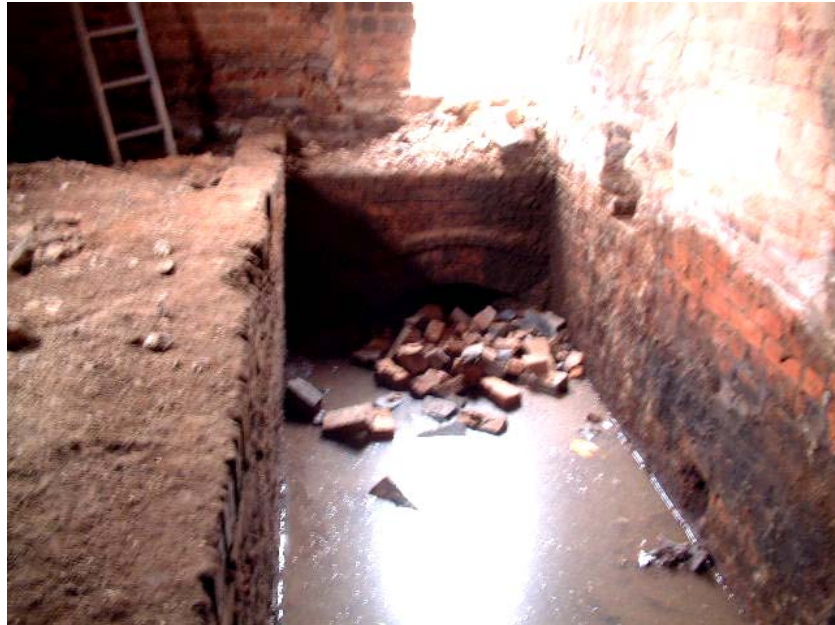
Plate 17

The partially excavated wheel chamber looking south towards the drain

Originally the waterwheel was external, but it was enclosed when the mill was enlarged. The wheel chamber was partially emptied at the time of the survey and to the depth that it was visible, was constructed of brick with a brick arched outlet (Plate 17), which is culverted under the yard and back to the watercourse to the south. The space above the wheel chamber at second floor and attic level has been utilised with the floors extended over the space. Cement render hides the water inlet, in which a timber launder (water chute) would have sat at the inner side of the penstock. Modern cement render and also hides detail on the inner (western) wall of the wheelhouse. There was originally an access through the eastern gable end of the building, the majority of the external face of which is now covered by the raised bank that provides the driveway to the lower levels to the south (Plate 18). This doorway would originally have provided access into a link building between the main mill and the detached building on the east, which has lately been used as a stable (Plate 19).

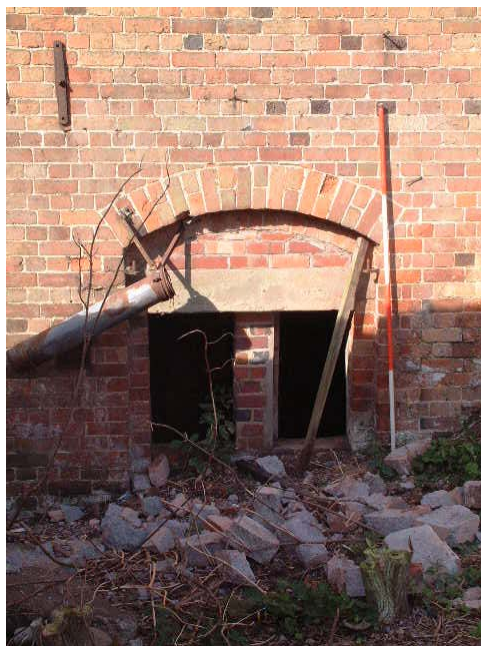
Plate 18

Former door into link building (now gone), which was between the mill and the building lately used as a stable (scale 2 metres)

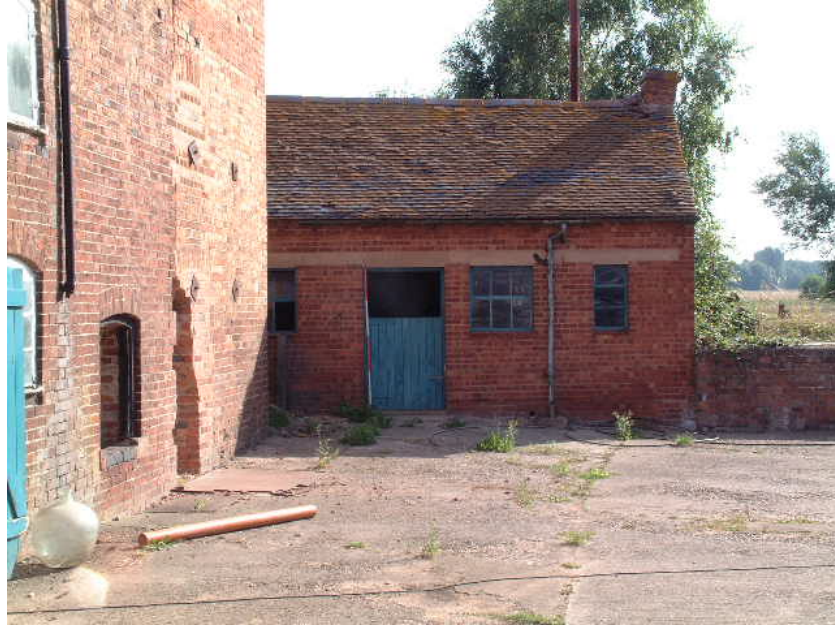
Plate 19

The stable block at the eastern end of the mill (scale 2 metres)

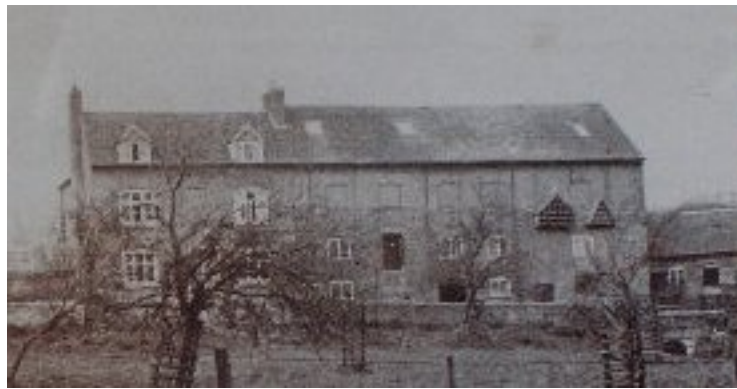
Plate 20

The mill and farmhouse viewed to the north from a photo dating to around 1918 (Photograph kindly supplied by Mark Blakeway)

The documentary evidence sheds some light on phasing and dates of construction, alteration and demolition. The photograph, dated to before 1919 (Plate 20), shows the extended and heightened mill. The link building between the mill and the present stable had by now gone. Detail of the mill shows two dovecotes on the wall at the eastern end. The watercolour painting of the mill and farmhouse (Plate 21) sheds a little more light with regard to dating. The house is shown before the porch was added to the frontage and as the porch appears on the 1902 map, the depiction can be dated to before this. The painting shows a typical large panelled Georgian style door and overall evidence from the fabric of the house suggests it is transitional (Regency) in style and may be dated to approximately 1790-1800. The frontage is 'grander' than the rear, with larger window apertures and a pair of gabled dormers to the attic. This indicates that the mill dates from between circa 1800 and 1838 and is more likely to date from around 1810-1820, as the style of window and lintel matches those used to the rear of the farmhouse. A deed of 21 years in length dating from 1820, for the spinning of yarn at the mill (Simmons quoted in Gwilliam 1980), suggests that 1820 is an acceptable date for the first turning of the waterwheel.

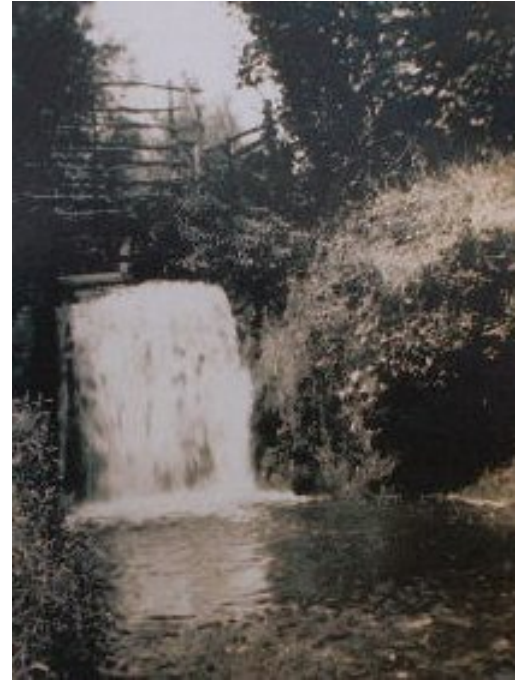
Plate 21

The weir overflow from the millpond in a photograph taken around 1918

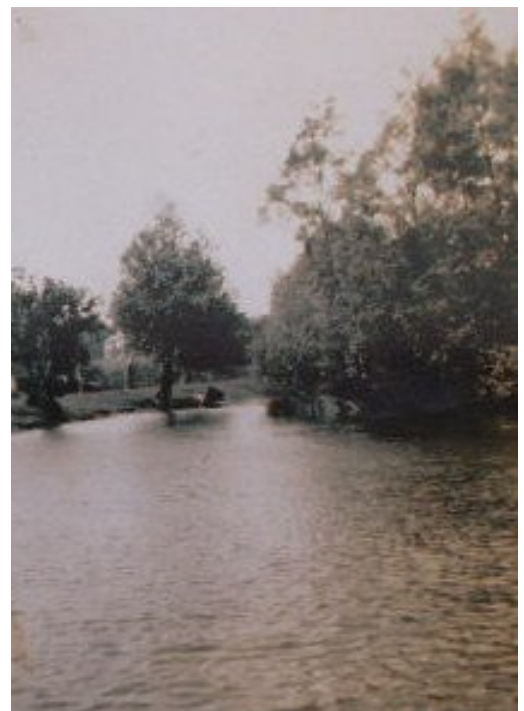
Plate 22

The millpond viewed from the mill from a photo dating to around 1918 (Both photographs kindly supplied by Mark Blakeway)
