*Historic Building Recording at Mearse Farm,
Inkberrow, Worcestershire*

A report for WeatherArk Ltd

October 2005

Project: PJ 147

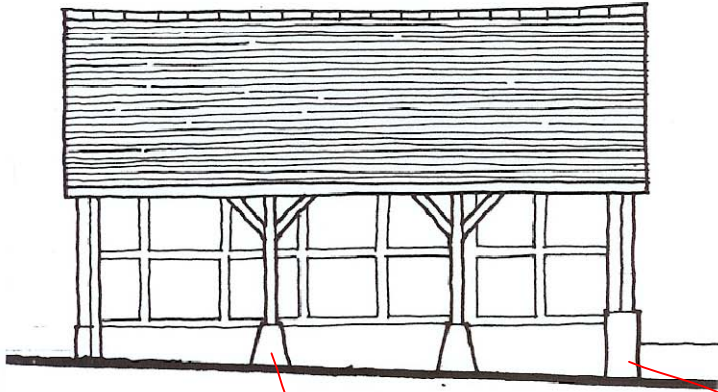
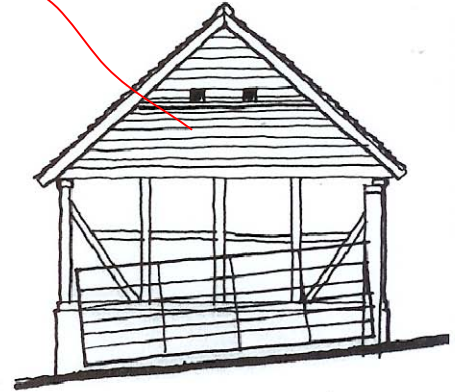
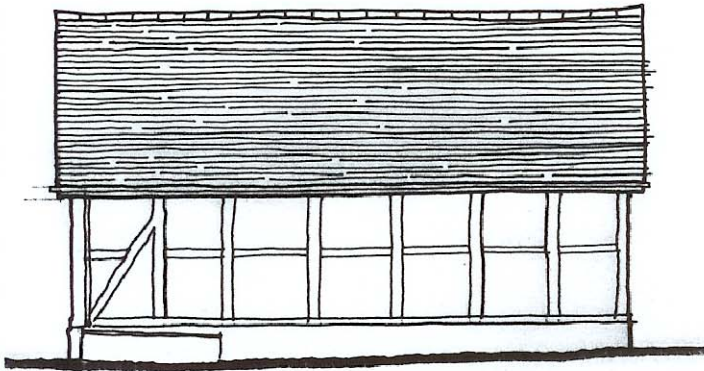
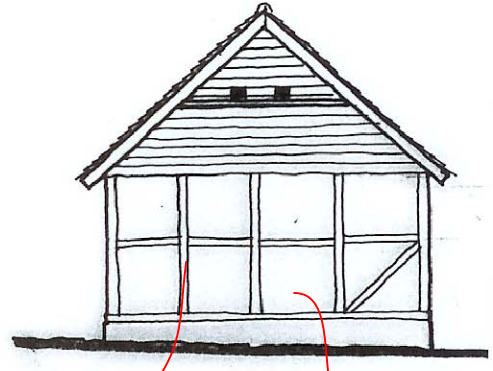
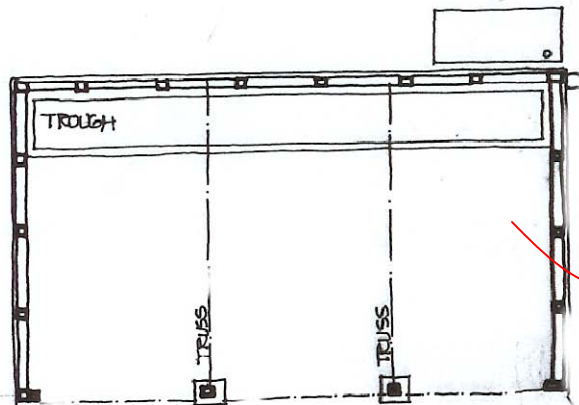
Figure 6: Building 1, former shelter-shed

Stone post-pads

Pigeon loft inside

Stone dwarf wall

Slender timber framing

Brick infill

Pigeon loft over

Building Number 1 was not part of the required building recording as specified in the brief, however, as the building was to be altered it was recorded as a matter of course. It stands on the northern perimeter of the farmstead aligned south-east to north-west. The structure represents a rectangular, former three-bay shelter shed (animal shelter / cowhouse), open on the south-western side. The building is of timber frame on a stone dwarf-wall with a pitched clay tile roof (Plate 1). The infill panels to the frame are constructed from a combination of 2 ½” and 3” brick between slender timber rails nailed to the uprights. The posts below the bridging beam to the open side stand on stone blocks, which may be re-used ‘staddle stones’ from a granary building, which is not now upstanding on the site. The roof trusses are of king post with the principals pegged to the tie beams with a single peg. One truss (3rd from the eastern gable –Truss T3) shows evidence of having been fabricated from earlier timbers of a timber frame structure, it displays better quality than the waney edged timbers of the other trusses and has empty mortises and peg holes on the underside of the tie-beam (Plate 2); there is evidence that various other timbers are also re-used. Scribed carpenters marks can be seen on trusses T2 and T4. A dovecote or pigeon house (Plate 3) is located in the rafters between trusses T1 and T2 with access for the birds in the south-eastern gable end. The floor is of rammed earth and small stones and a concrete feeding trough survives at the rear of the shed.

The fabric evidence suggests an 18th century date of construction and the building is all of one phase, apart from evidence for some later repairs.

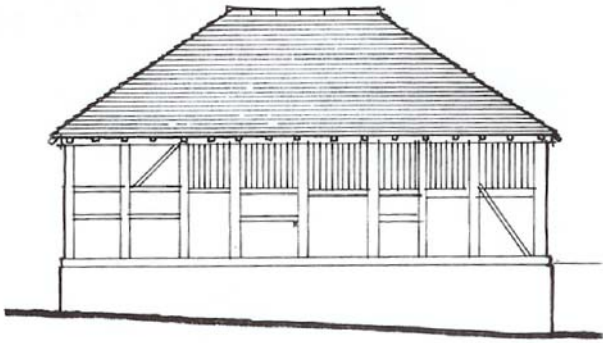
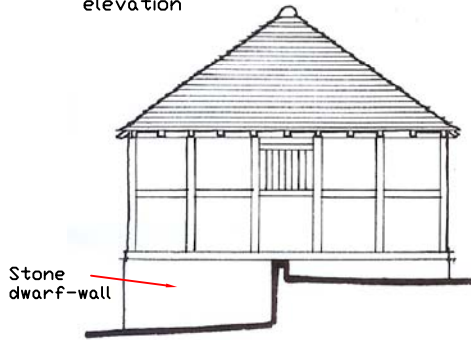
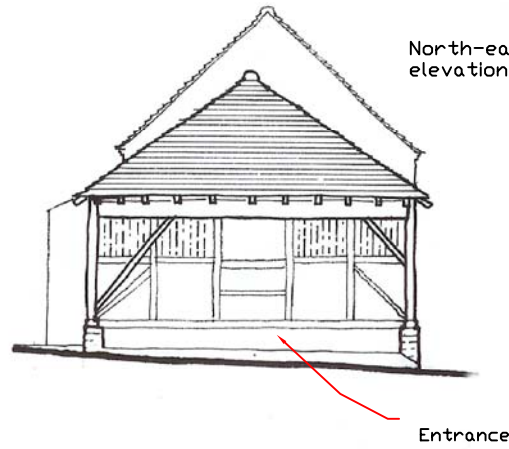
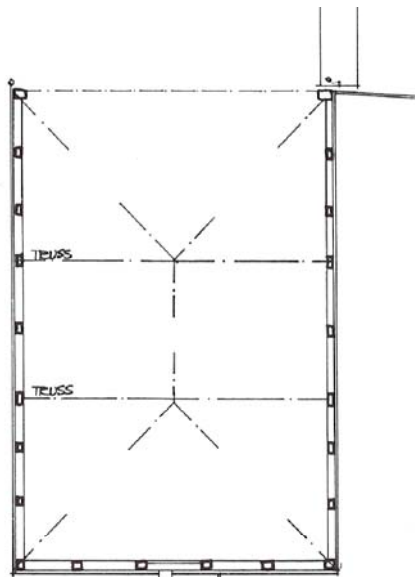
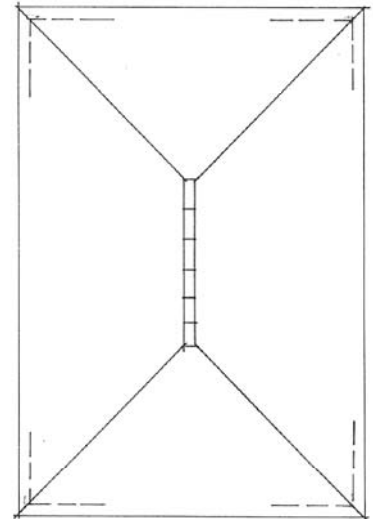
Figure 7: Building 2, former cartshed

Plan

Building Number 2 stands on the north-eastern side of the site, opposite Building 1. It is of a similar basic construction as Building 1, of timber-frame with brick noggin sitting on a stone dwarf wall, which was rough coursed at lower levels and ashlar faced below the sill beam. The building was formerly a cart or implement shed, open on the northern side. The roof is hipped at both ends (Plates 4 and 5).

This building showed extensive re-use of timber from an earlier timber-framed building. The kingpost trusses of the build have been carpentered from earlier queen-post trusses and have also been narrowed from the original span. The northernmost truss has empty mortises and peg holes in the tiebeam and also stave holes, indicating that the original building was wattle and daubed, rather than the panels being infilled in brick as in the current build (Plate 6). One interesting detail can be seen below the tiebeam of the same truss. The carpenter had scribed the position for the mortise to be cut in for a brace to the supporting post (for the timbers original use) but made a mistake with the measurements and subsequently scribed a cross to highlight the mistake (Plate 7). Other reused timbers can be seen within the wall-frames, one

The fabric of Building 2 suggests an 18th century date of construction, probably contemporary with Building 1 and similarly the building is all of one phase, apart from later repairs and consolidation.

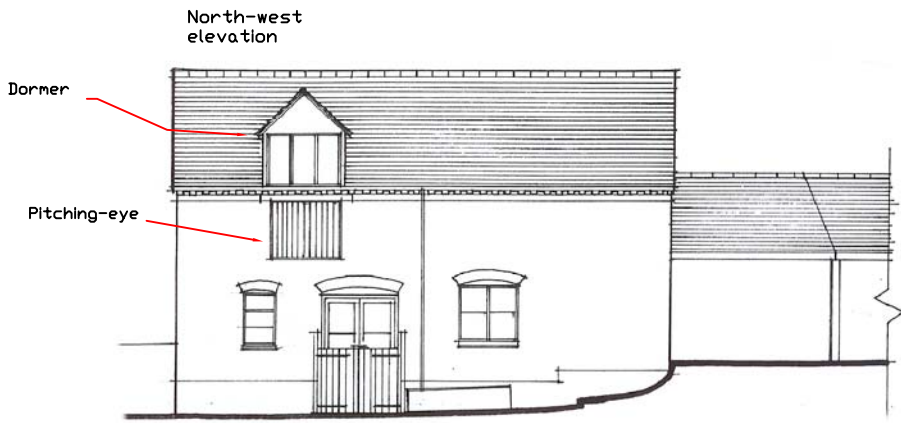
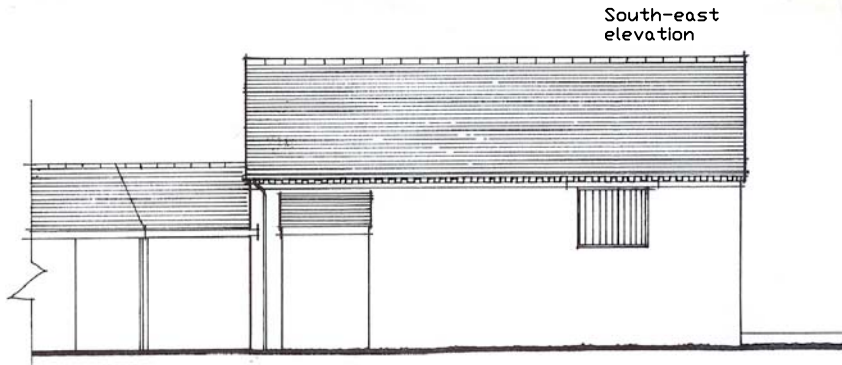
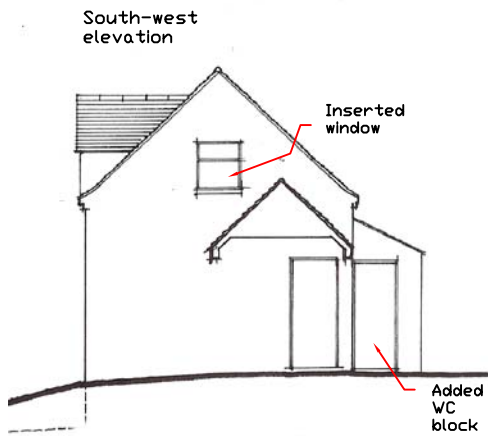
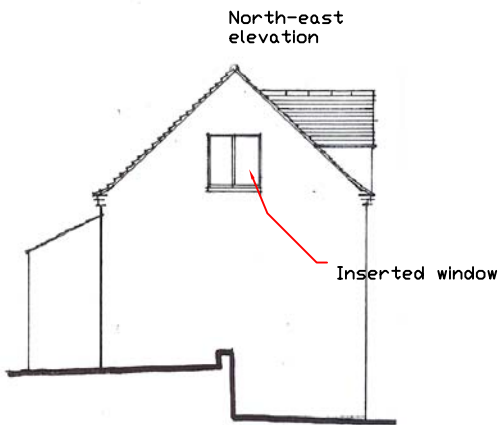
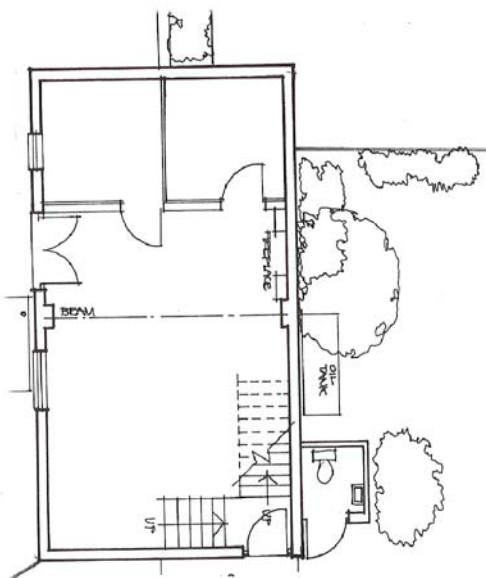
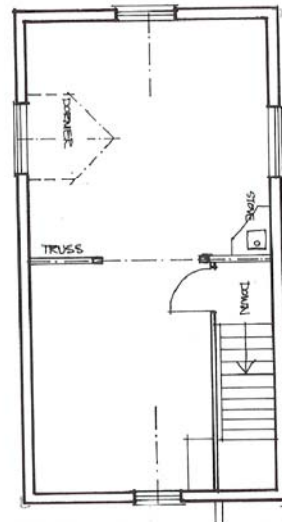
Figure 8: Building 3, former stable and hayloft

Plan

Building 3 is located to the south of Building 2 on the same alignment. The building is a two storied brick and sandy lime mortar construction, coursed in a variation of English bond, with three rows of 9 x 3 inch stretchers to each row of headers. The roof is pitched handmade clay tile with an inserted dormer window on the western side (Plate 10).

Internally, there is nothing of significant architectural interest, as it seems the building had most recently been used as domestic accommodation, or perhaps office space, with boarded and plastered walls and boarded out upper floor with modern concrete to the ground floor.

Originally the building would have been a stable with a hayloft above. The eastern and western elevations have pitching doors at upper level, where hay would be pitched into the building from the top of a cart pulled alongside. This could then be dropped down into the stable as required. The original stable door in the western elevation has been replaced with a modern 'French' type door and the original slat vented window to the stable area has also been replaced. The smaller aperture on the western elevation was probably a window to a tack-room within the stable, which has also gone. A window has been inserted into the upper level of each gable end and there is evidence for a single story extension (now gone) at the southern end (Plate 11). A modern lean-to WC has been butted onto the eastern elevation at the southern end.

A mid-19th century date is proposed for this structure, with alteration to domestic accommodation in the middle decades of the 20th century.

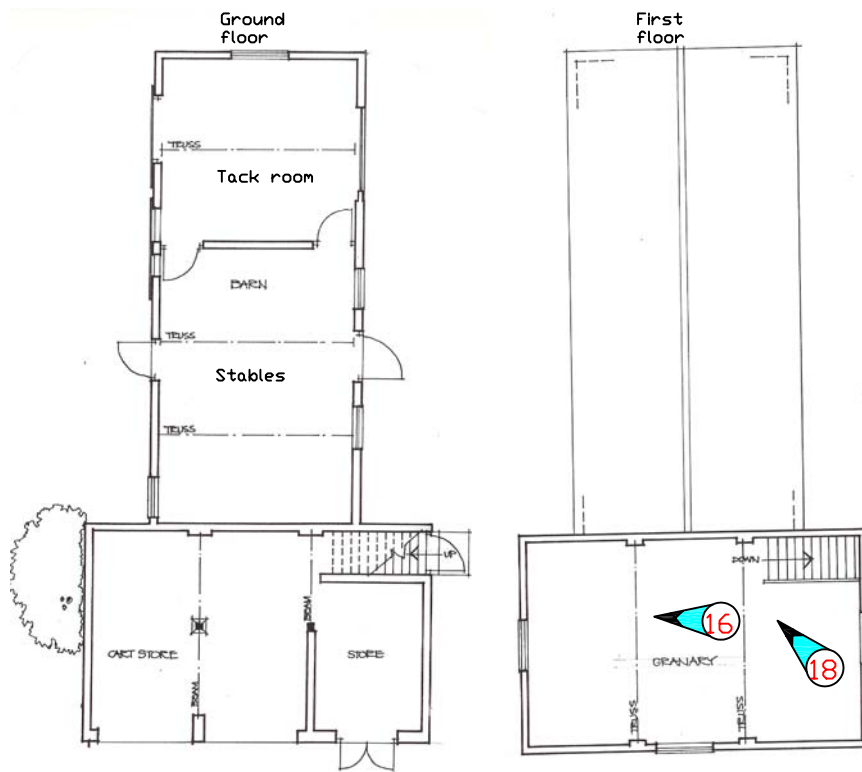
Figure 9: Building 4, former stable and granary over cartshed (including upper floor photo directions)

Plan

Building 4 encompasses two separate spaces, although the building footprint is of one phase. There is a former stable aligned approximately north-east to south-west (Space 4A), which has been modified at the northern end removing evidence of the former use here, although it was possibly a tack-room separated by an internal brick dividing wall. Standing at right angles to Space 4A at the southern end, there is a cartshed with granary above (Space 4B). The building is constructed in orange 9 ¼" x 3" brick and lime mortar in a Flemish bond, with a corrugated asbestos pitched roof to Space 4A and a handmade pitched clay tile roof to Space 4B (Plates 12 and 13).

This part of building 4 is single storied with slat vented windows and a split stable door to the south-eastern elevation and a large inserted garage style door at the northern end. There is a boarded over window below rough segmental brick arch in the northern gable end and the north-western elevation also has slat vented windows and a split stable door.

Internally the stable originally had three stalls, these have now been removed along with the timber partition of a feeding passage on the western side. The floor is of brick, with a later concrete surface in the tack-room area, which had lately been used as a garage.

There is evidence that the roofline of the building has been raised. The former, lower roofline, can be seen as a scar on both gable ends (Plate 14) and the side walls have been heightened with slatted timber cladding. The slender roof trusses, purlins and rafters indicate (Plate 15) a late 20th century alteration; probably at the same the garage doors were added.

This part of the building is two-storied, with a granary over the cartshed entered via steps on the eastern side. In the lower level of the entrance door there is a ‘cat-hole’, now covered over. This would have allowed farm cats in and assist in helping keep down the mouse and rodent population.

The granary roof trusses are mass produced kingpost standing on brick piers built into the side-walls. One truss has a wooden socket nailed to the top of the tiebeam (Plate 16). This was probably a pivot point for lifting full sacks through a trap door in the floor down onto carts below. Raw material would have been loaded into the building through an eye in the eastern elevation (Plate 17). The quality of the building is demonstrated in the brick pier at the top of the stairs, which uses bullnose bricks adjacent to the entrance so that farm workers couldn’t be injured on a sharp edge (Plate 18).

The lower floor is a two bay cartshed with a processing room beneath the stairs, which has been separated from the cart-bays by an inserted wall. The area had been used for grain processing until recently and modern machinery and a grain bin were still in-situ (Plate 19).

The carpentry incorporated in the first floor beams and supporting posts also shows the quality of the build, each being chamfered and stopped (Plate 20). The posts stand on sandstone blocks similar to those used as post-pads in Building 1.

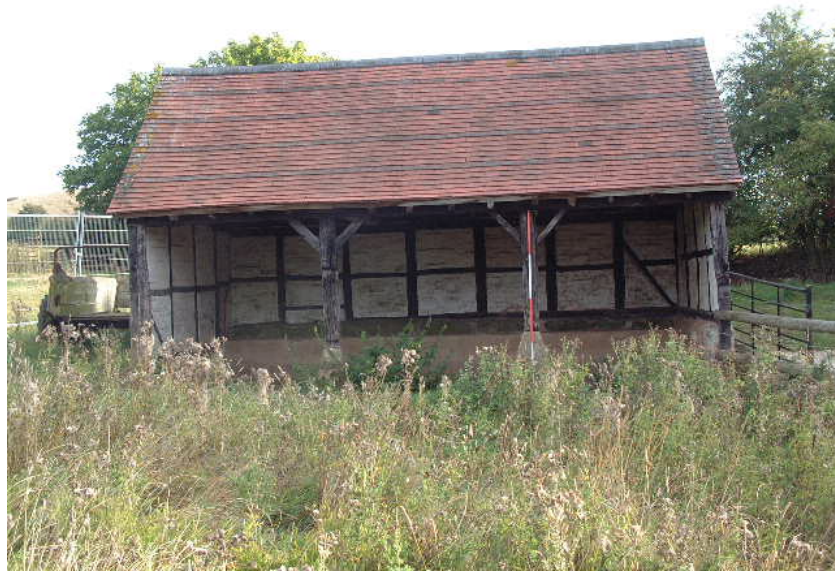
Plate 1

The shelter shed (Building 1) looking east (scale 2 metres)

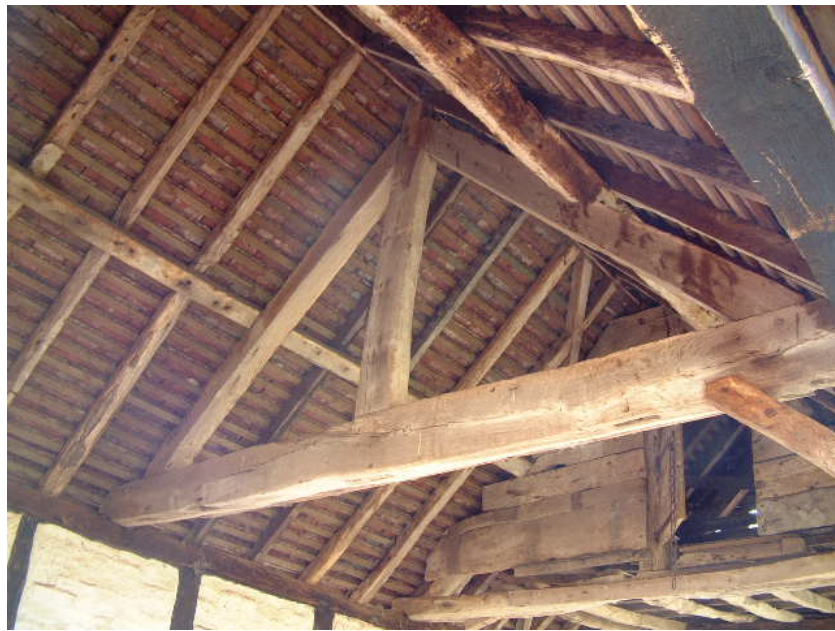
Plate 2

Re-used timber as tiebeam in kingpost truss (Building 1)

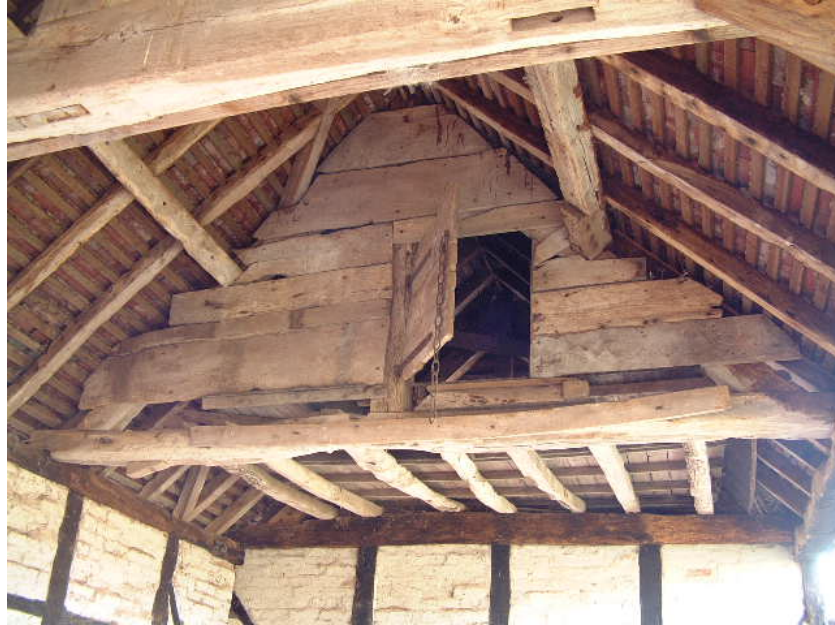
Plate 3

Pigeon loft in the rafters of Building 1, looking south

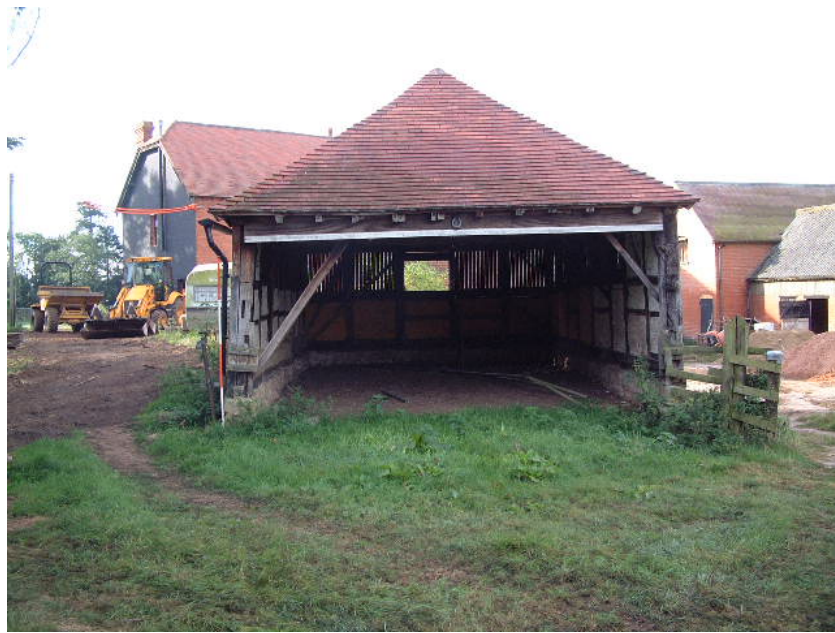
Plate 4

Building 2 looking south-west (scale 2 metres)

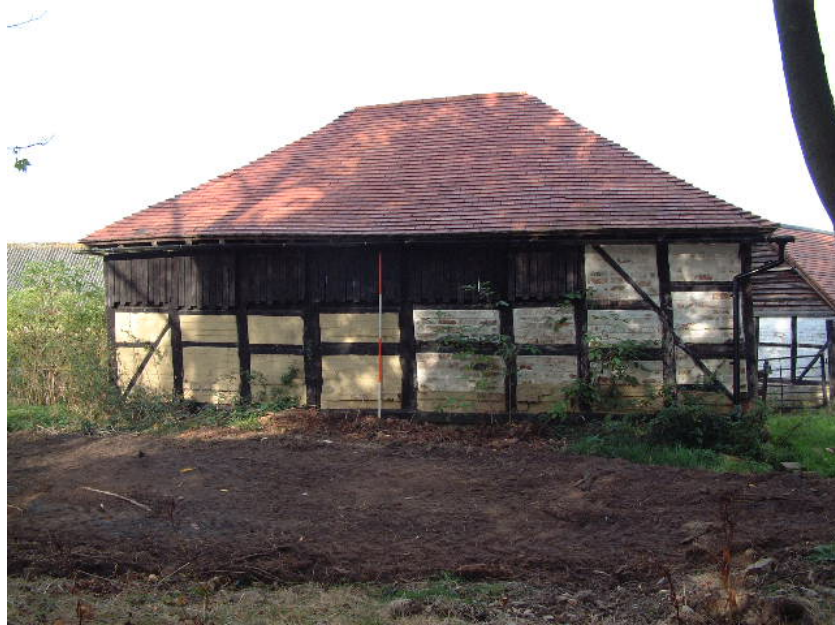
Plate 5

Building 2 looking north-west (scale 2 metres)

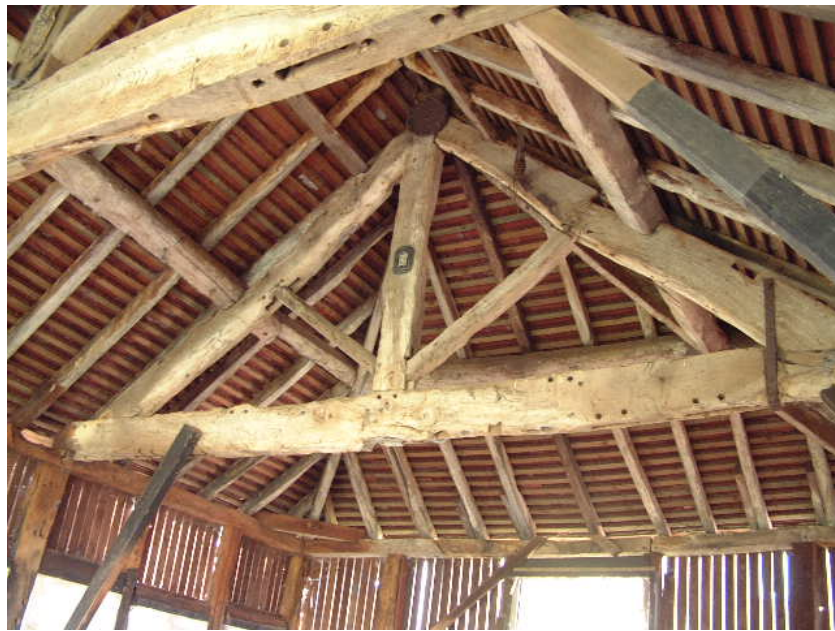
Plate 6

Re-used timbers with empty mortises, stave holes and peg holes in Building 2 truss

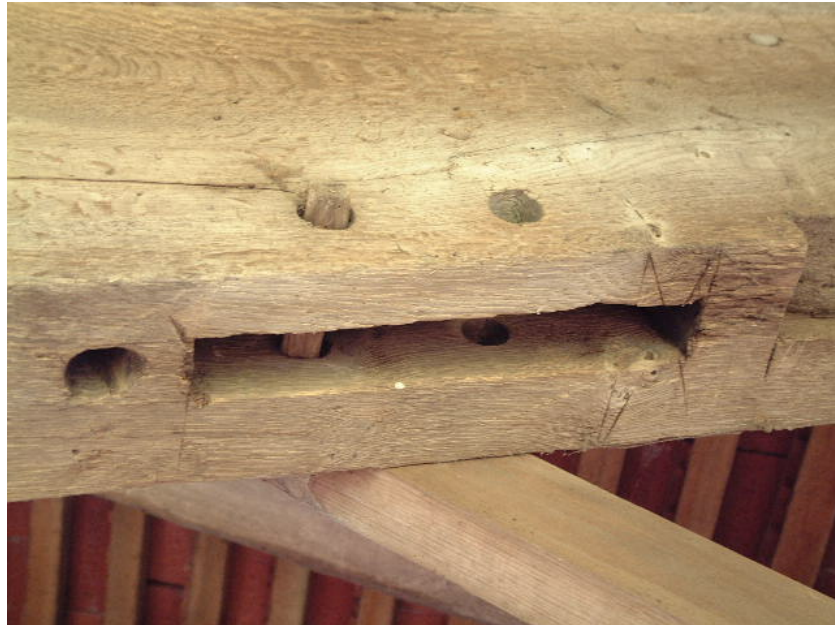
Plate 7

Carpenters scribe marks show that he had made a mistake when marking out for this mortise (Building 2)

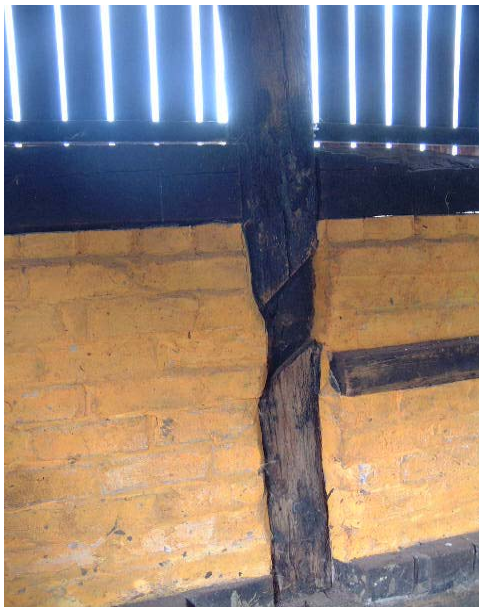
Plate 8

Half-lap joint indicating that this timber in Building 2 is re-used from an earlier timber-framed building, probably to take a sill beam to post tension brace.

displaying a half-lap from a brace joint (Plate 8) and another with a groove to take the lower ends of wattle staves (Plate 9).

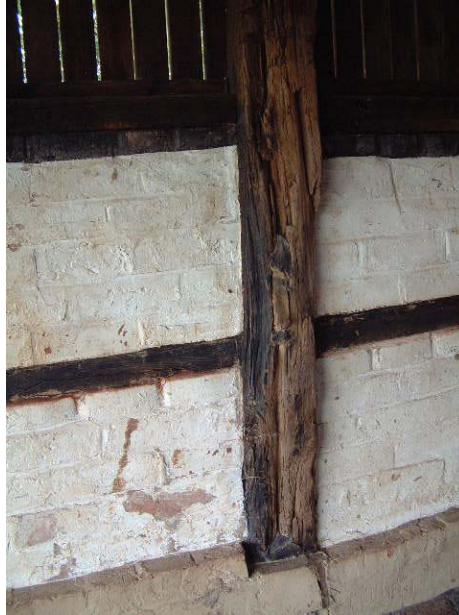
Plate 9

Another re-used timber has a groove to take the bottom end of wattle staves for wattle and daub panelling. The timber would originally have been horizontal (Building 2)

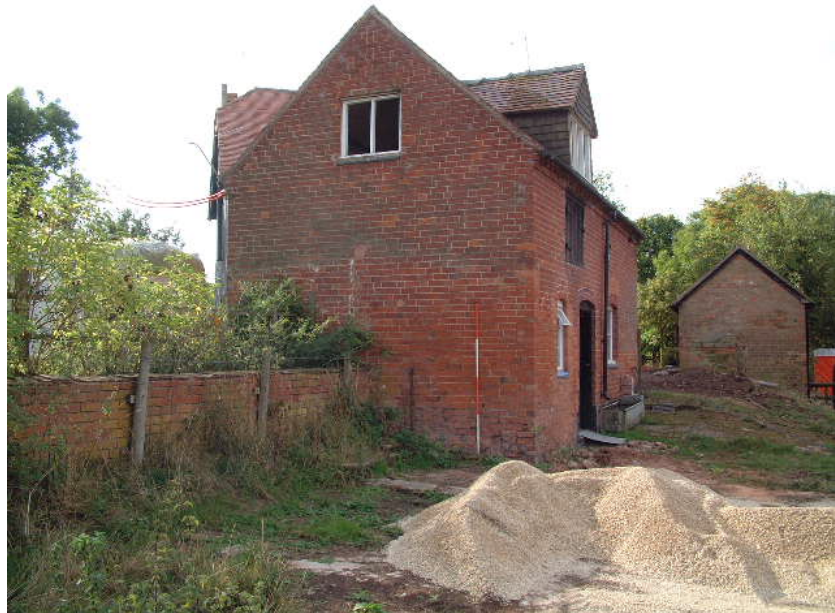
Plate 10

Building 3 looking south (scale 2 metres)

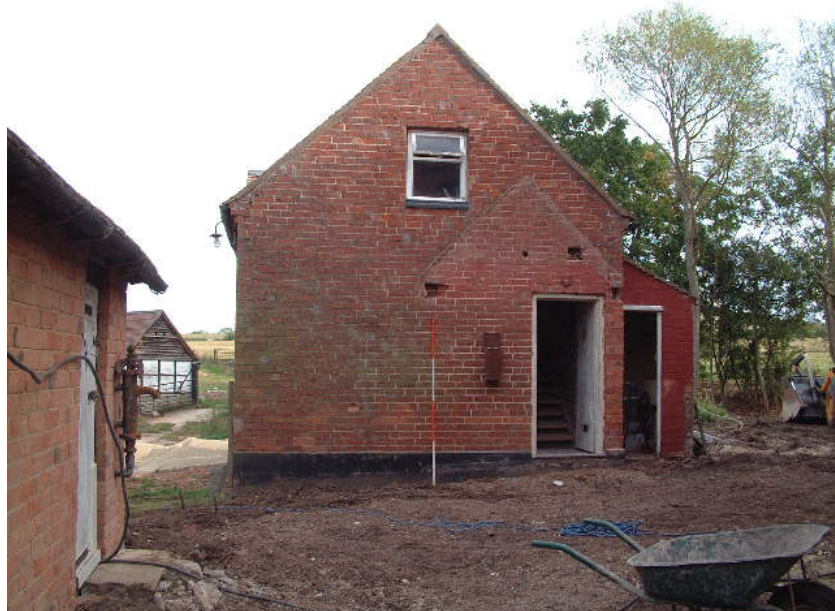
Plate 11

Building 3 looking north-east (scale 2 metres)

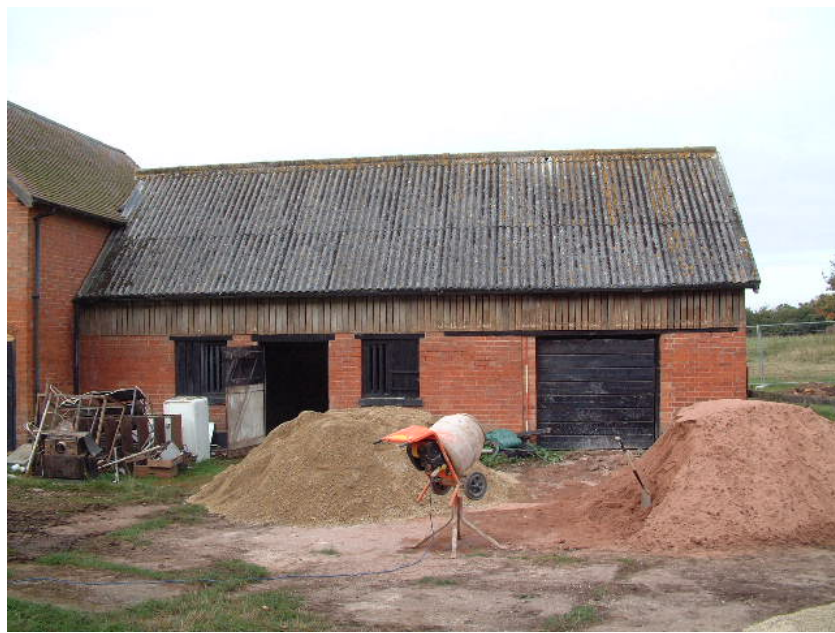
Plate 12

Building 4A looking north-west (scale 2 metres). Space 4B is at right angles to it on the left of the picture

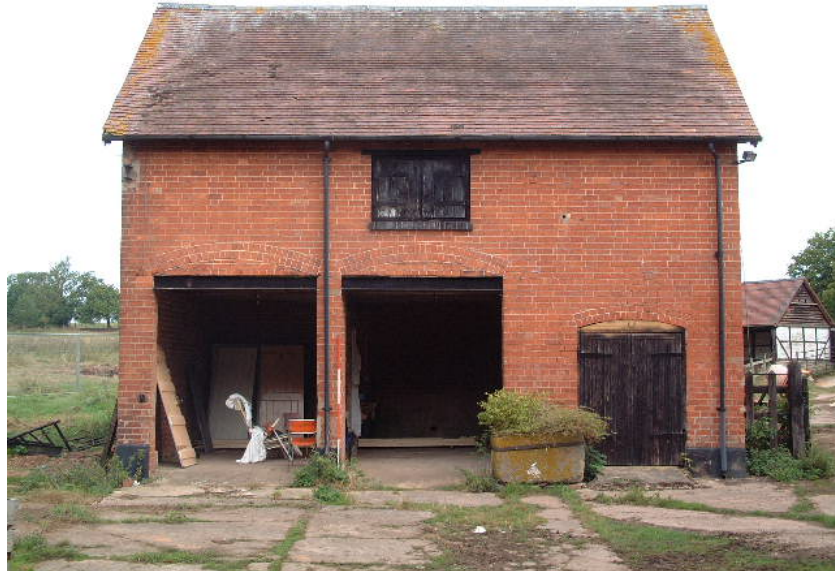
Plate 13

Building 4B looking north-east (scale 2 metres)

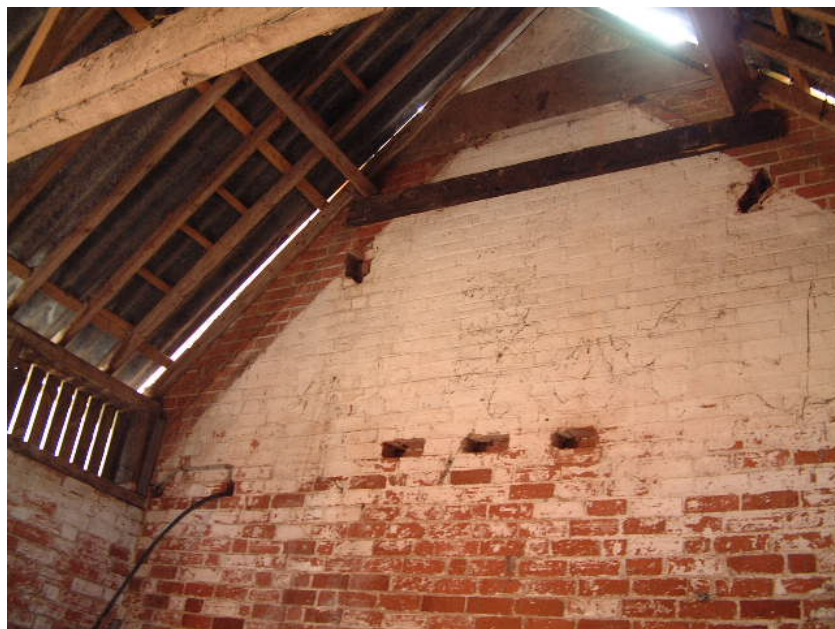
Plate 14

The former roofline of Building 4A is preserved on the gable end of Space 4B, note also the holes in the wall to receive the roof purlins.

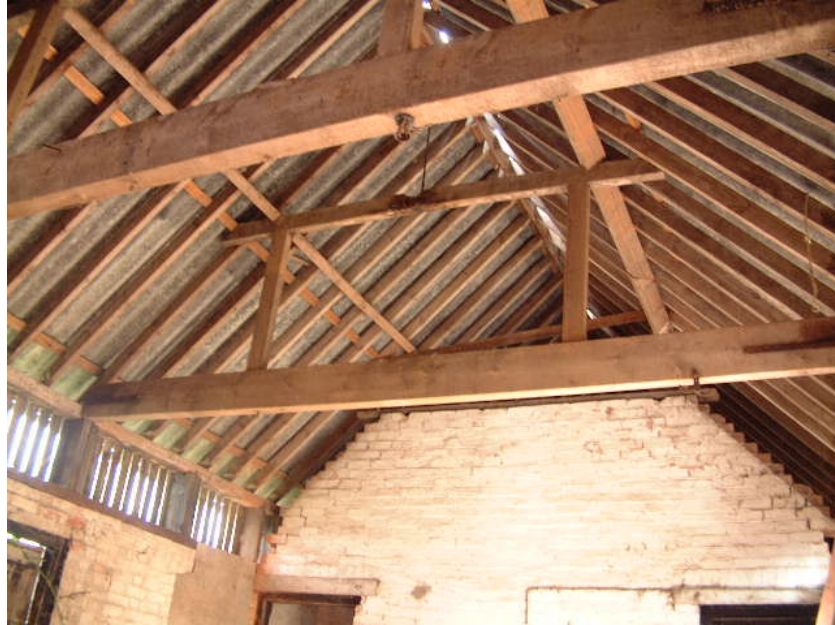
Plate 15

20th century roof trusses in Building 4A

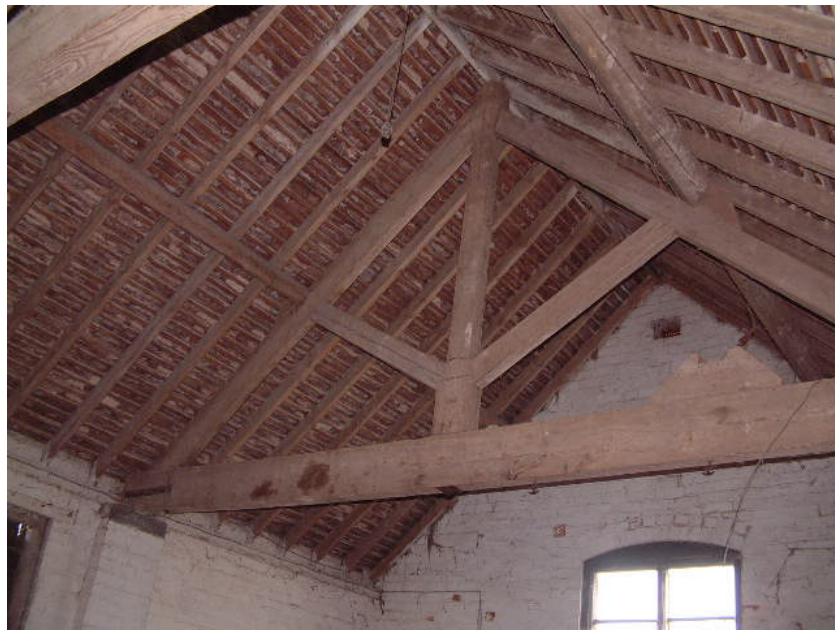
Plate 16

Kingpost roof-trusses in the granary (Building 4B), note the bracket on the tiebeam, which would have acted as a pivot point to haul sacks up and down from the cartshed below

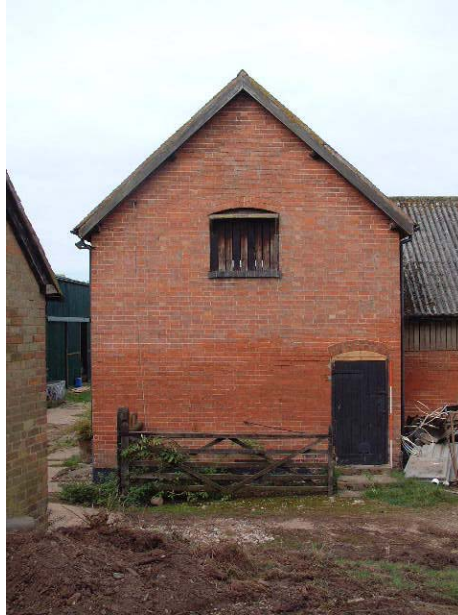
Plate 17

Pitchin- eye and door to the stairs in the eastern gable end of Building 4B (scale 2 metres)

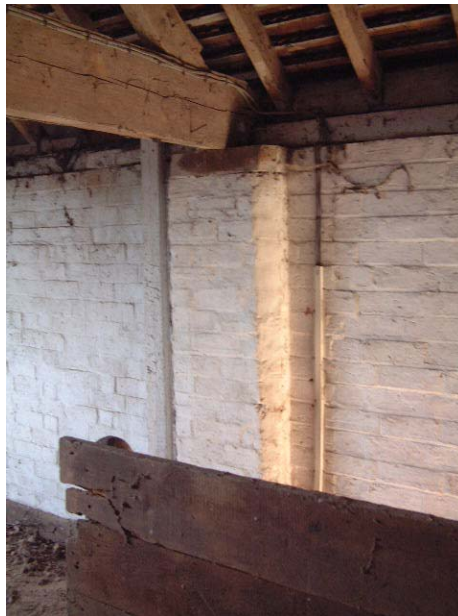
Plate 18

The rounded bricks on the truss support pier at the top of the stairs into the granary. All the other piers have straight edges

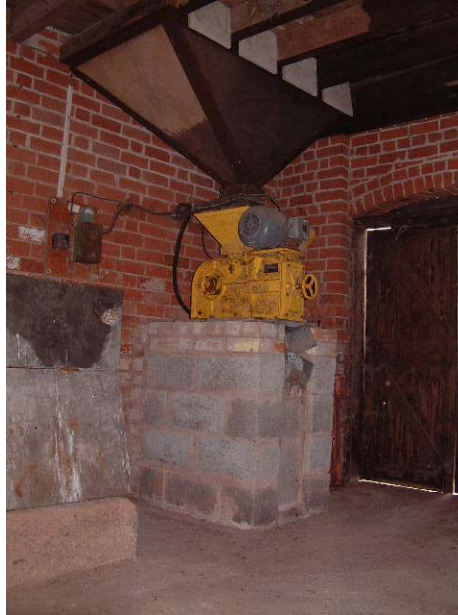
Plate 19

Modern grain processing infrastructure in Building 4B

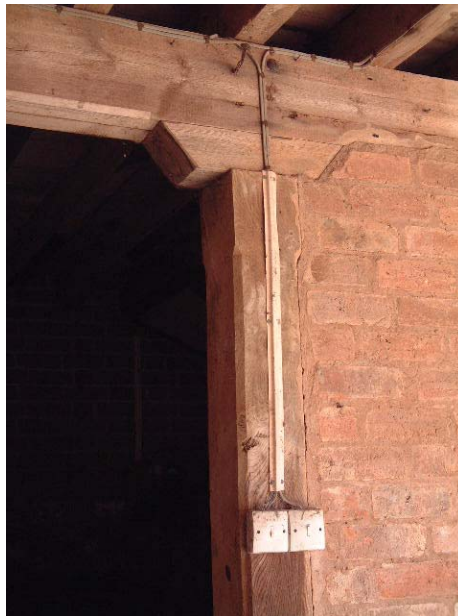
Plate 20

The high quality of carpentry in Building 4B is indicated in the chamfered and stopped post and beam. The wall is a later insertion

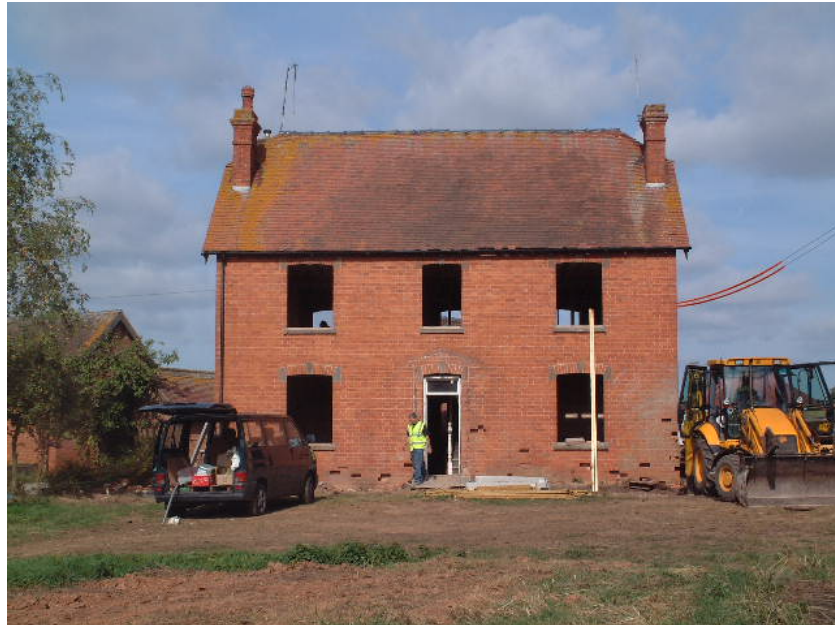
Plate 21

Mearse farmhouse looking north

The farmhouse did not form part of the required building survey, but is worthy of mention here. The structure stands at the far southern end of the site and is a brick construction below a clay tile half-hipped roof. It has a chimneystack at each end of the building and a central doorway with a symmetrical arrangement of windows (Plate 21).
