*An Archaeological Watching Brief
at Little Malvern Court,
Little Malvern, Worcestershire*

A Report for Mrs T.M.Berrington

Project: PJ 150

WSM 34497

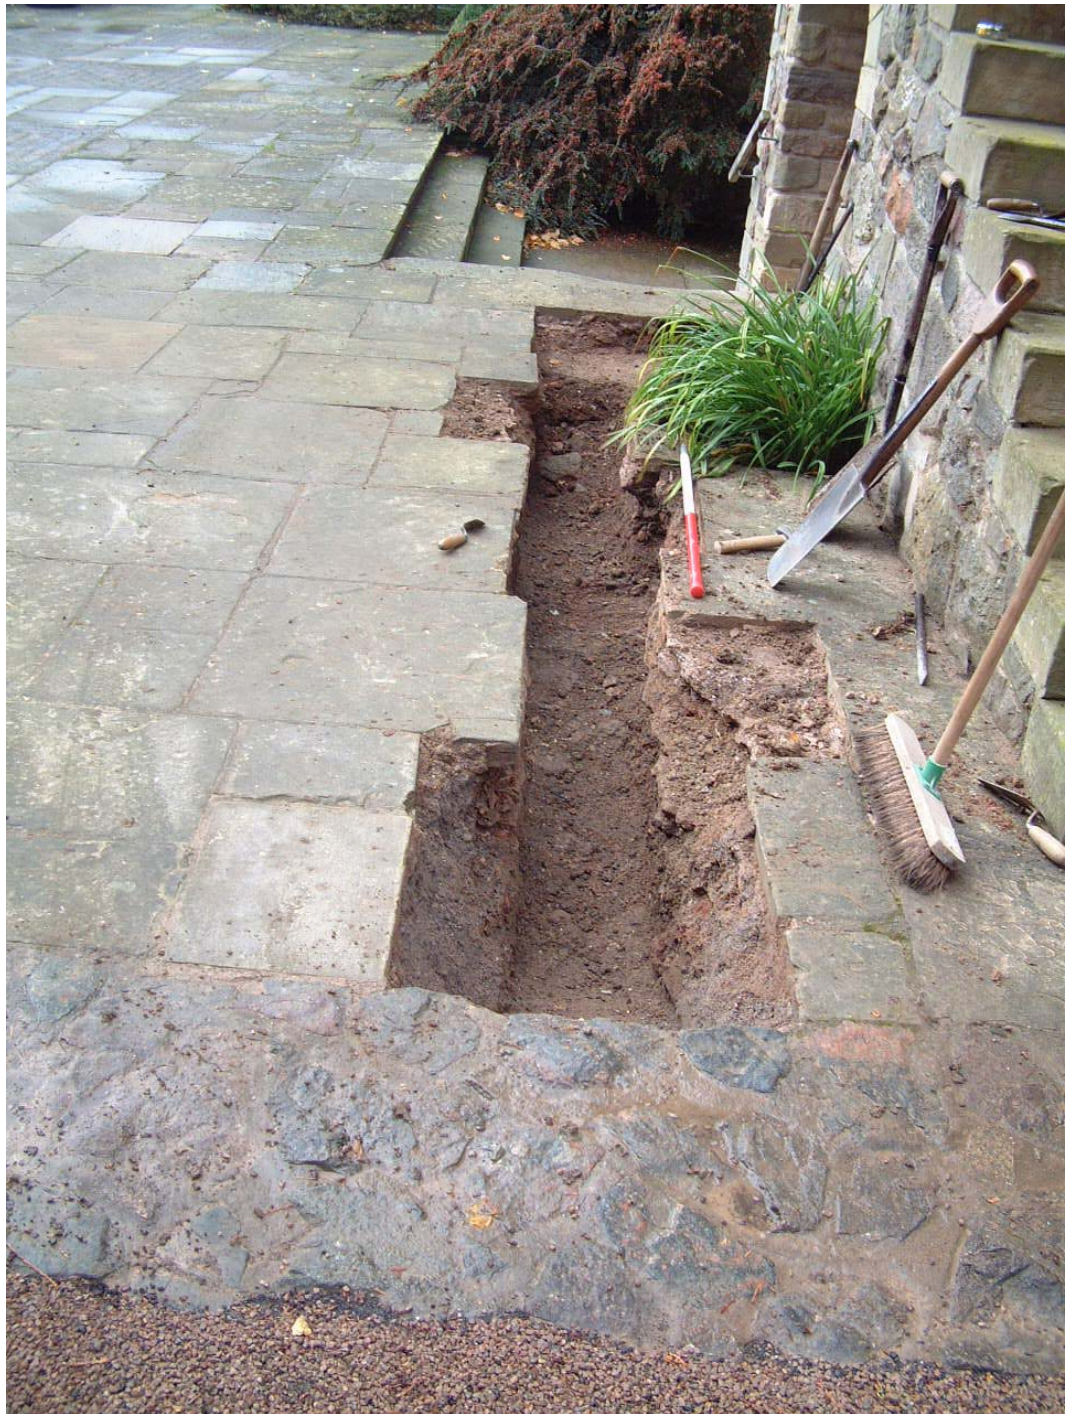
The stone courtyard flags [300] on the line of the ducting trench route were lifted and the concrete screed below [301] broken with a Kango hammer, before being removed. The material below was excavated to a maximum depth (from the stone flagged surface) of 0.45 metres, which was all made up ground. The deposit was loose greyish-brown sandy silt with a high proportion of brick, tile and mortar rubble and small stone fragments. The deposit had been disturbed by the 2 ½” gas main, which ran down the centre of the trench. Finds from this area included both medieval and post-medieval tile and pottery (see below).

The excavated ducting trench to the south of the former nave wall, now demarcated by modern stone at the edge of the external courtyard. The material below the flags is a make-up layer associated with the levelling of the courtyard in the 1960's (scale 1 metre)

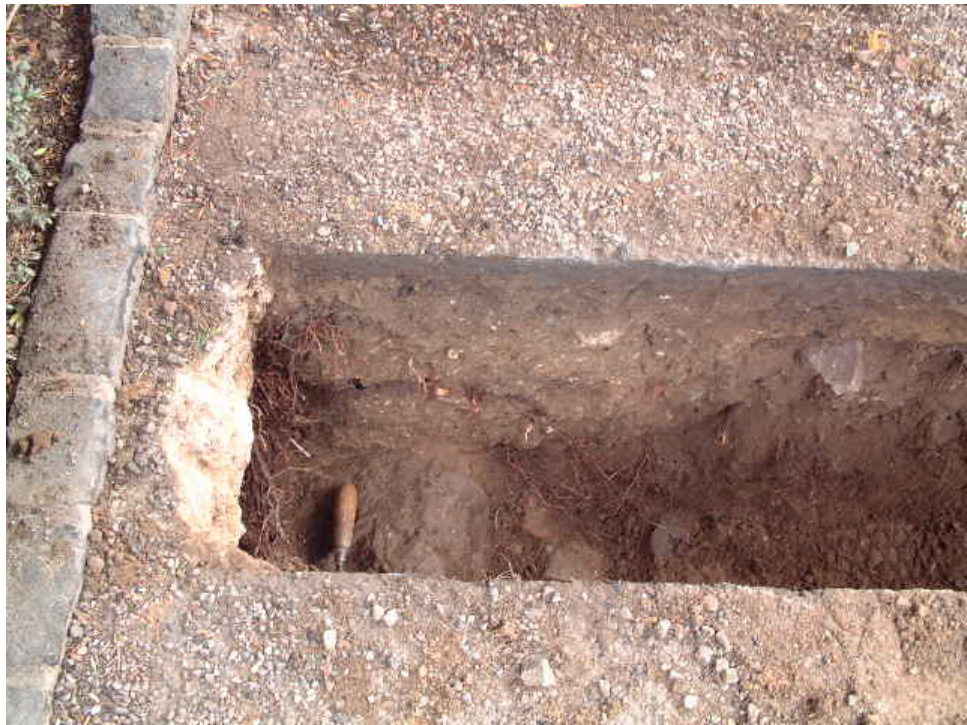
Plate 2

The ducting trench was tunnelled below the kerbstones on the northern side (line of the north wall of the nave) and the line of the south wall of the nave on the opposite side, both of which are demarcated by stone sets at ground level. On the northern side a rough stone block [203] was encountered 0.30 metres below the present ground level. This was not on the line of the former wall of the nave and may have represented a fallen stone from the demolished wall. The size of the excavated trench and constraints of the tunnelling process meant that this could not be resolved. The stone was covered by a dry dark garden soil with abundant small roots [205], this sloped down to the south over the stone and up on the other side of the kerb. The soil represents the Victorian shrubbery border, before the re-landscaping and terracing of the mid to late-20th century. On the opposite southern side, stone was encountered [204] on the line of the southern nave wall. Unfortunately, this had been punched through during the laying of a gas main, which coincidentally was on the line of the new ducting trench. The stone may have been part of the remnant wall of the church nave as the evidence suggests that any foundations would be below this depth.

Stone [203] in the base of monitored area 2, looking west

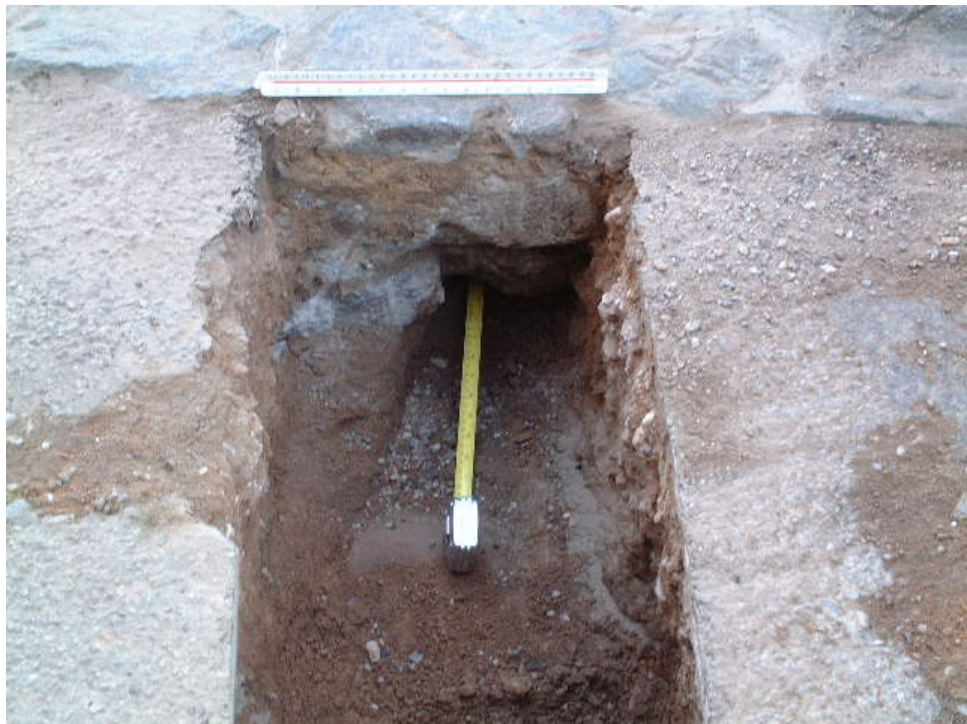
Plate 3

Stone [204] in the base of monitored area 2, on the line of the south nave wall (looking south). The stone can just be seen where the ducting trench is tunnelled under the modern wall that marks the line of the south wall of the former nave of the church
