*An Assessment of an Historic landscape at
Old Parsonage Farm, Kyre, Worcestershire*

An Archaeological Assessment of Landscape Components at Old Parsonage Farm, Kyre, Worcestershire

A report for John and Nicky Beavan

Project: PJ 101

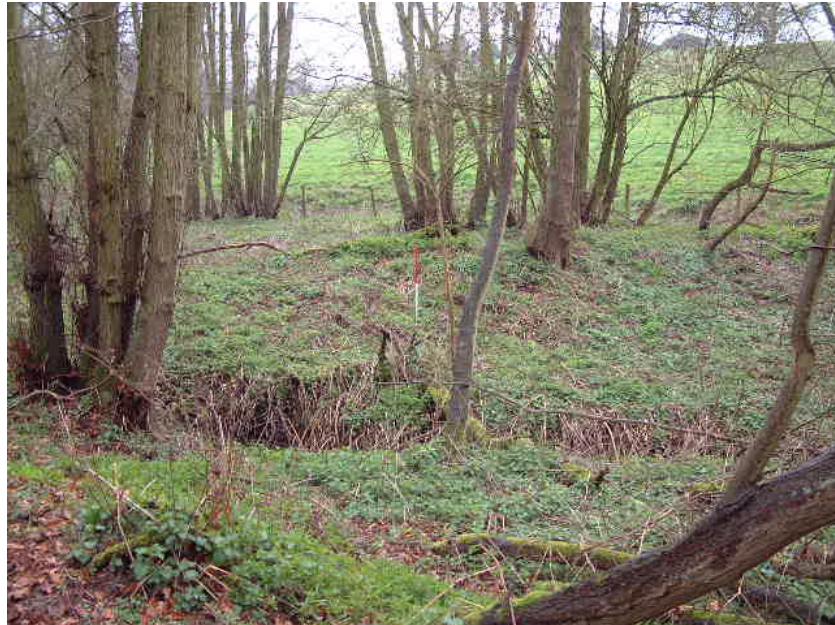
Plate 1

It is likely that simply damming back the watercourse created the pond. A denuded earthen dam was located to the north (Plates 1 and 2), still standing to a height of around 1 metre high.

Remains of earthen dam associated with pond shown on tithe map (Looking west; Scale 1 metre)

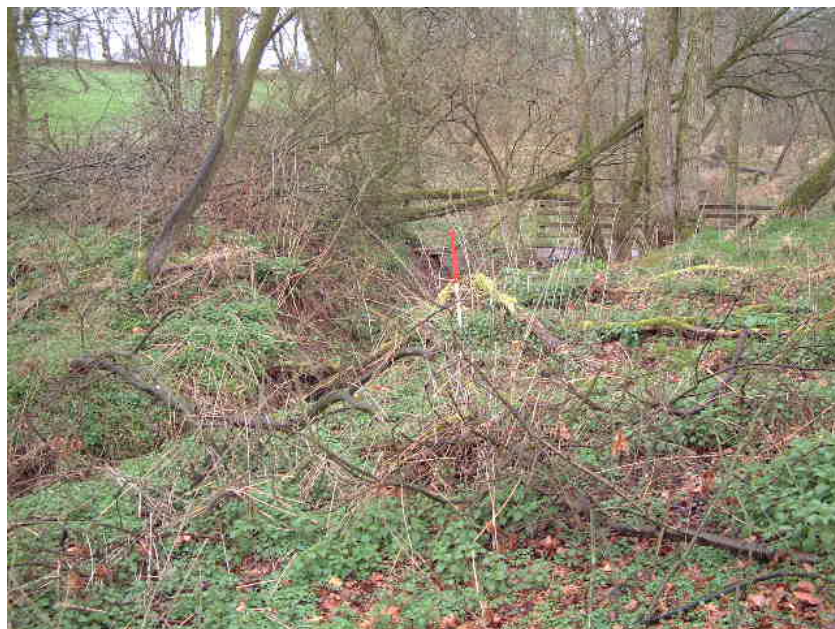
Plate 2

Remains of earthen dam associated with pond shown on tithe map (Looking north; Scale 1 metre)

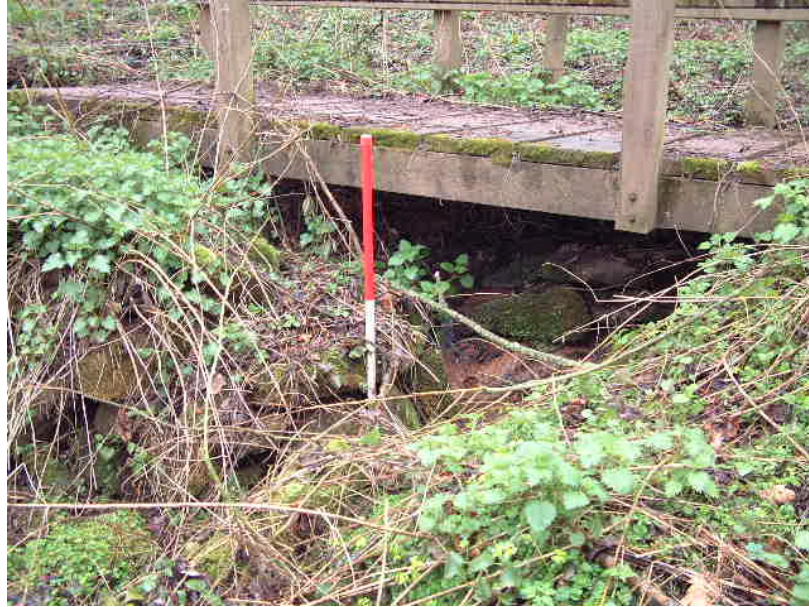
Plate 3

Below and adjacent to the south of the modern bridge, there were possible water features that may be directly linked to the leisure aspect of Kyre Park. A waterfall and possible rapids were noted. The waterfall had a drop of over 1.5 metres and the associated rapids would make the feature appear larger.

Stone built waterfall below the present footpath bridge (Looking south; Scale 1 metre)

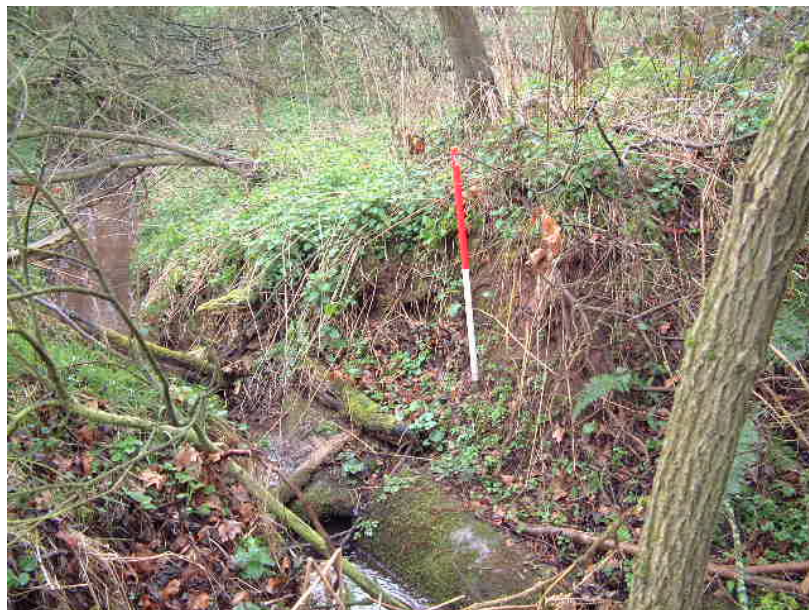
Plate 4

The remains of an earlier footpath bridge were located around 7 metres to the south of the modern timber bridge (Plate 4). This was of rammed red clay abutments; the span had collapsed and was not evident. The water in the stream had apparently been culverted through earthenware pipe, suggesting that the span was also of clay simply laid across the pipes and compressed, although a spread of stone across the area (Plate 5) suggests that the bridge facings may have been, at least in part, of rough sandstone coursing.

Clay abutment of former footbridge south of the present stream crossing (Looking west; Scale 1 metre)

According to the overlay of the EDM survey data onto the 2nd edition Ordnance Survey map, the east-west footpath across the site is now 7 metres further to the north. This evidence is supported by the remains of a pair of clay bridge abutments either side of the watercourse at this point. The following items should be noted with regard to any rebuilding of a bridge at this point:

- ❑ The reinstated bridge may carry the re-routed public footpath and, therefore, health and safety considerations must be paramount in its construction. Appropriate legislation and planning conditions must be taken into account.
- ❑ The actual construction of the bridge is unknown; the hypothesised clay and stone-faced construction has been suggested from circumstantial evidence.

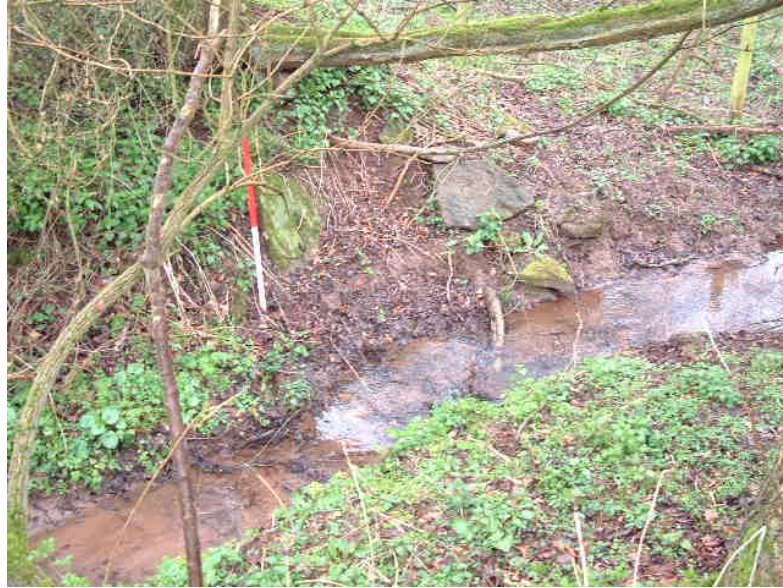
Plate 5

Stone slabs scattered along the stream and in the bank may be from the former footbridge or possibly artificial rapids at the head of the waterfall below the present footbridge (Looking west; Scale 1 metre)

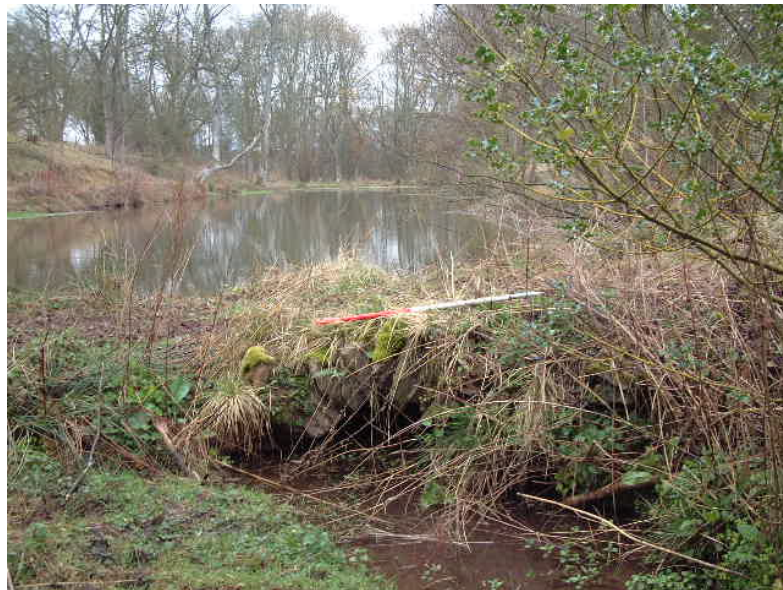
Plate 6

On the opposite (northern) side of the footpath bridge there was a flat scarred area that may represent a small, possible natural pond, although this is somewhat confused by a mound of earth and discarded tree stumps that at first sight appear to be a further dam. The evidence is inconclusive, although it does appear the material is dumped rather than a constructed dam (Plate 8). Further to the north at the head of the large pond there is a low level dry stone arched footbridge, almost totally obscured by vegetation (Plates 6 and 7).

The existing pool beyond the dry-stone arched footbridge (Looking north; Scale 1 metre)

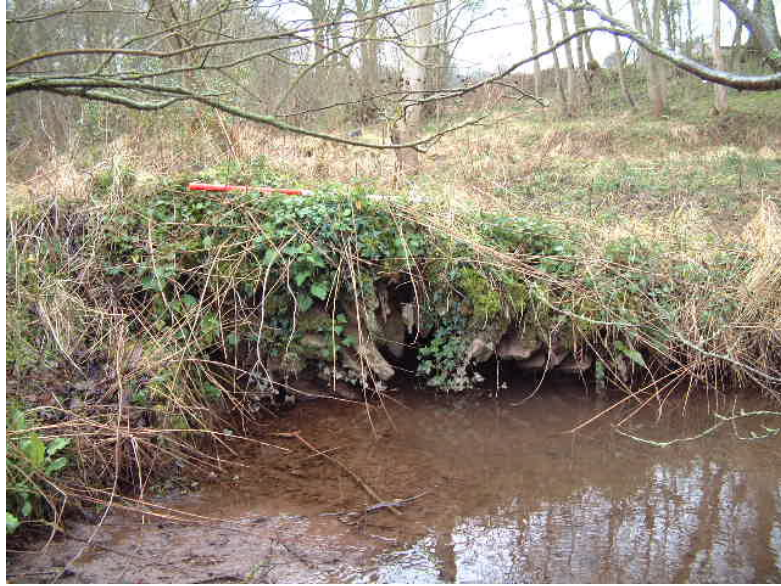
Plate 7

The rubble stone arched bridge at the head of the existing pond is still standing. The condition of the bridge cannot be determined as it is largely obscured by vegetation, although close inspection suggests it is stable. It may be that removing vegetation will compromise the structure in the short term, but will be necessary should the condition of the bridge be important more long term.

The method of construction will also only be more fully understood when the bridge and surrounding area is clear. As the form of this bridge may yield valuable information regarding the rebuilding of the former footbridge to the south, it may be important to carry out some clearance work and record the method of construction. Limited intervention into the bridge construction should be made unless the condition is deemed to be poor.

The flat arch of the dry-stone bridge (Looking south; Scale 1 metre)

- **The existing stone bridge (PF2)** should be sympathetically cleared of vegetation and an assessment of condition made. The assessment results will determine the programme of works (if any) required on the bridge. A policy of minimal intervention should be adopted and the bridge should only be repaired/consolidated in a like for like manor if necessary. This should be undertaken over a timescale that reflects the condition of the bridge, i.e. if the bridge is deemed to be in a poor condition then the work should be carried out as a priority.

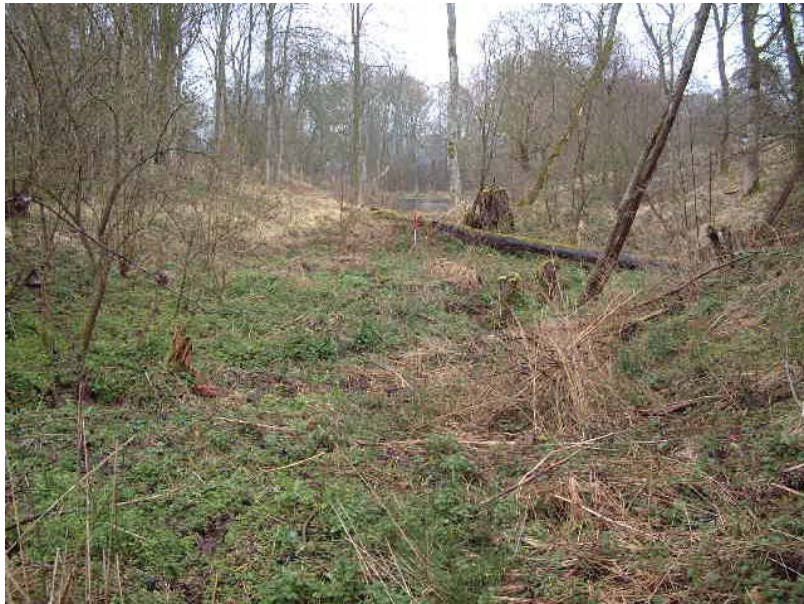
Plate 8

A possible former pond to the south of the existing pond. The mound in the top of the picture appears to be the stumps of recently felled trees, but these may be hiding evidence for a dam. The evidence is tentative (Looking north; Scale 1 metre)

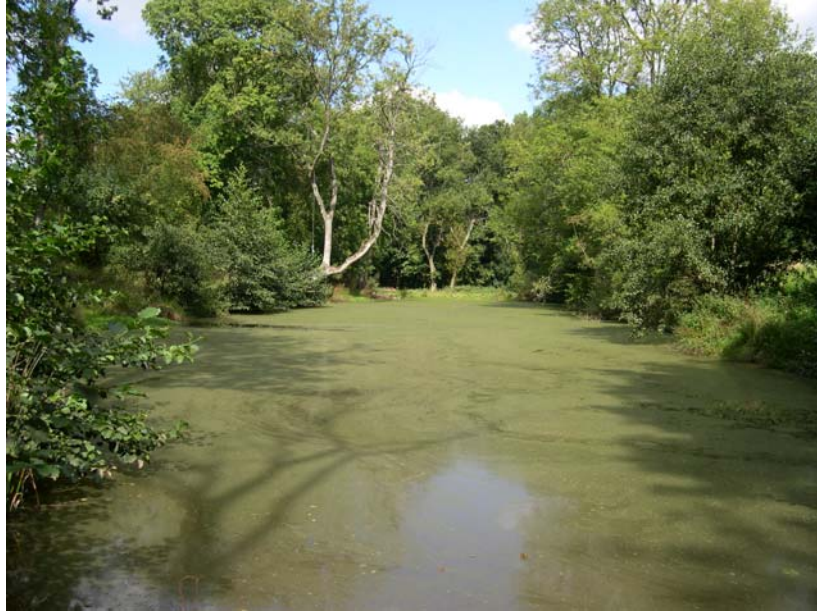
Plate 9

The existing pool showing algal scum (Looking north)
