A Report for Mr and Mrs Brandreth

Project: PJ 191

WSM 37310

1. Project Background

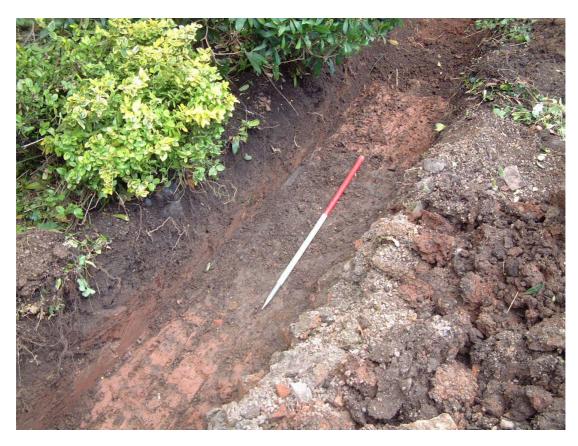
Plate 1: Deposit [103] looking south-west

Sandwiched between the layers of undisturbed and redeposited natural, was a deposit of greyish-brown silty clay containing pockets of disturbed natural reddish clay, occasional subangular stones and rare charcoal flecks [103]. The deposit was 15-centimetres deep and extended to around 1-metre along the excavated pipetrench and notably contained a large quantity of pottery sherds. The feature was part excavated (50% of visible deposit) and the

pottery retrieved for analysis (see below). The ceramic material ranged in date from the late 12th century to the 19th century, indicating that the deposit in which it was found, was dumped in the 19th century, suggesting this occurred when the present house was built.

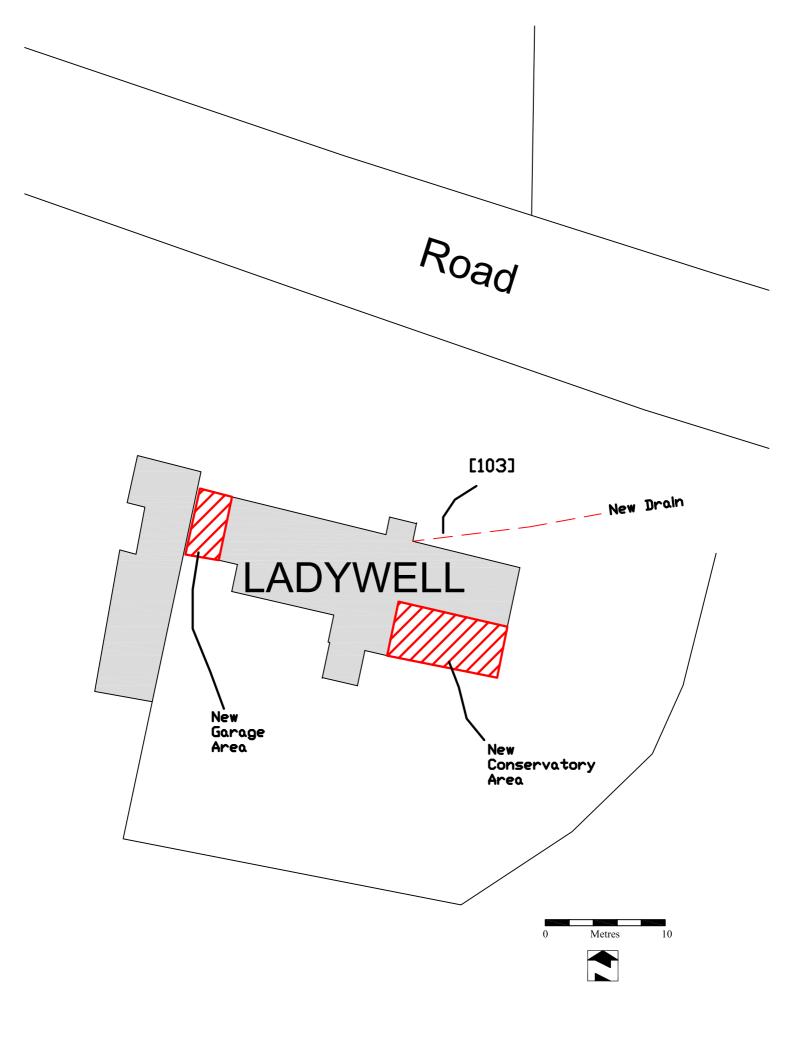
Figure 3: The Site, Showing Areas Observed

The watching brief was carried out on three areas of the site, which were disturbed by foundation and service trenches, the areas are shown in Figure 3.

The watching brief was carried out in two stages, the first monitored the excavation of foundation trenches for a new garage adjacent to the west of the present house, and on a new drainage run across the approach driveway along the house frontage (north). The second element of the fieldwork (Stage 2) monitored the excavation of foundation trenches for a new conservatory, at the southern side of the house (Figure 3).
