*Historic Building Recording of
Former Farm Buildings at
Himbleton Manor,
Worcestershire*

A report for Mrs V Crosbie-Dawson

November 2007

Project: PJ 201

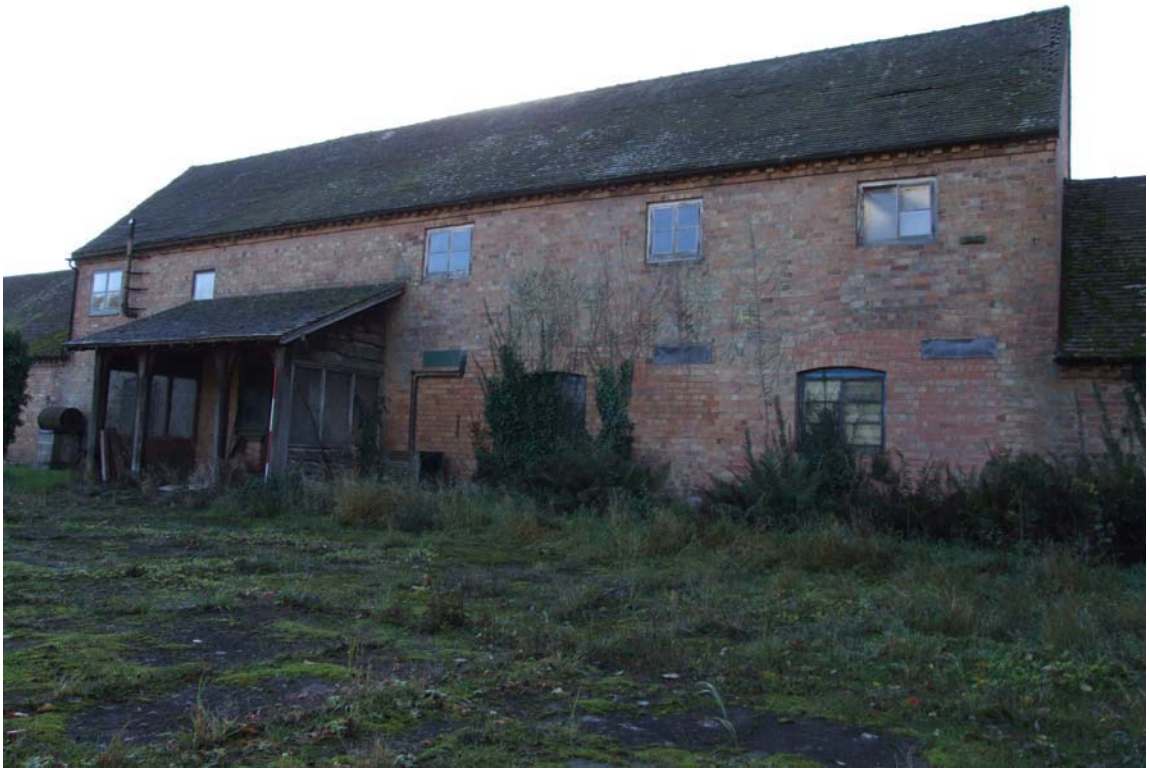
Plate 1: The northern range, looking south-east

The northern range consists of a central two-storey element with flanking single storey units at each end; the whole is of one build (Plates 1 and 2). The structure is of 9" x 3" handmade bricks laid in a common bond, with three courses of stretchers sandwiched between header courses, bonded in a gritty, buff coloured lime mortar. Architectural detailing is limited to dentilated eaves and cornice, rough segmental brick arched lintels above lower windows and doors; upper windows have plain brick lintels. Roof cover is of plain handmade clay tile. Original doors have pegged frames with chamfers and stops (Plate 3).

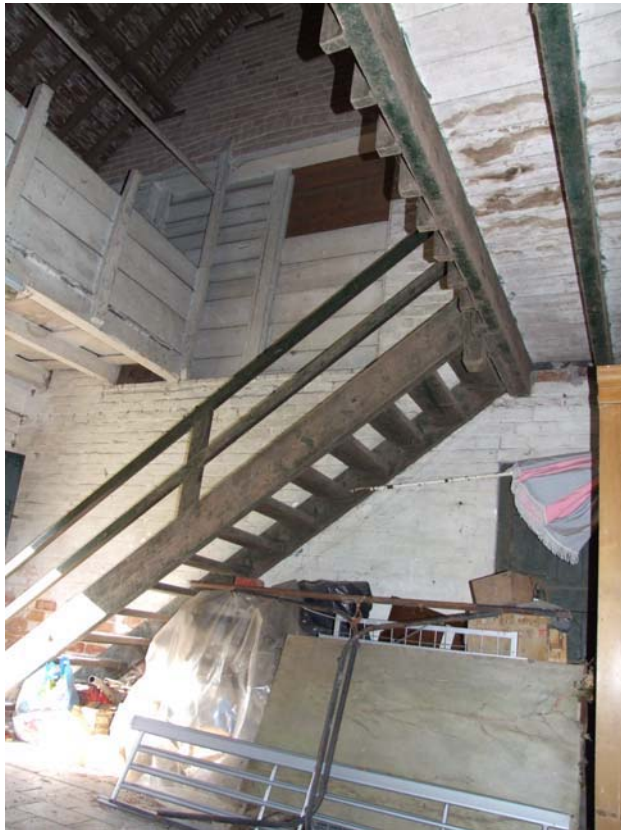
Plate 5: Stairs, landing (right) and bridge (left) in the cart bay of the northern range

The two-storey section of the range is split internally into three bays, all of different proportions (see Figure 5), each accessed from the other by a single personnel door at lower level, with further doors at each end allowing access to the single storey elements of the ranges. The upper floor is divided into two lofts, with access via stairs in the central bay (Plate 4) and access between the two via a landing above the stairs. A further bridge between the two upper rooms has been inserted into the same bay. It is likely that the stairs and landing are also an insertion, as the bay originally represented a loading bay, with cart access from the northern side; this doorway has now been modified, providing windows and a single door to the central section, with an external porch. The floor of the former loading bay retains its original 12" x 6" blue engineering brick floor. The evidence suggesting that the stairs and bridges are inserted, is that their locations would foul the useable space in the loading bay and the internal openings at upper level, which would have been used as access for loading onto carts below (Plate 5).

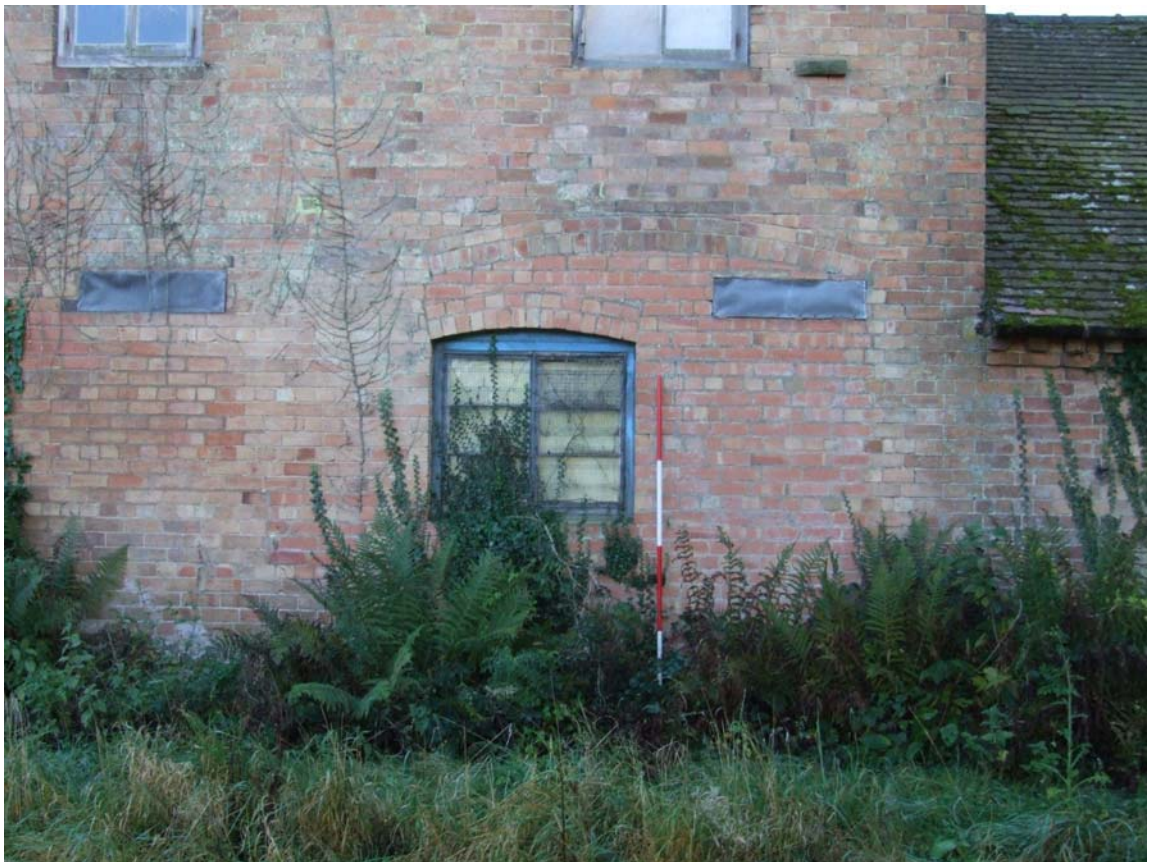
Plate 6: Blocked doorway with later inserted window in the north elevation of the northern range

There is a further blocked cart door to the northern elevation (at the western end), which gave access for a small cart into the end bay. This was blocked, probably in the late 19th or early 20th century, and a window inserted (Plate 6); it seems likely that this was carried out at the same time that the central doorway was modified and the stairs and bridges were inserted. This suggests a change in use of space at this time, which much have been related to a contemporary change in farming practice.

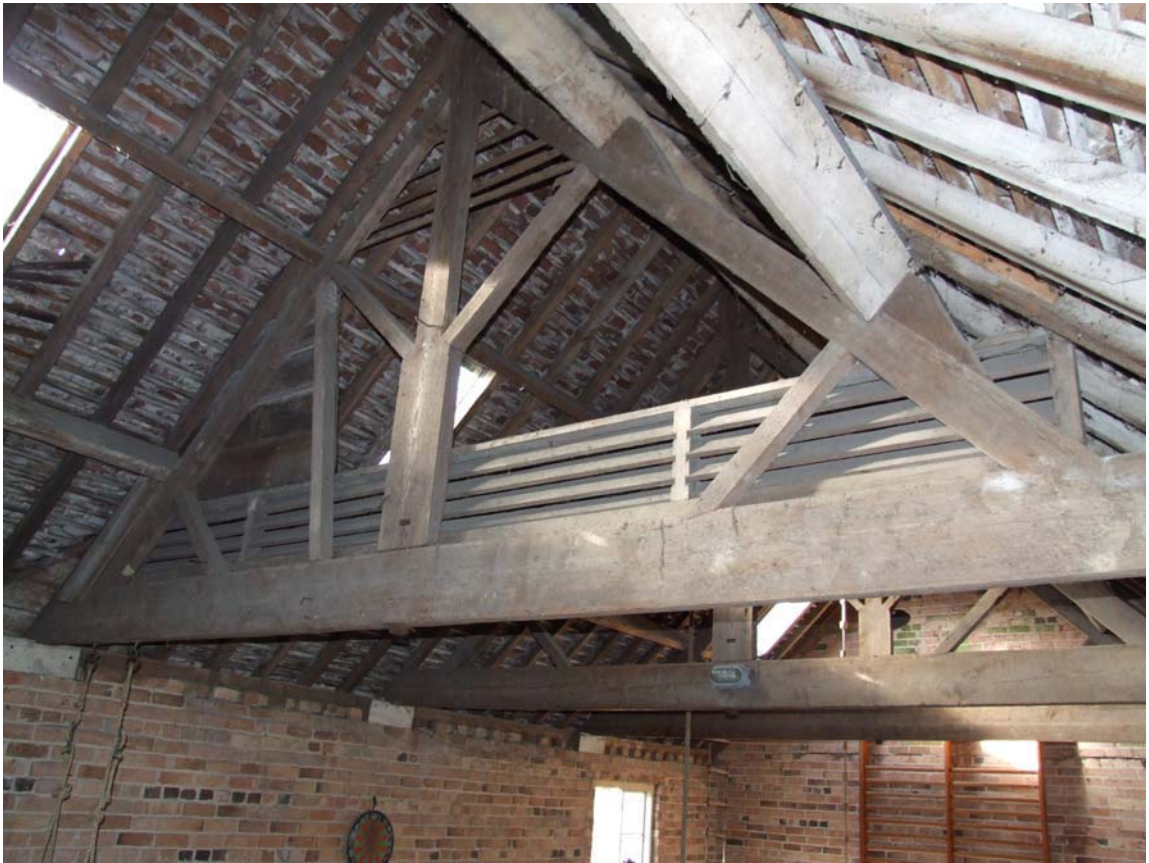
Plate 7: Truss in the northern range, typical of those used elsewhere at the site

The roof structure is supported on typical 'off the shelf' king post trusses, with the post bolted from below the tiebeam into a nut inserted into a rebate in the post. Struts brace the truss from the tiebeam and from the king post to positions on the principal rafters below the purlins,

which are supported by cleats nailed to the principals (Plate 7). Further light is allowed into the upper floor space via roof lights, which may be original.

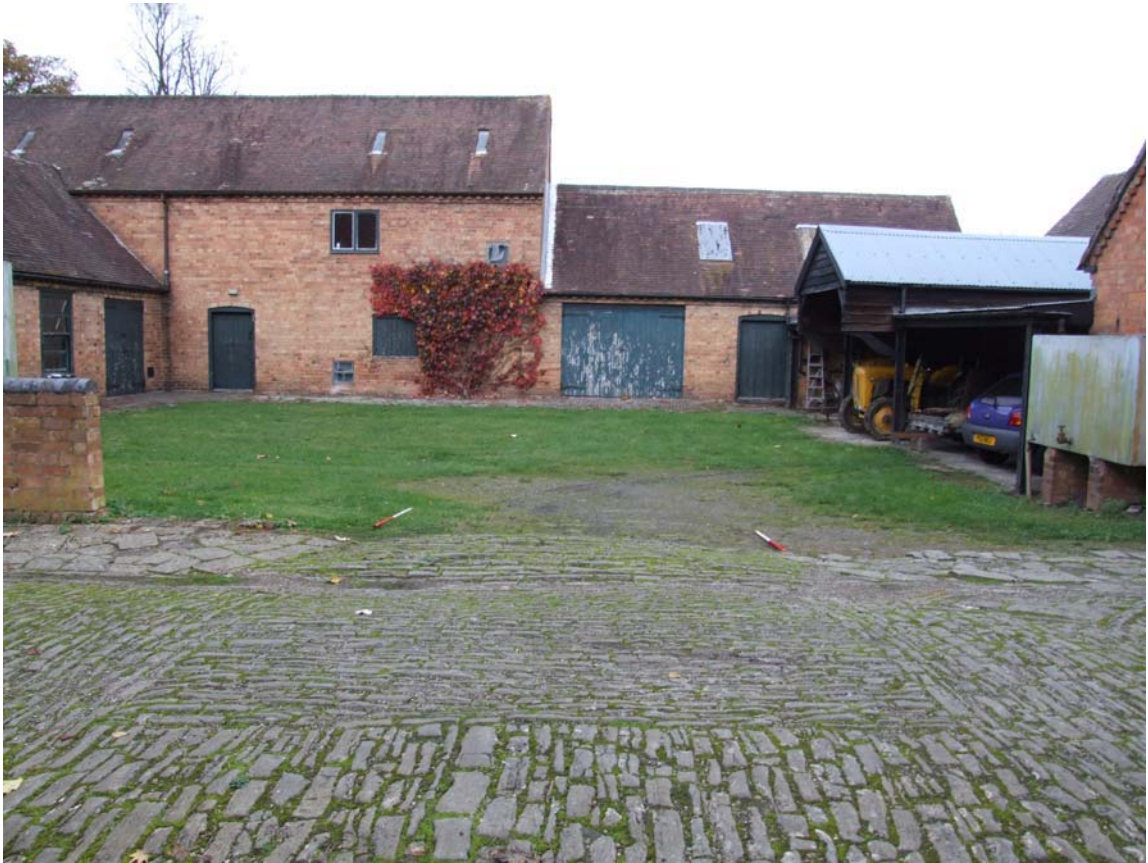
Plate 9: Stone drive heads towards double doors of east part of the northern range

The single storey elements of the range have no light or access from the northern side (the fields side). The western unit represents a former 4 bay open fronted implement / cart shed, with a stable taking up the bay which butts the double storey unit; the evidence suggests that the eastern unit was formerly used as a secure storage area, though the former usage can only be determined from the configuration of doors (Plate 8). There are a pair of double doors below an RSJ lintel, which would allow cart / vehicle access, and a single personnel door and window. A concrete floor adjacent to the double doors has replaced the original brick floor. It is difficult to determine whether the double doors are inserted, as there is conflicting evidence; the use of the RSJ below the cornice seems anomalous and suggests insertion, though RSJ's (rolled steel joist) were available from 1866 and an RSJ is used as a lintel in the central range (see below). The evidence suggesting insertion comes from analysis of the brickwork to the east of the doors. The brickwork at the single doorframe ends in full bricks, with bats (cut brick spacers) used within the adjacent brickwork, in comparison the brickwork at the double doors frame ends with bats against the frame. This evidence is however countered, as a pair of kerbs curve from the present stonework driveway and aim directly towards the double doors (Plate 9).

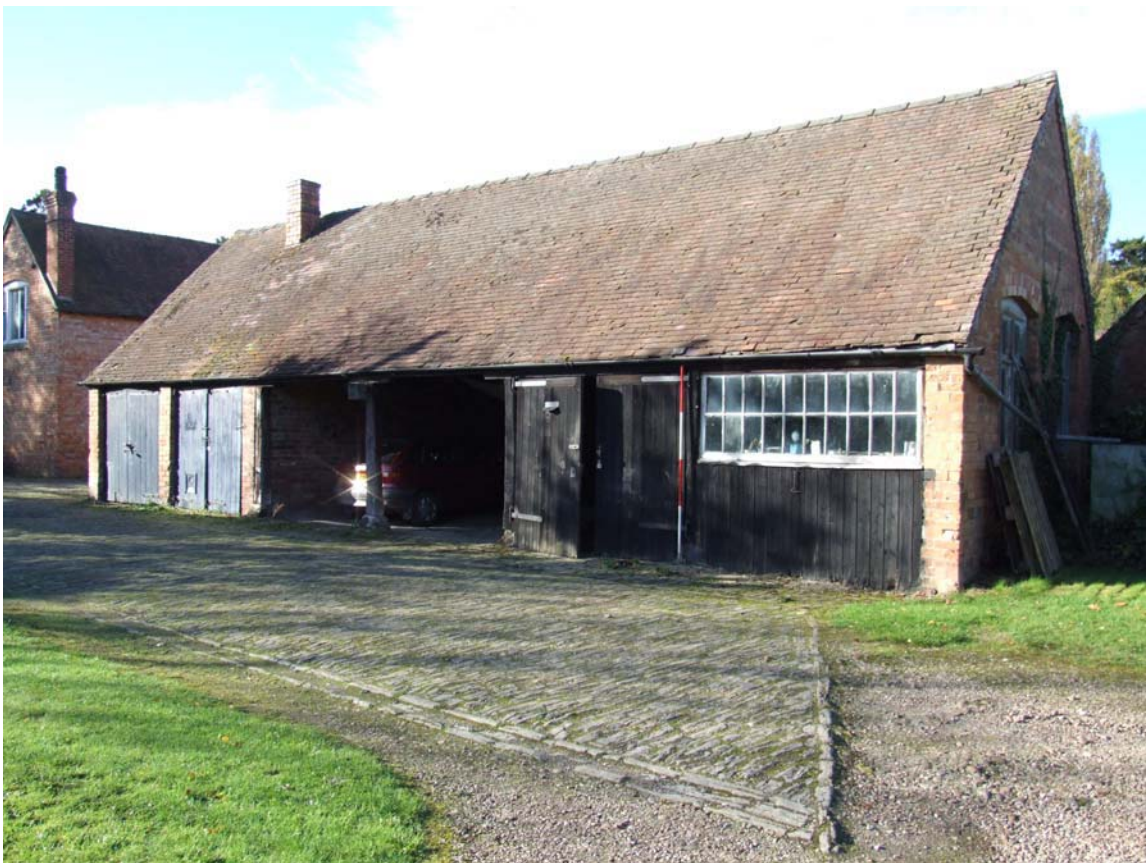
Plate 10: The eastern range looking south-west

The eastern range is now used for garaging and storage of gardening equipment (Plate 10); its original use was as a cart shed, with an inserted loft room used as an overseers office (Plate 11). The structure is of similar materials and style to the northern range, with a handmade clay tile roof over brick and mortar walls in a common bond. The eastern side of the unit was originally open, with the wall plate supported on a series of 5 timber posts, each chamfered and stopped, forming 5 cart bays, with the southern end bay secured by a partition wall. There are a pair of cart doors to the front (east) of the enclosed bay, with a former side (south) access door, which was bricked up, probably in the early 20th century. Further modification / alteration to the unit can be seen in the adjacent bay, where an upper floor has been inserted; this is only above this single bay, supported by the dividing wall and the inserted wall that divides the 2nd and 3rd bays. The upper floor is accessed via a contemporary door and stairs from the eastern side. The upper space appears to have been used as an overseers or farm bailiffs' office; a bailiff is referred to at the farm in all the early trade directories (referred to above). The space is furnished with a fireplace, with a chimney springing from halfway up the original dividing wall. This suggests that there was originally an upper floor and that the inserted dividing wall, stairs and present floor are replacements for the earlier structure, which would probably have been accessed by a ladder and open on the present cart bay side, thus oversailing the original cart bay below. There is further modification at the northern end, with the former open front now covered across to provide security for the present workshop and a pair of large six-light timber framed window units inserted into the northern gable to introduce light to the enclosed space (Plate 12).

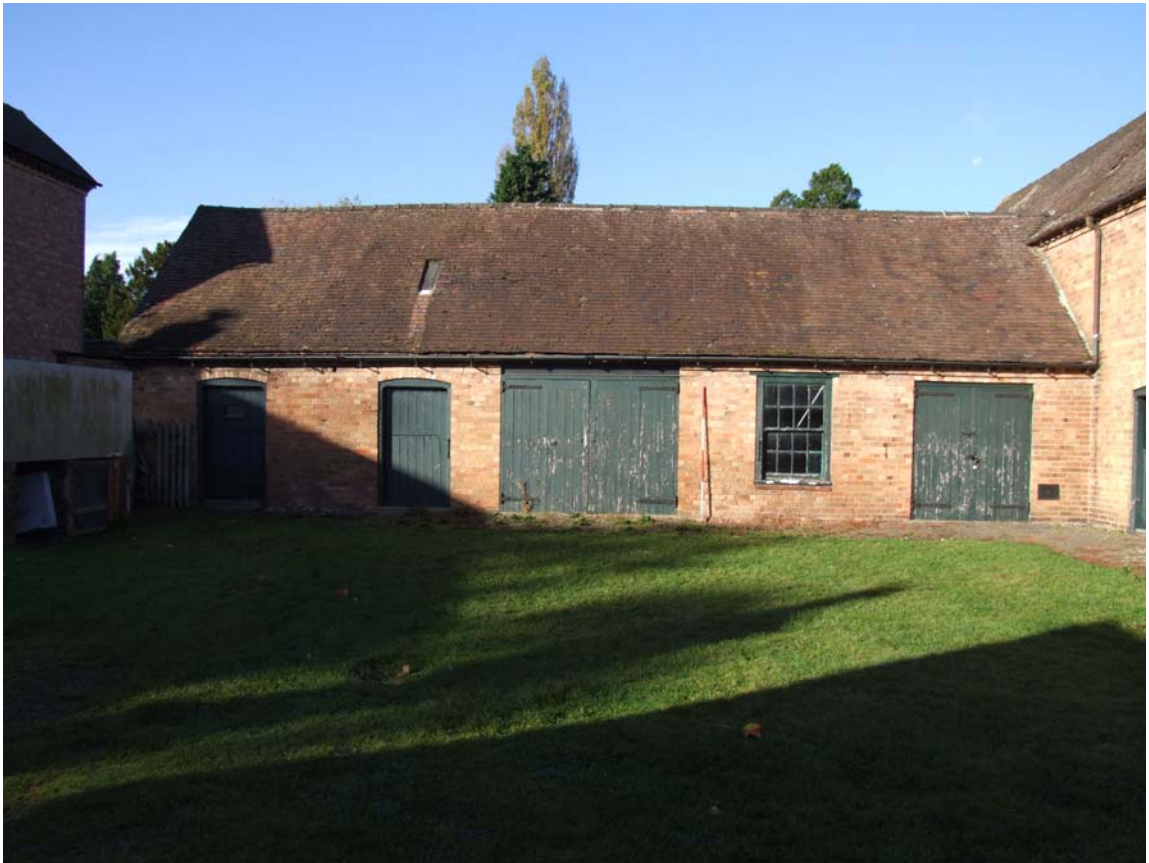
Plate 15: The central range looking west

bond in its walling, though the access door is identical to the original units from elsewhere at the site, with chamfered and stopped door frames and pegged joints. This suggests re-use of materials. Original use of this space is unknown, but as there is a loft over, it is a possibility that it was used as a stable, possibly for a riding horse. The lean-to element has a corrugated roof, with the roofline raised at a central bay, providing cover for a large cart or possibly the best trap (Plate 15).

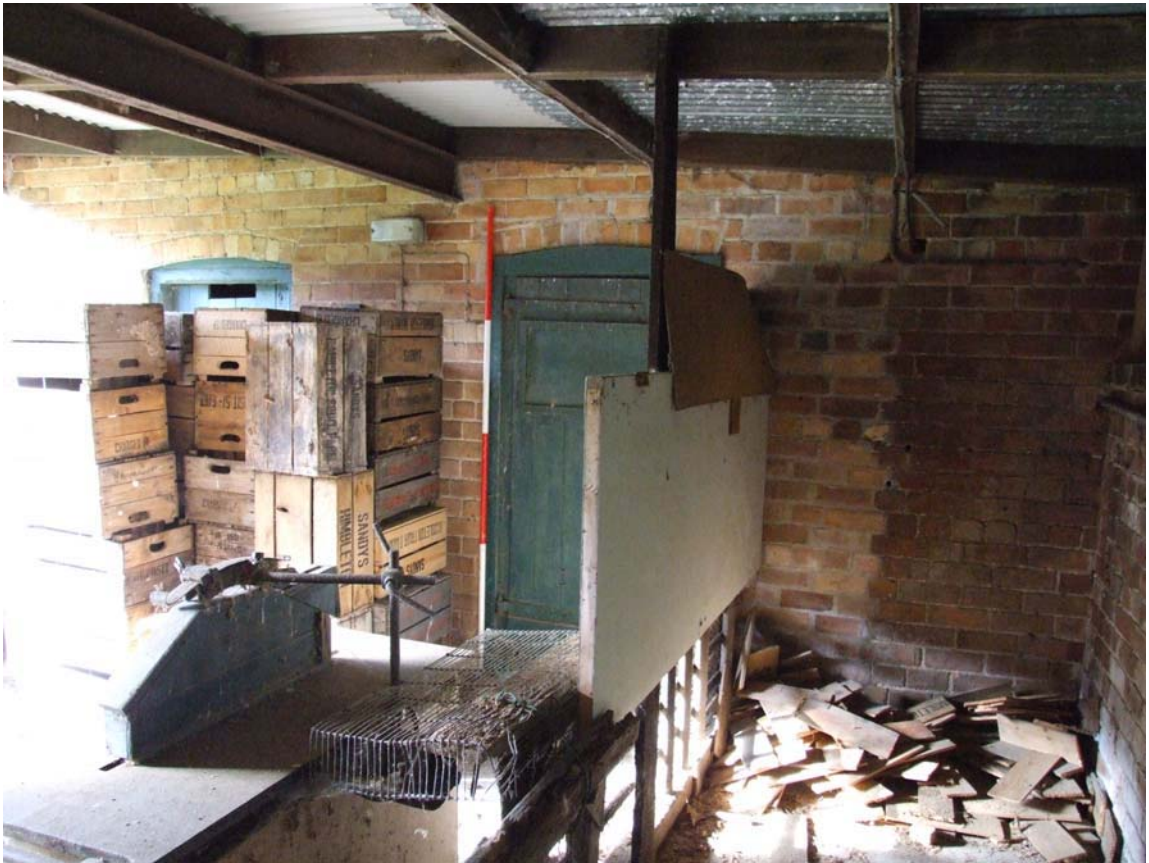
Plate 21: Stable block in the north-west corner of the complex, with later wall (right)

Some time after 1904, a small rectangular building was constructed abutting the northern end of the piggery (Plate 21). This appears to have formed a pair of stables, though the area is smaller than would be expected, perhaps suggesting they were intended for ponies or foals; the spaces now have limited access and are used as a generator house. An 'owl hole' in the southern gable indicates that there was originally a hayloft above; owls were encouraged to assist in keeping down rodent levels.

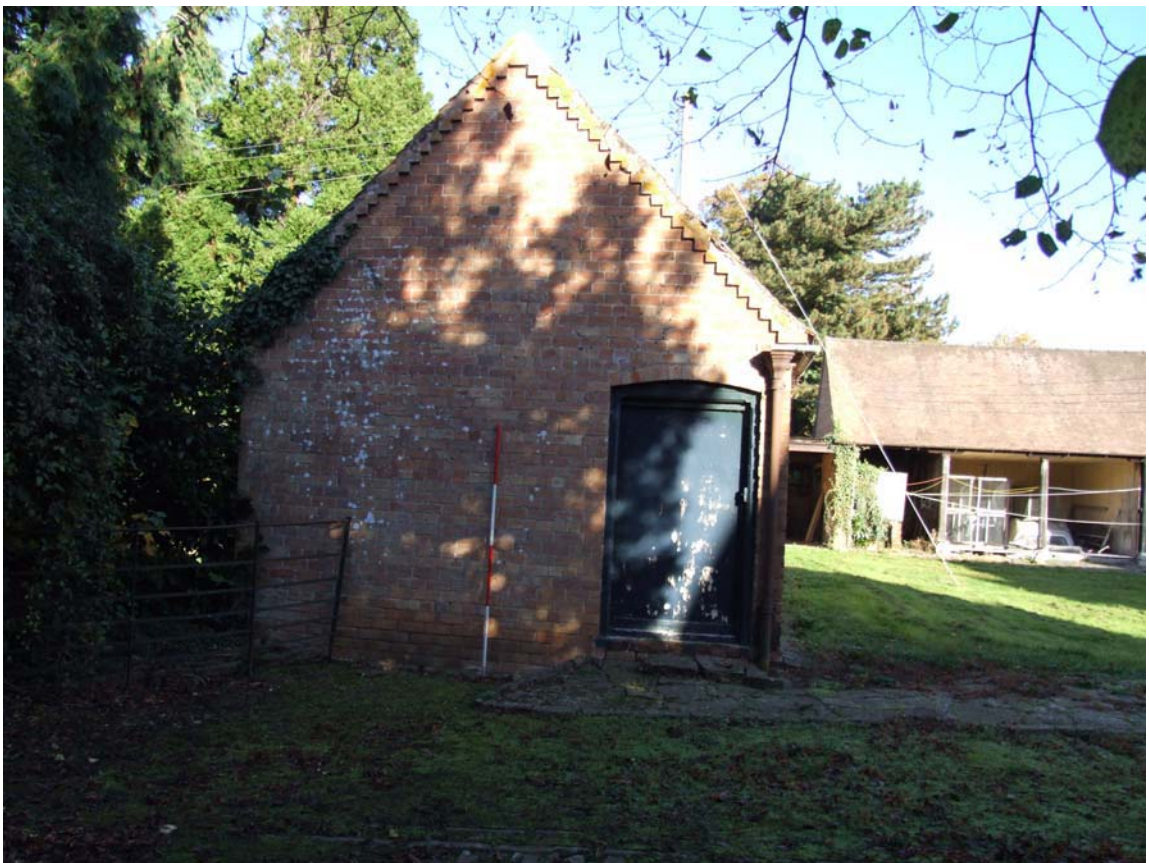
Plate 22: Feed processing block at the southern end of the western range

A further block at the southern end completes the western range. This was constructed in similar style and materials as the remainder of the original fabric of the site and housed a pair of separate rooms, probably for the production and storage of foodstuffs for the animals. There is a hearth in the inner space (northernmost) below the remains of a chimney; this was probably used for boiling pigswill and providing heat for other animal feed processing functions (Plate 22).

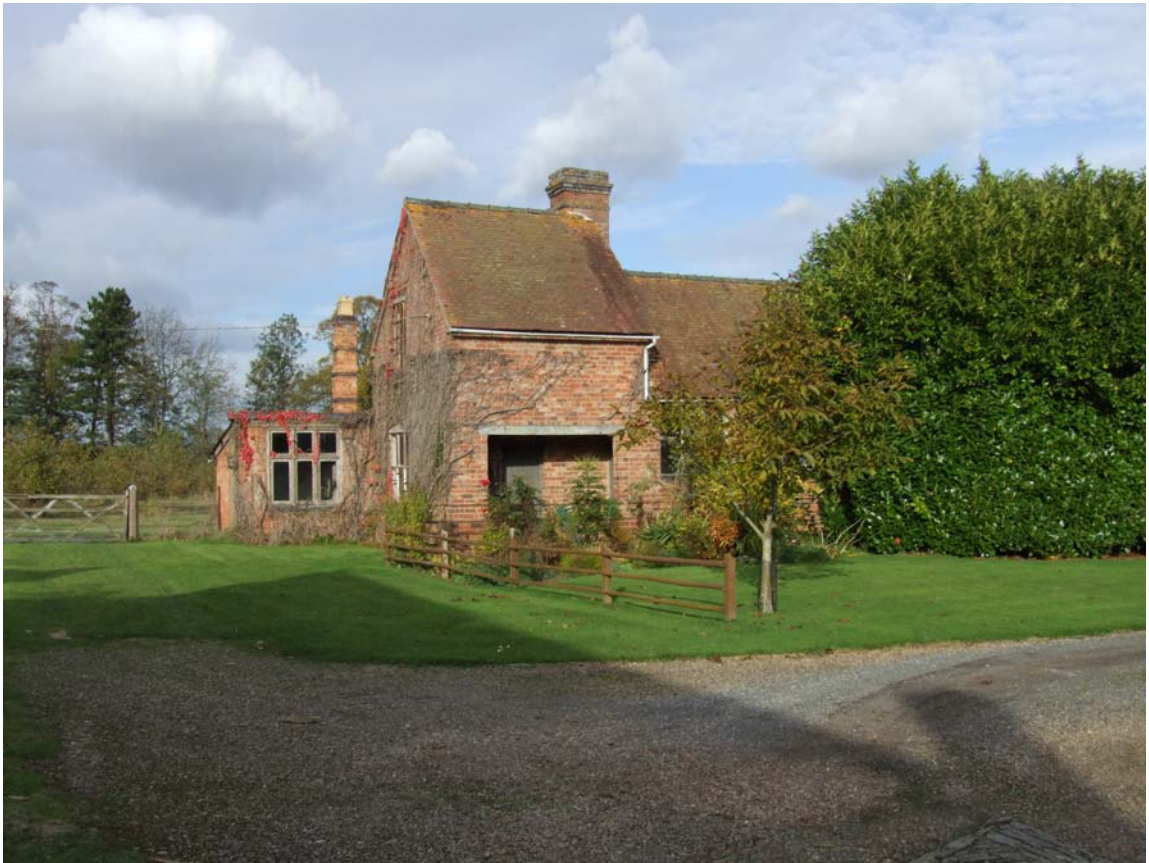
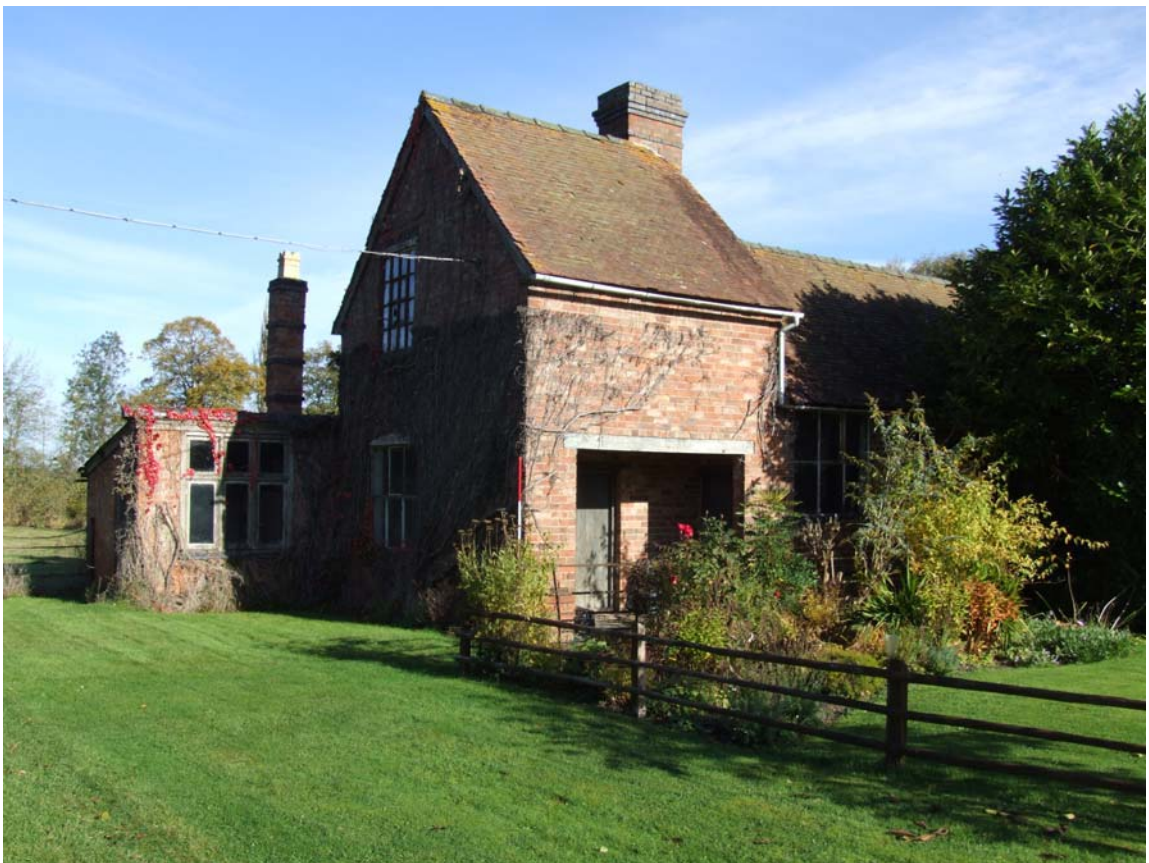
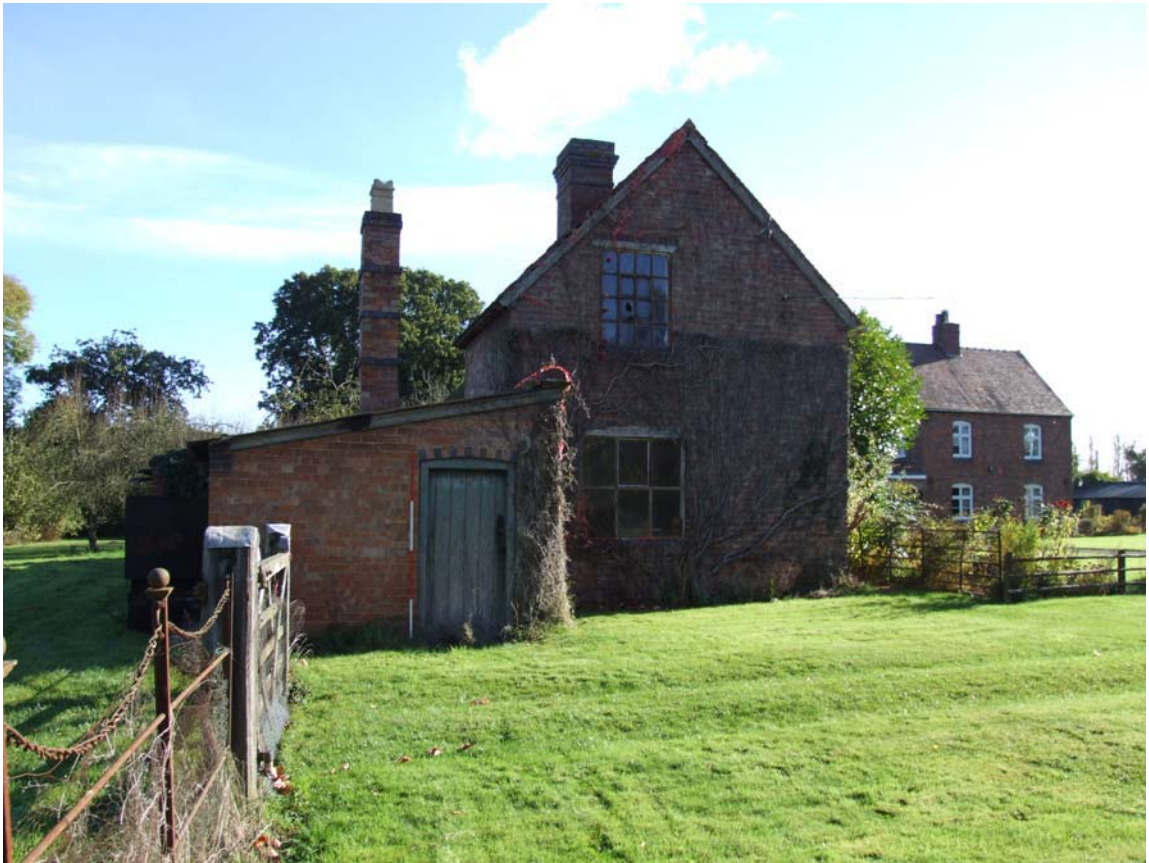
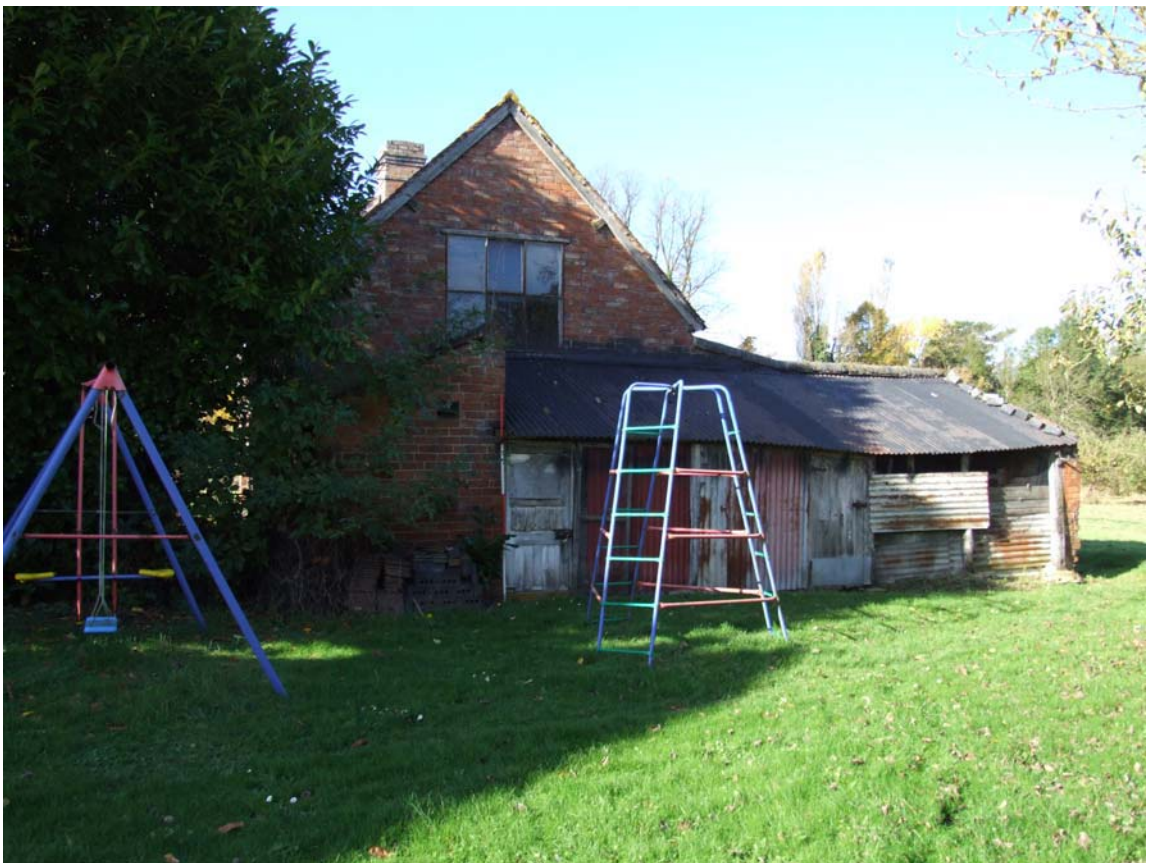
The Jubilee Rooms, or 'Assembly Rooms', is a separate building on the north-eastern side of the site (Plates 23 to 26). It first appears on the Ordnance Survey map of 1904 and according to the present gardener at Himbleton Manor, it was built for Queen Victoria's jubilee, though it is not known if this was the 1887 Golden Jubilee, or the 1897 Diamond Jubilee. The rooms were subsequently used as an assembly hall for the villagers of Himbleton.

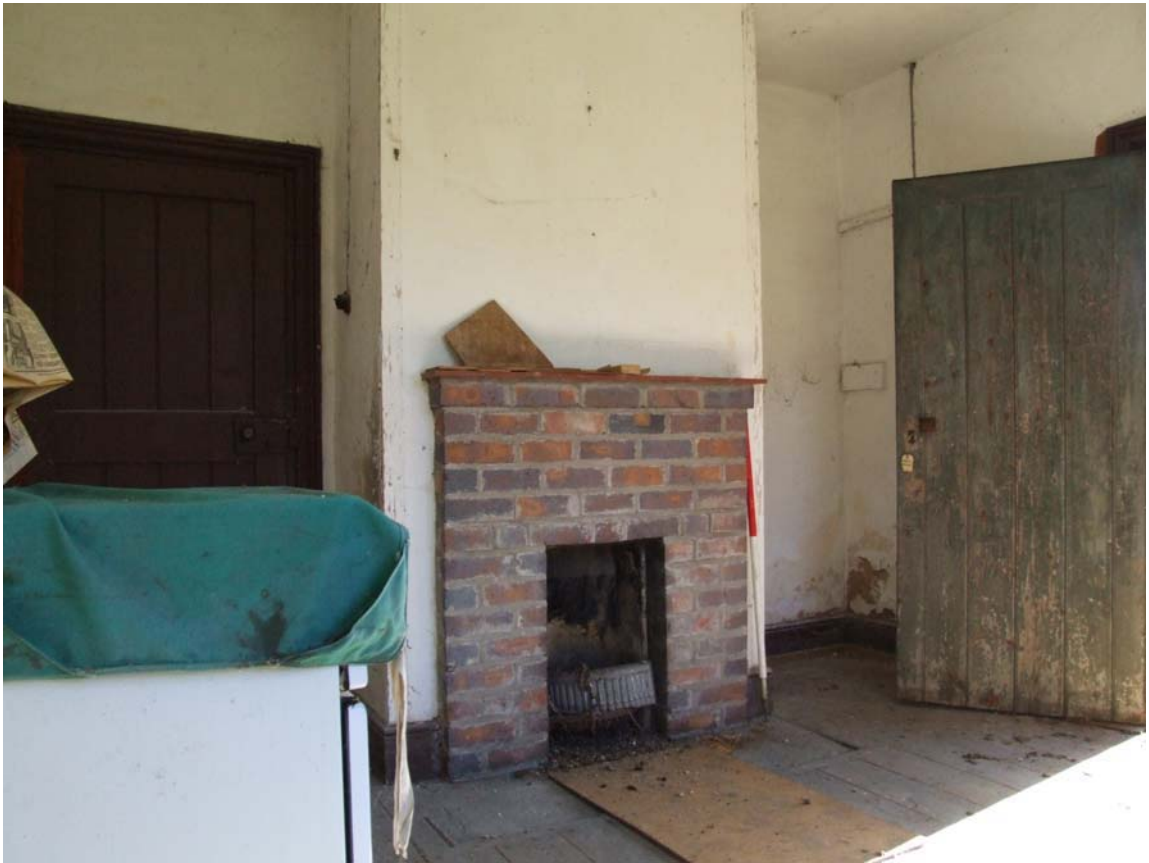
Plate 29: Jubilee Rooms kitchen area

The kitchen and bedroom block is a taller build than the assembly room, but part of the same structure and contemporary. A lobby encloses stairs to the bedroom and the main entrance to the assembly room. A 16 light cast-iron window lights the bedroom with a central opening vent, the hearth has long since been bricked up. The room still houses a single cast-iron bed (Plate 28). The kitchen below retains its hearth and original 6-light iron window (Plate 29).

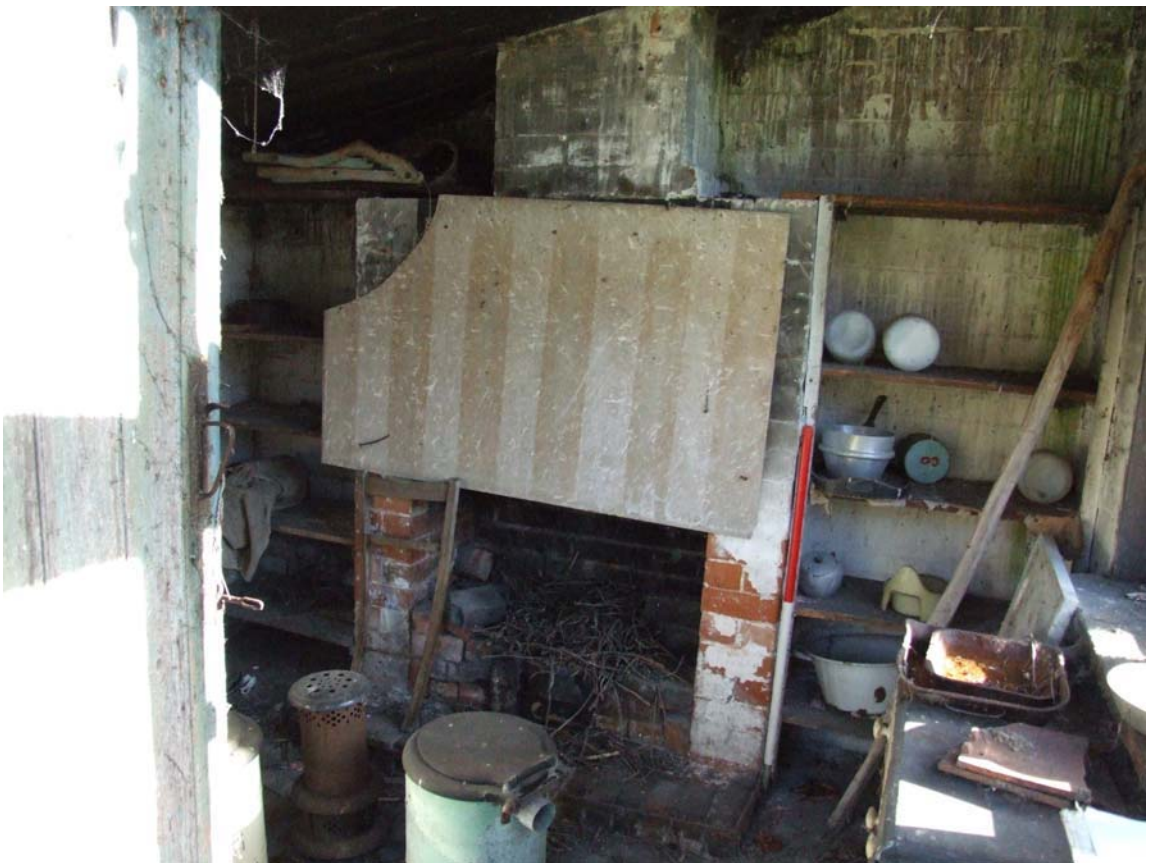
Plate 30: Jubilee Rooms annexe

The square building at the north-western corner still retains its hearth, though the grate has been removed. The single cell unit is lit by a 6-light window unit (Plate 30). The room has lately been used as a store, but traditionally it may have been used as a day room for the head gardener, though there is no definitive evidence for its purpose.
